Engineering Reconnaissance of the 24 August 2016 Central Italy Earthquake. Version 2

Geotechnical Extreme Events Reconnaissance Association

Report No. GEER-050B

22 November 2016

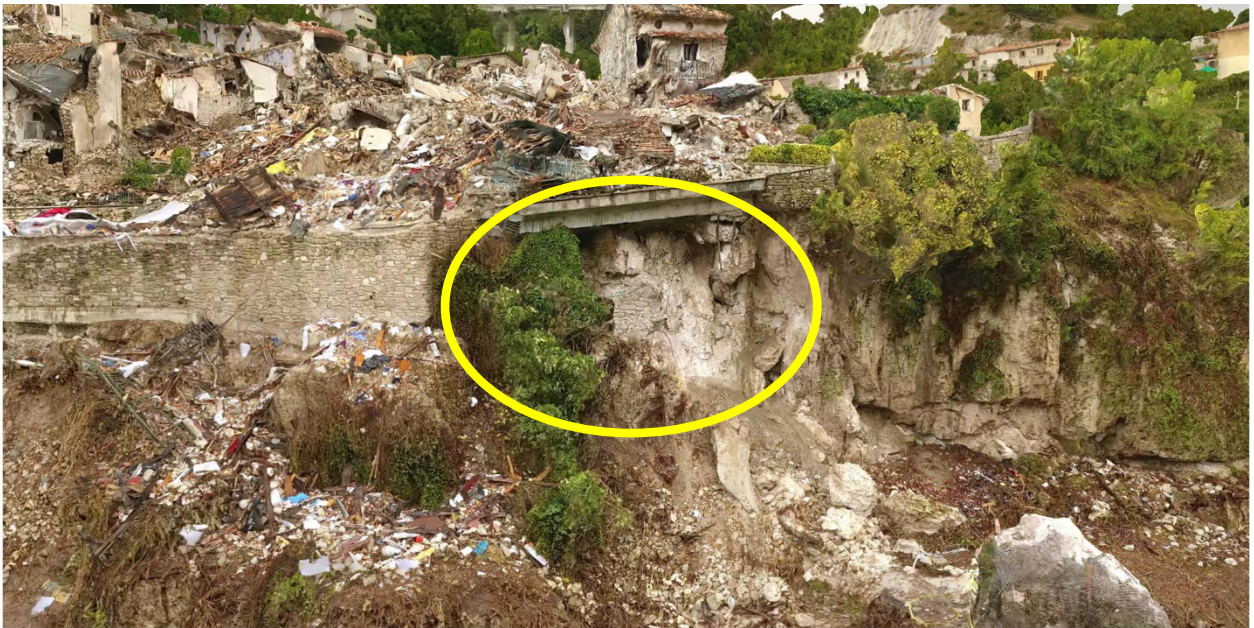
Figure 4.26. 3D model image of retaining wall damage from landslide below Pescara del Tronto (42.75057 N 13.27223 E).

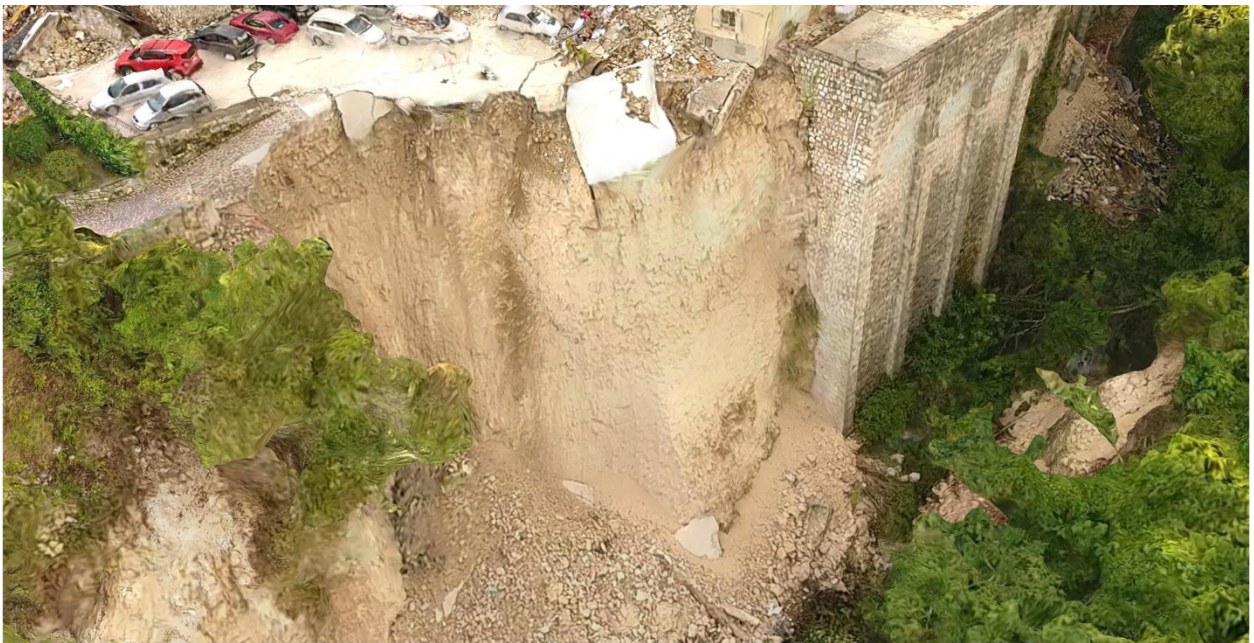
Figure 4.31. Model image of slope failure and possible retaining wall collapse (42.75109 N 13.27208 E).

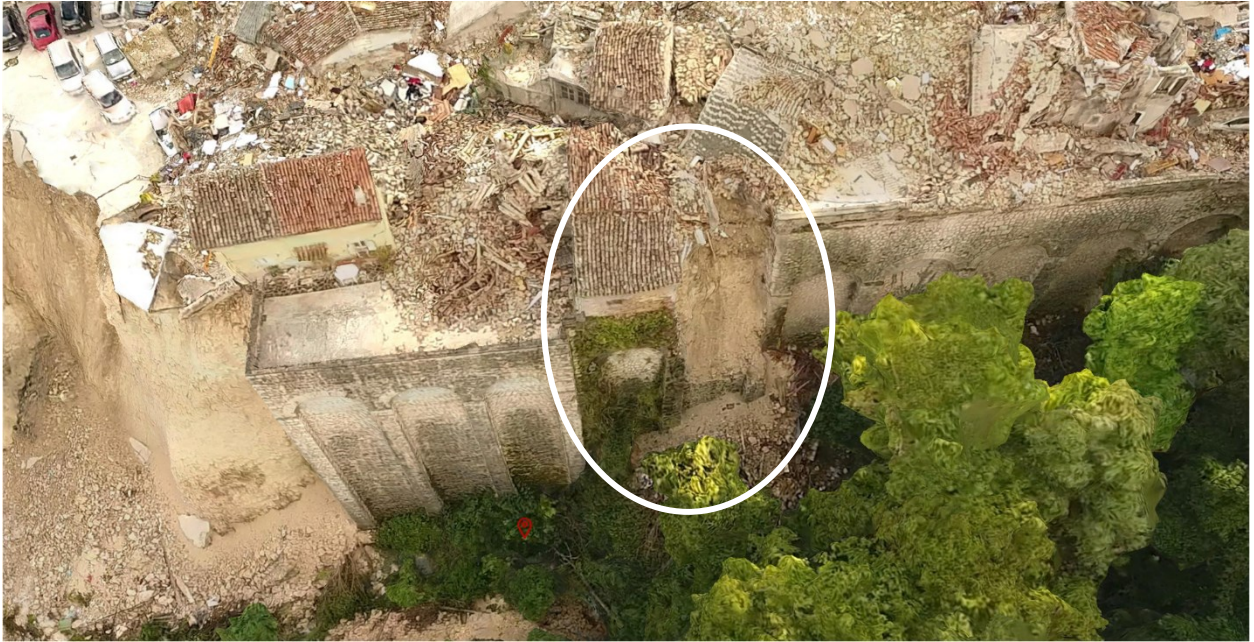
Figure 4.32. Model image of a smaller retaining wall failure and subsequent landslide in Pescara del Tronto (42.75136 N 13.27194 E).

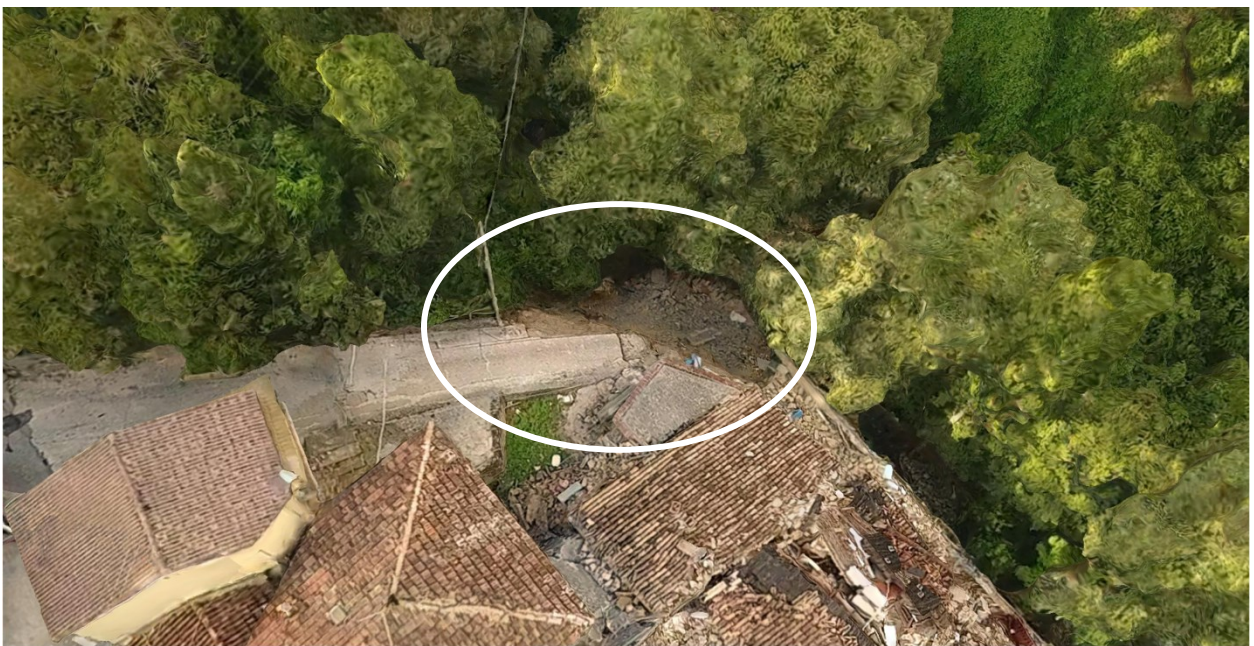
Figure 4.33. Model image of a landslide following a corner retaining wall failure in Pescara del Tronto (42.75166 N 13.27111 E).

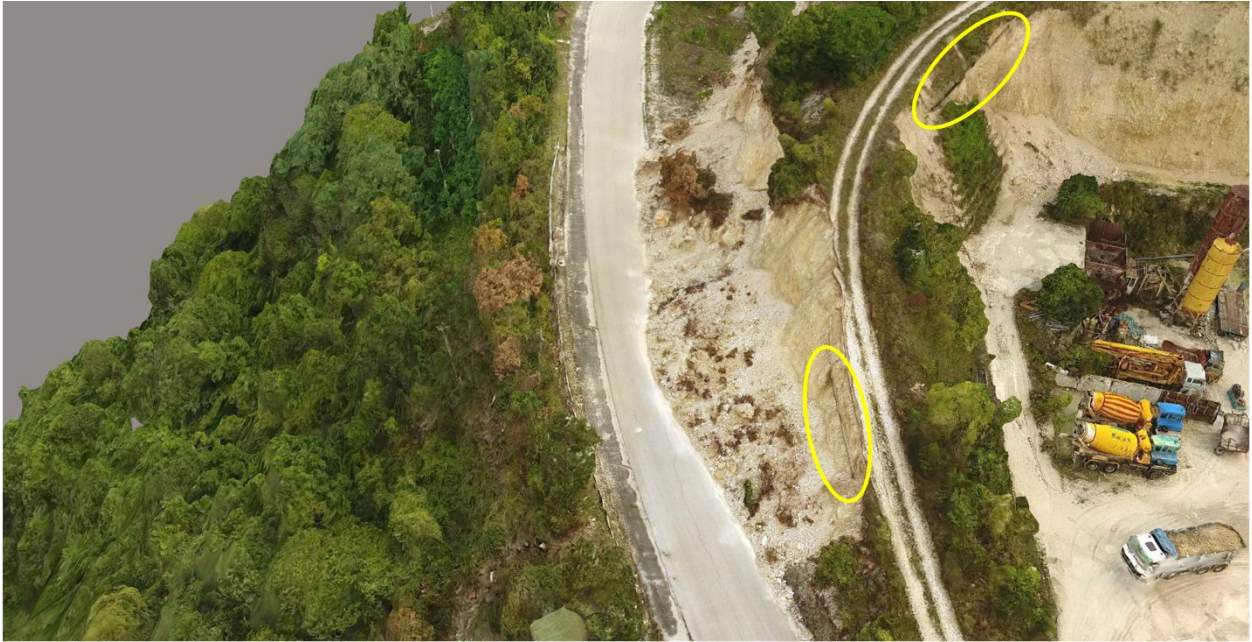
Figure 4.39. Landslides along dirt haul road in Pescara del Tronto, with exposed pipelines. The earthquake caused up portions of the slope up to 5 meters wide to fail, including portions of the dirt haul road itself.

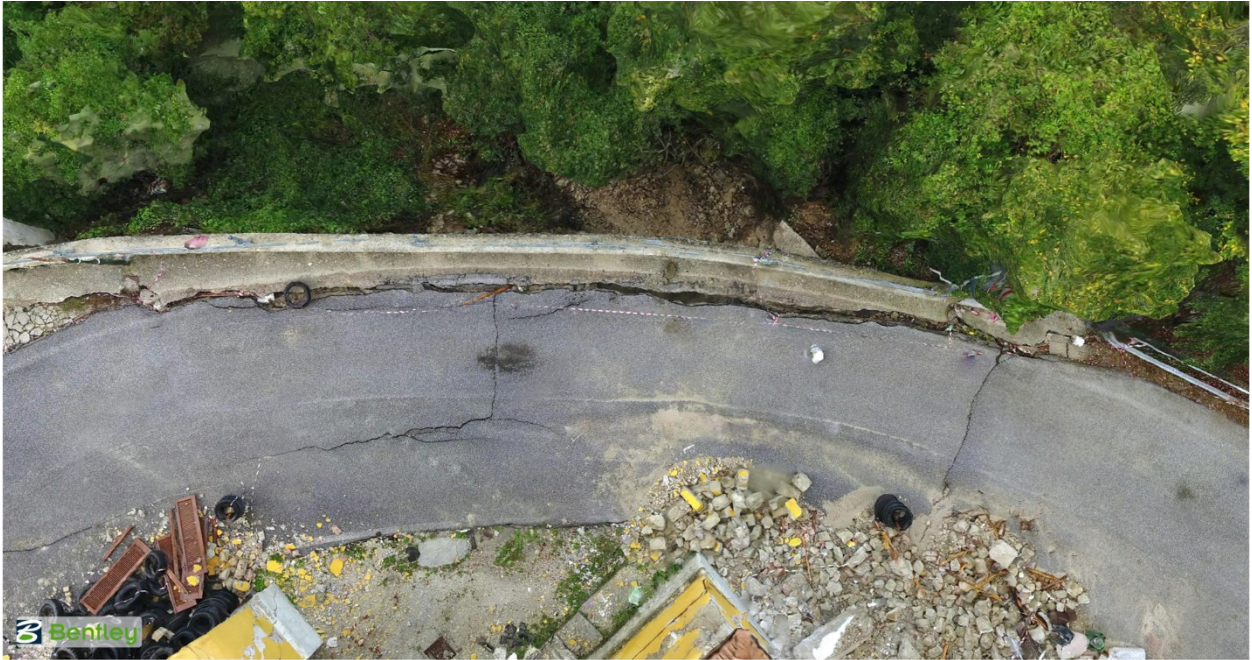
Figure 4.44. Rotated retaining wall below the road Frazione Fonte del Campo and subsequent cracks up to 25 cm in width (42.69438 N 13.24995 E).

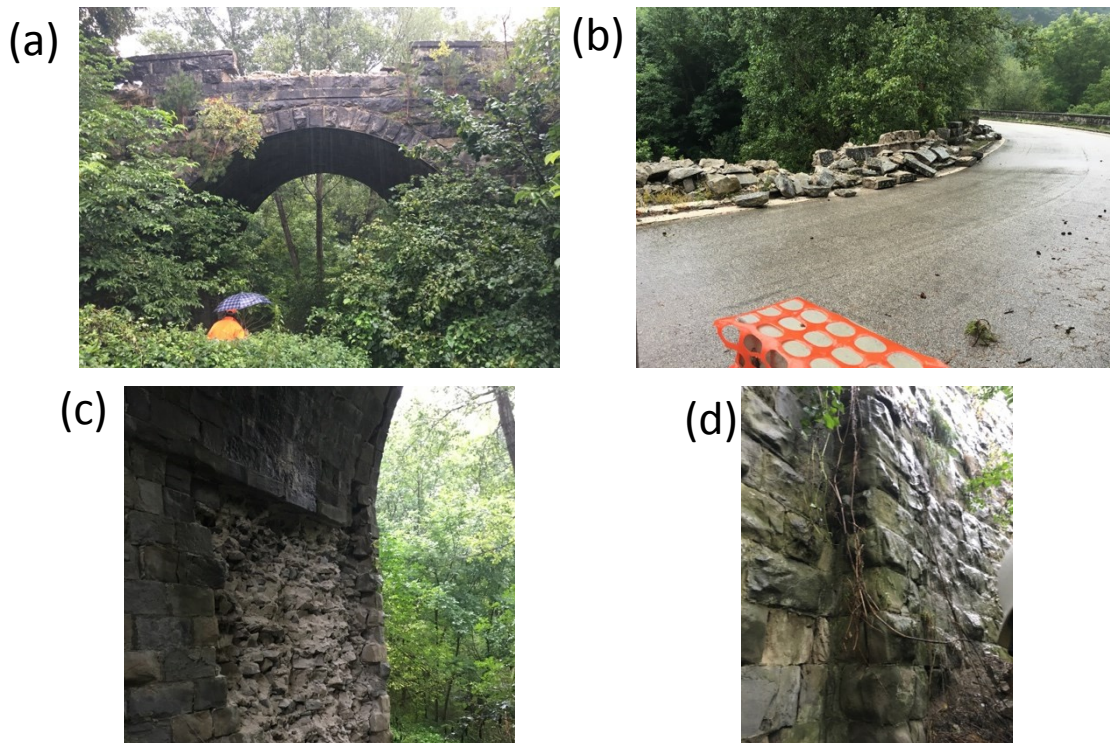
Figure 6.8. Central arch of the three arches masonry bridge along the Trisugo route (42.73538 deg, 13.253655 deg): partial collapse of the railing (a, b) spalling (c) and cracking (d) of some masonry elements.
