FAILURE OF TAPO CANYON TAILINGS DAM

By Leslie F. Harder Jr.,¹ Member, ASCE, and
Jonathan P. Stewart,² Student Member, ASCE

ABSTRACT: The failure of the Tapo Canyon tailings dam was one of the most striking failures of an earth structure to result from the January 17, 1994 Northridge, California earthquake. The failure involved a 60-m-wide breach of a tailings dam with a maximum height of 24 m, and 60 and 90 m downstream displacements of two sections of the dam. The failure resulted from liquefaction of the impounded tailings and possibly of the embankment materials. A significant volume of liquefied tailings passed through the breach in flows which extended hundreds of meters downstream within a natural drainage channel. The tailings dam failure, which occurred in a largely undeveloped area, caused no deaths or injuries, but did result in considerable economic losses for the owners of the tailings dam and a downstream water-treatment facility affected by the tailings flow slide. In this paper the writers will outline the construction history and geologic conditions at the site, and describe the strong influence of these factors on the characteristics of the embankment failure.

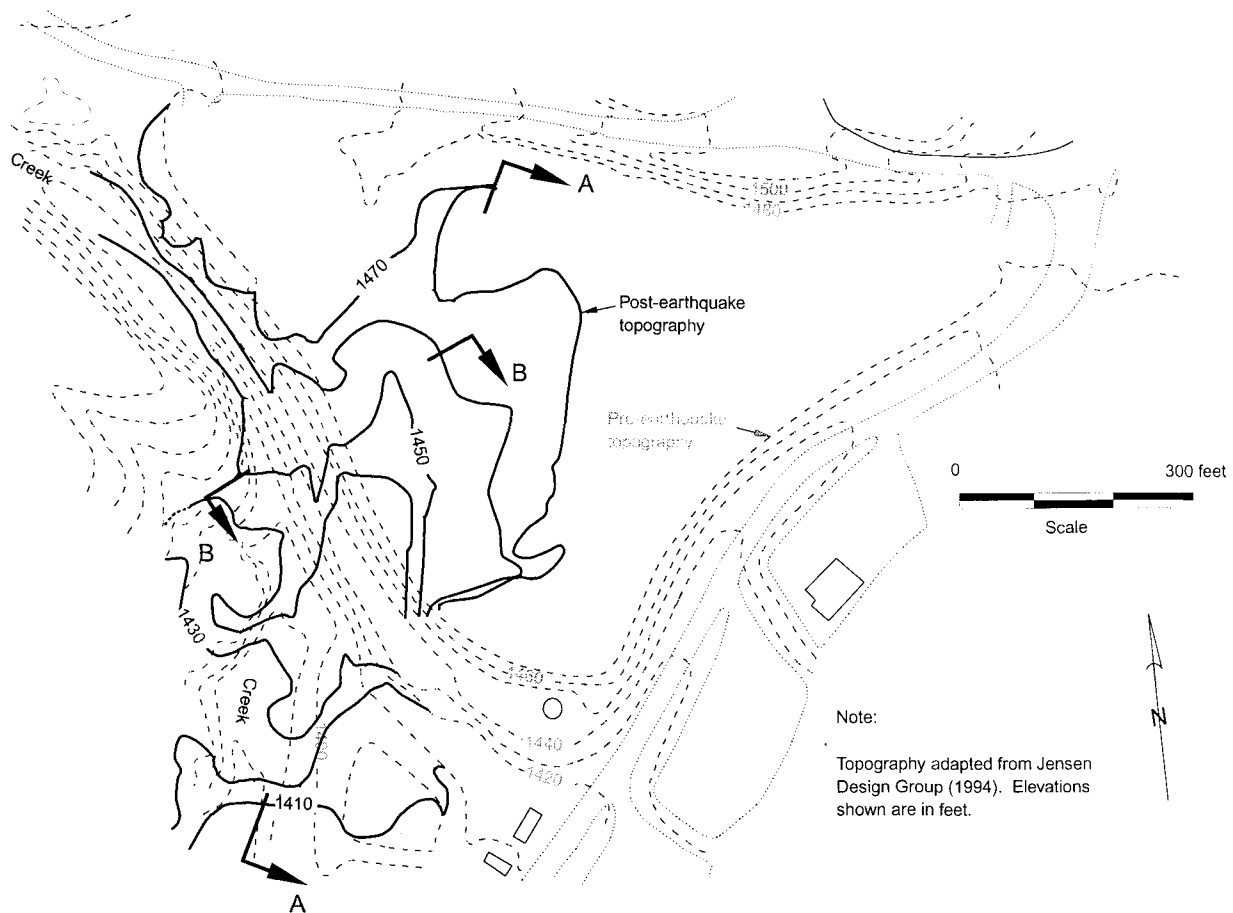
FIG. 4. Topography of Tapo Canyon Pond No. 6 Prior to and Following Northridge Earthquake

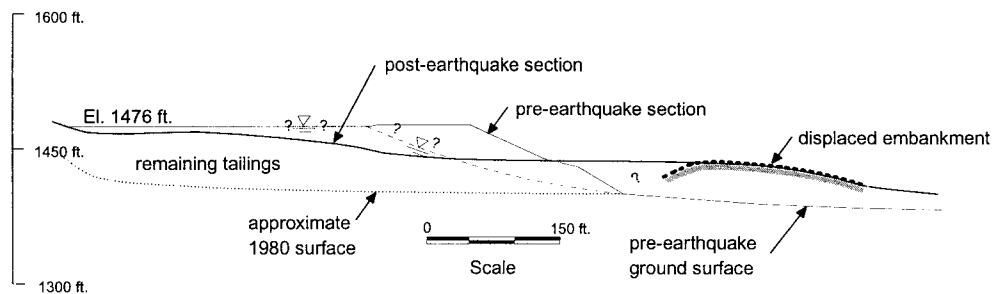
FIG. 5. Section A-A from Fig. 4 Showing Failed Tailings Dam and Resulting Flow Slide

left from mining of the original hill. This is the location of the highest fill and is the only place where the pond was apparently being retained by the later-stage retention embankments alone. Fig. 5 presents a section through this portion of the facility showing the 1980 section and the pre- and postearthquake sections.

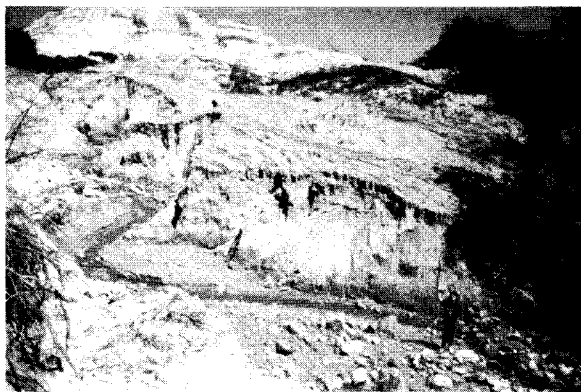
FIG. 6. Edge of Lobe of Viscous Tailings Flow Near Creek, Photograph Taken 180 m Downstream of Failed Pond, Looking North

Some of the retained tailings flowed out of the breach in a viscous flow which travelled over 180 m downstream, as shown in Fig. 6. Within the pond, the surface of the remaining tailings sloped down concentrically towards the breach in a manner similar to a viscous fluid passing through a funnel (Fig. 7). The surface layer of waste concrete on the eastern pond surface broke up into large blocks and spread apart, as shown in Figs. 7 and 8.

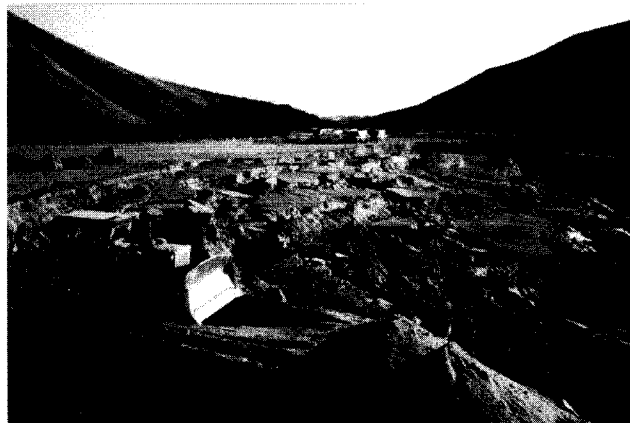
FIG. 8. Photograph of Displaced Concrete Blocks on Surface of Tailings (Note: Trucks in Background for Scale)

One of the more notable features of the flow slide was the fact that some of the blocks of concrete waste on the eastern surface of the pond underwent significant displacements on relatively mildly sloping tailings surfaces. These blocks, typically 1.2–1.8 m thick and weighing hundreds of tons, were found to have moved directly across the tailings surface as the surface sloped down toward the breach. Fig. 8 shows a portion of the broken concrete surface and the displacements between blocks. Track marks left in the surface of the tailings could be found behind the displaced blocks. Figs. 11 and 12 show a pair of blocks which slid over 26 m across the sloping tailings surface following the breach of the tailings dam. Each block is approximately 7.5 m across and weighs about 200 t. The surface across which the blocks travelled has a slope of approximately 12.5° from the horizontal. The blocks' lateral movements were apparently halted by either reaching the bottom of the slope, as in the case with the pair in Figs. 11 and 12, or by buildup of tailings material ahead of the block (note waves of pushed-up material in Fig. 8).

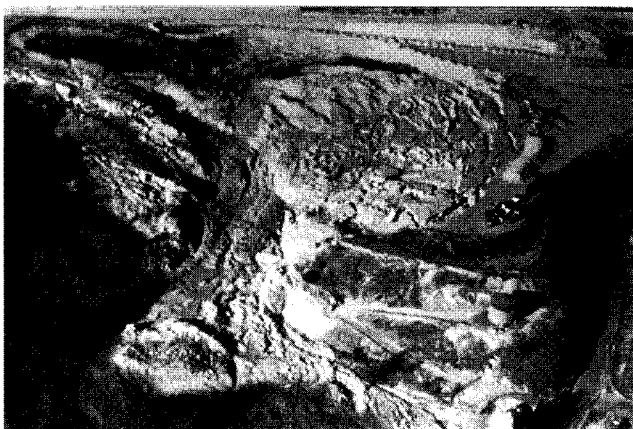
FIG. 7. Aerial View of Tailings Dam Failure (Photo Courtesy of Yoshi Moriwaki, Woodward-Clyde Consultants)

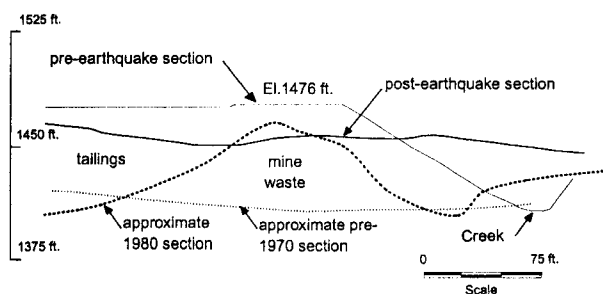
FIG. 9. Section B-B from Fig. 4, Showing Failed Embankment Section Northwest of Breach

In addition to the main dam failure, the remaining portion of the southwestern dam was extensively damaged. Portions of the embankment on this side settled as much as 3 m and spread laterally in both the upstream and downstream directions, as shown in Figs. 9 and 10. The large displacements resulted in extensive cracking, with crack openings and vertical offsets exceeding 1 m at many locations. Portions of the buttress and riprap added in 1987 ended up on the opposite (western) side of the creek from where they had been constructed, temporarily damming the creek. The nature of the observed lateral spreading in this area (i.e., the lack of a complete flow failure; see Fig. 9) is probably due in part to the presence of the old mine waste piles and possible rock ridges beneath the dam. The embankment displacements in this area were also likely limited by the presence of the opposite (western) creek bank against which the debris came to rest.

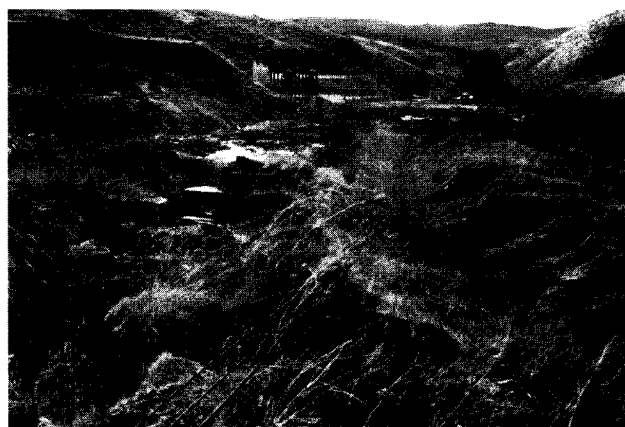
FIG. 10. View along Axis of Failed Southwest Embankment, Looking Southeast

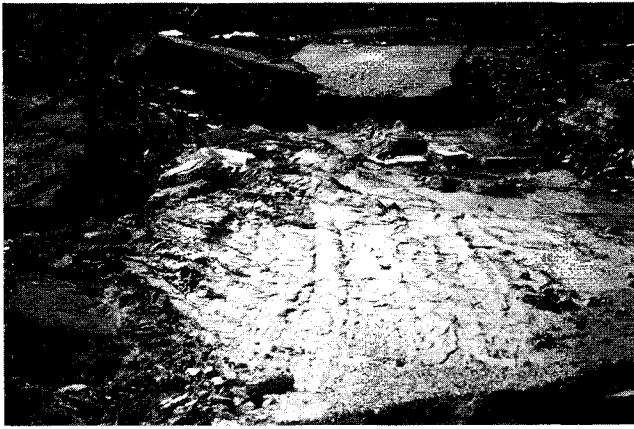
FIG. 11. Pair of Concrete Blocks Which Traveled 26 m across Tailings Surface

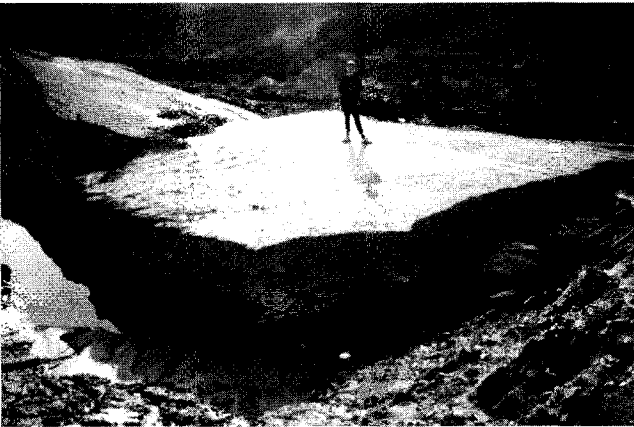
FIG. 12. Close-up Photograph of 200-t Concrete Block Which Traveled across Tailings Surface
