MPL participation in SEALAB II

**MPL PARTICIPATION IN SEALAB II**

SIO REFERENCE 66-3

1 FEBRUARY 1966

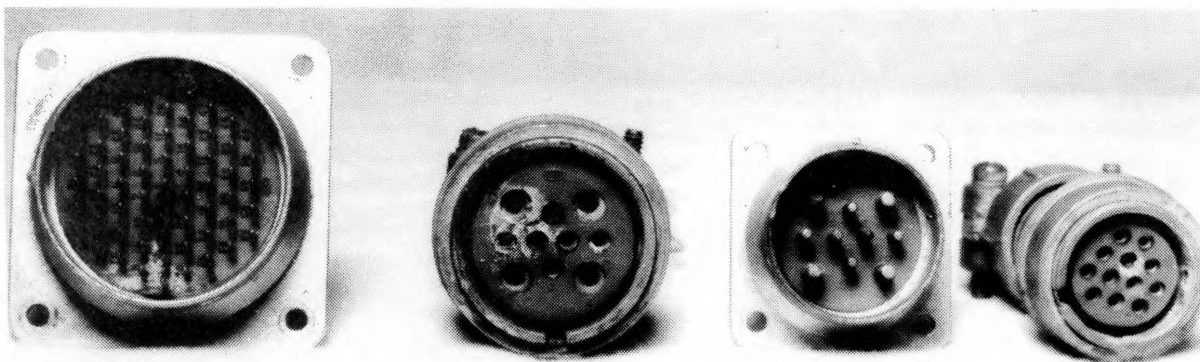
Figure 14. Connector corrosion and contamination

As mentioned previously, the majority of the malfunctions associated with the *SEALAB* project were attributed to connector failure associated with these sea cables. Figures 14, 15, and 16 show various degrees of corrosion and contamination which was observed on these connectors after recovery. In most cases, specific troubles can be traced to a particular connector-pin combination where the corrosion is severe. The cause of this corrosion is unknown; however, three hypotheses are offered:

- (1) Direct contact with sea water sometime during the handling process.
- (2) Pin-to-pin arcing or electrolysis while the connectors were still in the alcohol fluid.
- (3) High ambient humidity and possible salt water splash in the environment near the *SEALAB* trunk.

In considering the above items it is interesting to note that: (1) Corrosion was also evident on the *SEALAB* rack-mounted connectors (see Figure 8b), and (2) the single connector associated with the communications cable, which is terminated only by floating transformer windings, showed no signs of deterioration.

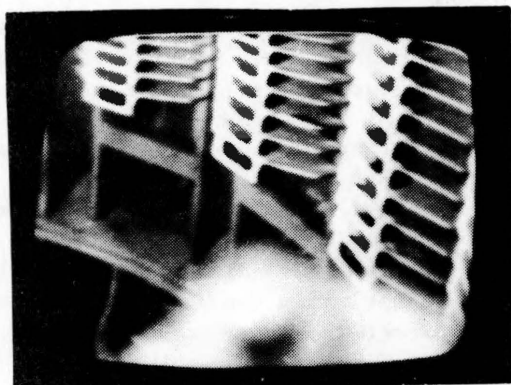
Figure 26. Location of faulty card  
(bottom of Module 3)

showed that the anomalous voltage readings still existed on channels 7 and 8. Following this test, SEALAB was requested to disconnect the plug at the rear of the electronics rack so as to permit measurements to be made on the cable itself. At this point the operations were interrupted by preparation for a dive by the aquanaut assisting in the test, Art Flechsig.

While the cause of the trouble in the A to D link was not conclusively determined, there is a strong suggestion that a combination of electrical leakage in the connector in the SEALAB electronics rack in conjunction with electrical damage to the diode gate card were the cause of trouble and that the trouble was corrected by both the replacement of the card and by the removal of the plug from the chassis socket thereby giving it an opportunity to dry out and relieve the severity of the electrical leakage.

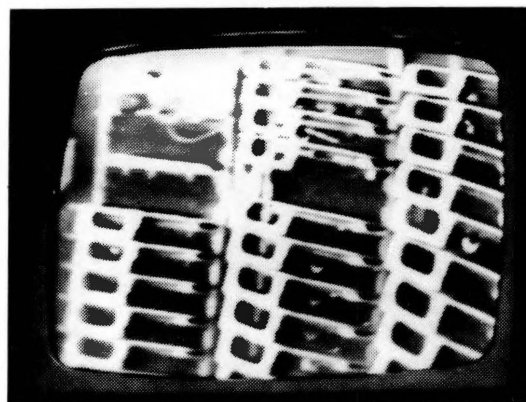
Figure 27. Slot from which spare diode matrix card was extracted

At this point the remaining task was to extract the spare card from its position in module 3, five slots down from the top (Figure 27), and insert it in the bottom slot in the same module from which the faulty card had been removed. Unfortunately the vantage point of the camera for the upper slot of module 3 was poor in that the fingers were hidden by the manipulator body. Accordingly in order to extract the card it was necessary to position the manipulator vertically with reference to the fifth card down in module 4 and time the traverse from corresponding points on modules 5 and 4 until a reproducible traverse could be made by timing. The traverse was then timed from the center of the card handle on module 4 to the supposed position of the card handle on module 5. At this point, the manipulator was extended until contact with the card handle was indicated by a slight shift in the position of the module, and the raise-lower function was jogged until the jaws engaged the slot. Next, the manipulator was extended to stall-out, following which it was relaxed slightly by again observing the motion of the module. With the jaw open solenoid actuated, the manipulator rotate function was jogged to center the

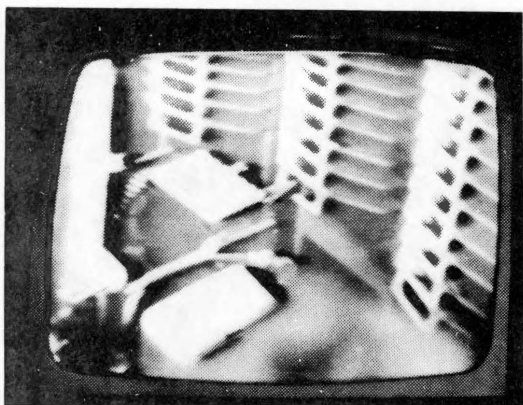
Considerable difficulty was experienced in replacing the card in the bottom slot. Visibility conditions were quite poor in that the lighting at the bottom of the module was inadequate for a sharp TV display (Figure 28) and the use of only one camera made it very difficult to estimate distances or orientation of the card at the bottom of the module. A number of tries were required before the card was finally engaged in the slot. Although an accurate measurement of time was not kept on this operation, insertion of the card

Figure 28. Manipulator in position to engage bottom card of Module 3

in this slot required about 20 minutes compared to the two or three minutes required for inserting the faulty card in the top slot of module 11 where visibility conditions were ideal (Figure 29). The card was successfully inserted and homed in place to full-pin contact by the manipulator and the A to D converter card reinstalled in the SEALAB rack. The data transmission link was then found to be operating satisfactorily.

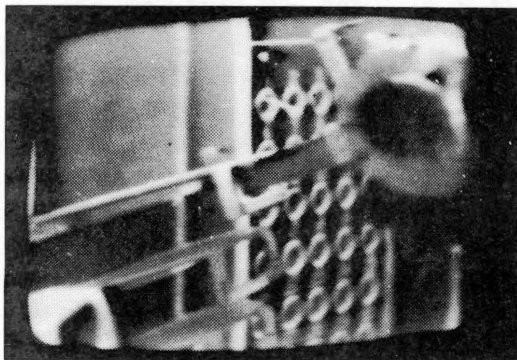
Figure 29. Manipulator in position to engage top card in Module 11
