Report of Trip to SR-86, District 11, Near Brawley, California: Work Conducted under Strategic Plan Task 4.14

Technical Memorandum TM-UCB-PRC-2005-1

February 15, 2005

Pavement Research Center
Institute of Transportation Studies
University of California Berkeley and University of California Davis

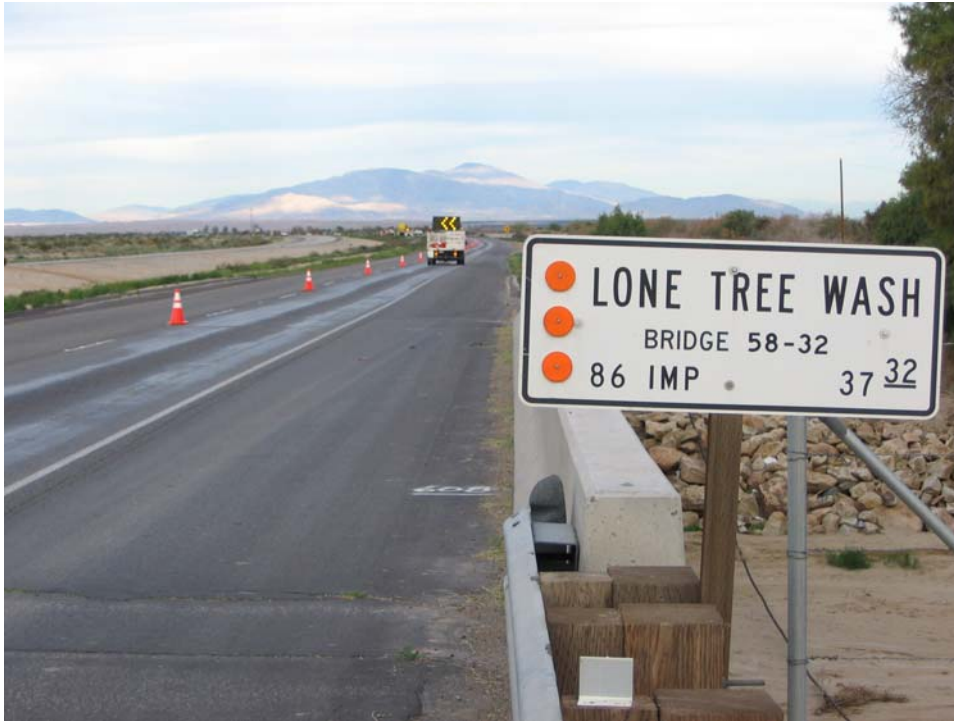
In short, flushing exists throughout the entire pavement section except for the 1-mile section south of the INS station. An OGAC layer was paved in this area because of braking and the extended duration of heavy loading near the INS inspection station. Figures 4-13 show that severe flushing starts at Station 606 (300 m ahead south of the beginning of construction according to the *Title and Location Map*) and lasts all the way until the OGAC section (1 mi. south of the INS station). Throughout the same section, wheelpath rutting ranges from 2 to 38 mm (measured during the first week of December 2004).

Figure 6. Station 608 (PM 37.3), facing north—flushing evident in #2 lane.

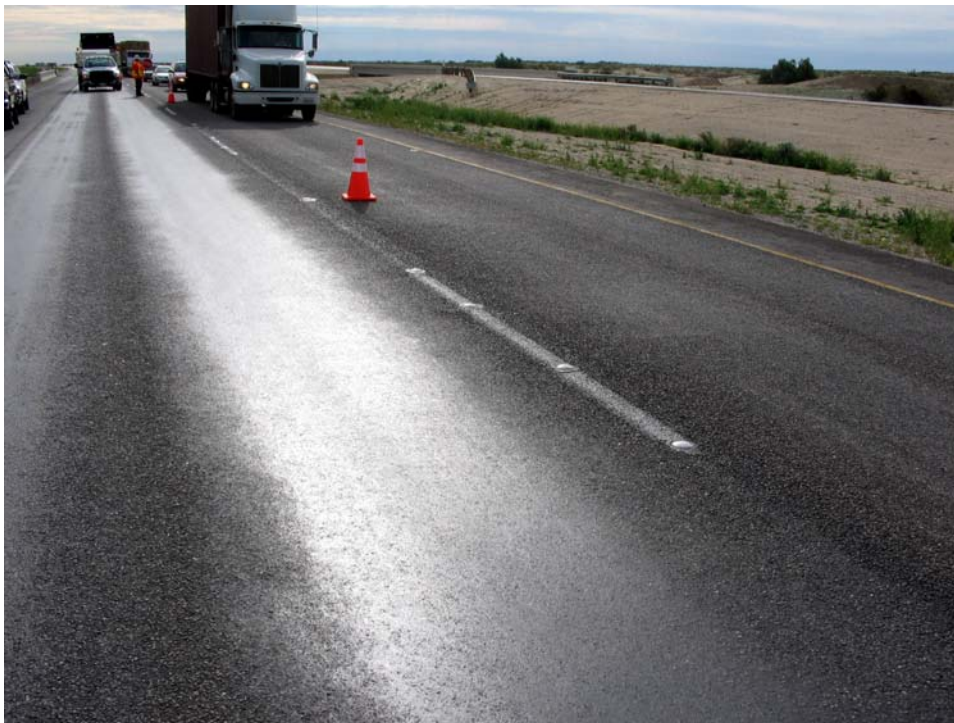
Figure 7. Station 610+40, facing south—flushing evident in #2 lane.

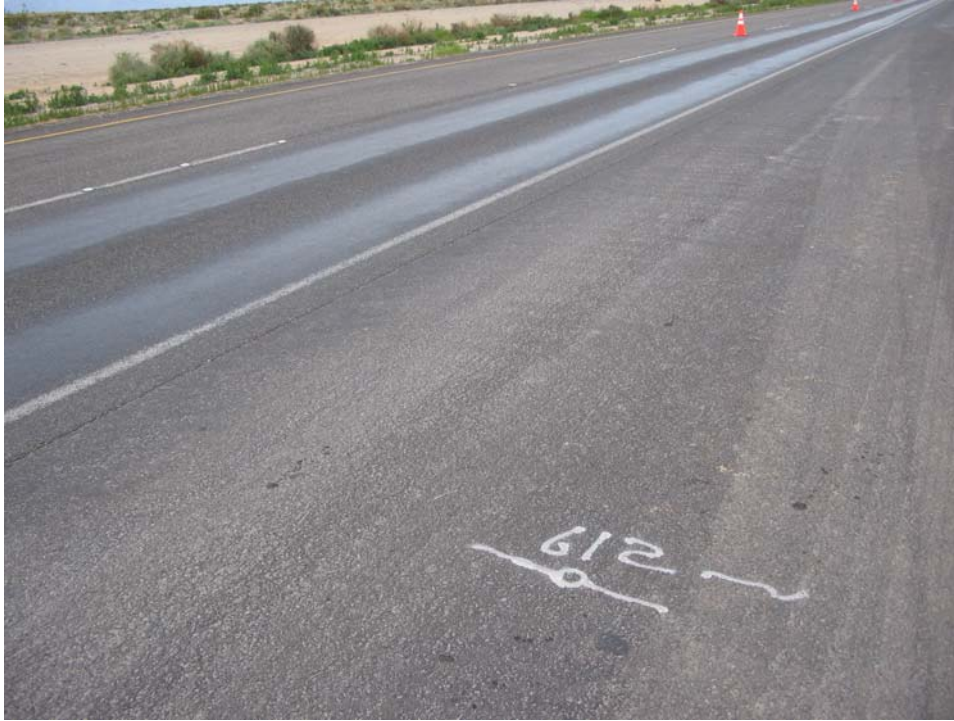
Figure 8. Station 612, facing north—flushing evident in #2 lane.

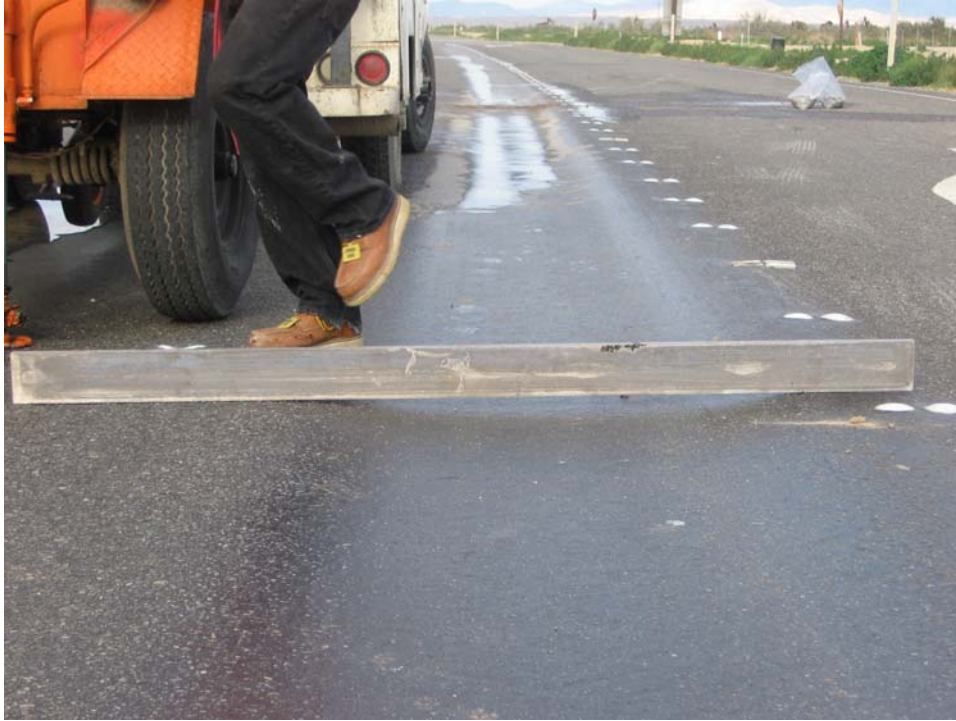
Figure 10. Station 616+21, facing north—note rutting and flushing.

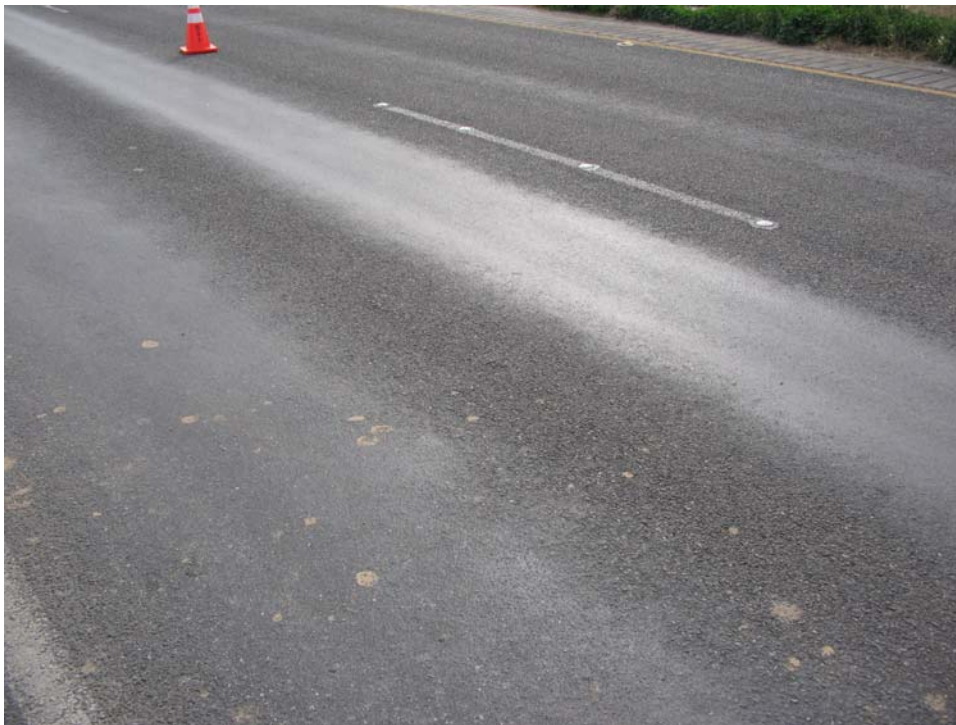
Figure 11. Station 617+60, facing south—clear evidence of flushing in #2 lane.

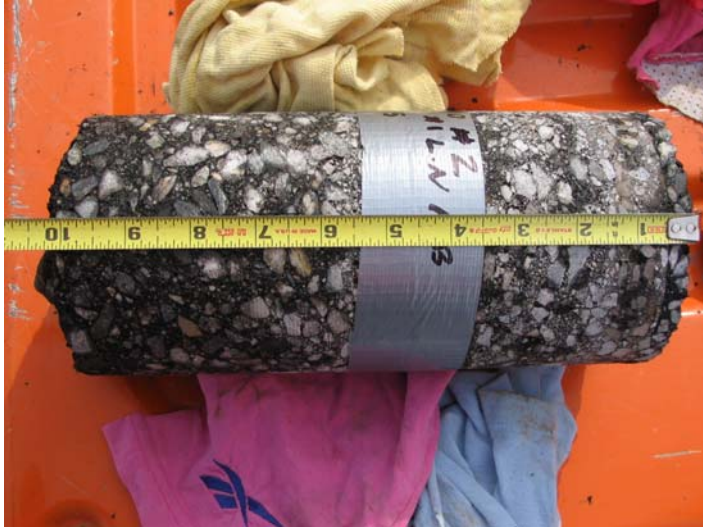
Core Location	610+40 No. 2	
Overall Core Thickness	258 mm	
Chip Seal Thickness	11 mm	
Rut Depth	Left Wheelpath	Right Wheelpath
	N/A	N/A

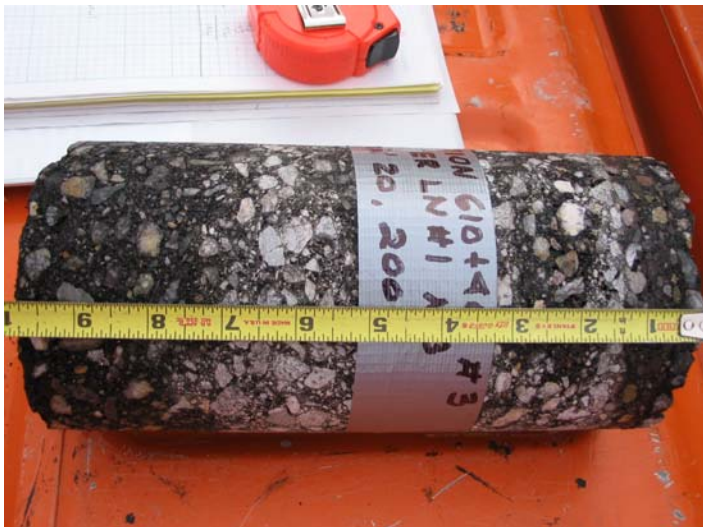
Core Location	610+40 No. 3	
Thickness (1st layer beneath chip seal only)	118 mm	
Chip Seal Thickness	10 mm	
Rut Depth	Left Wheelpath	Left Wheelpath
	N/A	N/A

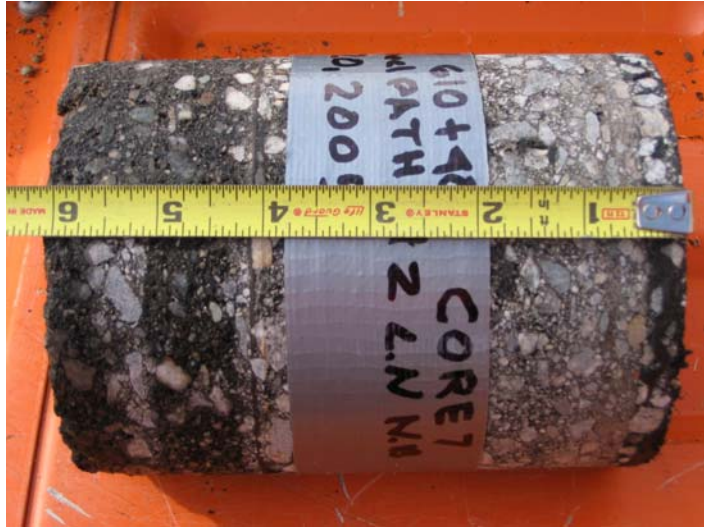
Core Location	610+40 No. 7	
Overall Core Thickness	157 mm	
Chip Seal Thickness	13 mm	
Rut Depth	Left Wheelpath	Right Wheelpath
	2 mm	2 mm

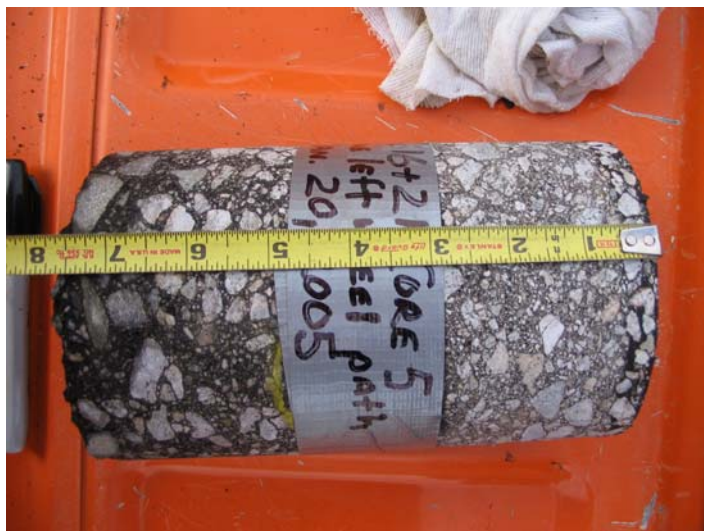
Core Location	Station 616+21, Location 5	
Overall Core Thickness	199 mm	
Chip Seal Thickness	14 mm	
Rut Depth	Left Wheelpath	Right Wheelpath
	23 mm	33 mm

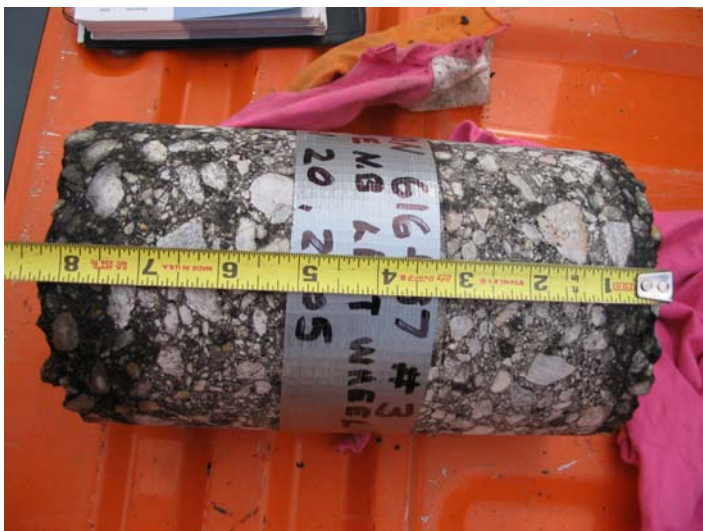
Core Location	Station 616+37, Location 3	
Overall Core Thickness	209 mm	
Chip Seal Thickness	11 mm	
Rut Depth	Left Wheelpath	Right Wheelpath
	N/A	N/A

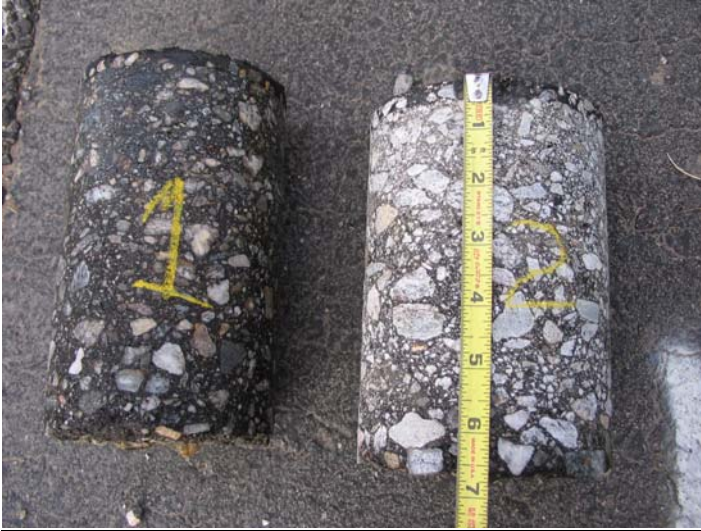
Core Location	Station 616+37, Location 4	
Overall Core Thickness	211 mm	
Chip Seal Thickness	13 mm	
Rut Depth	Left Wheelpath	Right Wheelpath
	18 mm	38 mm

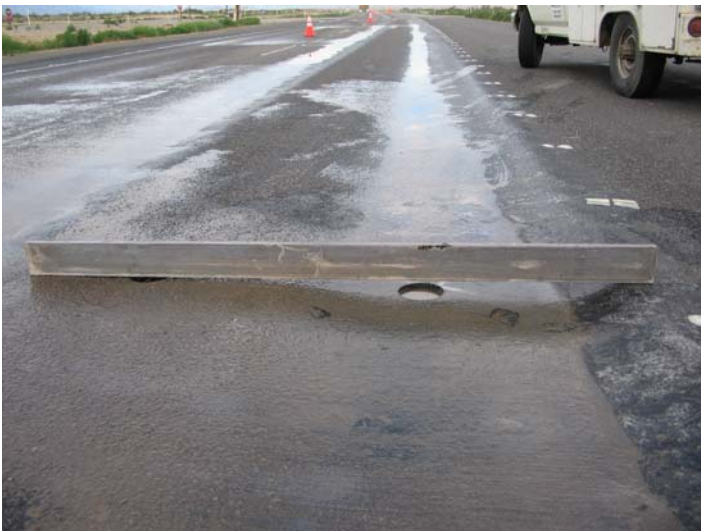
Core Location	Station 616+37, Location 5	
Overall Core Thickness	194 mm	
Chip Seal Thickness	12 mm	
Rut Depth	Left Wheelpath	Right Wheelpath
	18 mm	38 mm

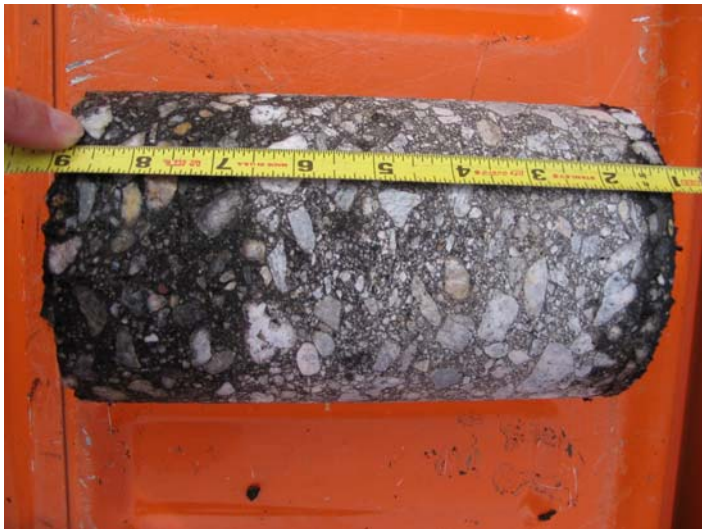
Core Location	Station 617+60, Location 5	
Overall Core Thickness	206 mm	
Chip Seal Thickness	12 mm	
Rut Depth	Left Wheelpath	Right Wheelpath
	6 mm	16 mm

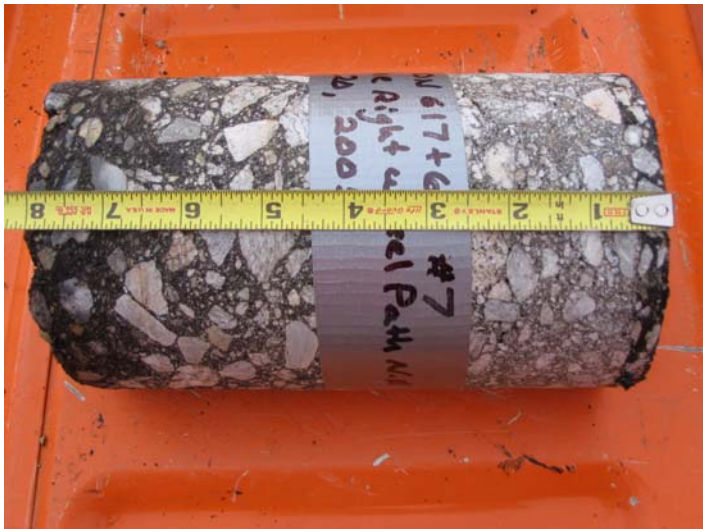
Core Location	Station 617+60, Location 7	
Overall Core Thickness	206 mm	
Chip Seal Thickness	11 mm	
Rut Depth	Left Wheelpath	Right Wheelpath
	6 mm	16 mm

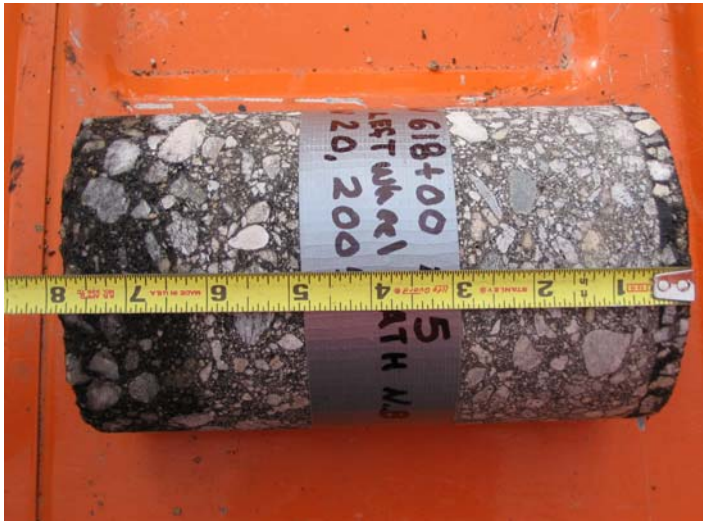
Core Location	Station 618+00, Location 5	
Overall Core Thickness	201 mm	
Chip Seal Thickness	10 mm	
Rut Depth	Left Wheelpath	Right Wheelpath
	11 mm	16 mm

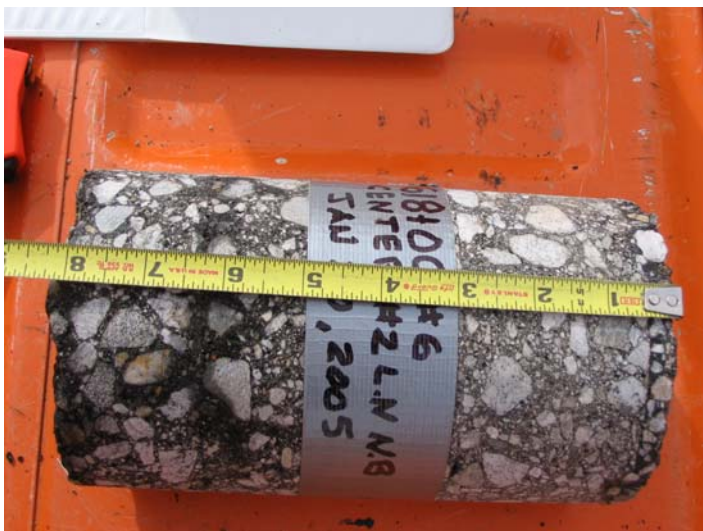
Core Location	Station 618+00, Location 6	
Overall Core Thickness	207 mm	
Chip Seal Thickness	10 mm	
Rut Depth	Left Wheelpath	Right Wheelpath
	11 mm	16 mm

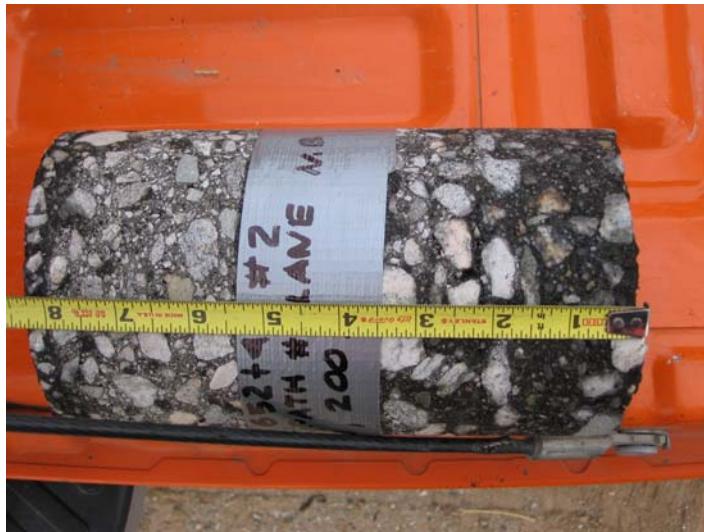
Core Location	Station 652+40, Location 2	
Overall Core Thickness	210 mm	
Chip Seal Thickness	10 mm	
Rut Depth	Left Wheelpath	Right Wheelpath
	N/A	N/A

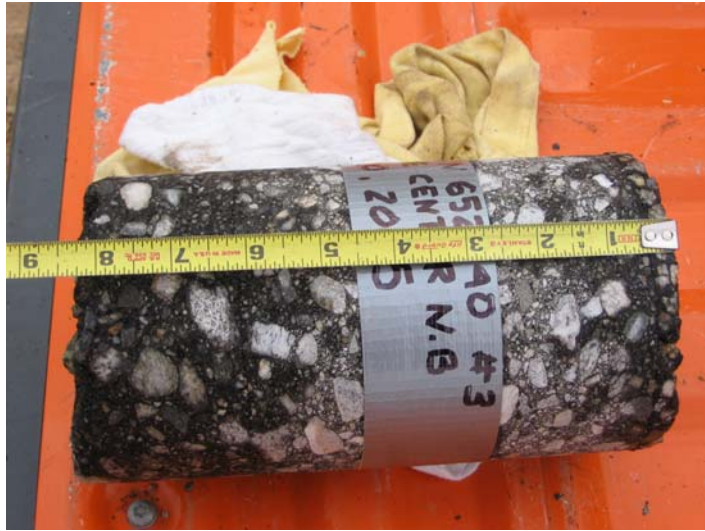
Core Location	Station 652+40, Location 3	
Overall Core Thickness	217 mm	
Chip Seal Thickness	11 mm	
Rut Depth	Left Wheelpath	Right Wheelpath
	N/A	N/A

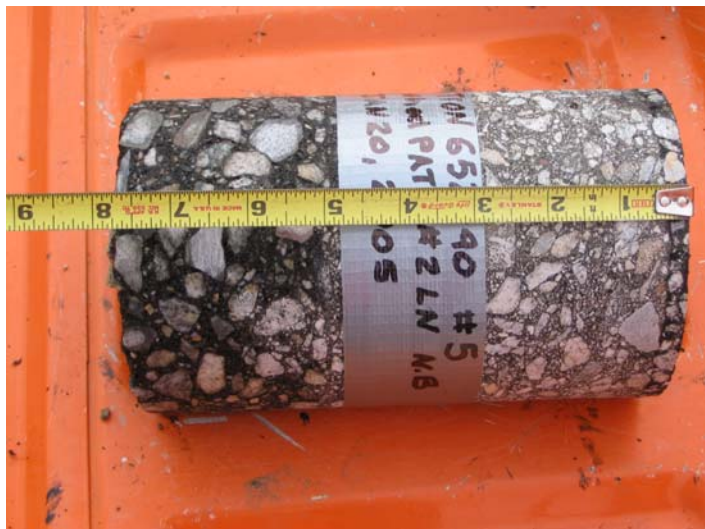
Core Location	Station 652+40, Location 5	
Overall Core Thickness	198 mm	
Chip Seal Thickness	10 mm	
Rut Depth	Left Wheelpath	Right Wheelpath
	12 mm	18 mm

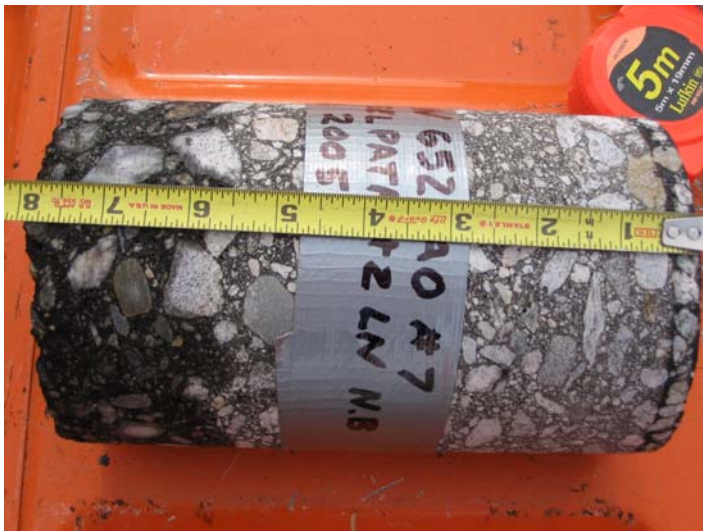
Core Location	Station 652+40, Location 7	
Overall Core Thickness	199 mm	
Chip Seal Thickness	9 mm	
Rut Depth	Left Wheelpath	Right Wheelpath
	12 mm	18 mm

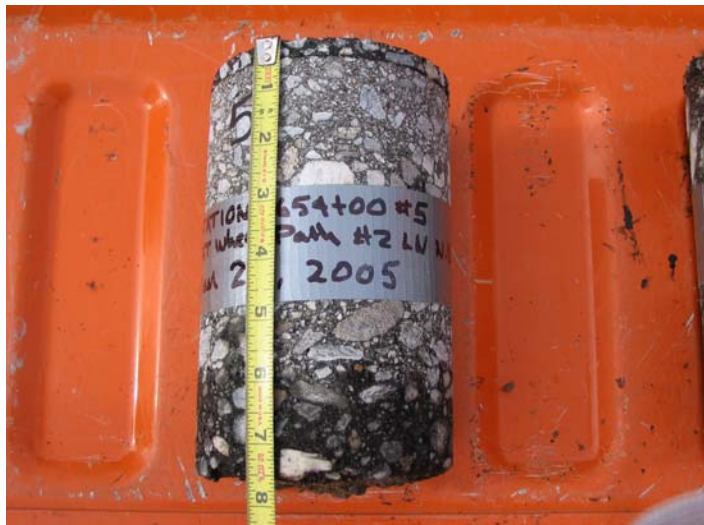
Core Location	Station 654+00, Location 5	
Overall Core Thickness	191 mm	
Chip Seal Thickness	10 mm	
Rut Depth	Left Wheelpath	Right Wheelpath
	2 mm	11 mm

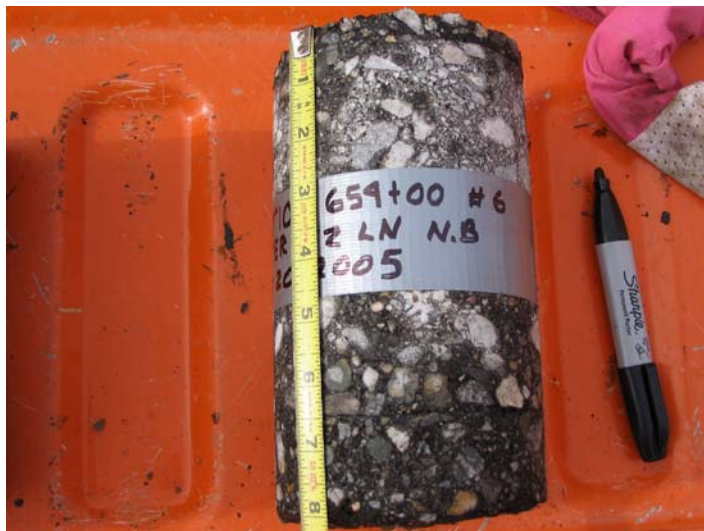
Core Location	Station 654+00, Location 6	
Overall Core Thickness	206 mm	
Chip Seal Thickness	12 mm	
Rut Depth	Left Wheelpath	Right Wheelpath
	2 mm	11 mm

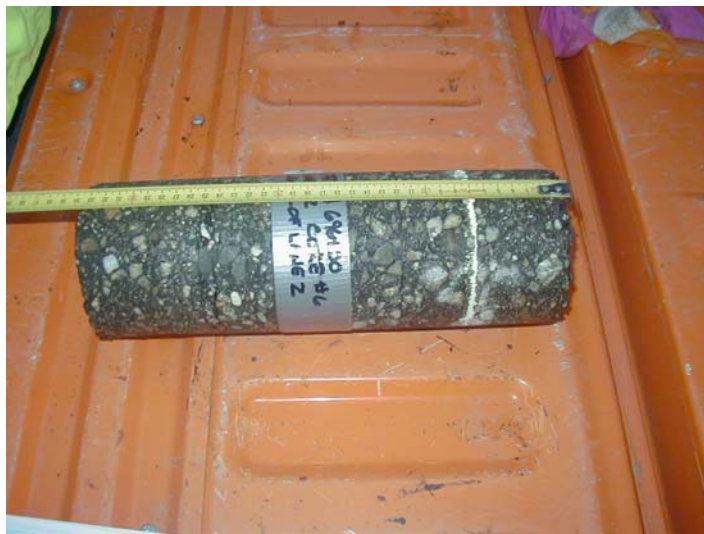
Core Location	Station 696+00, Location 6	
Overall Core Thickness	335 mm	
OG Layer Thickness	7 mm	
Rut Depth	Left Wheelpath	Right Wheelpath
	N/A	N/A
