Early Shear Failure of a 3-Peg Modified Dome Patellar Implant.

Case Report

Early Shear Failure of a 3-Peg Modified Dome Patellar Implant

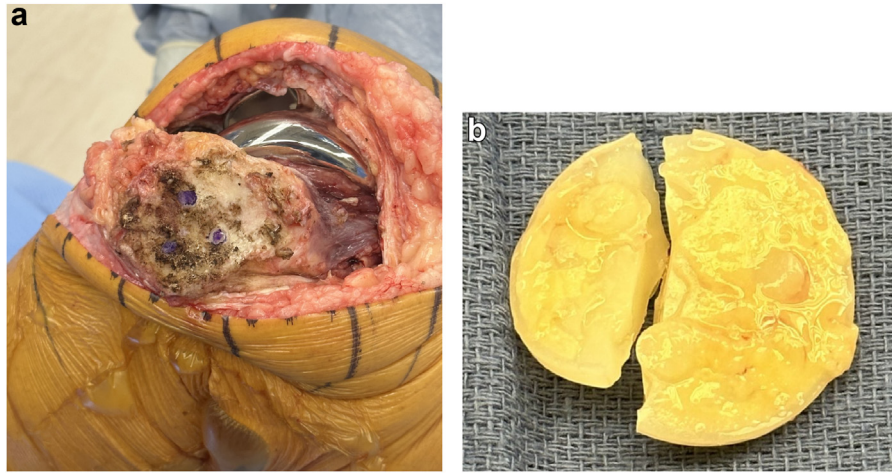
Figure 3. (a and b) Intraoperative findings of failed patella implant. (a) shows the debrided patella with the 3 polyethylene pegs well-fixed within the patella (marked with violet pen). (b) shows the fractured polyethylene button, which was located in the medial gutter.

In May 2023, a revision procedure was performed consisting of an extended arthrotomy, synovectomy, modular tibial bearing exchange, and revision of the patellar implant. [Figure 3a](#) shows the intraoperative findings of the patellar implant's shearing from its 3 pegs, which were still well fixed within bone. In addition, the patellar implant had broken into 2 pieces ([Fig. 3b](#)). The patellar pegs were removed with the Ultra-Drive (Zimmer-Biomet), an ultrasonic cement removal device, and the patellar bone deficiencies were

Our explanation for the early failure is mechanical shear. Intraoperative inspection showed all 3 pegs solidly fixed with cement in the patellar bone, which required removal with ultrasonic tools. All pegs failed at the level of the prosthetic-bone interface, similar to the failures reported by Stulberg and by Huang [4,10]. We believe multiple causative factors were involved in this case, resulting in a “perfect storm” creating shear forces great enough to cause early failure. In Table 1, we summarize factors that may contribute to increased patellar shear.

augmented with 6 2.0-m patellar rebar screws placed vertically [7]. Another patellar implant of the same design and size was cemented into the patella using 3 new peg holes drilled adjacent to the prior holes. After performing a lateral retinacular release, the revised patella showed central patellar tracking testing with a "no thumbs" technique. Radiographs of the reconstructed patella are shown in [Figure 4a-c](#). He underwent an uneventful recovery and, at 12 months postoperatively, reports returning to all customary activities with good pain relief.
