Liquefaction effects in the 2020 Mw 6.4 Petrinja, Croatia, earthquake

Liquefaction effects in the 2020 M_w 6.4 Petrinja, Croatia, earthquake

Zorana Mijic^{a,*}, Sonja Zlatović^b, Jack Montgomery^c, Katerina Ziotopoulou^d, Verica Gjetvaj^e

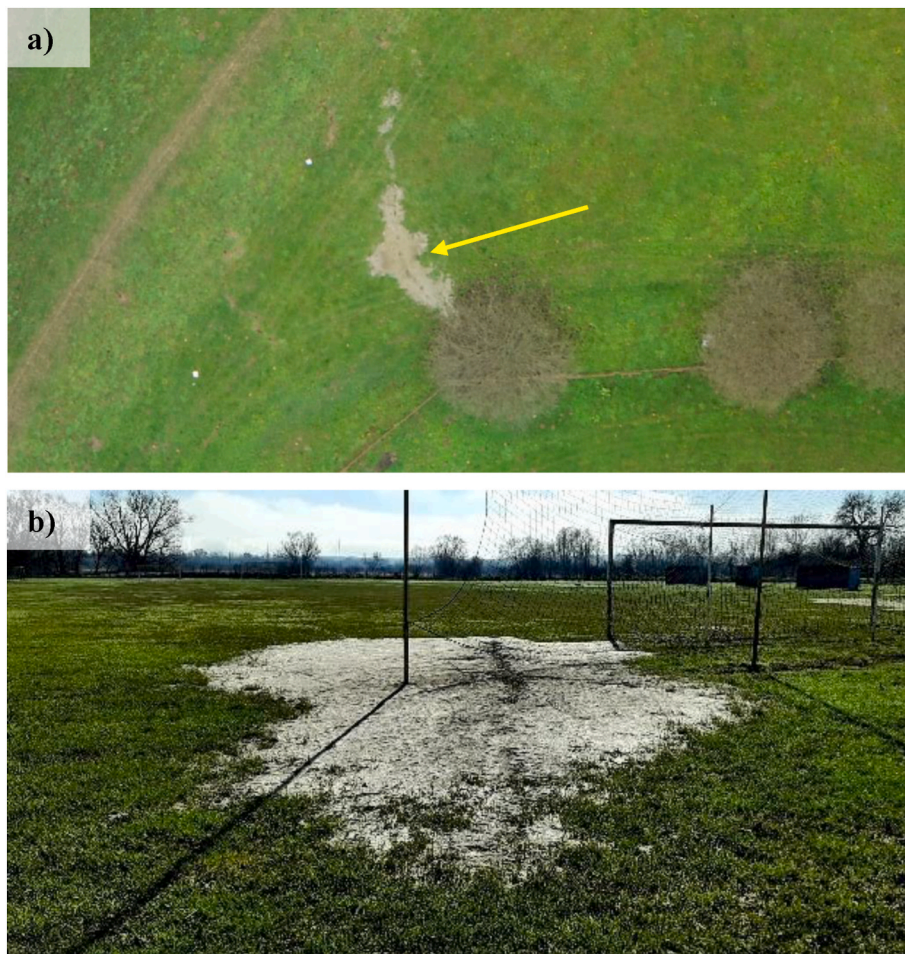
Fig. 2. Liquefaction ejecta in the free field: (a) aerial view of ejecta north of Glina [45.3439N, 16.0847E] (base map: © OpenStreetMap contributors) and (b) ground-level photograph of ejecta in Letovanac [45.506N, 16.198E], northwest of Petrinja.

are shown as purple circles in Fig. 1. An example of a site where ejecta were mapped is presented in Fig. 2a. The absence of ejecta away from Drencina, Glina, Moscenica, Petrinja, and Sisak and near the Kupa, Sava, and Odra rivers is not necessarily due to mitigating factors but rather the limited coverage of aerial photographs. Similarly, the presence of vegetation, structures, and other features in the aerial photographs had the potential to obscure ejecta. There is also some uncertainty associated with the interpretation of ejecta in the aerial photographs due to their limited resolution. The locations of ejecta marked by the cyan triangles in Fig. 1 are approximate as they are based on news and social media posts [26–30].

Liquefaction ejecta were frequently observed in the free field, typically emerging through extensive ground cracks (Fig. 2). The groundwater table was often near the ground surface. In Petrinja, a multichannel analysis of surface waves (MASW) was conducted after the earthquake to compare the subsurface conditions at free-field sites with and without ejecta (A. Salkovic and I. Salkovic, personal communication, Nov 2023 and Aug 2024). The data were acquired using a 24-channel array of 4.5 Hz vertical geophones at 2-m intervals and a sledgehammer as a seismic source [18]. The Geometrics Geode seismograph was used to record the seismic data in a roll-along acquisition fashion, moving the array 10 m between shots. The total length of the array with four rolls was 86 m. For each position, strikes were conducted at –4.0 m, 0 m, 4 m, 8 m, and 12 m. Data reduction and analysis were

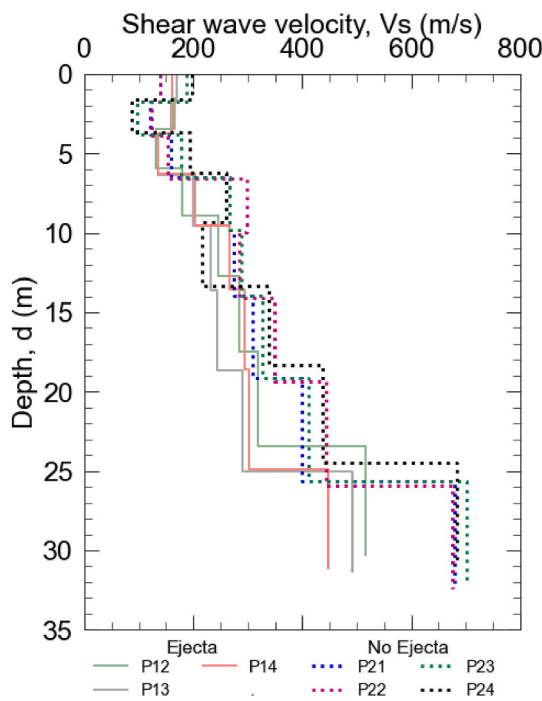
Fig. 4. One-dimensional shear wave velocity profiles of two nearby sites in Petrinja: site with ejecta [45.4484N, 16.2769E] and site without ejecta [45.4461N, 16.2760E] (A. Salkovic and I. Salkovic, personal communication, Nov 2023 and Aug 2024).

dispersion curve was performed and resulted in one-dimensional mid-point representation of the shear wave (V_s) profile [18]. As shown in Fig. 4, the average shear wave velocities in the depth ranges from 0 m to 6 m and from 9.5 m to 18.5 m at the site with ejecta are comparable to the average shear wave velocities in the same depth

ranges at the site without ejecta (150 m/s vs. 140 m/s and 260 m/s vs. 270 m/s, respectively). However, the site without ejecta has stiffer soil in the depth range from 6 m to 9.5 m compared to the site with ejecta (270 m/s vs. 190 m/s).

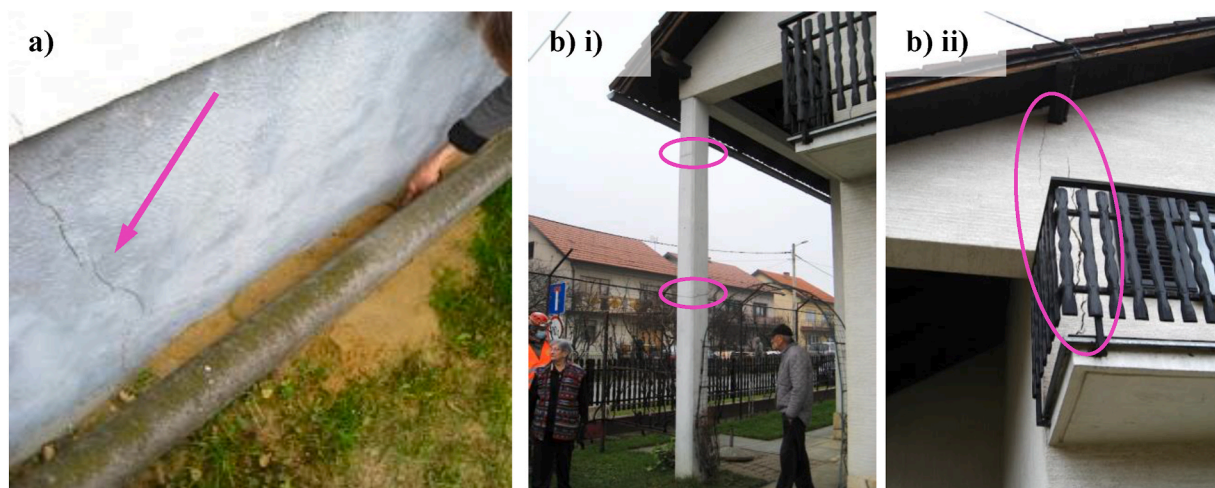
Fig. 5. Structural damage associated with liquefaction: (a) diagonal foundation crack adjacent to sandy ejecta [45.4349N, 16.2683E] and (b) co-located damage at [45.43515N, 16.26844E] with (i) horizontal cracks in column adjacent to uplifted ground and ejecta and (ii) vertical cracks in exterior wall adjacent to the column shown in (i).

Liquefaction ejecta caused differential settlement of some light-weight residential structures in Petrinja. Ejecta were identified in yards and adjacent to house foundations. Diagonal cracks in foundations and exterior walls were typically initiated near the ejected soil (Fig. 5a). At one property, horizontal cracks appeared in the isolated house column (Fig. 5b–i), while vertical cracks were visible in the exterior wall of the second story near the column (Fig. 5b–ii). This property had ejecta along the fence foundation about 2 m from the column and the uplifted ground near the column.

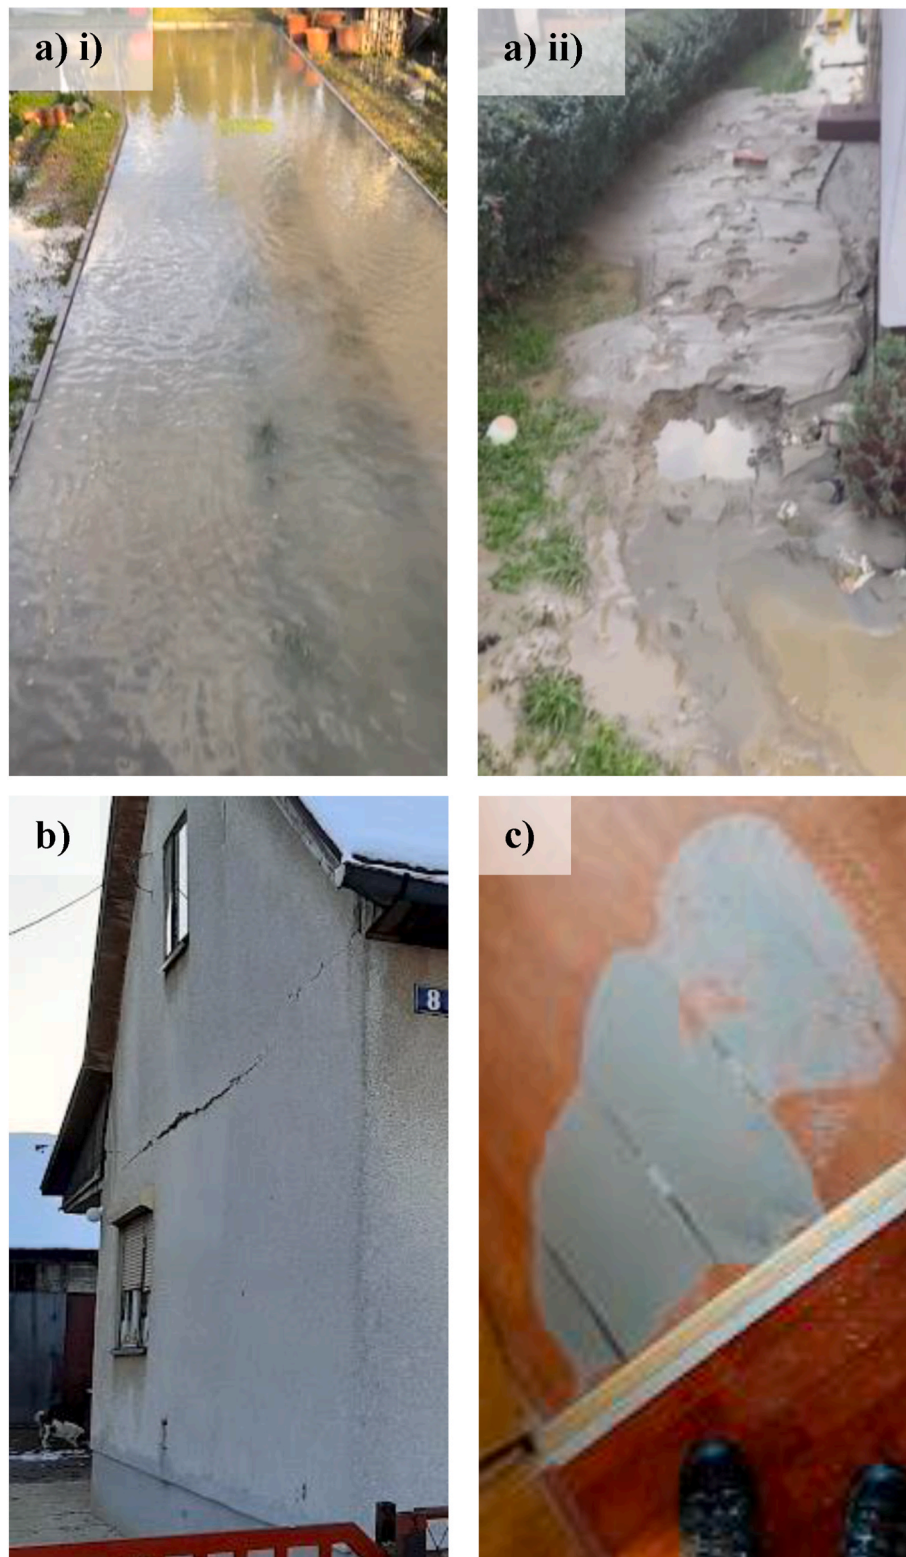
Fig. 6. Liquefaction effects at Milan Makanac St: (a) (i) liquefaction-induced flooding and (ii) sediment ejecta at 11 Milan Makanac St [45.4361N, 16.2629E], (b) structural damage, as evidenced by horizontal crack between the first story and the attic, at 8 Milan Makanac St [45.4359N, 16.2627E], and (c) ejecta inside the house at 10 Milan Makanac St [45.4358N, 16.2628E].

Examples of liquefaction-induced damage at residential properties in Milan Makanac St, Petrinja, are presented in Fig. 6. The property at 11 Milan Makanac St sustained liquefaction-induced flooding wherein the discharged groundwater was mixed with sediment ejecta (Fig. 6a). Although the structure was not visibly damaged, the DPM30 testing revealed soil whose penetration resistance to a depth of 8.5 m ranged typically from 1 MPa to 3 MPa, indicating loose material. At 8 Milan Makanac St, sandy material was ejected through the well into the air to a height of about 1.5 m above the ground surface, according to the resident of the adjoining property. Traces of ejecta were visible on the rim of the well and on the surrounding ground. Approximately 5 m from the well, a horizontal crack developed in the exterior wall of the house, between the first story and the attic (Fig. 6b). At 10 Milan Makanac St, the house adjacent to this well had ejecta on the floor (Fig. 6c) and a horizontal crack in the ceiling along the wall.

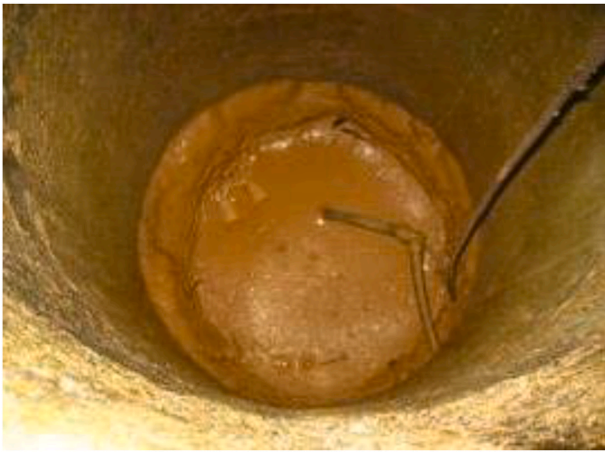
Fig. 7. Residential water well partially filled with liquefaction ejecta at Dre-nacka St, Petrinja [45.456224N, 16.316443E].

Sediment ejecta often appeared in residential water wells that extended through non-liquefiable soil layers into the underlying liquefiable sandy soil (Fig. 7). Wells filled with sediment ejecta were rendered unusable after the earthquake.

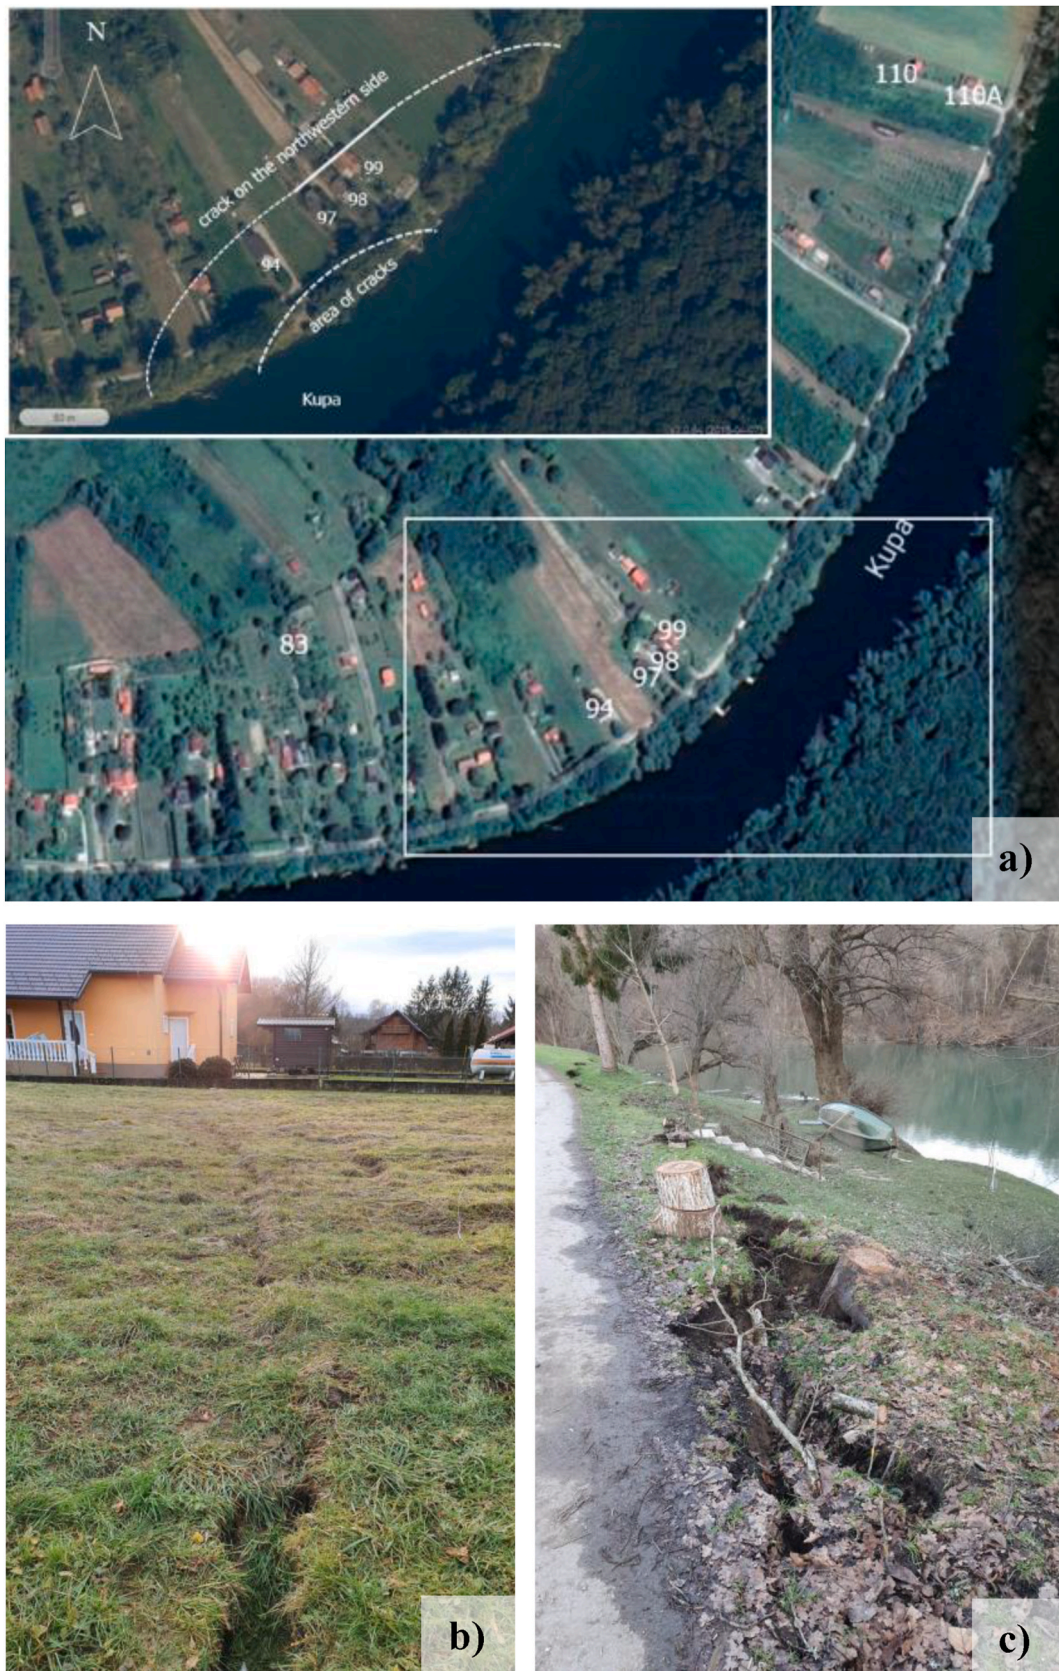
Lateral spreading was observed in the villages of Bok Palanjecki (northeast of Sisak) and Stari Brod (northwest of Petrinja), as shown in Fig. 1. In Bok Palanjecki, lateral cracks were observed on both banks of the meandering Sava River. While no structural damage was noted, a private driveway was offset horizontally by up to 10 cm and vertically by up to 30 cm. In Stari Brod, approximately 2 km from the fault rupture, lateral spreading and ejecta were identified for several residential properties along the Kupa River. Ejecta were observed around the houses and in the open areas of the properties at 83, 94, 97, 98, 99, 110, and 110A Izisce St (Fig. 8a). Liquefied soil was also ejected through water wells. At 97 Izisce St, sandy ejecta were found both outside the well and 6 m below ground surface inside the well. Lateral spreading affected the properties at 94, 97, 98, and 99 Izisce St. Fig. 8a shows two major sets of cracks: one across the level ground farther away from the river, roughly along the northwestern facade of the houses (Fig. 8b), and another closer to the Kupa River, along the transition zone between the level and sloping ground (Fig. 8c). These cracks indicate this portion of the ground moved laterally toward the Kupa River due to liquefaction of underlying sandy layers.

At 97 Izisce St, the house was slightly tilted toward the river, suggesting ground movement toward the river. However, the house was not severely damaged even though the adjoining patio settled notably relative to the house. At 98 Izisce St, the house sustained substantial damage due to differential settlement and sliding. The same crack observed in the backyards at 97 and 98 Izisce St propagated through the house at 99 Izisce St, inducing severe damage (Fig. 9a–d). This and additional cracks throughout the house also caused damage to the pipes (Fig. 9c and d). The DPM30 testing near the foundation of the 99 Izisce St house revealed low penetration resistances in the upper 7 m of the soil profile (Fig. 9e). The penetration resistances in the approximate depth range at 98 Izisce St were comparable, while those at 97 Izisce St were slightly higher (by about 1 MPa) in the 2.7–3.9 m and 5.9–7.0 m depth ranges. Fig. 9e also shows the approximate N_{SPT} at the house at 99 Izisce

Fig. 8. Liquefaction-induced damage in Stari Brod [45.480N, 16.183E]: (a) distribution of properties impacted by ejecta (83, 94, 97, 98, 99, 110, and 110A Izisce St) and lateral spreading (94, 97, 98, and 99 Izisce St), (b) crack along the northwestern exterior side of the houses (shown as solid line in panel a), and (c) parallel ground fissure in greater proximity to the Kupa River (shown as shorter dashed curve in panel a).

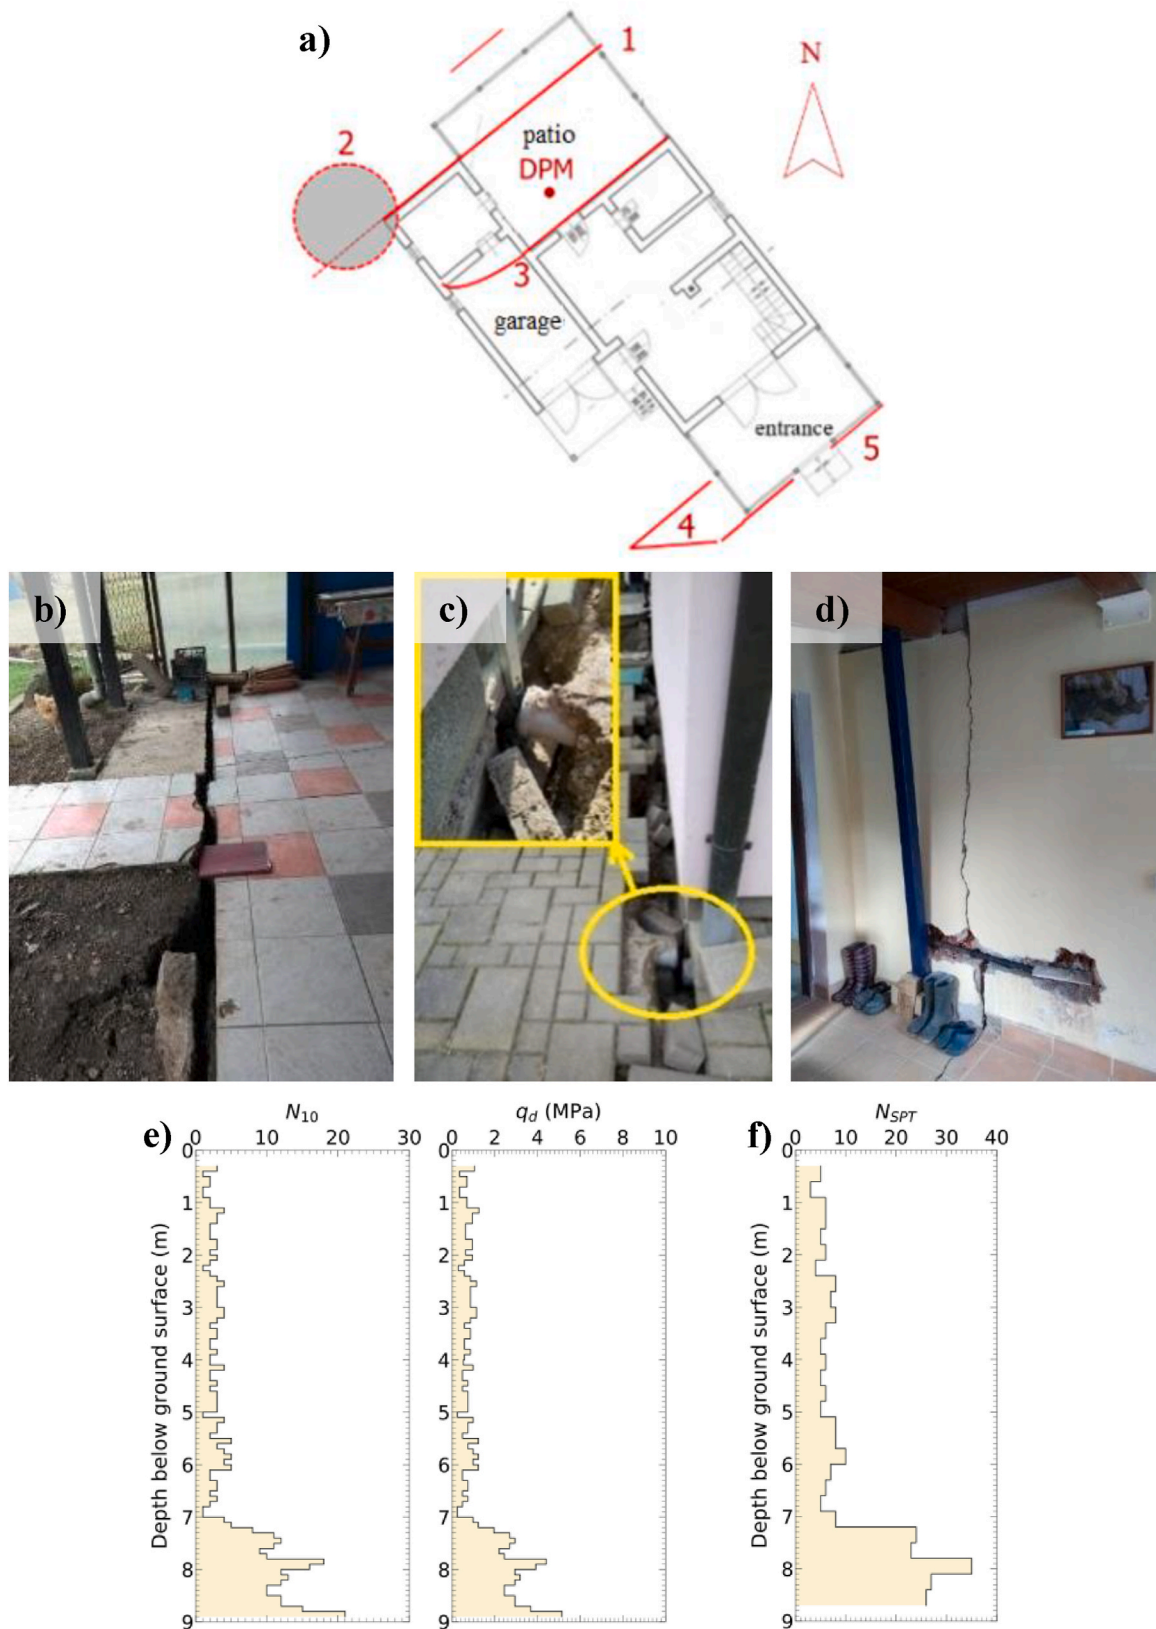
Fig. 9. Damage documentation and subsurface investigation at 99 Izisce St, Stari Brod [45.48023N, 16.18434E]: (a) floor plan showing documented cracks in red, (b) crack through the patio (marked as crack 1 in the floor plan) with depth exceeding 1 m, horizontal separation of 10 cm, and vertical displacement of 8 cm, (c) uplifted ground with displaced pavers and ruptured roof drainage pipe (marked as crack 2 in the floor plan), (d) water-pipe rupture caused by crack through the wall and floor (marked as crack 3 in the floor plan), (e) dynamic probing medium (DPM30) [45.48025N, 16.18429E] blow count per 10 cm penetration, N_{10} , and dynamic point resistance, q_d , versus depth, and (f) equivalent standard penetration test (SPT) blow count per 30 cm penetration, N_{SPT} , versus depth. Cracks denoted by 4 and 5 in the floor plan indicate cracks in pavement and southeast wall, respectively.

St. The upper 7 m of the profile would classify as loose, while strata below this depth would classify as medium dense. However, there is significant uncertainty in this correlation with SPT blow count and no energy measurements are available from the DPM30 testing, which would allow for more robust interpretation of these data or consideration of other factors like rod friction. Additionally, no parameters other than N_{10} or q_d are obtained from the DPM30 testing. Given these uncertainties and limitations, additional fieldwork, including cone penetration testing (CPT) with pore water pressure measurements and detailed logging of continuous, high-quality soil samples, should be performed at these locations to better understand the subsurface conditions and improve the usefulness of these case histories.
