Impacts of 2020 Beirut Explosion on Port Infrastructure and Nearby Buildings

Natural Hazards Review, 23(2)

Salah Sadek¹, M. ASCE, Mayssa Dabaghi¹, A.M. ASCE, Timothy M. O'Donnell², S.M. ASCE, Paolo Zimmaro^{2,3}, M. ASCE, Youssef M.A. Hashash⁴, F. ASCE, and Jonathan P. Stewart², F. ASCE

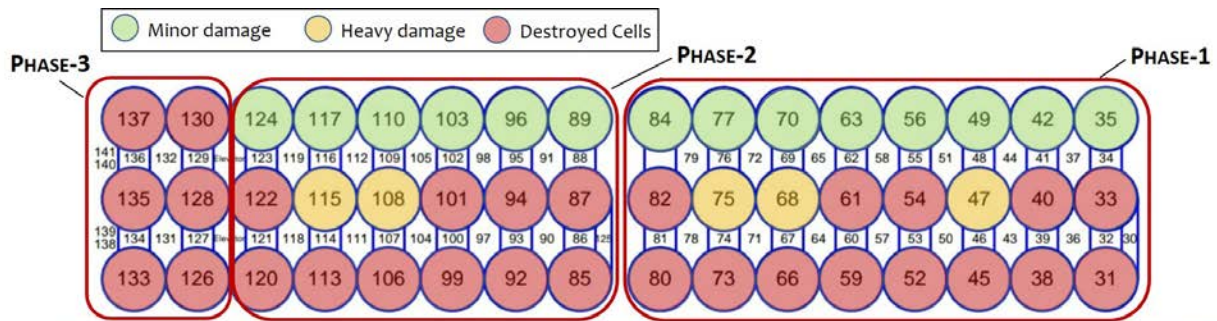
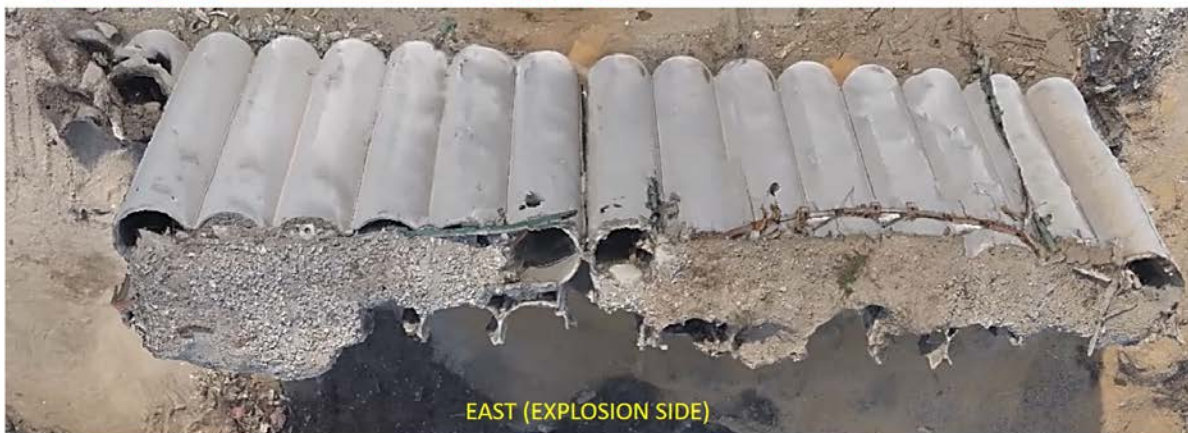
189 **Figure 4:** Plan view showing the configuration of the grain silo complex. Color code indicates damage
 190 levels from the 4 August 2020 blast. Photo is a composite aerial imagery with laser scan survey looking
 191 down (provided by Mr. E. Durand)

221 Multi-epoch LiDAR scans of the silos were performed on September 17 2020, November 23, 2020
222 and March 28 2021 by Mr. Emanuel Durand of Amann Engineering. These scans allow for the tilt
223 of the surviving silos to be assessed at the times of the scans. Figure 7 shows orthometric views
224 of the west side of the silos from the September 17 scan, with coloration indicating horizontal
225 displacements relative to vertical. The results from this initial scan show a consistent tilt
226 westwards (away from the blast) on the order of 25 cm. Scans taken on November 23 do not
227 indicate any additional movement. As shown in Figure 8, in the time period between November
228 and the last scan taken on March 27, 2021 movements now towards the east have occurred,
229 mainly involving silos that are part of the Northern block (Silos 35 to 82 on Figure 4).

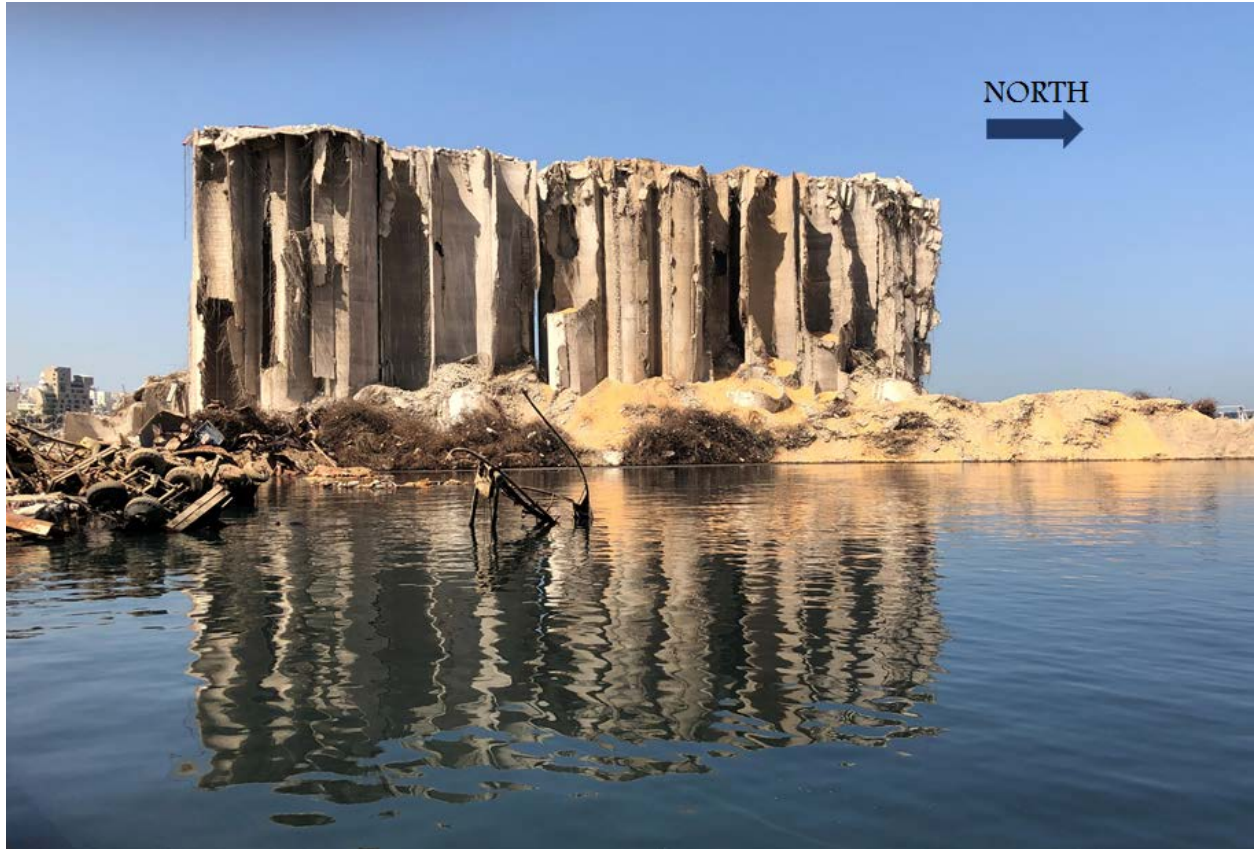
207 Figure 6 shows the extensive damage to the silos from the explosion, which was as close as 50 m
208 to the silos. The silos visible in the photograph are from the 2nd and 3rd rows, because the first
209 (eastern-most) row of silos was completely destroyed by the blast. Near the base of the silos in
210 Figure 6 is spilled grain. The specific condition of each silo after the blast is shown in Figure 4
211 using three categories: intact, heavily damaged, and destroyed. The explosion exposed the gap
212 at the construction joint between the Phase I and Phase II silos, which is visible in Figure 6. The
213 gap does not appear to have widened as a result of the blast. Most cells were partially filled at
214 the time of the explosion, except for the six southernmost cells (126 to 137 on Figure 4). Along
215 the west-facing third-row of cells, those that were partially filled survived, whereas those that

216 were empty (at the south end) were completely lost.

218 **Figure 6:** View from the east of silos following the blast. Picture taken from Quay 10. ($33^{\circ}54'6.35''\text{N}$;
219 $35^{\circ}31'16.19''\text{E}$).

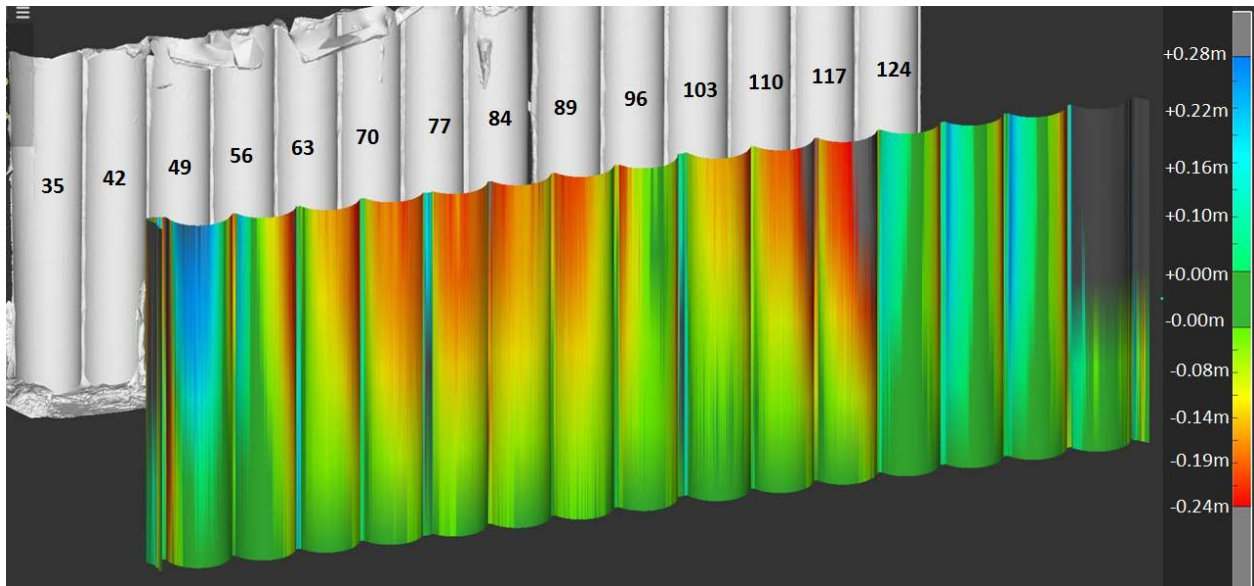
235
236 **Figure 7:** Horizontal deflections of west side of silos as evaluated from LIDAR point cloud data. The
237 horizontal deflections indicate a consistent tilt away from the blast at the top of multiple silos with a
238 maximum of around 24 cm on September 17, 2020 (negative values indicate movement towards the west-
239 away from the blast epicenter). *Adapted from scans provided by Mr. Emmanuel Durand-Amann*
240 *Engineering.*

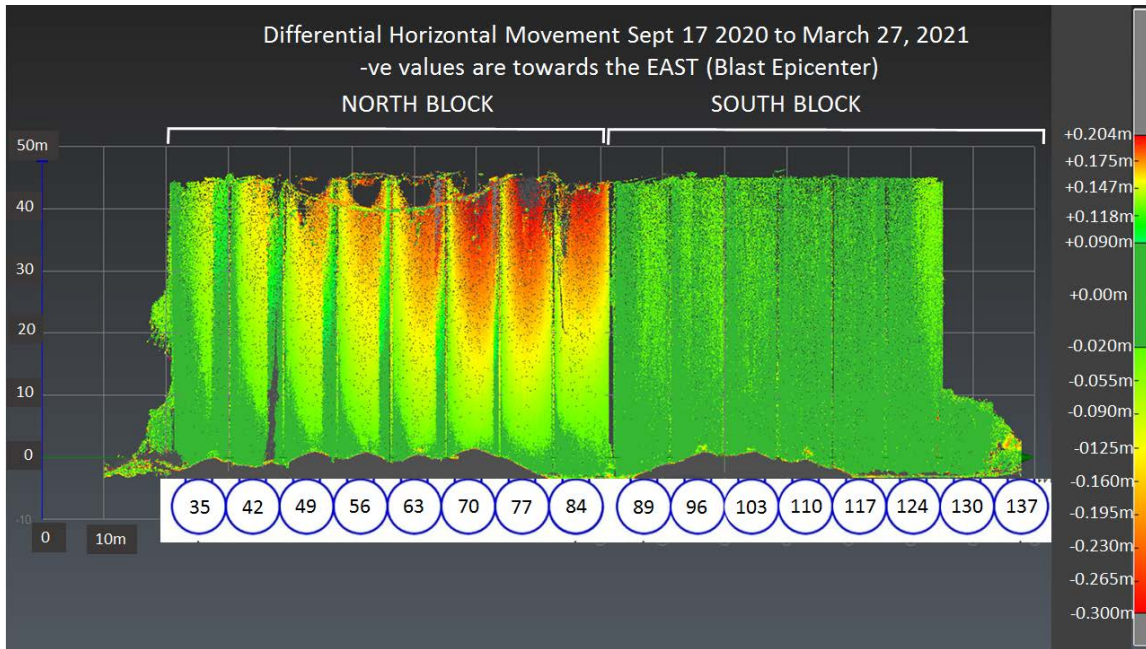
242 **Figure 8:** Point cloud data shaded with reference to differential horizontal movement between the date
 243 of September 17, 2020-first post blast readings and March 27, 2021 (negative values indicate movement
 244 towards the East-towards the blast epicenter). *Adapted from scans provided by Mr. Emmanuel Durand-*
 245 *Amann Engineering.*

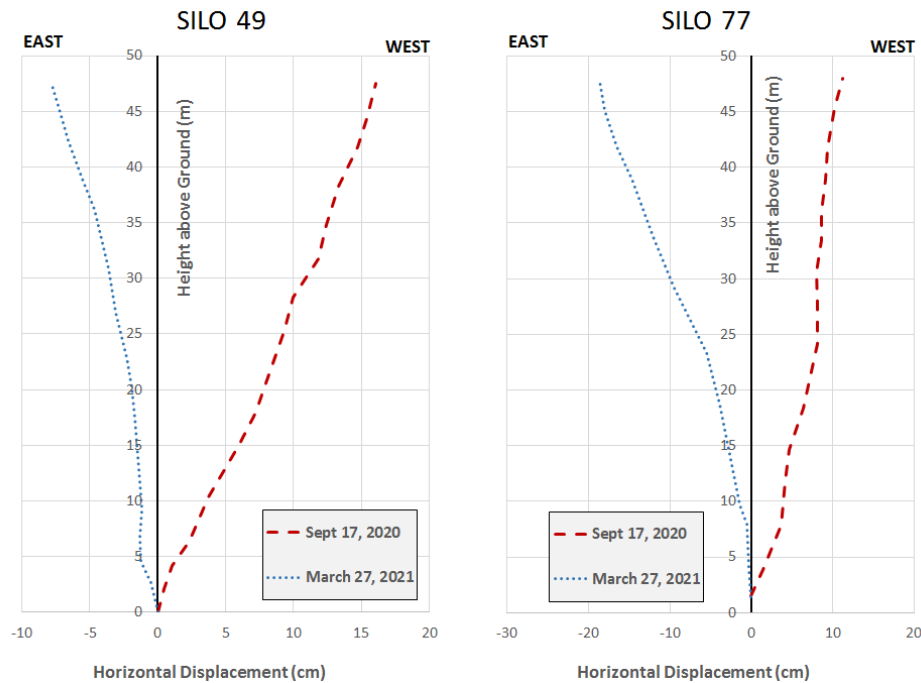
230 Representative deviations from vertical for Silos 49 and 77 are shown on Figure 9. The reasons
231 for the reversal/recovery of the tilt may be attributed to heavy rainfall causing further erosion
232 and expansion of the crater at the blast epicenter, combined with gradual creep effects at the
233 foundation level now that the piles supporting the silos and/or connecting caps have likely been
234 sheared and/or damaged.

247 **Figure 9 -** Representative horizontal movements shown for Silos 49 and 77 (Northern Block) showing the
 248 post blast readings (September 17, 2020) and readings taken on March 27, 2021. *Extracted from scans*
 249 *provided by Mr. Emmanuel Durand-Amann Engineering.*

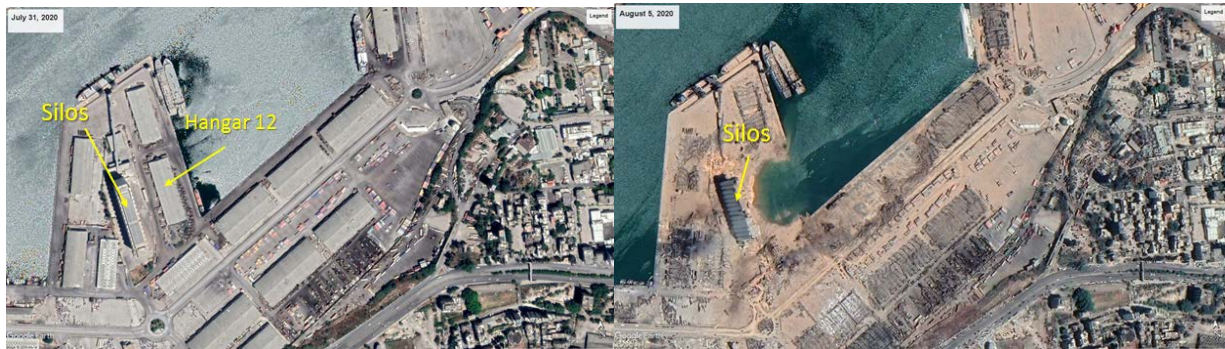
251 The blast at Hangar 12 left a crater of nearly 120 m diameter. Figure 10 includes before and after
252 aerial views of Hangar 12 and the crater. In the aftermath of the event, detailed bathymetric
253 surveys were conducted by teams from the Lebanese army using boat-mounted bottom profilers.
254 This survey provides water depths to ~1cm resolution. The nominal pre-explosion depth in Basin
255 3 was 10.5 m (this depth was maintained to accommodate the needs of cargo ships serviced by
256 the Port). Figure 11a shows the post-event depth contours 4 days following the blast, and Figure
257 11b shows a west-east cross-section through the crater.

258
259 **Figure 10:** Aerial views of ground zero (Hangar 12) prior to (31 July 2020) and immediately following (4
260 August 2020) the explosion (Google Earth).

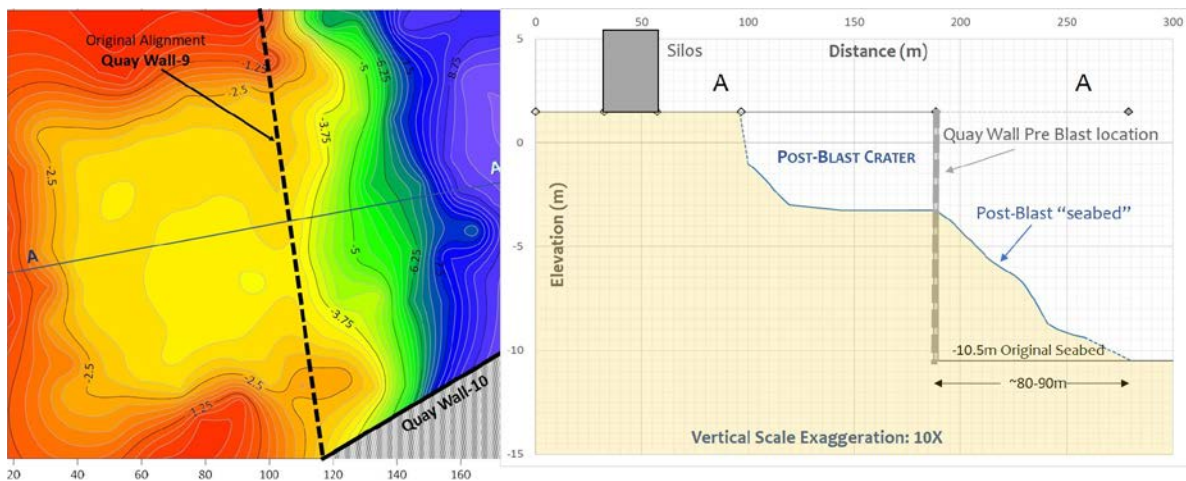
261
262 **Figure 11:** (a) Water depths from bathymetric survey conducted on August 8, 2020; (b) west-east cross-
263 section through center of crater. Bathymetric data from the Lebanese army.

264 The geometry and size of the crater clearly correspond to the blast location (Hangar 12). The
265 crater is 120 m in diameter and roughly 4.5 to 5 m deep; the depth would likely have been greater
266 had it not been for the presence of water at ~elev. 0m. Volume calculations were conducted on
267 the 3D crater and “flow-out” material into the basin (Sadek et al., 2021a). These showed that the
268 volume of material displaced into the basin was roughly 38,500 m³, compared to 45,500 m³ of
269 material lost from behind the original location of the quay wall. The “missing” balance of ~7000
270 m³ was likely fill material behind the quay wall and above the water level that was ejected into
271 the air and deposited away from the blast zone. These numbers confirm the likelihood that the
272 material retained by the quay wall flowed/ran out into the basin for a considerable distance as
273 shown in Figure 11b (on the order of 80 m).

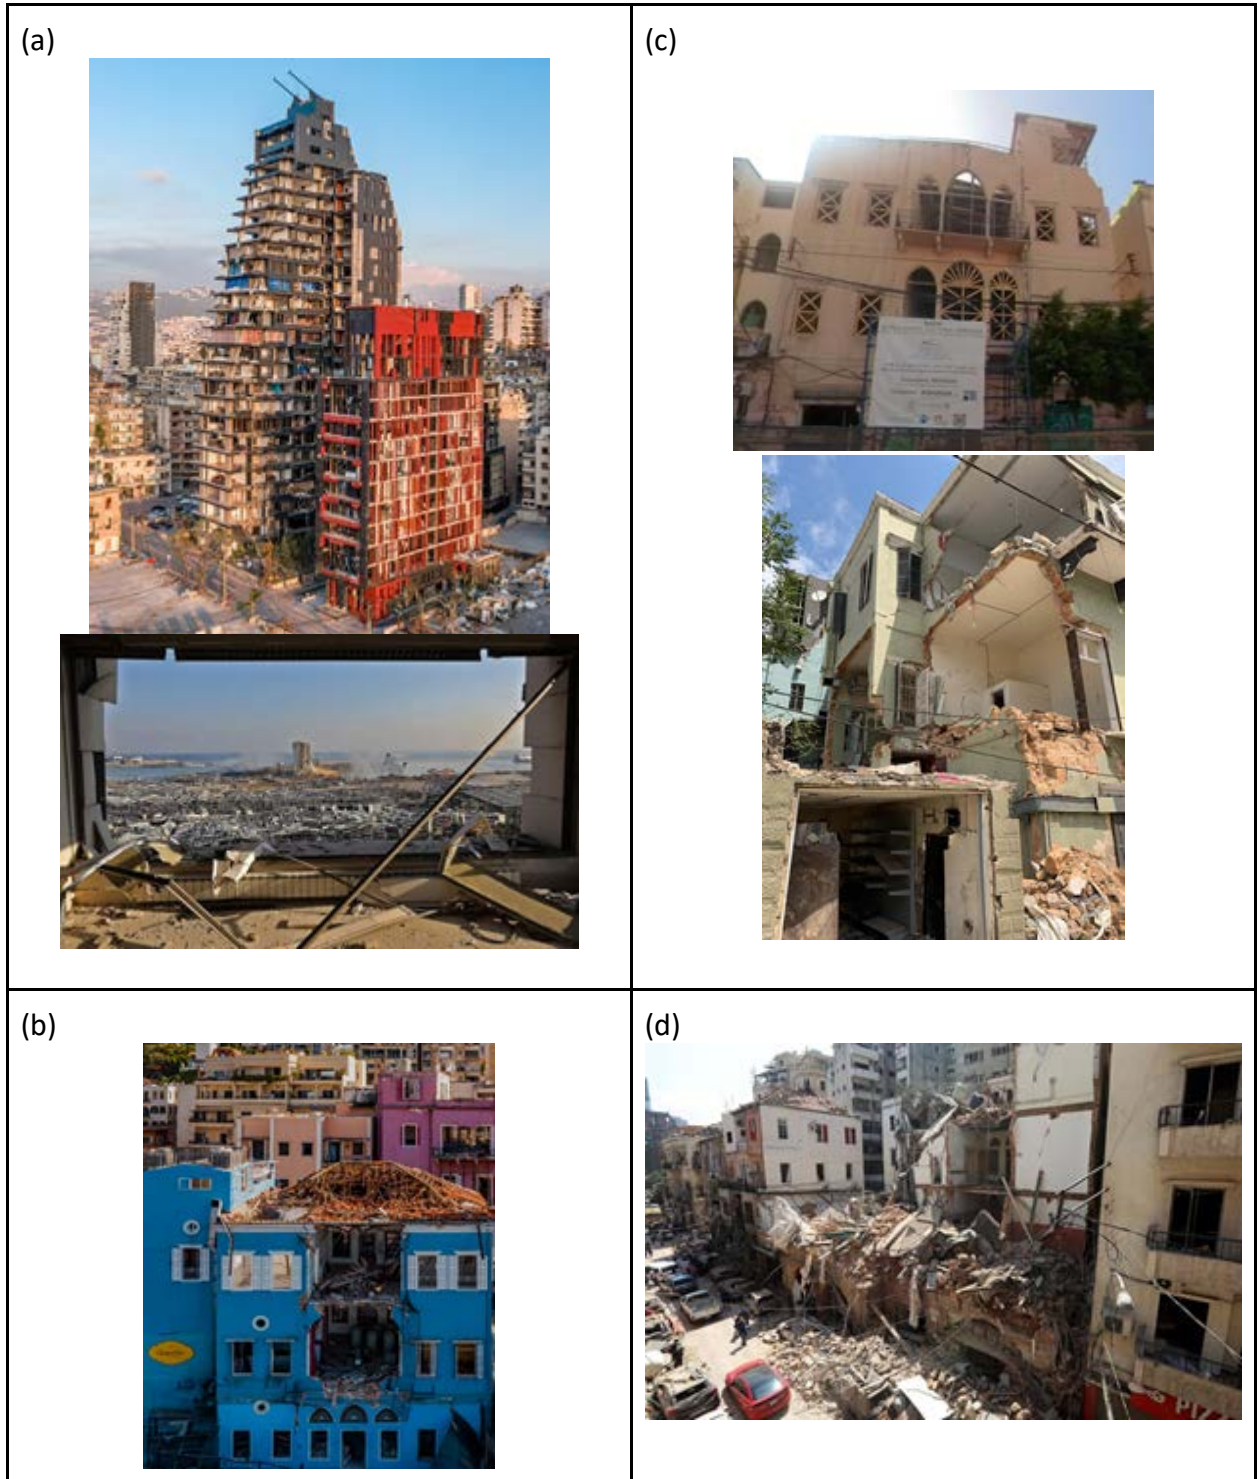
361 Figure 13 illustrates RC and SM buildings with variable levels of damage. Figure 13 (a) shows two
362 modern high-rise RC structures with a D2 damage classification. These buildings, located ~700 m
363 from the explosion, sustained moderate damage to non-structural components (e.g., cladding
364 and false ceilings) but no apparent structural damage. Figure 13 (b) shows an SM building that
365 sustained heavy structural damage (D3), namely, significant cracking of its exterior bearing walls,
366 failure of its façade arches and balconies, and partial collapse of its roof. Finally, Figure 13 (c) and
367 (d) show two partially collapsed (D4) and one totally collapsed (D5) SM buildings, respectively.
368 Sadek et al. (2021a) provides additional examples. The damage classification of all 182 buildings
369 is available in the published dataset (Sadek et al., 2021b).

373 **Figure 13:** Examples of buildings with variable levels of damage from the August 4 blast. (a) RC structures
374 that sustained moderate non-structural damage (cladding, false ceilings ...) but no apparent structural
375 damage (D2); (b) stone masonry building that sustained heavy damage (D3) with significant cracking of
376 exterior bearing walls, failure of façade arches and balconies, and partial collapse of the roof; (c) partially
377 collapsed stone masonry buildings (D4); and (d) totally collapsed stone masonry building (D5). Sources: (a
378 - upper image) ©RAMI RIZK ; (a - lower image) AP photo by Hassan Ammar; (b) ©RAMI RIZK; © GEER/AUB-
379 MSFEA; and (d) Reuters.

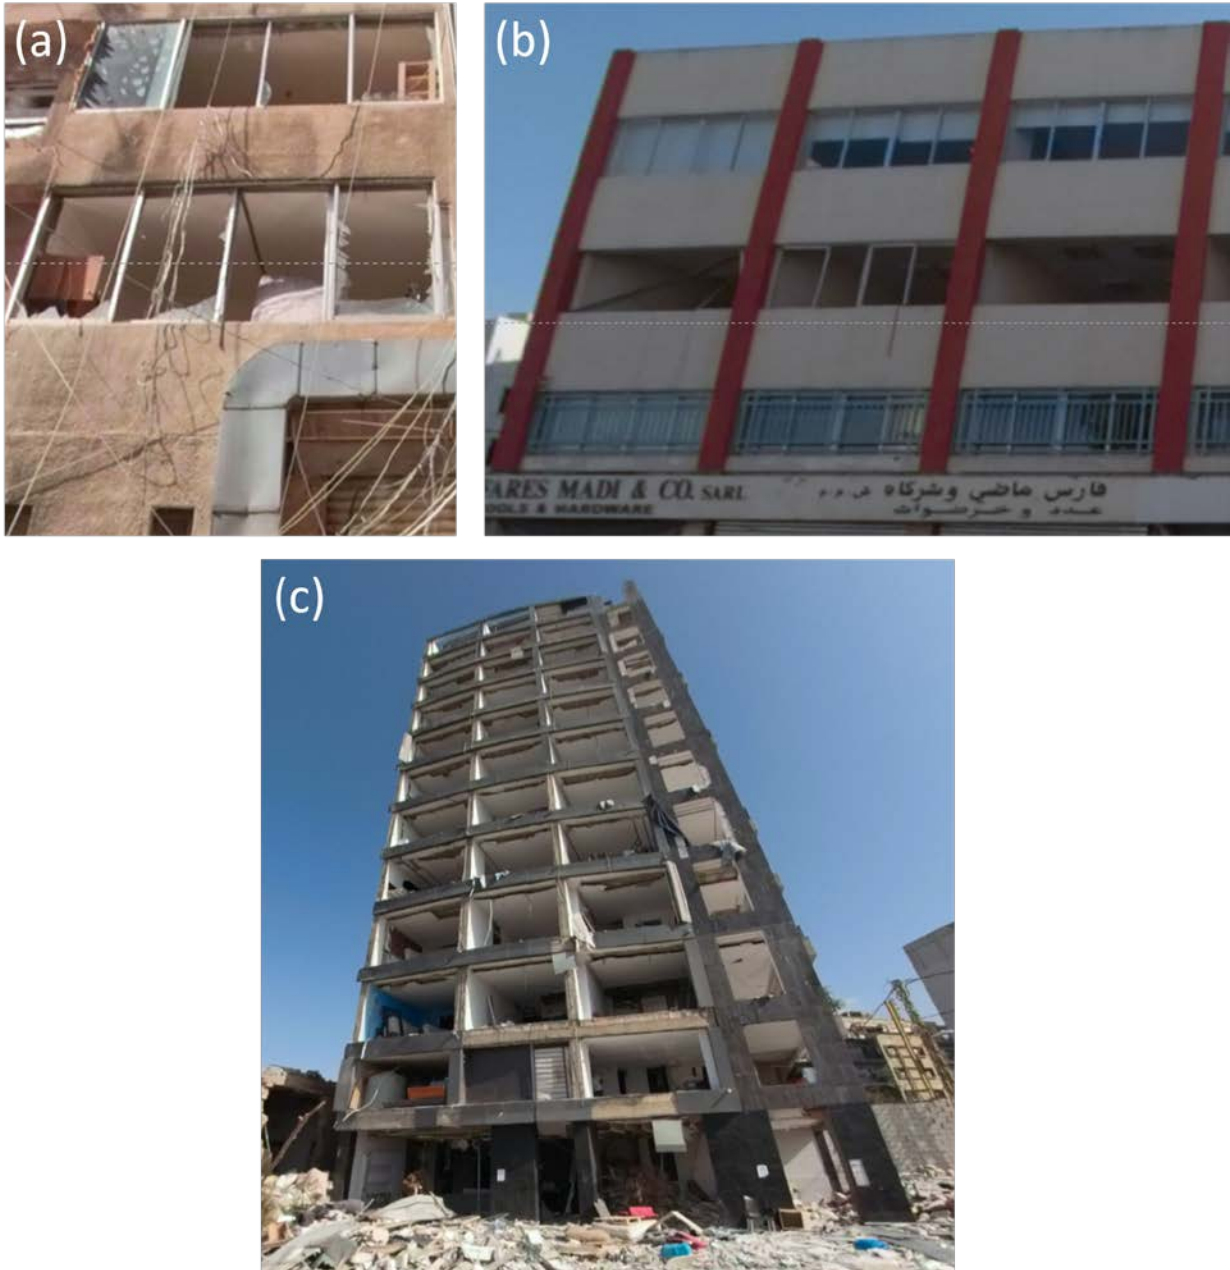
404 Figure 14 shows example photos of façades experiencing damage classes Wxx-1 where damage
 405 was mainly related to broken windows (Figure 14a), Wxx-2 where windows were broken and
 406 frames were damaged (Figure 14b), and Wxx-3, the highest façade damage level, where there
 407 was complete blow-out of frames (Figure 14c). Photos shown in Figure 14 were taken in different
 408 districts of Beirut.

410 **Figure 14.** Example of façade damage levels (a) Wxx-1: damage to windows only, (b) Wxx-2: damage to
 411 windows and frames, and (c) Wxx-3: complete blow-out of frames.
