Collapse of a concrete wall building in the 2010 Chile Earthquake

Report No.
UCB/SEMM-2014/02

Ahmet Can Tanyeri, and Jack P. Moehle

March 2014

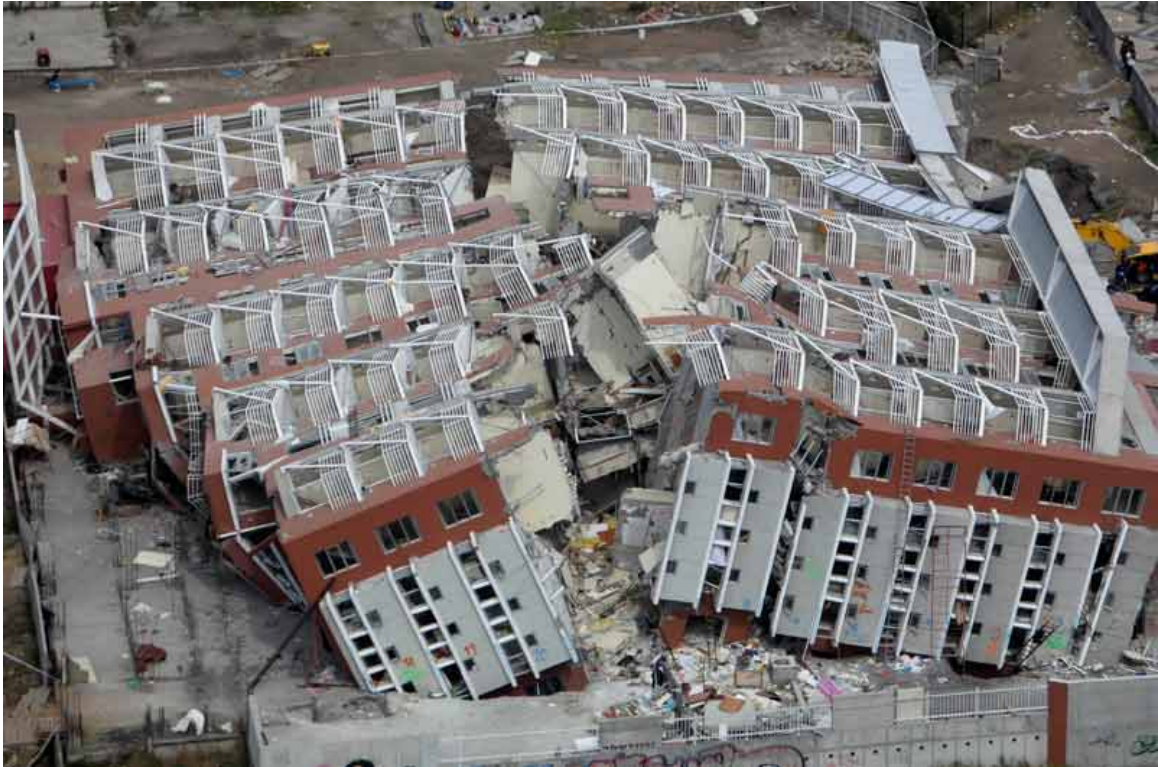
During the earthquake, the Alto Rio building overturned from the base level and came to rest on its east side (Figure 1). Examination of the building in its final resting place indicated that the main failure occurred in or near the first story, and that the building rotated approximately about the central corridor as it fell to the east. According to this mechanism, the west side of the building failed in tension whereas the east side failed in compression, with portions of the east side being thrust into the subterranean levels. A small amount of longitudinal movement was apparent where the building fractured at the base, but this appears to have occurred as the building collapsed, not beforehand (IDIEM, 2010). The building was also fractured at the ninth level, probably due to impact with the ground and walls of the adjacent parking structure, snapping the building in two as it hit the ground. Inspection of the foundation and soil did not identify significant damage.

Fig. 1 - Alto Rio building after the earthquake (from <http://skyscraperpage.com/cities/?buildingID=85186>)

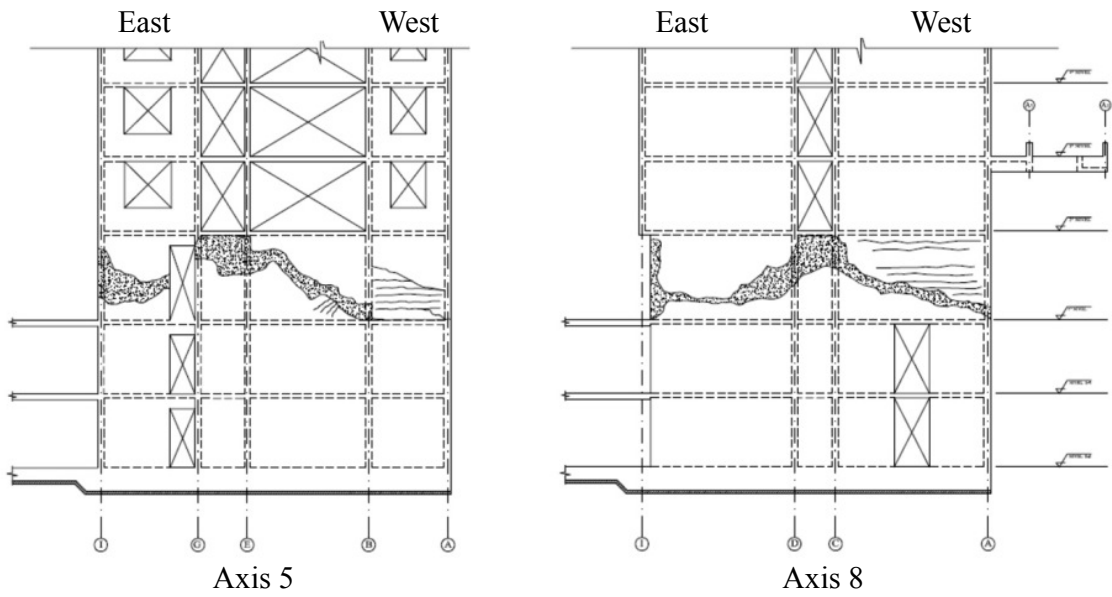
Figures 10 and 11 show damage maps identifying the principal fractures near the base of the building along axes 5, 8, 11, and 13, including:

- Walls along axes 8 and 13 show apparent compression failures on the east side near the first level. Detailed surveys showed both concrete crushing and longitudinal reinforcement buckling. Wall piers along axes 11, 17, and 24 suffered similar failures at the setback level (between first and second floor).
- Large horizontal cracks along axes 5 and 8 indicate that the wall on the west side near the first level sustained significant tension, consistent with actions expected as the building overturned toward the east. Photographs of the failure interface on the west side showed both fractured bars and failed lap splices. Similar damage was absent on the east side, although such damage would have been obscured by crushing failures on that side.

- The solid wall panels in the first story, just below the stack of corridor openings, sustained major damage (axes 5, 8, and 13). Damage in these panels may be due to large shear forces that result from opposing tension and compression forces in the wall boundaries adjacent to the corridor. Such “solid wall panels” have been damaged in past earthquakes (Naeim et al. (1990)).

Fig. 10 - Sketch of damage on axes 5 and 8 (after IDIEM, 2010)

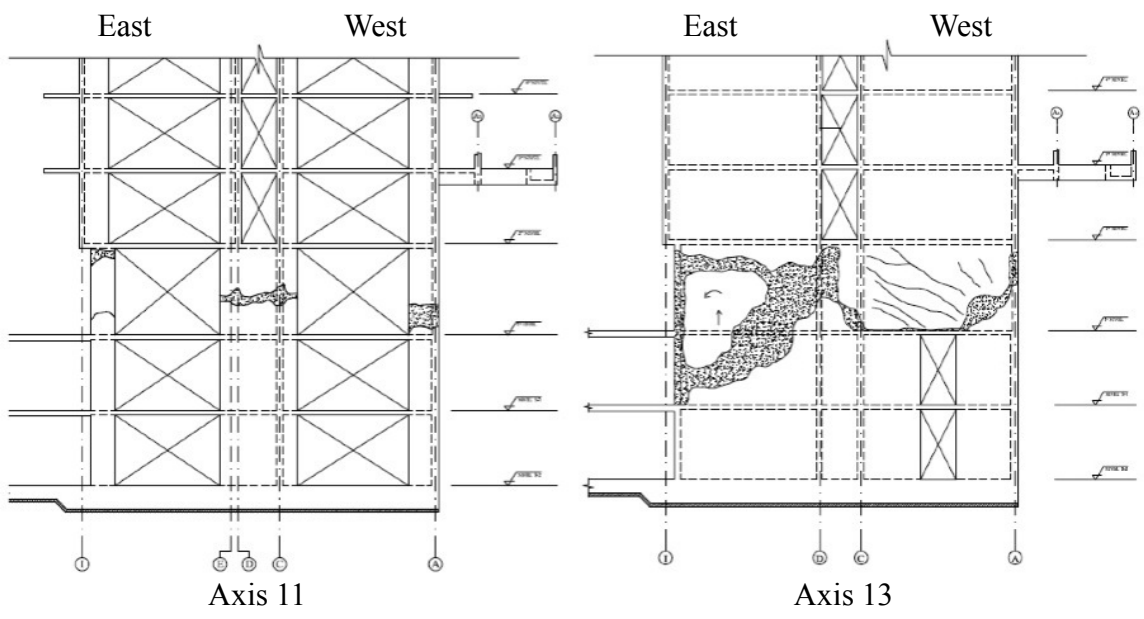
Fig. 11 - Sketch of damage on axes 11 and 13 (after IDIEM, 2010)
