# **THE PERFECT STORM**

## **FLOW THROUGH A RESTORED COMPOUND CHANNEL TASSAJARA CREEK, DUBLIN, CA**

**ASSESSMENT OF THE ROUGHNESS, FLOW, FLOODPLAIN CONVEYANCE, AND  
COMPOUND CHANNEL CAPACITY OF THE RESTORATION OF TASSAJARA CREEK FROM  
THE HIGH-WATER MARKS OF A 20-YEAR STORM**

**MAY 17, 2006**

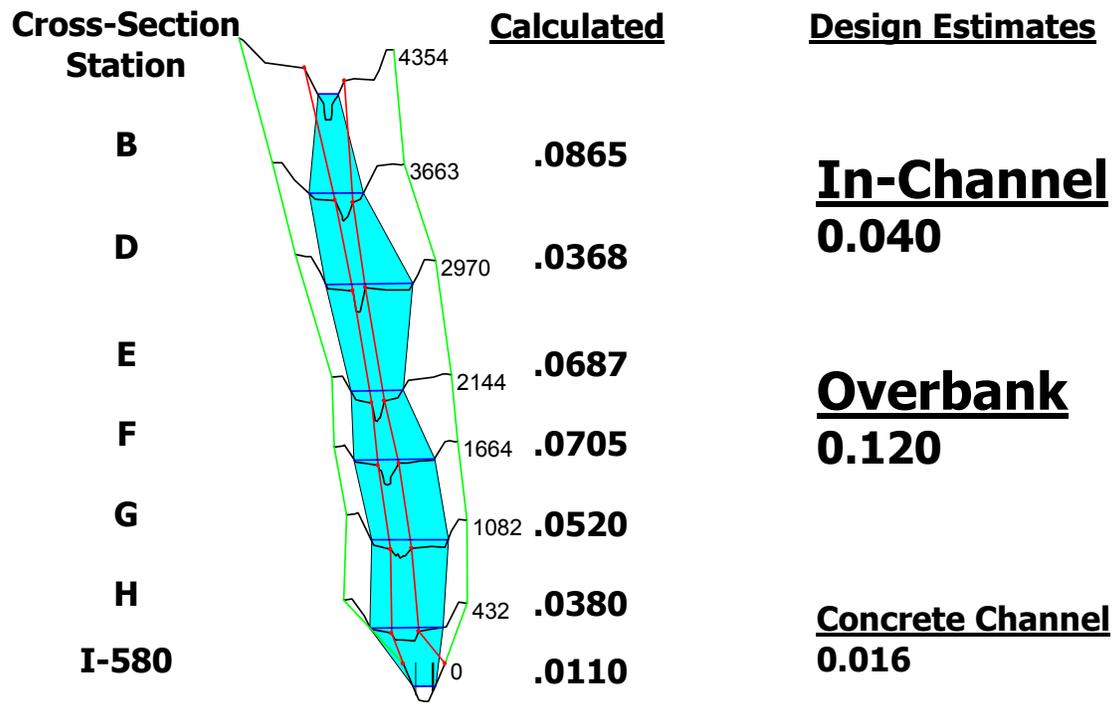
**Figure 5. Roughness Comparison Using December 2005 HWMs**

By contrast, the project design utilized uniform roughness coefficients for the entire reach of the restored channel – values of 0.040 for in-channel and 0.12 for overbank roughness. For all but two of the cross-sections we surveyed (Cross-Sections D and H), our calculated roughness coefficients exceeded the project design’s in-channel roughness value of 0.040. However, for all of our cross-sections, the roughness coefficients we calculated were lower than the design’s overbank roughness of 0.12.

We noted a significant amount of vegetation on the low-flow channel's natural terrace, likely the cause of the high roughness coefficients we calculated. However, only ten years have elapsed since project completion, and the vegetation we observed is still quite young. Experience has shown that in the long run, roughness tends to decrease as competition for resources increases, and larger trees, such as willows, effectively shade out smaller varieties (Lovett 1999, Hecht 2006). Therefore, it is likely that the roughness coefficients we calculated will decline in the future, thus decreasing friction and lowering water elevations as velocity increases.

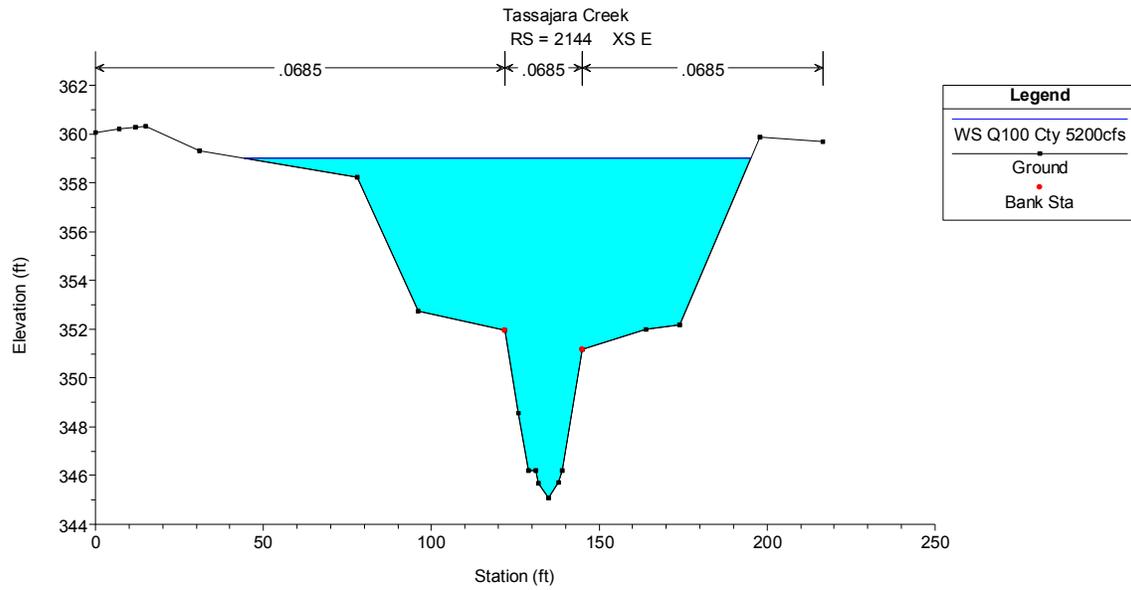
**Figure 37. Cross-Section E at 5,200 cfs (AC Q<sub>100</sub>)**

At each cross-section we surveyed along the compound channel, Tassajara Creek has the capacity to fully contain the 100-year flow of 5,200 cfs. However, cross-section E provides for only 0.88 feet of freeboard, which is less than the one-foot minimum that Alameda County requires. This results from the narrow span of the channel's upper terrace, which is only 115 feet across at the top, compared to the widths of other cross section terraces, which range from 170 to 200 feet. The design plans required the accommodation of two large oak trees on the left bank of the floodplain near cross-section E (Cook 2006). Even with the smaller area at cross-section E, however, we still find that the restored portion of Tassajara Creek should contain a 100-year flood discharging 5,200 cfs.

The cross-section (Cross-Section E) that provides less than one estimated foot of freeboard requires further study. Based on observation of the floodplain relative to the compound channel, we hypothesize that the compound channel was designed to be narrower at this cross-section to accommodate the root systems of several large oak trees on the 100-year floodplain. We recommend further study and monitoring of this cross-

section, in light of the area's rapid growth, which permits development very near the banks of the creek since it has been removed from the "100-year floodplain" as defined by FEMA, but not necessarily from the floodplain of significantly larger floods such as the 200-year flood, or the 500-year flood, i.e. the floods which have a 0.5% chance and 0.2% chance of occurring, respectively, each year (Kondolf 2006b).

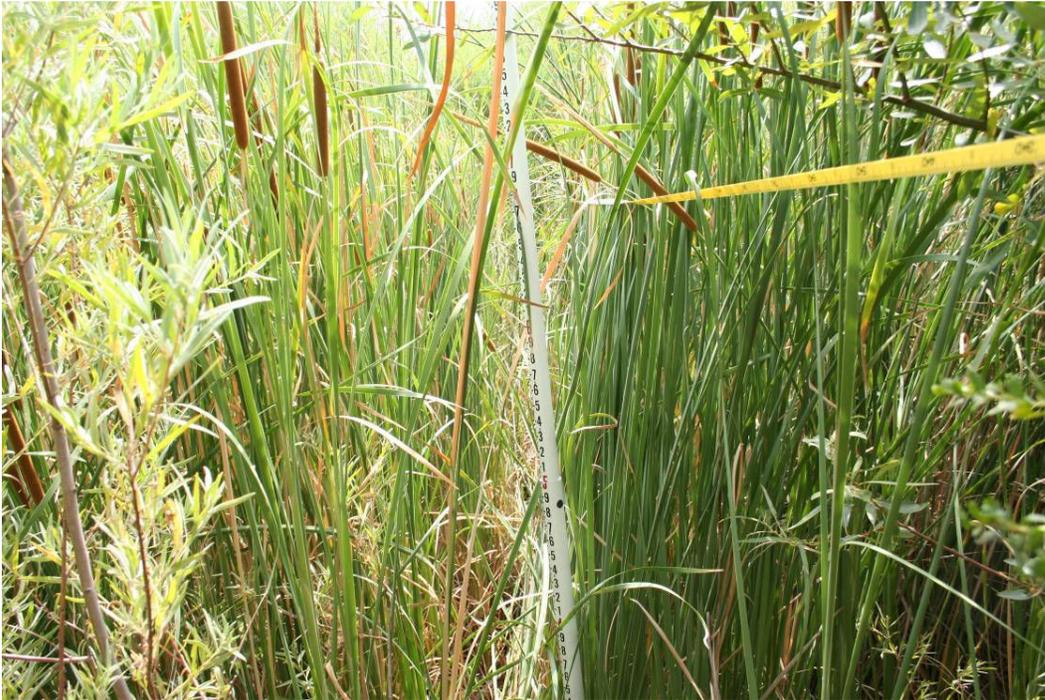
**Picture A-1**

**(View of vegetation growth during cross-sectional survey.)**

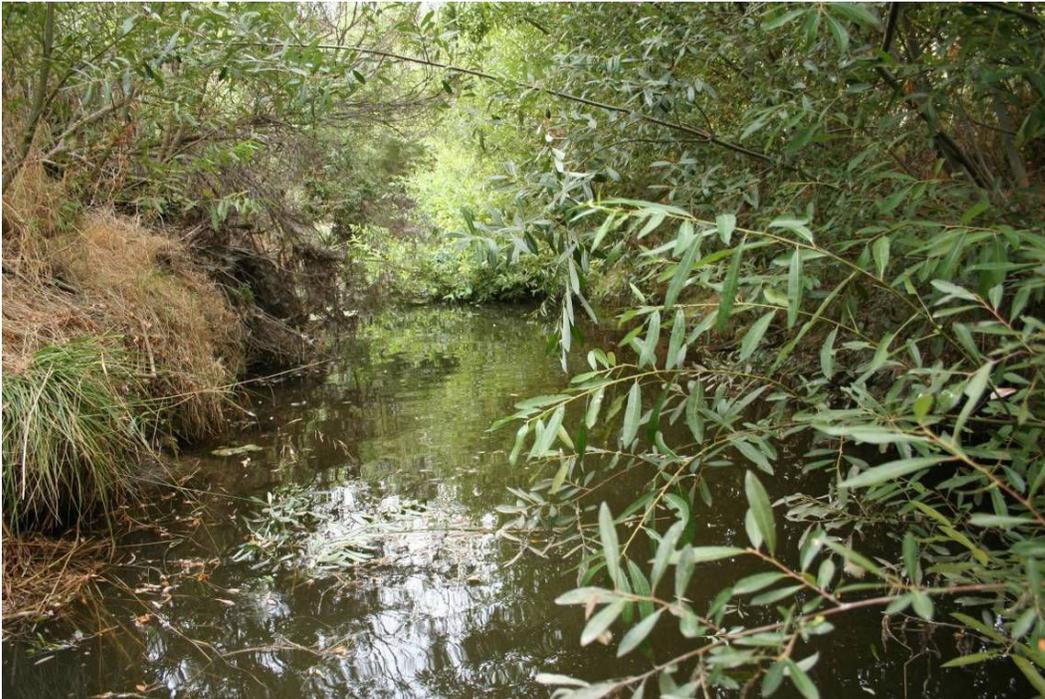
**Picture A-2**

**(View of low-flow channel and vegetation.)**

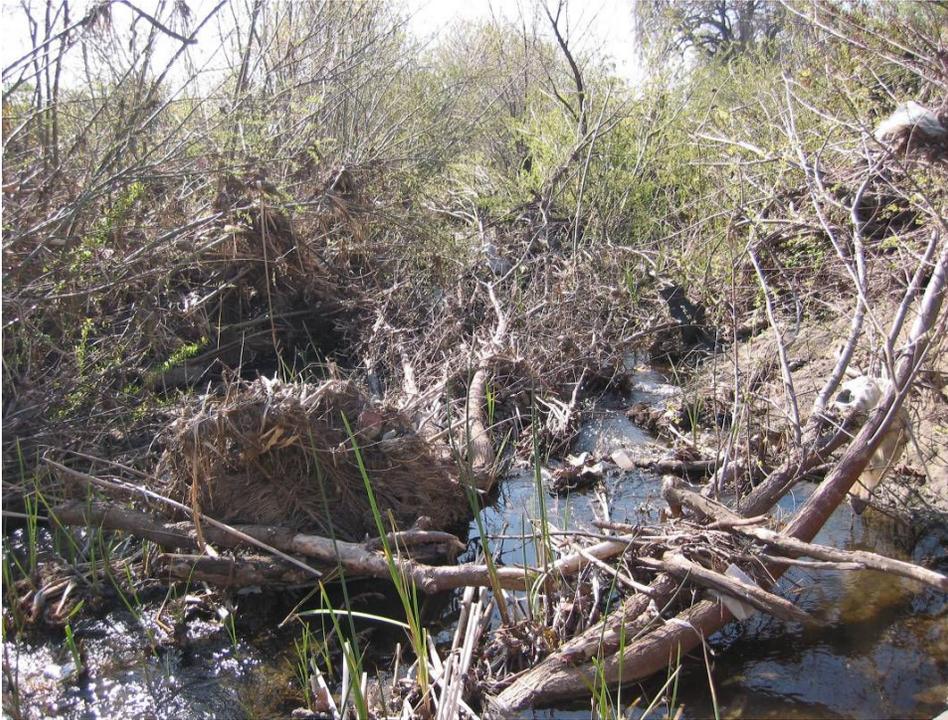
**Picture B-1**

**(Debris from December 2005 storm.)**

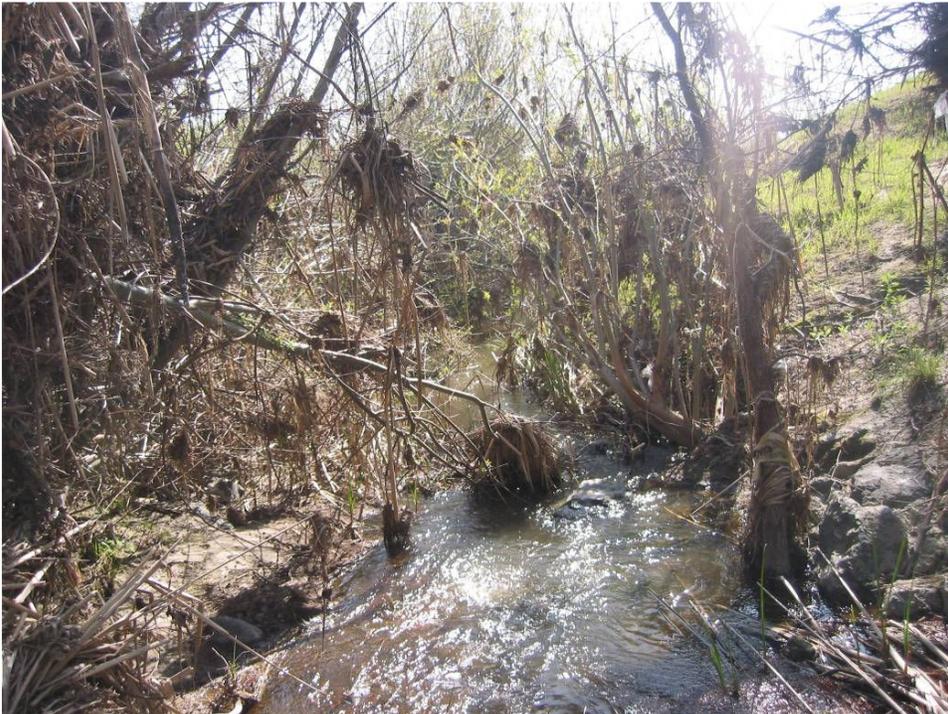
**Picture B-2**

**(Debris from December 2005 storm.)**

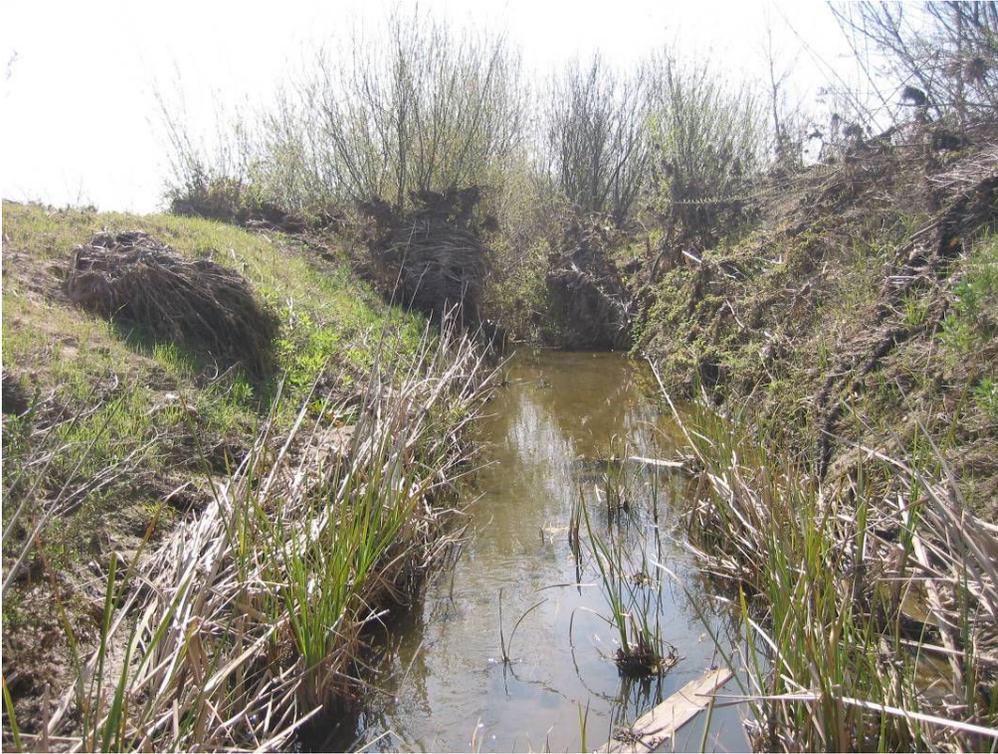
**Picture B-3**

**(View of low-flow channel and high water marks.)**

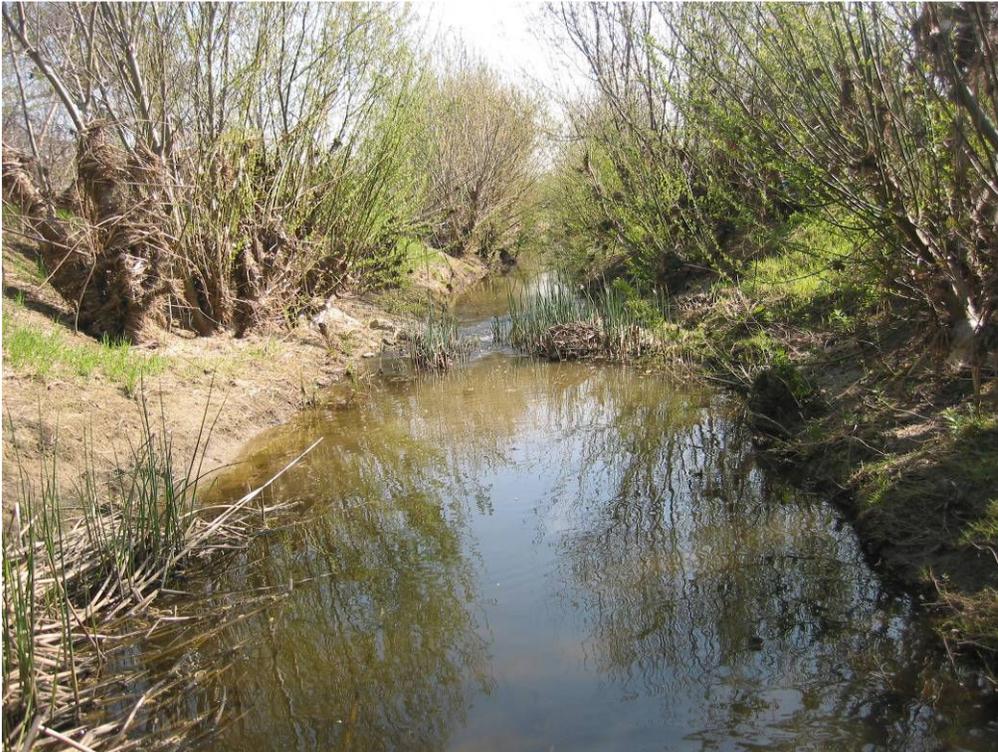
**Picture B-4**

**(View of low flow channel and natural floodplain terrace with high water marks.)**

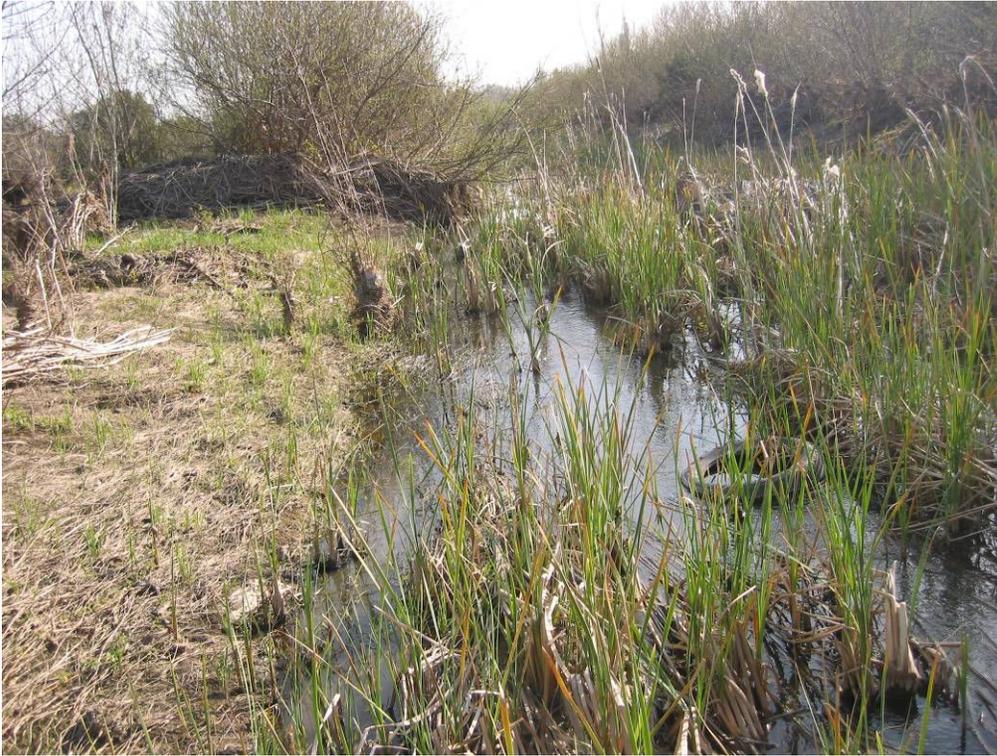
**Picture B-5**

**(Debris from December 2005 storm in lower reach.)**

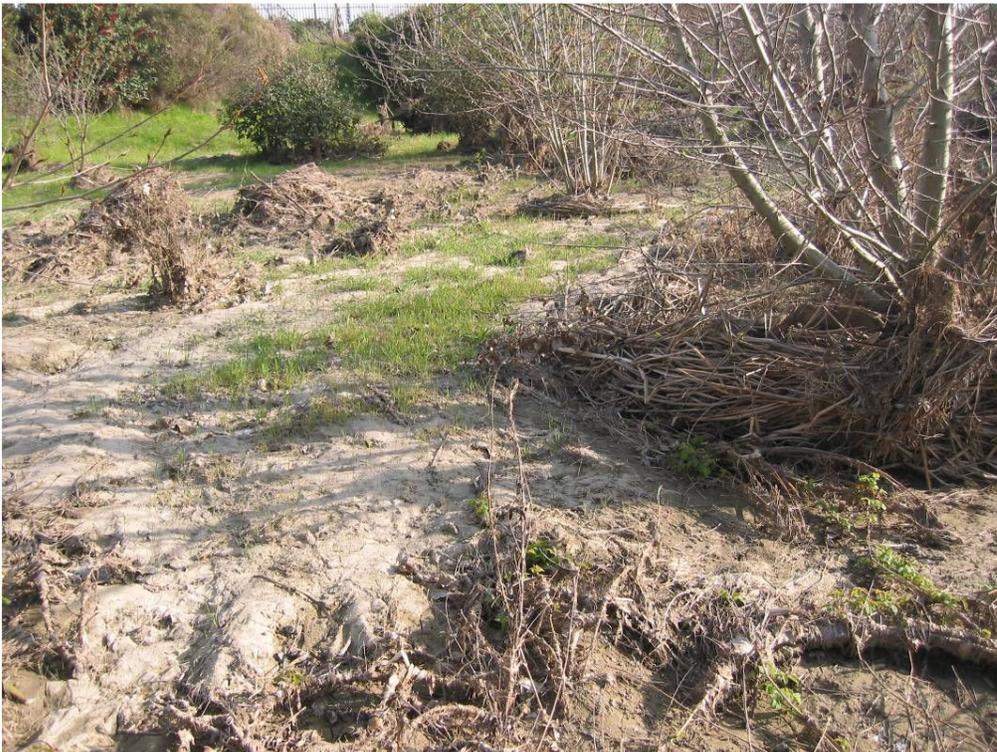
**Picture B-6**

**(Sediment deposition on floodplain.)**

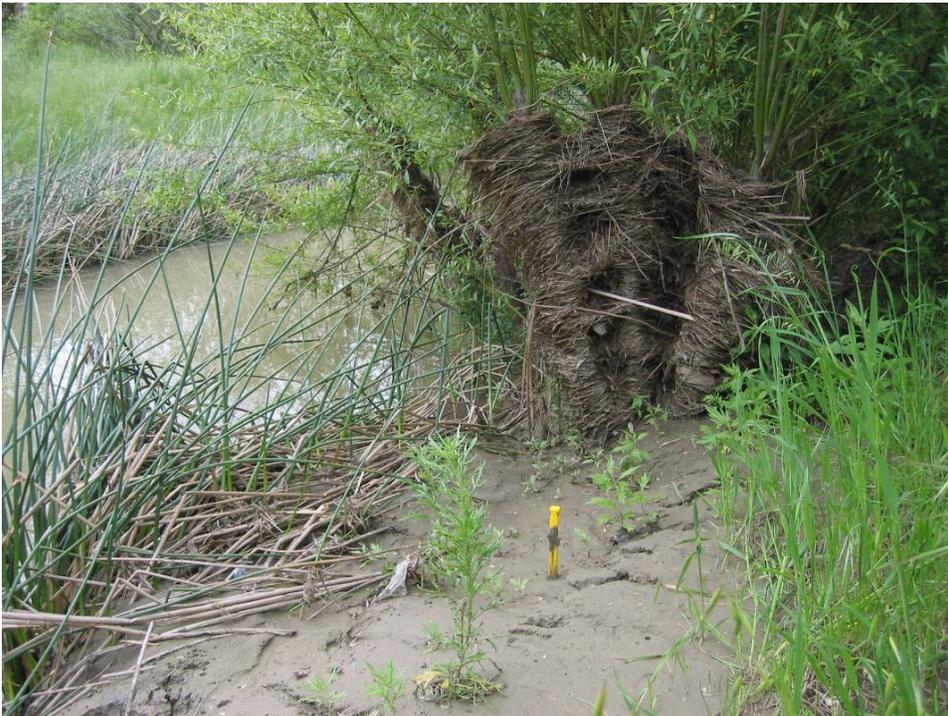
**Picture C-2**

**(View of sediment deposition on natural floodplain terrace.)**

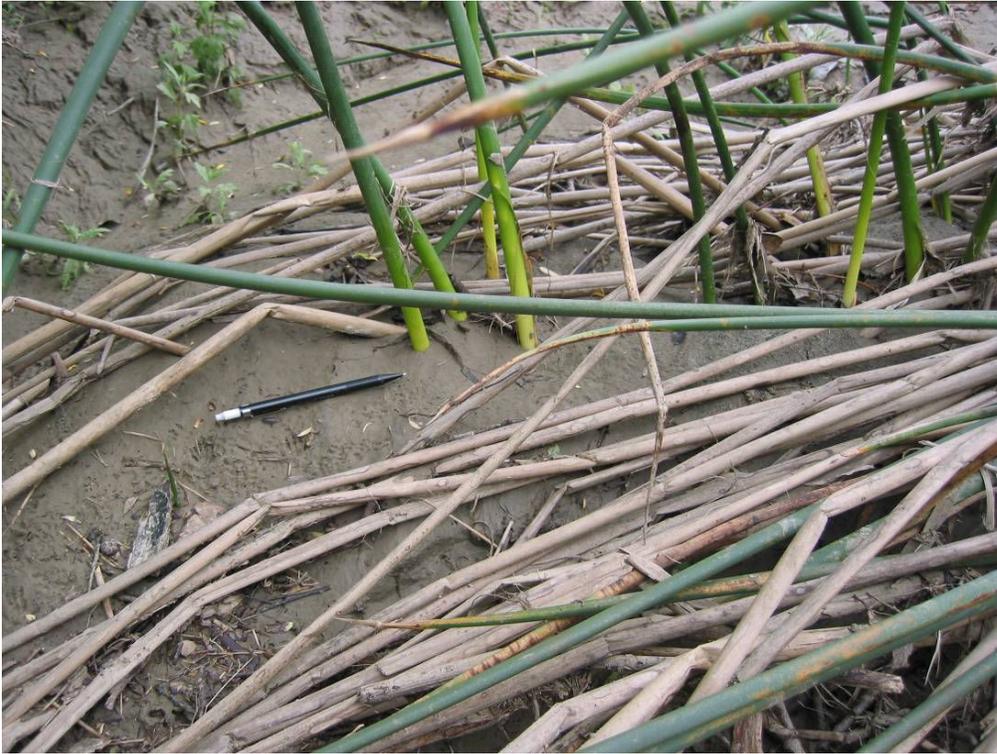
**Picture C-3**

**(Vegetation on natural floodplain terrace, with pencil for scale.)**

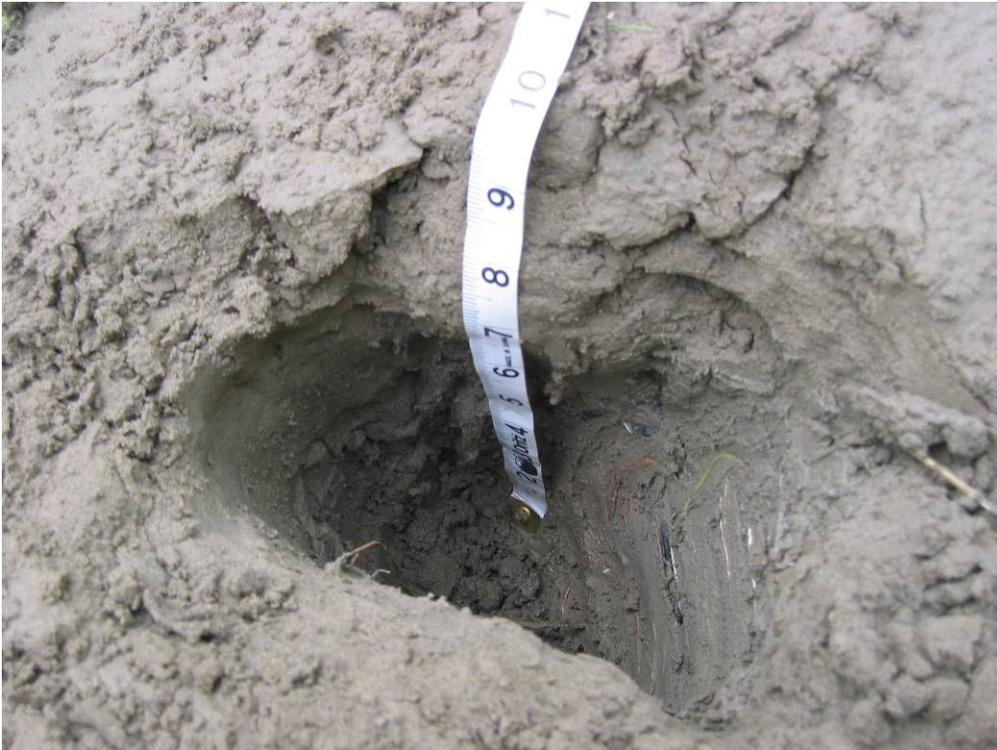
**Picture C-4**

**(Measurement of sediment deposition depth on natural terrace.)**

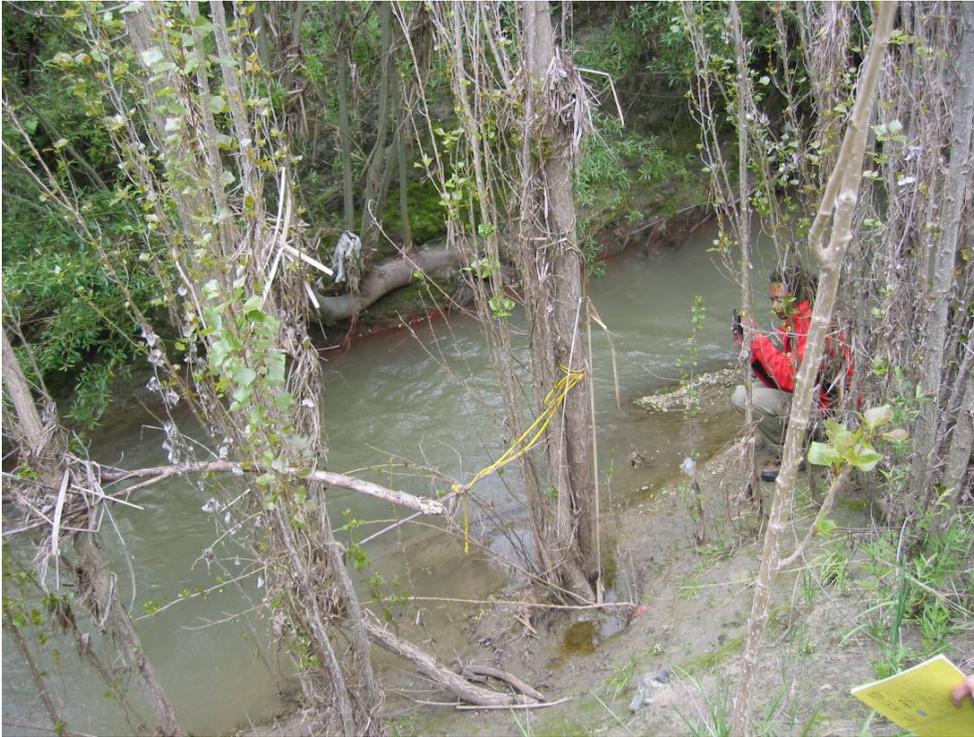
**Picture C-5**

**(View of the low-flow channel with vegetation and sediment deposition on natural floodplain terrace.)**
