Monitoring channel change at the Sausal Creek Restoration Project, Oakland, California

MONITORING CHANNEL CHANGE AT THE SAUSAL CREEK  
RESTORATION PROJECT, OAKLAND, CALIFORNIA

University of California  
Landscape Architecture 222  
Professor G. Mathias Kondolf  
Spring 2006

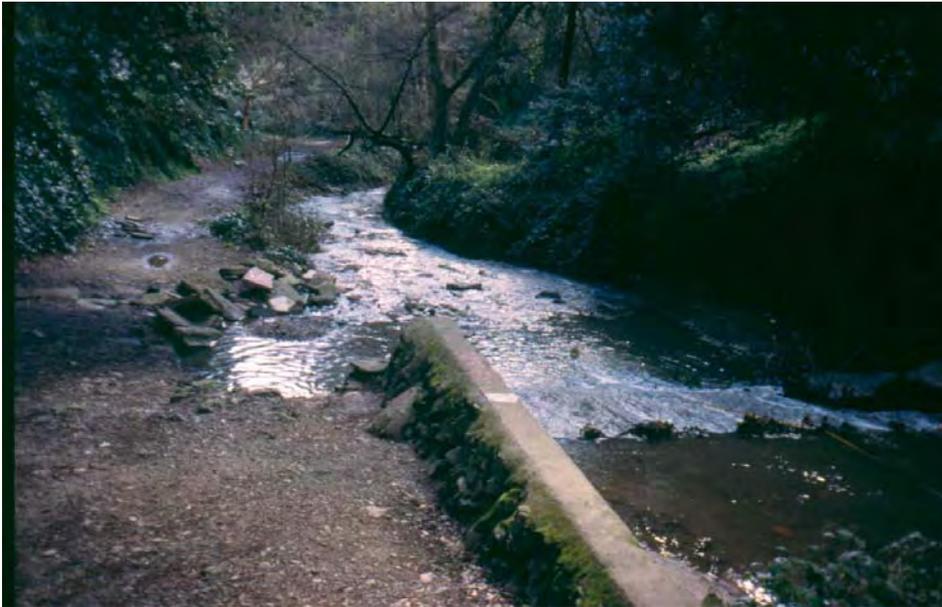
**Figure 6. Pre-Project Conditions at Sausal Creek Restoration Site**

Channel bank erosion at failing concrete check dam before project construction, looking in downstream direction. Photo: Drew Goetting (WRI), 2000

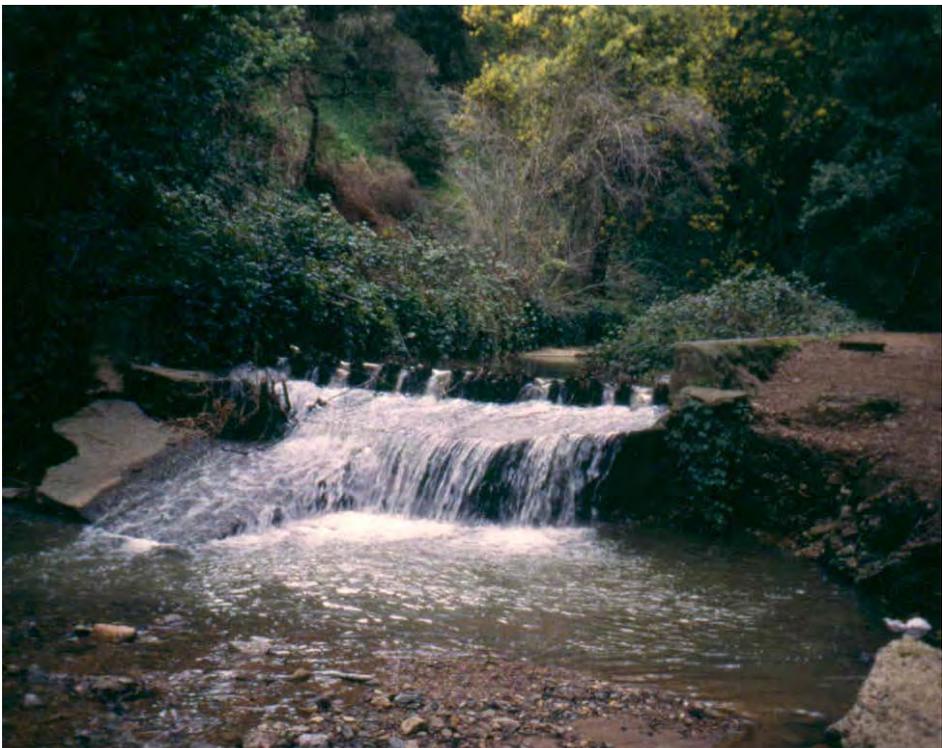
**Figure 7. Pre-Project Conditions at Sausal Creek Restoration Site**

Failing concrete check dam before project construction, looking in upstream direction. Photo: Drew Goetting (WRI), 2000

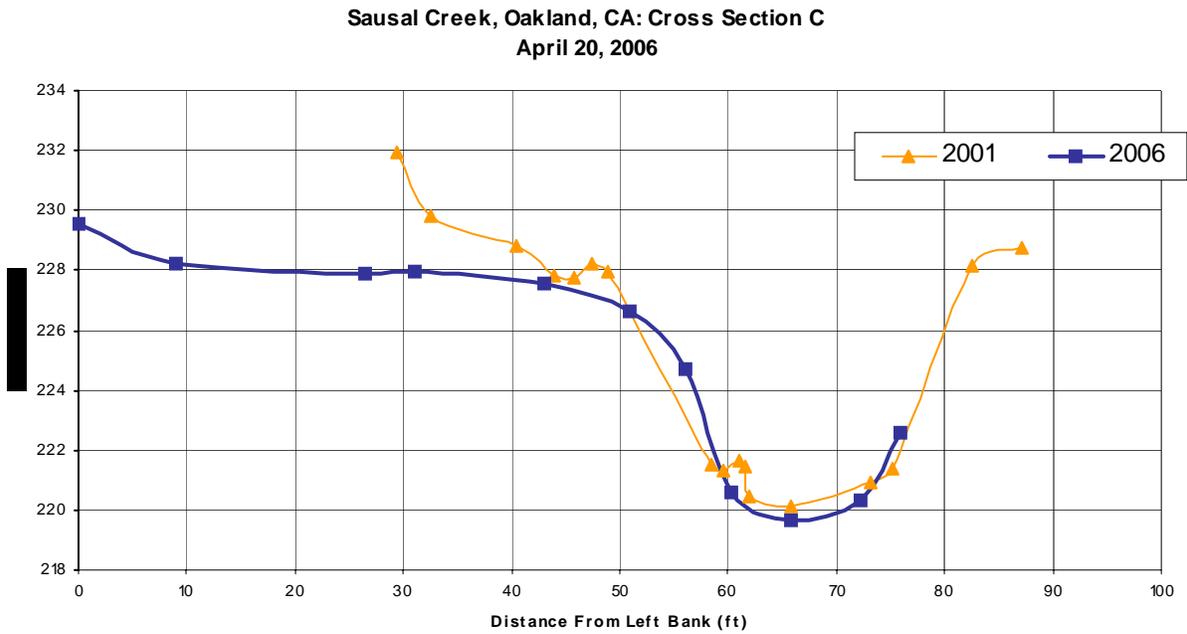
Figure 18. Cross Section C Survey

We did not locate the original rebar for cross-section C. However, the 2001 survey is in close alignment with the 2006 cross-section survey. E&L conducted a survey for cross-section C in 2005 at an unreferenced location. The channel banks appeared to remain stable between 2001 and 2006, while the bed has down-cut approximately 0.4 feet from the original surface elevation in 2001 (Figure 18). The upper left bank of the 2001 channel has been set back approximately 50 feet to create a wide terrace at the trail elevation. This change in the channel bank occurred after the 2001 as-built survey, when additional grading at the site was conducted to construct the pedestrian trail (Drew Goetting, Restoration Design Group, personal correspondence, April 2006).

Evidence of minor channel incision between 2001 and 2006. Change in slope on upper left bank is likely due to grading after implementation and as-built survey of restoration project.

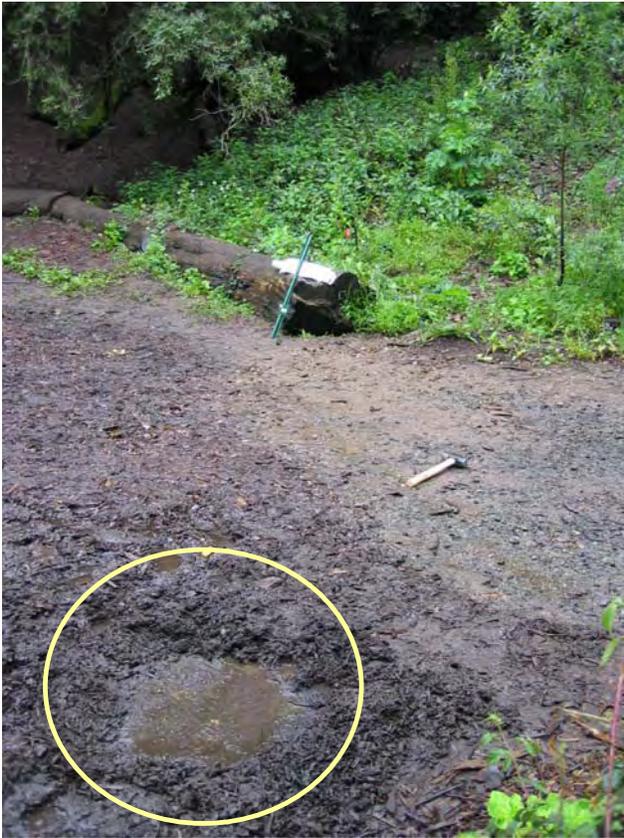
**Figure 20. Manhole near Cross Section C**

Manhole cover (56-000-63) partially buried by mud along cross-section C used as benchmark survey point.  
Photo facing south: TG, 4/12/06

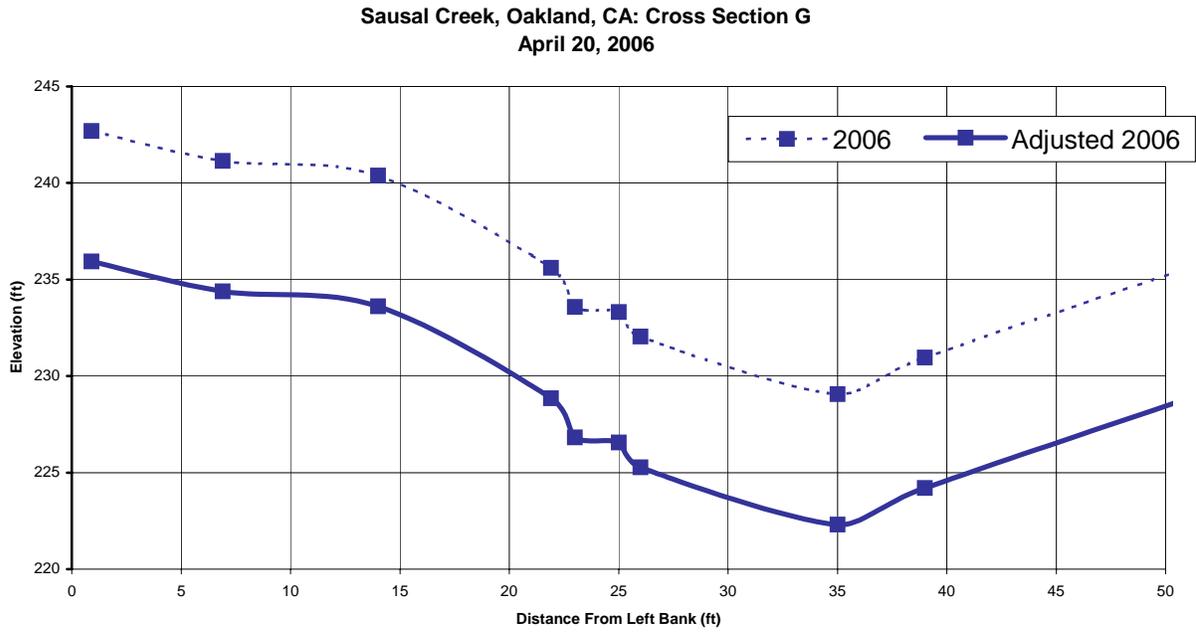
Figure 31. Cross Section G Survey

The as-built survey location for cross-section G could not be determined and a marker for the 2005 cross-section G was not found. Therefore, the 2006 survey establishes baseline conditions (Figure 31). Cross-section G is located around the bend of the trail, 101 feet from Cross Section F. The post marker is located on a moderately steep slope, densely vegetated with native shrub and herbaceous species (Figure 32). A tall (8-foot) wild rose bush (*Rosa* sp.) occurs between the trail and the post marker. We adjusted the elevation at G based on a fixed benchmark (the manhole cover near cross-section H), due to apparent error in vertical elevation calculated from a turning point survey measurement.

Cross-section G with adjusted elevation (solid line) to account for survey error.

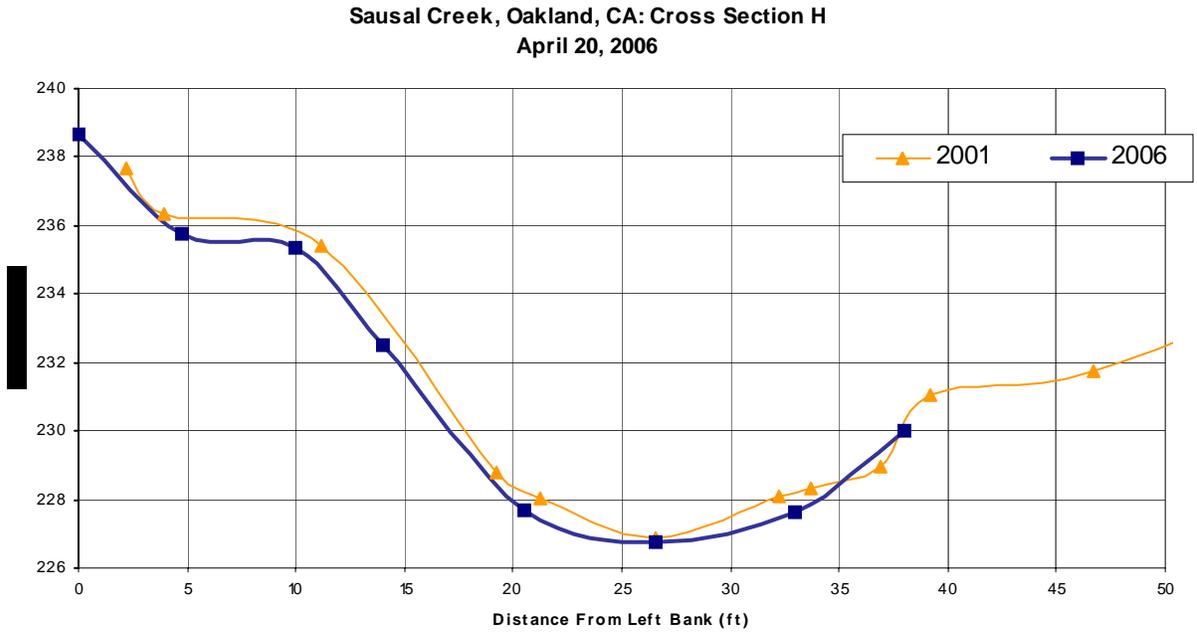
Figure 33. Cross Section H Survey

We established a new location for cross-section H. E&L did not survey cross-section H in 2005 and we did not locate the original rebar marker. However, the 2006 survey elevations align with the 2001 as-built elevations, suggesting that the new location is very close to the original (Figure 33). It is uncertain whether the differences in surface elevations are due to true changes in channel morphology or differences in survey point measurements along the cross-section. If the measured elevations are accurate, it appears that there has been widening of the channel bed and bank relative to the 2001. However, there was no evidence of active erosion observed in the field to explain the differences in bank slope elevations.

Uncertain whether difference in channel and left slope elevations are due to true changes in channel morphology along cross section or to differences in survey point measurements.

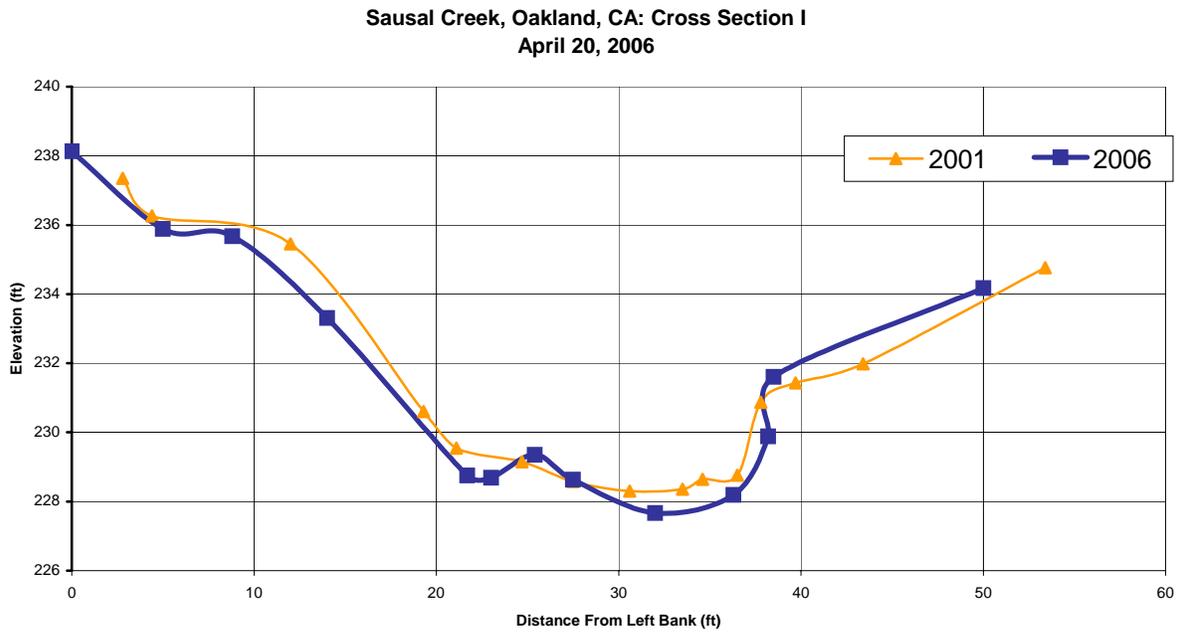
Figure 35. Cross Section I Survey

We located the original rebar marker for cross-section I and marked it with a green post. The post is located 159 feet along the trail past Cross Section H. Cross-section survey data from 2001 is in alignment with the current survey (See Figures 35 and 37 for profiles and current conditions). Since 2001, there appears to be a widening and deepening of the stream channel. The survey also indicates that a secondary channel has formed along the left bank. Erosion on both channel banks may have lowered surface elevations since the 2001 survey, although there were no observations made in the field to confirm the presence of active erosion on the bank slopes.

Stream channel has slightly deepened and widened since 2001 and a secondary channel has formed along the left bank of the streambed.

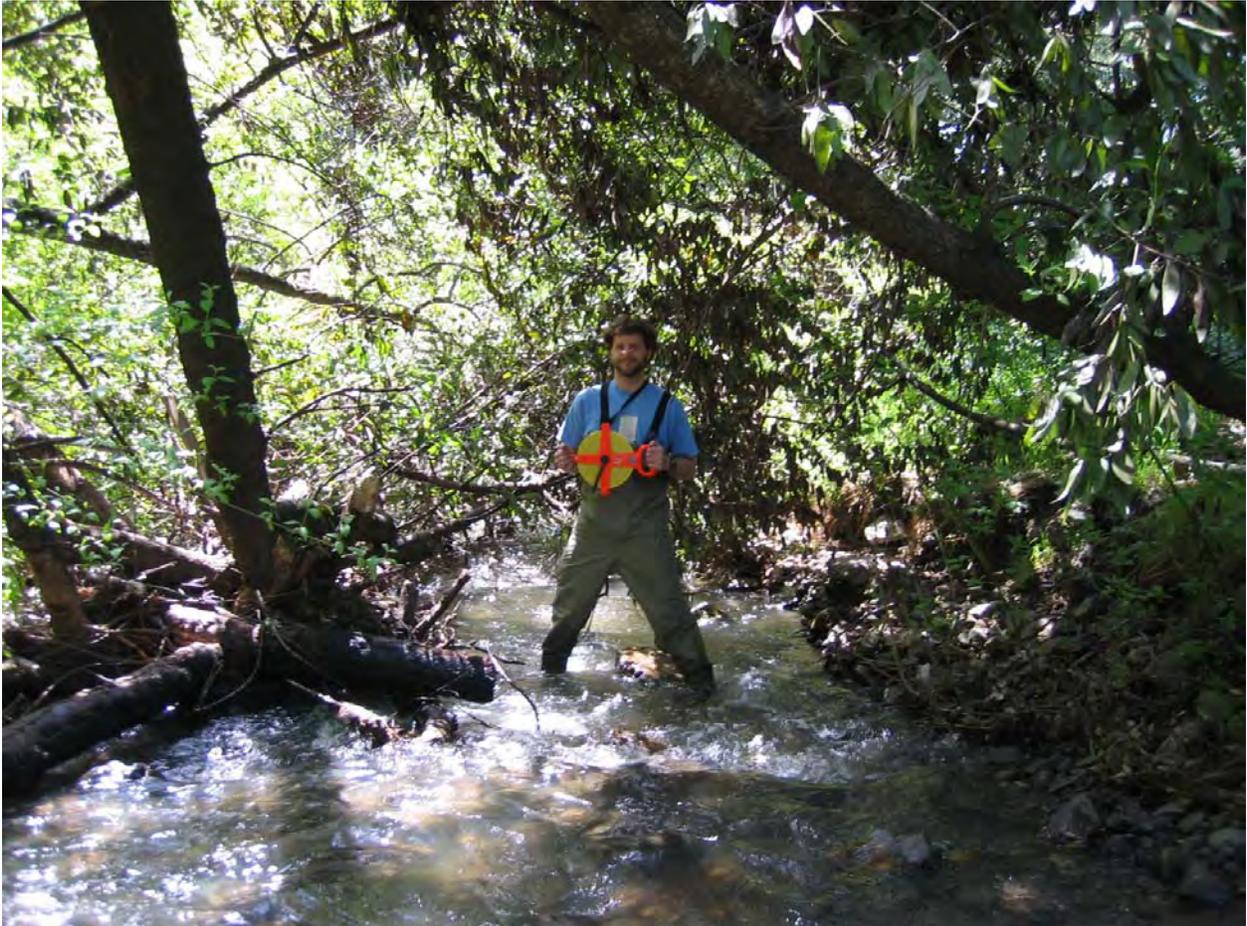
**Figure 37. Cross Section I Channel Conditions**

Fallen bay tree within stream channel across cross-section I alignment. Photo: KT, 4/20/06

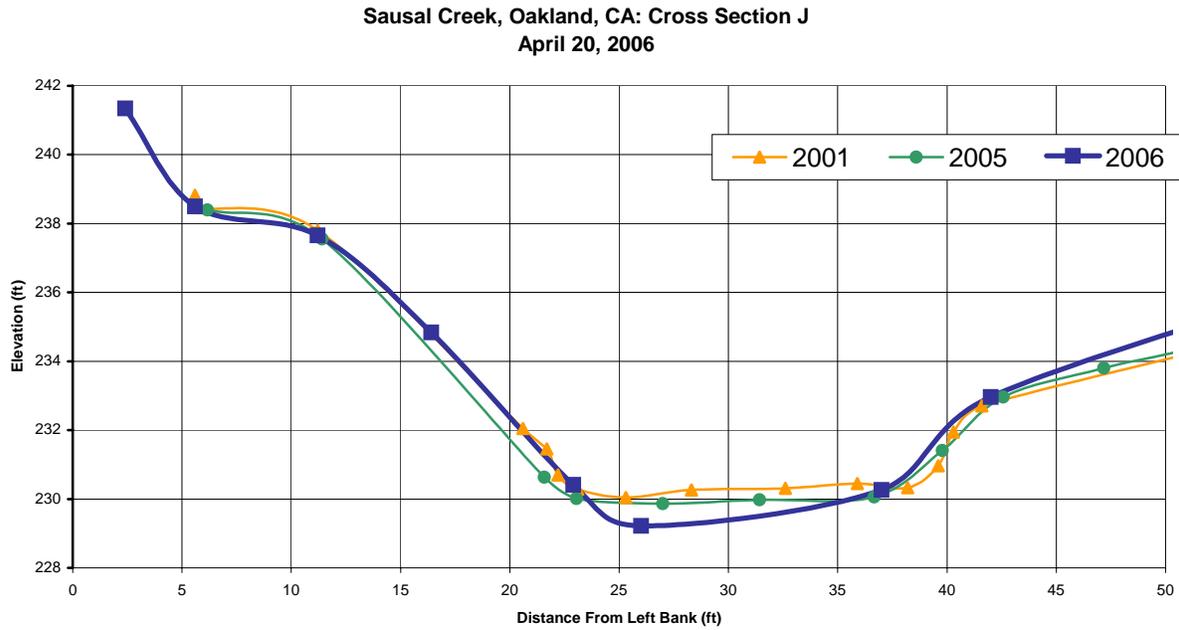
Figure 38. Cross Section J Survey

We relocated the cross-section J rebar marker. The current survey was in alignment with the 2001 as-built and 2005 surveys (Figures 38 and 41). There was a substantial decrease in bed elevation since 2001. Between 2001 and 2005 the thalweg elevation decreased by approximately 0.2 feet. From 2005 to 2006, there was a decrease in thalweg elevation of approximately 0.7 feet. There also appears to have been an increase in elevation on the left bank, likely due to differences in point survey locations. Similarly, different point location measurements of previous surveys may explain differences in shape of the right stream bank.

The streambed elevation was relatively stable between 2001 and 2005, but decreased by approximately 0.7 feet at thalweg between fall of 2005 at April 2006 survey.

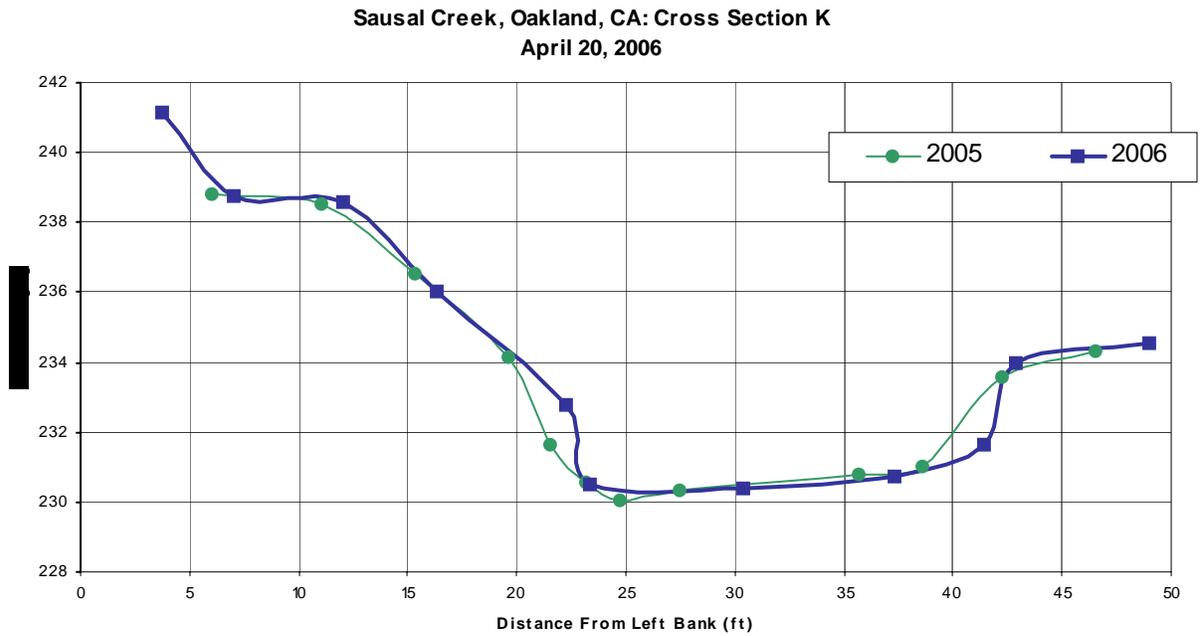
**Figure 42. Cross Section K Survey**

We relocated the rebar marker, but there was no as-built survey conducted at cross-section K. The cross-section location was in alignment with the 2005 survey (Figures 42 – 44). There does not appear to have been a significant change in bed elevation since 2005, although there are

notable differences in the slope of the lower stream banks. It is impossible to determine if these differences are real or due to shifts point elevation locations.

No apparent change in bed elevation since 2005 survey. Differences in lower stream channels are likely due to differences in locations of point elevation measurements.

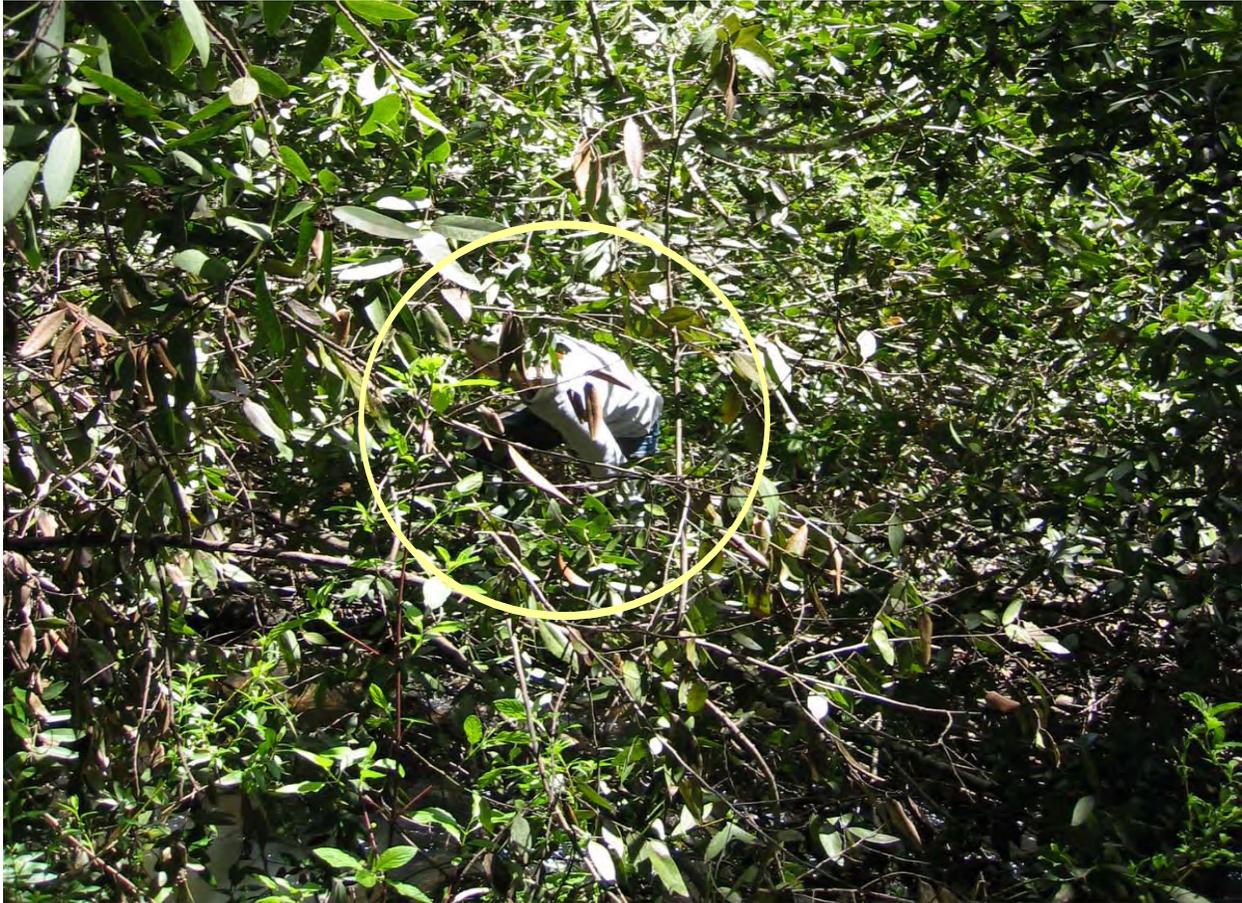
**Figure 45. Example of Surveyor at Inaccessible Survey Location**

After establishing the new cross-section locations, we discovered that creek conditions at some of the cross-sections were not well suited or accessible for surveys (Figure 45). Dense vegetation along some transects may have led to measurement error of horizontal distances and elevations. . In general, the right stream bank was difficult to survey due to steep slopes and dense vegetation. In some cases, we were unable to obtain accurate surface elevations along the cross sections due to impenetrable vegetation. Given that the cross-sections are now permanently established, we recommend bringing a machete to clear overgrown vegetation along the cross section alignment during future surveys at the site.
