Post-Project Assessment of the 2003 Cerrito Creek Restoration and Recommendations for Additional Stormwater Management

Michelle Adlong, Michael Cook, Matthew Kennedy

December 14, 2011 - LAEP 227

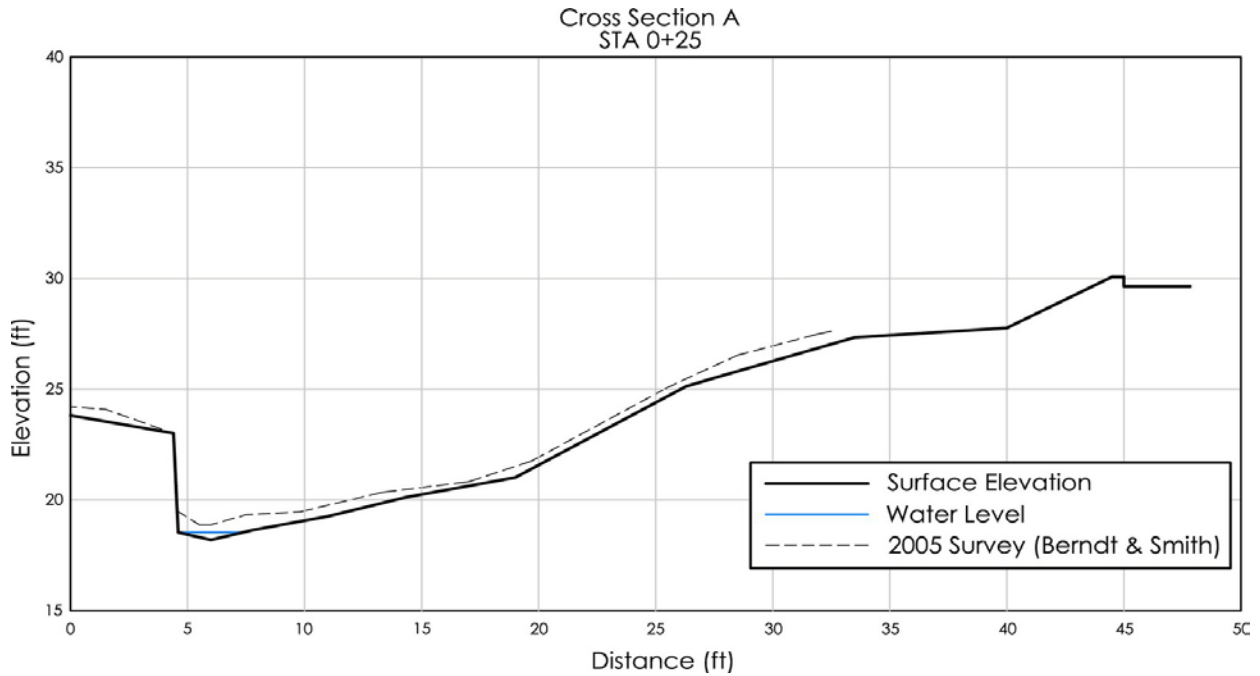
Our most accurate cross-section, cross section A, showed that that the creek had down-cut approximately 8 inches, further exposing the base of the masonry wall directly adjacent to the channel's flow. Additionally, the right bank had eroded slightly, possibly due to overland stormwater runoff flow or the impacts of human use. A comparison of cross-sections B,C,D, and E to those surveyed in 2005 could not be accurately made because of the error in the cross-sectional survey locations.

Figure 4: Cross Section A at STA 0+25, showing recent (2011) and past (2005) surface elevations.

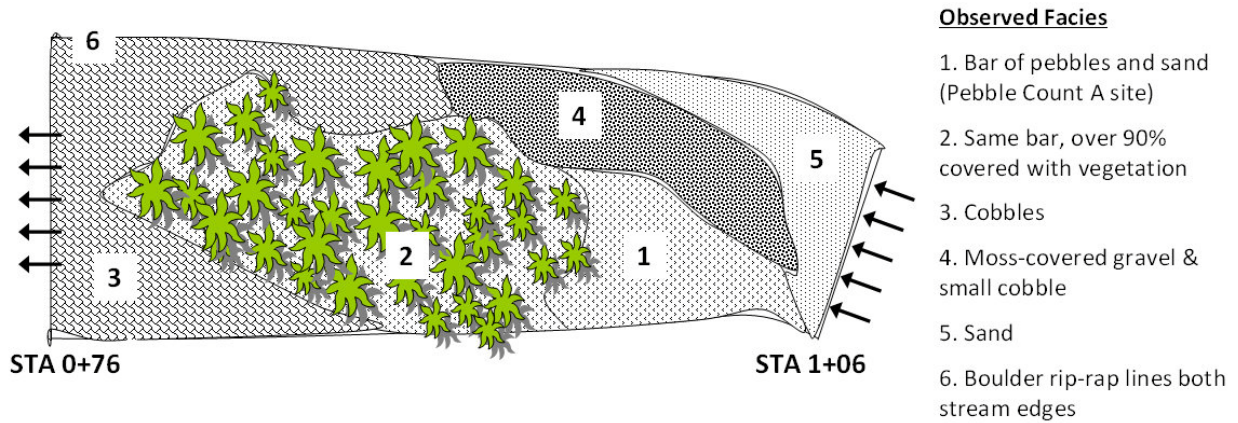
Facies Map A (Figure 9) shows sediment deposition following a creek bend. A bar of primarily small pebbles and sand stretched nearly entirely across the stream bed. Surrounding the bar were deposits of different size, including sand, small gravel, and large cobbles. Pebble Count A was conducted at this bar and the results are plotted in Figure 10. The pebble count revealed a high percentage of fine sediment and a median pebble diameter of between 8-16 mm. Much of the bar was covered by watercress, which may have been present due to the small sediment size and the high levels of nutrients such as nitrogen or phosphorus (SFBRWQCB 2008). Facies Map B (Figure 11) also revealed sediment of diverse sizes distributed between two rock weirs. The weirs constricted the flow, directing it at high velocity downstream and likely influencing sediment sorting. Pebble Count B was conducted at the main gravel bar and showed a sediment of slightly larger size than in Pebble Count A, but still of median diameter between 8-16 mm.

Figure 9: Facies Map A, from 76-106 feet upstream of Kains Avenue. Pebble count A (see Figure 12) was performed at location 1 in this map . Note: Not to scale.

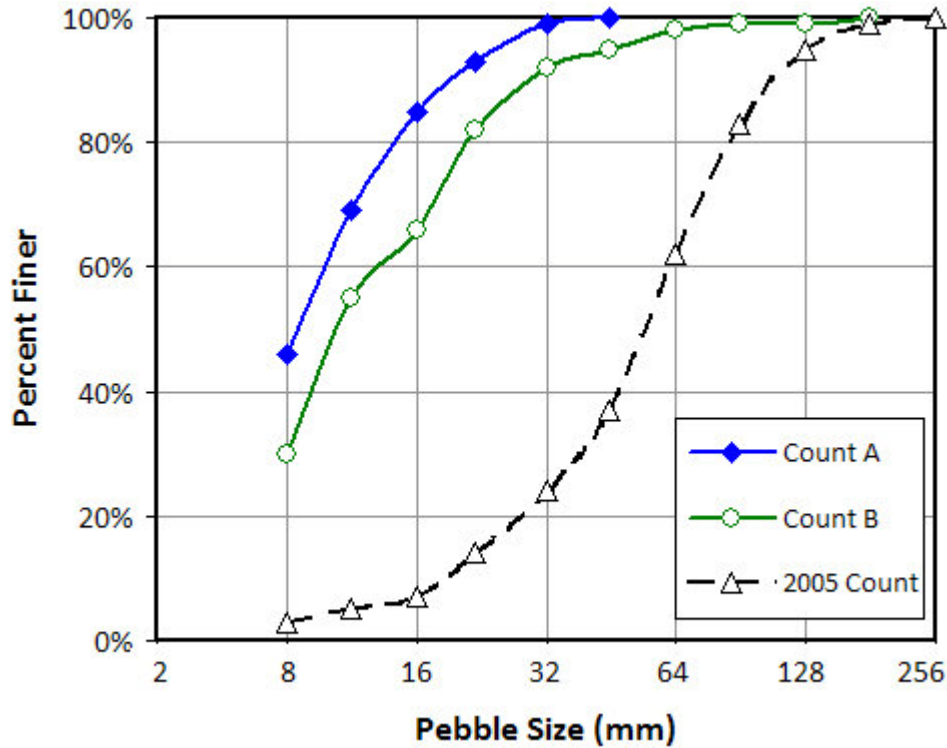
In 2005, the sediment was uniform with a median diameter of 45 mm, and the upstream reach was muddy and lacked any sediment (Berndt & Smith 2005). Both of our pebble counts reflected a significant decrease in sediment size, although some minor facies not characterized by a pebble count appeared to have larger sediment size. We theorized that the 2005 count reflected cobble that was anthropogenically deposited during the 2003 restoration, while in the six years since the entire stream bed had become covered with sand, gravel, or cobble. Sediment deposits of the size observed may enhance fish spawning habitat in the future, though deposits characterized by our pebble counts may be slightly finer in size than might be ideal (Kondolf and Wolman 1993).

Figure 10: Pebble count results for gravel bars at (a) 91 feet upstream of Kains Avenue culvert, and (b) 220 feet upstream of Kains Avenue culvert. Pebble count data is shown in Table 2.

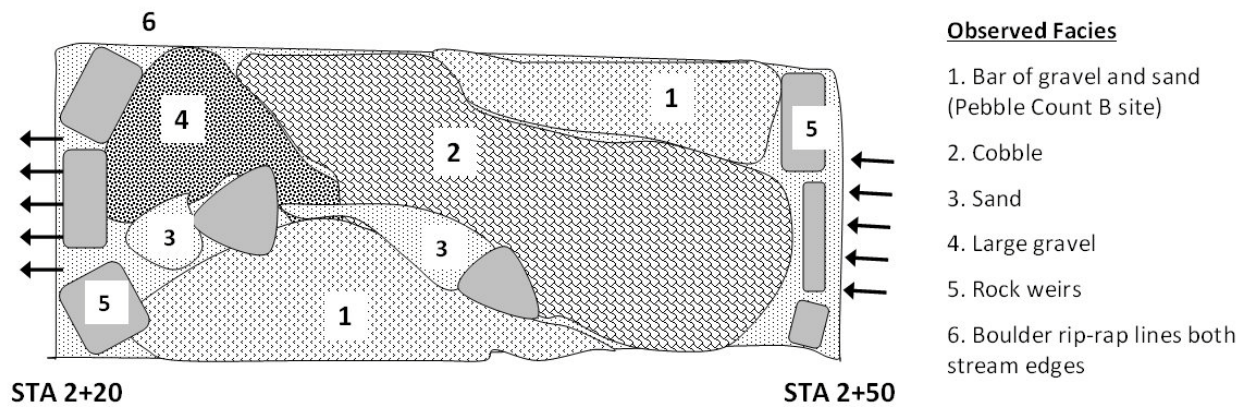
Figure 11: Facies Map B, from 220-250 feet upstream of Kains Avenue. Pebble Count B (see Figure 12) was performed at location 1 on this map.. Note: Not to scale.

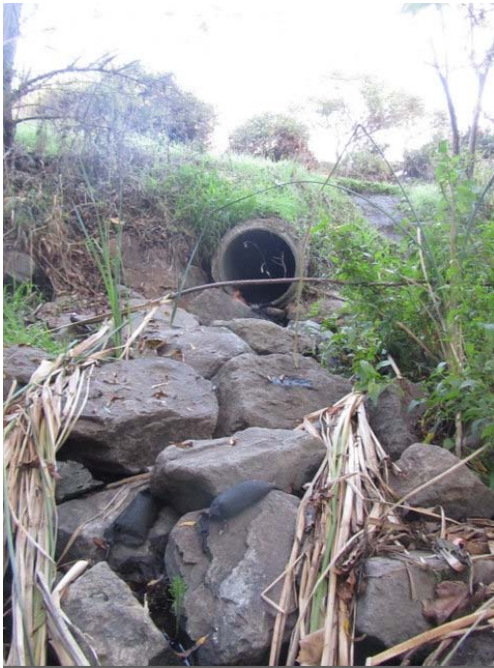
Figure B2: Stormwater outfall from El Cerrito Plaza parking lot to Cerrito Creek.

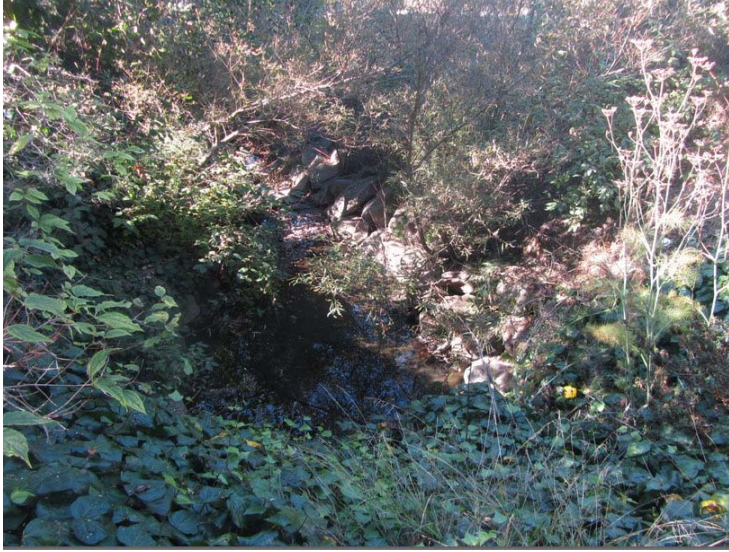
Figure B5: Deep pool just downstream of Talbot Avenue culvert. Invasive species as well as native plants are visible.

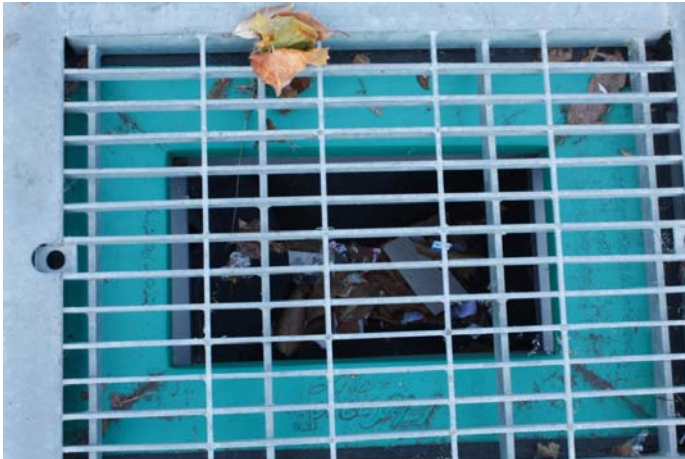
Fossil filters within the stormwater catch basins were installed in 2003 to filter all the water from the roof and parking lot drainage systems (Aliquot, 2011). When maintained properly and regularly, fossil filters can remove hydrocarbons, metals and particulate matter. At the shopping plaza, the extent and frequency of maintenance was unclear and compliance monitoring seemed to be self-regulated. Upon inspection of two of the catch basins, the fabric of the fossil filters appeared torn and there was an accumulation of trash inside the basin, indicating that the fossil filters may not be functioning as intended. A photo of the fossil filters can be found in Appendix B, photo B6.

Figure B6: View into a parking lot drainage basin showing collection of debris and rubbish. Scheduled maintenance for these structures was undetermined.
