Continued monitoring of the Tassajara Creek restoration project 2004

Oden, Matt

DeHollan, Aurel

2004-05-01

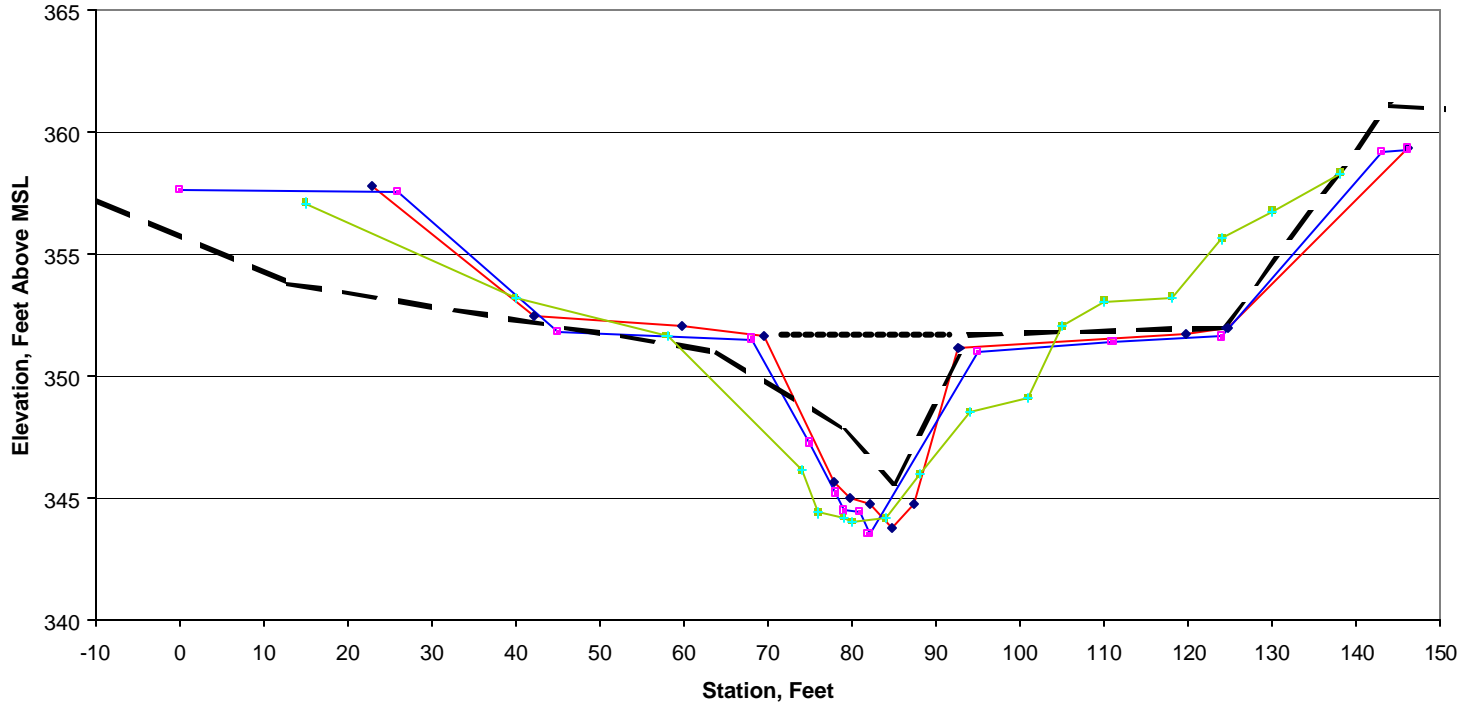
Figure 4.

Cross-section EE' suggests signs of aggradation, erosion, and deposition. Figure 4 shows the channel morphology and the aforementioned aggradation of the creek bed. The overlay suggests that the banks on both sides of the channel eroded considerably during the wet season widening the channel, and that the right side of the floodplain terrace experienced deposition ranging from one to three feet. We cannot confirm the erosion because of the incomparable distances between survey, nor the deposition because our field work took place months after the high flow events and grasses were growing on the floodplain terrace. This limited us from noting how fresh the deposition was. The overlay suggests that the left bank eroded significantly, but we did not take note of this in the field. However, we did note high water marks to be 7.1 feet above the thalweg for this cross-section, thus placing the flows of this year as high as the channels bank full discharge, which is not high enough to directly erode the left bank.

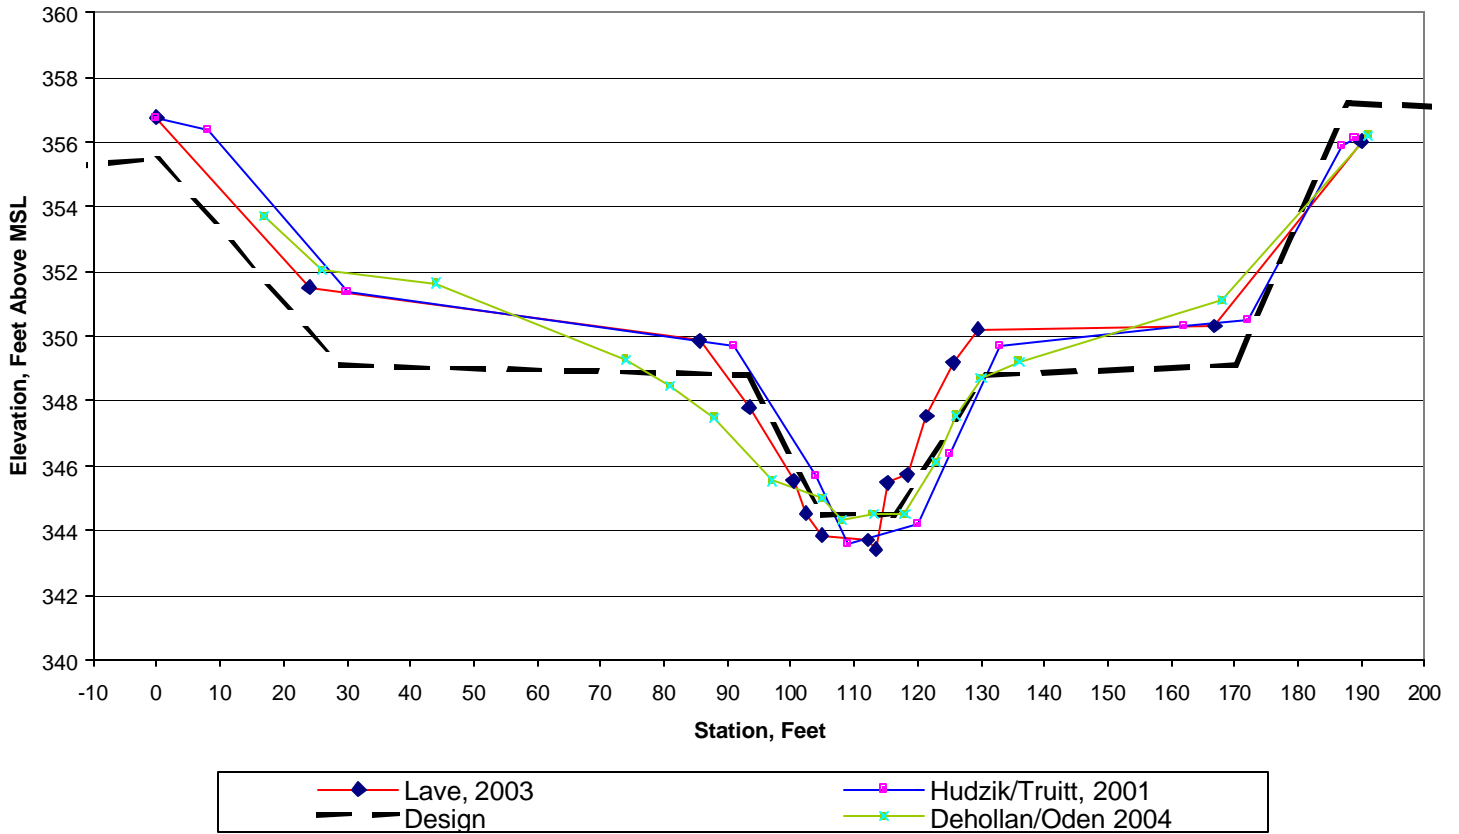
Figure 5.

Cross-section FF' also suggests aggradation, erosion, and deposition, though not as noticeably as EE'. Figure 5 reveals that the channel may have widened mostly due to erosion on the left side, but the right side appears to have also eroded slightly.

Unfortunately, we cannot confirm these findings because of the incomparable distances. The right floodplain terrace looks similar to previous studies, but the left seems to have received some minor deposition since the last survey.

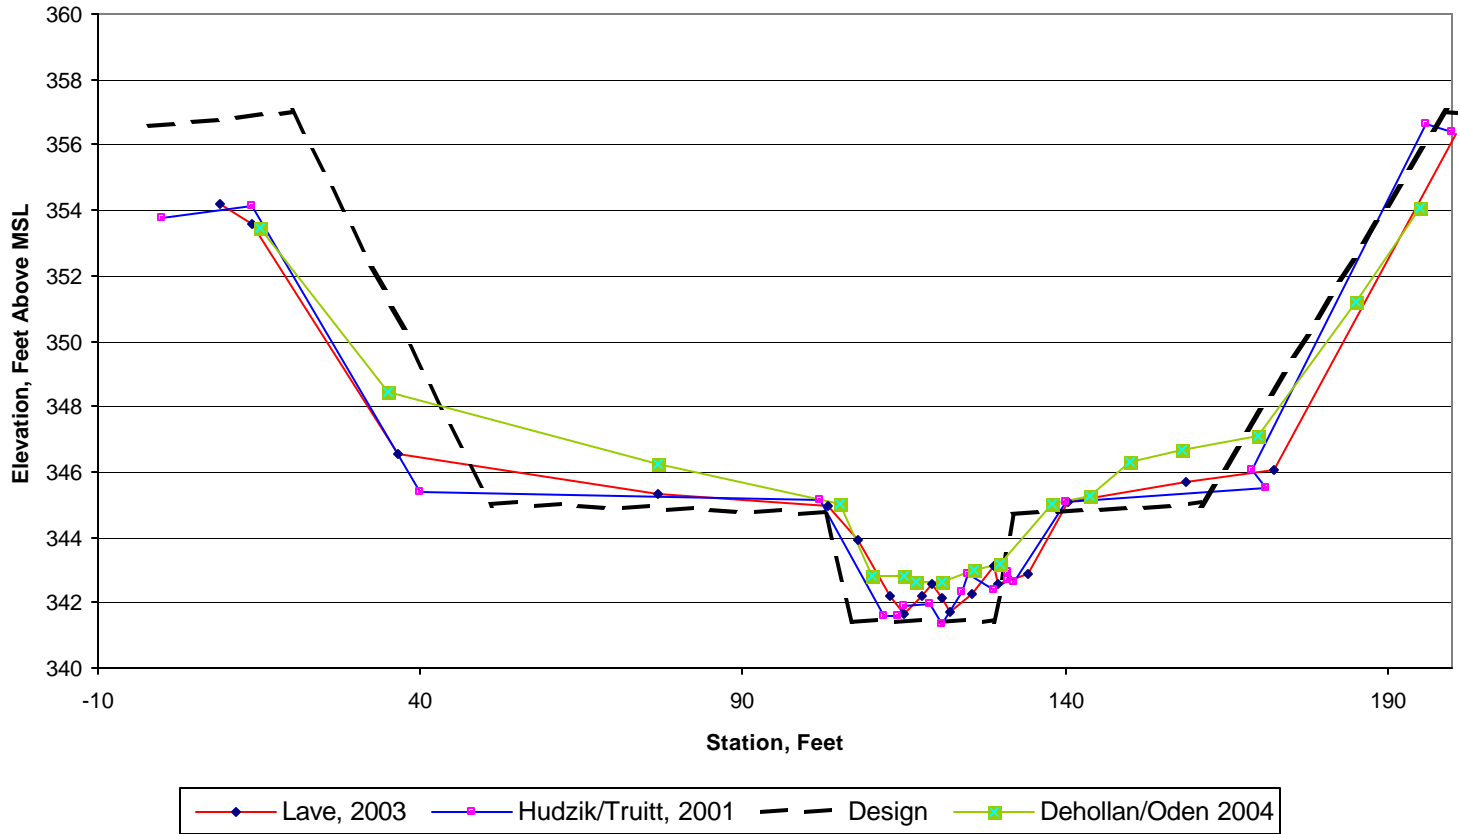
Figure 6.

Cross section GG' shows that Tassajara creek responded to the high flows of the 2004 water year through aggradation of the creek bed and deposition on the floodplain terraces in this part of the lower reach (Figure 6). The overlay suggests that the floodplain terrace rose between zero and three feet following the high flow events, with the left side showing considerably more deposition. Unfortunately, our field observations cannot confirm this notion. The channel structure appears to be comparable to the previous surveys.

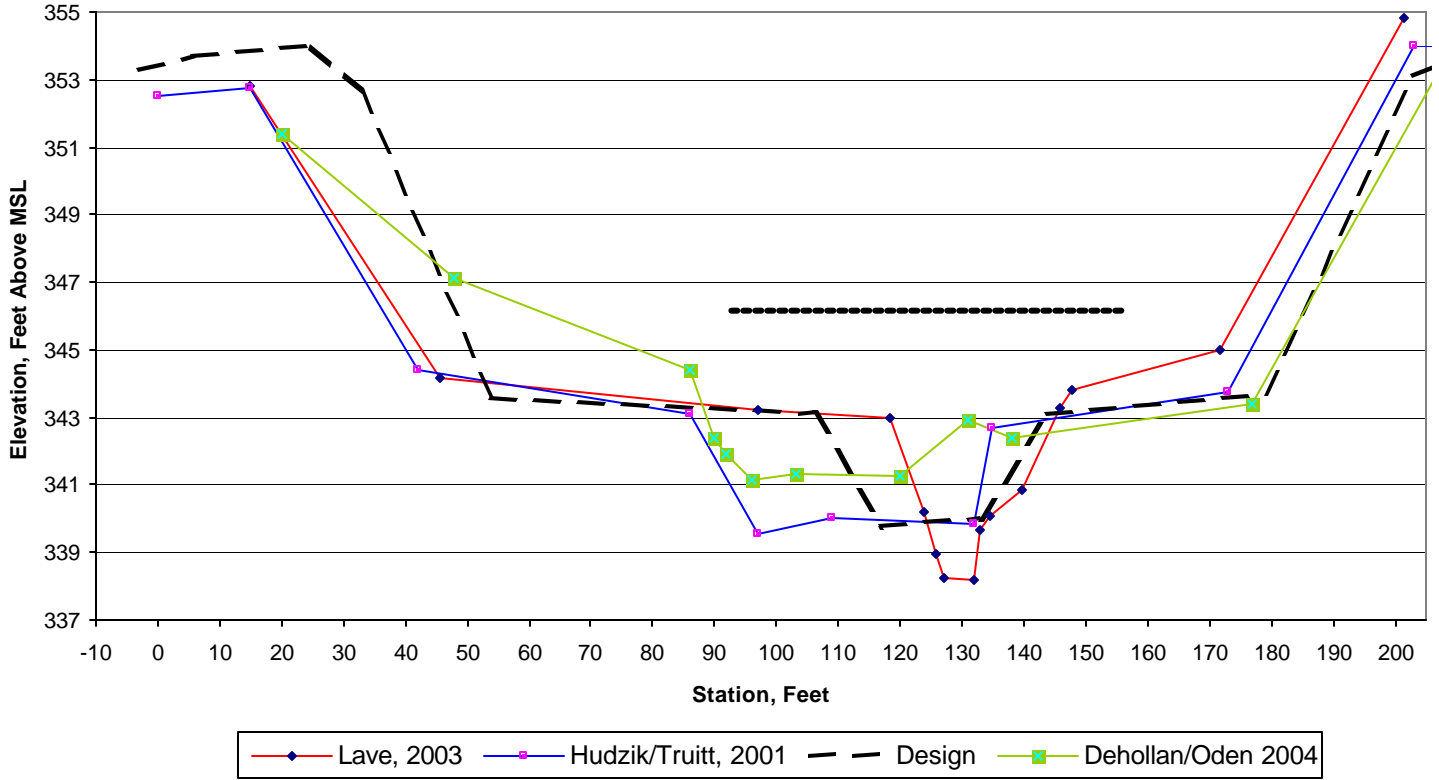
Figure 7.

Cross section HH' shows signs of channel widening and aggradation since Lave's 2003 survey, as well as significant erosion of the river's left bank (Figure 7). In our survey we noted two small channels flowing through an area where reeds had colonized the creek bed, but more water was flowing through the small channel furthest east. The right floodplain terrace is almost non-existent, as it has assimilated with the bank to form one continuous slope leading to the channel. Therefore, what appears to be deposition may actually be erosion from the bank resituating the left floodplain terrace at a higher elevation. We also noted high water marks at five feet above the thalweg for this location,

thus placing the high flow of 2004 along the left bank and flowing out onto the right floodplain terrace.

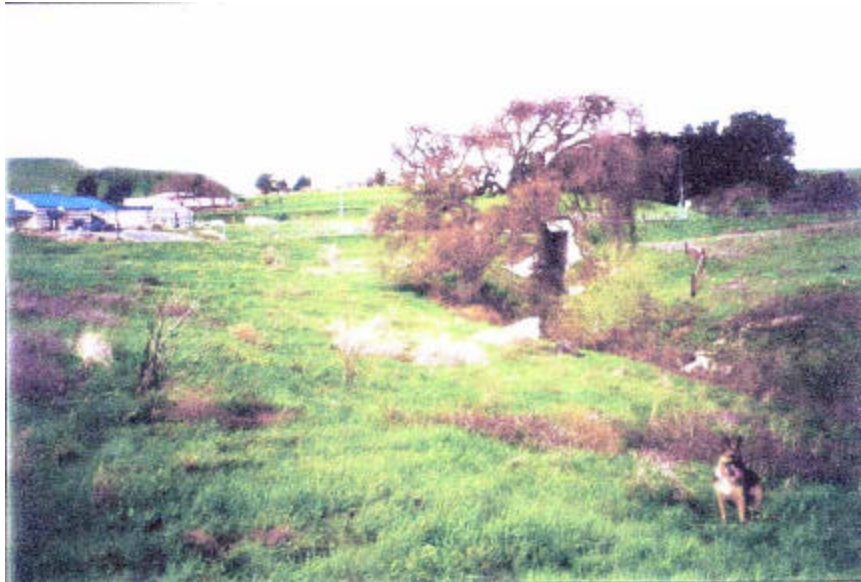
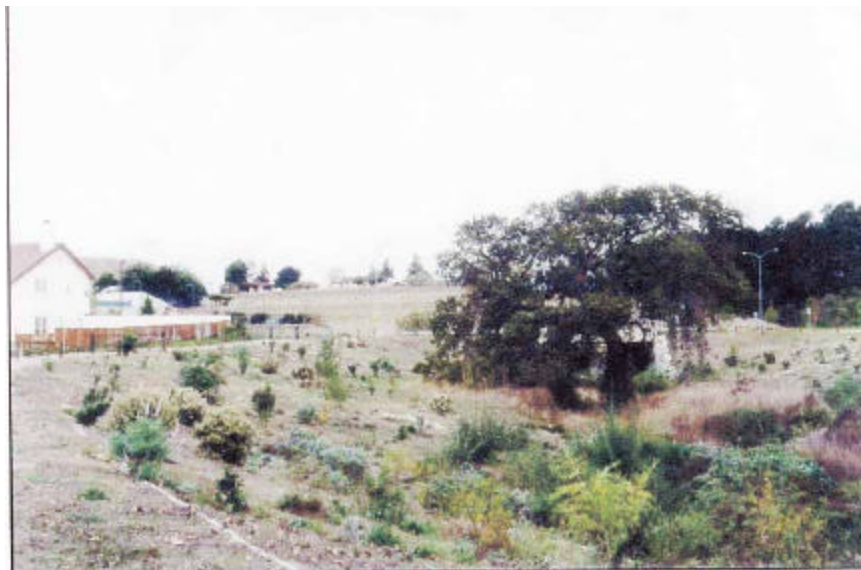
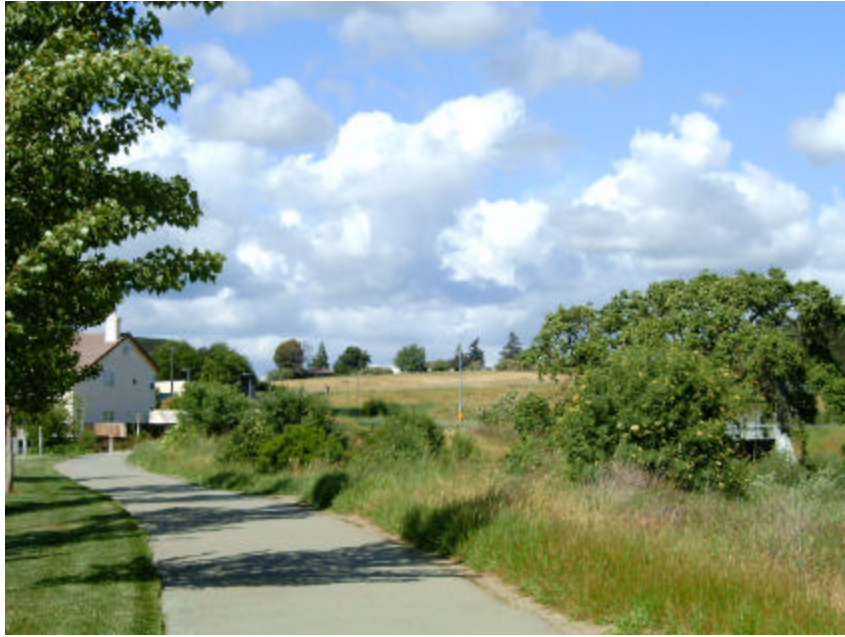
Photo Series 1

Photographs of the restoration area show maturation of riparian vegetation. In 1999 Restoration Resources contracted with Summerhill Homes to restore wildlife habitat and create recreational area creek side. They planted over 5000 trees and created an irrigation system to be used for three years. A close look at photo series 1 & 2 shows that the original project goals of restoring riparian habitat and creating vegetative trails along the restoration reach have been successful since the irrigation system was discontinued in 2002 (Restoration Resources, 2004). The upstream and downstream photos taken from each cross section (Figures EE.3, 4, FF.3, 4, GG.3, 4, HH.3, 4) give further proof to the success of the project, as riparian vegetation appears to be fully established and growing vigorously to the point that the density of growth is making surveying increasingly difficult. The increase in vegetation increases the roughness of the channel, which in turn will lower the velocity of the water during storm events (Chow 1959). This will help to protect the channel from being drastically altered in high flow events, so that the riparian habitat, recreational area, and highly valued oaks can be preserved.
