Tassajara Creek restoration project: Continued riparian habitat monitoring

**Tassajara Creek Restoration Project:
Continued Riparian Habitat Monitoring**

**Michelle Trinh and Julie Percelay
University of California, Berkeley**

December 12, 2008

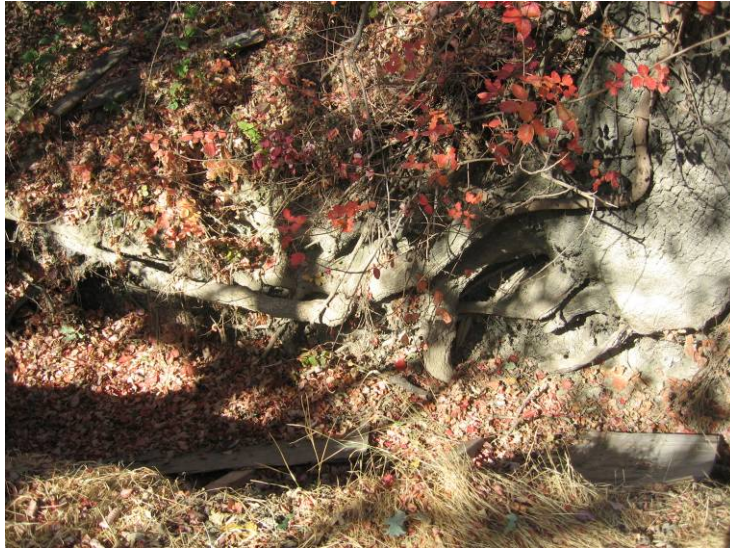
All mature oak trees in the restoration project appear healthy. The channel was diverted around the oak trees in Reach 2 to prevent incision of the channel around the roots. The diversion was successful and the water does not flow past the oak roots. Some roots of the oak trees are exposed (Figure 7 and 8), but their condition has been stabilized over time because the incision of the banks around the roots was stopped by after construction of the restoration project (Ellyn Davis, personal communication, 2008).

Figure 6: Oak Tree Roots Exposure

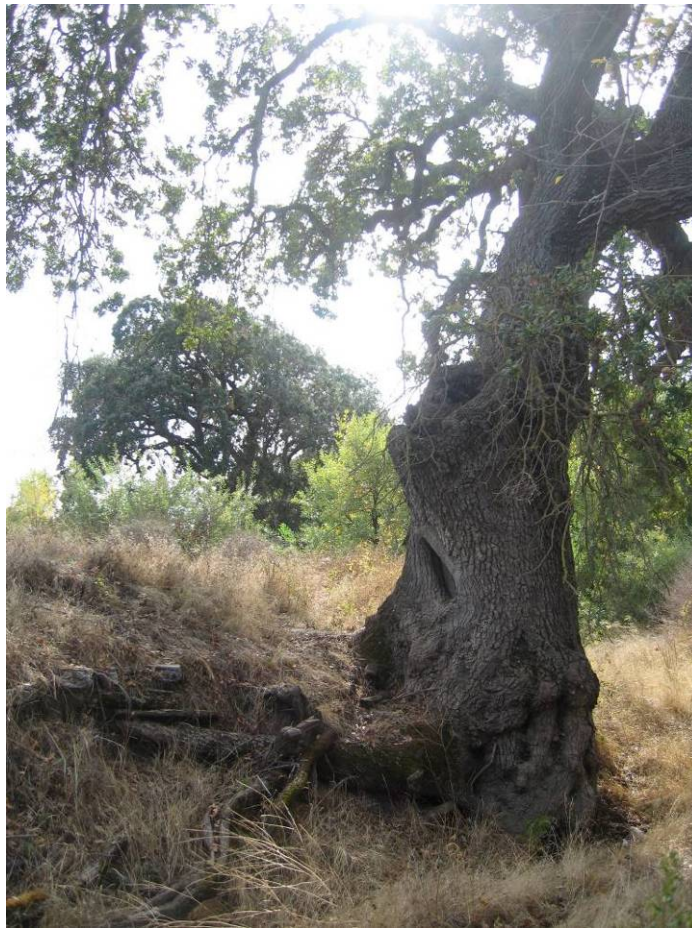
Figure 7: Oak Tree Roots Exposure

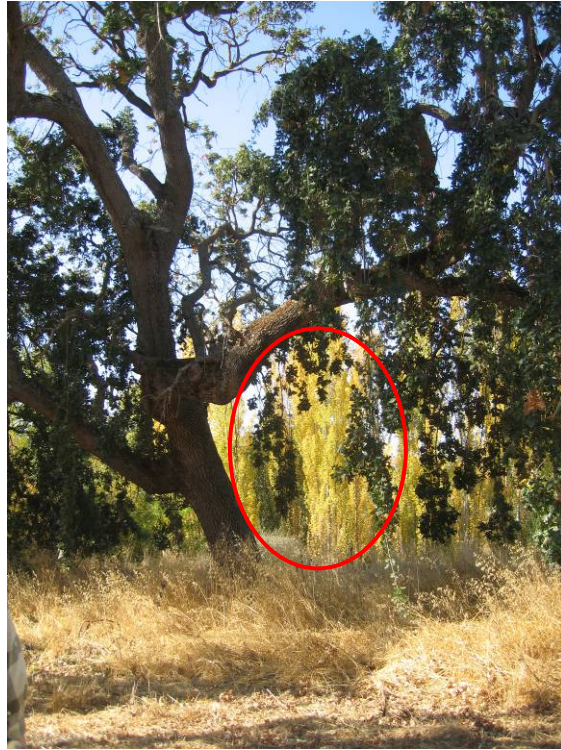
The restoration project contained few invasive weeds. A grove of poplar trees was established in Reach 2 prior to the restoration project construction (Figure 9), and maintenance crews have been unable to eradicate them (Stuart Cook and Ellyn Davis, personal communication, 2008). A large pampas grass plant (*Cortaderia jubata*) was also seen in Reach 2 near the Dublin Boulevard Bridge (Figure 10). We recommend removing this weed before it becomes an invasive colonizer (National Parks Service website). Other weeds included fennel, however it is not considered invasive. Damage from deer and other rodents was not noticeable. The plants also did not appear to be suffering from any disease.

Figure 8: Poplar Trees in Background with Oak Trees in Foreground

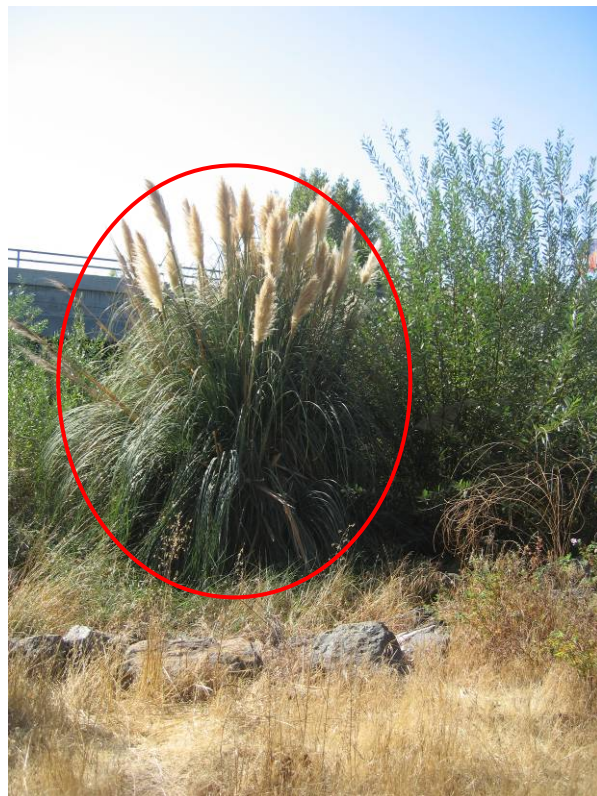
Figure 9: Pampas Grass Weed (*Cortaderia jubata*) at Dublin Boulevard Bridge

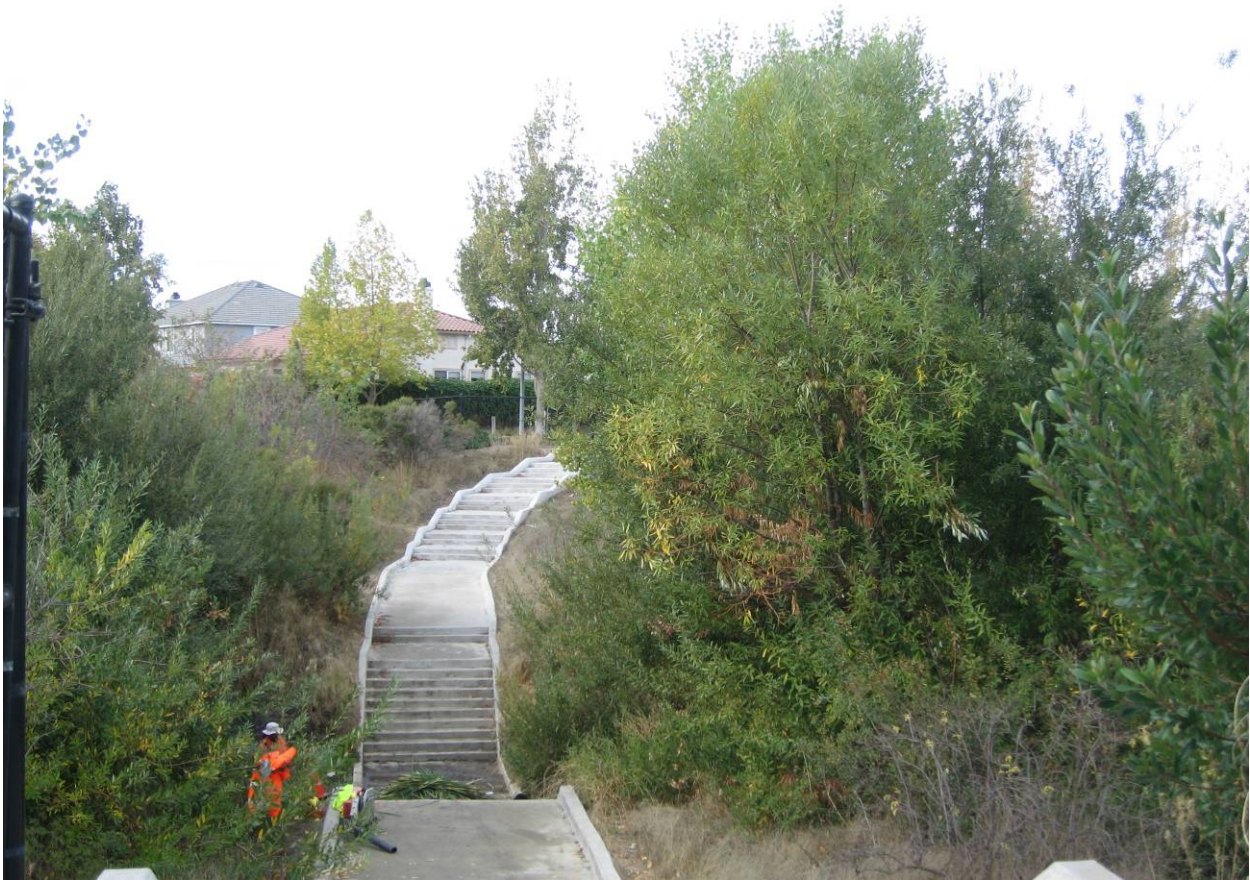
Irrigation maintenance is no longer in place since irrigation of the restoration project ceased in 2003. The riparian habitat has survived well without irrigation. An annual maintenance activity was observed after the first large storm of the season on November 4, 2008. A maintenance crew under contract with the City of Dublin was cleaning the pedestrian walkway in Reach 2 (Figure 11) and clearing tall approximately 100 yards north and south of the walkway.

Figure 10: Annual Maintenance at the Pedestrian Walkway (Reach 2, Right of Bank)

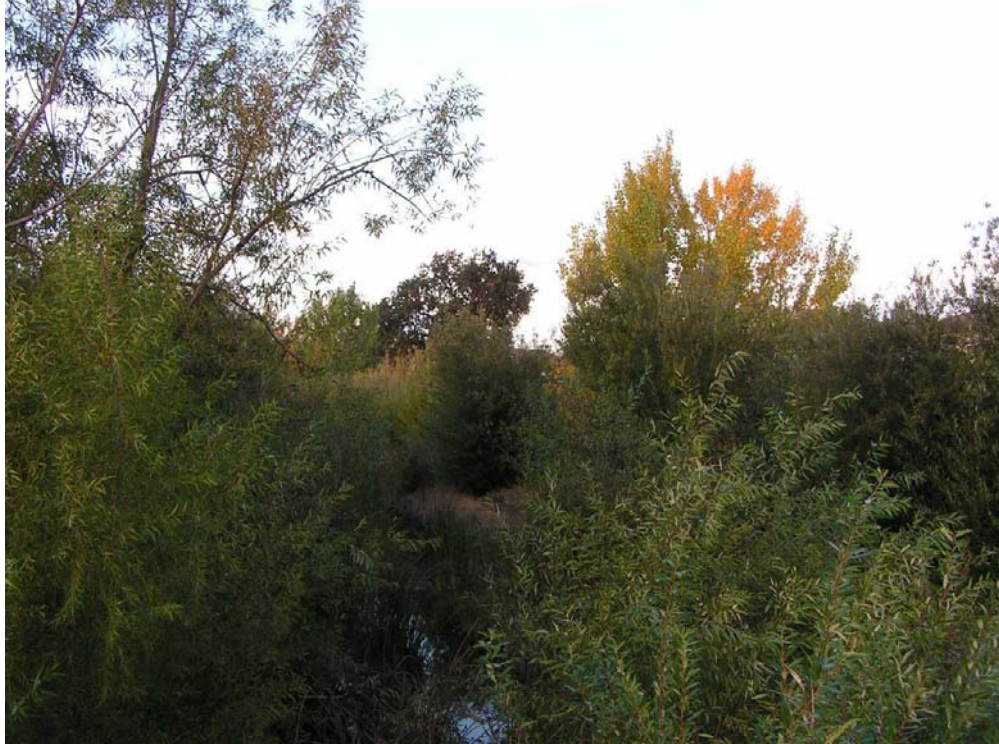
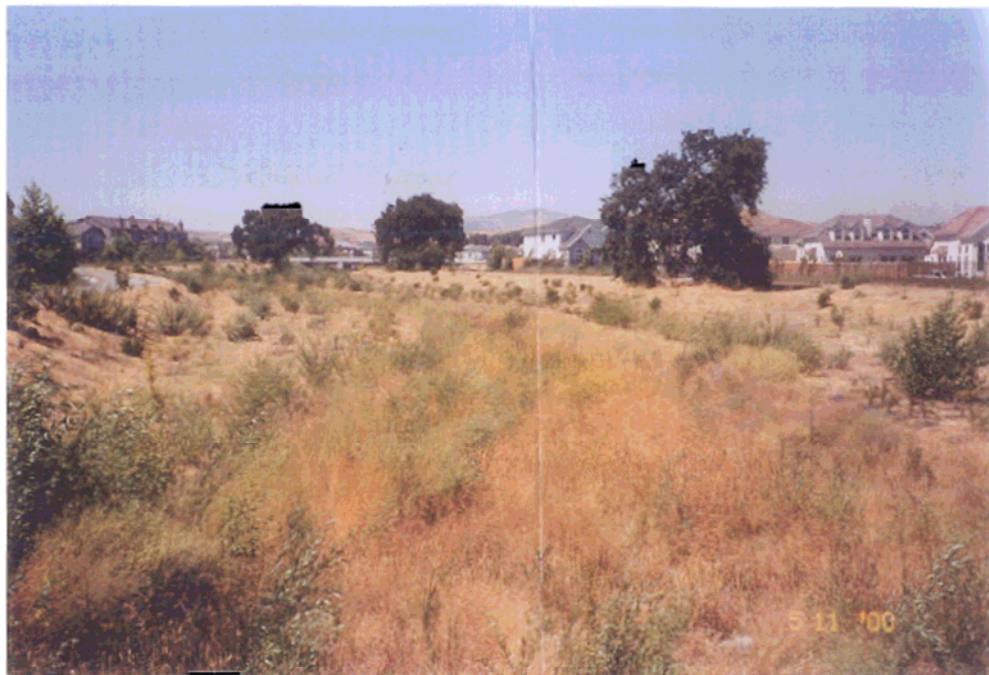
**Upstream View to North of Dublin Boulevard Bridge
(note natural colonization of emergent vegetation in channel)**

Figure 20: Upstream View to North of Dublin Boulevard Bridge (N 37 42.350' W 121 52.711'), top picture taken on November 4th 2008, bottom picture taken in 2001 (Davis Environmental Consulting, 2001).
