Looking forward, looking back : monitoring the Tassajara Creek Restoration Project

Looking Forward, Looking Back: Monitoring the Tassajara Creek Restoration Project

Chad Krofta
Michael Novotney
Department of Civil and Environmental Engineering
University of California, Berkeley

Final Draft
December 3, 2003

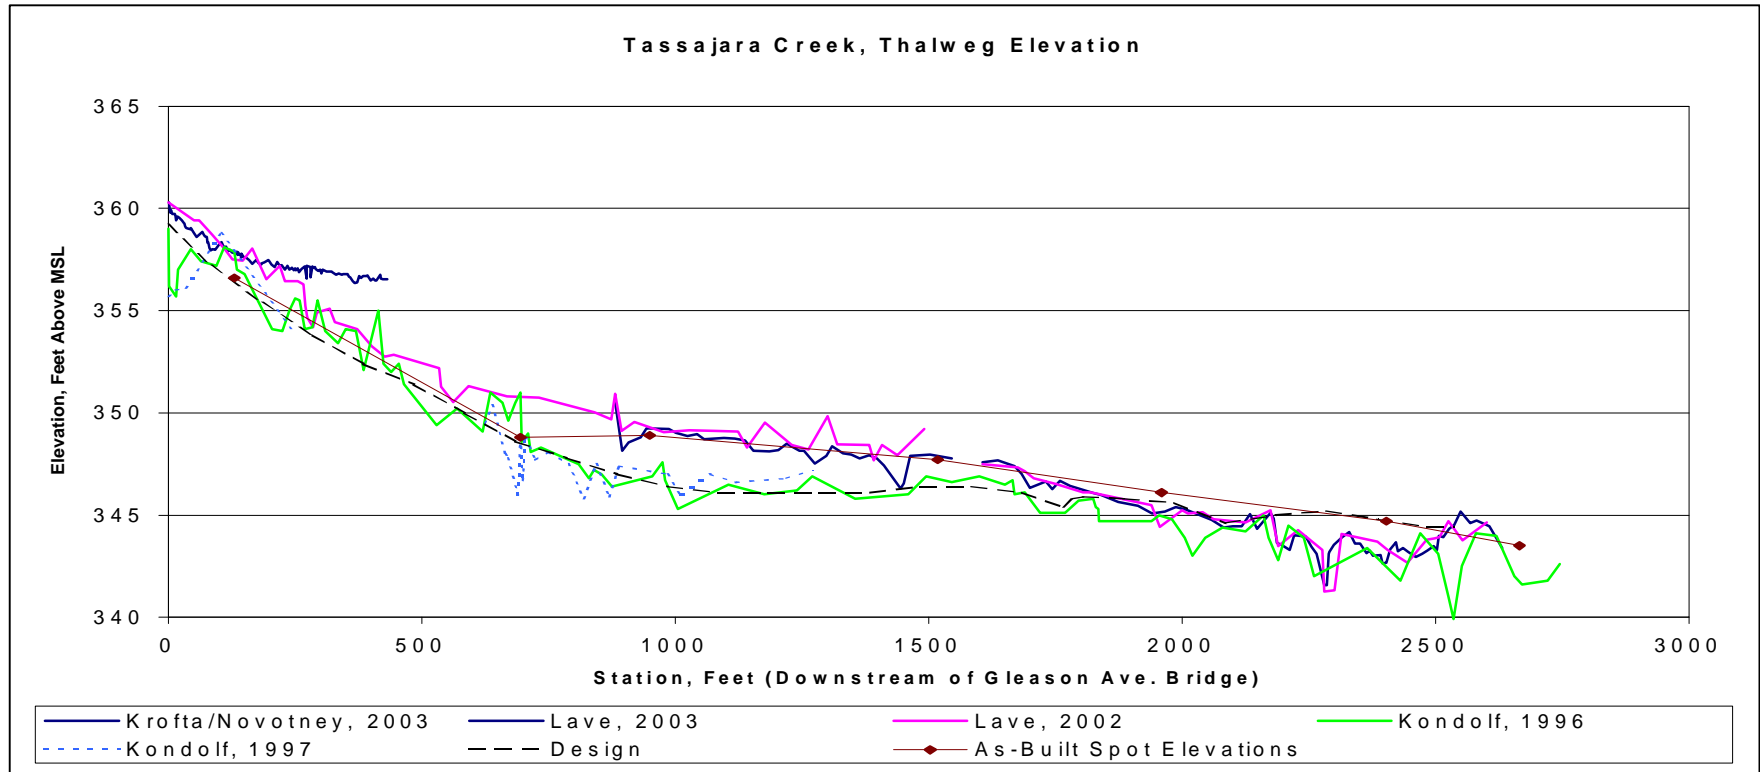
Figure 16.

As discussed above, our field work also identified a debris jam caused by large wood in the vicinity of station 1400 (Figure 16). Large wood was also found in other portions of the channel, although it had not caused a jam such as that seen in this area. In addition to the large wood, the jam contained numerous cans, bottles, household debris, and construction waste (Figures 21 and 22). There is the potential that some of this debris, including debris not visible from the surface, may degrade the water quality within the creek, which would conflict with the previously stated objective of improving water quality in the stream.

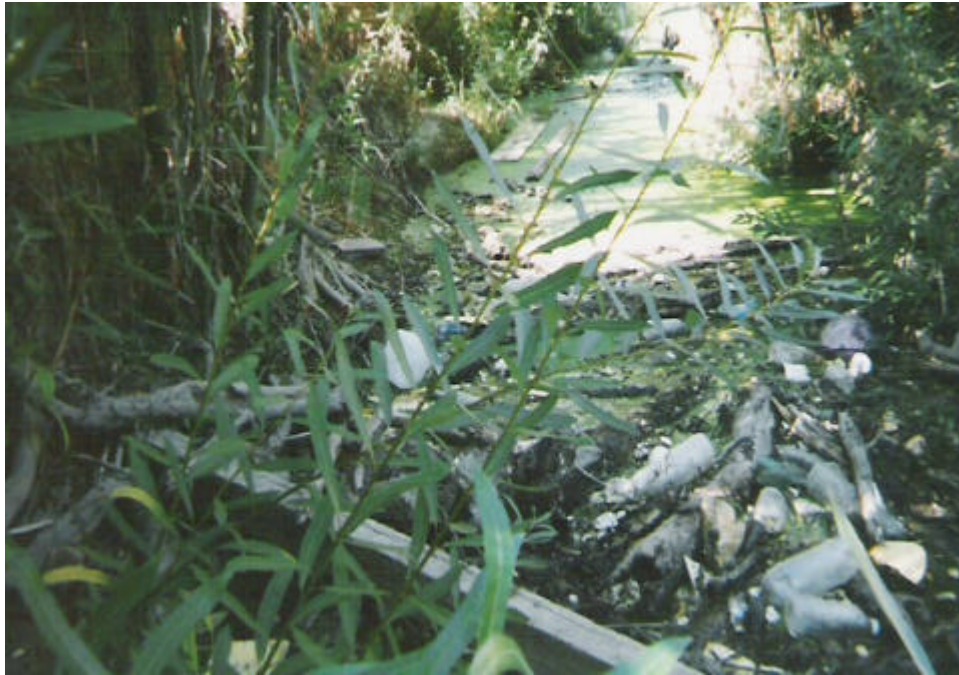
Figure 21.

A debris jam upstream of Central Parkway. October 12, 2003.

The monitoring should not only continue to track changes in channel morphology, as proposed in the original monitoring plan by Hudzik and Truitt (2001), but should also track the additional objectives highlighted in our appended monitoring plan (Figure 23). This is due to the fact that our field work revealed several potential threats to the success of the Tassajara Creek restoration project. The exposed oak tree roots have the potential to undermine the survival of these trees as well as the stability of the channel banks. It is recommended that these trees be monitored in subsequent studies of Tassajara Creek. It may even be appropriate for a professional arborist to assess the current health of these trees and provide measures to save them and maintain channel bank stability. The debris jam consisting of numerous solid waste items has the potential to degrade water quality in the creek. It is recommended that the debris jam should be monitored during future studies of the restoration project. If it persists, it should be assessed by an engineer to determine the hydraulic effects of removing debris from the jam. After this assessment has been completed, it is recommended that all material with the potential to degrade water quality be removed.

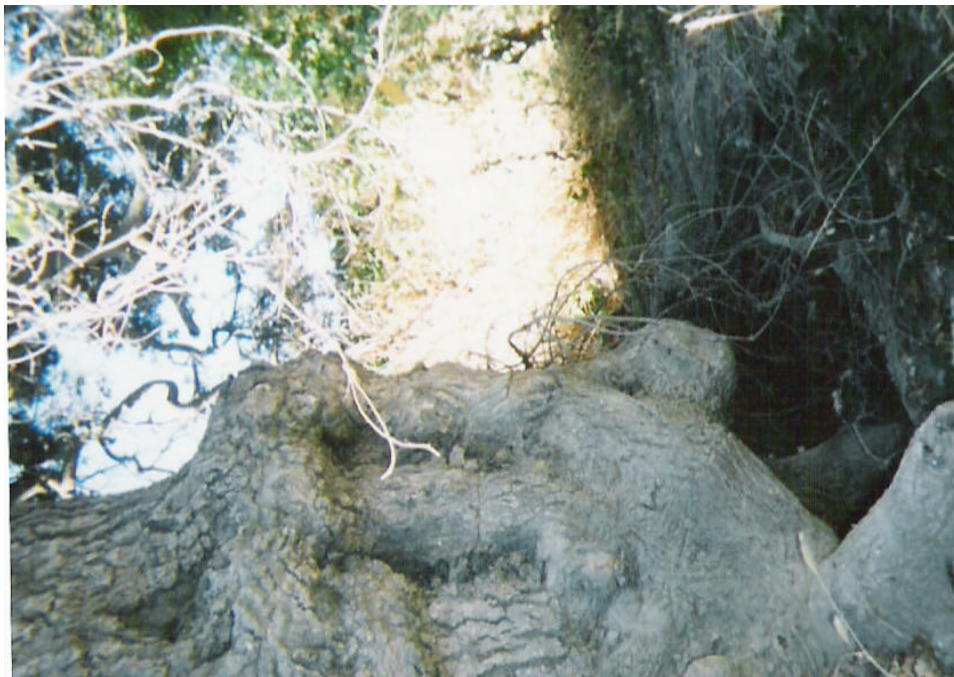
Although we found no evidence that Tassajara Creek is continuing to incise and that the creek appears to be stable, at least at this point in time, our field work did identify several conditions that threaten the stated goals of the restoration project. We observed portions of the root masses

of several of the old-growth oak trees that were exposed (Figure 21). Survival of these oak trees is critical to the success of this project, as the demise of the trees would conflict with the previously stated objective of native plant preservation. In their 1997 site investigation, Kondolf and Matthews stated, “While some trees increase bank stability with their root masses, if trees are undercut and fall into the channel, they may divert flow into banks, leading to increased bank erosion” (Kondolf and Matthews, 1997). As the roots of these trees become increasingly exposed, the trees become prone to falling into the stream during high flow events. Therefore, preservation of these trees is also in the best interest of bank stability.

An oak tree with exposed roots. Photo is rotated counter-clockwise 90 degrees. October 12, 2003.

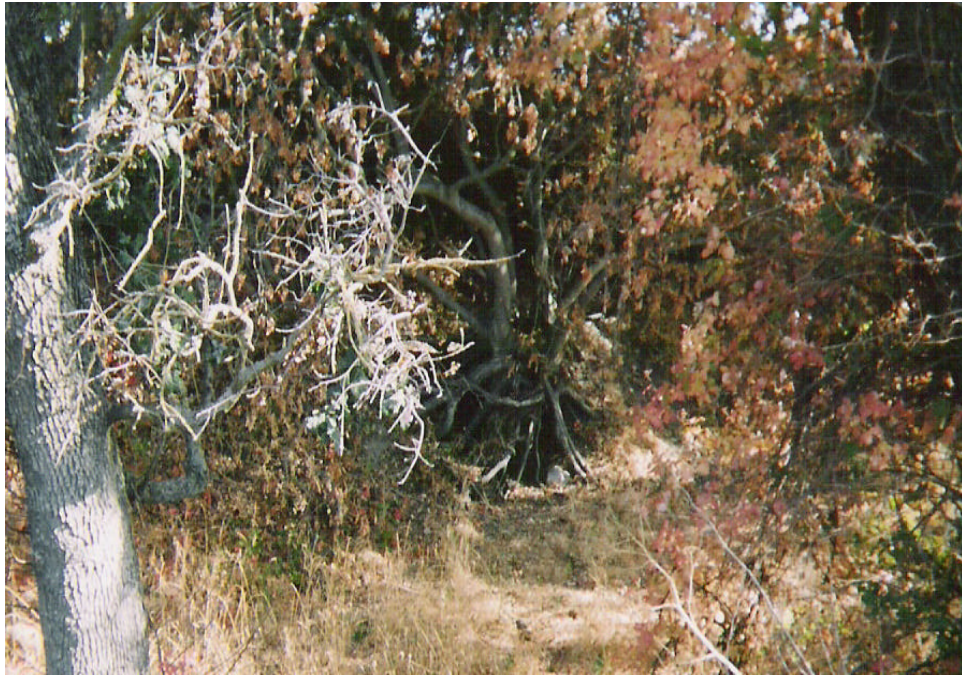
An oak tree with exposed roots. October 12, 2003.
