Post-Project Appraisal for the Winter Creek Restoration Redwood Grove, UC Botanical Gardens at Berkeley

LA 227 River Restoration
Term Project Paper – Final Draft
December 11, 2010

Abstract

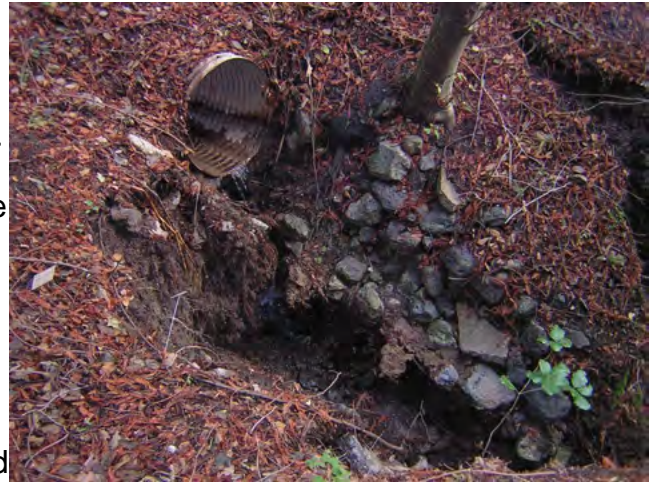
Figure 1. Culvert on Winter Creek in 2005.

The project was completed in response to severe erosion caused by a pipe culvert that carried runoff from the Lawrence Berkeley Laboratory (LBL) and other developments in Strawberry Canyon (Carmichael, 2010). According to the 'Save Strawberry Canyon' citizens' group, LBL has expanded its footprint in the canyon from 134 to 200 acres over the past 20 years (Save Strawberry Canyon, 2010). Recent expansion of parking areas at LBL (Fig. 3) increased the flashiness of the stream creating a scour pool and 12-foot drop in grade immediately

downstream of the pipe (USACE, 2007). In 2004, the walls of the scour pool collapsed, and adjacent banks began slumping into the pool. Continued erosion of the channel was likely to undermine the outlet of the culvert, several large redwoods along creek bank, and the sole access road to the Redwood Grove (RWQCB, 2006). In addition to the threat to trees and infrastructure, continued erosion would have contributed excess sediment to the Strawberry Creek watershed. The UC Botanical Garden worked in conjunction with Campus Capital Projects and LBL to complete a restoration plan, which was prepared by Philip Williams and Associates (PWA). The design objectives of the project were to use rock grade control structures to stabilize and raise the streambed, creating a series of step pool and riffle sequences. The unstable creek banks were to be regraded, stabilized, and revegetated with vegetated soil lifts and brush mats in combination with specific native planting and seeding plans. An outfall dissipation gabion basin was created to absorb some of the energy flowing out of the culvert. Design for the project began in 2004, but due to permitting and funding constraints, the restoration was not implemented until 2009. Hanford A.R.C. was responsible for restoration construction.

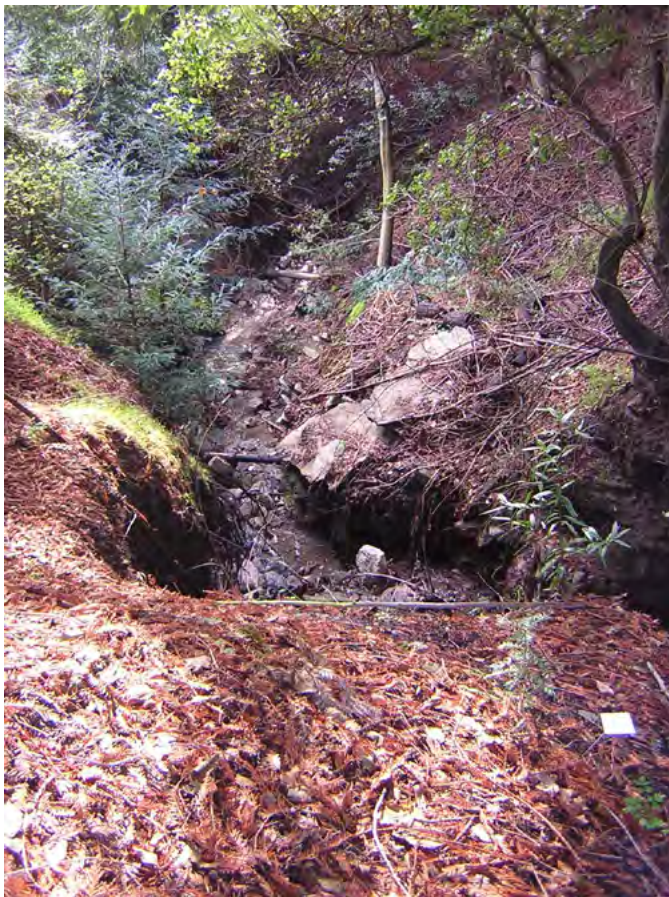
Figure 4. Pre-restoration. Winter Creek, looking upstream. 2005.

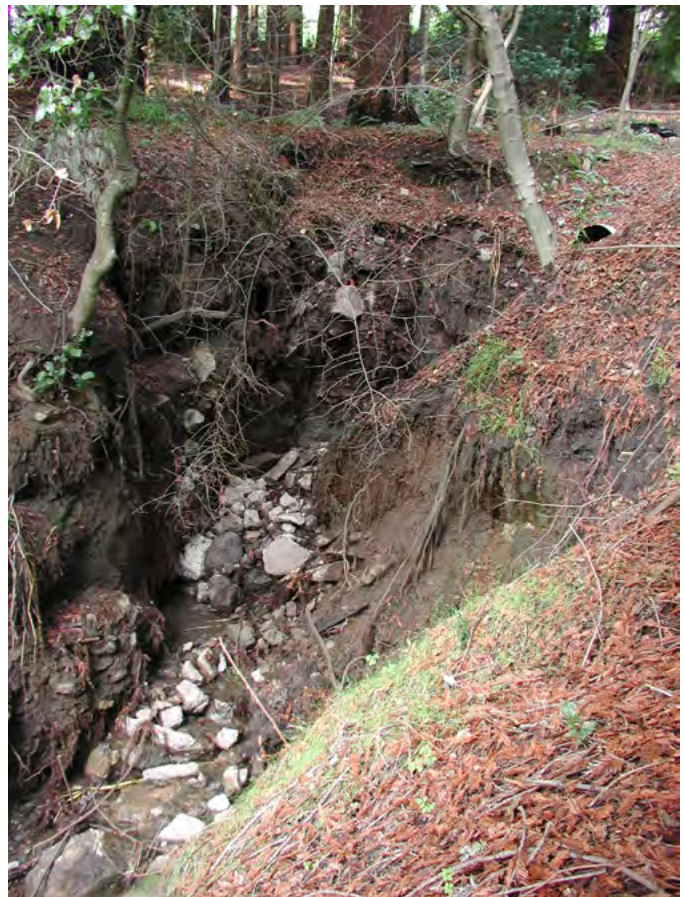
Figure 5. Pre-restoration. Winter Creek, looking downstream. 2005.

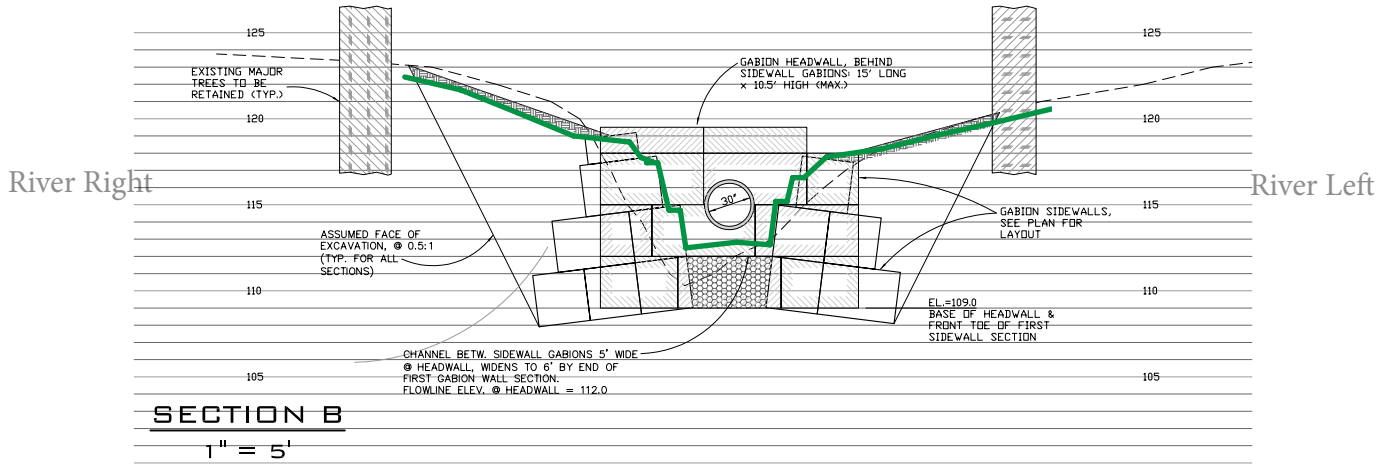
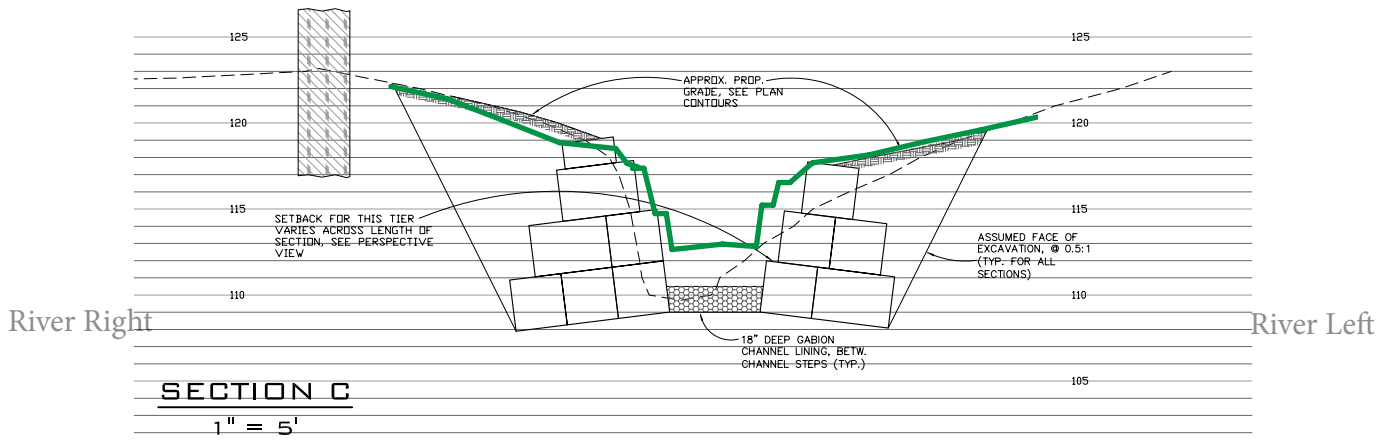
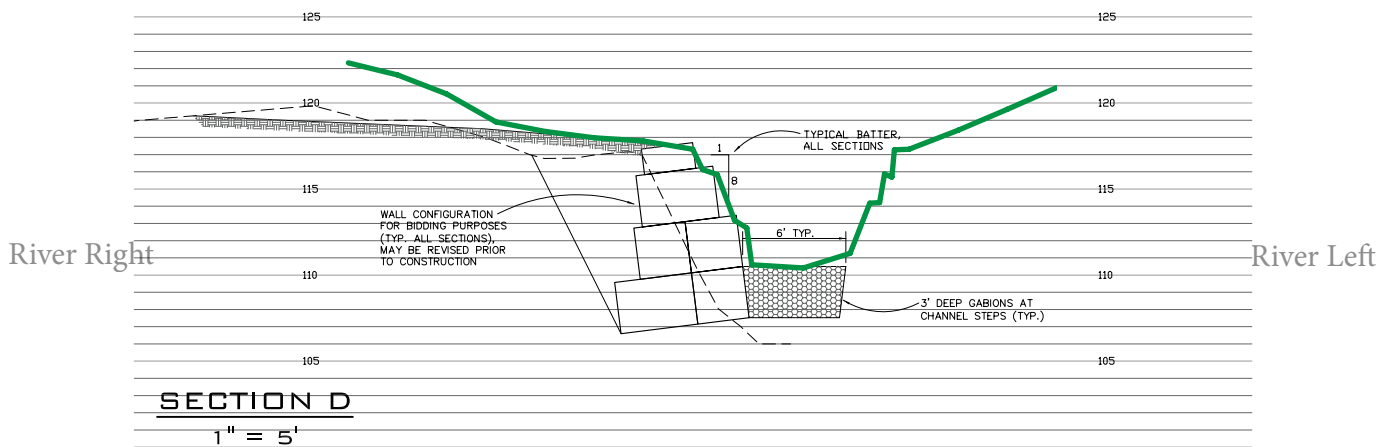
Figure 13. Cross Sections B-D

It appears the designed bank cuts were not constructed as applied to the slope than originally designed for in the following cross sections in the gabion reach: cross section D, high on the right bank (Fig. 13), cross section G, beyond the highest gabion on the left bank (Fig. 14), cross sections H and I beyond the highest gabion on the left bank and cross section J, high on the right bank (Fig. 15). It can be observed on the plan drawing (Fig. 10) that at least one large redwood tree (designated by the dark circles) remains near each of these cross sections. In order to maintain the trees, the contractors may not have been able to apply the cuts proscribed by the design documents. As the slopes in these areas are steeper than the design slopes they may experience erosion in the future if not monitored.

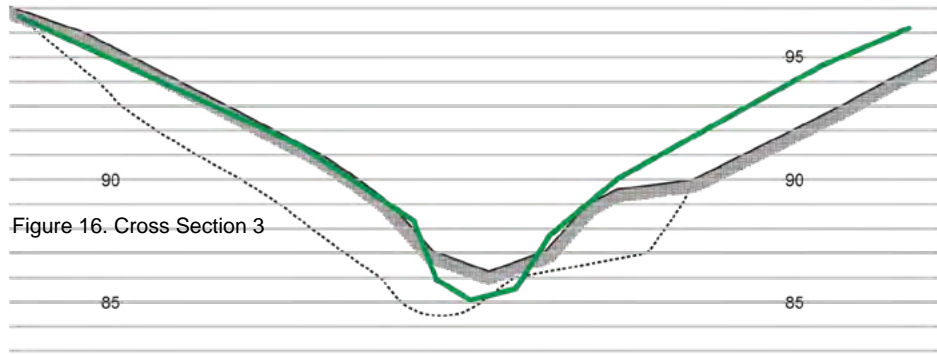
Figure 16. Cross Section 3

Similar to the gabion reach, it appears the designed bank cuts were not constructed and more fill was applied to the slope than originally designed for on the right bank in cross section 3 and dramatically on the left bank in cross section 4. Again, this may be due to large redwood trees the contractors were forced to maintain during construction. As these slopes are steeper than originally designed for they may experience erosion and contribute to bank failure if not monitored appropriately in the future.

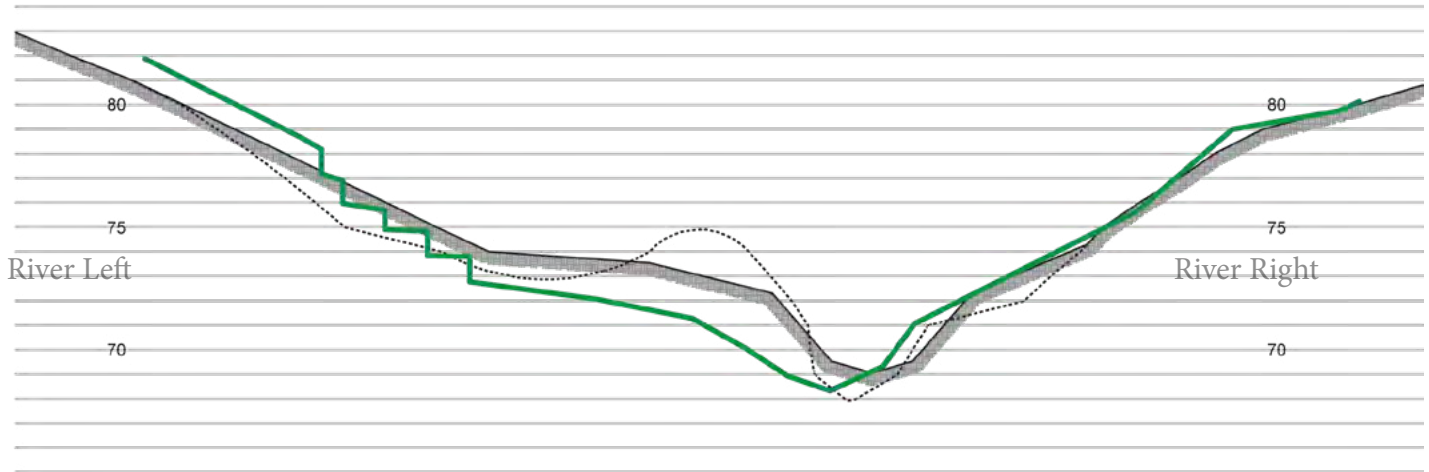
XS 1 Figure 18. Cross Section 1

Cross-sections 1 and 2 (Fig. 17) correspond fairly well with the topography designed for the site.

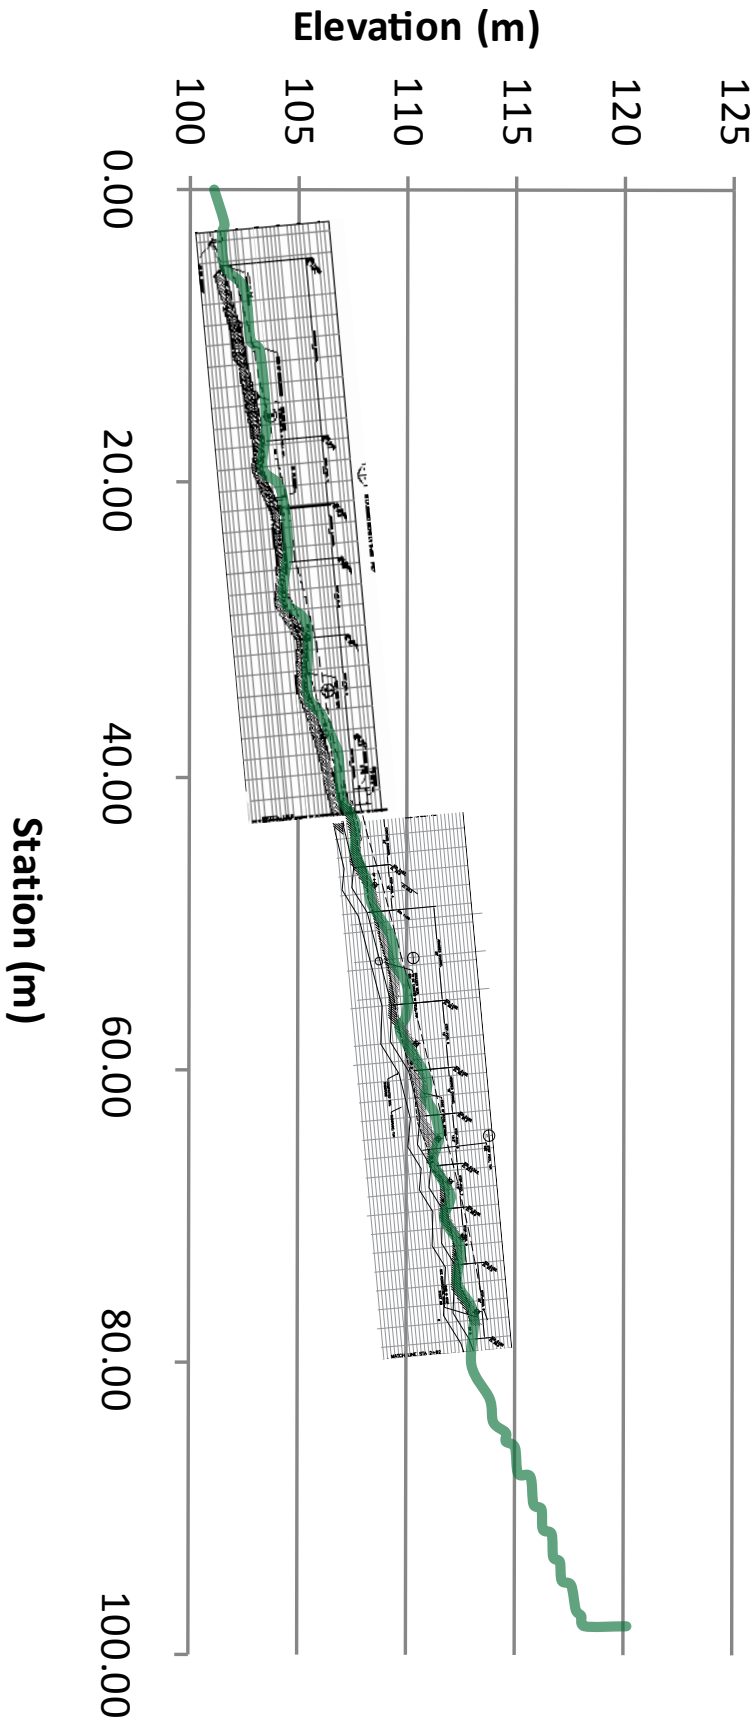
The longitudinal profile (Fig. 18) correspond with the topography designed for the site. The longitudinal profile in the designs shows the step pools at a coarser level of detail than the data collected in the field (Fig. 18).

Figure 20 shows the surveyed longitudinal profile overlaid in green on top of the designed longitudinal profile.

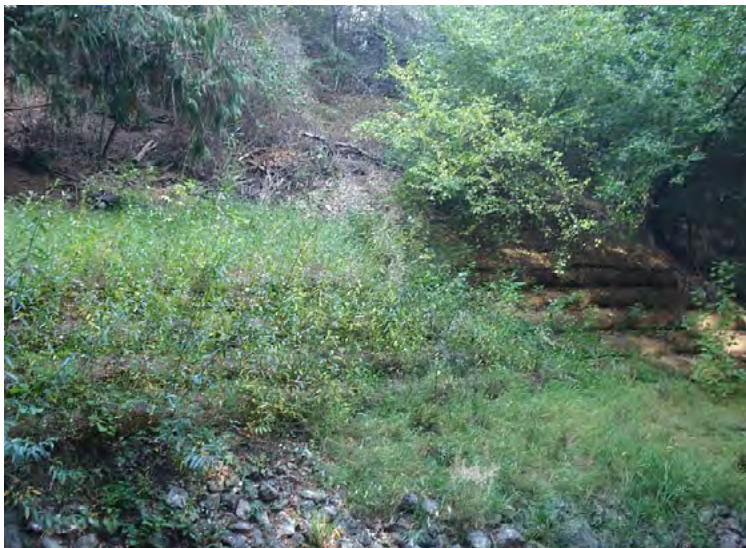
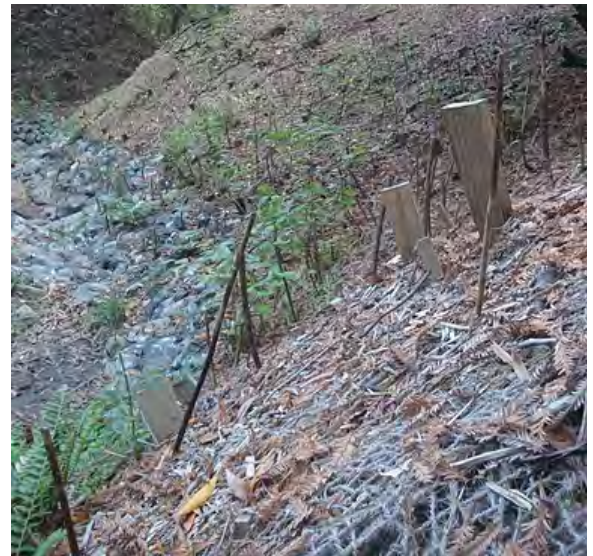
We found leaves growing on many of the dogwood and willow live pole plantings to be evidence that the live pole plantings were out of dormancy. Therefore, we counted all bare live pole plantings observed as dead. It is evident from these counts that the dogwood and willow live pole plantings did not have a high survival ratio (Table 4). It was observed that the plantings located on the left bank (looking downstream below the footbridge) were more successful. The only observable difference between the left and right banks was the greater amount of shading caused by the redwoods above the right bank.

Figure 22 Successful willow planting in sunnier conditions compared to shaded willow live pole planting that did not survive.
