Understanding the water, understanding the canyon: establishing a baseline study of the Redwood Canyon reach of Cerrito Creek in Blake Garden

Understanding the Water, Understanding the Canyon

ESTABLISHING A BASELINE STUDY OF THE REDWOOD CANYON REACH
OF CERRITO CREEK IN BLAKE GARDEN

CAMILLE THOMA & DULCE RIVAS

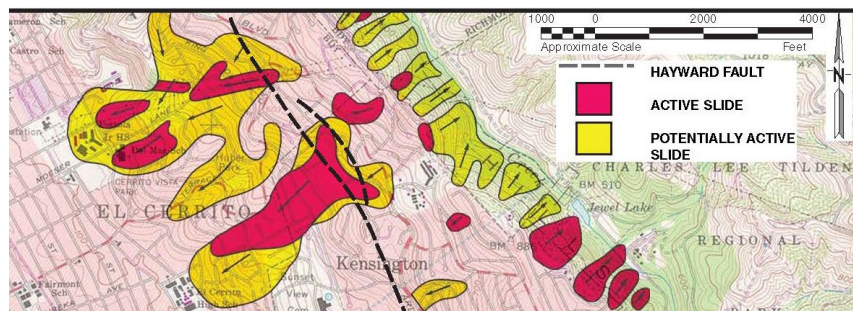
Figure 1. Blakemont Slide Zone. Image: Kropp & Associates.

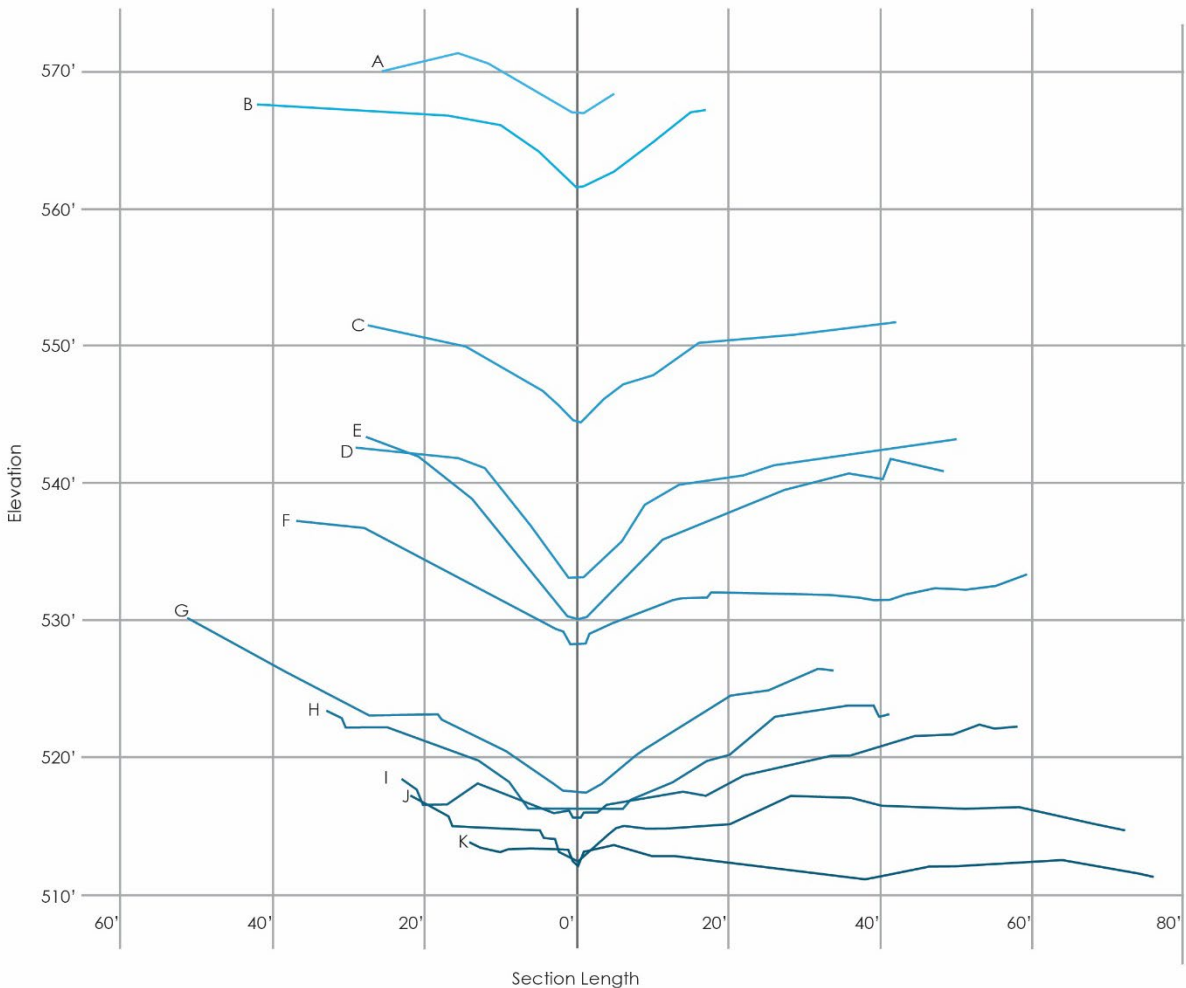
As the main stream channel is dry most of the year and receives relatively low flows in the rainy season, the channel has remained stable for many decades. The cross sections did help discern the form of the Redwood Canyon in areas with dense vegetation can obscure the topography. One such area are the low points between the channel and the fence line in sections I, J and K which appear to likely the former stream channel seen in the Symmes plan that connected the springs and ponds below the Carmelite Monastery to the Redwood Canyon reach.

Figure 8. Compiled cross sections for main stream channel with thalwegs aligned.

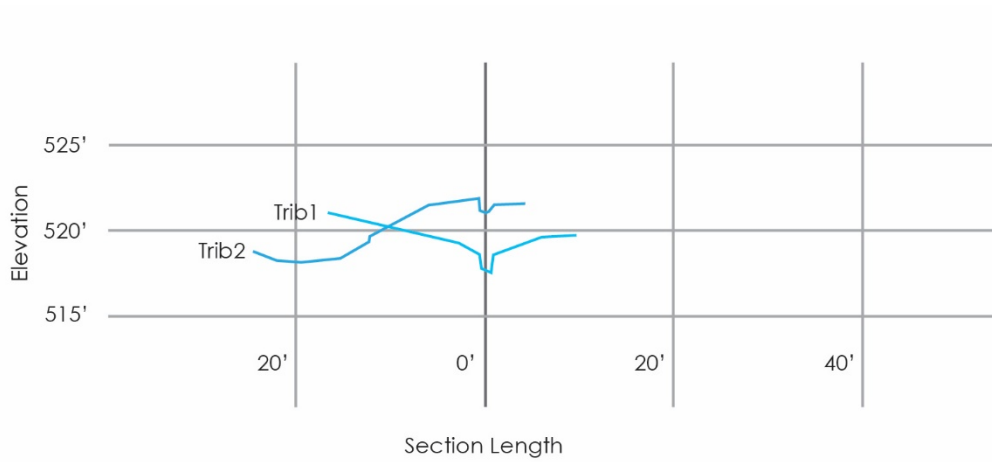
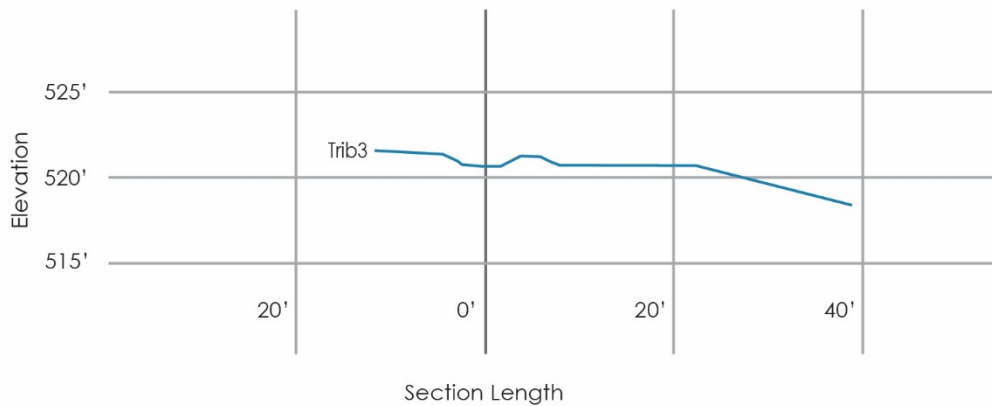
The following cross sections show the small tributaries and how the water is entering the property at the fence line adjacent to 22 Jessen Court. Two streams (Trib 2 & 3) enter from the fence before merging into one stream (Trib 1) that runs into the first pool.

Cross Section Trib1 (see Appendix B for individual cross sections) shows incision of just under one foot (.8 and .95). There is undercutting along the channel, which could impact the redwood to the south of the channel if the undercutting continued and the channel migrated.

During high intensity storms, the path between station points 5-10 floods from water that is seeping under the current berms. Cross Section Trib3 shows where water moves around the trees to the low point at station point 22.. The cross section reveals how flat the slope is in this area which is difficult to discern with the eye.

Figure 9. Compiled cross sections for Tributaries 1 and 2 which run parallel to the main stream channel.

Garden staff will need more analysis to decide whether to armor these new channels to protect the trees in this novel ecosystem or to let the incisions continue and let the channel migrate on its own, potentially damaging other trees' roots.

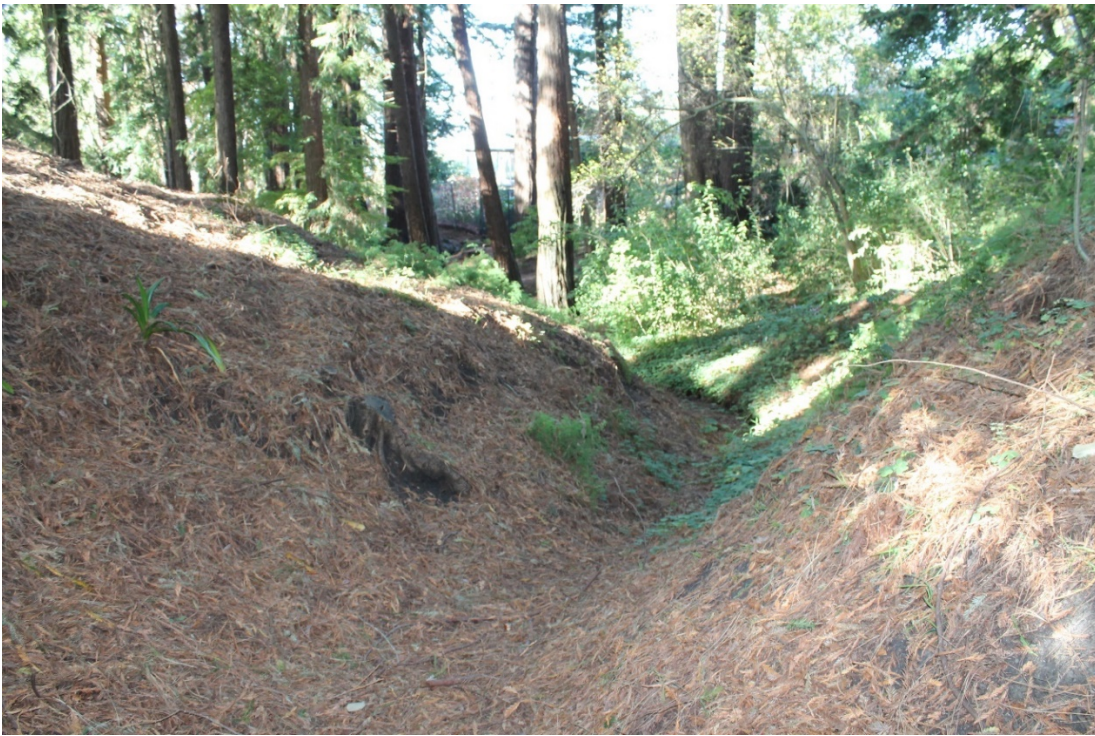
Figure A5 View looking downstream from Cross Section E. There is increased vegetation starting where water emerges for the first time in the stream bed.

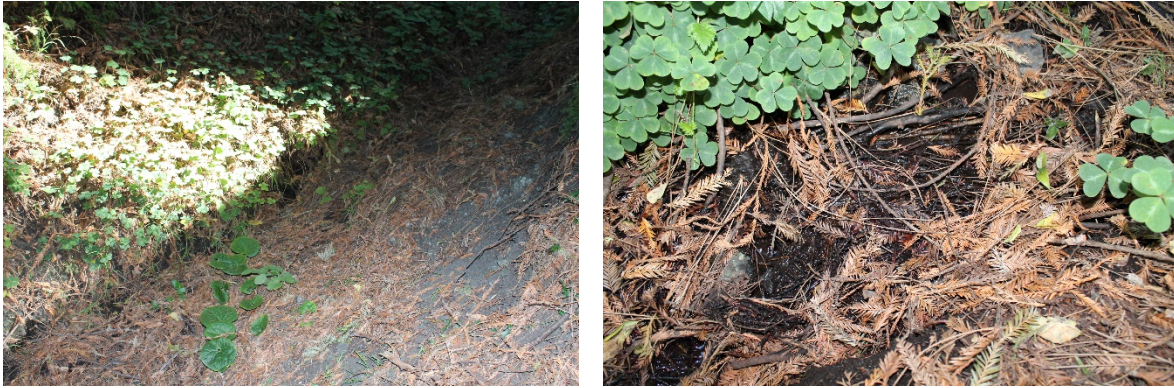
Figure E5 First emergence of water in the main stream channel, just below Cross Section E.

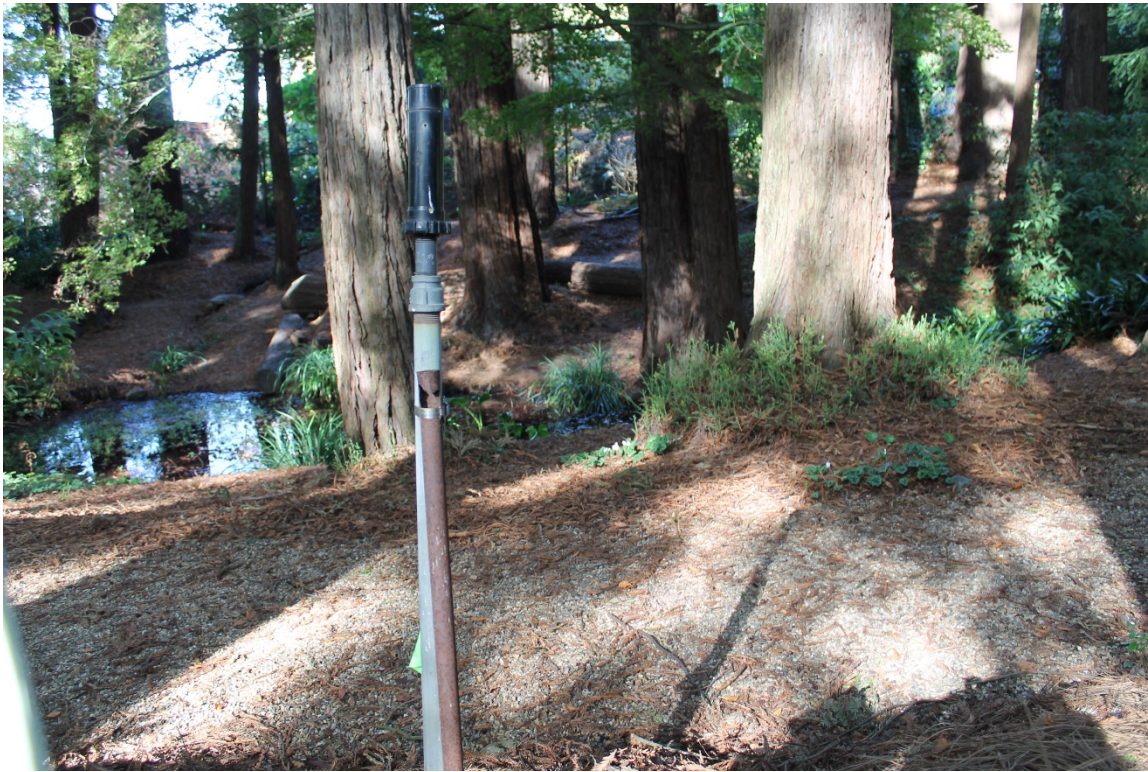
Figure E8 Cross View north across the first pool at Cross Section H.

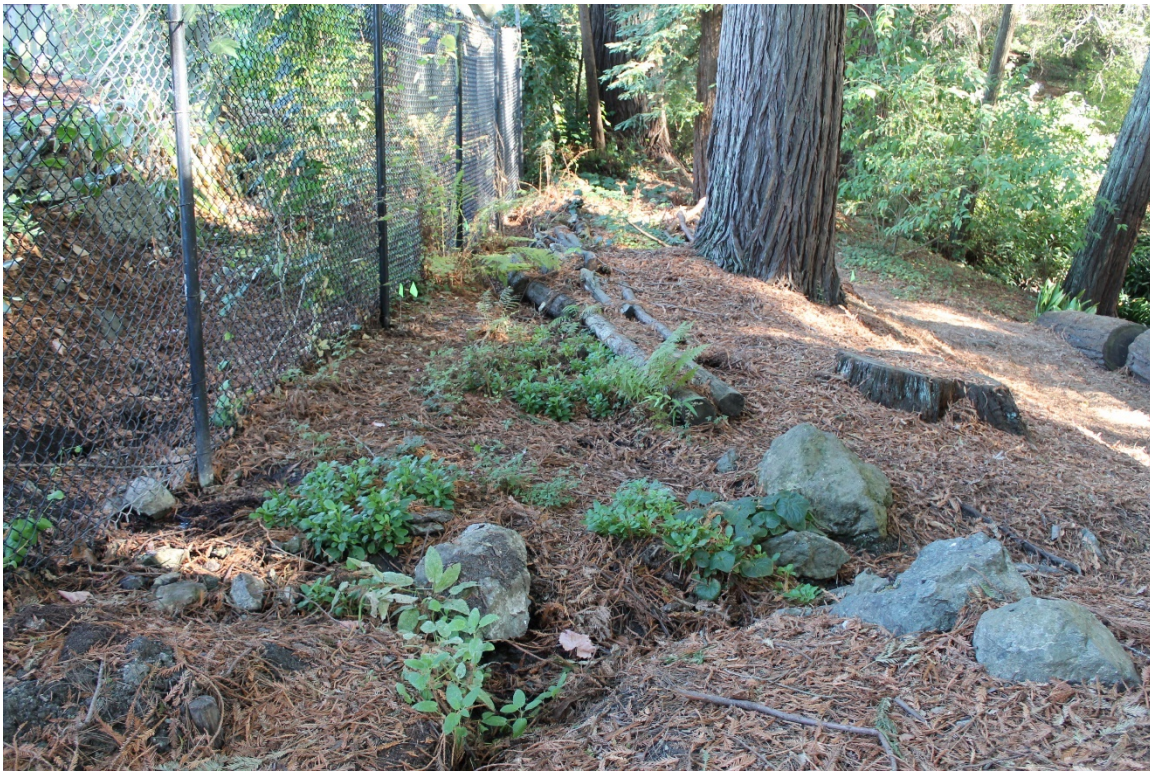
The development of the property below the Carmelite Monastery into Jessen Court has affected the hydrology of the site. The properties covered existing ponds and a stream that ran into the Redwood Canyon Reach (see Figure 6. Symmes plan). In 2007 there was an unresolved conflict between the garden and neighbors over the cause and responsibility for damage associated with changes in drainage. The redirected water resulted in the loss of two Coast Redwoods (*Sequoia sempervirens*) due to water damage to their roots. (Blake Garden archive).

Figure E9 Tributary streams coming from neighboring properties. To the right, a stump of a Coast Redwood that was removed in 2007 from water damaged roots.

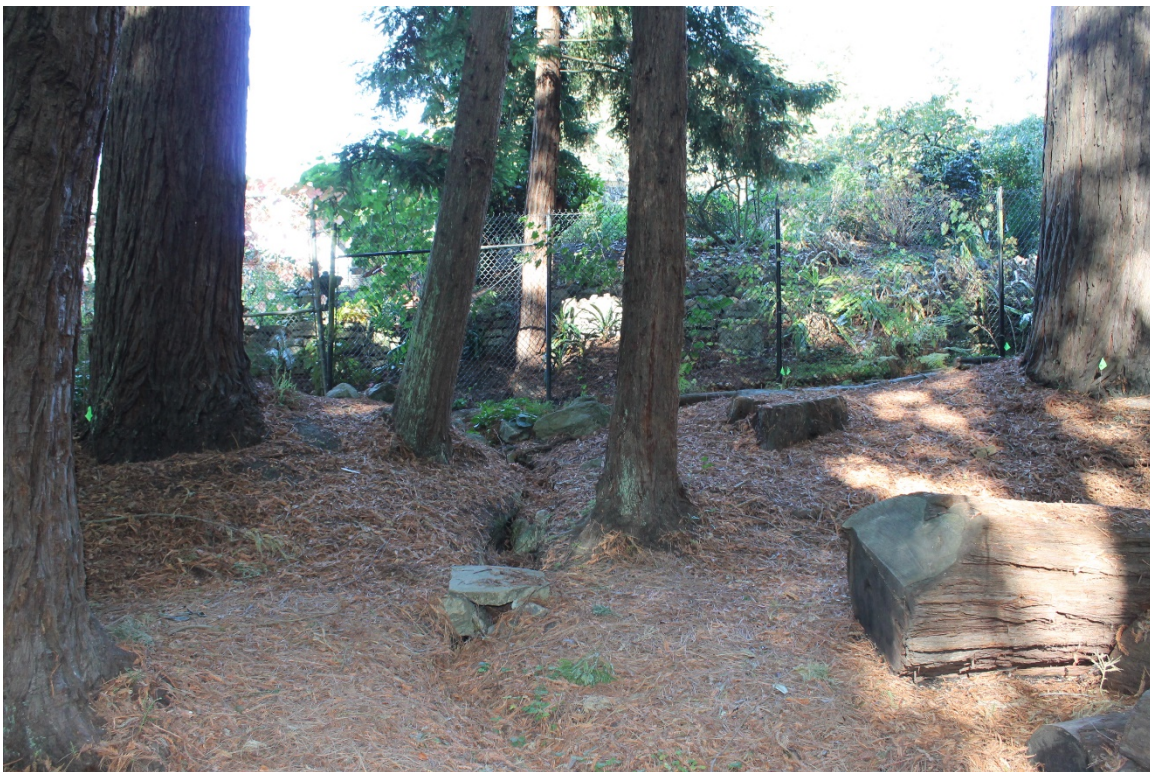
Figure E10 Looking upstream to Cross Section Tributary 1.
