The George H. Scripps Memorial Marine Biological Laboratory of the Scripps Institution of Oceanography, University of California, San Diego

Historic Structure Report to the California Office of Historic Preservation

SIO Reference 79-26

October 1979

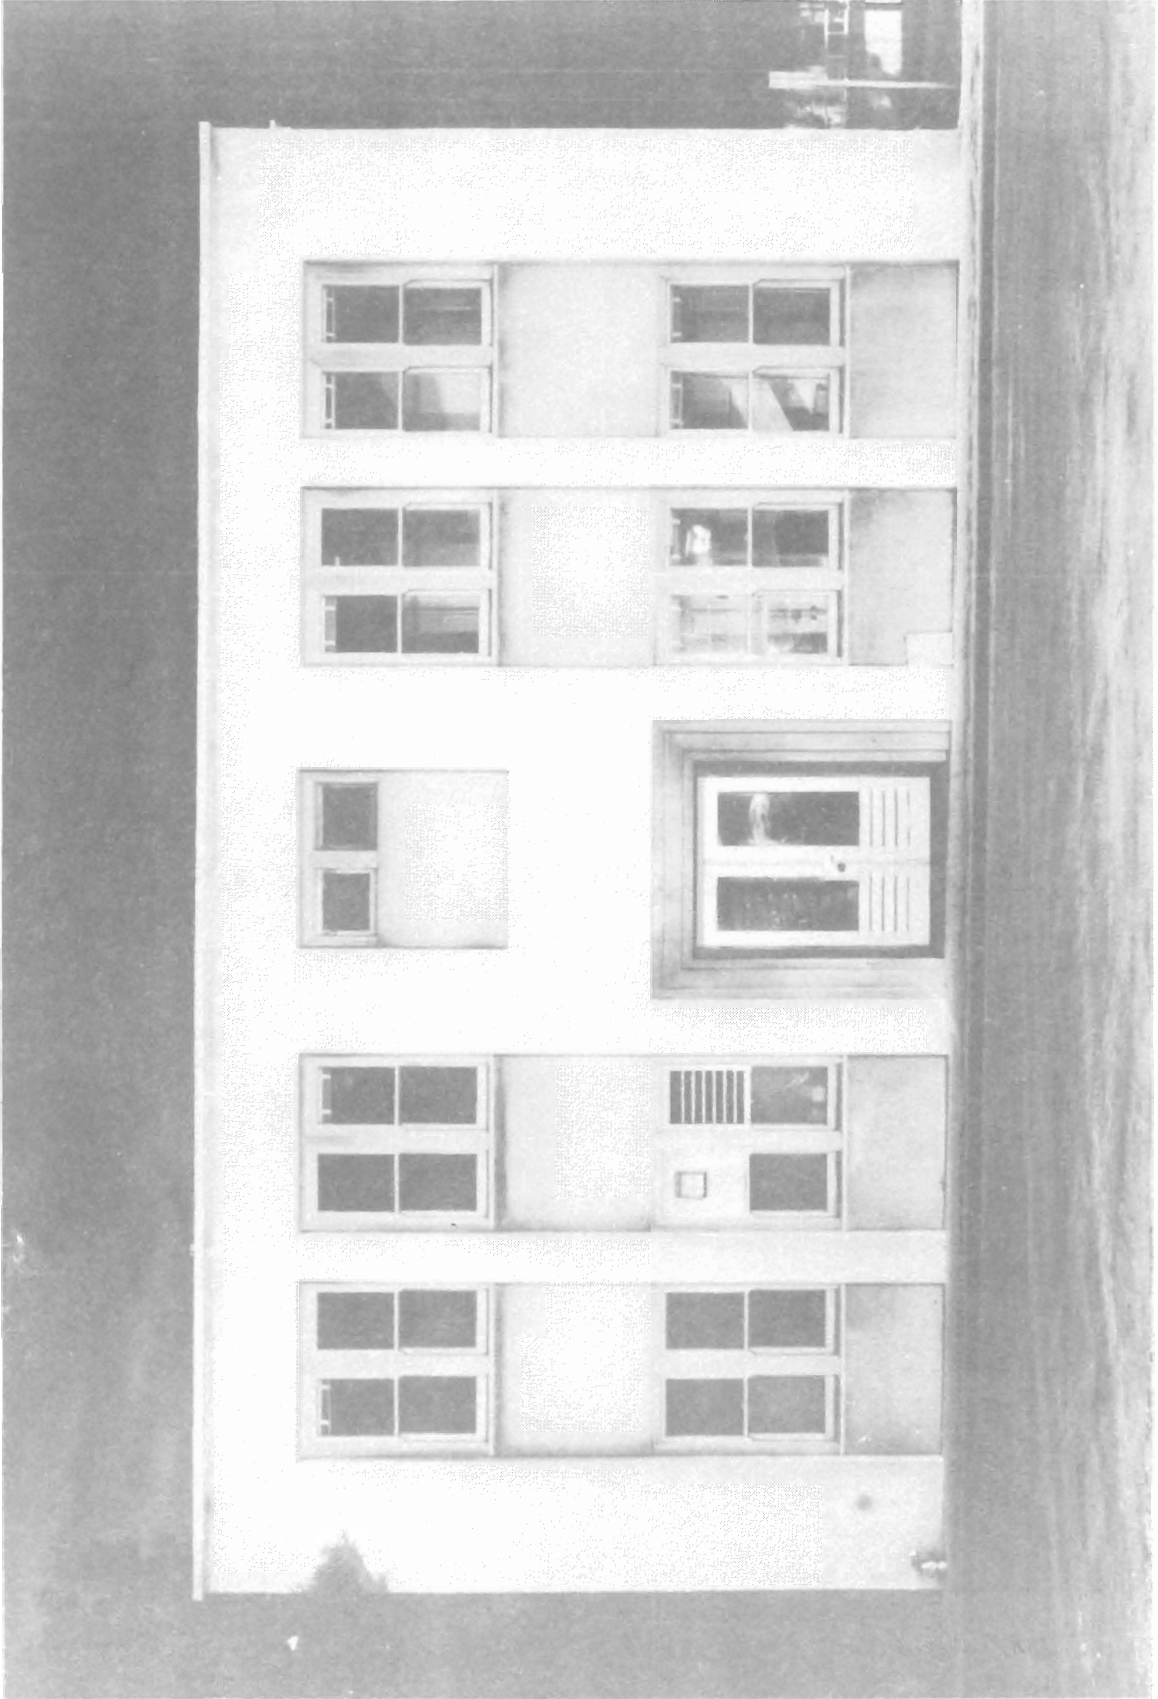
Figure 7. East view of Scripps Laboratory in 1977.

The exterior of Scripps Laboratory (figures 7-8) is much as it appeared after the 1932 remodelling, changed from its original appearance only by the change in window style. The dividers between lights of the original steel-frame windows tended to disappear from sight; in the wood-framed windows they are apparent. The windows are in pairs throughout the building (except at the southeast corner of the first floor on the south wall, where one is missing). Windows are of only two sizes: pairs of wide windows between columns on the north and south walls, and pairs of narrow windows on the east and west walls. Six window lights have been removed and replaced by air intakes and exhausts; two large vent pipes rise along the north wall. The exterior is painted uniformly with a buff paint, including all window frames, trim, and doors. Originally, at the completion of construction, it was plain concrete, with varnished woodwork on the doors.
