Sausal Creek Restoration at Dimond Park: Vegetation and Geomorphology Post-Project Appraisal

Final Draft: Sausal Creek Restoration at Dimond Park: Vegetation and Geomorphology Post-Project Appraisal

Carl Bello, Rex Chen, Taylor Lithgow, and Emily Meyers

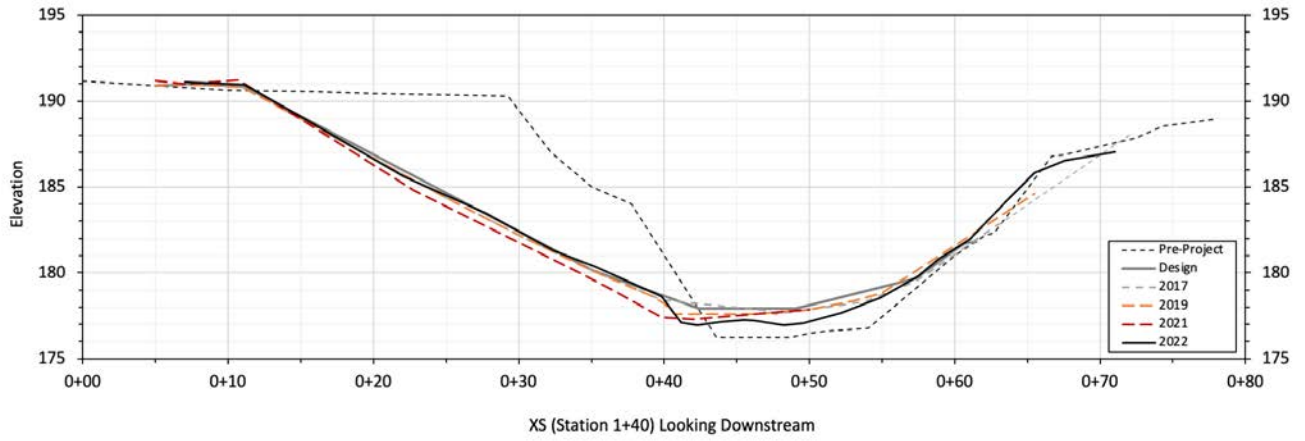
The left and right banks at T3 have little to no change in elevation from the design, 2017, and 2019 surveys, with a maximum change of about -0.25 ft. However, the main channel bed elevation decreased by about 1 ft since 2017, and predominantly impacted the left toe. The 2021 cross section indicated about 2 ft of erosion on the left bank, which we did not observe in our 2022 survey (Figure 1).

The channel bed changed the most over time. The bed incised about 1 ft since 2017 and predominantly impacted the left toe. Decreased sediment supply and increased runoff could have caused this incision. Sediment supply most likely decreased due to increased bank stability and vegetation growth. Runoff most likely increased due to development within the watershed, which increases impervious surfaces (decreases infiltration). T3 also occurs at the tail end of a riffle, and scouring behind boulders in the bed could have contributed to the elevation decreasing at the transect.

Figure 1. T3 cross-section looking downstream over time

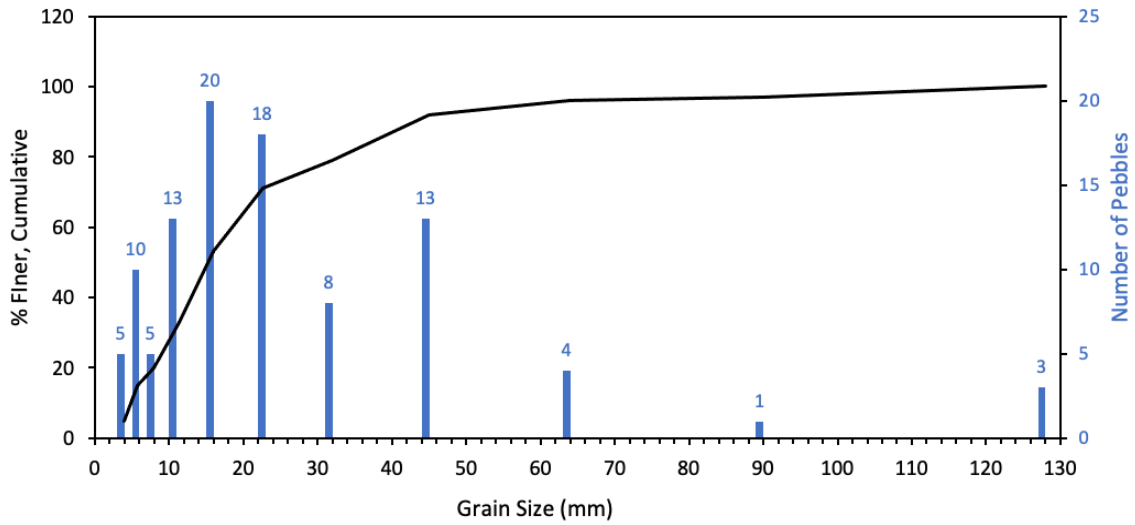
The channel bed's median grain size (d_{50}) was 16 millimeters (Figure 2), which indicates that the channel contains mostly medium to coarse gravel (Wolman 1954). We also observed cobbles in the channel (Photos 7 & 8).

Figure 2. Pebble count grain size distribution and cumulative distribution at T3

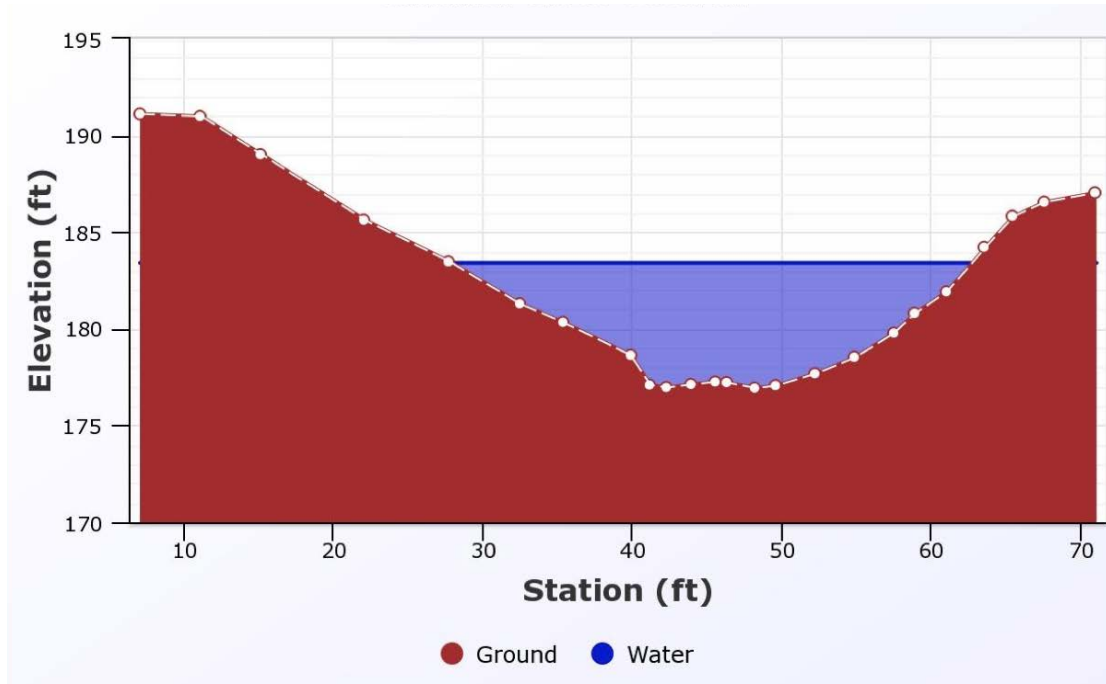
At T3, the changes in channel geometry since construction did not result in flooding over the left or right banks during the 10-year storm event (Figure 3) but did result in overtopping over the right bank during the 50-year event (Figure 4). Based on our sensitivity analysis for the 50-year event (Figure 5), overtopping over the right bank occurs when $n > 0.078$. Beyond the right bank, adjacent to the survey area, we observed a metal fence (the survey ended at a rebar monument against the fence) and beyond the fence is a level townhouse backyard.

Figure 3. Water surface elevation for peak flow during a 10-year flood at T3 under surveyed conditions completed in November 2022

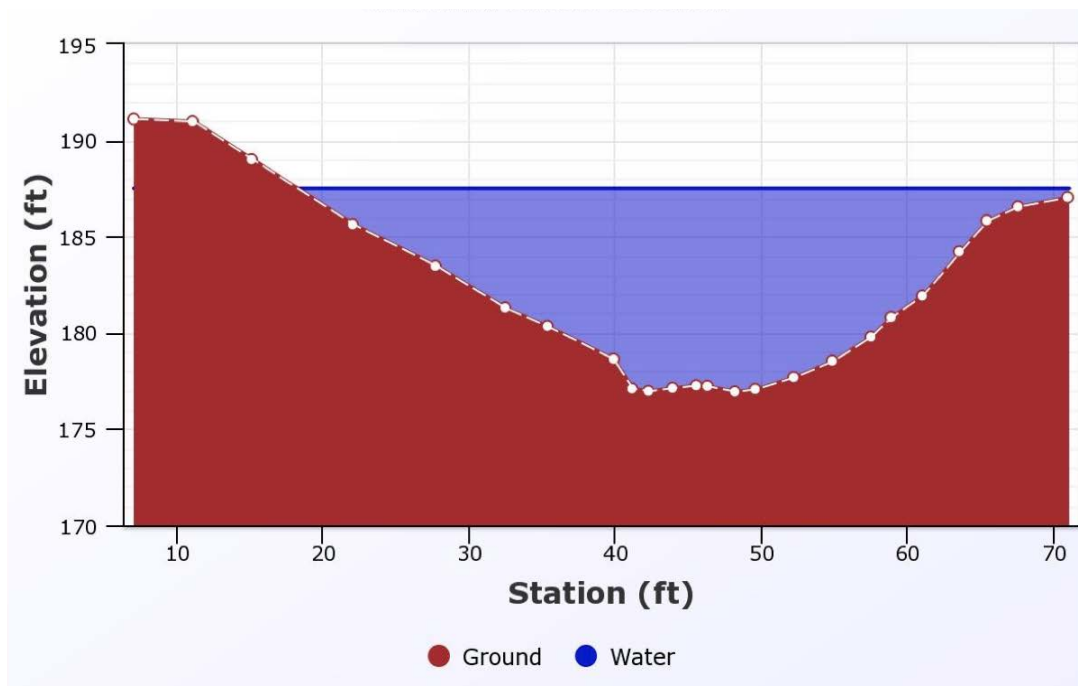
Since construction, the increase in vegetation growth and density increased channel roughness, which slowed the channel velocity. According to our estimated results, changes in channel geometry allow the cross section to convey the Q_{10} with a slightly lower water surface elevation (~ 0.2 ft) than in 2017 but at a larger maximum depth of 6.47 ft compared to 5.19 ft (Table 3), possibly due to the 1-ft incision in the channel bed. According to our estimated results, changes in channel geometry and the increase in channel roughness could cause water levels to overtop the right bank during the Q_{50} .

Figure 4. Water surface elevation for peak flow during a 50-year flood at T3 under surveyed conditions completed in November 2022

For the Q_{50} , RDG concluded that although the flow overtopped the right bank, it was most likely contained just outside of the survey limit (RDG 2012). We recommend that future monitoring efforts also further investigate flooding in this area since we did not analyze how or if the overtopped flow would be contained or redirected away from the adjacent properties beyond our survey limits. This investigation could include interviewing the adjacent property owner and

visually inspecting cross sections immediately downstream of T3 to see if there are low points that will redirect the overtopped flow.

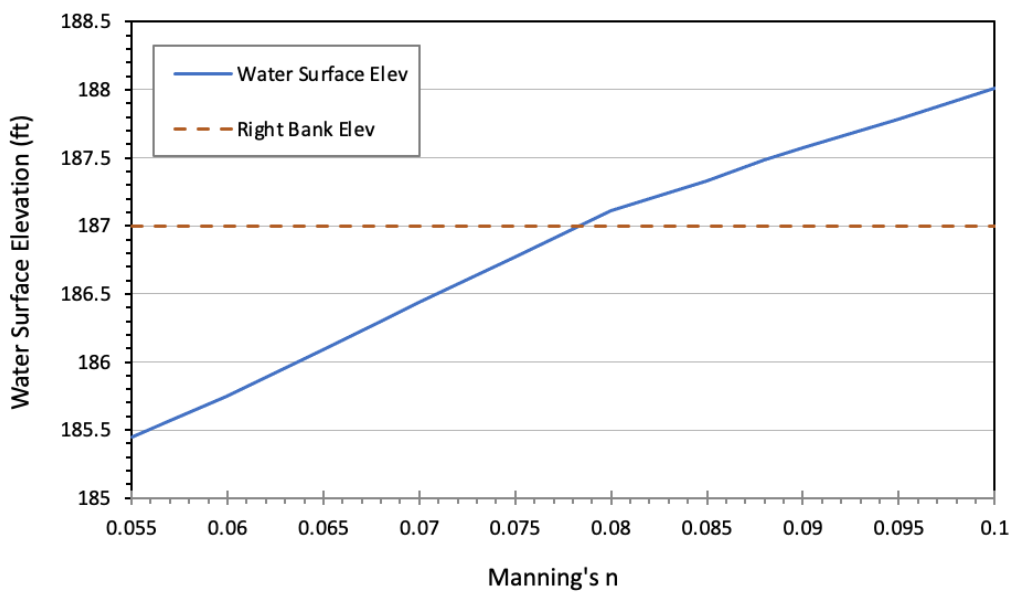
We performed a sensitivity analysis for the 50-year storm to see how the roughness coefficient (n) affected the calculated water surface elevation. We compared our flood analysis results for $n = 0.088$ to the results RDG modeled for pre-project and design conditions (RDG 2012).

Figure 5. Water surface elevation sensitivity analysis based on changing Manning’s n for peak flow during a 50-year flood at T3 under surveyed conditions completed in November 2022

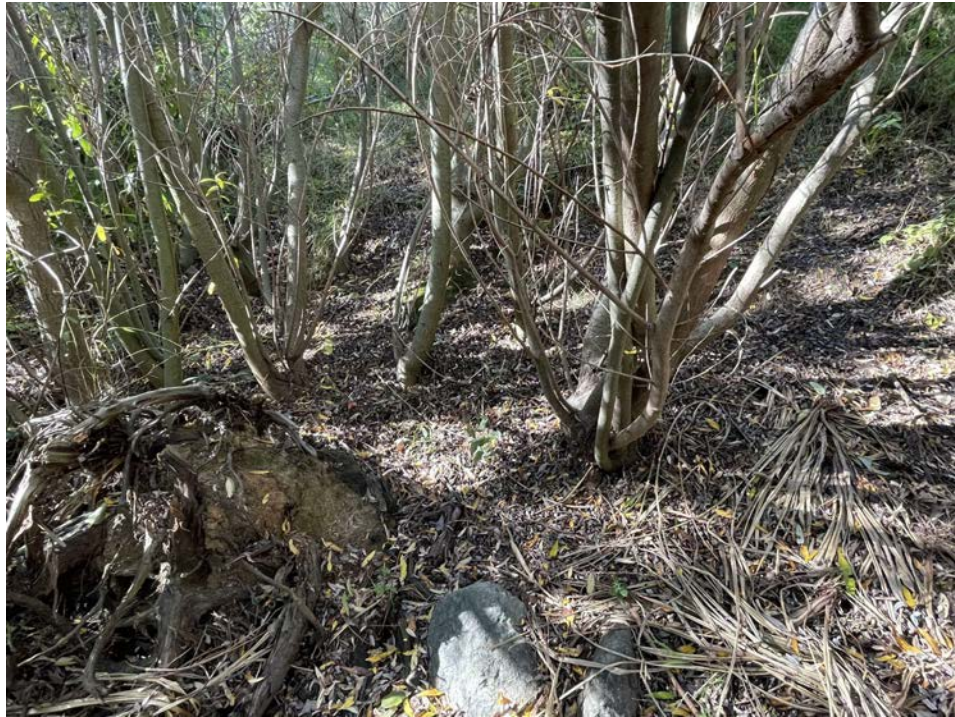
We found willows thriving in the creek (not quantified). The vigorous growth of willows shaded areas from sunlight, potentially creating observable adverse effects on the survival of shrubs nearby (Photo 1). The impacts of canopy shade on understory plants are complicated and depend upon the shading tolerance of different species (Valladares et al. 2016).

Photo 1. Impacts of willows on surrounding shrubs at T1 right bank.

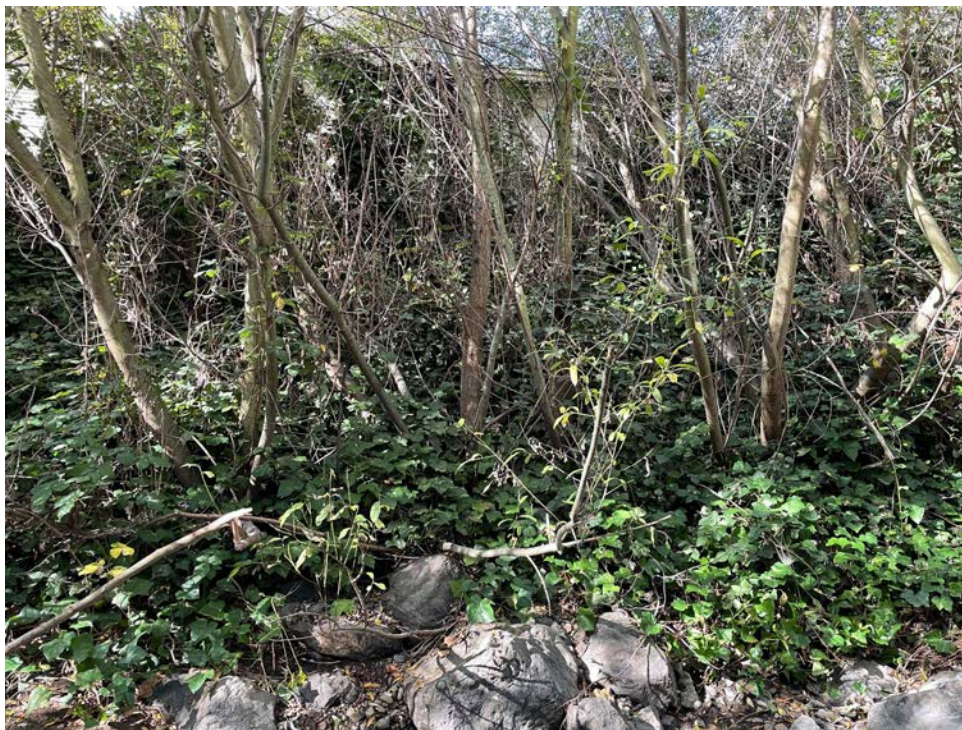
T1 has limited invasive and non-native species. In T2, the right bank is overgrown with invasive English ivy (~90% understory cover). In T3, English ivy has started to grow on the left bank (<5% understory cover). English ivy tolerates shaded conditions, thriving beneath the willows at the T2 right bank, and outcompetes native plants (Photo 2). Invasive species within the area favor likely shaded conditions more than planted native species, resulting in decreased native flora diversity. We propose continual maintenance of invasive species to reduce competition between native and invasive species, promoting the health and establishment of native species.

Photo 2. Coexistence of willow and ivy at T2 right bank.

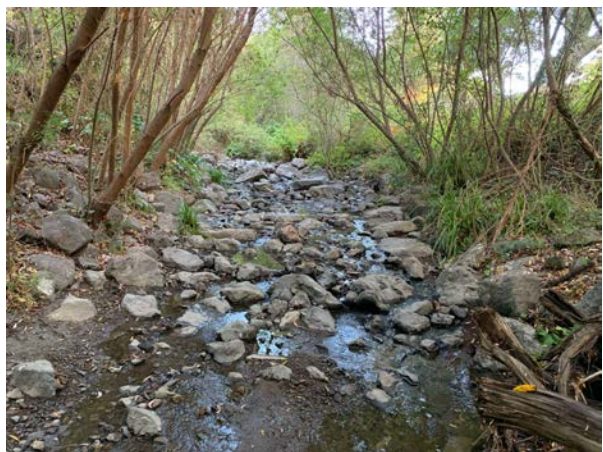
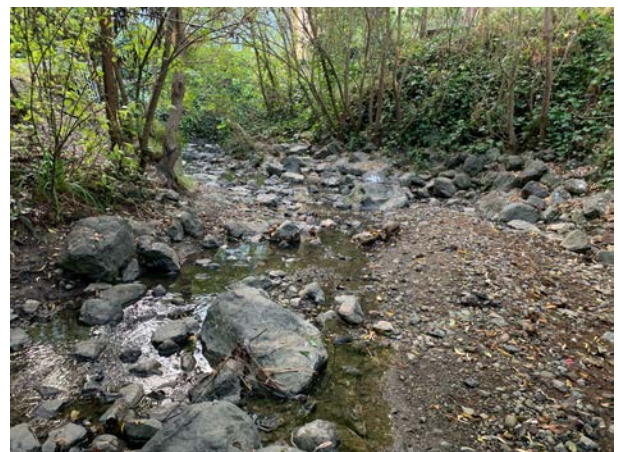
Photo 7. T3 looking upstream (NNE)

Photo 8. T3 looking downstream (SE)

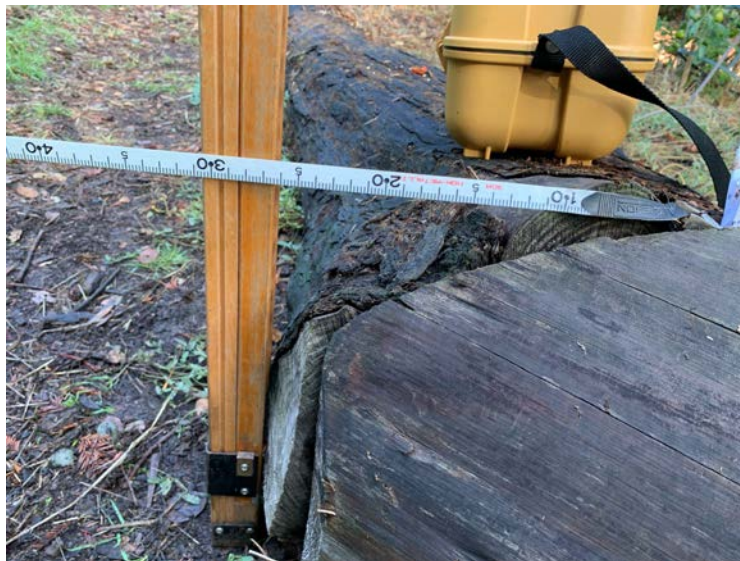
Photo 10. T3 survey starting point. 2022 T3 measurements began at the rod location shown. Measurements taken in the past began at the rebar (not shown) to the right of the log intersection.

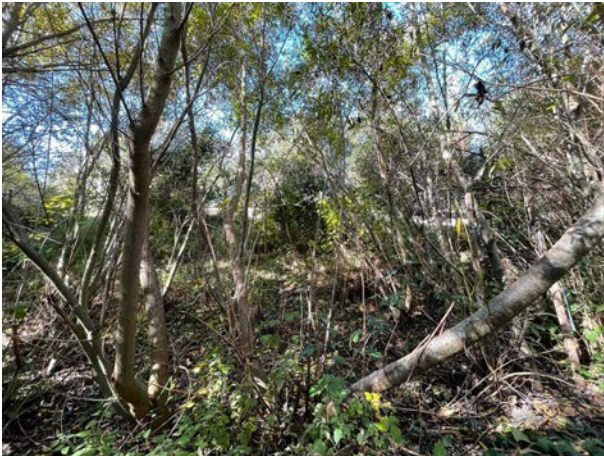
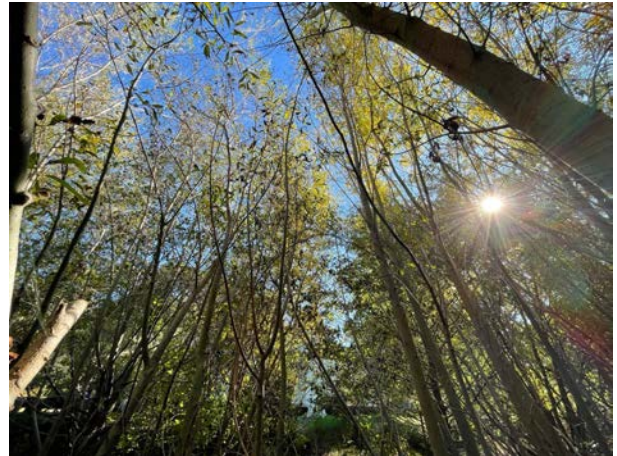
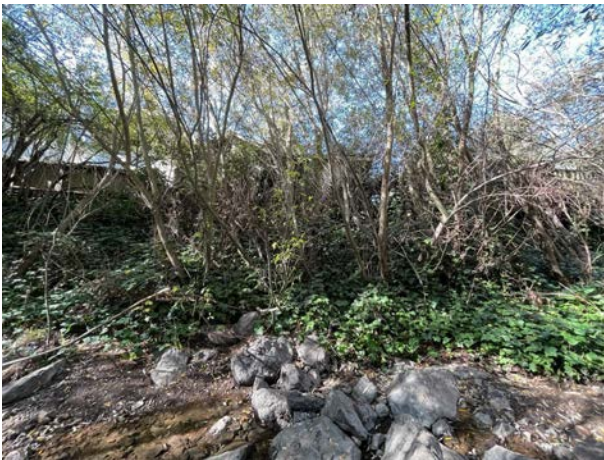
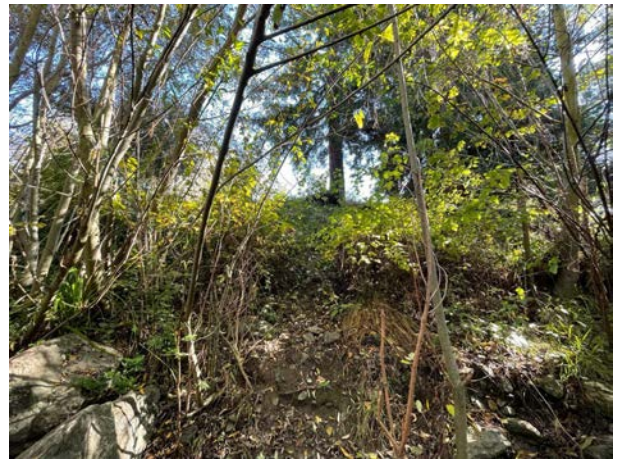
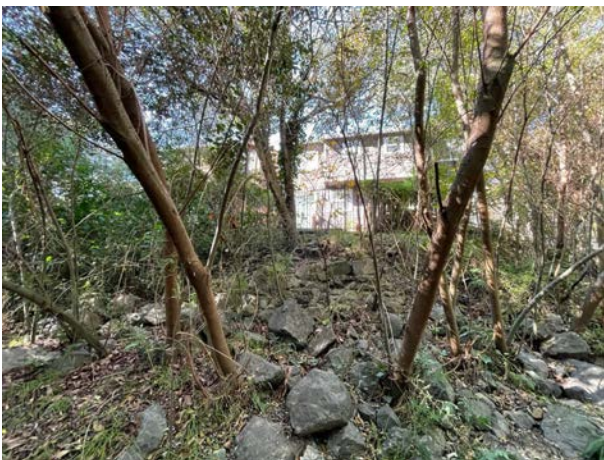
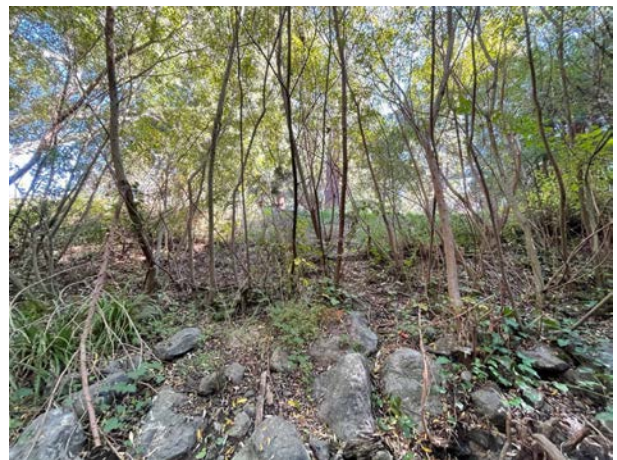
Vegetation (canopy) cover exceeds the required performance criteria of 75% cover after five years (RDG 2017) at T1, T2, and T3. Willows largely contributed to the vegetation (canopy) cover (Photos 11-16).
