Local site effects and incremental damage of buildings during the 2016 Central Italy earthquake sequence

ABSTRACT

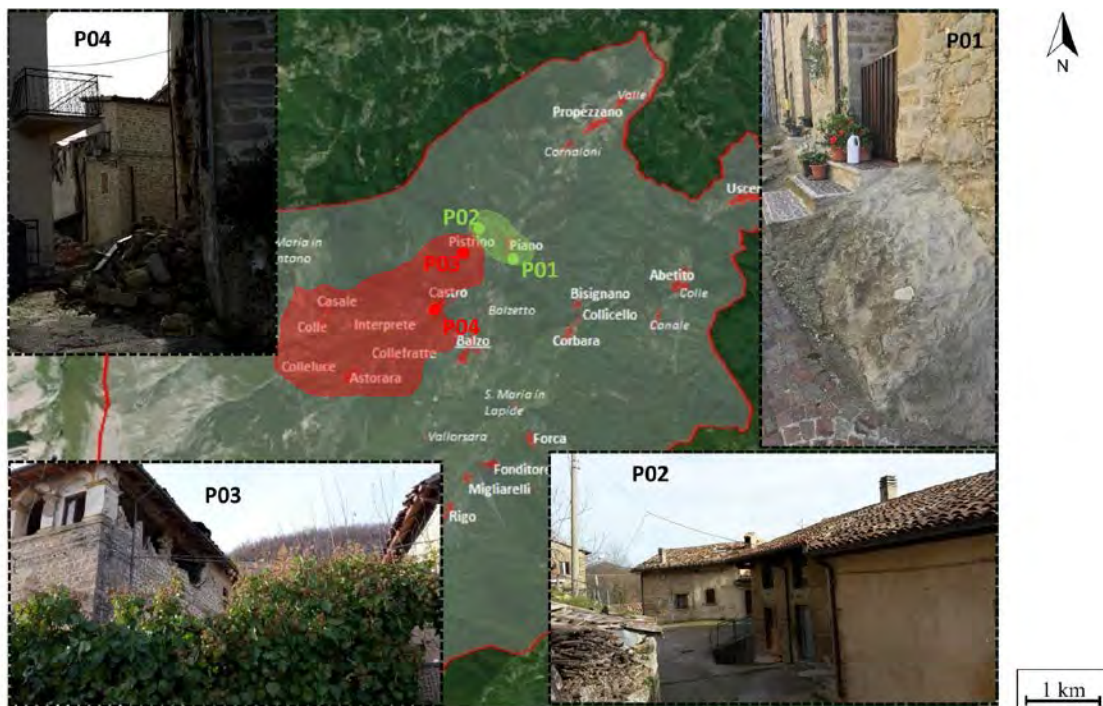
222 Other Montegallo's hamlets, such as Astorara, Castro, and Colleluce in the southwestern
223 part of the area at a distance of 1.5 to 2.5km from Piano, located on quaternary deposits
224 resting on rock, experienced high levels of damage and several cases of total collapse (D5).
225 For example, Figure 3-P04 shows a street in Castro that was blocked by the debris of a
226 damaged building. Given the proximity between Castro (highly damaged) and Piano
227 (practically undamaged), and the very similar structural systems and construction standards,
228 it is probable that Castro experienced stronger ground motions than Piano, due to significant
229 topographic amplification. A view of the 3D model obtained with a drone survey over the
230 entire area can also be found in BYU-PRISM (2016). It shows the typical crest configuration
231 of the zone, leading to possible 2D topographical effects.

233 **Figure 3.** Spatial distribution of building damage across the municipality of Montegallo.

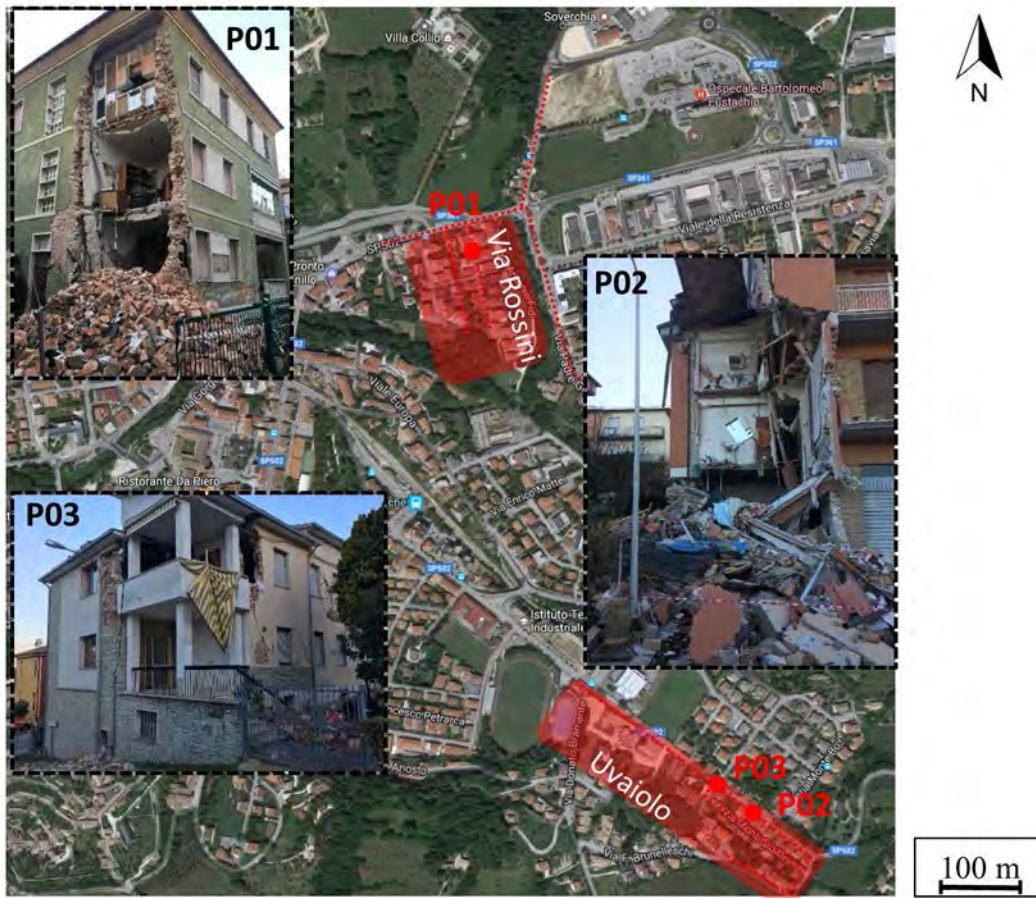
235 Other examples of local site effects were identified in some areas of San Severino Marche
 236 (number 11 in Figure 2). San Severino Marche is a town in the Province of Macerata, in the
 237 Marche region, located about 50 kilometers south-west of Ancona and about 25 kilometers
 238 south-west of Macerata. It has about 12,000 inhabitants, and it comprises more than 40
 239 hamlets. Unlike Montegallo, San Severino has districts where most of the buildings are of
 240 reinforced concrete, built in the 1960s and the 1970s. Within San Severino Marche, two
 241 neighborhoods along Via Mazzini and Via Rossini attracted most of the GEER
 242 reconnaissance team attention due to the evident and quite localized damage observed
 243 (Figure 4). Via Mazzini is located uphill while buildings along Via Rossini are constructed
 244 on the ancient riverbed of the Potenza River. It is deemed that stratigraphic amplification is

245 likely to have taken place due to the presence of soft shallow sediments resulted from the
 246 river artificial channeling operations. Similar damage patterns and site effects have been
 247 observed in Tolentino (number 10 in Figure 2), as described in GEER (2017).

Figure 4. Characteristic building damage within the town of San Severino Marche.

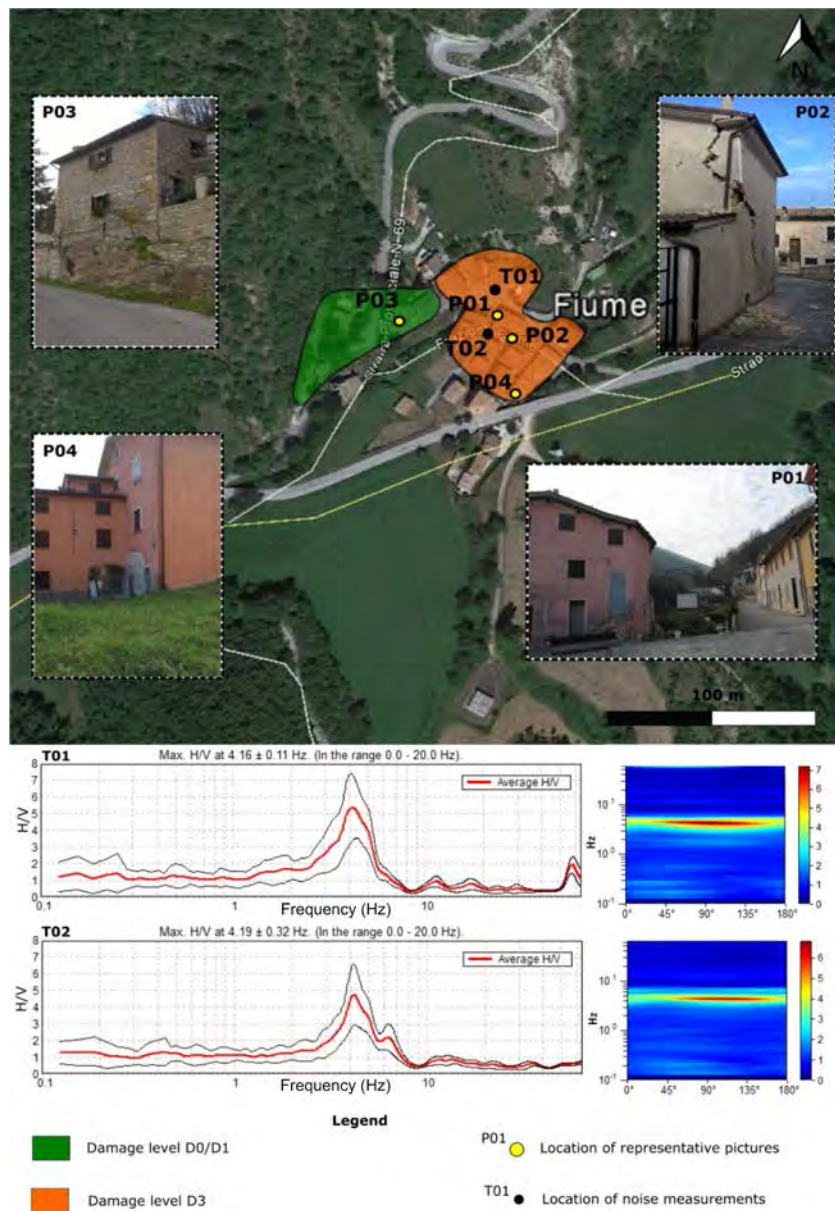
261 The Fiume building stock consists mainly of low-rise unreinforced masonry structures,
 262 some of which retrofitted to some extent. Locations and pictures of representative structures
 263 inspected in Fiume are reported in Figure 5 illustrating the severe and extensive damage.
 264 Notably, the degree of damage to buildings was highly variable across the village. The

265 eastern part of the hamlet, founded on colluvial and alluvial deposits resting on bedrock,
266 suffered high levels of damage (D3) as shown in reference pictures P01-P02-P04, whereas
267 the western part, built on travertine rock, had only negligible damage (D0/D1, P03).

268 Two noise measurements (T01-T02 in Figure 5) were performed in the damaged zone
269 (east side of the hamlet) during the GEER mission. A portable Tromino tomograph was
270 employed and the total duration of each measurement was approximately 15 minutes.
271 Horizontal-to-Vertical (H/V) spectral ratios were computed by using the geometrical mean of
272 horizontal components. In addition, H/V ratios were computed by rotating the horizontal
273 component between 0° and 180° (directional or polar HVSR), in order to investigate
274 preferential directions of site amplification (i.e., the polarization of ground motion). Both
275 H/V and polar H/V are reported in Figure 5 showing a large H/V peak around 4 Hz, which
276 shows significant stiffness contrast between the upper soil layers and the underlying bedrock,
277 i.e. a typical proxy of local site amplification.

293 **Figure 5.** Damage zonation within the village of Fiume (up). Location and results of noise
 294 measurements in terms of H/V spectral ratio (bottom left) and polar plot (bottom right).

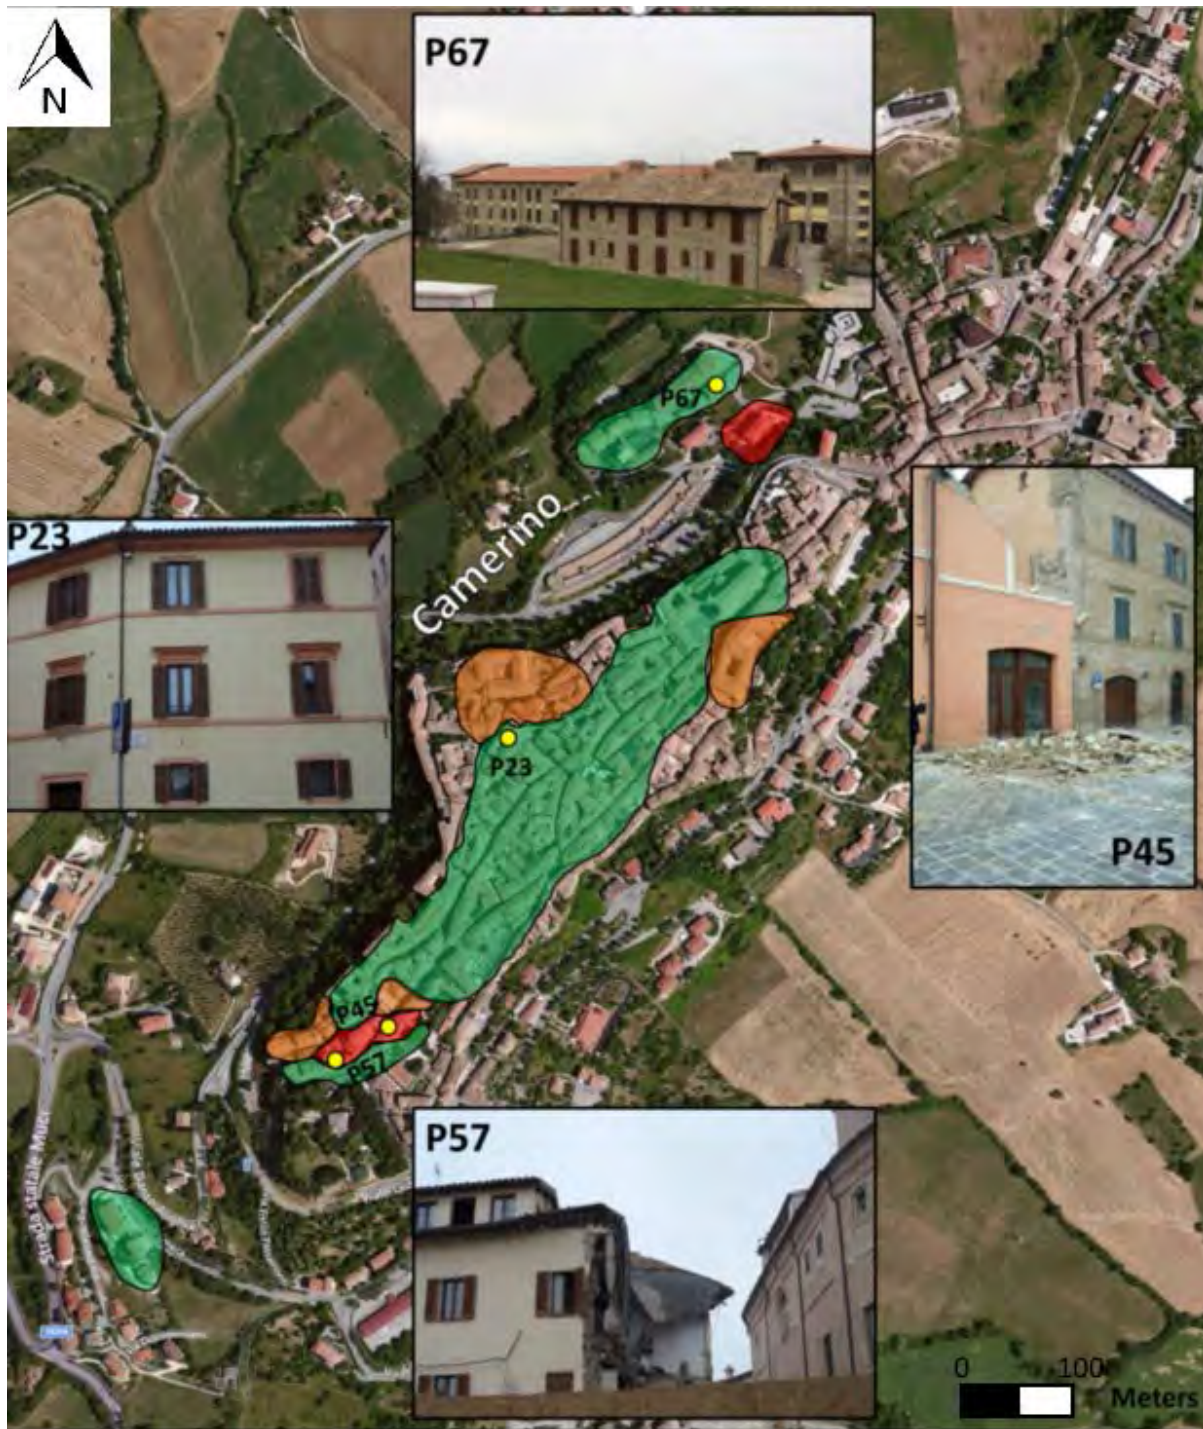
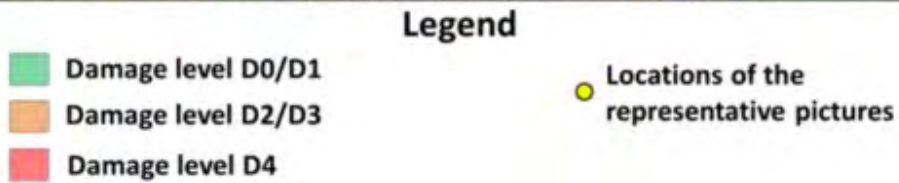
320 Figure 6 depicts the damage distribution across the main village, as inspected after the 30
321 October event. Relatively low damage (D0 or D1) were observed within the inner part of the
322 ridge characterized by local bedrock (GRS) outcrops. Higher damage levels (D2-D3) were
323 observed for many of the low rise (2-3 stories) unreinforced masonry buildings, even if some
324 of them were partially retrofitted. The damage is mainly localized on the hillside, where
325 potential topographic amplifications and permanent deformation (due to slope instability)
326 may be occurred. The highest damage level (D4) was observed at the SW side of the historic
327 center and at the bottom of the Camerino hill, where several masonry structures collapsed.
328 The observed damage distribution pattern in Camerino is consistent with site effects that
329 could be inferred from the geological map shown in Figure S5. Strong amplification of

330 earthquake ground motions is highly probable given the thin soft layers of eluvio-colluvial
331 soils (ML) overlying the bedrock.

Figure 6. Damage zonation within the historic center of Camerino with pictures of the representative structures inspected.

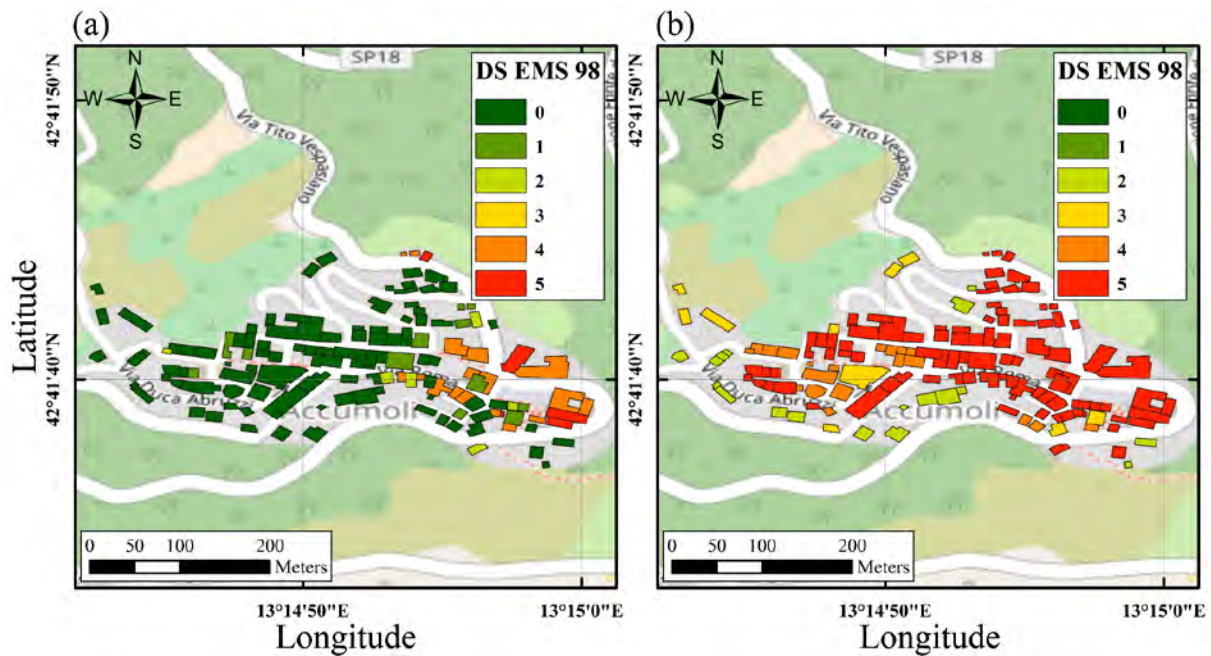
357 Figure 7 illustrates the structural damage levels observed during the two surveys, after the
358 24 August (left) and the October events (right). After the August 24th event, the most severe
359 damage was observed at the eastern side of the village, while the vast majority of the building
360 stock retained its structural integrity null or with minor damage (D0-D1). However, at the
361 end of the seismic sequence, Accumoli was almost completely destroyed. Few buildings, in
362 the south end of the village survived the sequence of events with limited damage (D2).

364 **Figure 7.** Damage levels in the main village of Accumoli (a) after the first earthquake and (b) at the
 365 end of the entire sequence.

366 The evolution of structural damage during the earthquake sequence is clearly reflected in
 367 the observed damage: 72% of the buildings experienced zero (DS0) and 8% minor damage
 368 (DS1) after the first earthquake, while not a single building was found intact or with minor
 369 damage after the seismic sequence. Large damage states were in contrast more populated (4%
 370 to 13% for DS2, 0% to 7% for DS3, 12% to 14% for DS4, and a major shift from 4% to 65%
 371 for DS5).

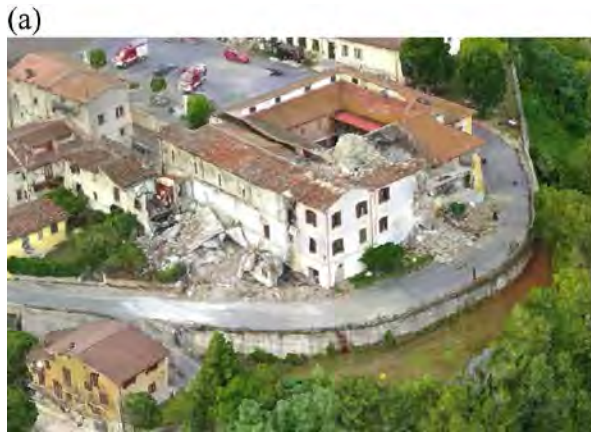
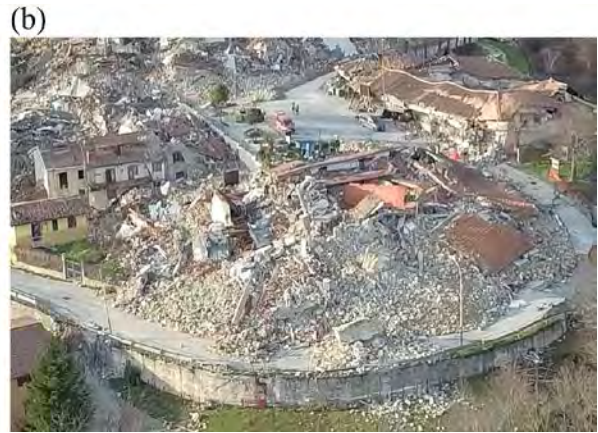
372 Figures 8a and 8b show an aerial view of the east part of the village during the first and
 373 the second surveys, respectively, including the local church and the police station, which
 374 eventually collapsed because of multiple earthquake excitations. Figures 9, 10 and 11
 375 illustrate characteristic cases of minor-to-moderate shear and out-of-plane damage after the
 376 August event that led to abrupt collapse because of the earthquake sequence. Age of
 377 construction, high spectral accelerations for periods lower than 0.3s (which match the natural
 378 periods of low-rise buildings) and the variation of spectral polarization across several events
 379 were likely the main contributors to the observed catastrophic damage patterns. Given the
 380 location of Accumoli, topographic effects may also have contributed to the observed damage.

382 **Figure 8.** Aerial photos of the east side of Accumoli after (a) the first earthquake and (b) the entire
383 earthquake sequence.

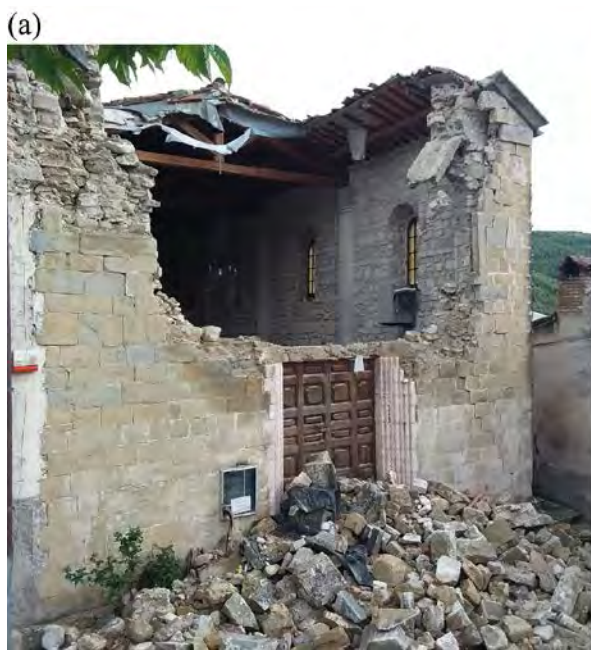
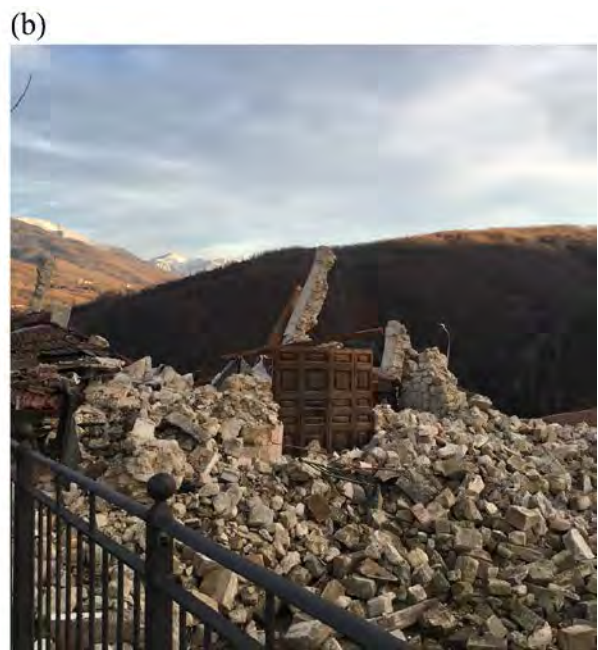
Figure 9. The local church: (a) after the first earthquake; and (b) after the entire sequence.

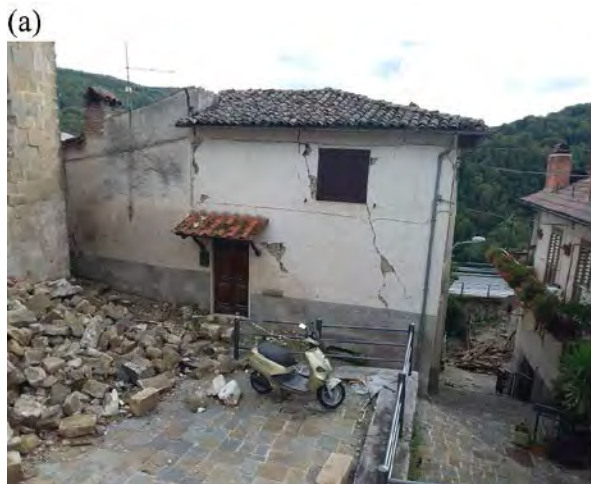
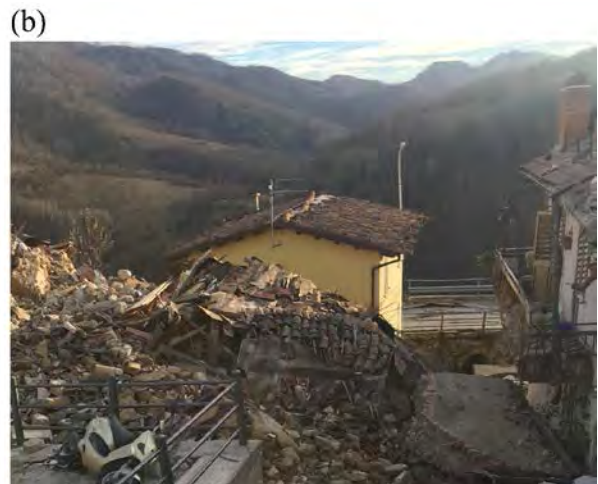
Figure 10. Masonry residential building: (a) after the first earthquake; and (b) after the sequence.

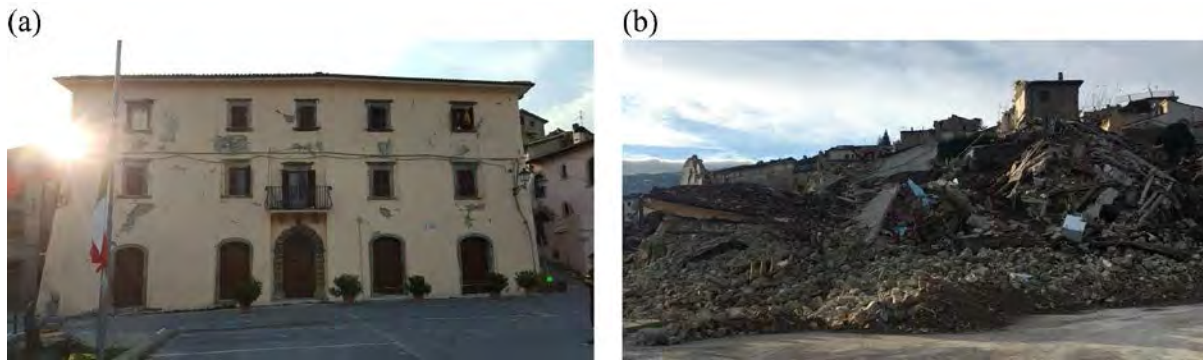
389 **Figure 11.** The town hall: (a) after the first earthquake; and (b) after the entire sequence.

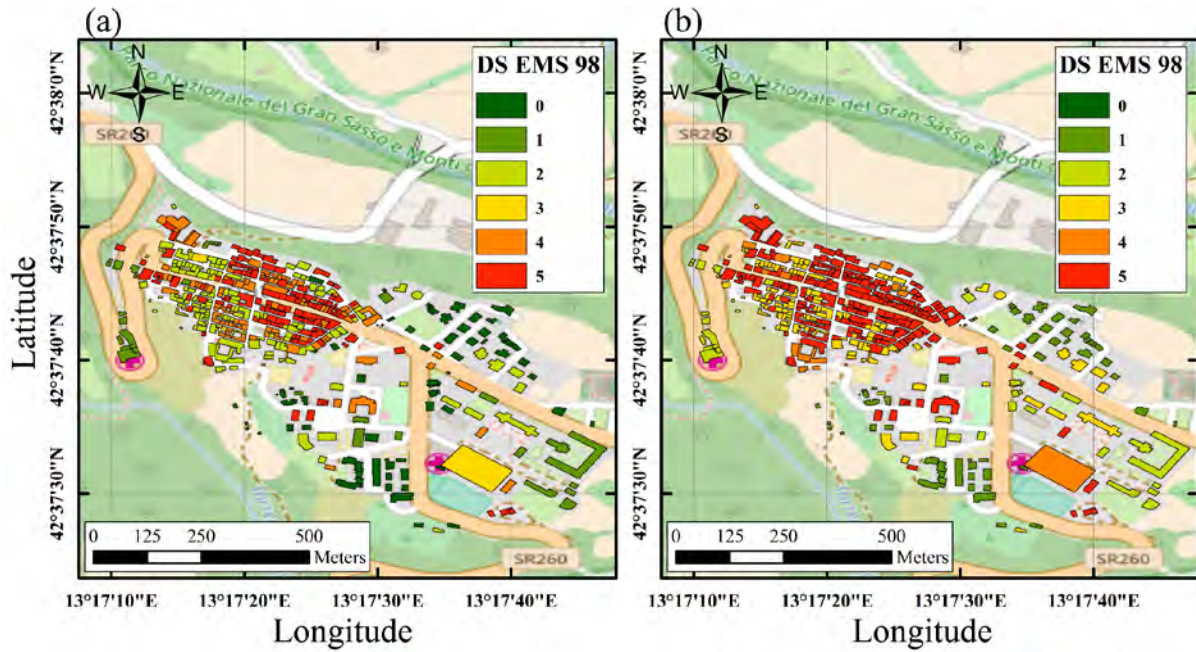
408 Figure 12 shows the structural damage levels observed during the two surveys. The 24
 409 August event caused severe damage to the south-east part of the historical city center along
 410 the main avenue (Corso Umberto I). As observed in the case of Accumoli, many buildings
 411 that were still standing after the first event with only a small residual capacity to additional
 412 horizontal actions, fully collapsed because of the subsequent September and October events.
 413 The shifting of damage states between the aftermath of the first event and the end of the

414 entire sequence is reflected in the following inspection results clearly indicating a major shift
 415 to most critical damage states: intact buildings (D0) were reduced from 30% to 18%,
 416 buildings with minor damage (D1) were increased from 5% to 10%, moderate damage (D2)
 417 was reduced from 24% to 6%, D3 increased from 1% to 21%, D4 decreased from 17% to 3%,
 418 and collapsed buildings (D5) had a significant increase from 23% to 42%.

419
 420 **Figure 12.** Damage levels observed in the center of Amatrice (a) after the 24 August earthquake
 421 (during the first survey), and (b) after the entire sequence (during the second survey).

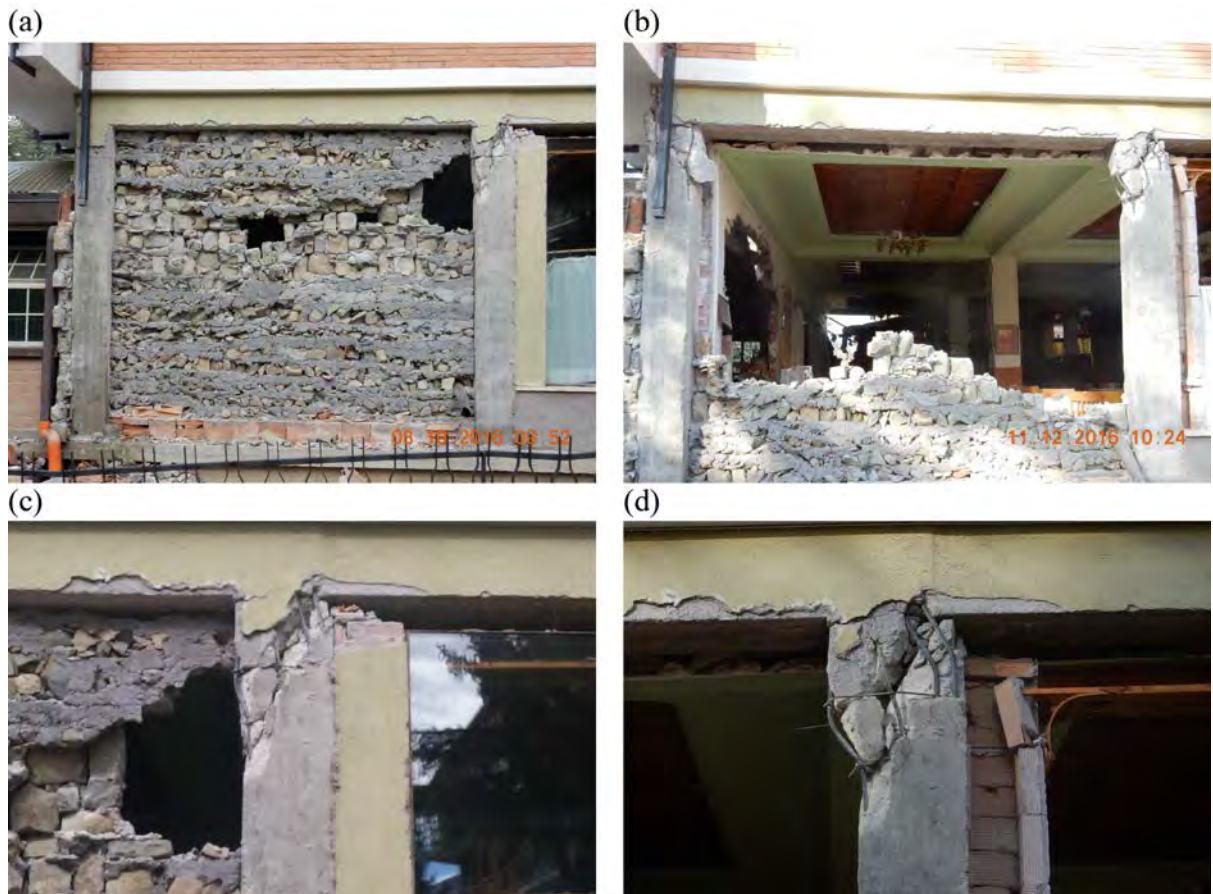
422 Even though the statistical sample of the reinforced concrete buildings was not adequate
 423 to quantify how damage accumulates for different structural systems under multiple
 424 earthquakes, an effort was made to compare characteristic cases at least qualitatively. An
 425 example of a reinforced concrete building is illustrated in Figure 13. The partial out-of-plane
 426 collapse of an external infill panel after the first event was followed by complete failure at the
 427 end of the entire seismic sequence. A closer inspection of the top right beam-column joint
 428 further reveals shear damage that was magnified, though not considerably, under multiple
 429 excitations, i.e. the reinforced concrete structure retained some of its capacity thus avoiding
 430 collapse. A similar example is shown in Figure 14. Cyclic degradation, concrete spalling and
 431 minor longitudinal rebar buckling were indeed observed in the absence of adequate

432 transverse reinforcement, however, global damage state remained constantly moderate
 433 despite the multiple earthquake events. In some cases, damage accumulation was more
 434 significant, as for instance, in the building depicted in Figure 15, where minor damage after

446 **Figure 13.** Reinforced concrete residential building (a,c) after the 24 August earthquake and (b,d)
447 after the entire sequence. (a,b) External infill failure and (c,d) shear failure at the column top.

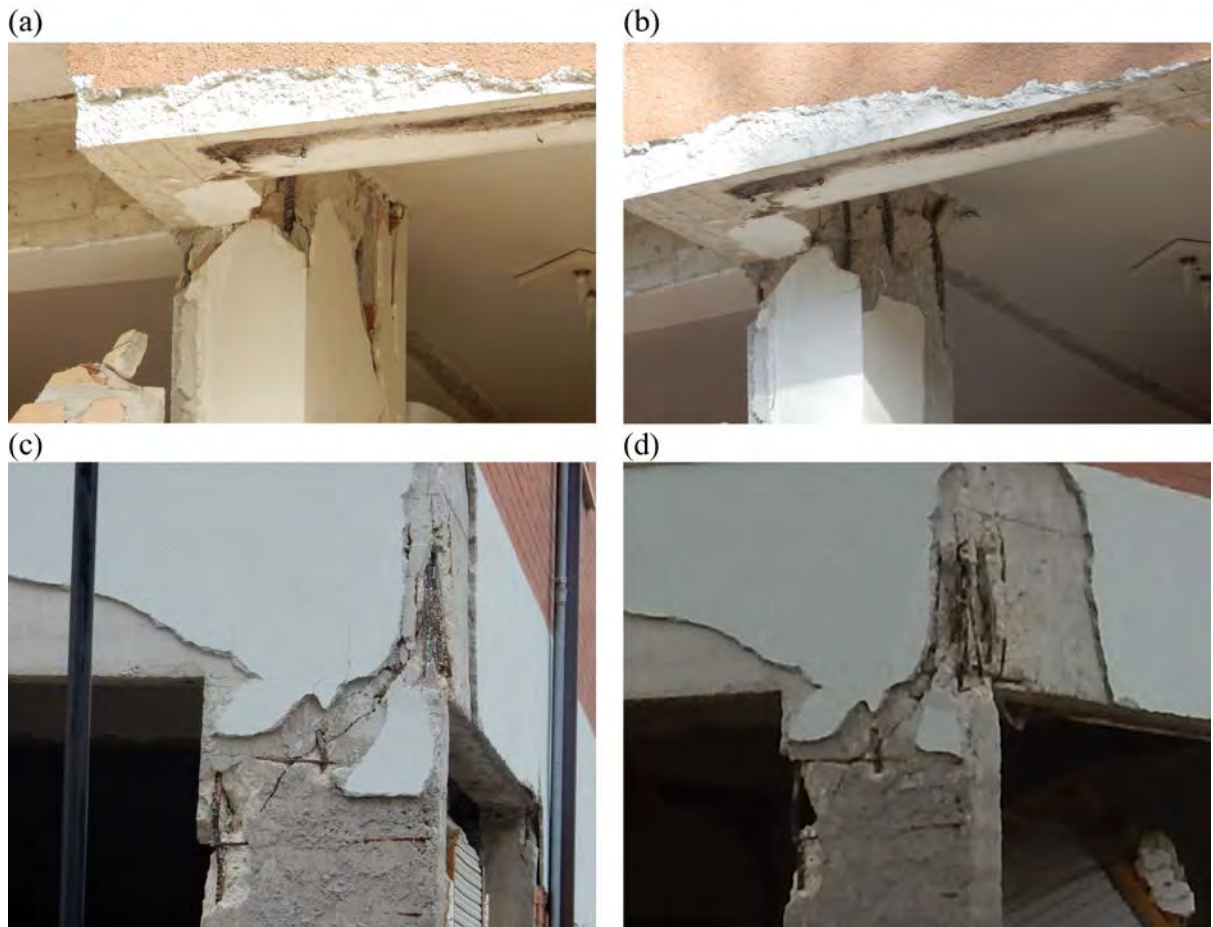
449 **Figure 14.** Beam-column joints. Concrete spalling and local bar buckling due to lack of transversal
 450 reinforcement after the 24 August event (a,c) and after the earthquake sequence (b,d).

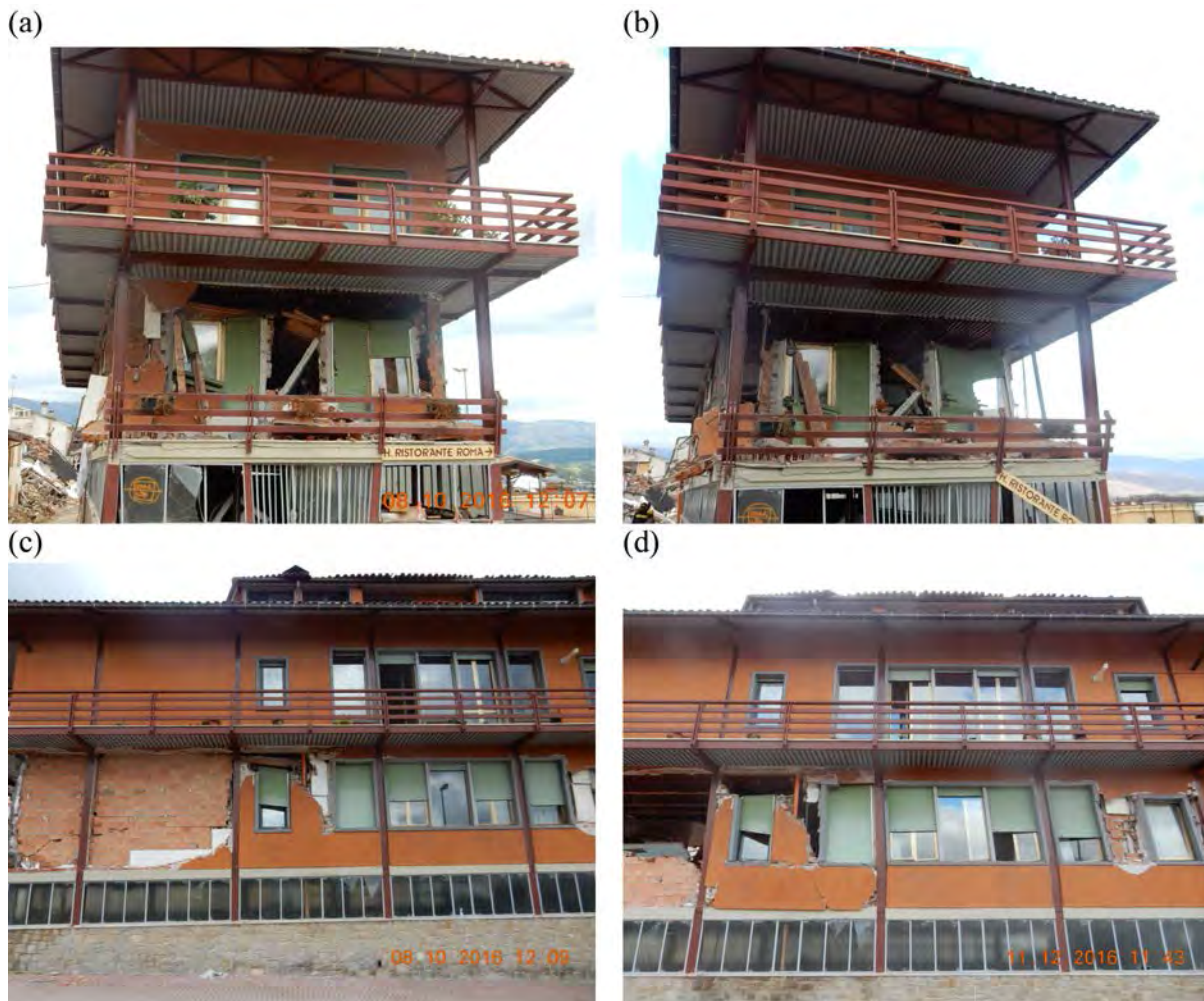
456 **Figure 16.** Steel residential building. (a,c) Limited damage after the 24 August earthquake and (b,d)
 457 extensive damage of the infill panels at ground level with evident residual drift after the entire
 458 sequence.

459 Such a steel structure consists of a basement, a ground floor, and two upper stories
 460 alongside a shorter top story that serves as a penthouse. After the 24 August event, the
 461 damage was mainly confined to the infill panels, with only small local flange instabilities
 462 observed at the top of two front columns of the ground floor. At the end of the entire seismic
 463 sequence, the building experienced permanent deformation along its longer direction, as
 464 shown in Figure 16. Such permanent deformation was localized at the second level of the
 465 building with a visible residual inter-story drift due to the relative positions of infills and
 466 openings. Preliminary finite element analyses of the building confirmed that the fundamental
 467 period of the structure is approximately equal to 0.75 sec. This was an uncoupled
 468 translational mode along the long side, which was mainly attributed to the orientation of the

469 steel columns with their strong axes aligned with the short side of the building. Naturally,
 470 residual drift developed along the longitudinal (weak) axis. Evolution of structural damage is

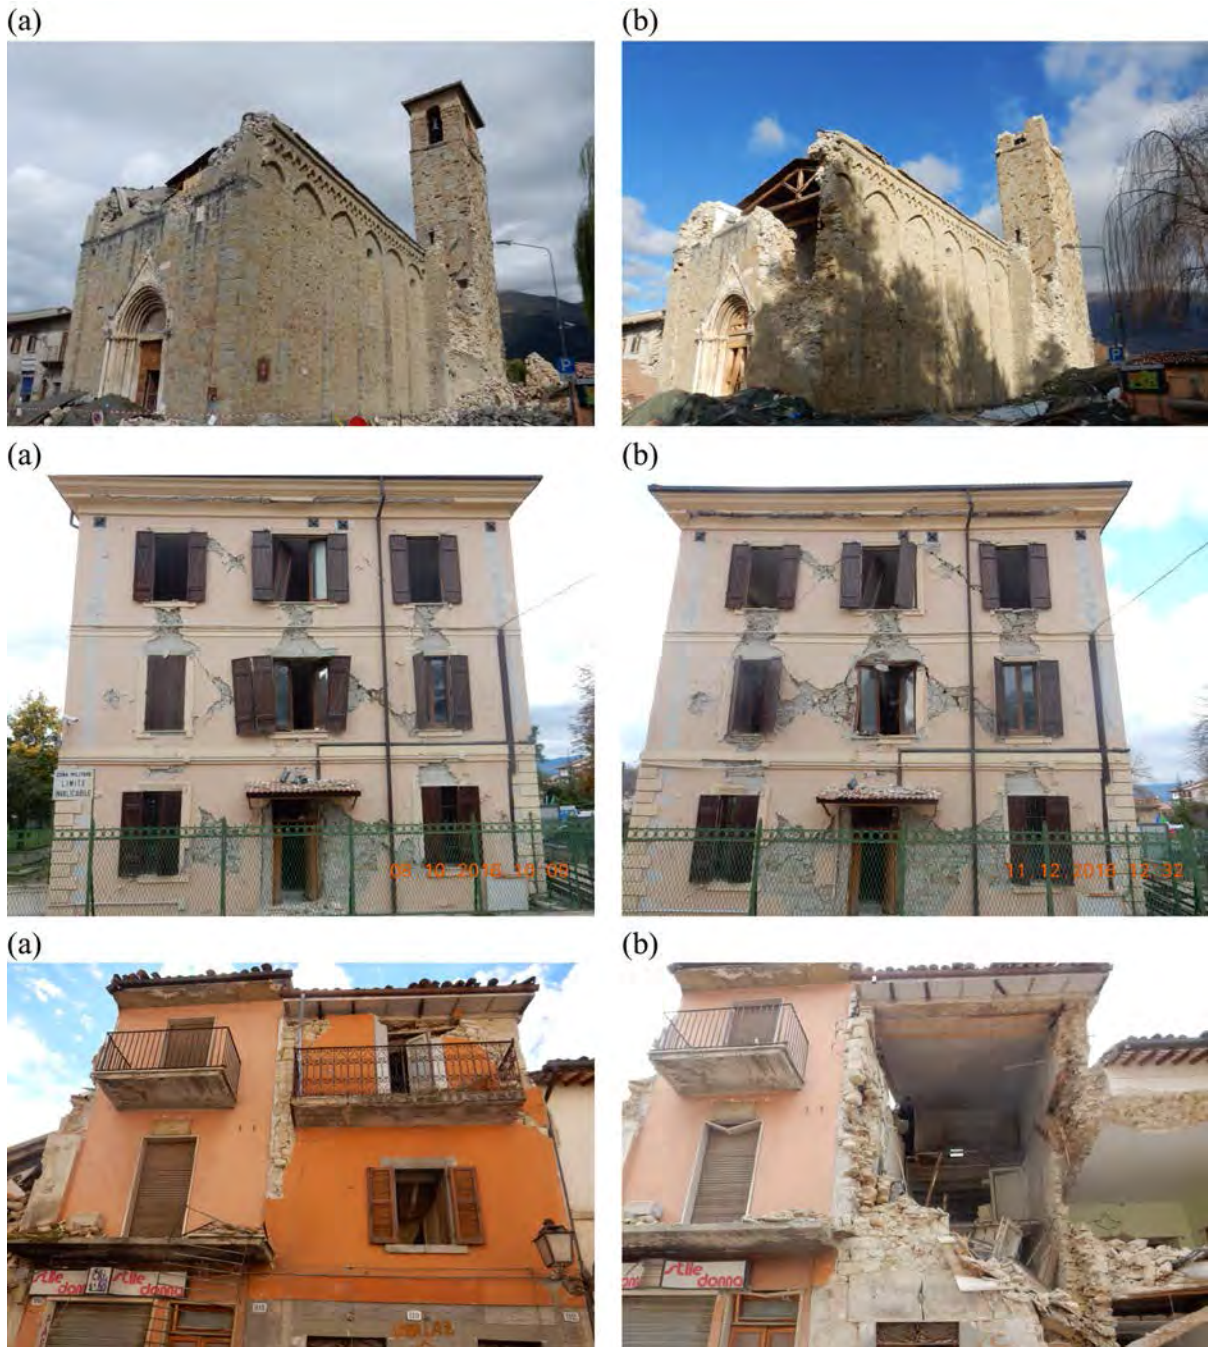
471 also clearly seen in several characteristic masonry structures, such as the church of
472 Sant’Agostino (Figure 17, top), the local police (“Carabinieri”) station (Fig. 17, middle) and
473 typical residential buildings (Fig. 17 bottom and Fig. 18).

475 **Figure 17.** Incremental structural damage of the church of Sant’Agostino (top), the local police
476 station (middle) and one of the several masonry buildings collapsed after (a) the event of 24 August
477 earthquake and (b) the entire sequence.

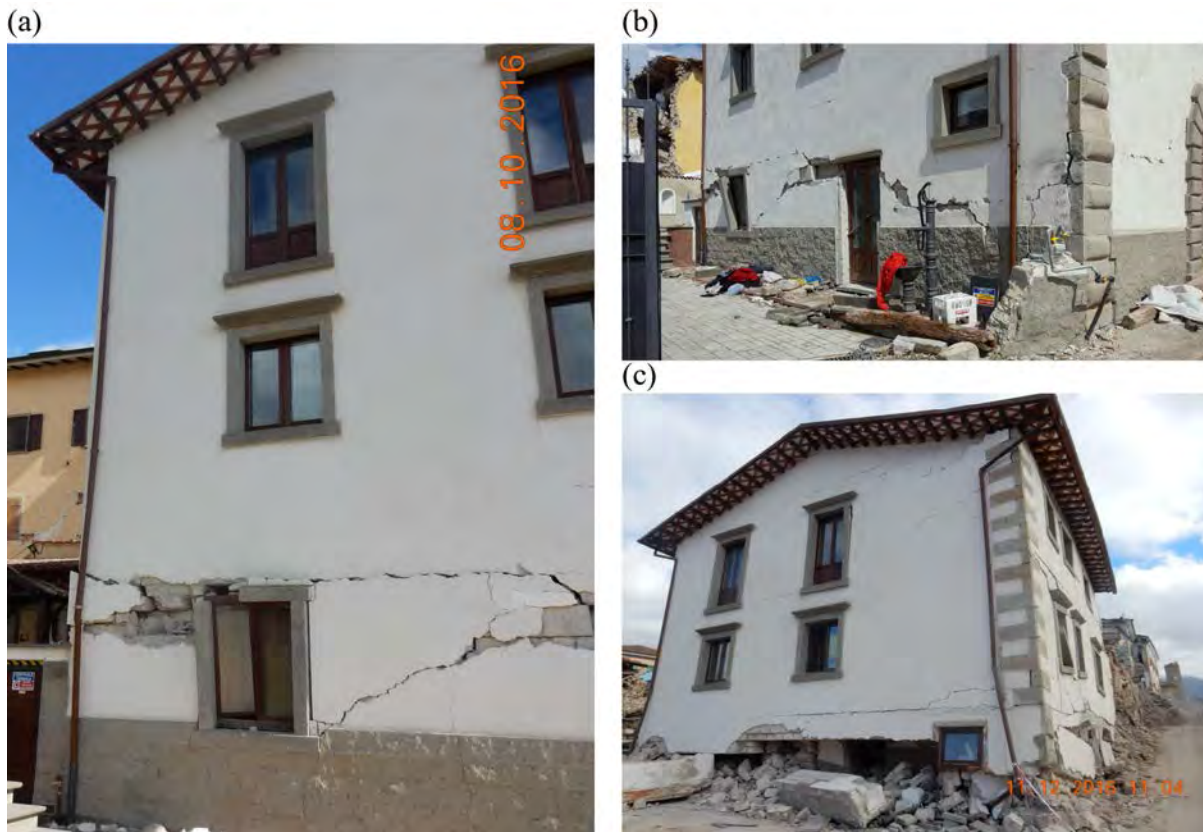
479 **Figure 18.** Residential masonry residential building after the 24 August earthquake (a, b) and (c) after
 480 the entire sequence. Shear failure of the ground floor bearing wall leads to soft story collapse at the
 481 end of the third event.

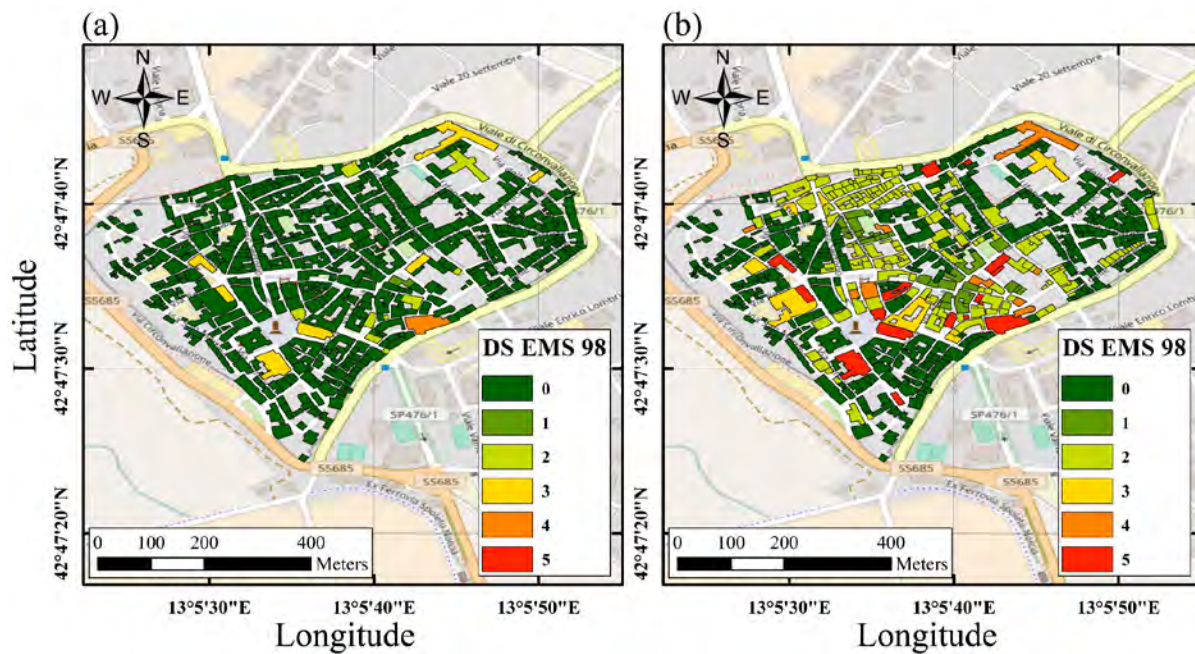
514 Figure 19 shows the structural damage levels observed during the two inspection
515 campaigns. Following the 24 August earthquake, only a small number of buildings
516 experienced medium or severe damage, located mainly in the historical center of the town.
517 This good performance can be primarily attributed to two reasons. First, after the 1859
518 earthquake, the reconstruction of Norcia was based on a set of new practical rules of thumb
519 prescribing a minimum wall thickness, the use of buttresses, the reduction of building height,
520 the use of vaults only at ground floor and the mandatory presence of good wall-to-wall
521 connections. The increased wall thickness is still visible in many structures, and in several
522 buildings, the wall thickness varies linearly along the height of the first story. Secondly, a
523 series of repair and strengthening works followed the 1997 Umbria-Marche event, which

528 observed at the end of the seismic sequence, mainly in heritage construction such as churches
 529 and monasteries. The following variation of cumulative damage was reflected in the
 530 statistical distribution of the different damage states: intact buildings (DS0) were reduced
 531 from 97% after the first earthquake to 67%, which was a substantial change in structural
 532 behavior. Minor damage (DS1) also increased at the end of the entire sequence to 4% from
 533 almost 0% after the first event. The same applies to moderate damage (DS2), it increased
 534 from 1% to 24%, previously, and to DS5 increased from 0% to 3% in the first event, DS3 and
 535 DS4 remaining practically constant.

536
 537 **Figure 19.** Damage distribution in the historical center of Norcia (a) after the 24 August event and (b)
 538 at the end of the entire seismic sequence.

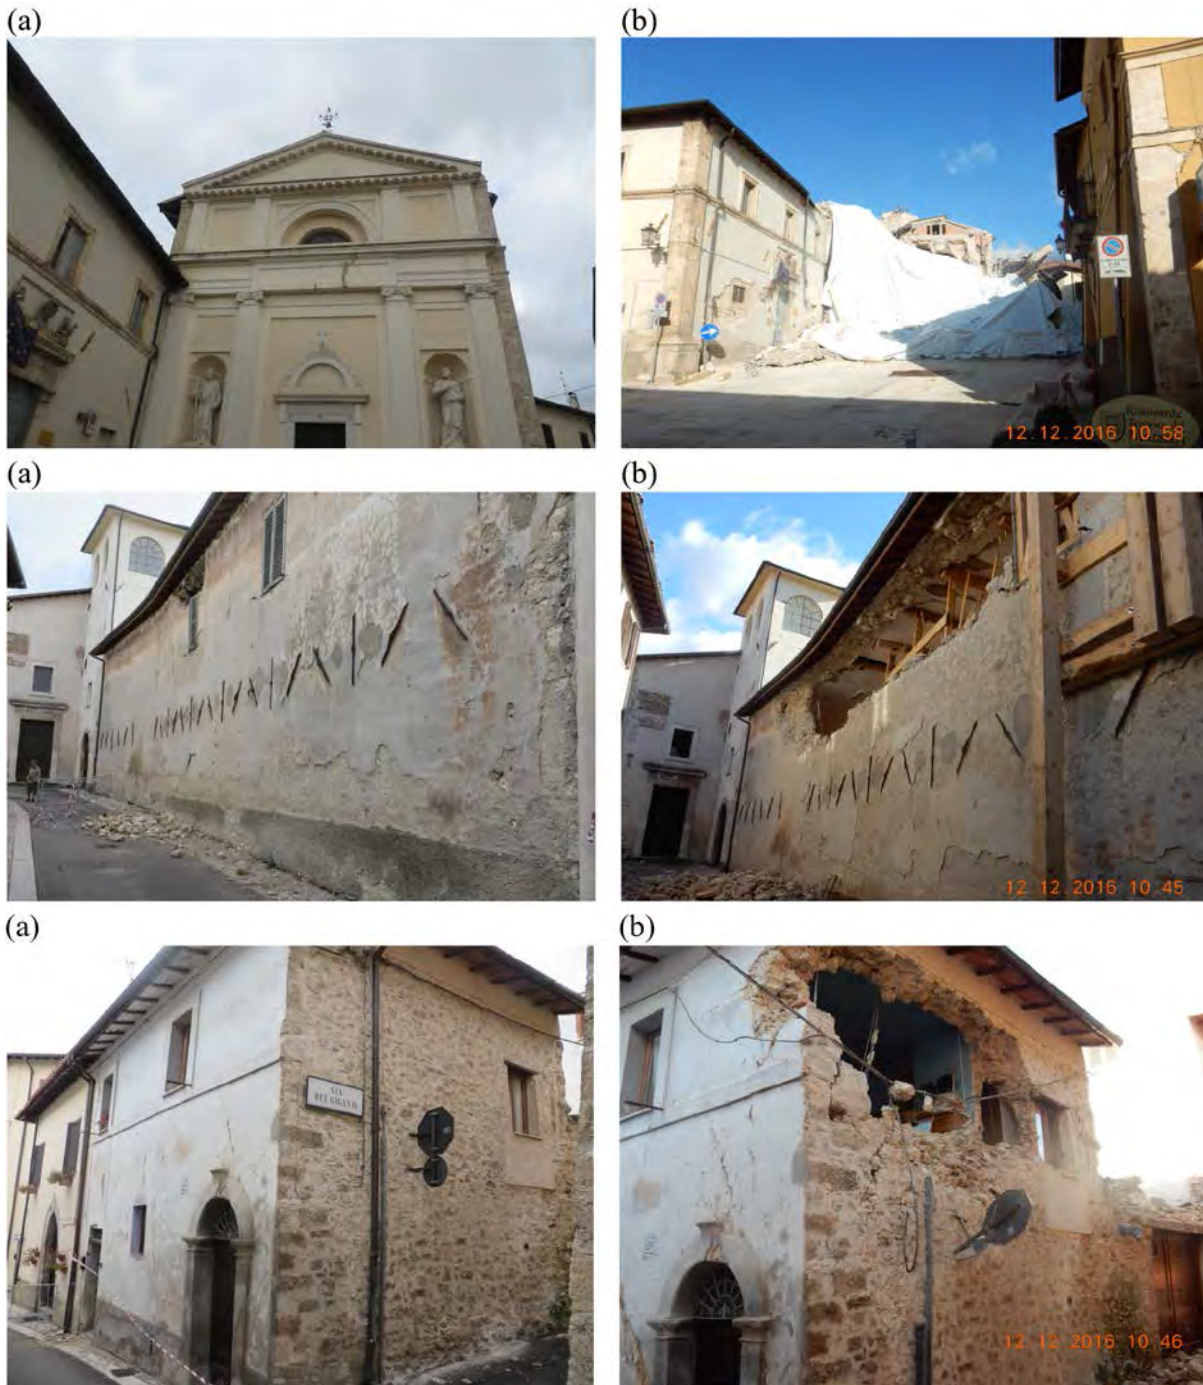
539 Figure 20 (top) shows one of the churches that was slightly damaged by the **M6.1** 24
 540 August seismic event but collapsed following the **M6.5** 30 October event. Many historical
 541 churches in Norcia experienced similar damage evolution, as shown for instance in Figure 20
 542 (middle), where the out-of-plane failure of a historic monastery and the partial loss of support
 543 of the roof is depicted. Notably, the wall failure was concentrated at a level higher to that of
 544 the seismic retrofit, thus highlighting that the retrofit shall not be only localized on the
 545 ground level but also take into consideration the reduced axial load and weak diaphragm
 546 action of the masonry walls at the higher level. Figure 20 (bottom) shows two masonry
 547 residential buildings with irregular masonry construction that experienced only minor
 548 cracking during the first earthquake, but significant out-of-plane and in-plane wall failure

549 under subsequent events.

551 **Figure 20.** Seismic damage observed in characteristic masonry buildings (a) after the 24 August
 552 earthquake and (b) at the end of the entire seismic sequence.
