Local site effects and incremental damage of buildings during the 2016 Central Italy earthquake sequence

ABSTRACT

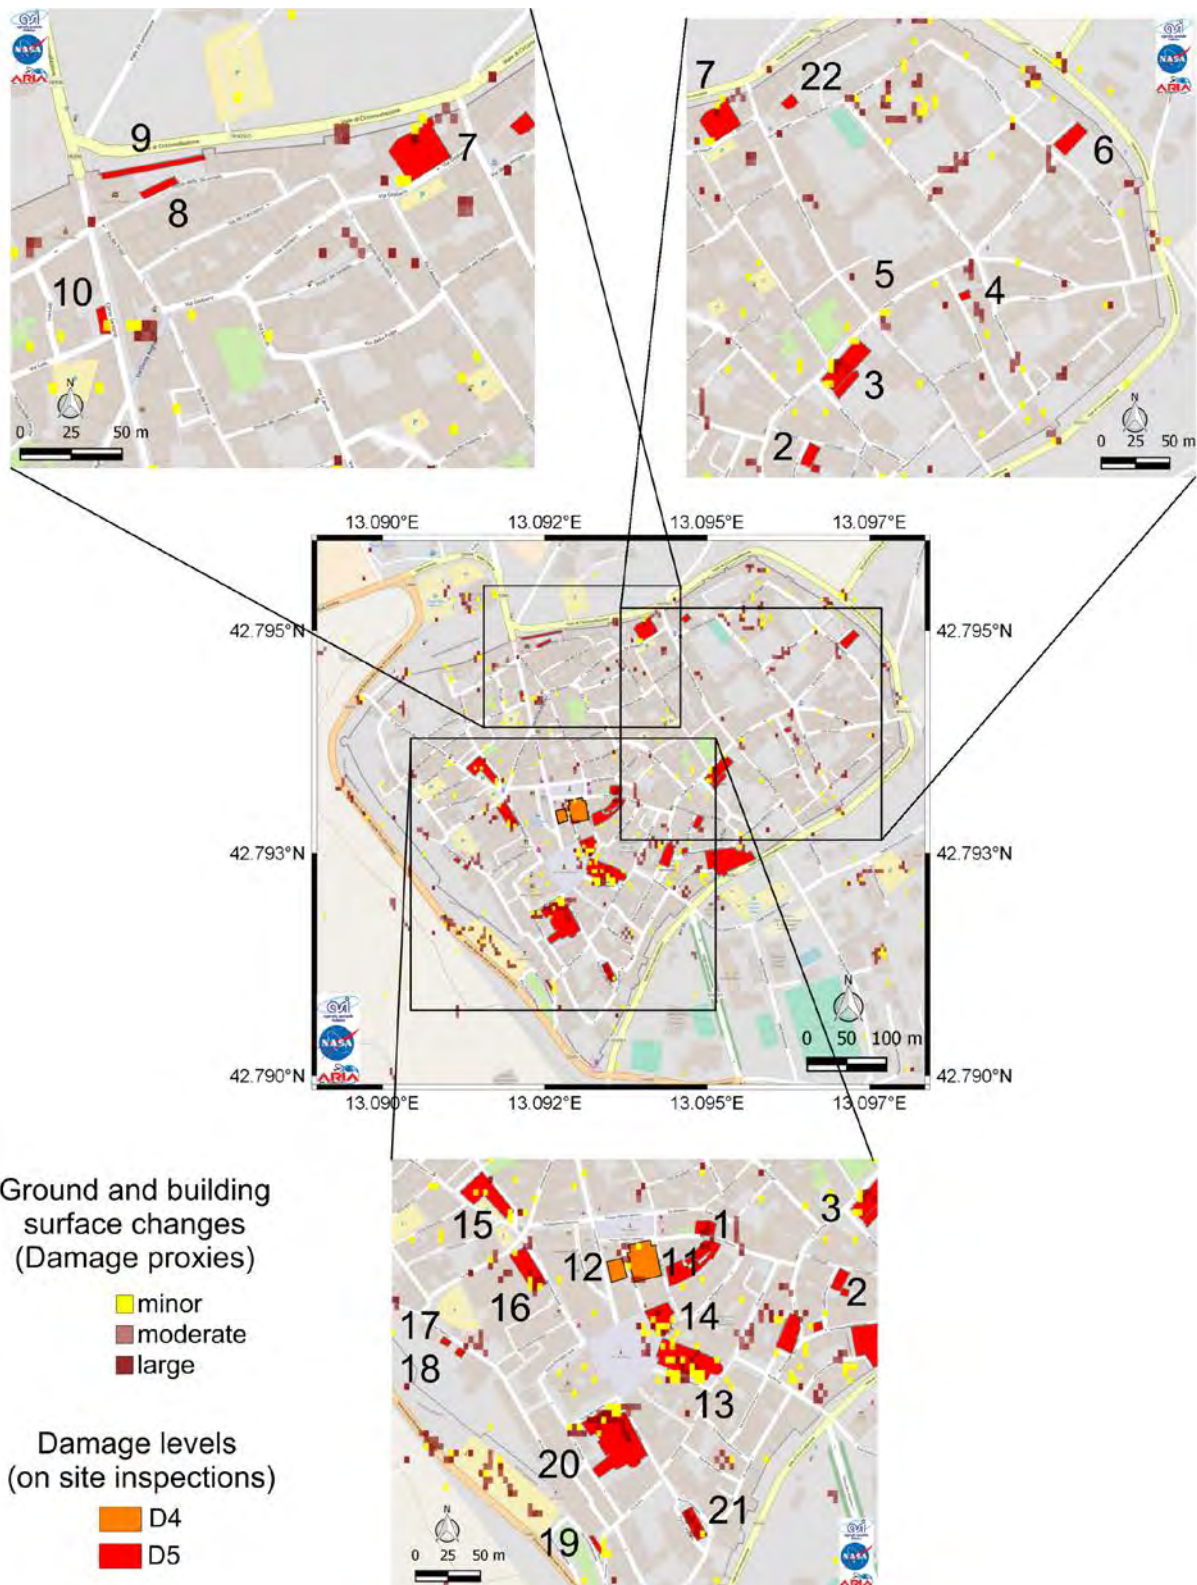
579 Figure 21 shows the DPM produced for the historical center of Norcia after the **M6.5** 30
580 October event, that is, the end of the earthquake sequence, superimposed with 22 structures
581 that were classified visually as completely collapsed (D5), and selected D4 structures.

582 By comparing the locations of these mapped structures and the damage zones from ARIA
583 imaging, a good agreement was observed. In particular, for all structures with an assigned
584 damage level of collapse (D5), the DPM accurately showed a concentration of red and dark
585 red zones, representing areas in which substantial deformations occurred.

587 **Figure 21.** Damage proxy map of Norcia, along with the identification numbers of all structures with
 588 assigned damage level D5 and selected structures with assigned damage level D4, from field
 589 inspections and available high-quality on-site information and photos.
