Post-project evaluation of Tule Ponds in Fremont, California : Integration of stormwater treatment and wetland restoration

Post-project evaluation of Tule Ponds in Fremont, California: Integration of stormwater treatment and wetland restoration

A paper presented to Matt Kondolf for the course Hydrology for Planners: LA222

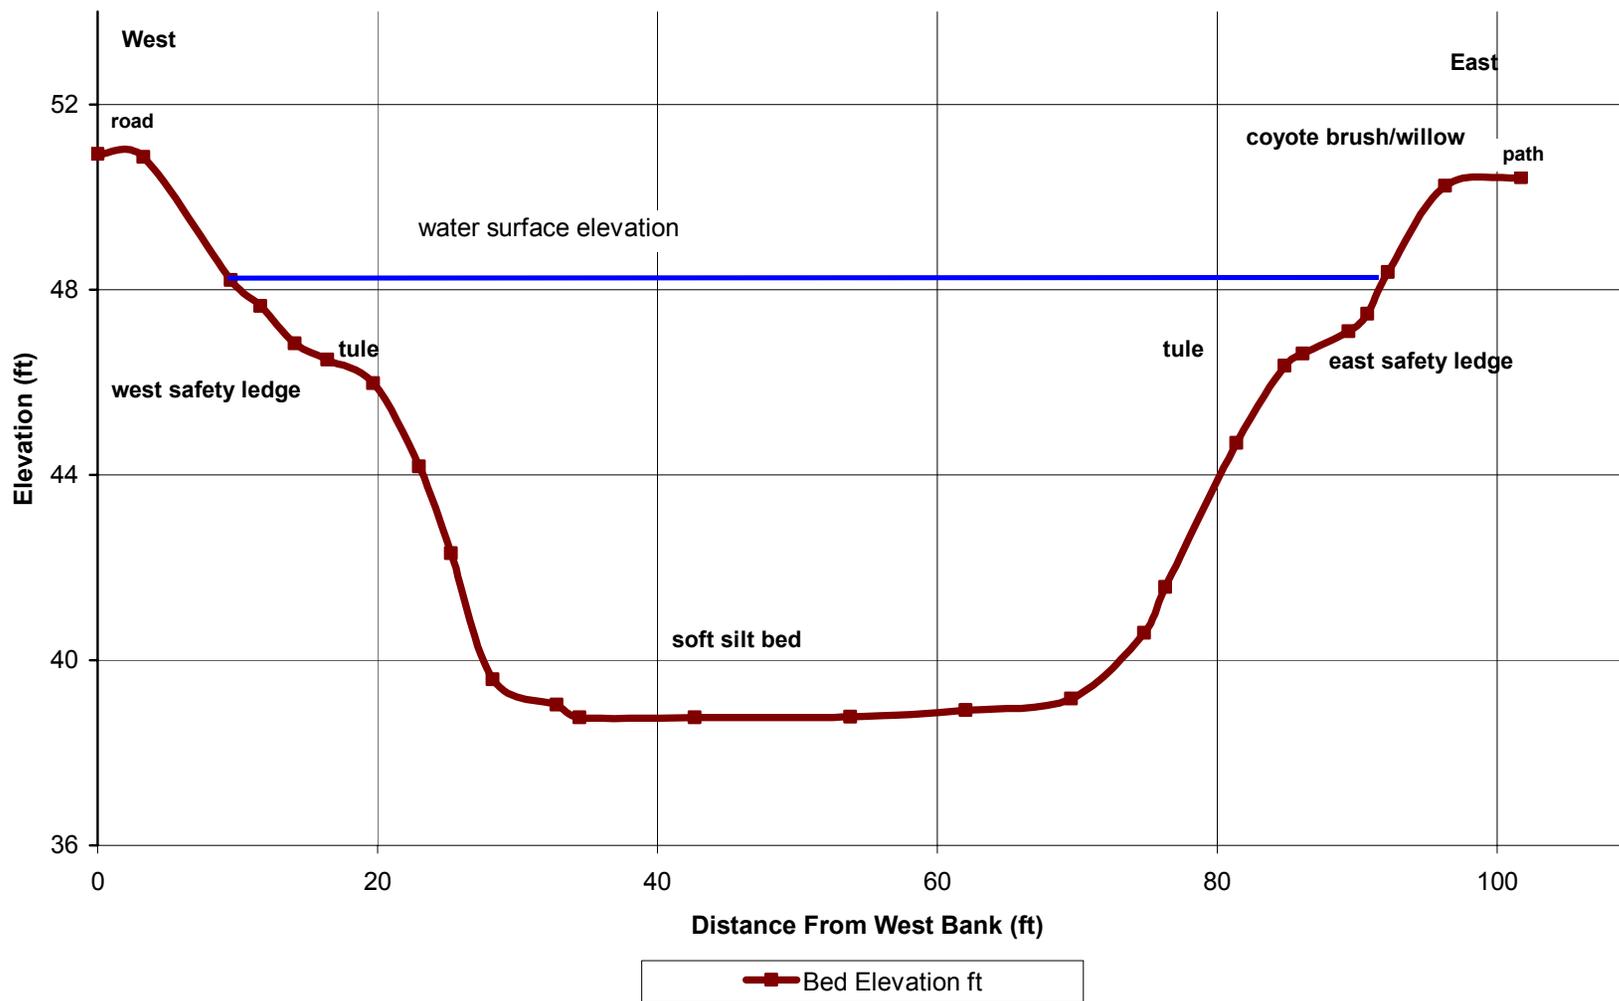
Figure 4

Pond A. The bed level in Pond A was 1.7 feet higher than the design. The water surface level was also higher than the water level slated for the design, though this is a result of large precipitation events in March 2006. According to Blueford, the water level declines after the last rains due to infiltration. The cross section (Figure 4) indicates that three bank slopes were shallower than designed and one had the same slope. The west and east safety ledges (or benches) were 1.5 ft and 2.0 ft shorter than the original 6.6 ft planned bench, and both sloped inwards. The long profile shows a slope of 2.7 : 1, and was initially designed to be 1.5 : 1 (Figure 5). Pond A had a distinctly soft layer of sediment that the survey rod sank into without any pressure. This extremely soft layer ranged from two to six inches thick and is likely a combination of sediment and decaying plant material.

Tule Pond System, Fremont, CA: Cross Section of Pond A
 April 14, 2006

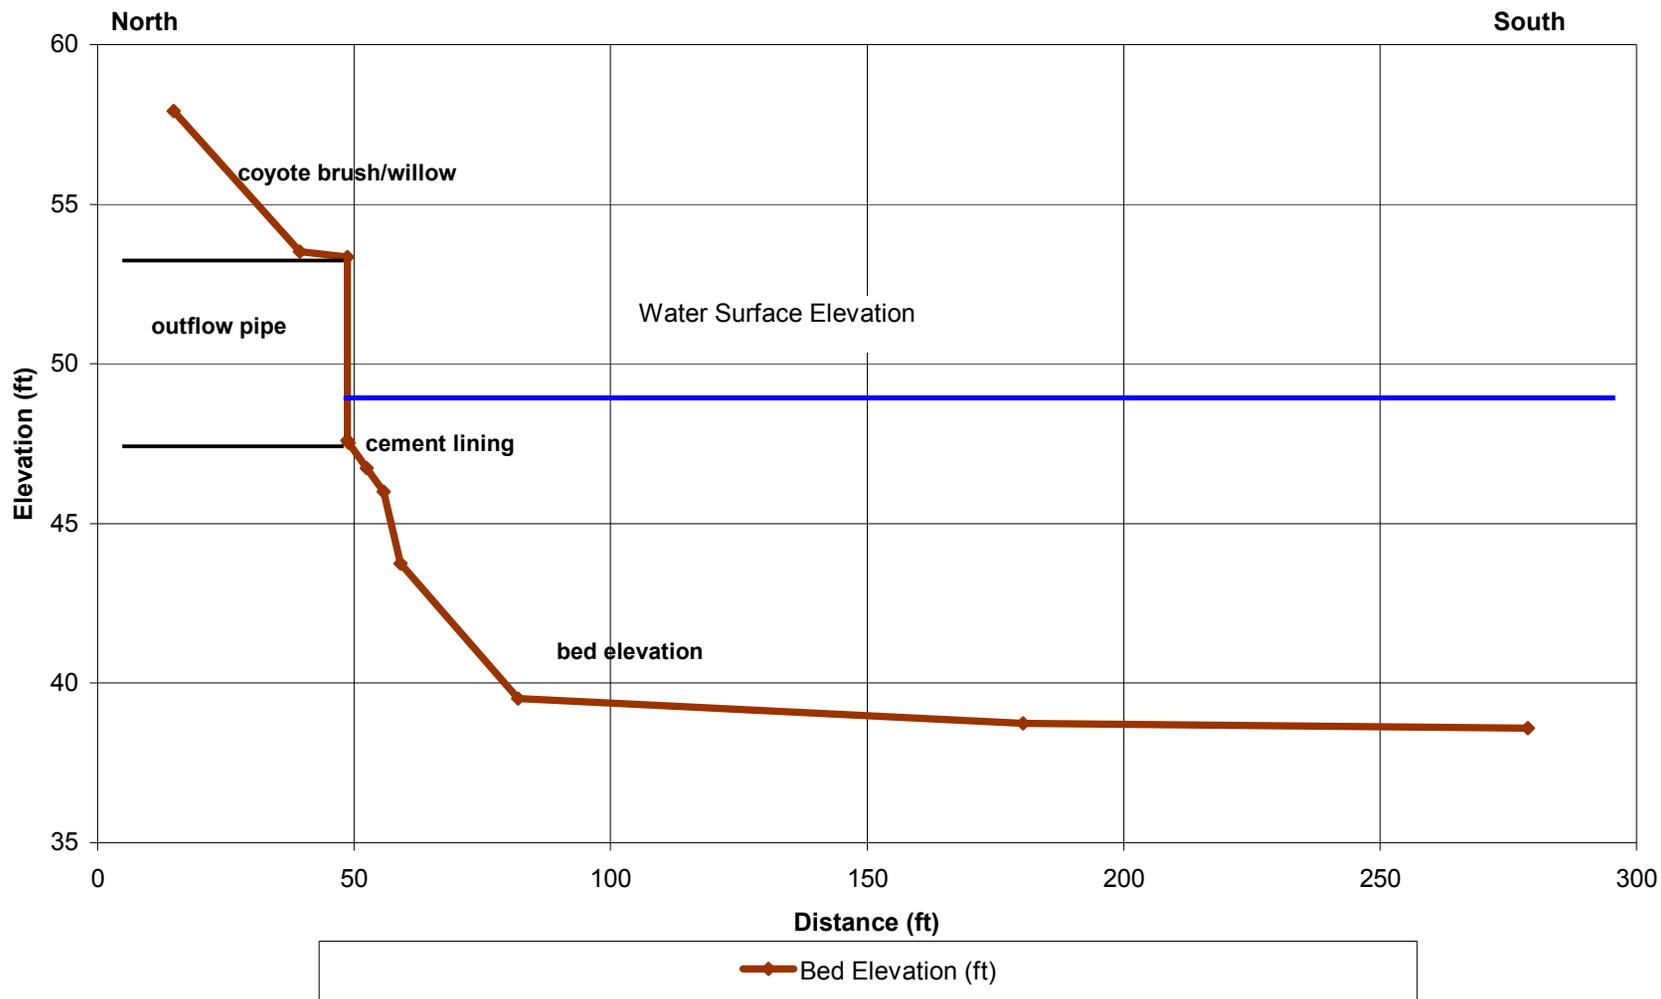
Figure 5

Tule Pond System, Fremont, CA: Partial Long Profile of Pond A
 April 14, 2006

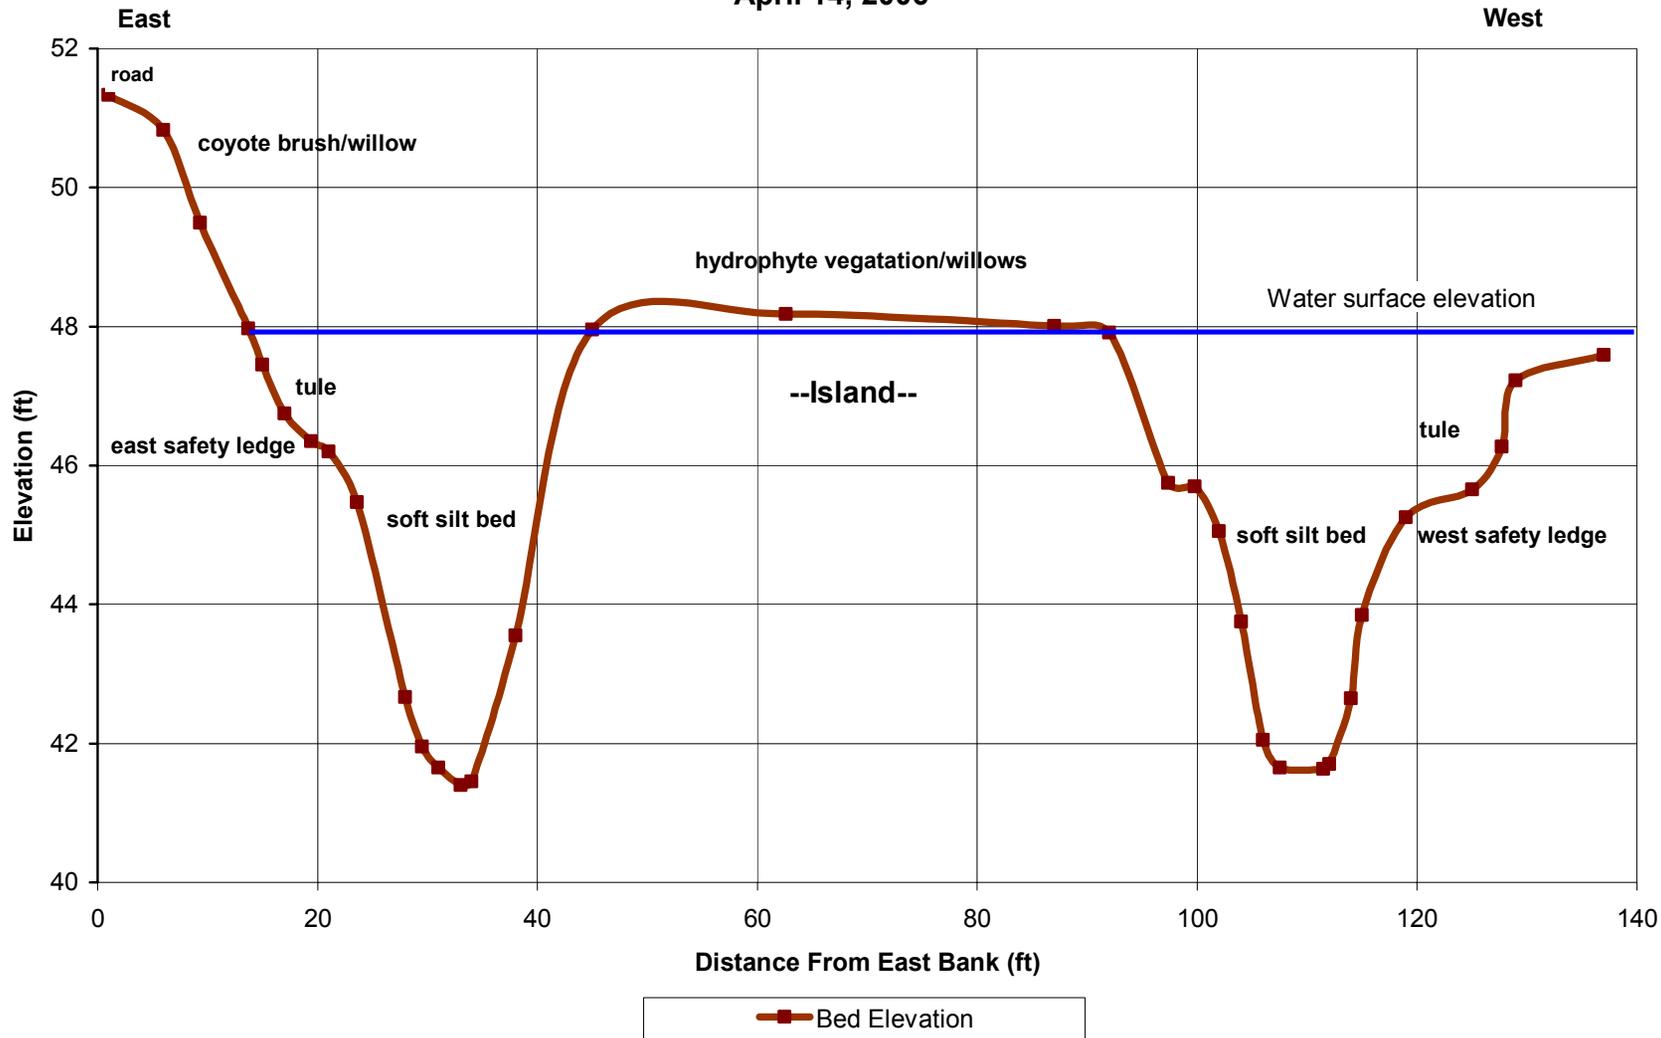
Figure 6

Pond B. The bed level of pond B was 1.4 ft higher than the design. The cross sections (Figure 6) indicate that all four bank slopes and both island slopes were shallower than designed (Table 2). The width of the ledge was 0.6 and 2.6 ft shorter than planned. The island elevation was, on average, equal to the water surface elevation of 48.1 ft, about 0.36 ft higher than the plans.

Tule Pond System, Fremont, CA: Cross Section of Pond B
 April 14, 2006

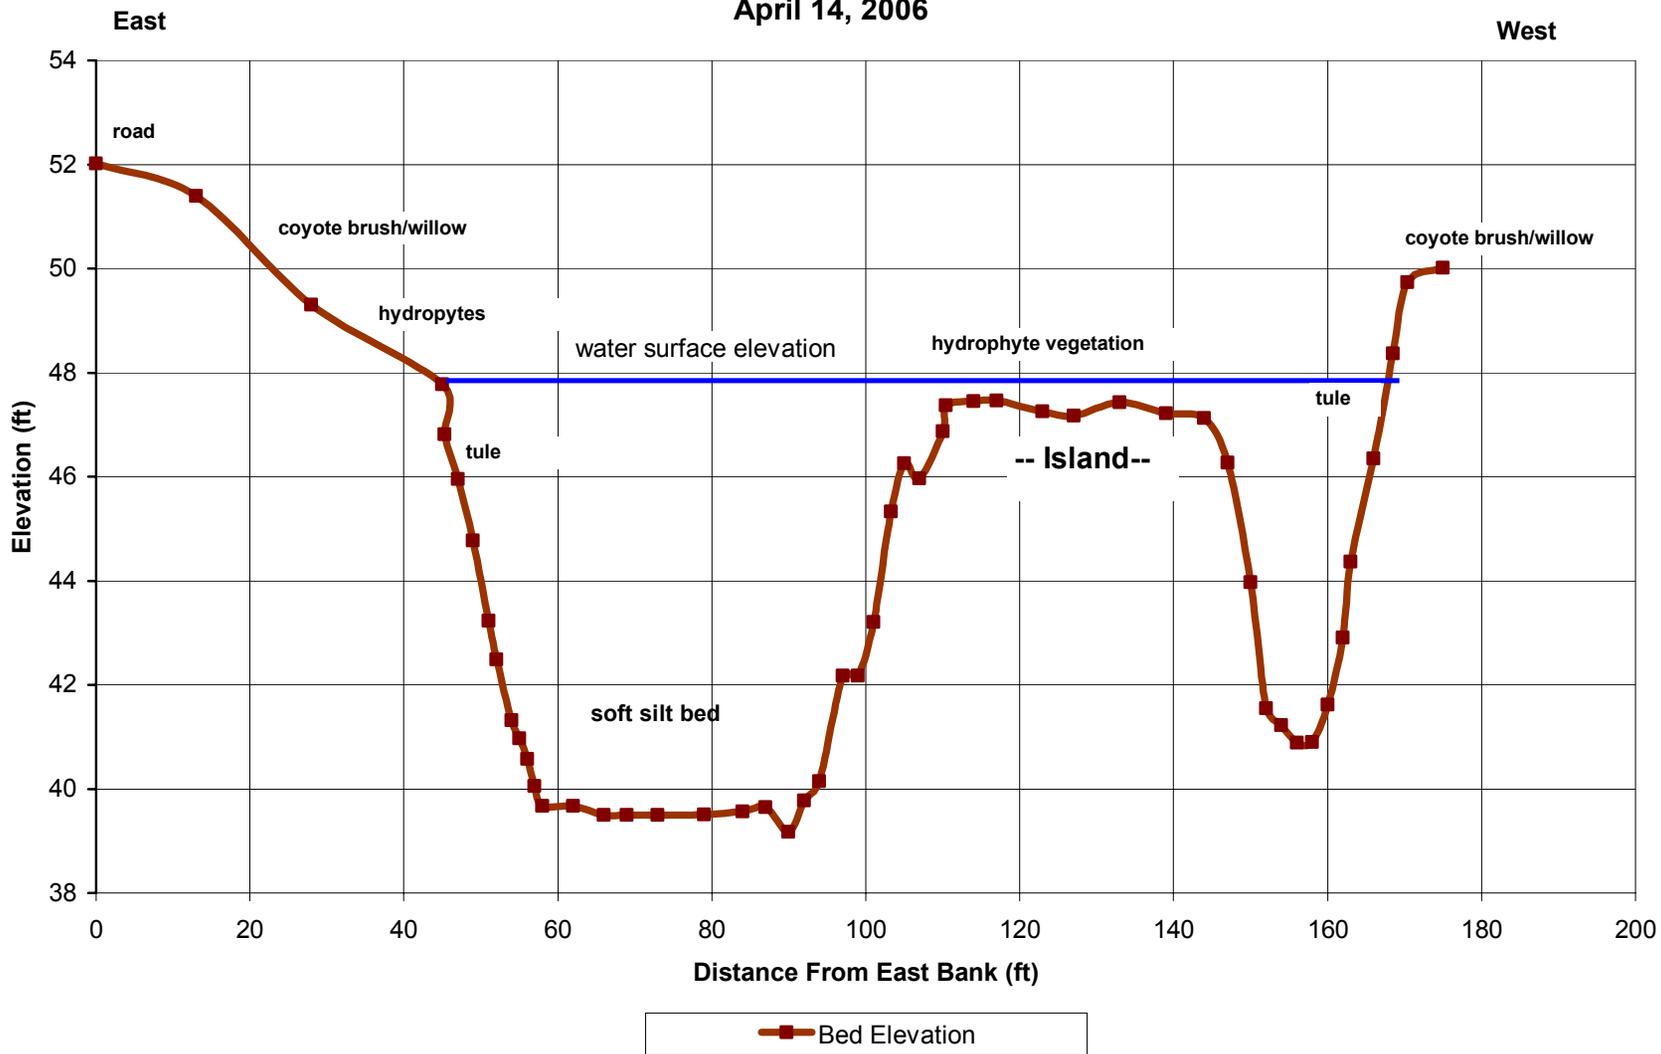
Figure 7

Pond C. The bed level in Pond C was 0.21 ft lower than designed. The cross sections (Figure 7) indicate that the two bank slopes were similar to the plan and the two island banks were shallower. The island elevation was nearly identical to the level in the plans (Table 2). Pond C does not have a ledge.

Tule Pond System, Fremont, CA: Cross Section of Pond C
 April 14, 2006

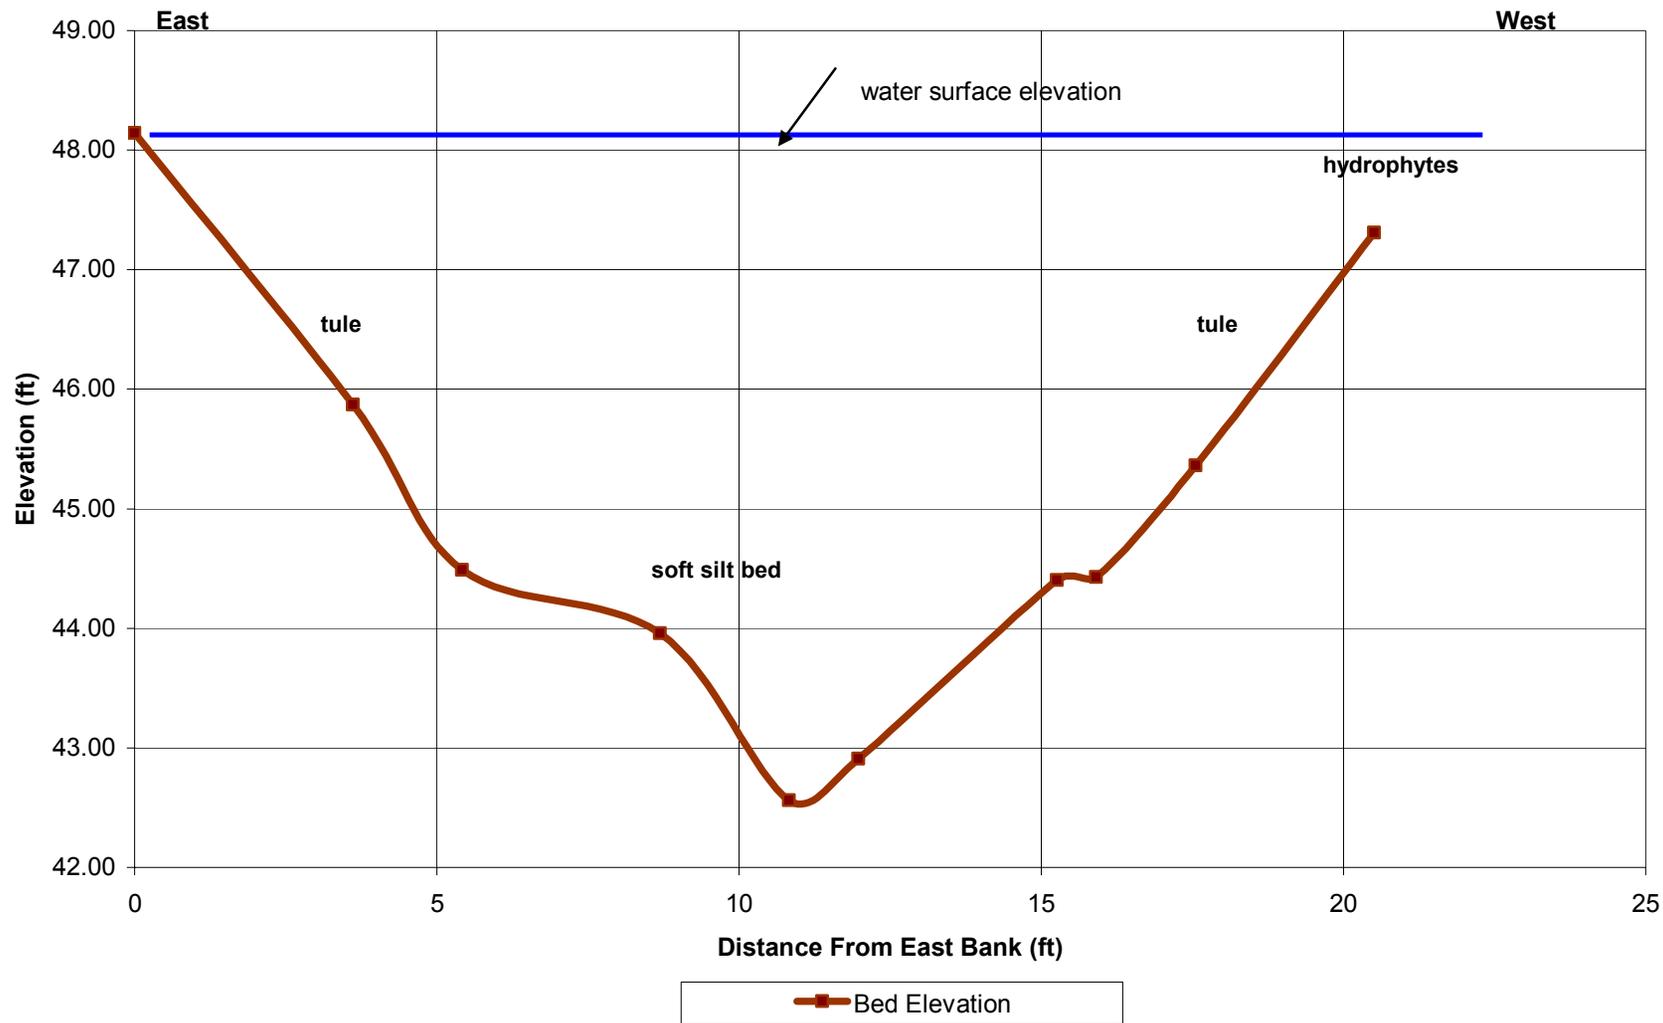
Figure 8

Inlets and bridges. The inlets in between the ponds were designed to contain a 2 : 1 slope and a depth of about 6.6 ft. Cross sections of the inlets show the slopes were either the same, or in one case, steeper than designed (Figures 8 and 9). Bridges 1 and 2 were 0.44 and 0.07 ft higher than in the plans, respectively.

Tule Pond System, Fremont, CA: Cross Section of Inlet 1
April 14, 2006

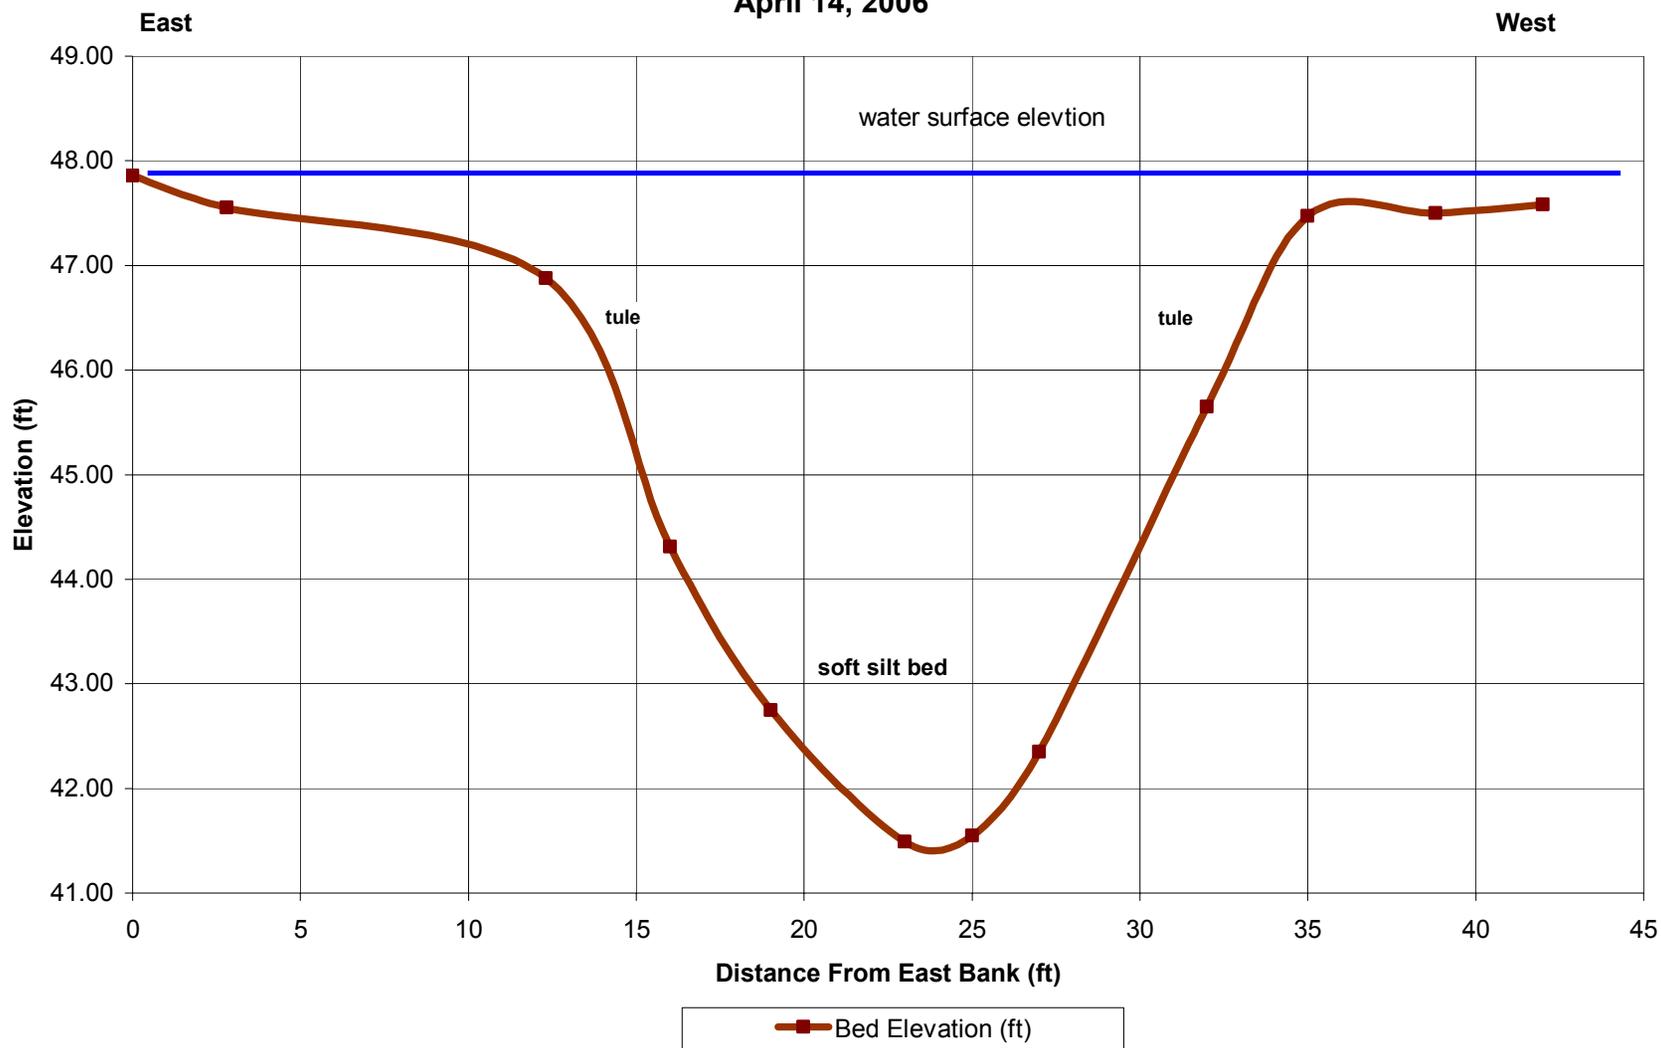
Figure 9

Tule Pond System, Fremont, CA: Cross Section of Inlet 1
April 14, 2006

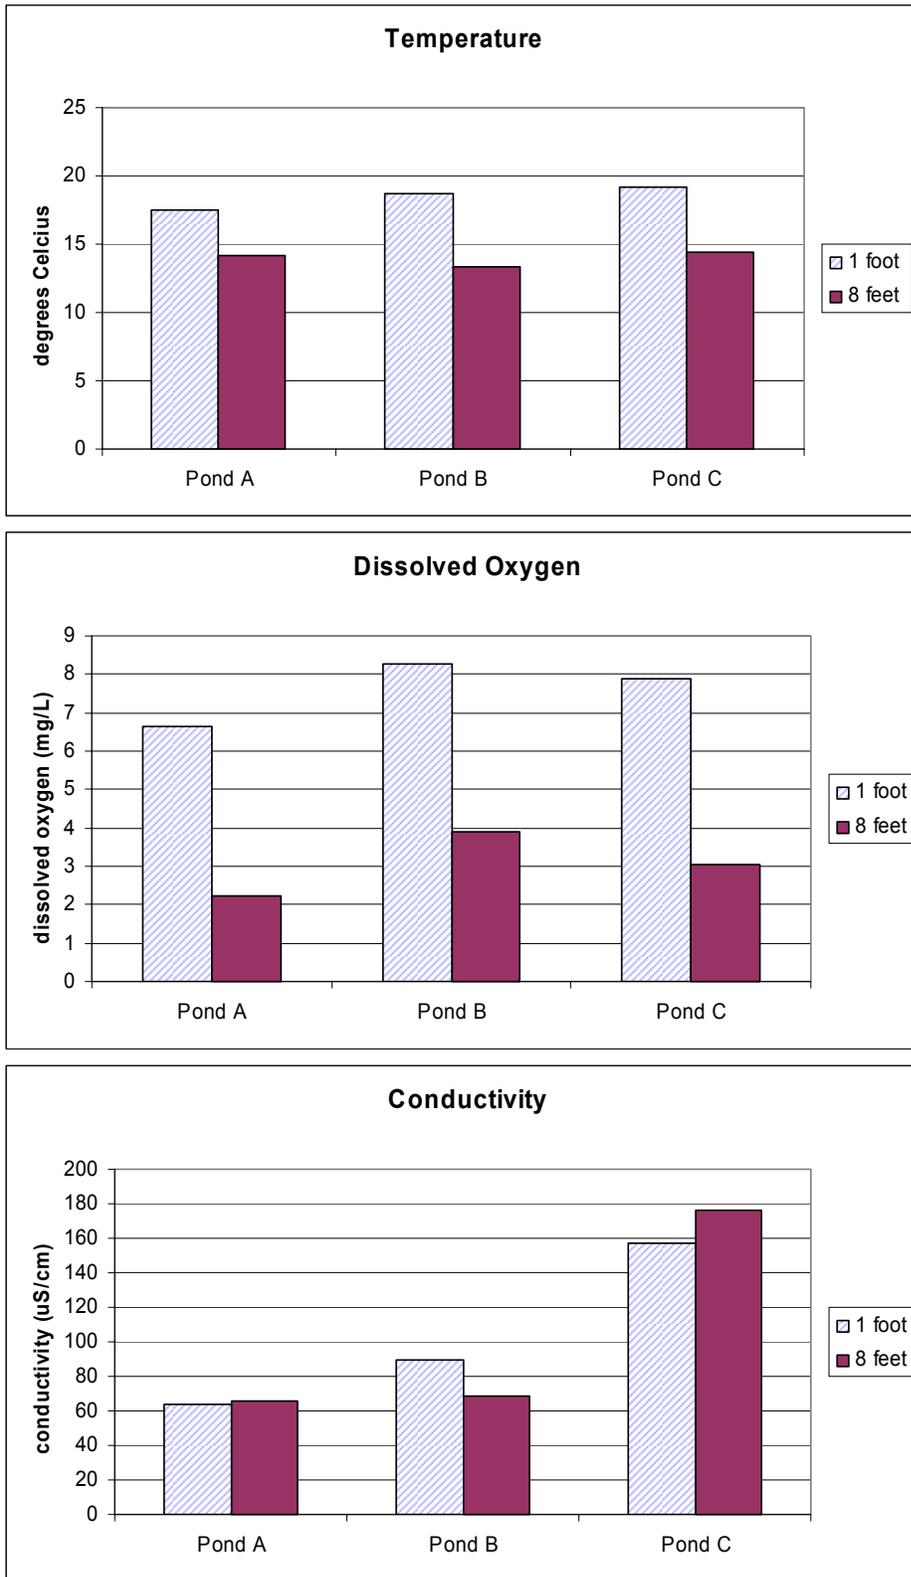
Water chemistry readings from two site visits are listed in Table 4 and Figure 10. Average dissolved oxygen levels were much lower at depths of eight feet compared to one foot. Conductivity was similar across a pond and at different depths but differed between Pond C and Ponds A and B. Only 1.0 ppt of salinity was detected in Pond C, the outlet, and Tyson Lagoon.

Figure 10. Water chemistry results at two depths below water surface elevation.

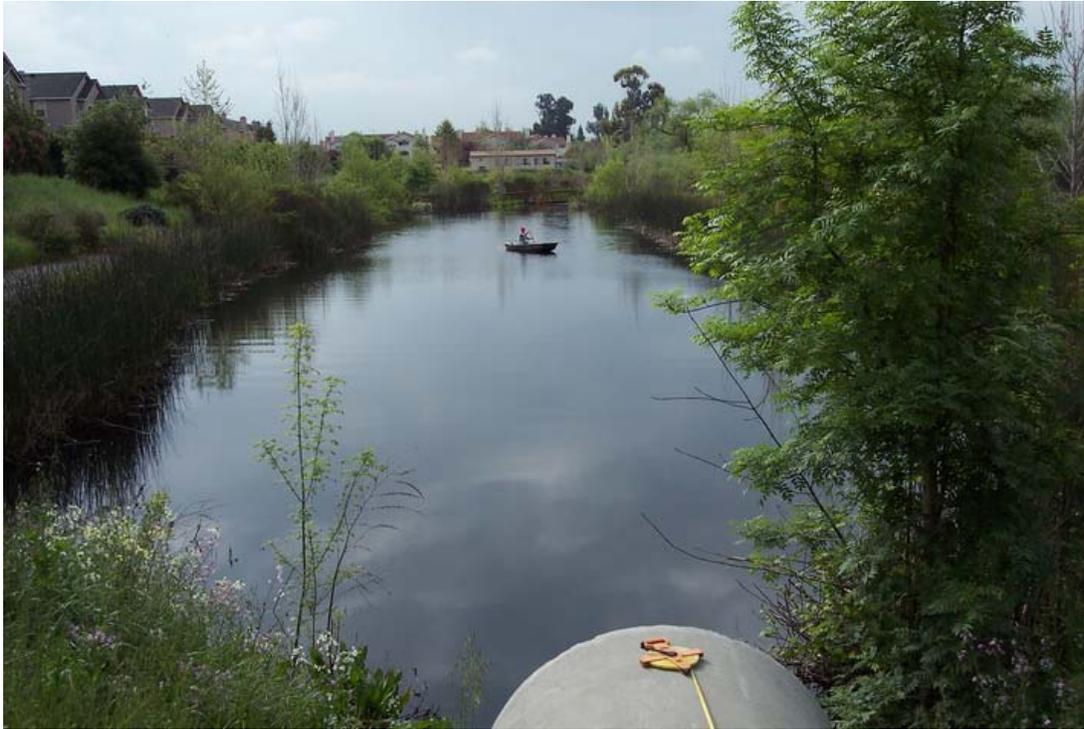
Photo 1. Photo taken of Pond A from the north end with main pipe inflow (bottom). We had to boat around the pond to survey the dimensions and take water chemistry readings. The thin ring of tule vegetation around the pond edge is growing mostly on an engineered “safety ledge”.

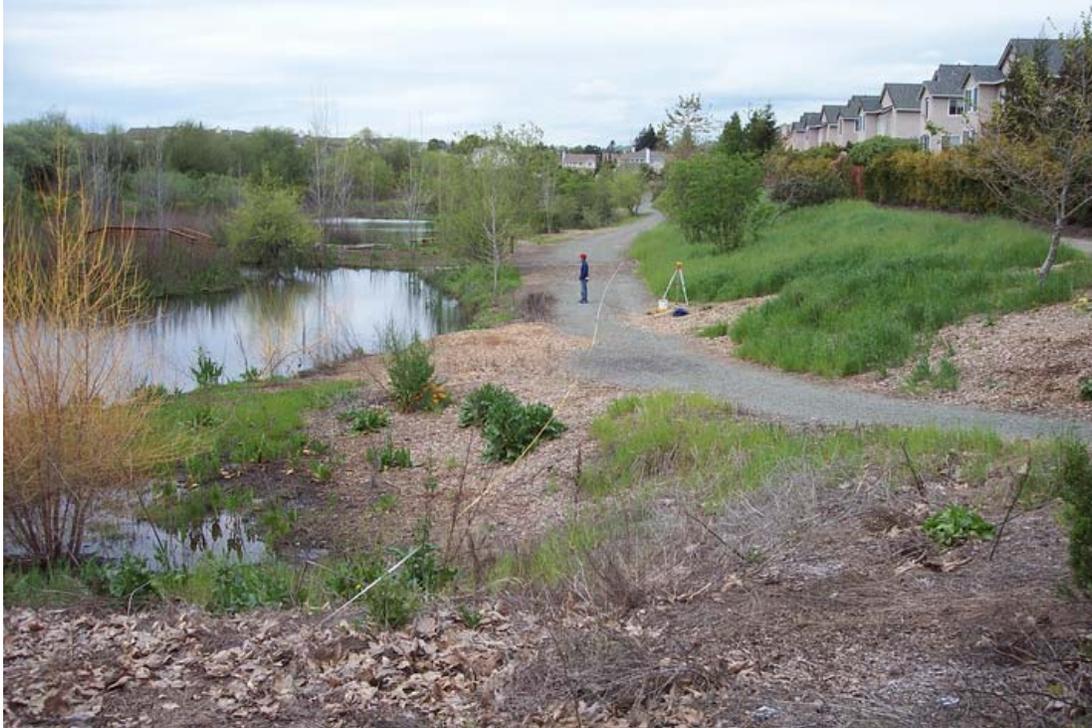
Photo 5. Pond C in the foreground surrounded by housing. The lower road is designed to allow vehicle access to the ponds for maintenance. Note that the entire area can handle much larger inflow during large storm events

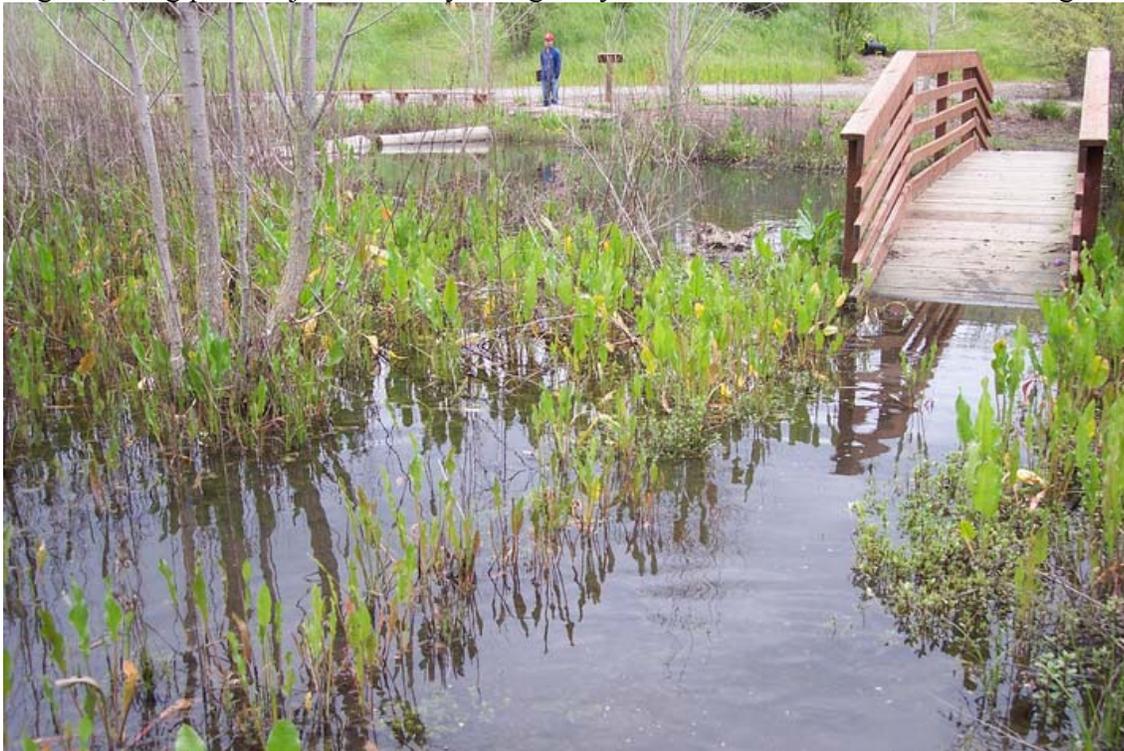
Photo 7. Example of hydrophytic vegetation common to the shallows (0.2 to 0.6 ft below water surface elevation) as seen here, and also on the islands. Treefrog tadpoles were abundant in this area. This area, including a path, was not designed to be under water.
