Redwood Creek, Marin County 2010 Monitoring Study of a Salmonid Habitat Stream Restoration Project: Seven--Year Post--Project Evaluation

Richard Crockett, Fiona Cundy, Colin Hanley
LA 227 | Stream and River Restoration
Term Project | December 2010

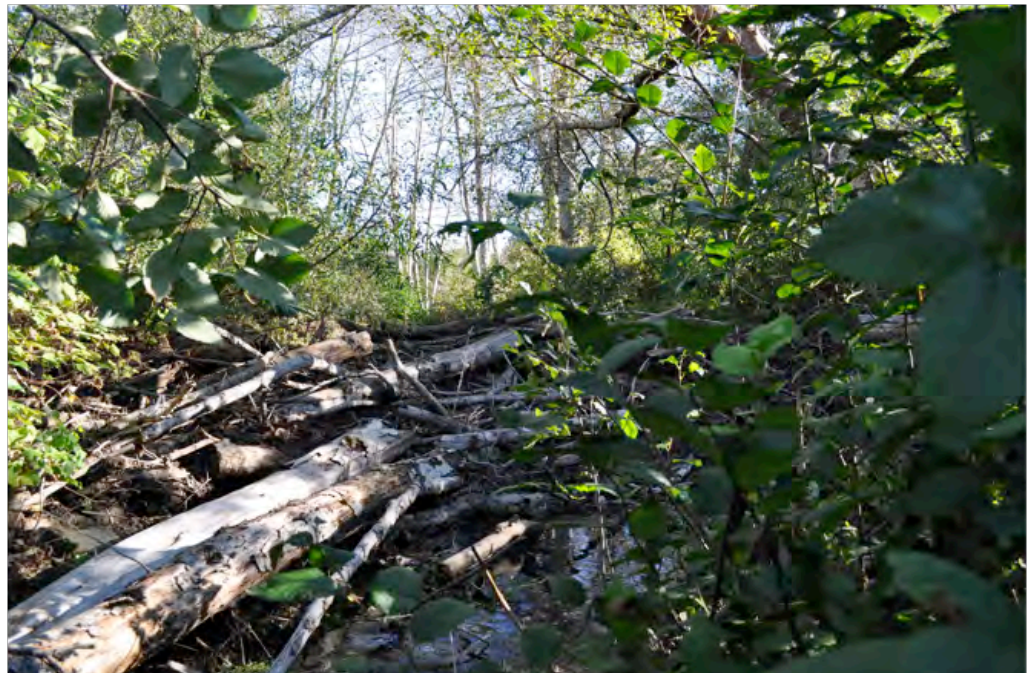
Figure 9C
2010
Willow and other
native vegetation types
have colonized along
the gravel bars. From
this view, entire large
tree trunks have added
to debris jam 6-7-8,
creating a solid woody
debris structure above
the water, ideal for coho
rearing habitat.

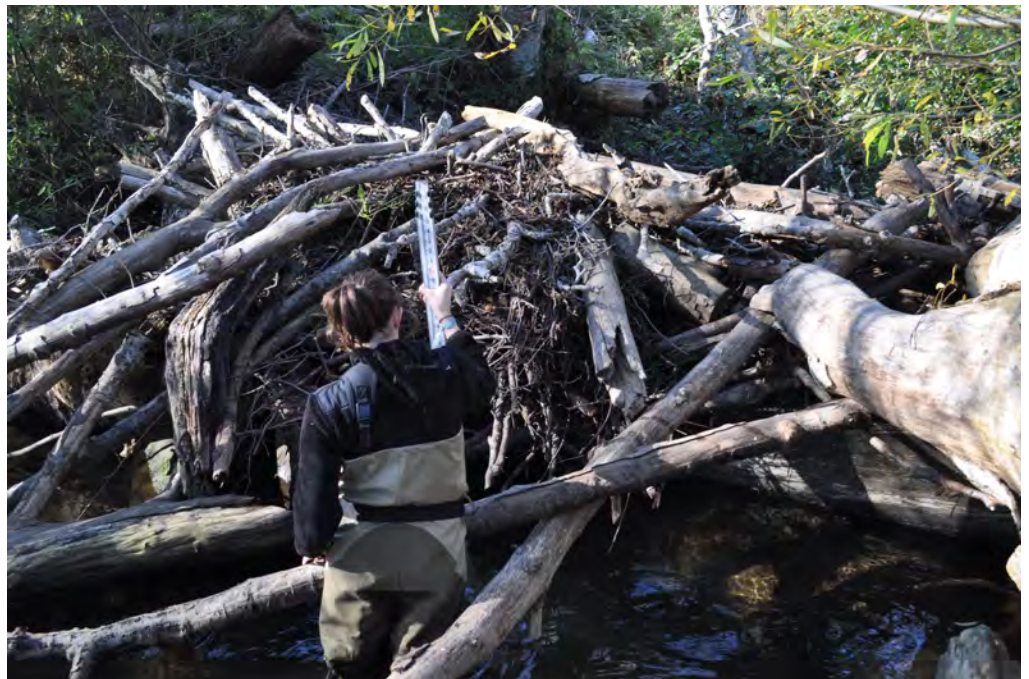
Within the bowling alley reach, we recorded very large woody debris accumulation at logjam 6-7-8. We tried to observe where the large amounts of debris were coming from and why they had stacked up so high at this woody debris structure, and not any of the others. About 150-200 feet upstream of logjam 6-7-8, we observed a collection of about a dozen large, dead, leafless alder trees, and about half consisted of only 10-foot-high tree trunks and their upper portions toppled (Figure 16).

Figure 10C
2010
Logjam 6-7-8 has grown
nearly 4' above the
surface of the water ,
consisting mostly of the
dead red alder branches
washing down from
upstream of the
restoration project.

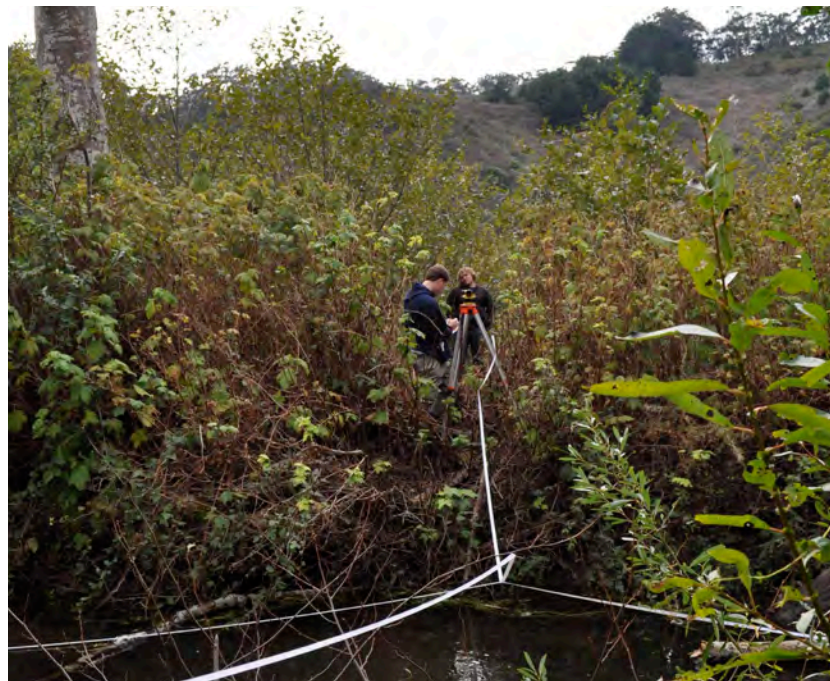
Figure 11C
2010
Revegetation in mats
and individual
species planted along
the stream banks and
along the edge of the
floodplain have grown
nearly 20 ft tall in some
areas, creating a dense
and native riparian plant
palette.

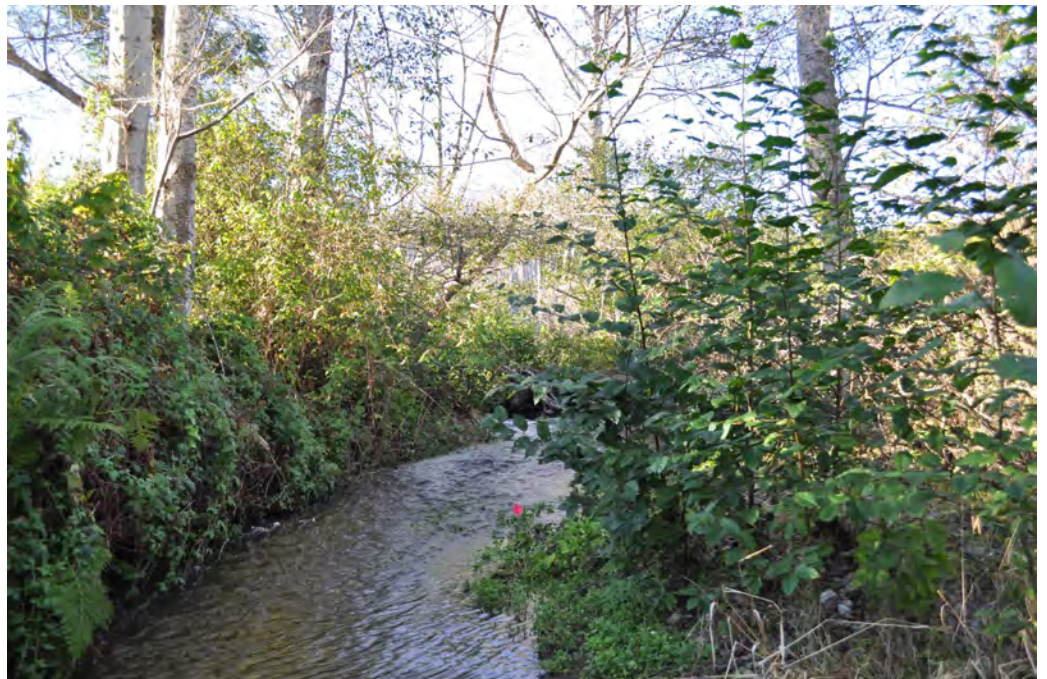
Figure 12C
2010
From this view,
vegetation growth
along the creek edges
and gravel bars
has grown tall and thick.
This section of the reach
shows areas of riffle
after logjam 6-7-8.

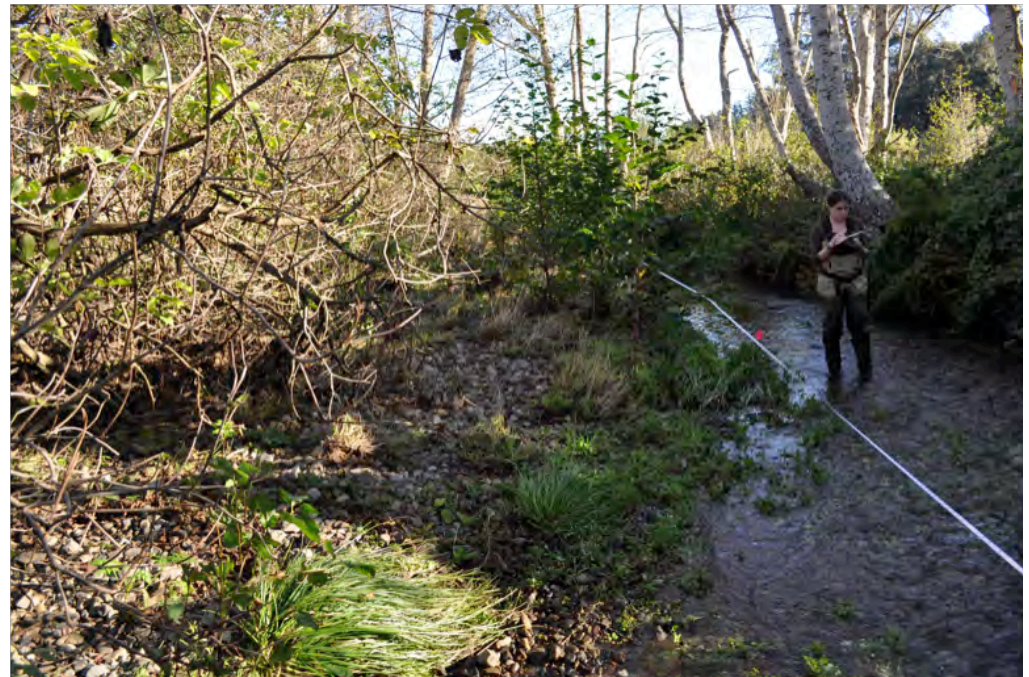
Figure 13C
2010
Vegetated gravel bars
have directed channel
movement, creating
fast flowing waters with
riffles between pools
formed downstream of
each logjam.

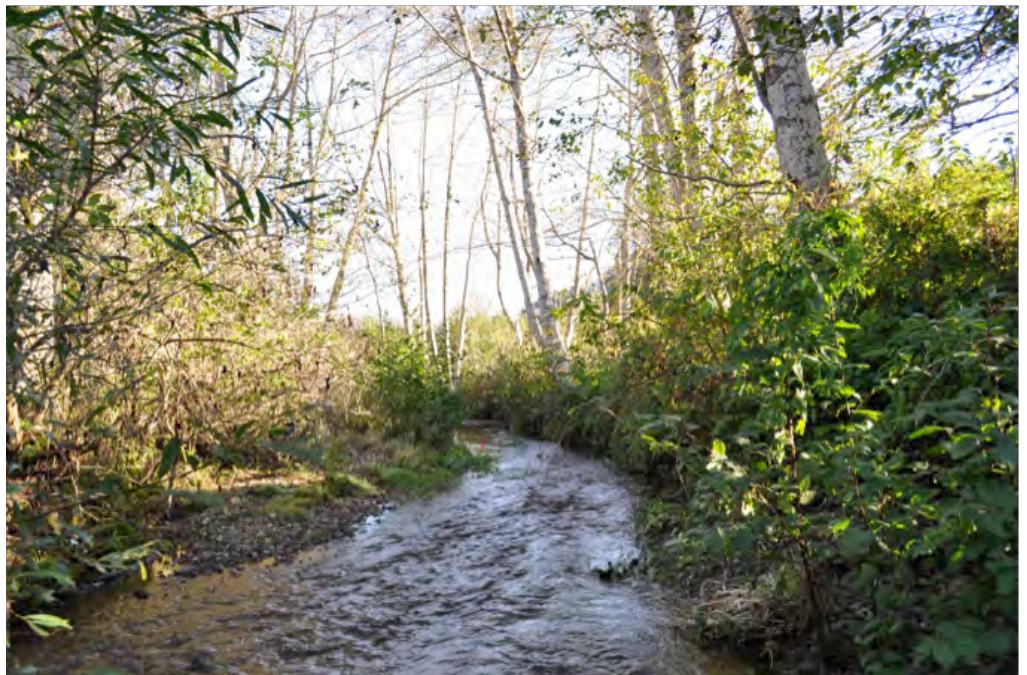
Figure 14C
2010
Vegetation growth
along gravel bars and
creek edges has
successfully provid-
ing habitat, nutrients
and cover to keep the
stream cool.

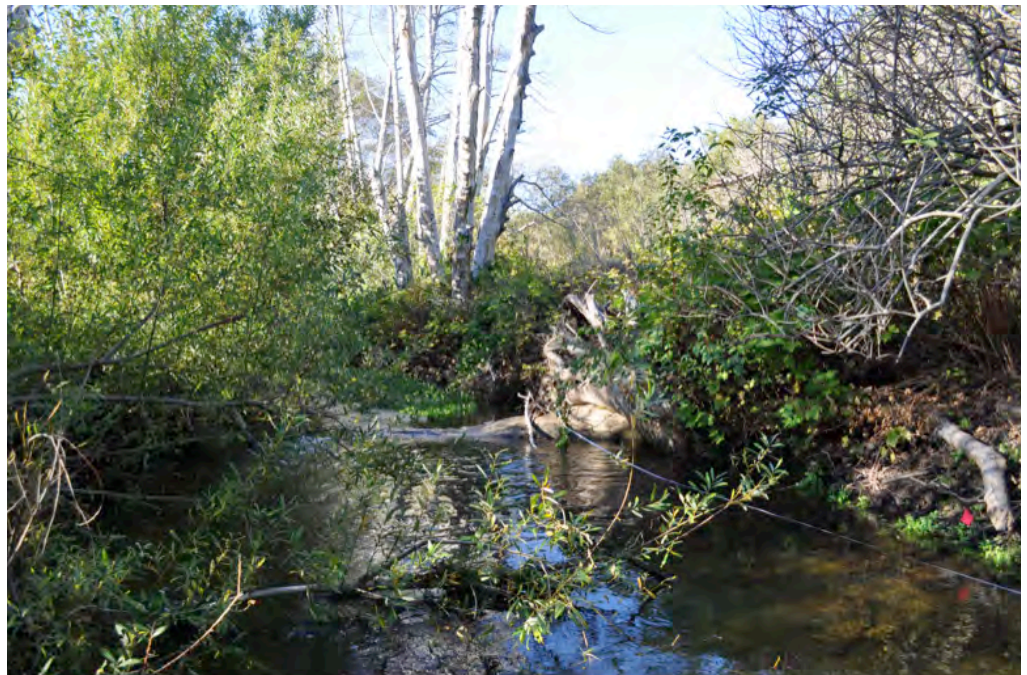
Seven years after restoration, the logjam structures have held their integrity. While the design of structure 6-7-8 has been the most successful in collecting additional woody debris, the other logjams, such as number 5 have not naturally accumulated additional woody debris collection as well.

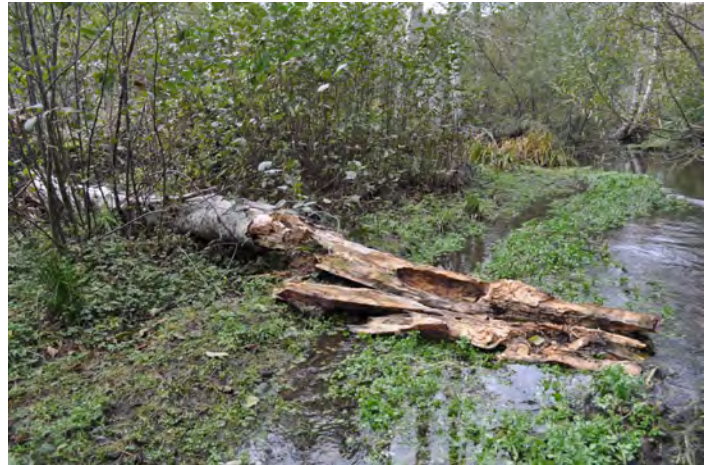
Photo 1

It is apparent at the Banducci Site, especially within this 432-foot reach that the leafless mature red alder trees along both sides of the bank are dying or dead. There are many downed trees along the bank and in the channel that are insect infested. In fact, in the three weeks that passed between our site visits, a tree that was upright had fallen into the stream. What looks to be a swift increase of woody debris supply directly upstream of logjam 6-7-8 has added to the debris jam size increase, as it appears from our observation that it is red alder logs that have piled up on the logjam. The reason for the mass death of these trees could be a number of factors. At Redwood Creek's Pacific Way site, downstream from the Banducci Site near Muir Beach, the NPS states in the EIR for that project that alders dying at that site is likely to be a result of the increased water table elevation caused by sedimentation in the creek channel. At the Banducci Site, tree age may also be a factor. Red alder is a short-lived tree with

Dead alder tree canopy just upstream from the 432-foot bowling alley reach.

In recent years, aerial imagery has become more readily available through online sources like Google Earth. With its ease of accessibility and increasing frequency of photography, aerial image time sequence analysis is an increasingly valuable tool to conduct post-project monitoring. With the aid of aerial imagery, we were able to track the progression of the mature red alder trees within our study reach, examine revegetation growth rates, and observe construction disturbances. Our fieldwork hypothesized that logjam 6-7-8 had backed up with large woody debris from upstream where about a dozen alder trees are collapsing into the creek and washing downstream. With aerial imagery, we were able to observe the progression of vegetation cover of Redwood Creek between 1998 and 2010. Despite seasonal difference, dead red alder branches and trunks become progressively pronounced in photos after phase one of the restoration project. We recommend that an arborist look into potential

causes of the tree health decline, including construction disturbances, increased post-project inundation, and disease.

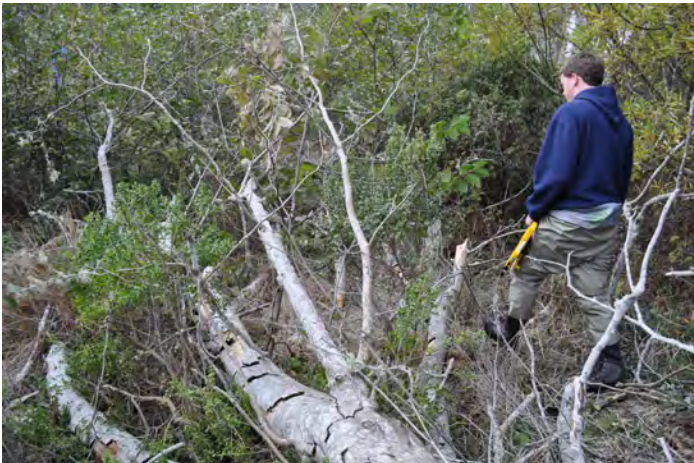
Photo 2

Alder trunks falling into Redwood Creek showing signs of interior decay.

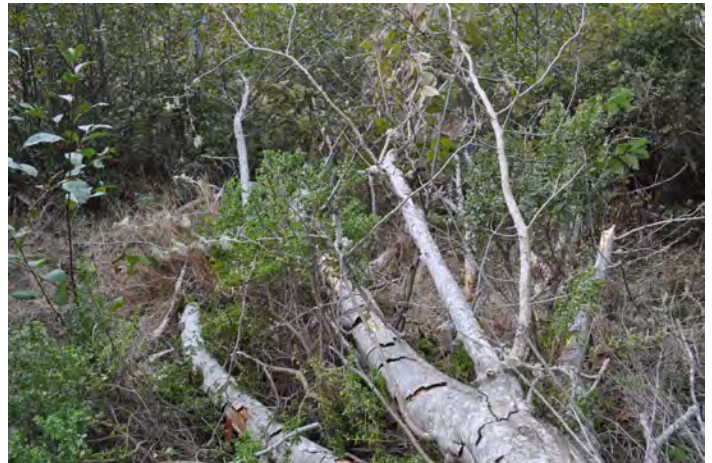
Photo 3

Woody debris added to the creek.

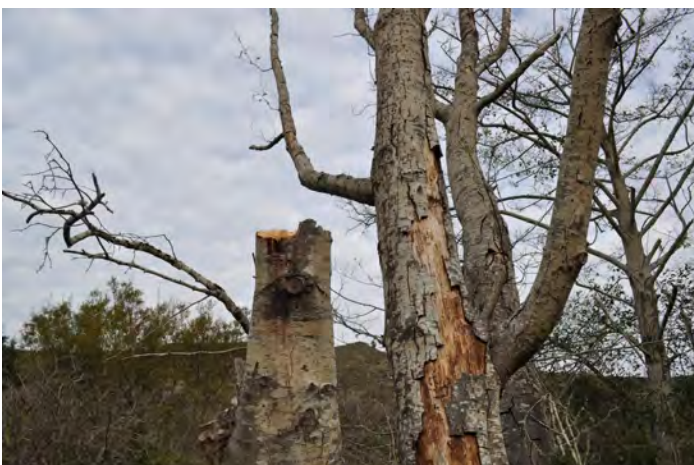
Photo 4

Alder branches and trunks providing woody debris growth at logjams downstream.

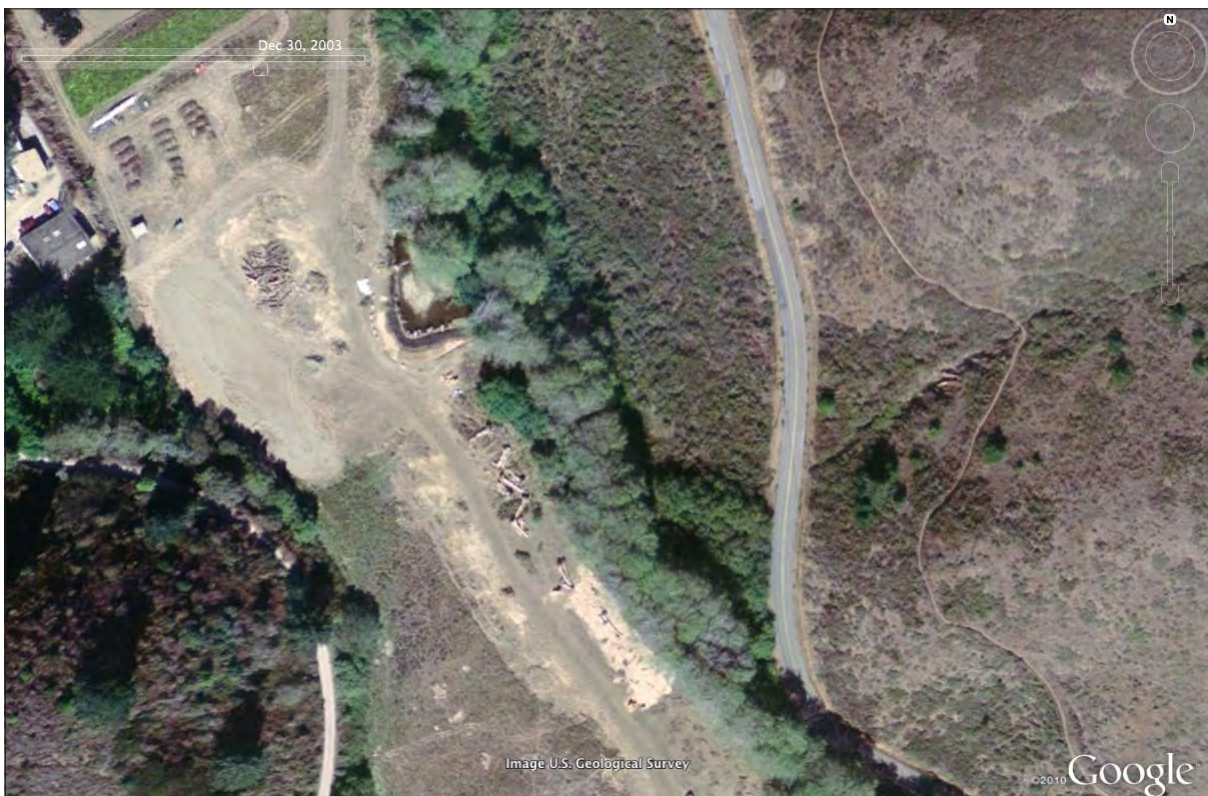
Figure 22

Aerial Imagery December 30, 2003. Restoration work of revegetation, levee removal, and logjam structures visible. Decline in riparian tree canopy health visible.

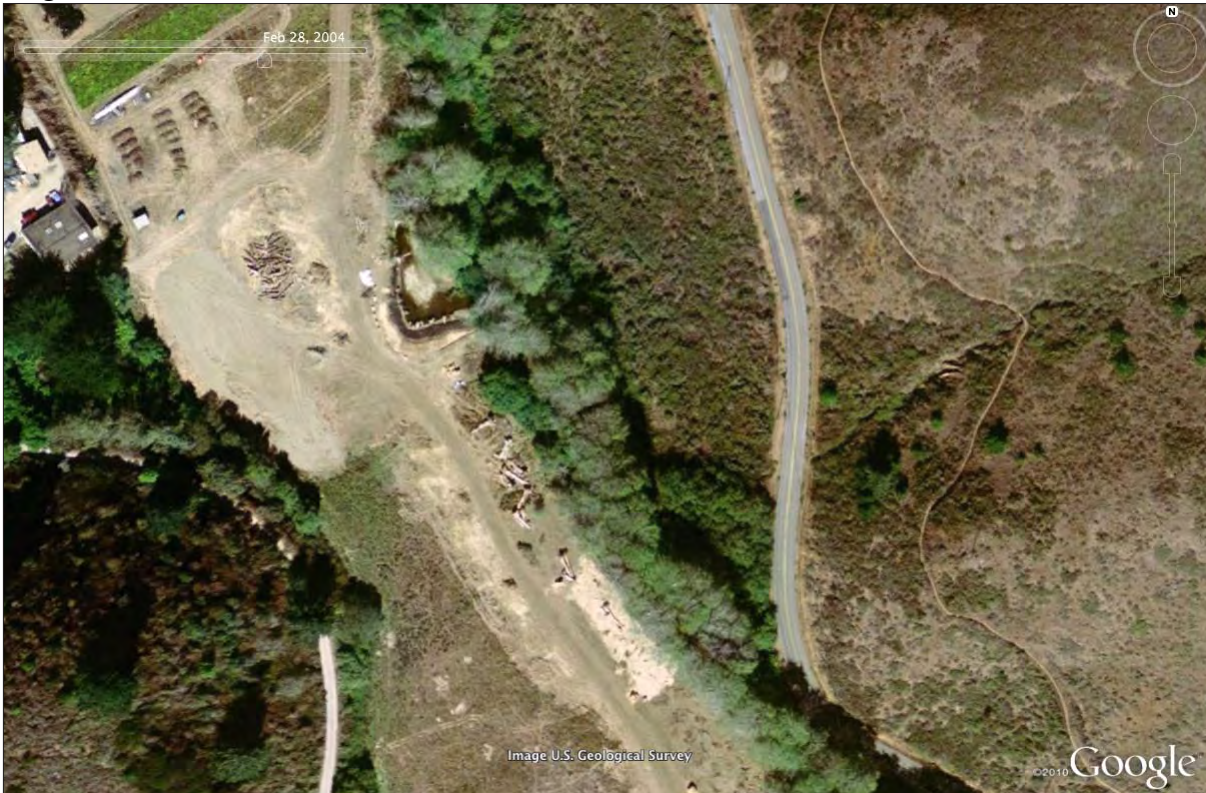
Figure 23

Aerial Imagery February 28, 2004. Restoration construction of 2003 completed. Riparian canopy health continues to decline.

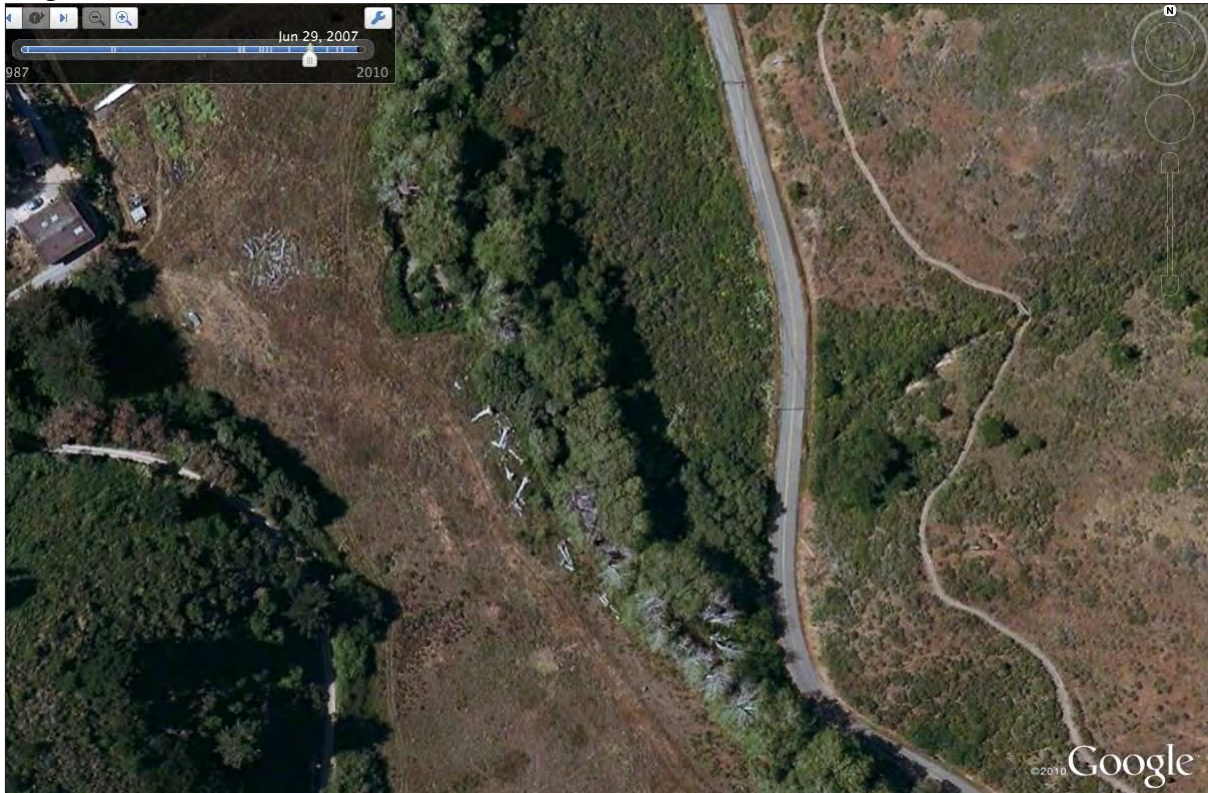
Figure 25

Aerial Imagery January 29, 2007. Continued visibility in decline of riparian tree canopy health. Success of revegetation along levee removed areas and logjam bank revetment successful.

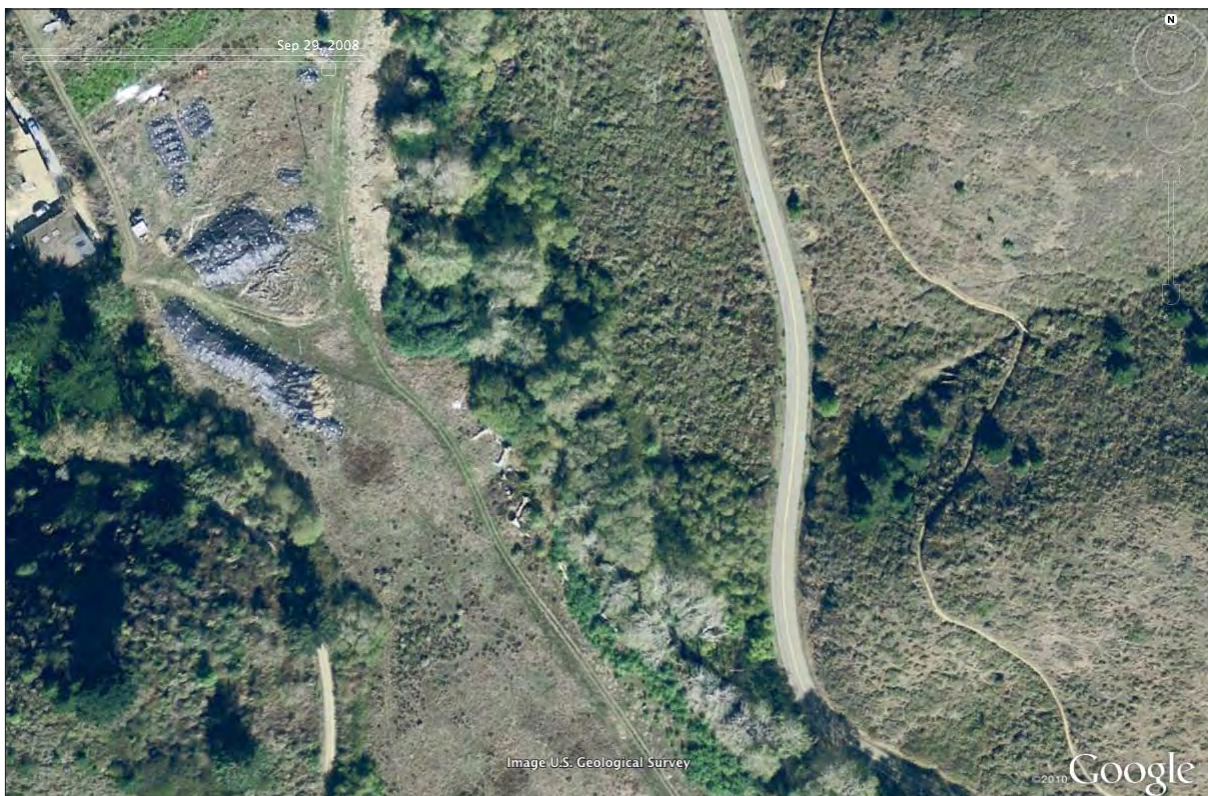
Figure 26

Aerial Imagery September 29, 2008. Five years post-project construction. Phase 2 of revegetation and levee removal visible. Riparian tree canopy health continually declining.

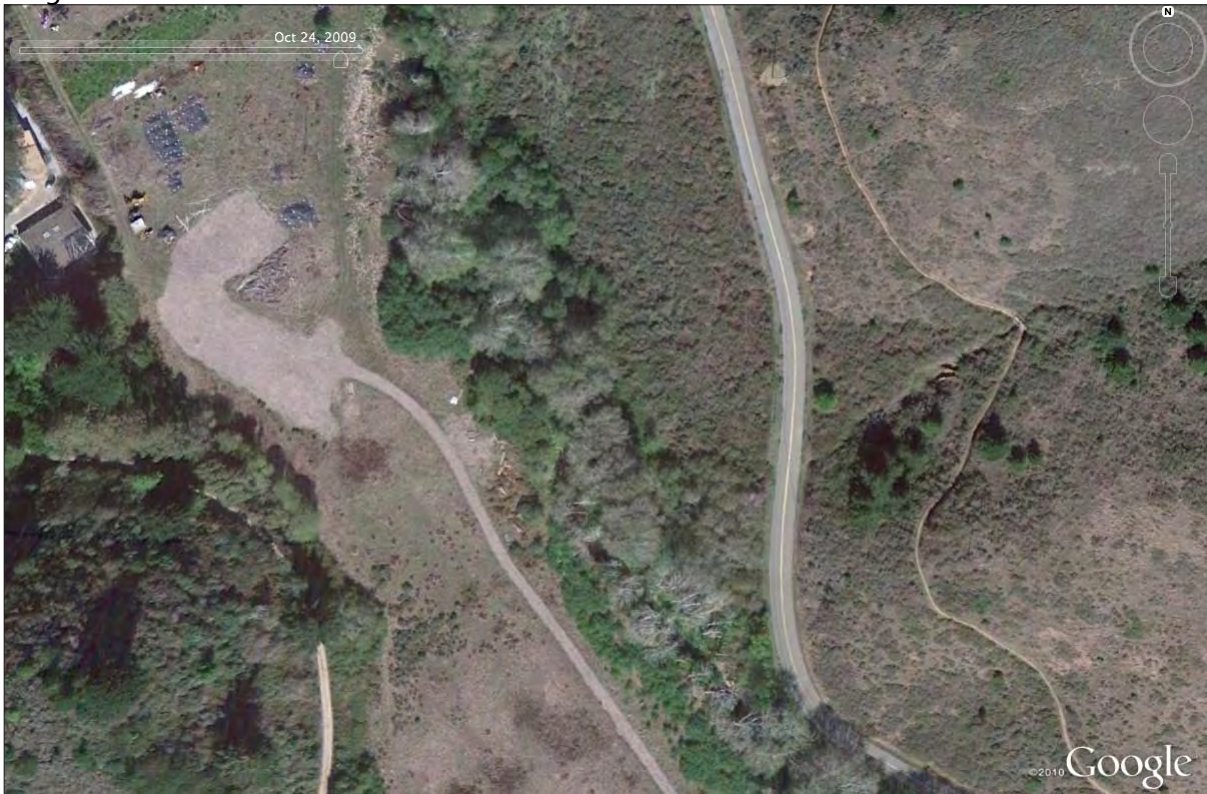
Figure 27

Aerial Imagery October 24, 2009. Six years post-project construction, riparian tree canopy health continually declining. Banducci Site responding well to restoration as a revegetated floodplain of Redwood Creek.

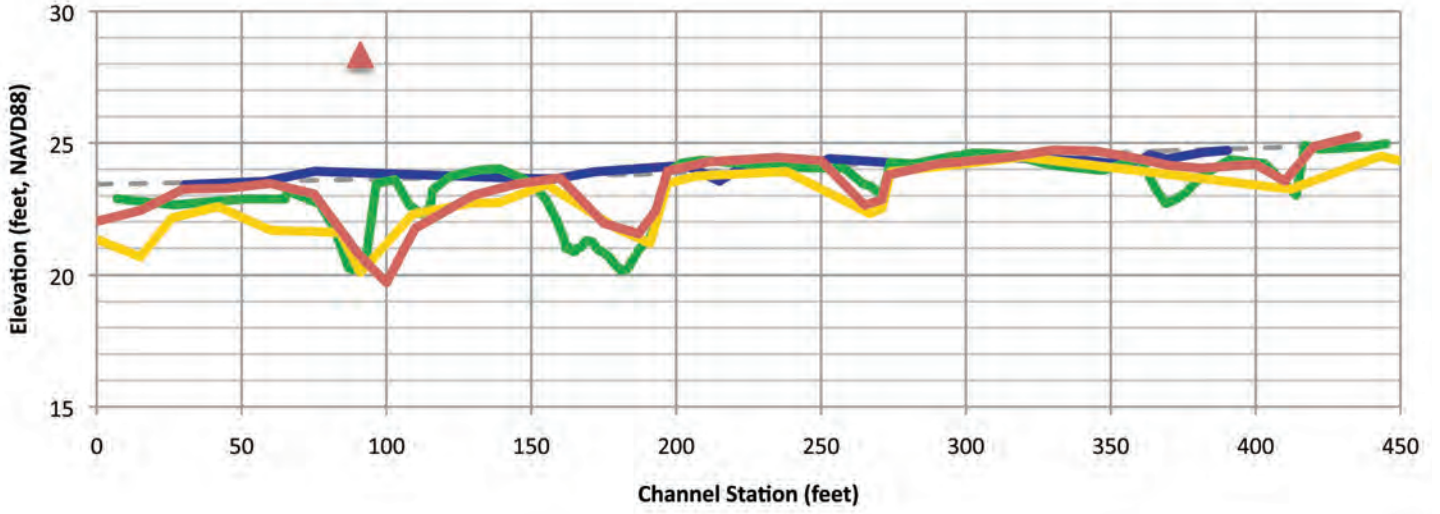
Figure 36

The pre-project channel profile (Figure 29) had a constant slope, with no variability. The distinguishing characteristic of the 2010 profile is the 2 to 4 feet deep pools near the large woody debris structures. Toby Minear, UC Berkeley graduate student, generously provided us with cross section and profile data from 2003 (immediately following placement of woody debris structures), 2005, and 2006. Each pool's depth, length, and relative location to the large woody debris structures has varied from year to year, but in each post-construction survey, the pools trend towards both deeper and longer with increased distance downstream. One potential reason for this is that the woody debris structures and thickening vegetation could be recruiting sediment towards the upstream reach, creating hungrier water and causing increasing pool scour with increasing distance downstream.

It would be interesting to observe how this profile trend might change in the future, particularly if the debris jam remains in tack. We hypothesize that the debris jam will have a backwater affect, slowing water velocities in the reach upstream.

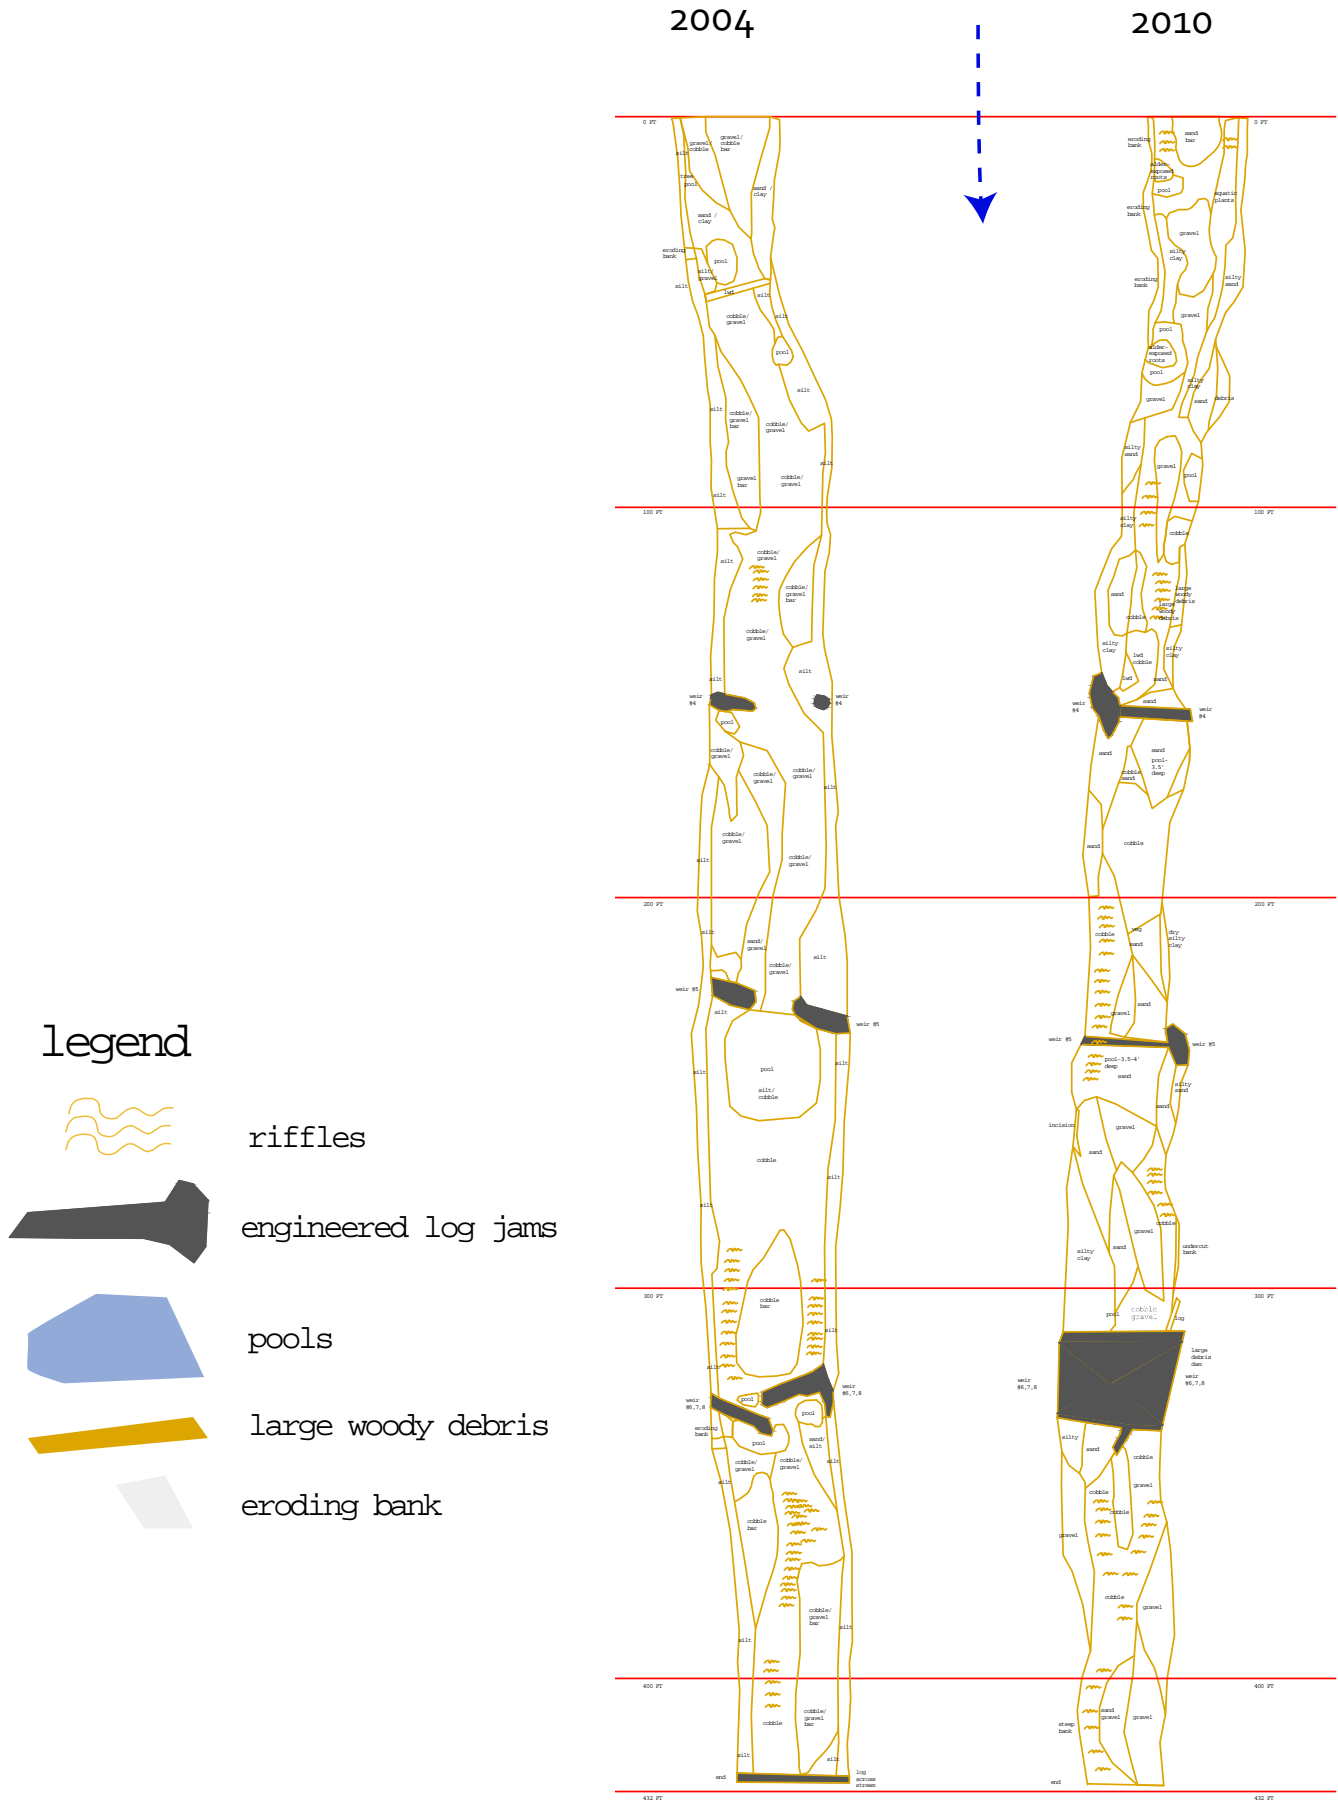
Figure 37
 Facies mapping overview of 432-foot reach comparing 2004 study with 2010 study

Figure 37 compares the 2004 facies mapping effort with our 2010 effort. The purpose of the facies mapping is to identify changes in the channel over the last six years and what these changes can tell us about how the channel is responding to the restoration interventions. We acknowledge the constraints with comparing these two mapping efforts that were done by two different groups of people six years apart and we also understand the limits of the information a facies map can tell us. That said, there are some things that can be learned from the facies map comparison.

In general, the channel has become more complex over the last 6 six years. Reorganization of materials has been significant. Most pools have been maintained and there are more fine sediments in the channel than there was in 2004. A number of logs and other wood debris that was in the middle of the channel or across it in 2004 are now gone. Today most large woody debris is found along the banks and behind logjam structures. In reach one (Figure 38), there has been a significant reorganizing of materials and erosion of the right bank. This has exposed tree roots and created pools along that bank. But, the scale of the right bank erosion should be a considered significant since in 2004 it was shown to only be eroding in a small area and now it is much of the reach. The pools have migrated but have been maintained. Also in reach one we can see that the channel bottom is more complex than in 2004. In reach two, logjam #4 has expanded the size of the pool downstream and accumulated some large wood debris upstream. There are more fine sediments in the reach than there were six years ago. In reach three, logjam #5 has maintained the large pool downstream. We recorded the beginnings of bank erosion just downstream of the logjam on the right bank and some on the left bank as well. There is also a more complex material being deposited downstream of the logjam were it was mostly just

cobble before. In reach four and five, the mapping comparison also shows the significant growth that logjam 6-7-8 has undergone as debris has piled up at the debris structure. Upstream from the three logjam complex there have been major changes to the stream as local hydraulic flow path has become more dynamic. In 2004, there was a significant cobble bar with riffles on both sides. At the time of our study, a deep pool exists behind the debris jam. Downstream of the logjam 6-7-8 debris jam the changes are somewhat less pronounced, riffles still remain and so does the large gravel bar on the left bank.
