Post-Project Appraisal of Arroyo Viejo Creek Improvement Project, Oakland, California

December 2005

LAEP 227: Restoration of Rivers and Streams

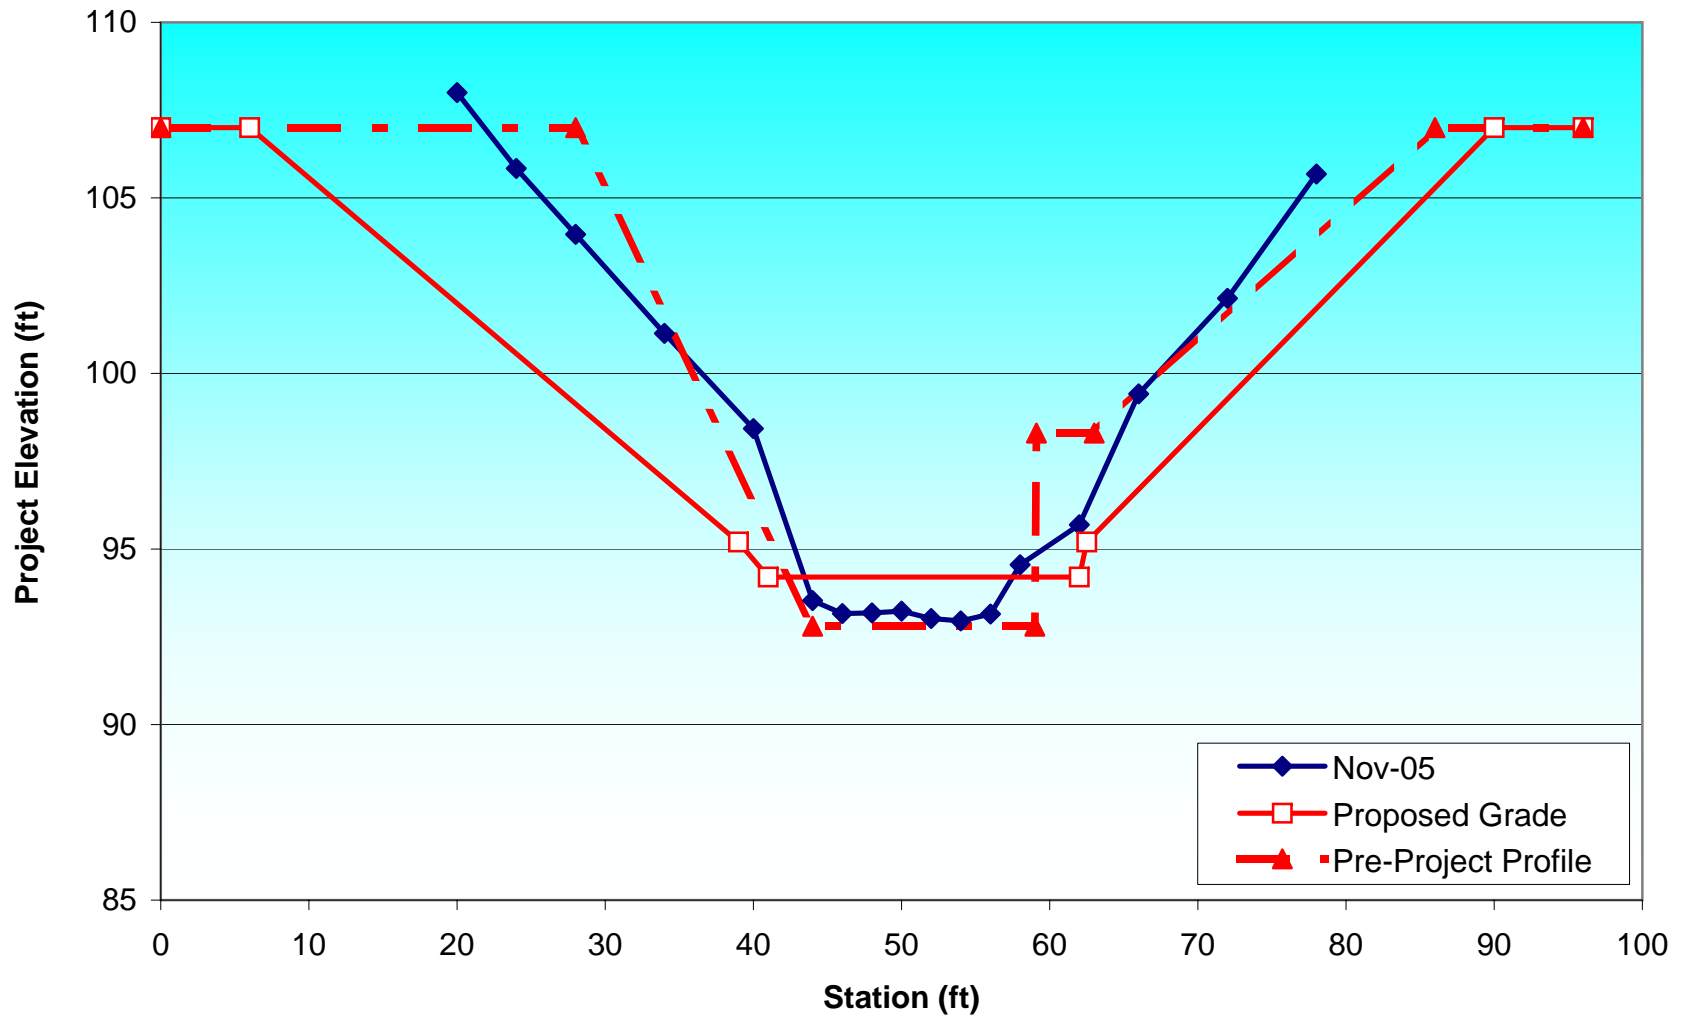
Figure 7(a): Cross Section A-A'

A-A' – This cross section was located at the east end of the project area. Project plans called for the removal of an existing concrete retaining wall and replacement with 2:1 (horizontal to vertical) earthen stream bank slopes and native vegetation. During construction, existing utilities were reinforced and stabilized. These utilities were not included in the design documents. Rock riprap was added on the creek bank slopes to prevent scour-induced erosion and potential damage to the utilities during a flood event (Photo 3). The as-constructed slope was 2:1 in this area, as specified on the project plans.

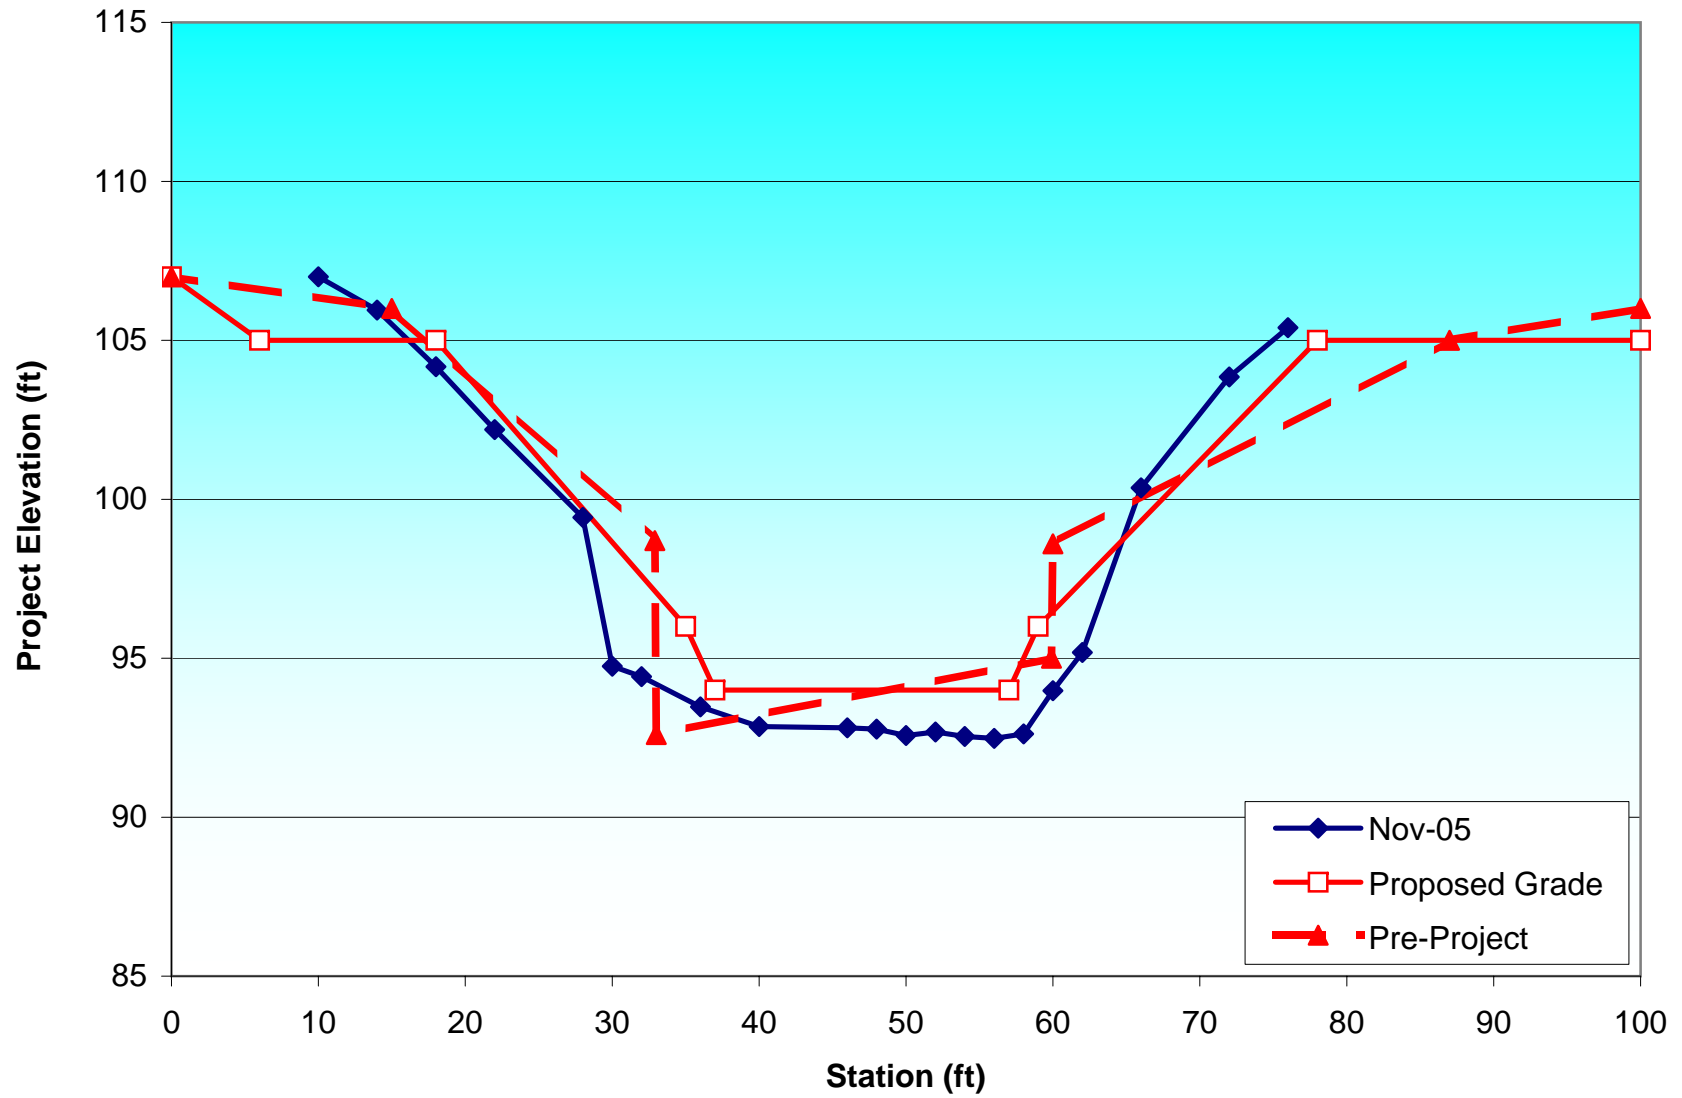
Figure 7(b): Cross Section B-B'

B-B' – This cross section was located just west of the steel-framed pedestrian bridge. The project plans called for 2:1 side slopes and native vegetation planting. The pre-existing concrete-lined channel was removed and the steel-framed pedestrian bridge was constructed. A gravel bar (Photo 4) was located in this area, and we conducted a pebble count on the bar. Our survey indicated that the channel width had increased slightly from the designed channel width. Creek bank slopes were approximately 2:1 and we observed stabilization fabric covering these slopes. In addition, logs were installed along the north edge of the stream to provide protection against scour-induced erosion. Some erosion was observed immediately under the steel-framed pedestrian bridge, as shown in Photo 5.

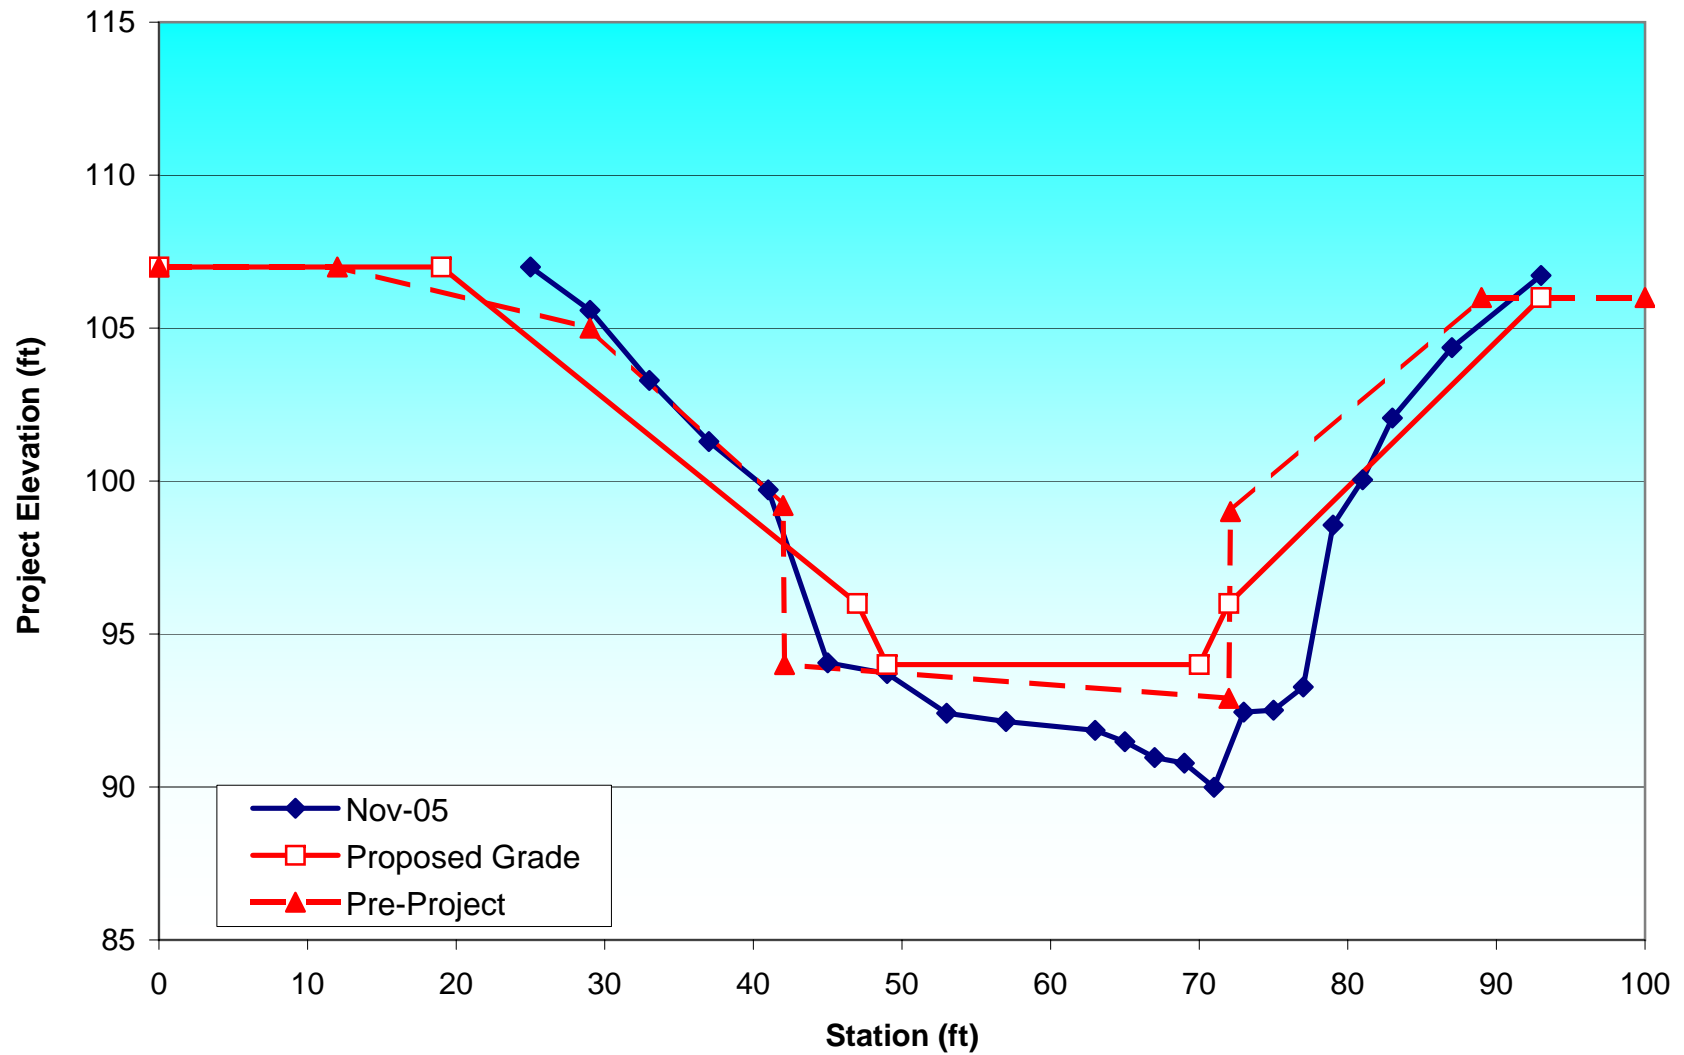
Figure 7(c): Cross Section C-C'

C-C' – This cross section was located near the end of the first meander that begins under the pedestrian bridge. The project plans called for 2:1 side slopes, native vegetation planting, and the initiation of a log revetment on the southern edge of the creek bank. Our survey indicated that the channel width had increased and become deeper than the designed channel depth, especially on the north edge of the cross section. The stream channel was heavily vegetated with watercress and cattails at this location. The log revetments were partially covered by vegetation cascading down the eroding right bank. Photo 6 presents a view of the location surveyed for section C-C'.

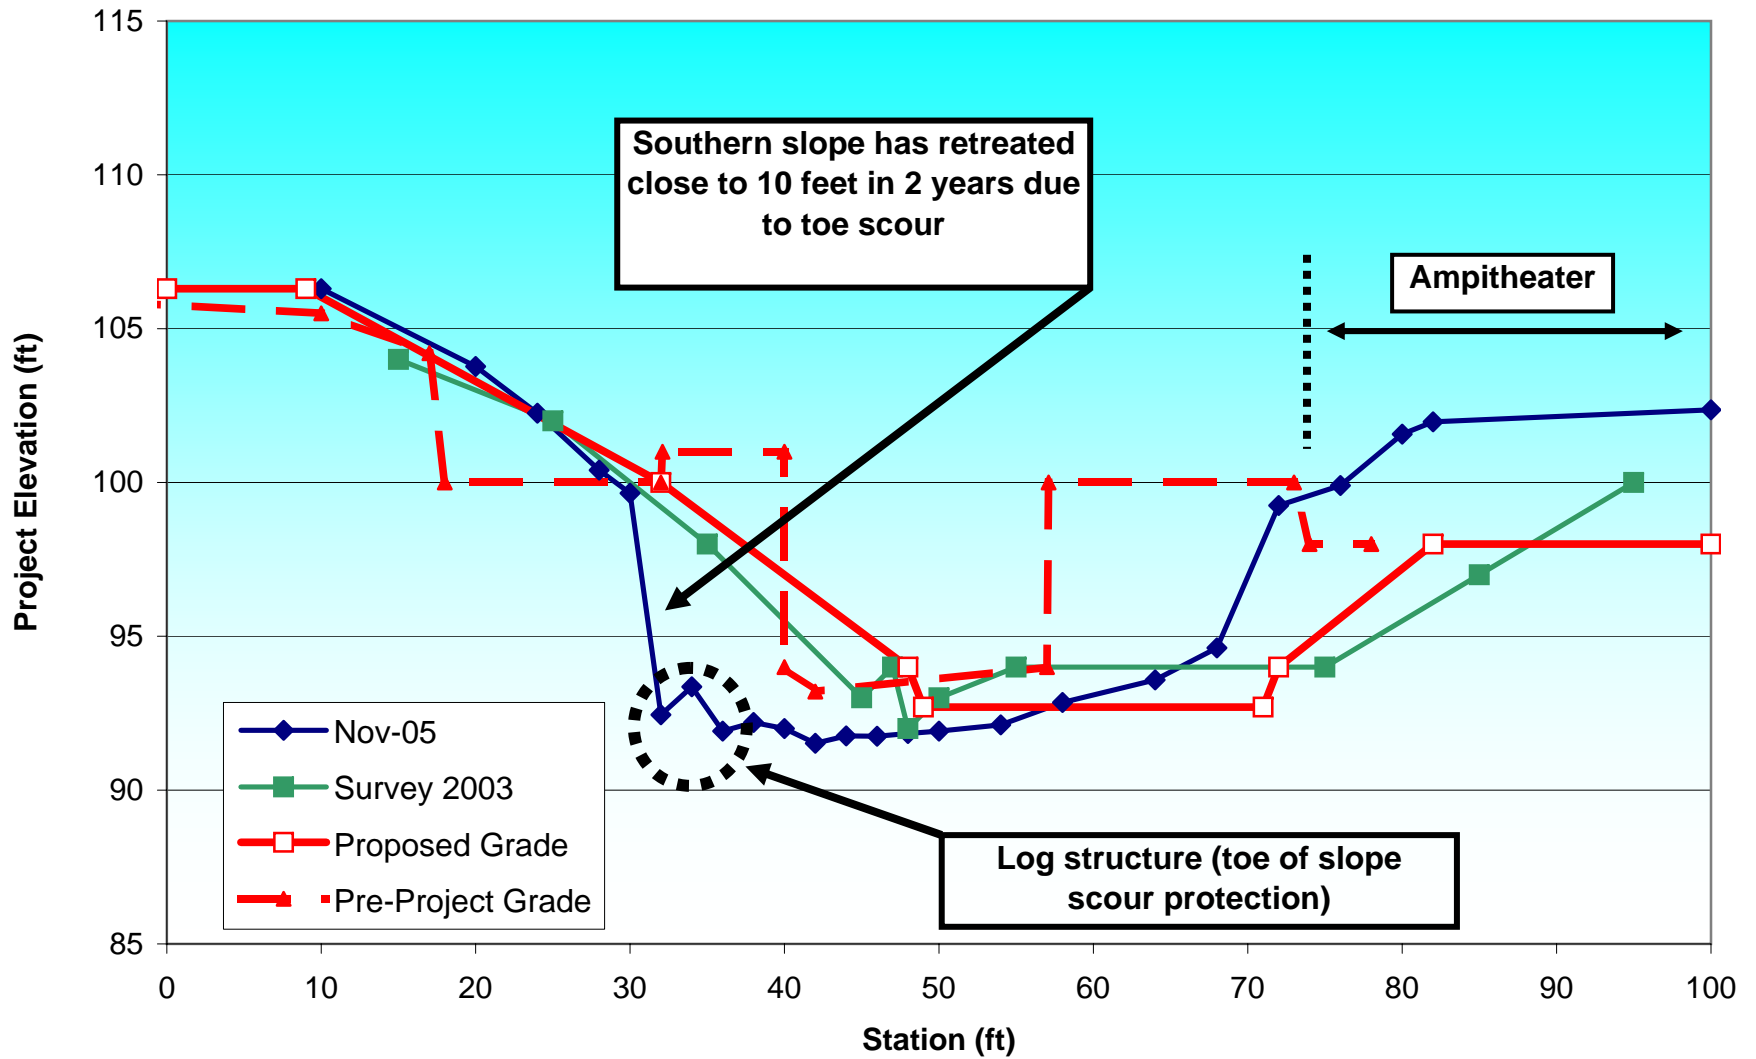
Figure 7(d): Cross-Section D-D'

D-D' (II-II') – This cross section was located south of the new amphitheater. As part of the restoration project, the old amphitheater and pedestrian bridge were removed; the abutments can be seen in Cross Section D-D'. The new amphitheater was constructed north of the creek (Photo 7) to allow more community interaction with the creek. Log revetments were called out on the project plans to be installed all along the outside of the meander bend, but we observed these log revetments only on the western (downstream) edge of the meander. Conceptual drawings (WRI, 2001b) also indicate that boulders were installed on the northern creek bank (south of the amphitheater) to provide scour protection. We did not observe these boulders during our field visit. We noted significant scour and slope instability along the southern creek bank in this area as shown on Photo 8. Project plans specified the creek bank slopes to be a maximum of 2:1 in this area; however, we measured the slope to be on the order of $\frac{3}{4}$ to 1, far above the acceptable slope. The log revetments installed to mitigate bank erosion appear to have shifted and moved during past high flow creek events. Photo 9 provides another view that shows the movement of the log revetments away from the creek bank. In addition, because these log revetments do not extend further up the slope, they do not provide sufficient scour protection during high flow events. The creek width is significantly larger than the design channel. The creek width has also widened since the survey by Kupers (2003).

This location also demonstrates the impact of vegetation on water velocities within the creek channel. We observed fresh scour along the northern creek bank, which probably occurred within a week

of our field visit and resulted from the thick stand of watercress nearby. The water located the path of least resistance, in this case the northern creek bank. The narrowed water passage increased velocities and resulted in erosion. Overall, this area is not statically stable and further future bank instability should be anticipated.

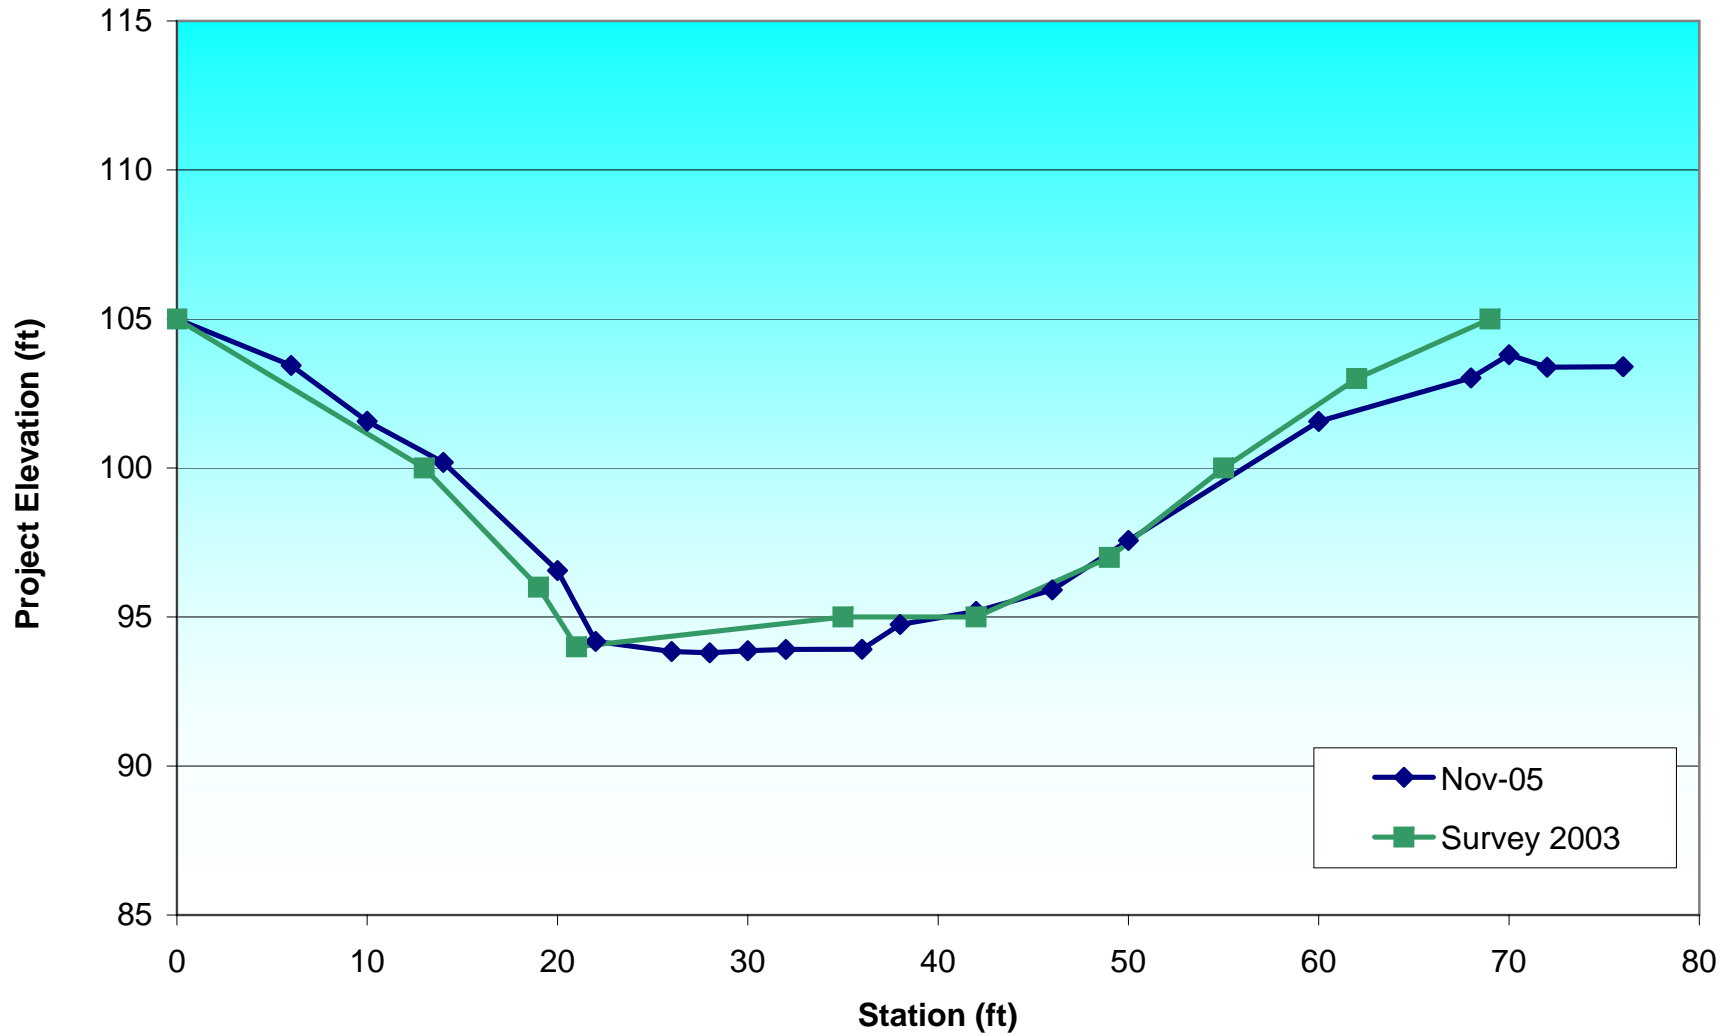
Figure 7(e): Cross Section III-III'

III-III' – This section was surveyed in an area of the creek that did not undergo significant modifications during the restoration construction. The section is located immediately east of the existing concrete retaining wall, as shown in Photo 10, and upstream of the Krause Avenue bridge shown in Photo 11. This area appeared to be geomorphically stable, since our cross section agreed fairly well with the previous post-project cross section survey (Kupers, 2003).

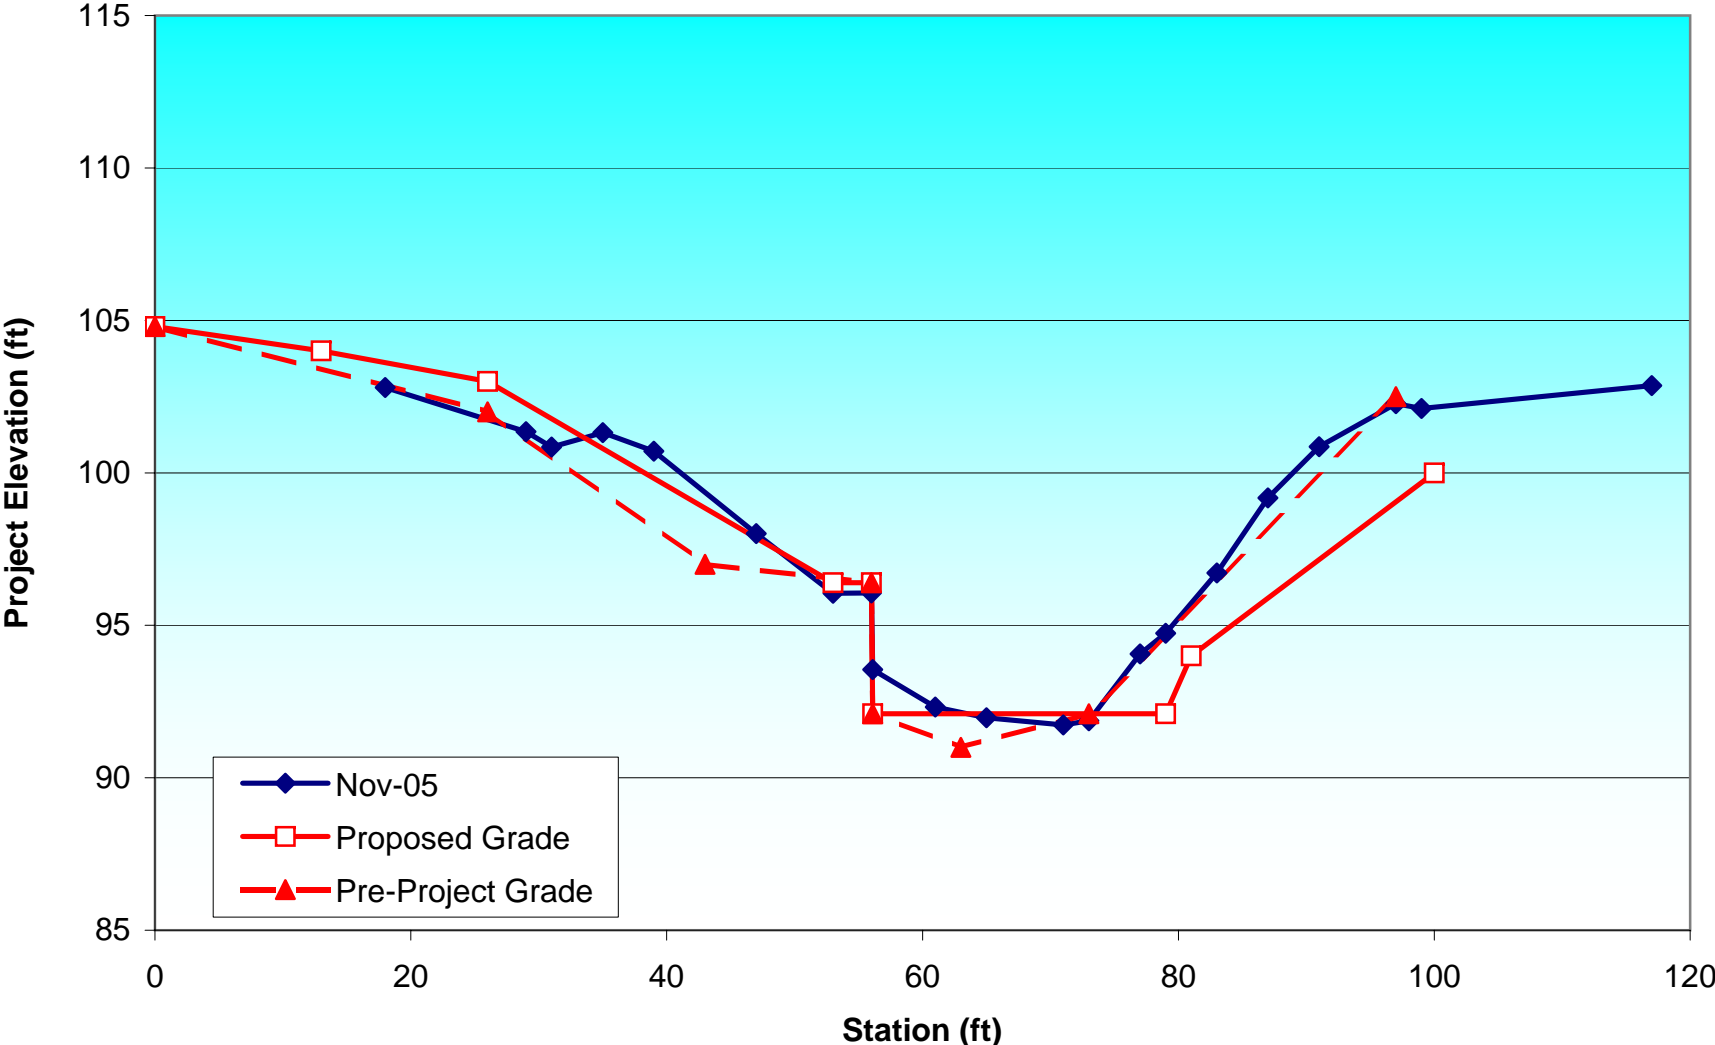
Figure 7(f): Cross Section E-E'

E-E' – This section is located west of the Krause Avenue bridge. This area of the project did not undergo significant channel modifications. The existing conditions appear to conform to the pre-project grade, not the design grade, which implies that no grading activities were undertaken in this area.

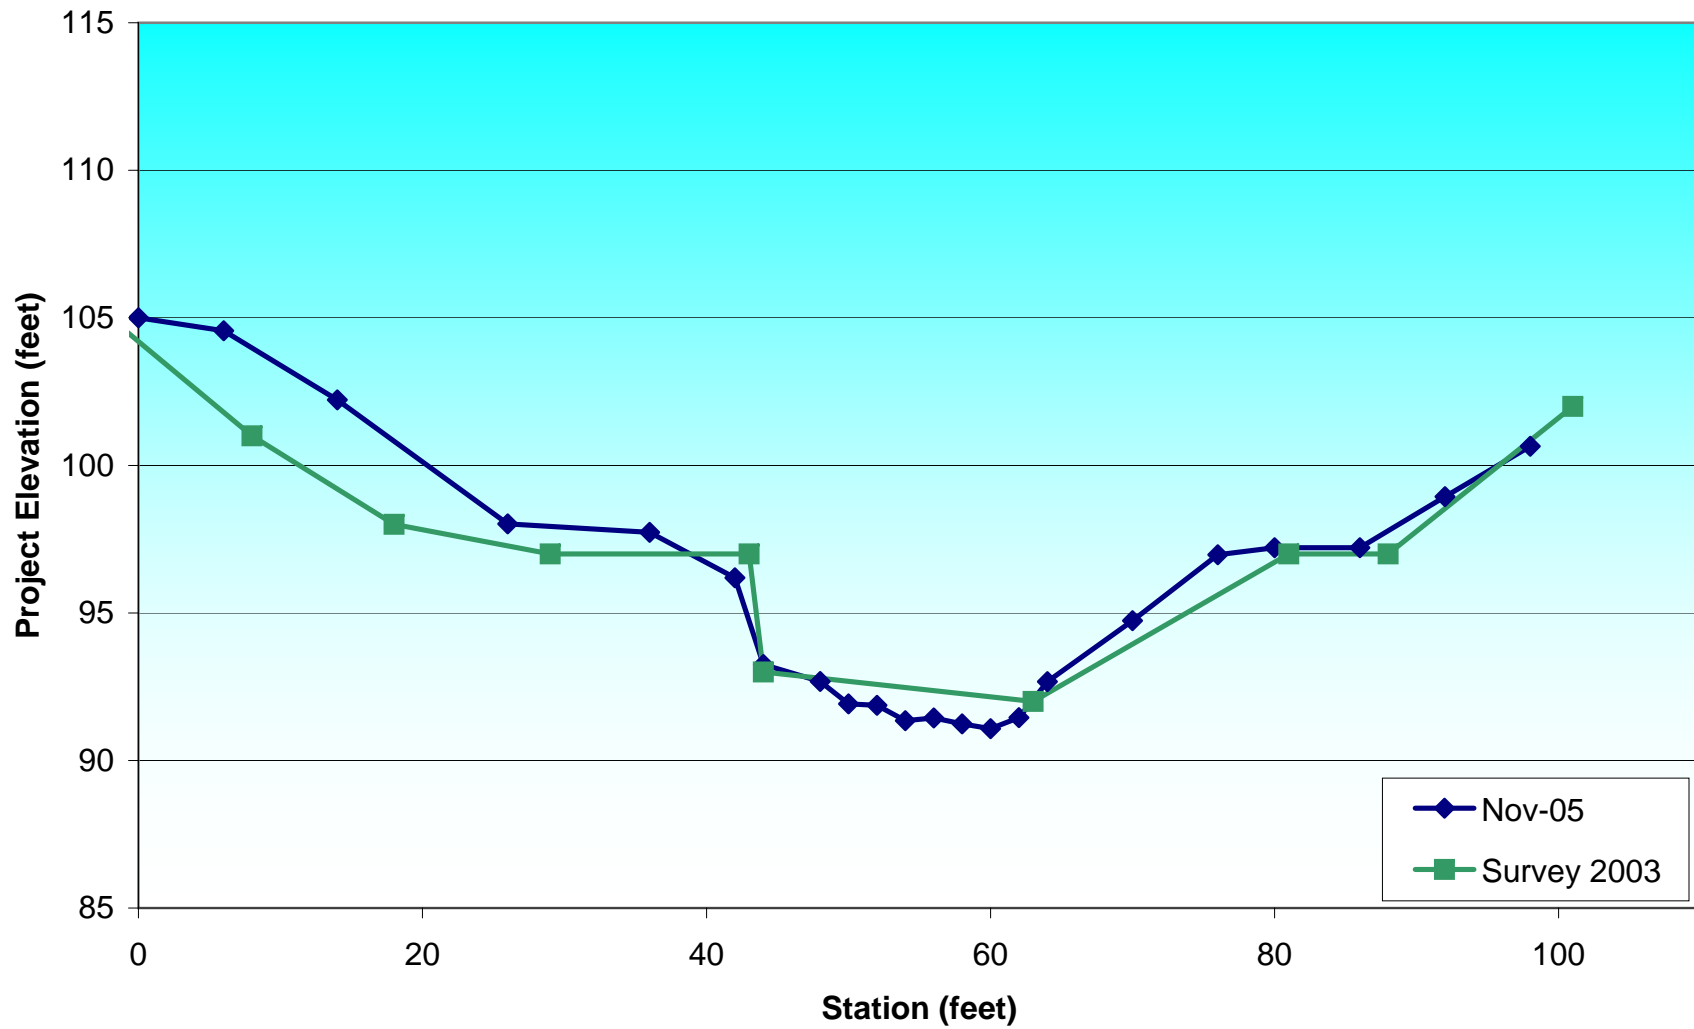
Figure 7(g): Cross-Section V-V'

V-V' - This section is located west of the Krause Avenue bridge. This area of the project did not undergo significant channel modifications. Our surveyed cross section was very similar to the previously surveyed section (Kupers, 2003). Photo 12 presents a view looking eastward where cross sections V-V' and E-E' were performed. The creek banks appeared to be stable in this area.

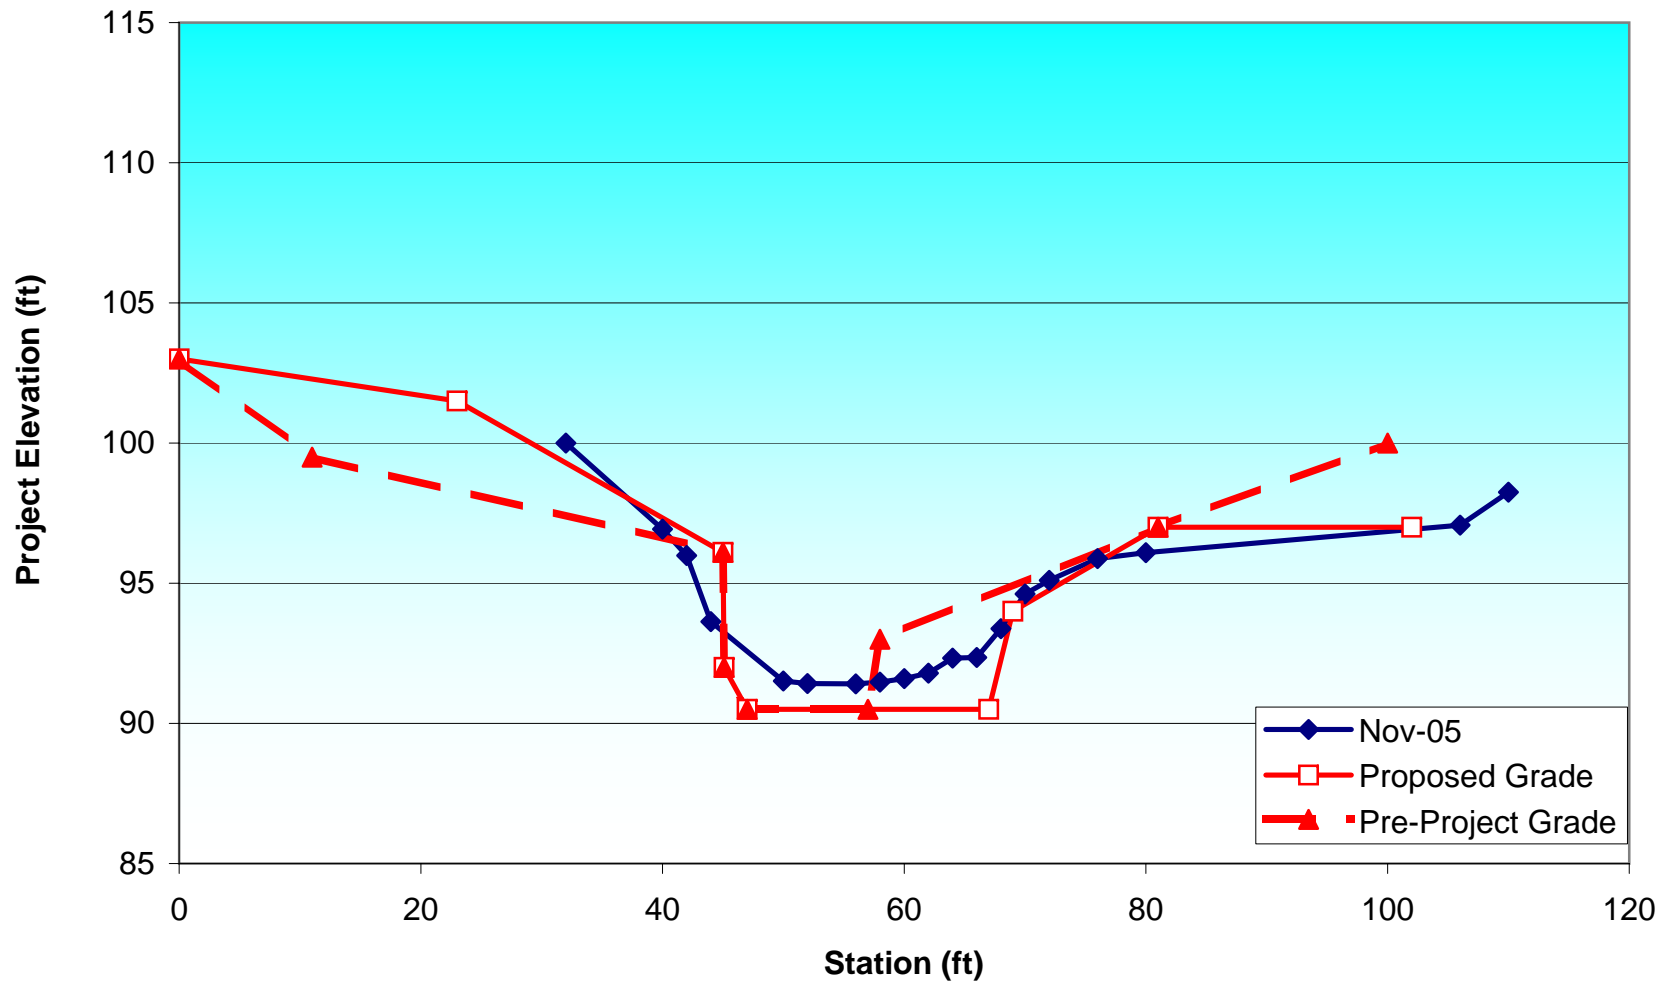
Figure 7(h): Cross-Section G-G'

G-G' - This section is located west of the Krause Avenue bridge. The creek did not undergo significant channel modifications during construction. Our surveyed cross section was consistent with the proposed grades outlined in the project design documents. Both creek banks appeared to be stable. Although the creek did not undergo significant alterations and the existing concrete retaining wall was left in place, this area provided abundant riparian habitat and substrate complexity within the creek channel.

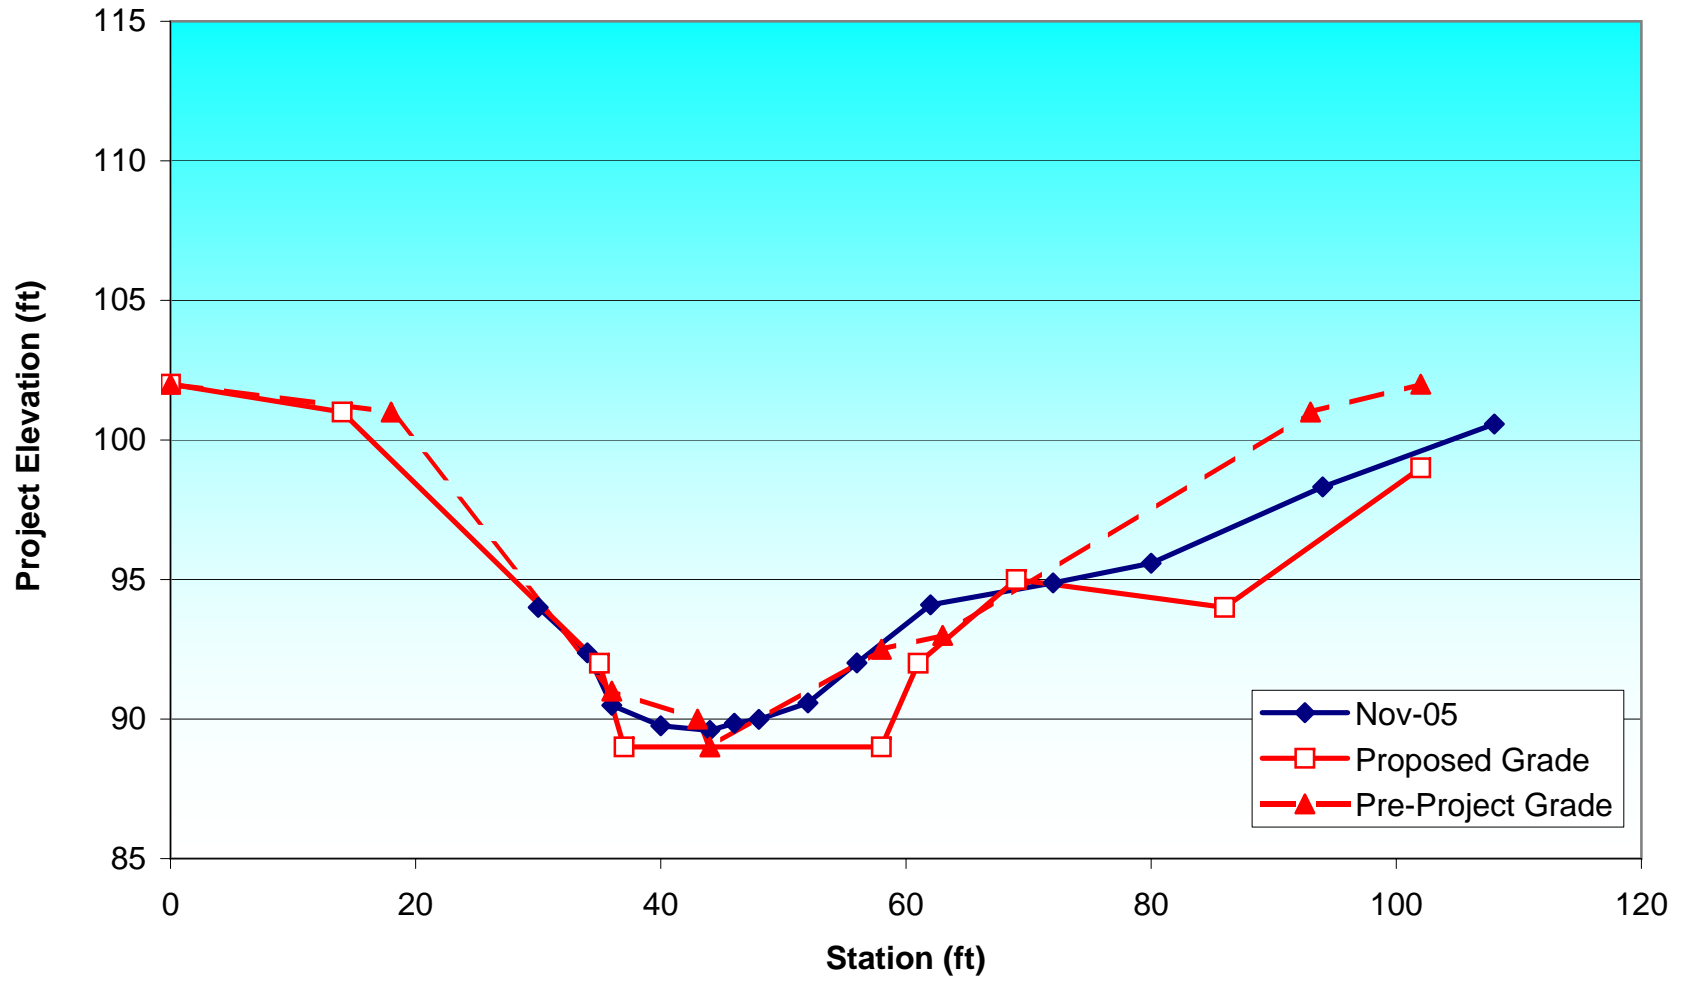
Figure 7(i): Cross-Section H-H'

H-H' - This section is located west of the Krause Avenue bridge. Our surveyed cross section was consistent with the proposed grades outlined in the project design documents. All creek banks appeared to be stable. As seen in the area of G-G', this area was not significantly modified and offered abundant riparian habitat and substrate complexity.

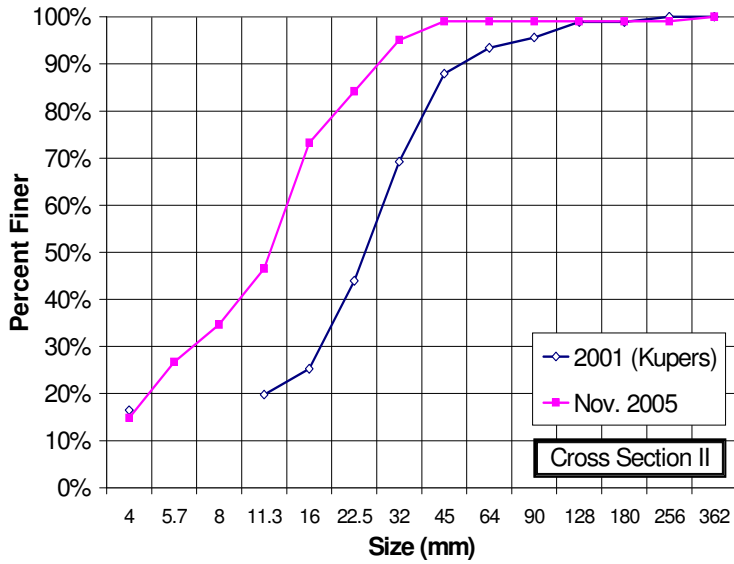
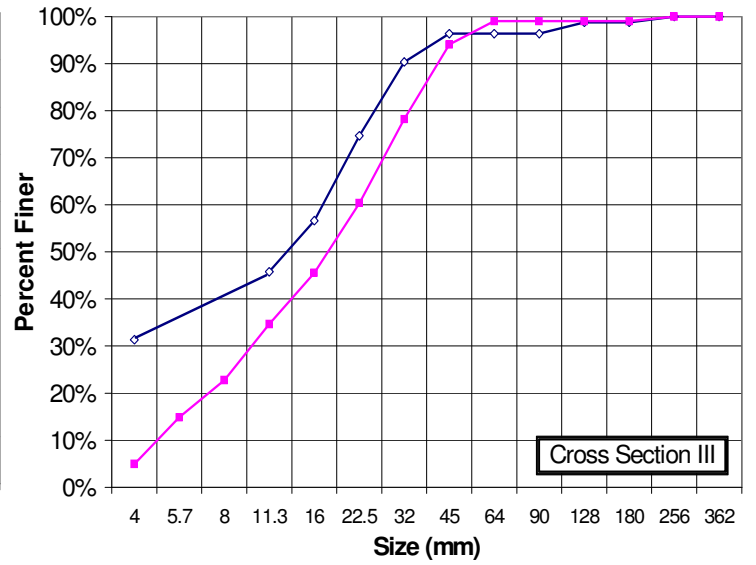
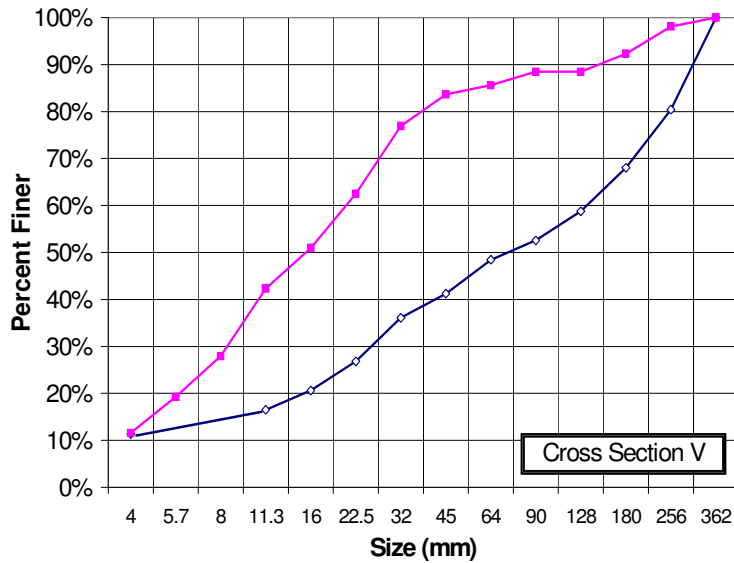
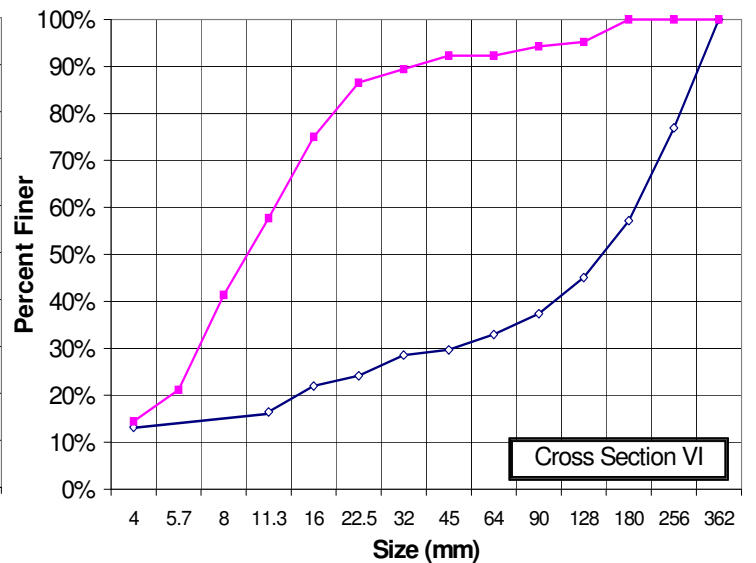
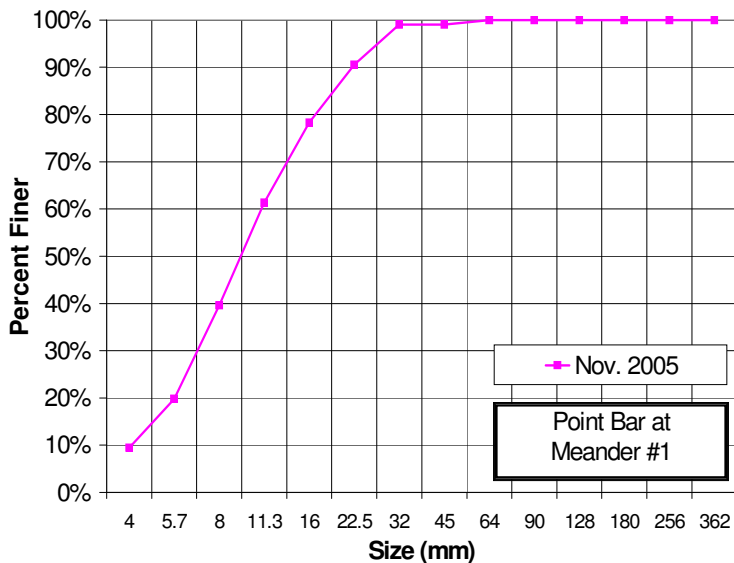
**Figure 8:
Results of Pebble Counts**

We conducted four pebble counts that approximately matched the locations used by Kupers (2001). Figure 8 shows the cumulative size distribution for these four pebble counts, plus one additional pebble count conducted at the only large bar onsite, just downstream of the pedestrian bridge. Three of the four pebble counts showed significant sediment fining since 2001, and one showed minor coarsening. One possible explanation for the fining is that the boulders and cobbles placed in the channel during construction have been mobilized and/or covered by finer sediments originating upstream.

Significant fining is evident at cross sections II, V, and VI, where deposition has probably filled in larger rocks placed during construction.

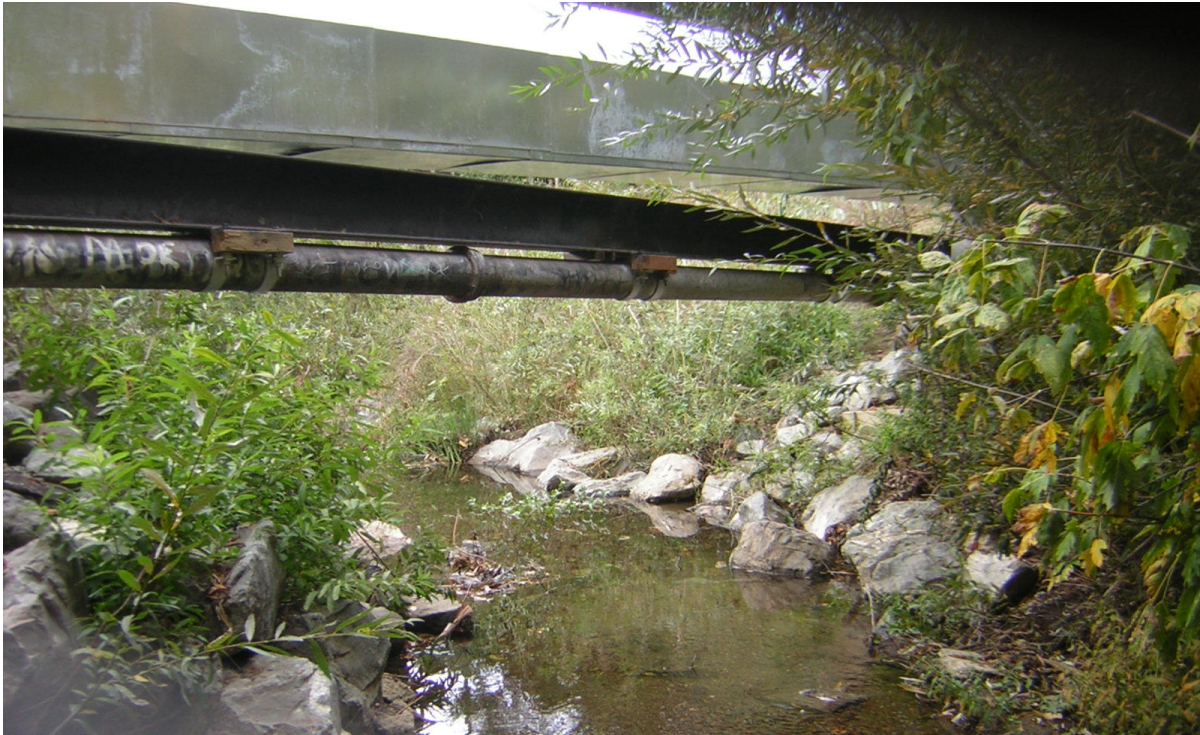
Photo 3. Looking west from the eastern end of the Project site, near the location of cross section A-A'. Utilities (not identified on the design documents) were protected and concrete rip rap was added to minimize scour-induced erosion of the stream bank. Vegetation growth can be seen through the placed rip rap boulders.

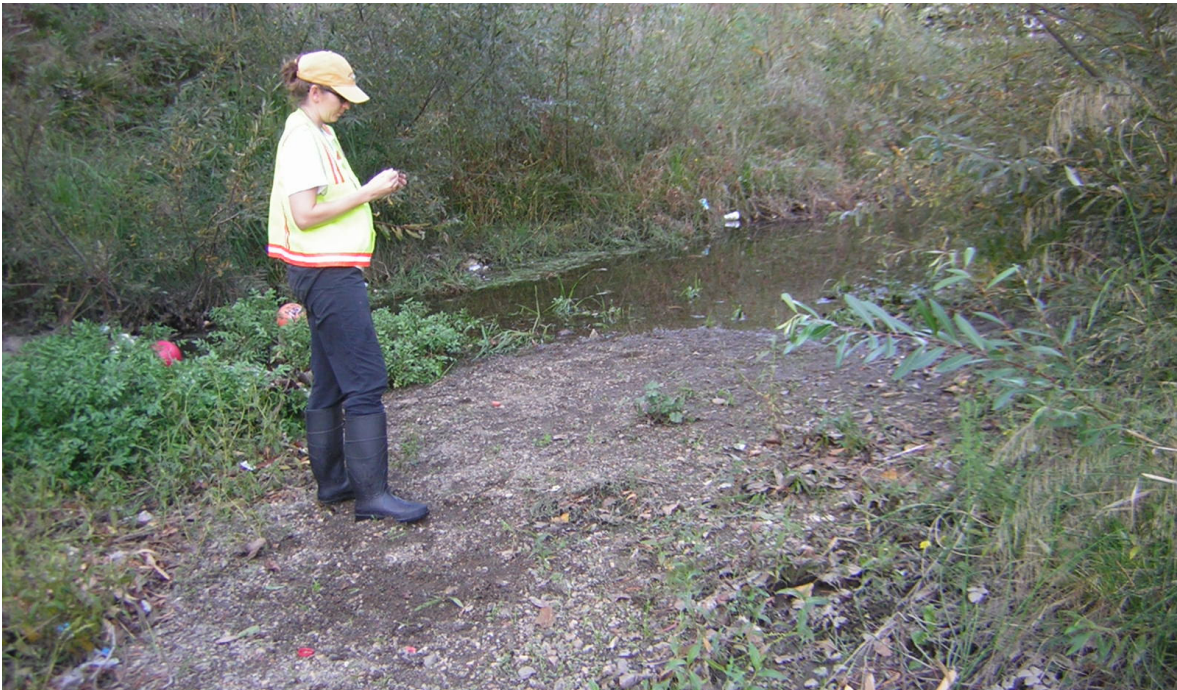
Photo 4. Location of cross section B-B' under the steel-framed pedestrian bridge. A gravel bar formed and log protection was added along the northern edge of the stream (outside the picture to the left). This was the location of our gravel bar pebble count.

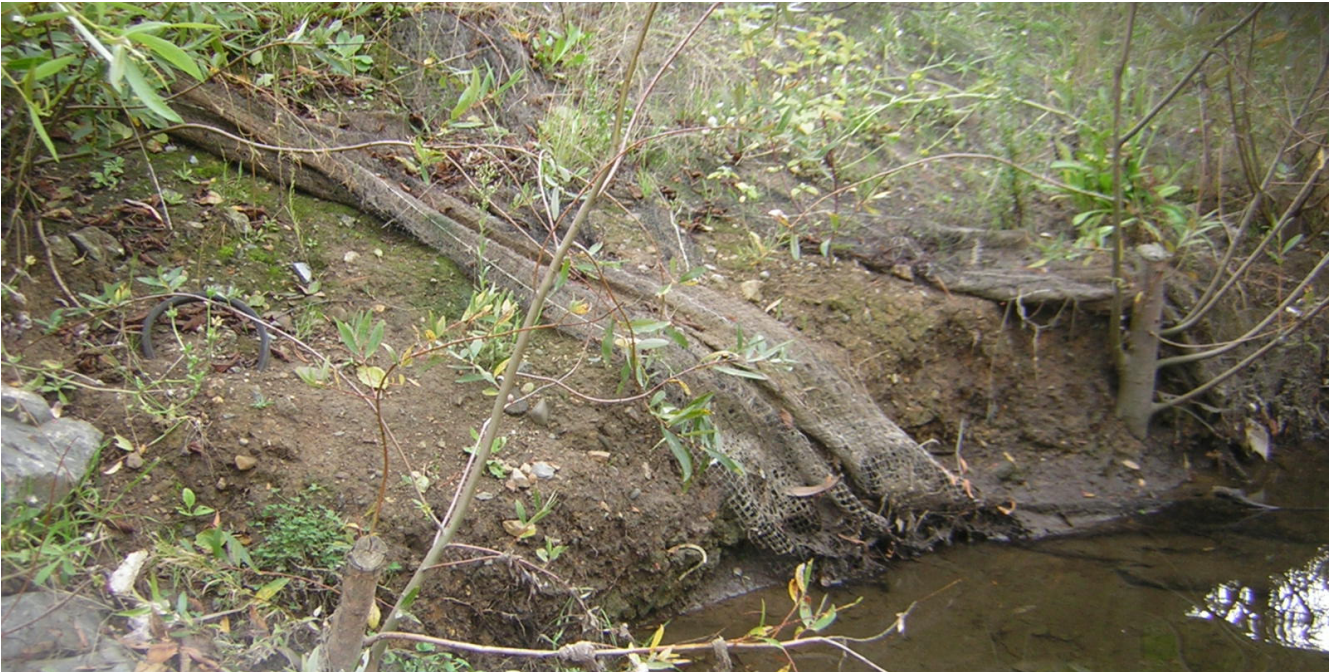
Photo 5. Erosion is evident immediately under the steel-framed pedestrian bridge as a result of the over-steepened creek bank in the vicinity of cross section B-B'. Active erosion is occurring behind the willow stakes.
