Post-Project Appraisal of Arroyo Viejo Creek Improvement Project, Oakland, California

December 2005

LAEP 227: Restoration of Rivers and Streams

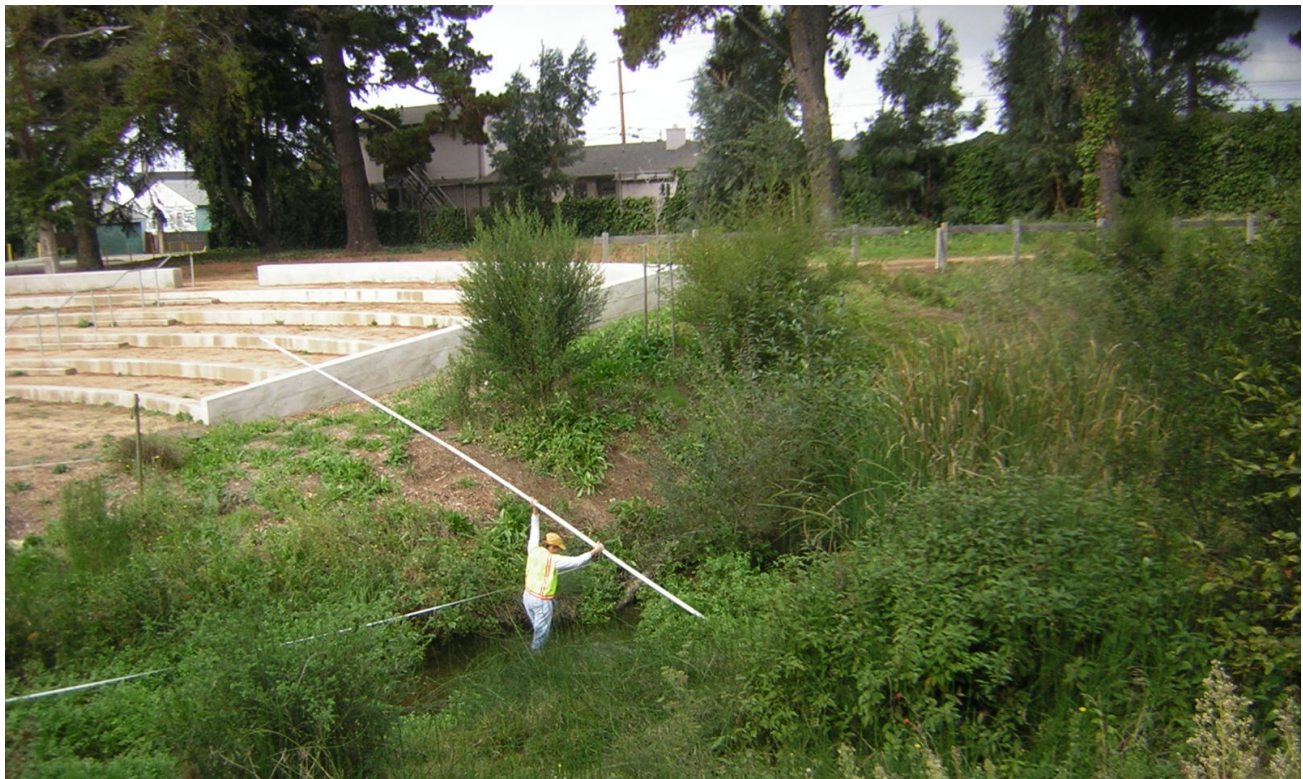
Photo 6. The location of cross section C-C' is towards the right of this photo. Note the growth of cattails and watercress within the creek.

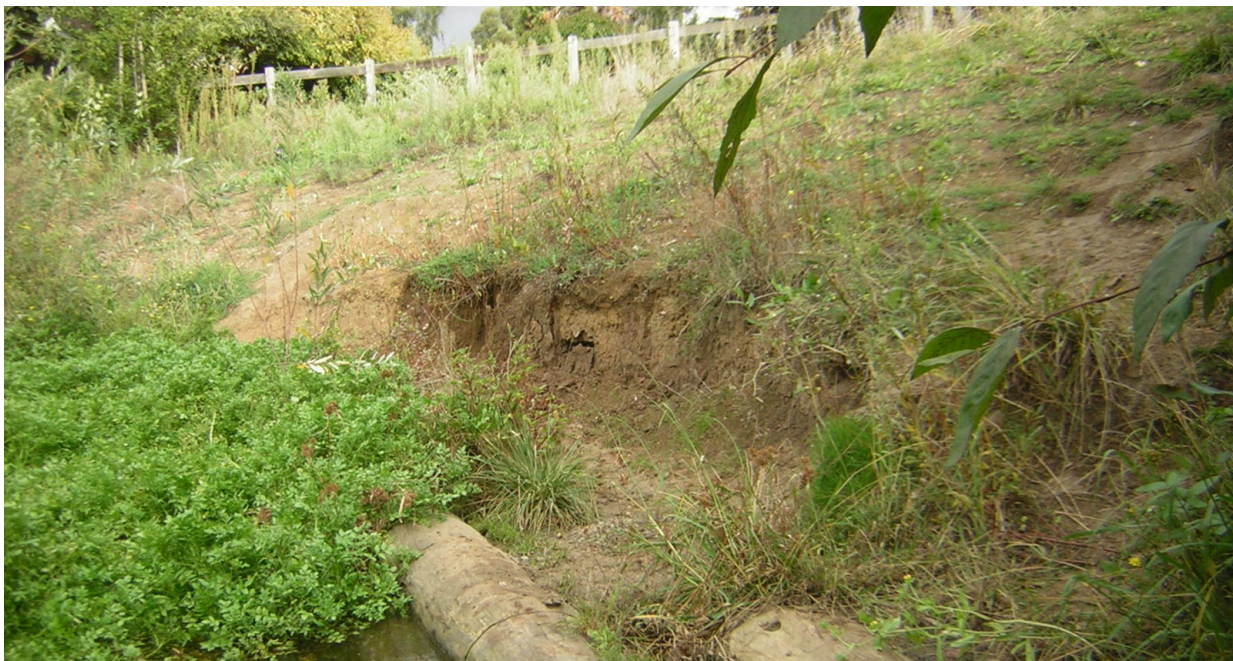
The project plans called for log revetments to be installed and tied down to the outer bank of the two significant meanders upstream of the car bridge (WMA, 2001). Figure 10 shows that at least portions of these log revetments remain. However, at Meander 2, erosion is occurring behind the logs revetments, so they are only partially protecting the bank (see Photo 8). At Meander 1, willows are better established and offer significantly more bank protection, so the potential loss of logs is not as great a concern.

Photo 8. Significant scour is evident as a result of oversteepened creek bank slopes. The log revetments installed to mitigate bank erosion have shifted and moved during high flow creek events. In addition, these log revetments do not provide scour protection during high flow events.

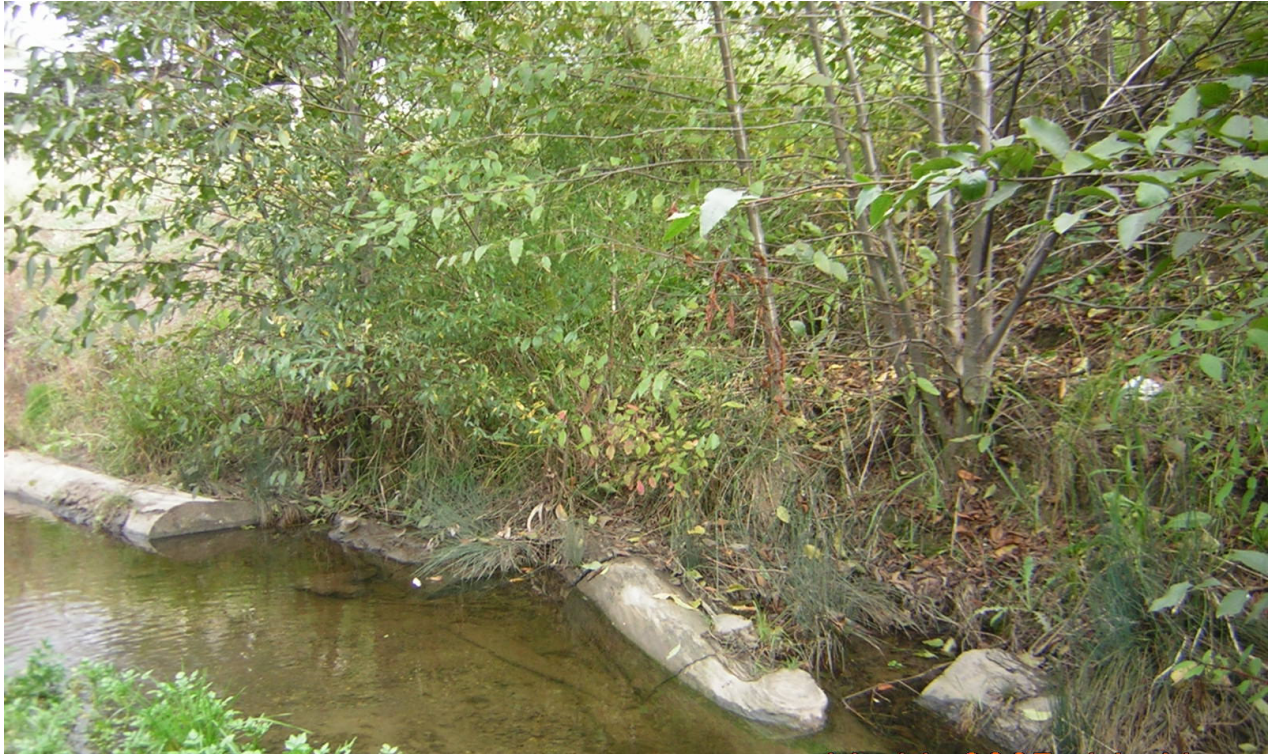
Photo 9. The installed log revetments have shifted and “floated” downstream as a result of inadequate restraint. Additionally, these logs do not provide significant scour protection during high flow events.

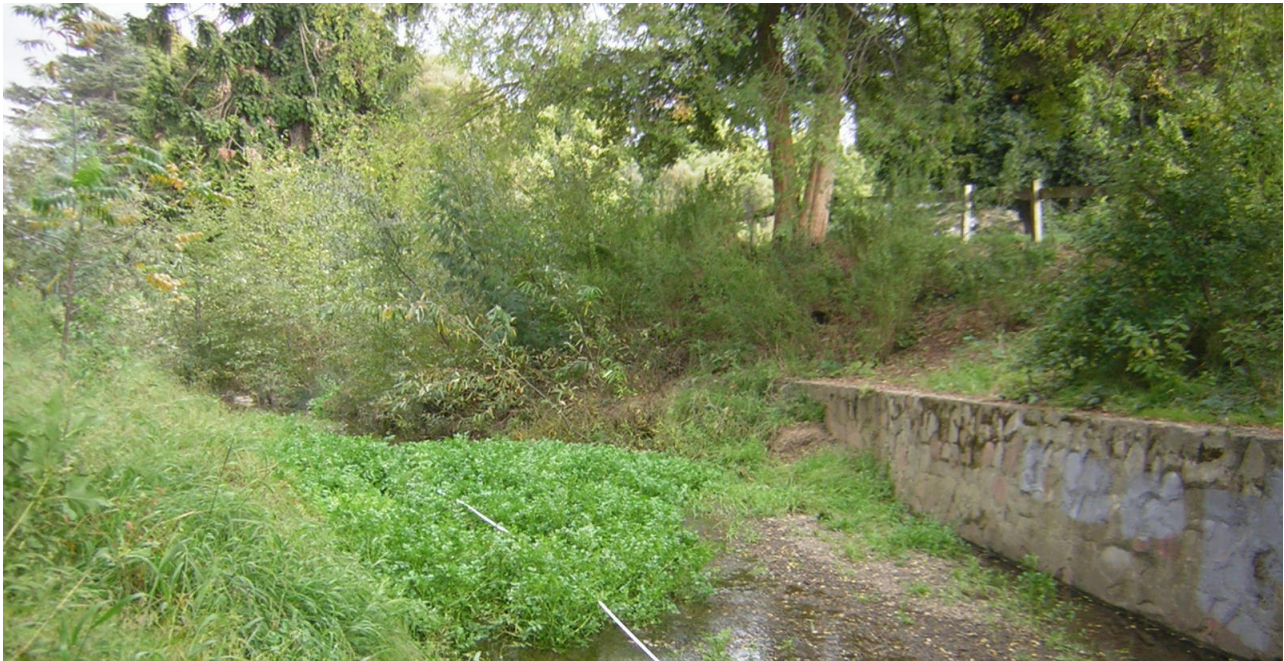
Photo 10. Looking toward the location of cross section III-III', which crossed the creek at the far end of the concrete retaining wall (along the right-hand side of the picture). Vegetation can be seen growing both on top of and at the base of the concrete retaining wall.

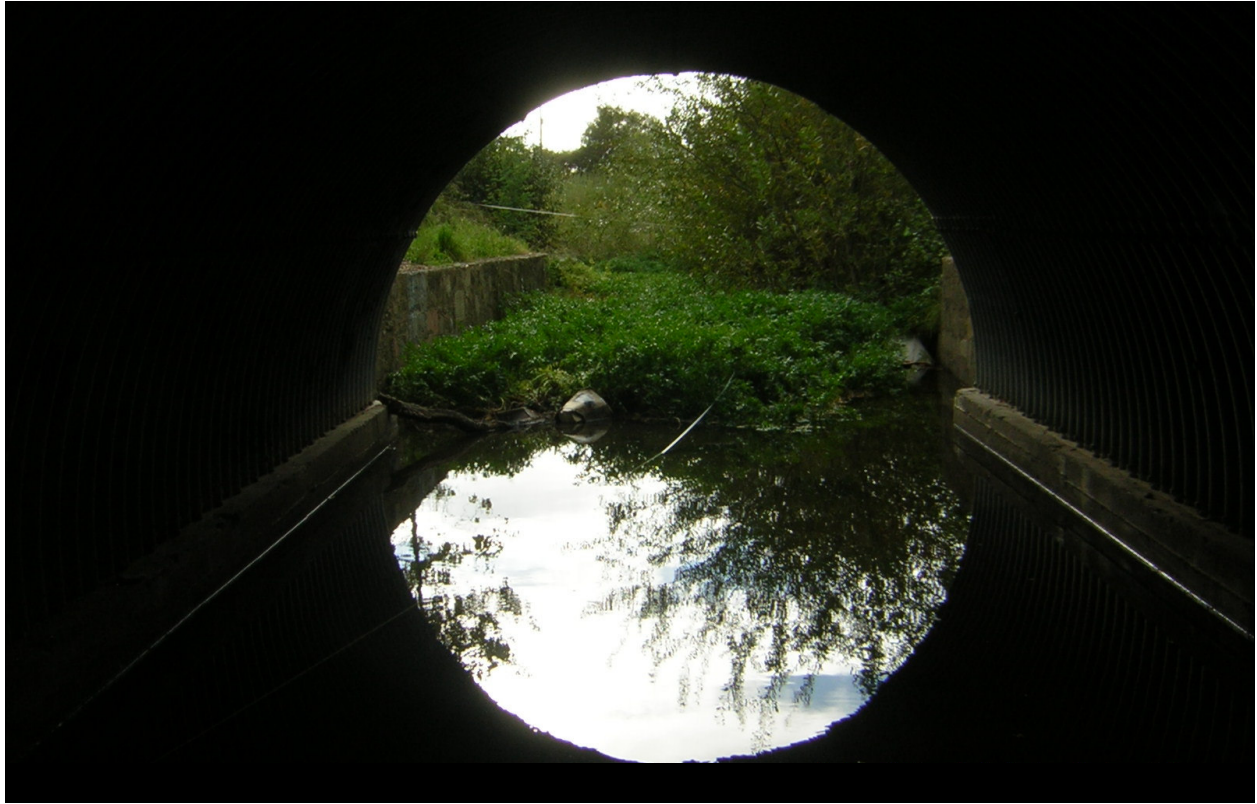
Photo 11. View looking west through the Krause Avenue bridge. We deduced that watercress is not attracted to deep water locations with little or no sunlight.

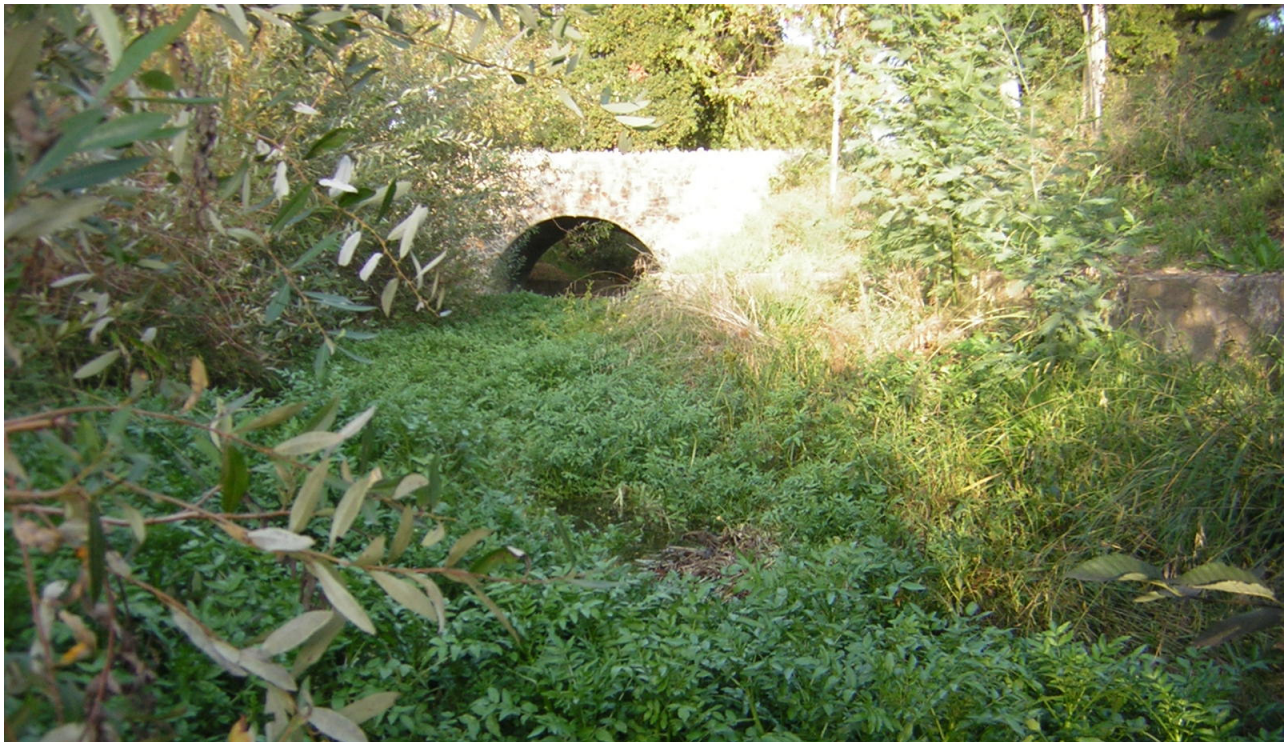
Photo 12. View looking east toward the Krause Avenue bridge. Cross sections E-E' and V-V' were performed across this stretch of creek. Vegetation was very thick along this stretch.

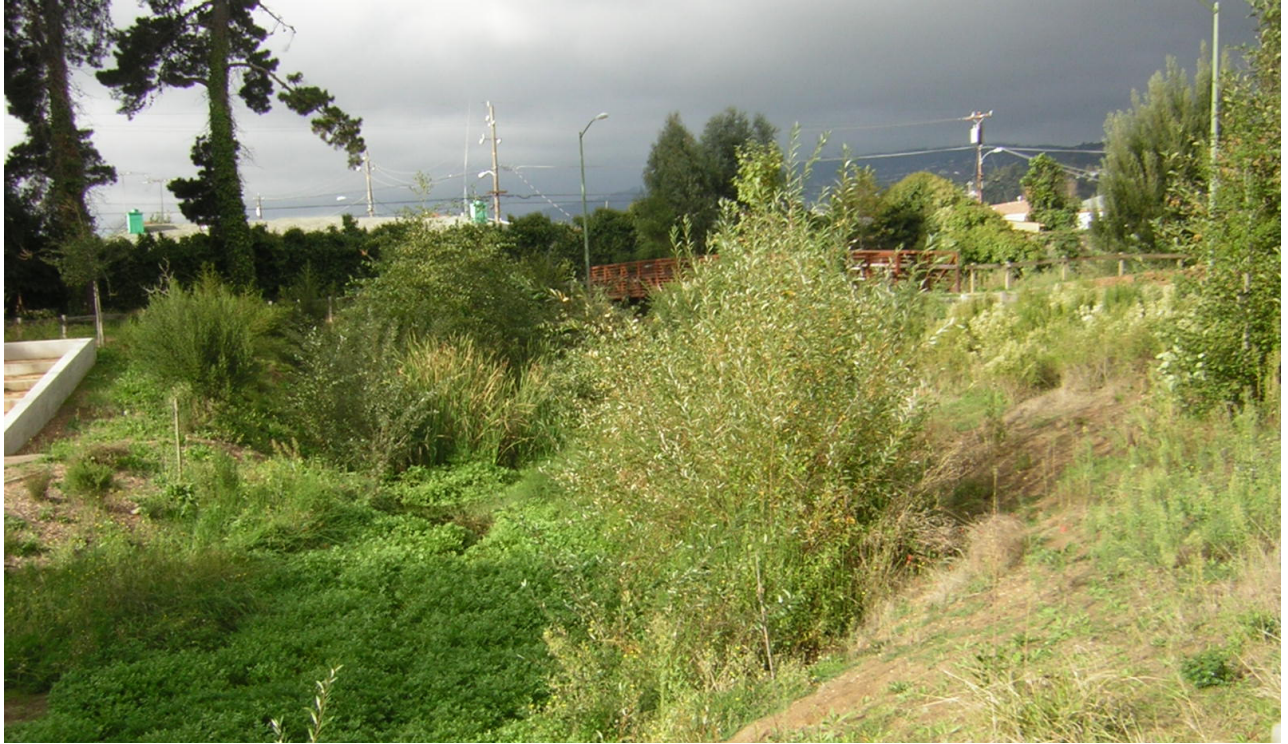
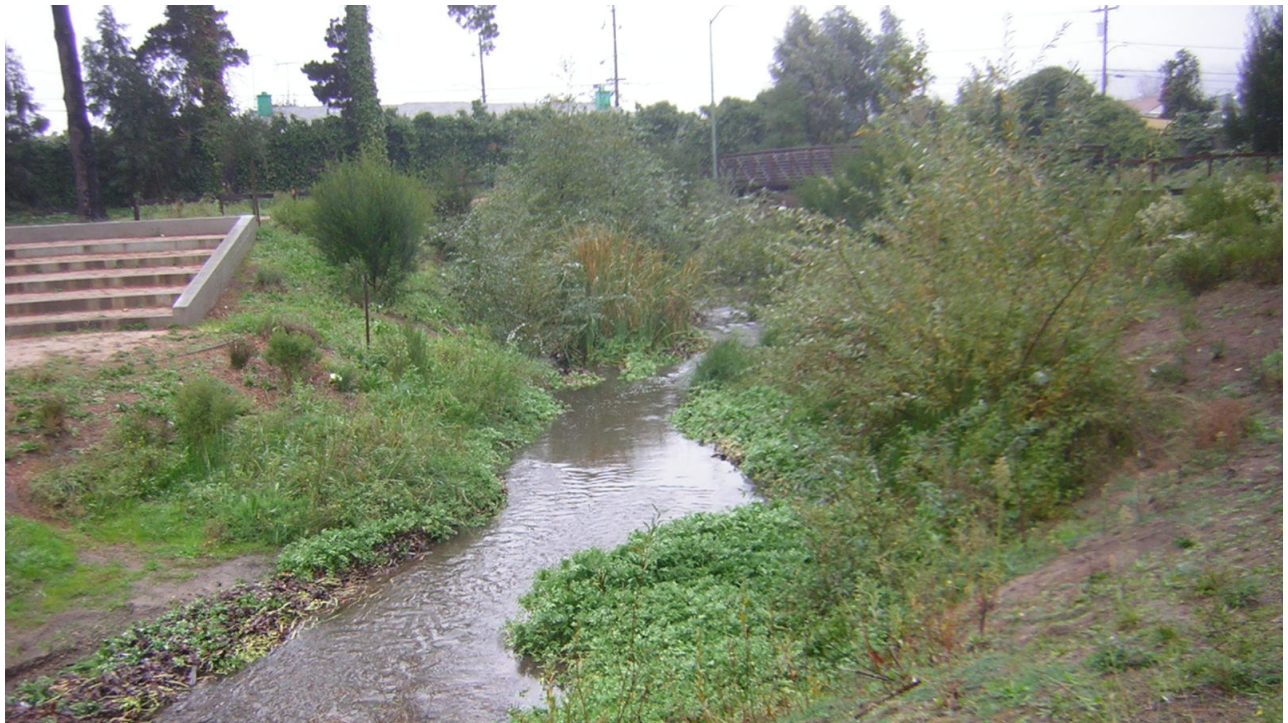
Photos 13 and 14. Two views looking upstream from the amphitheatre, one before the first storm of the season (11/11/2005) and the other immediately after the storm (11/29/05). The watercress (foreground) has been washed out of the middle of the channel, but the cattails upstream remain firmly rooted.

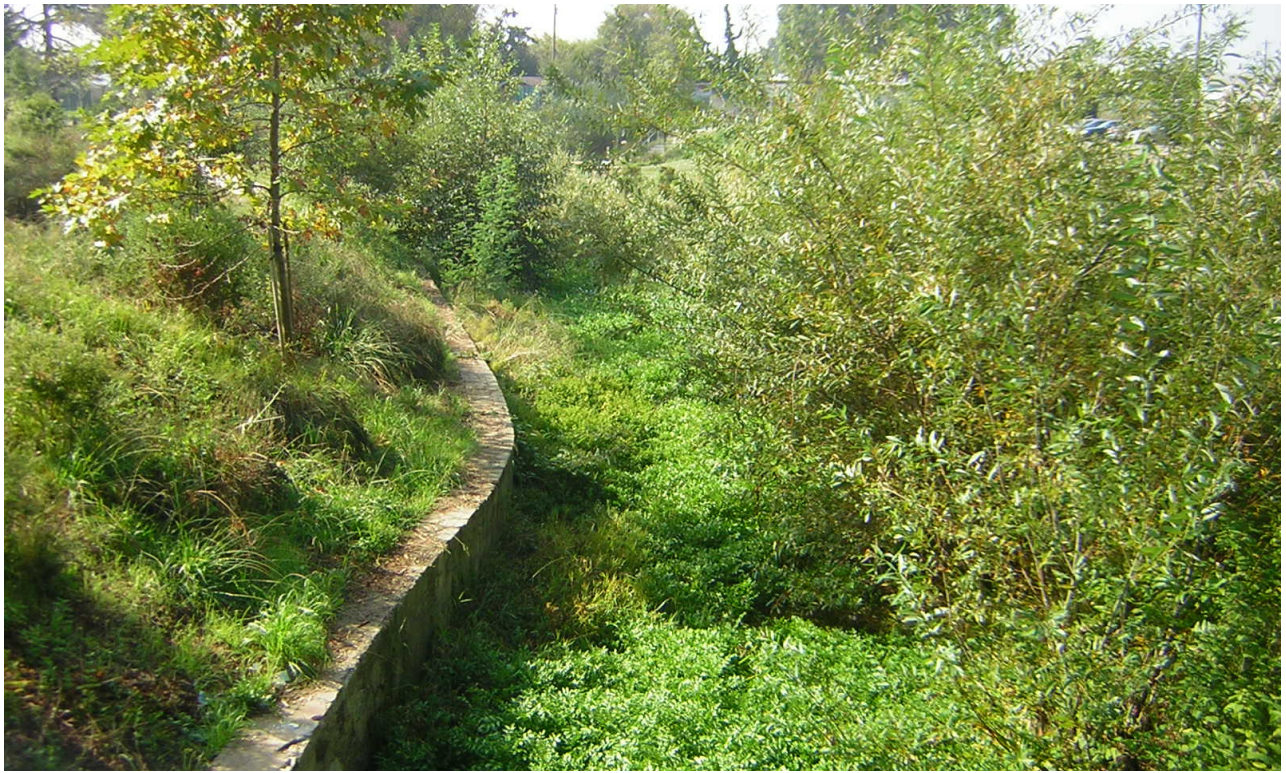
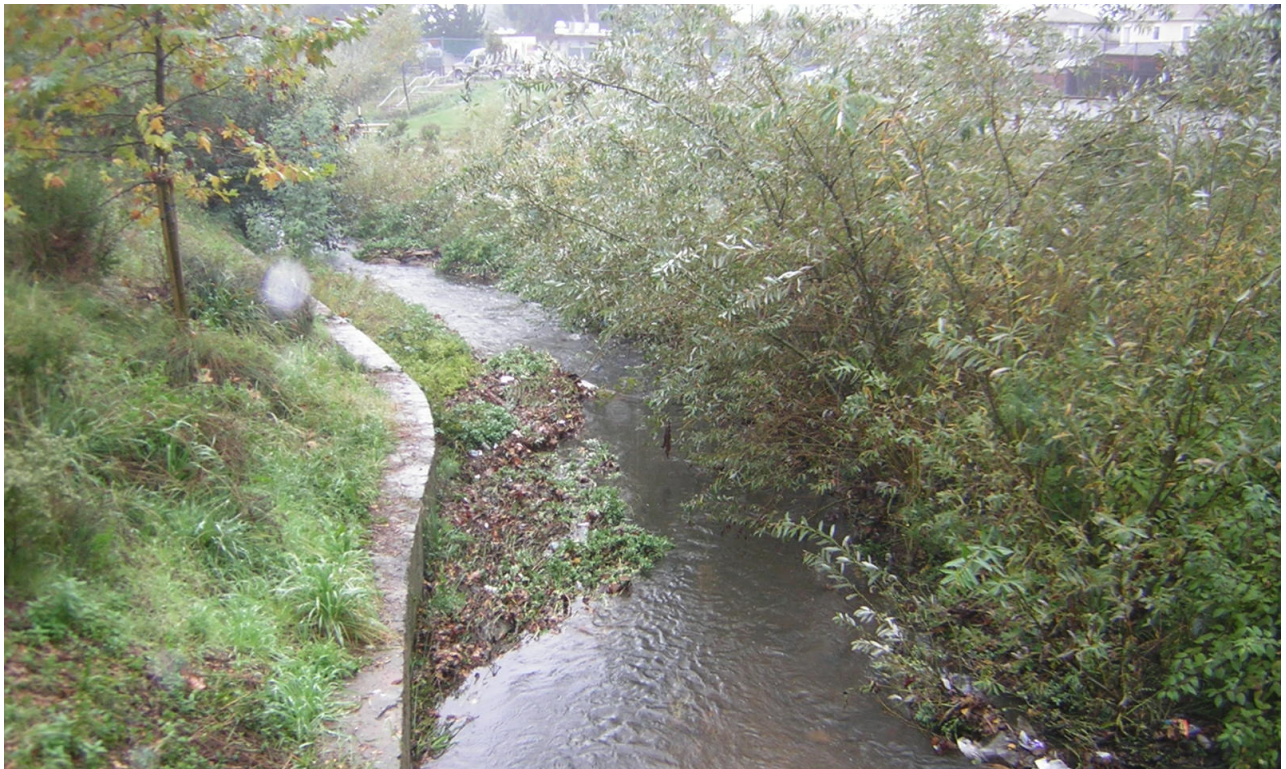
Photos 15 and 16. Two similar views looking downstream from the car bridge at Krause Avenue, one before the first storm of the season (10/21/2005) and the other immediately after the storm (11/29/05). Nearly all of the watercress has been washed out of the channel.

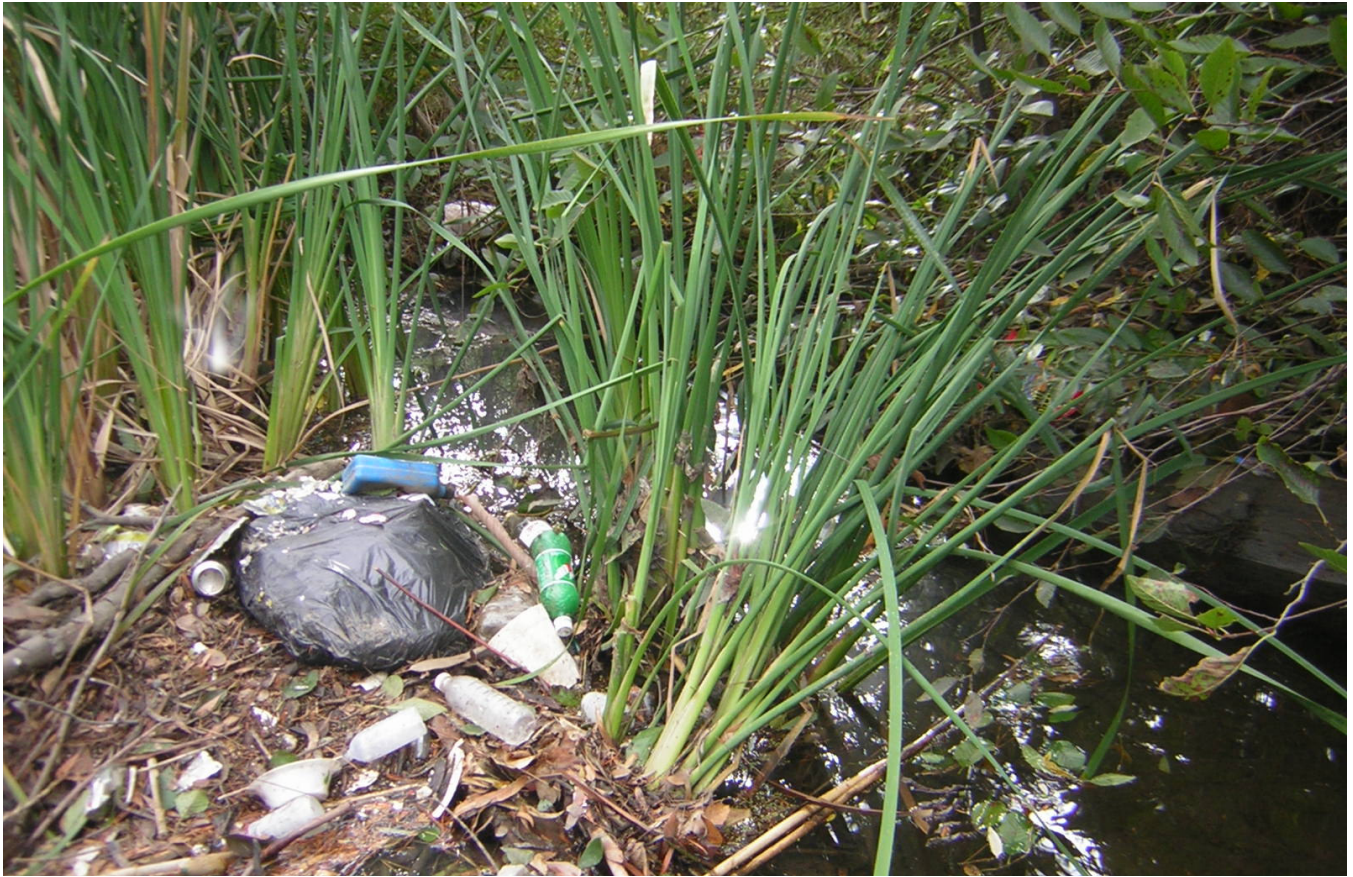
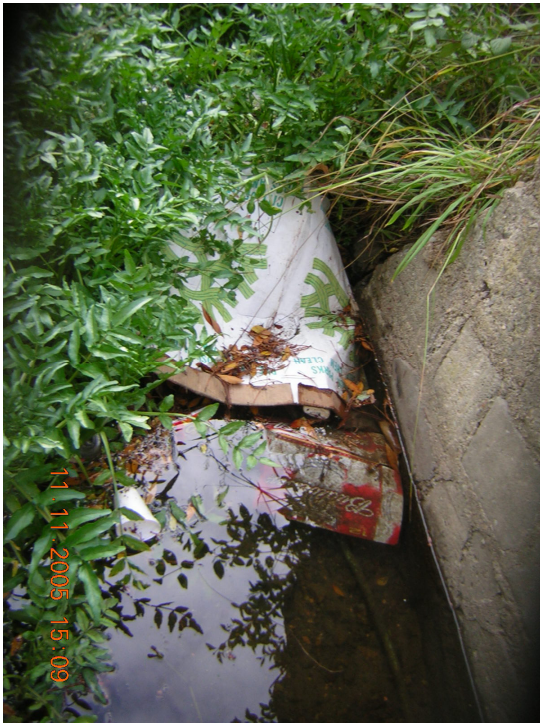
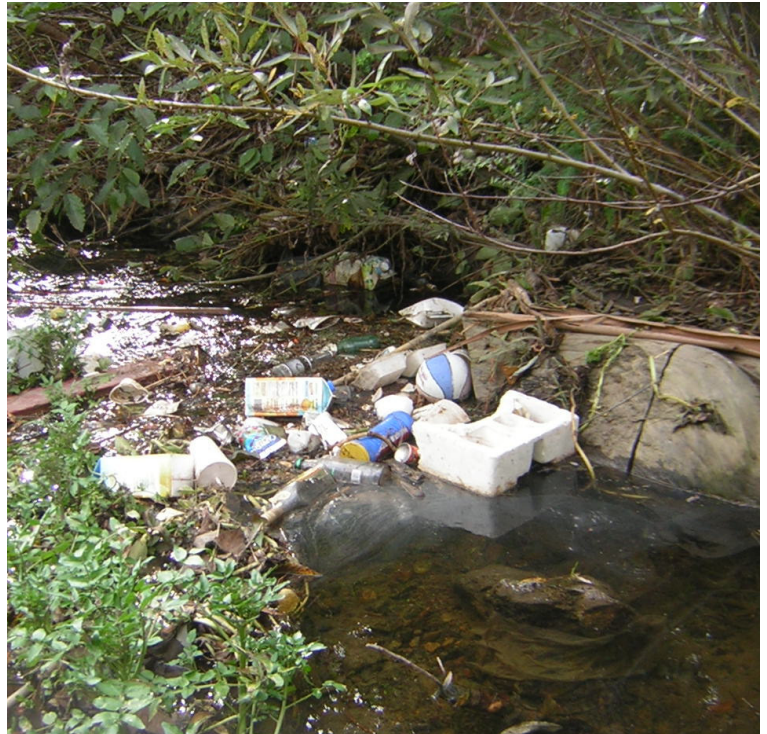
project's purpose and features to the community. The abundant vegetation alongside and in the channel is serving as an informal trash filter (Photos 17-19), and the situation is not only unaesthetic, but also has the potential to seriously degrade water quality by trapping toxic chemicals.

Photos 17-19: Aquatic vegetation is serving as an informal trash filter.

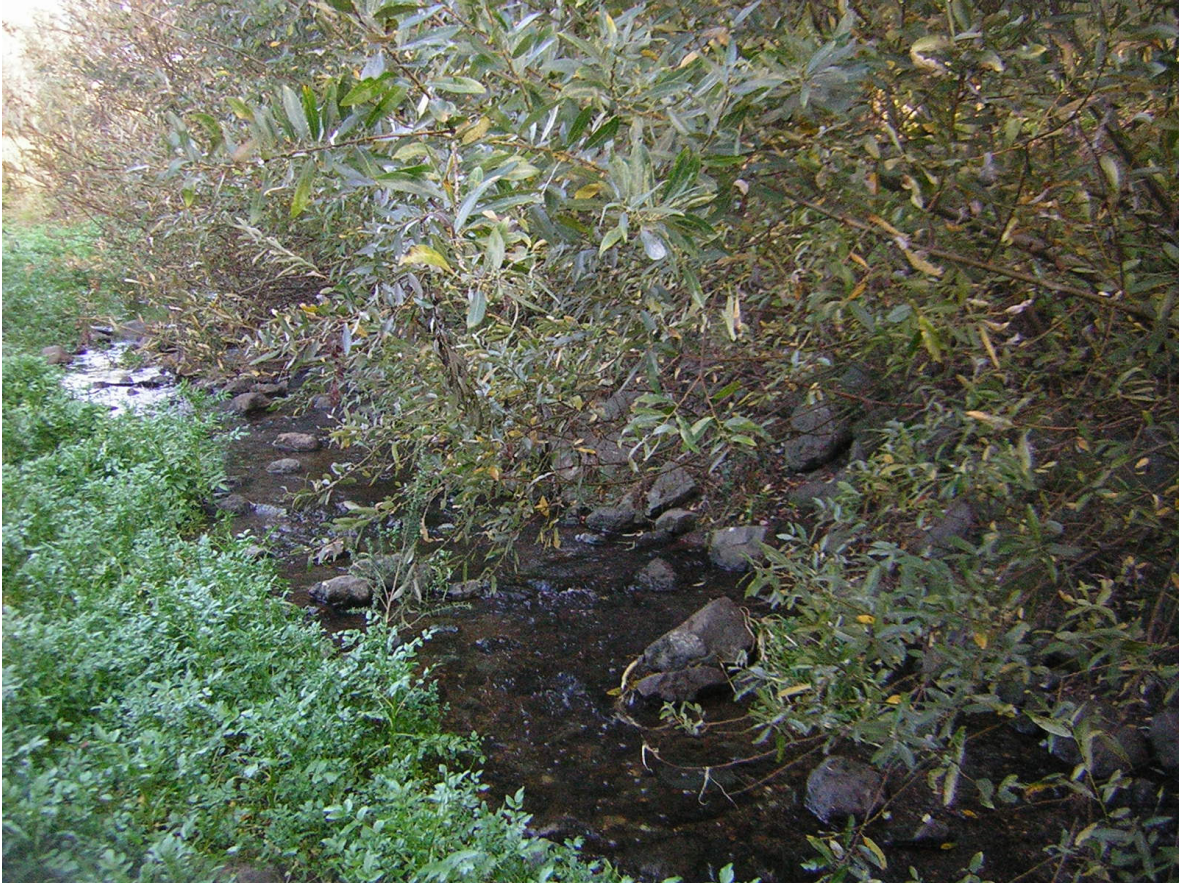
During construction, excavators discovered a concrete apron below the existing channelized streambed. In response to this discovery, vortex weirs ("rock riffles") were quickly designed and added in two locations (WRI, 2001a). The first weir was installed upstream of the amphitheatre bend, and the second about 100 feet upstream of the downstream culvert. Remnants of the second weir were evident at the site (see Photo 20), but the first weir seems to have been broken apart or covered by finer sediment and vegetation. The partial loss of the first weir may be another factor contributing to the erosion at Meander #2.

Photo 20: The last 100 feet of the site contains a long, continuous riffle. The vortex weir that was installed near this location here may be buried, or it may have broken up. We observed a number of appropriately sized rocks, but not in a vortex weir shape.

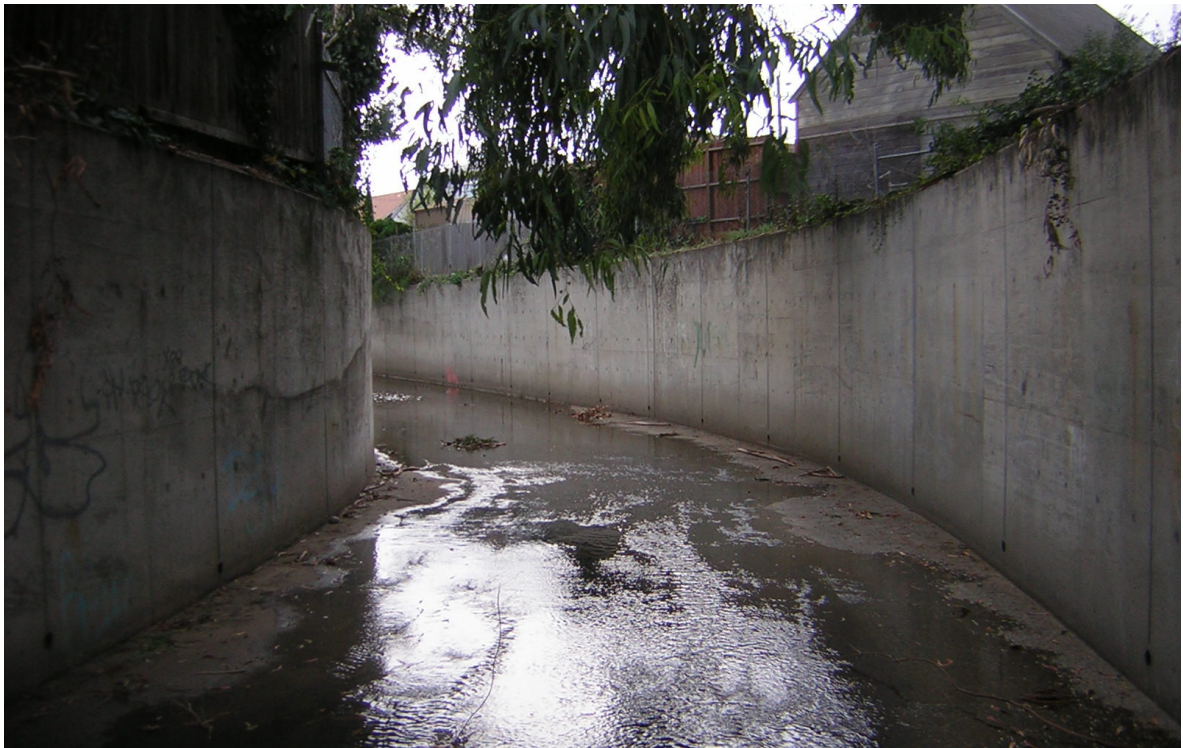
Photo 21: Downstream of the project reach, Arroyo Viejo creek is channelized and devoid of vegetation.

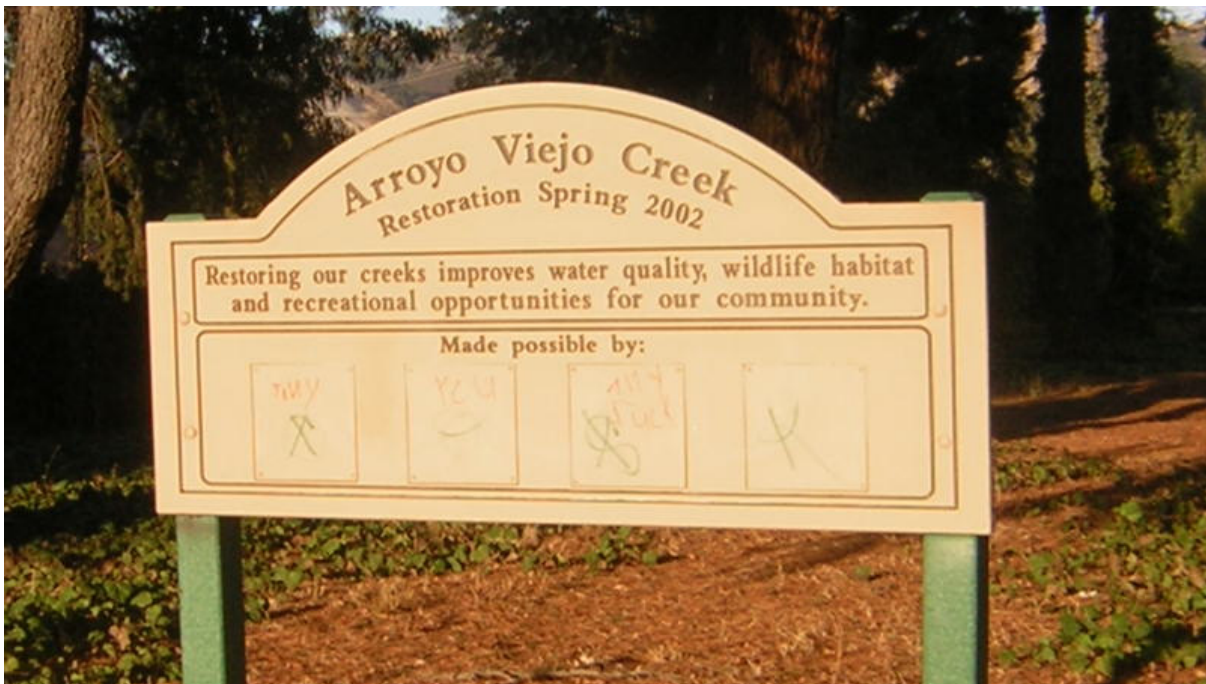
Photo 23: This is the only informational sign about the project on the site.

The final project objective concerns recreational amenities. The results of this project objective have been mixed. The community uses the site; we observed children and pets playing in the creek and families using the trails and pedestrian bridges. However, the signage that was envisioned in project planning documents is not present, as shown in Photo 23. As a result, the site may give the impression of having “gone wild” and being in urgent need of maintenance. Permanent signage would help explain the
