An investigation of the Therac-25 accidents

## An Investigation of the Therac-25 Accidents

Nancy G. Leveson  
Clark S. Turner

UCI Technical Report # 92-108  
(University of Washington TR # 92-11-05)

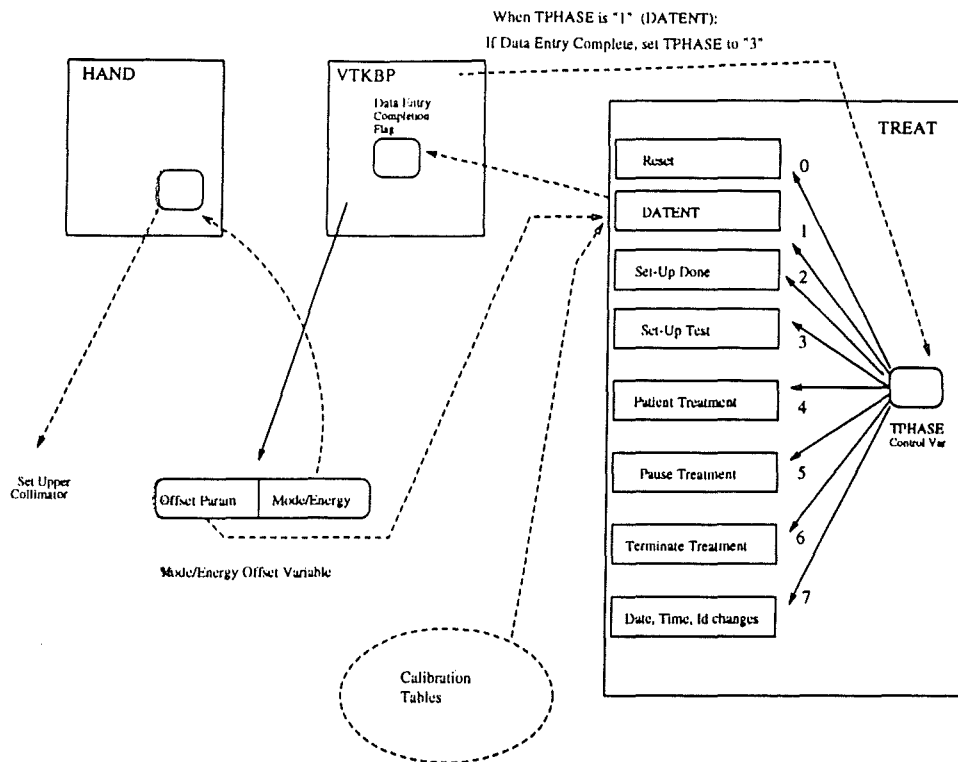
The command line at the lower right-hand corner of the screen is the cursor's normal position when the operator has completed all of the necessary changes to the prescription. Editing of the prescription is signified by movement of the cursor off of the command line.

As the program was originally designed, the data entry completion variable by itself is not sufficient since it does not ensure that the cursor is located on the command line and under the right circumstances the data entry phase can be exited before all edit changes are made on the screen.

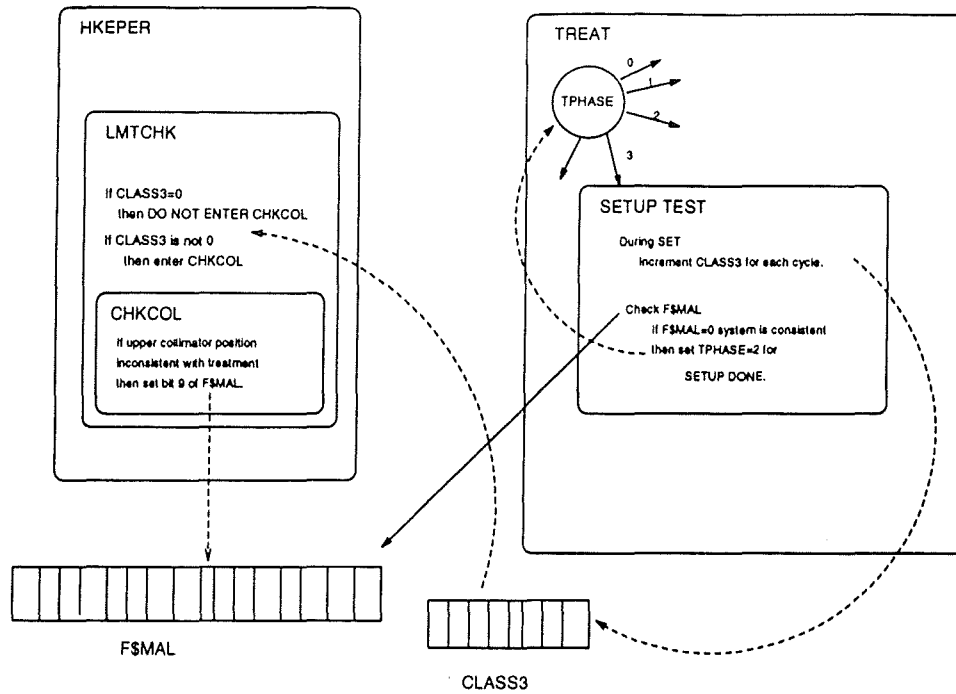
Yakima Software Flaw.

The second Yakima accident was again attributed to a type of race condition in the software — this one allowed the device to be activated in an error setting (a “failure” of a software interlock). The Tyler accidents were related to problems in the data entry routines that allowed the code to proceed to SETUP TEST before the full prescription had been entered and acted upon. The Yakima accident involves problems encountered later in the logic after the treatment monitor TREAT reaches SETUP TEST.

The overexposure occurred when the operator hit the "set" button at the precise moment that CLASS3 rolled over to zero. Thus CHKCOL was not executed and F\$MAL was not set to indicate the upper collimator was still in field light position. The software turned on the full 25 MeV without the target in place and without scanning. A highly concentrated electron beam resulted, which was scattered and deflected by the stainless steel mirror that was in the path.

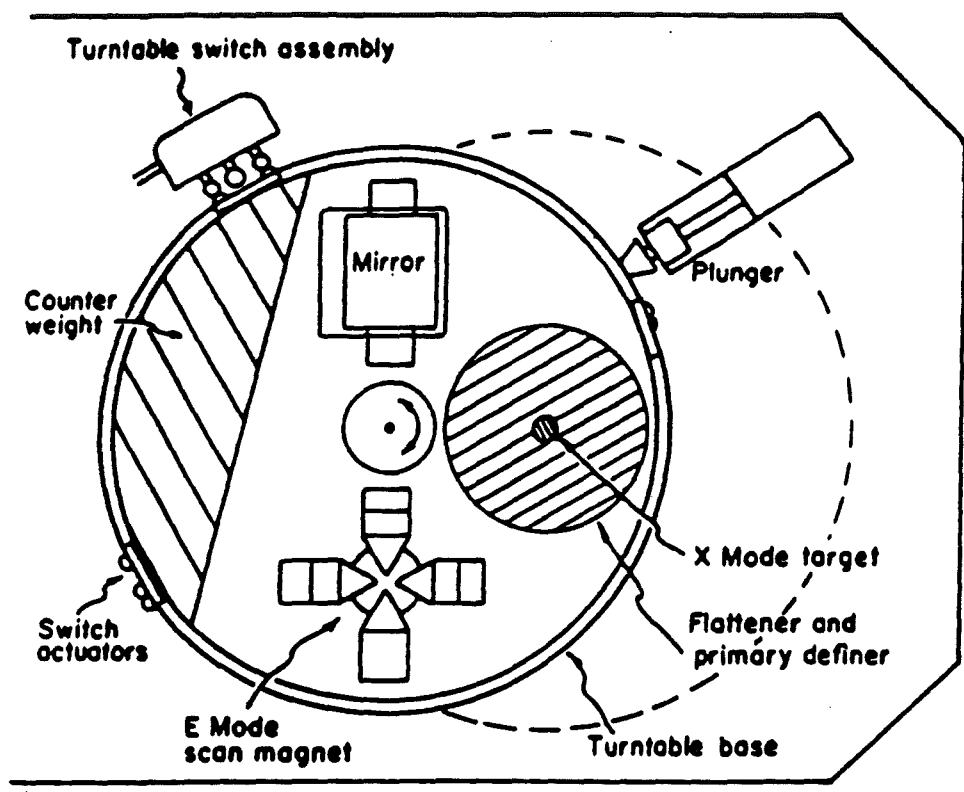
Figure A

No accelerator beam is expected in the field light position. A stainless steel mirror is placed in the beam path and a light simulates the beam. This allows the operator to see precisely where the beam will strike the patient so that necessary adjustments can be made before treatment starts. There is no ion chamber in place at this turntable position, since no beam is expected.
