Assessment of Channel Changes Three Years after Implementation of the Salmon Habitat Enhancement, Phase 1 on Redwood Creek at Muir Woods

Kondolf, Landscape Architecture 227
University of California, Berkeley
Fall 2022

Mariolina Nicolina Papa, Sergio Jimenez,
and Ruby Telfer

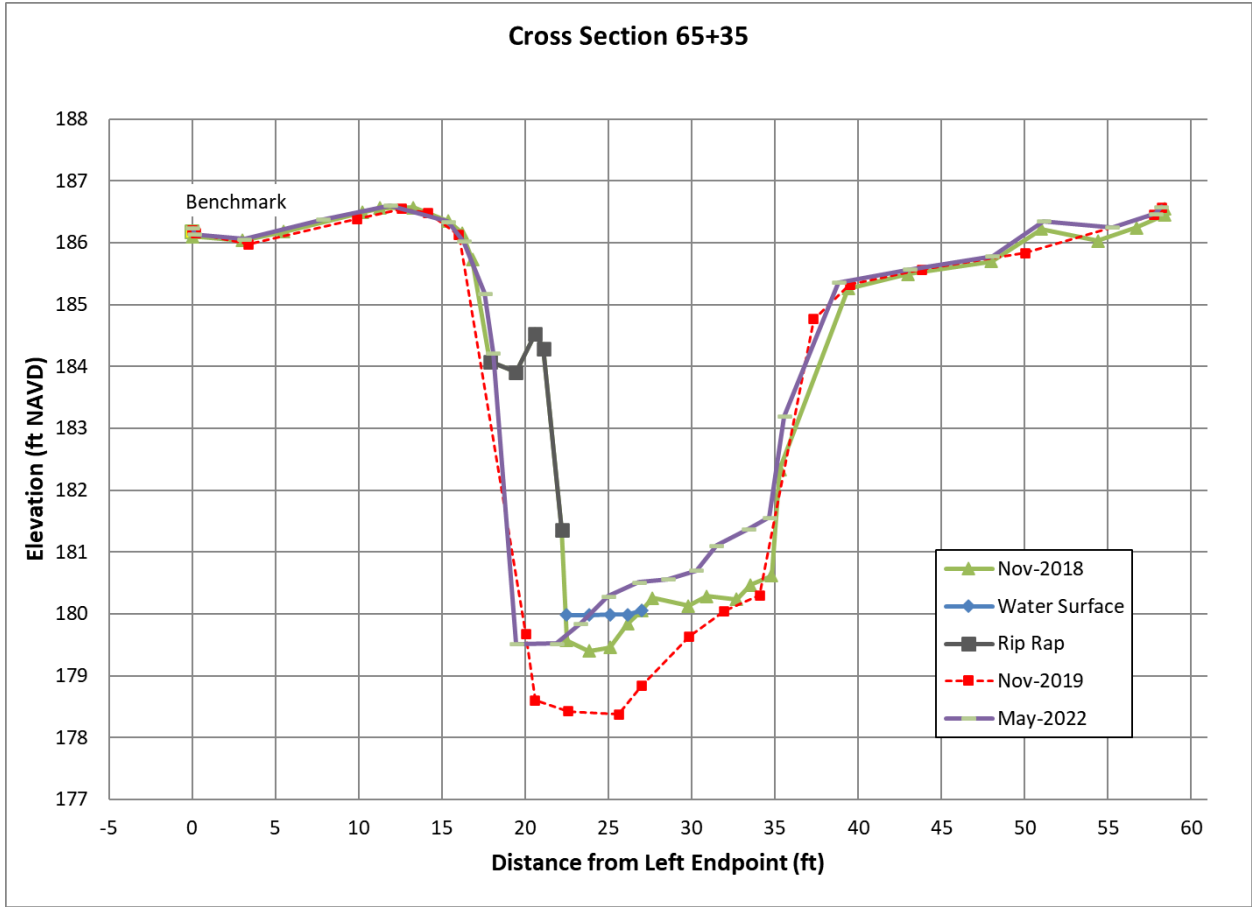
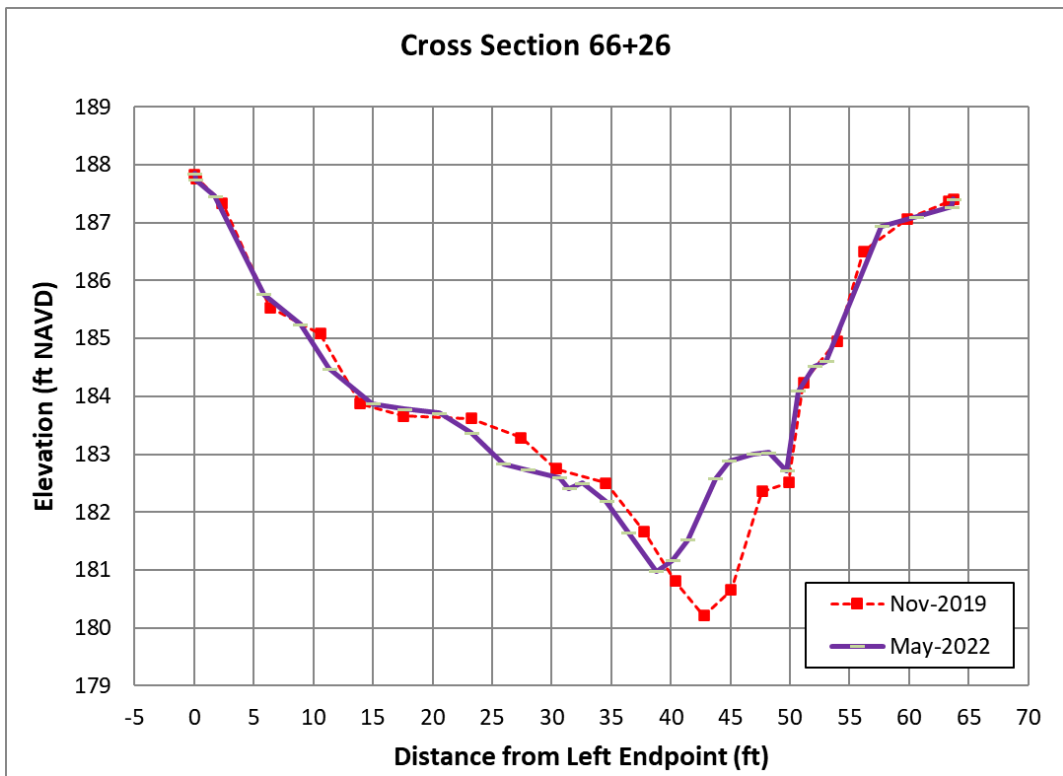
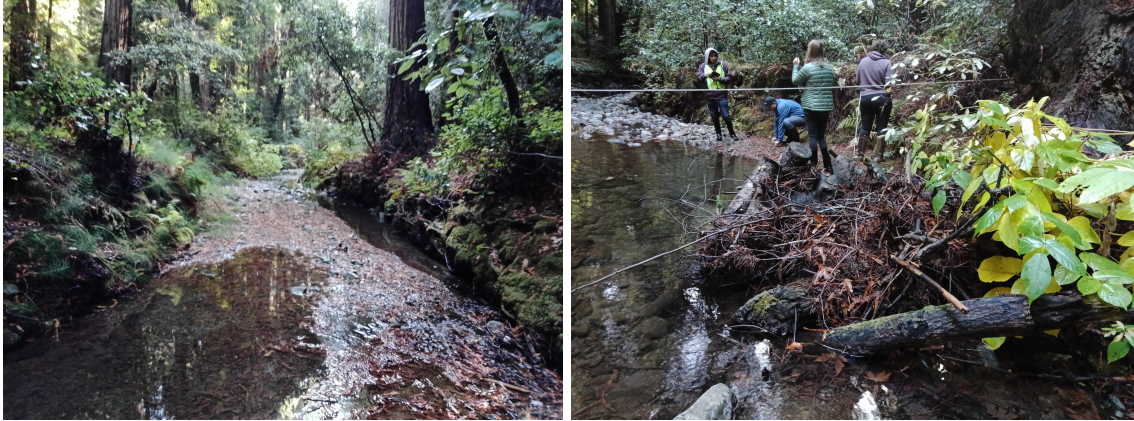
Figure 4. Cross section data for XS 66+26 (top) and 65+35 (bottom). Bottom left, picture of the pools downstream reach 65+35 (downstream view). Bottom right, LWD upstream XS 66+26 (downstream view).

The LWD7 (Figure 3) consists of placed large and small wood adjacent to the right bank. A pool excavated 2-feet deep in 2019 downstream of LWD7 has been partly filled by about one foot, as shown in XS 66+26. In the right side of XS 66+26 there is a deposit lens with maximum thickness of around 2 ft; we observed that this deposit is made up of very fine sandy sediments. Between project stations 6500-6550 ft, where riprap L13 was removed, a pool or lowered thalweg graded in 2019 is almost completely filled in, but a new pool has formed a little further downstream. Deposition has occurred on the right bank of XS 65+35 such that the channel bed on the right aggraded more than a foot compared to the pre-project condition (Figure 4). We observed at XS 65+35 that the wet channel is in contact with the left bank, which is undercut. Downstream there is a pool about 12 ft long and 7 ft wide, a little further downstream the wet channel is in contact with the right bank and has undercut the bank there as well (Figure 4). After riprap removal the wet channel tends to undercut the banks alternately in the right and left banks. This could be interpreted as a trend to recreate a more sinuous course over time.

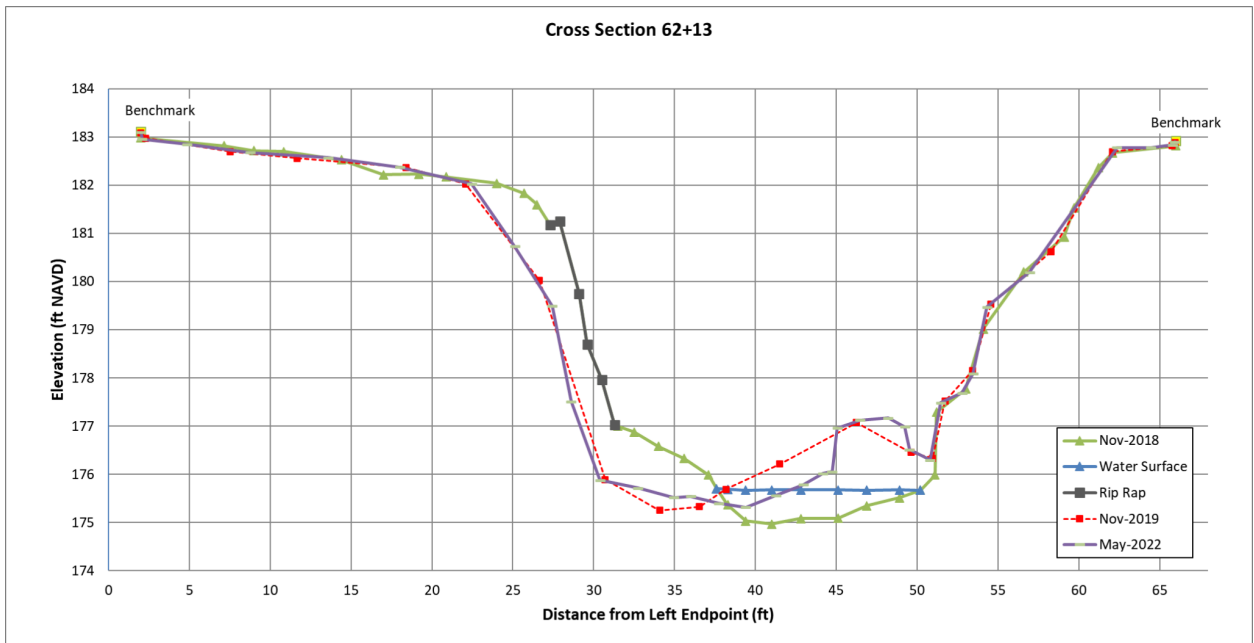
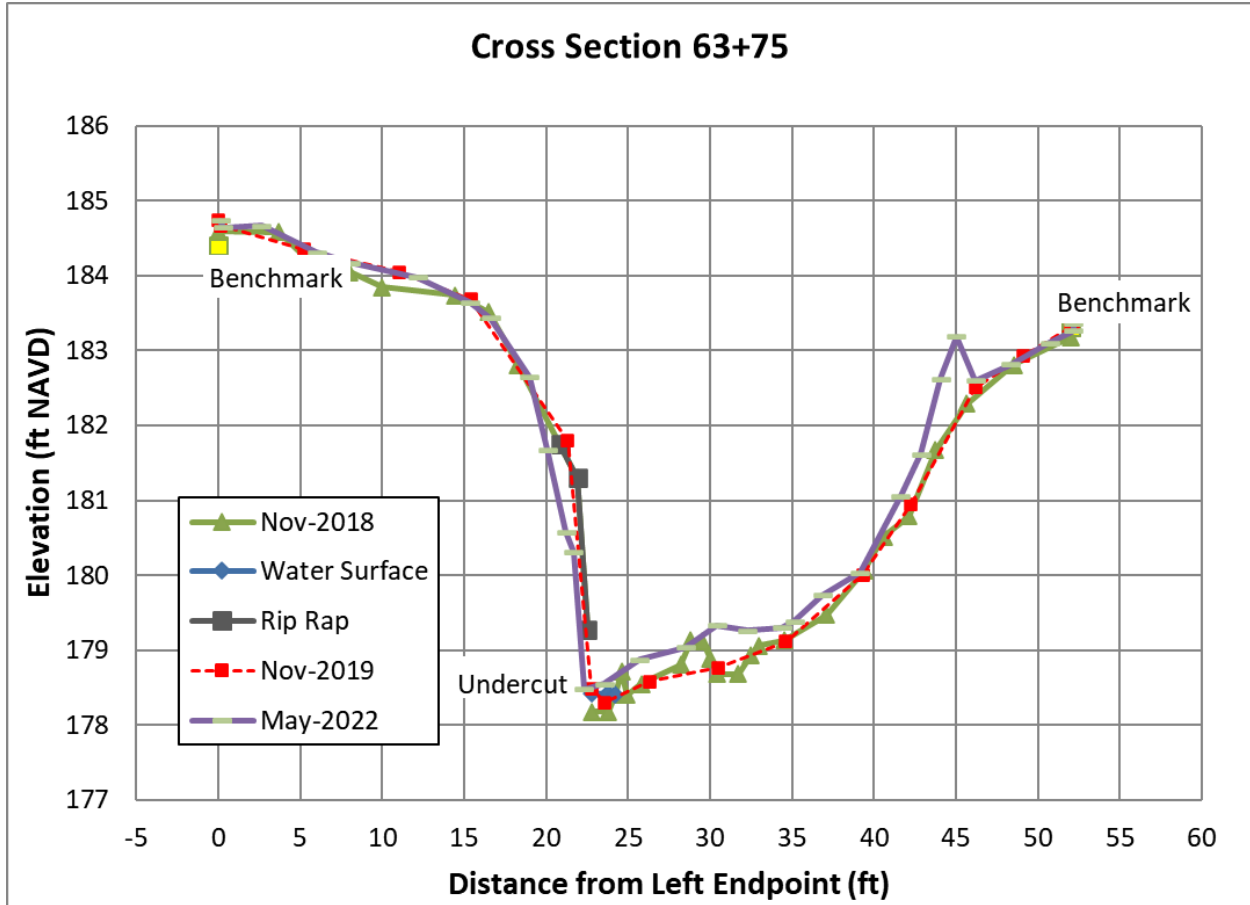
Figure 6. Cross section data for XS 62+13 (top) and XS 63+75 (bottom)

The thalweg profile of project stations 6100-6450 ft (Figure 5) shows little change between the 2019 as-built channel bed elevations and the current condition. The left bank is undercut in the area of XS 63+75. Some of the logs of LWD6 are held in place by vertical pin logs. Sediment deposition occurred at project station 6350 ft, whereas the pool deepened and lengthened downstream LDW6 where there is also a tributary confluence with Fern Creek (Figure A4 in Appendix). The left bank eroded in this area since 2019. However, further downstream the left bank where the L12 riprap was removed is protected by an unaffected erosion control fabric. Interestingly, unlike the section where L13 was removed (Figure 3), the NPS did not excavate a pool or place LWD at L12 during the project work. In this case, the process of alternating right and left bank under-excavation did not occur.

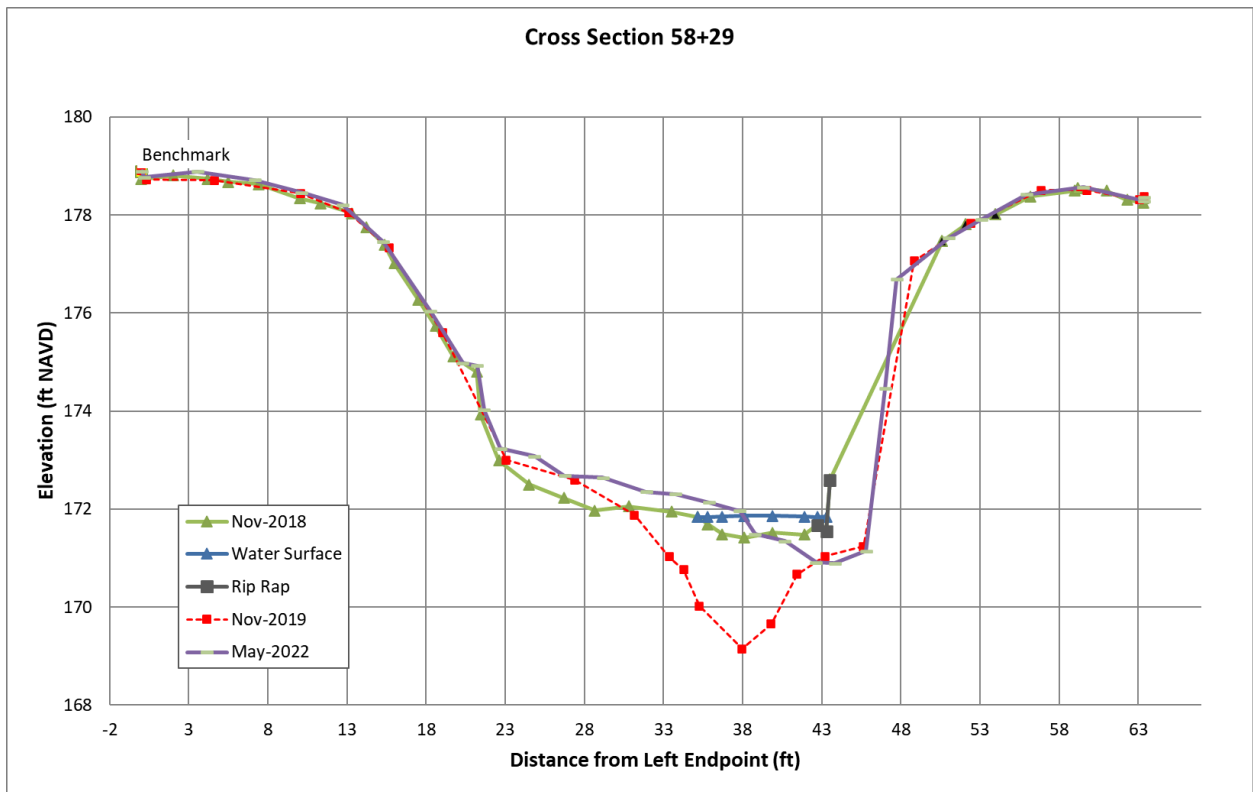
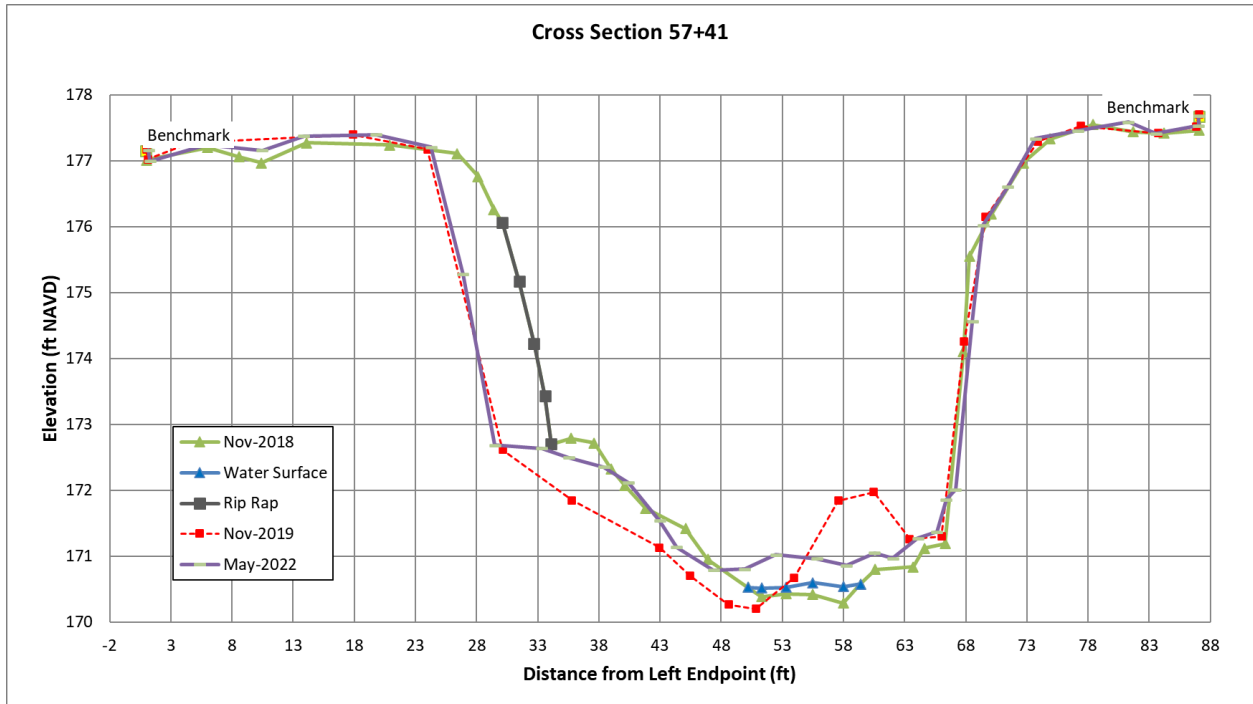
Figure 8. Cross section data for XS 58+29 (top) and 57+41 (bottom)

In Figure 7, the right bank from which riprap R8 was removed (between stations 5900 and 5850 ft) has maintained the same shape since 2019, but it is now undercut. Only two of the four placed logs in the LWD5 constructed log jam remain. The two remaining logs are oriented in the flow direction and the cross section no longer has logs that span the channel (Figure A22 in Appendix A). The 2019 excavation at approximately station 5800 ft filled in and the bed of XS 58+29 regraded to 2018 elevations, except along the toe of the right bank, where a lateral pool occurs (Figure 8). With XS 57+41 showing deposition on the left and erosion of the upstream end of a constructed bar on the right, the bed at this location has returned to conditions similar to pre-intervention conditions. The left bank where the L10 riprap was removed is protected by the erosion control fabric, with a portion of the left bank cut at the toe (Figure A23). However, further downstream at XS 56+97, erosion of about 1 ft has occurred at the toe of the left bank where the erosion control fabric is also torn (Figure 9). The top of the bar (downstream of station 5700 ft) has also lowered by about 0.3 ft. The LWD4 is maintained in place by vertical pin logs. The longitudinal profile shows that the pool excavated in 2019 (station 5650 ft) at LWD4 filled up, but a new one has formed downstream (approx. station 5625 ft) along the toe of the left bank. This pool formed at the endpoint of the LWD4 logs and includes an undercut left bank (Figure 10).

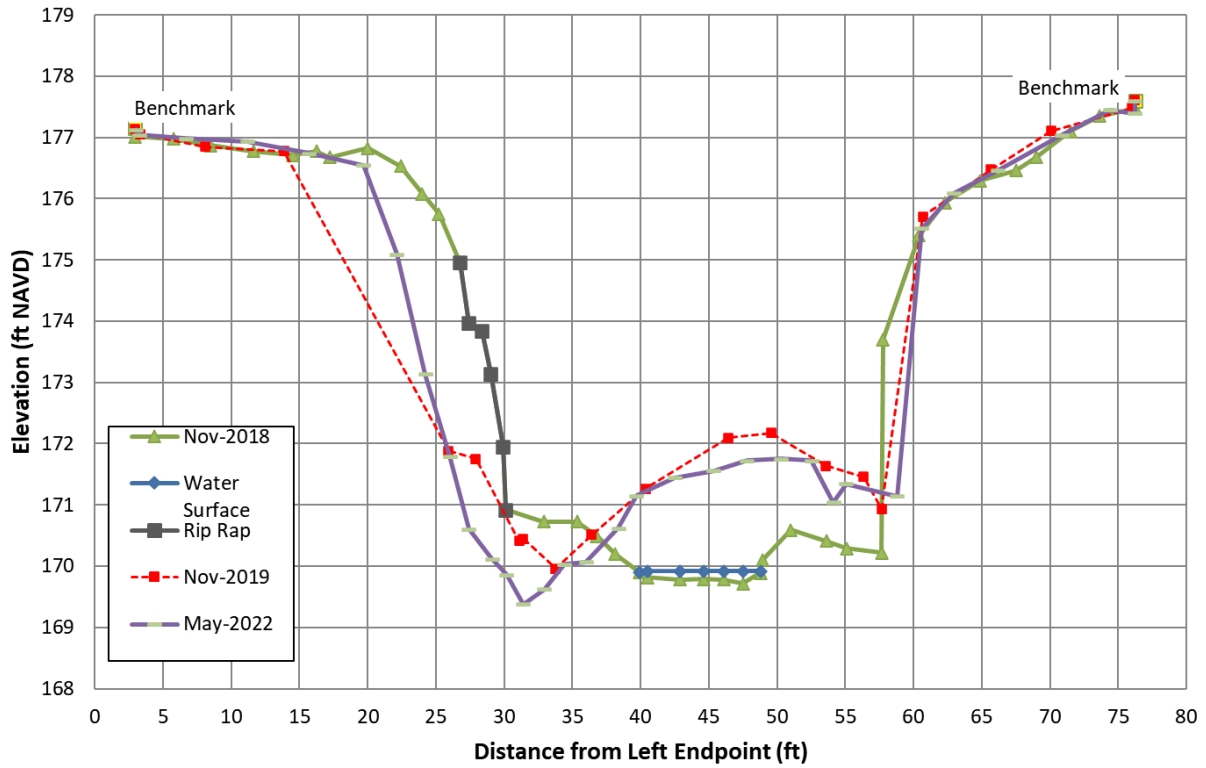
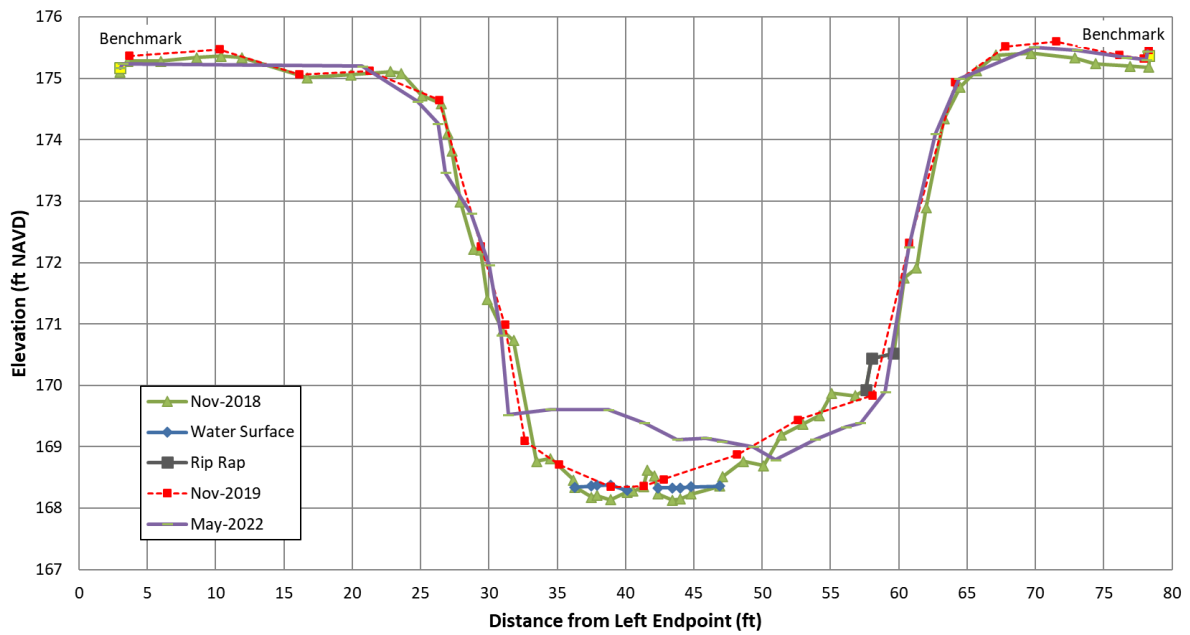
Figure 9. Cross section data for XS 56+97 (top) and 55+75 (bottom)

At XS 55+75 (Figure 9), sediment deposition occurred from the left bank's toe to 20 feet into the channel; then half a foot of erosion occurred near the toe of the right bank, where riprap R7 was removed. Some logs of the LWD3 were washed downstream, with one particularly long log remaining crosswise, likely stuck due to its length and the presence of a bend in the river (Figure 11). Here the pool dug in 2019 has expanded (station 5500 ft) and a second one formed further downstream (approx. station 5475 ft).

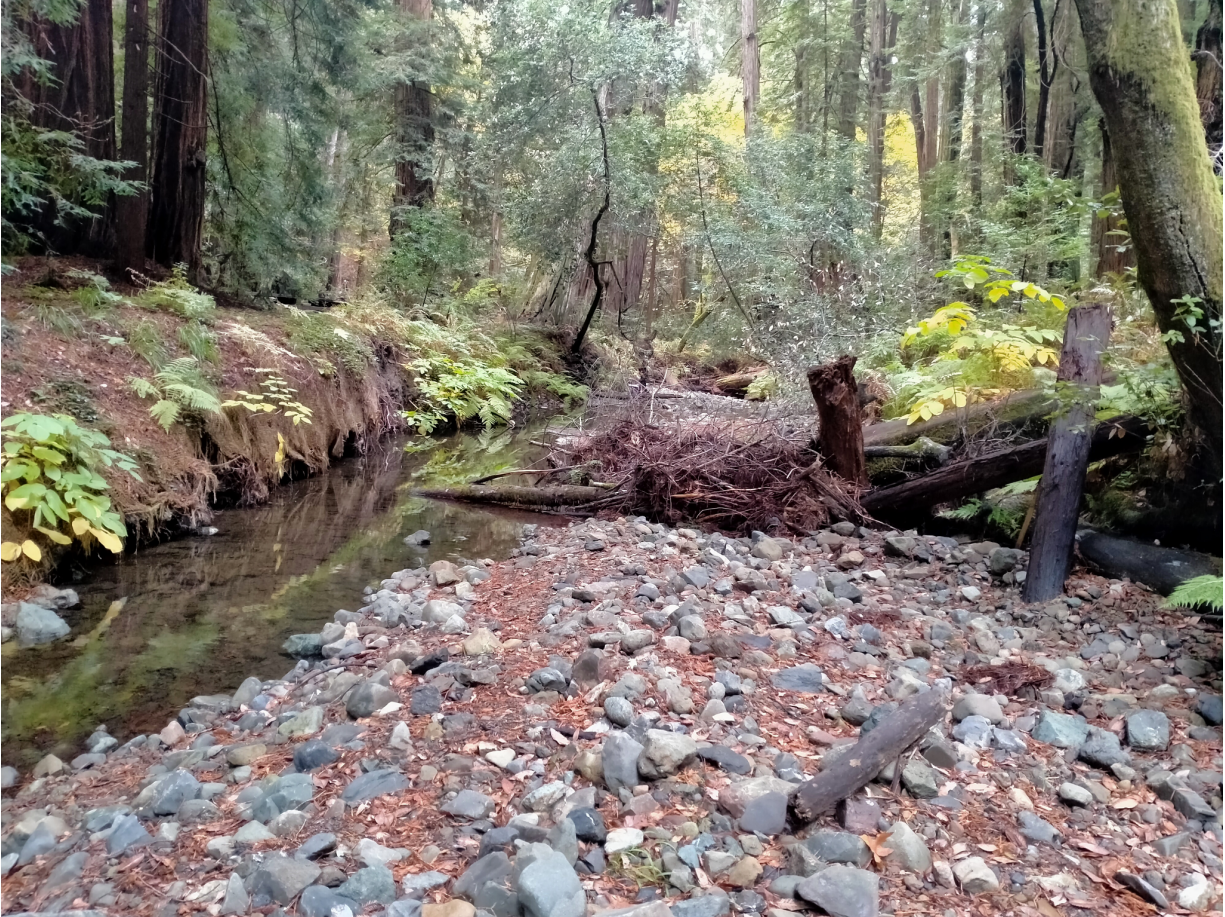
Figure 10. Downstream view of the river approximately at station 5650 ft with LWD4 on the right and undercut bank on the left in the place where riprap L10 was removed.

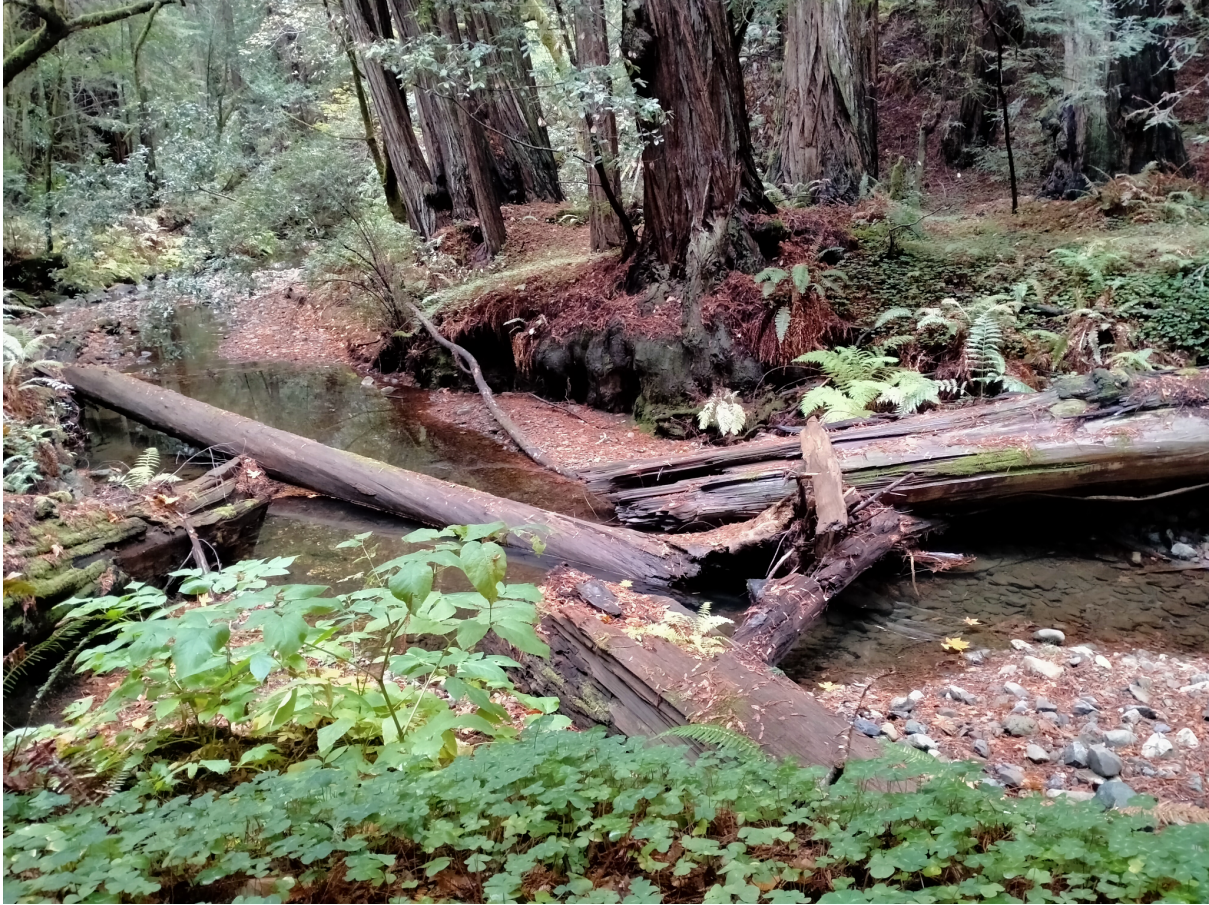
Figure 11. Downstream view approximately at station 5500 ft with one of the logs of LWD3 stuck against the left bank.

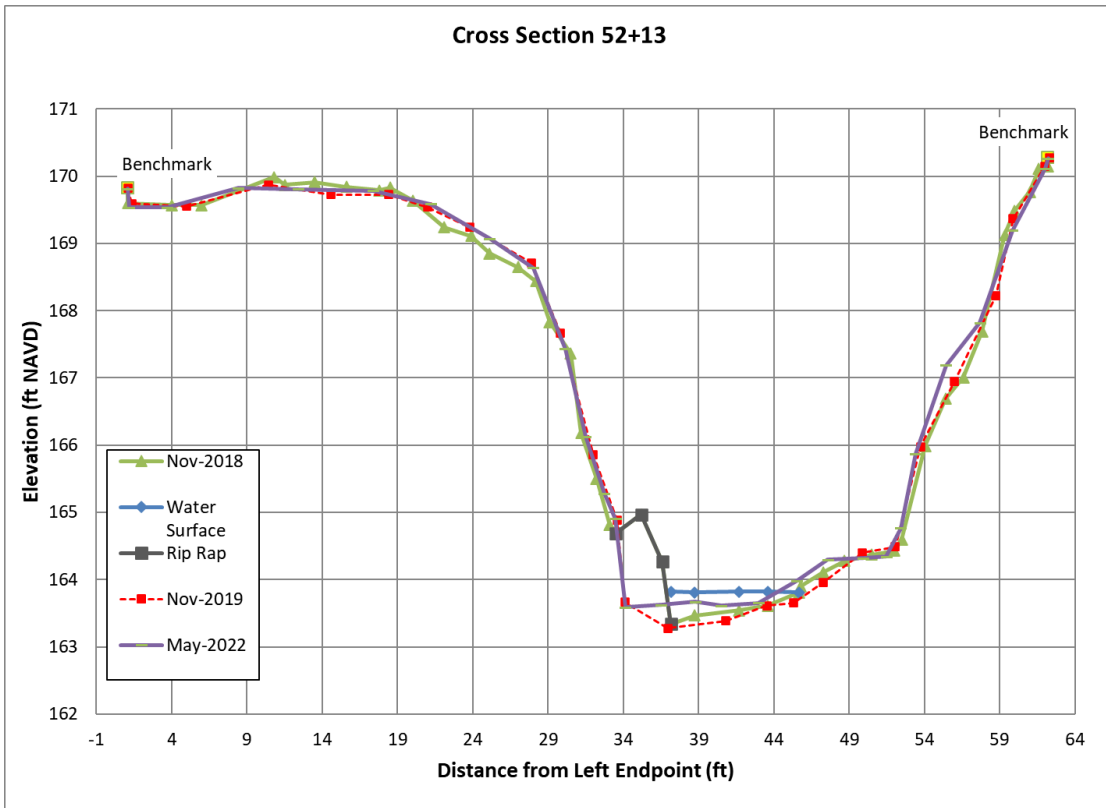
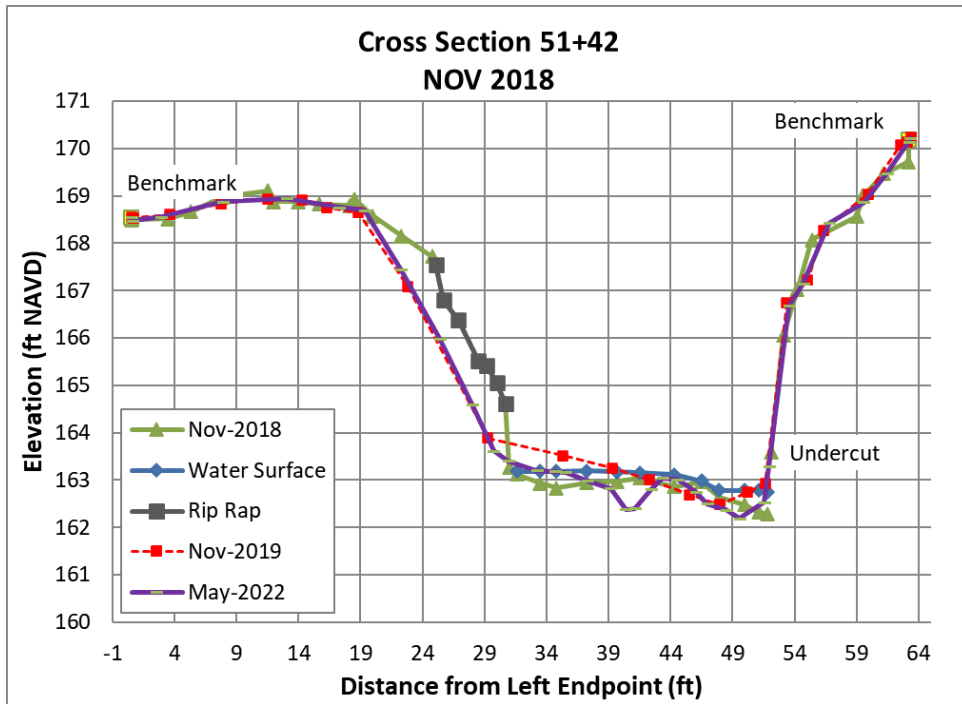
Figure 13. Cross section data for XS 52+13 (top) and 51+42 (bottom)

In Figure 12, the section in the Cathedral Grove reach where the riprap L7 was removed (between project stations 5250 and 5100 ft) has slight bed aggradation. However, an area of minor bed scour is observed in the central part of XS 51+42. The logs in LWD2, which were not secured in place with pin logs, have either washed downstream or washed to the toe of the left bank. At station 5050 ft, a sediment deposit has filled the pool that was constructed under the logs of LWD2 in 2019. There is a little aggradation of the riverbed between stations 5050 and 5000 ft. The LWD1 log jam remained in place, due to a long redwood log that spans the channel. Its ability to trap wood had been augmented by some placed pieces under the spanner in 2019; many of those pieces moved but are still part of a log jam at that location. Some of the dislodged upstream logs accumulated in this section. This large log jam also retained many small branches (small woody debris). At approximately station 4975 upstream of LWD1, a small pool constructed in 2019 has deepened, widened and expanded laterally upstream. The XS

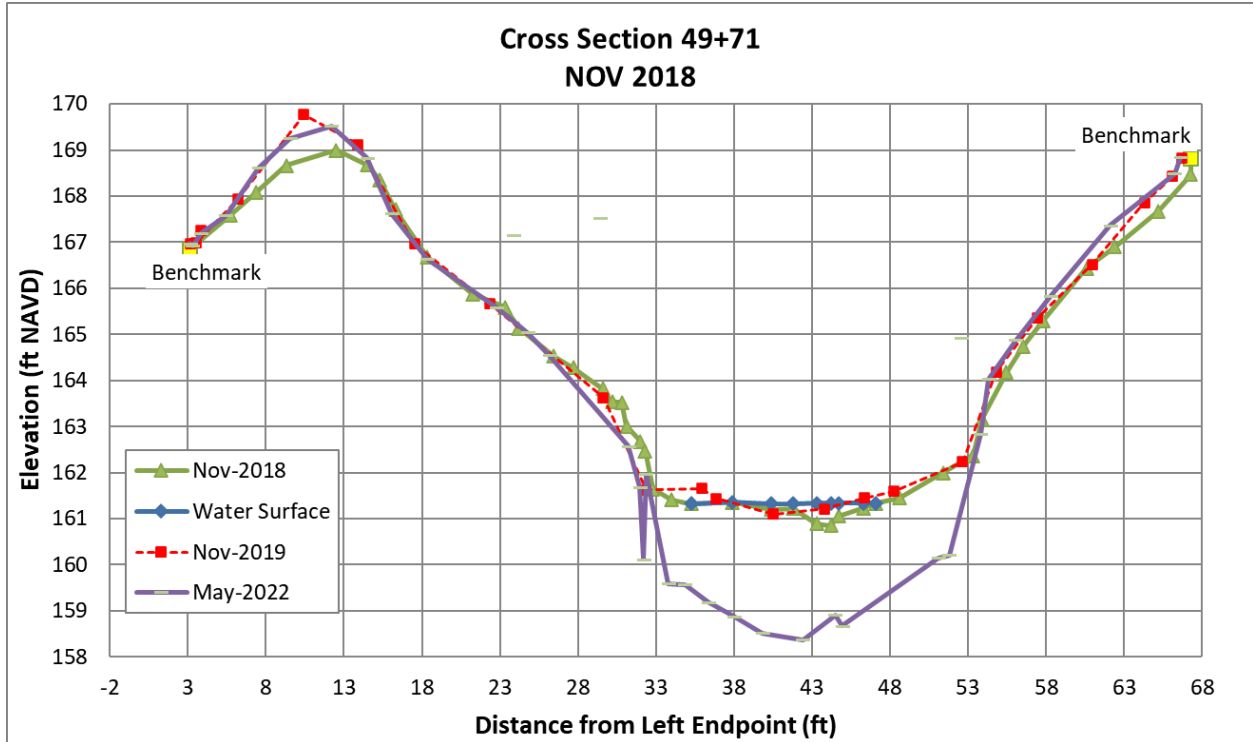
Figure 14. Cross section data for XS 49+71

49+71 in Figure 14 shows erosion along the entire cross section with maximum depth of scour in the center of about 2.5 ft. (Pools would be deeper when water surface elevation is included). Downstream of the log jam, where no project actions were conducted, the riverbed retains the simplified channel bed of the pre-project conditions.

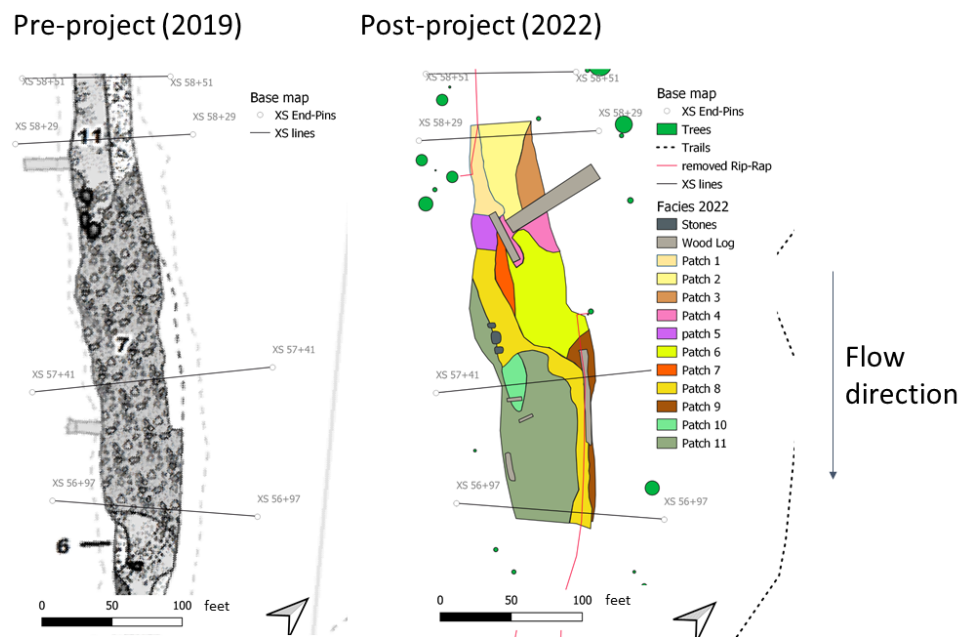
Figure 15. Pre-project facies map between XS 58+29 and XS 56+97 from the 2019 survey, from the NPS (2020), on the left, with annotations. Facies map from the 2022 survey, on the right.

Figure 7 shows the longitudinal profile in this area, Figure 8 shows the XS 58+29 profile and Figure 9 shows XS 56+97. The facies map (Figure 16) shows patches 1, 5, and 8 are within the wetted channel. The pre-project configuration is reported in Figure 16. We identified a higher number of patches with a unique assemblage of grain sizes in the recent survey than in the pre-project condition. This reflects a higher complexity of the riverbed morphology and more diverse array of grain sizes.

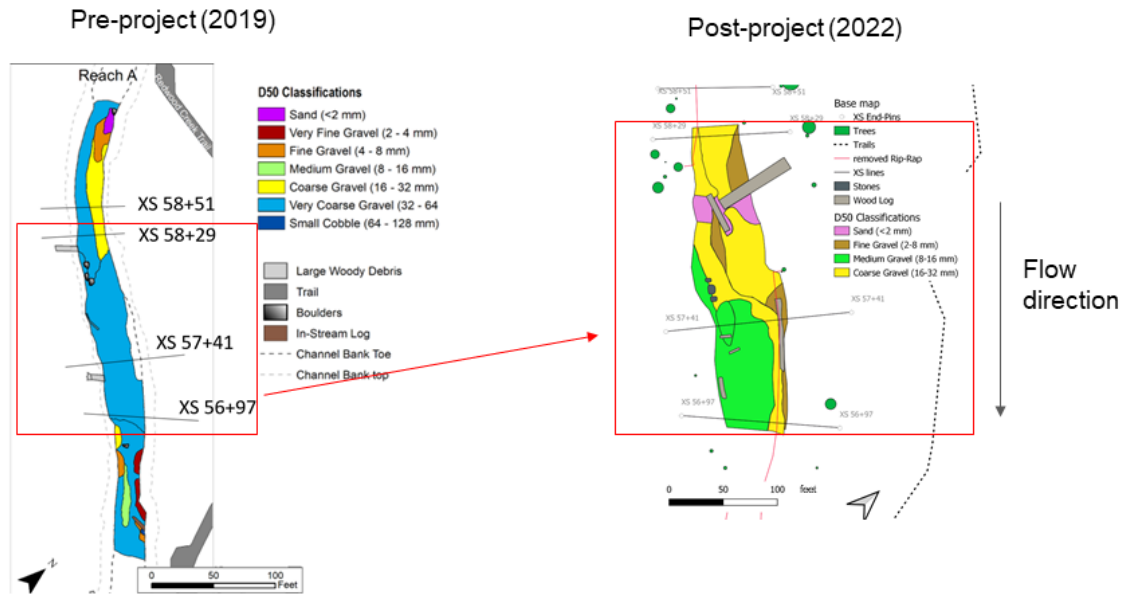
Figure 16. Comparison between D_{50} grain size map of the 2022 survey we completed and of the previous 2019 survey, adapted from Shoulders and Adams (2020)

On the map of Figure 16, the patches with the same D_{50} were grouped into a single unit. We used the same classes of D_{50} used in the pre-project analysis: sand (< 2 mm), very fine gravel (2-4 mm), fine gravel (4-8 mm), medium gravel (8-16 mm), coarse gravel (16-32 mm), and very coarse gravel (32-64 mm). Patches 4 and 5 had grain sizes that were too small to perform pebble counts, so we mapped these patches as sand.

We mapped four classes of D_{50} in the subreach we surveyed. In the pre-project condition, there were only two classes and the sediments were generally coarser than the pre-project patches. In particular, we can see the onset of areas of sand and fine gravel close to the LWD. Areas formerly with very coarse class sediments now have finer sediments, and the very coarse class is no longer present.

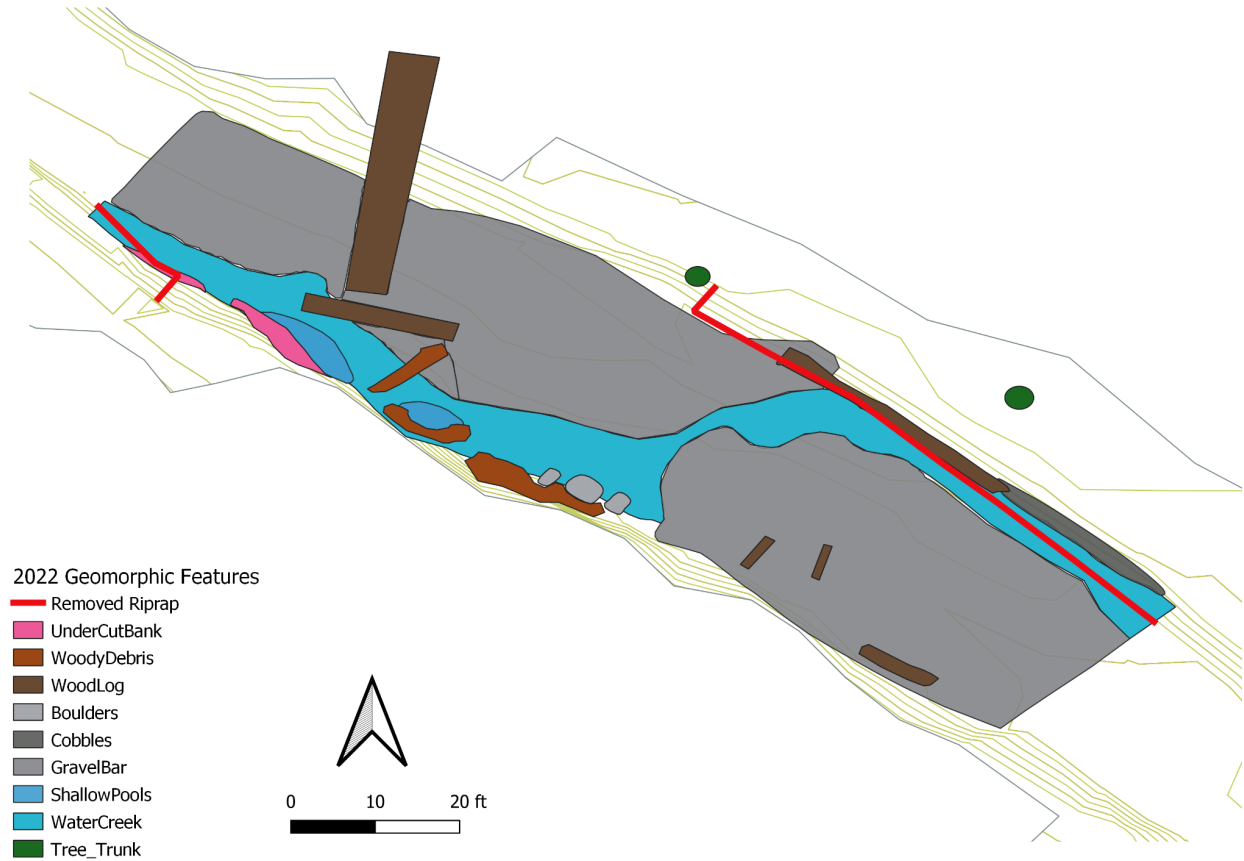
Figure 18. 2022 Geomorphic Features

Figure 18 illustrates the geomorphic map of Redwood Creek from XS 58+51 to XS 56+97. The 2022 geomorphic map of the reach contains two shallow pools, several logs, significant undercut banks on the right downstream side, large gravel beds, some small woody debris and a low flow channel meandering from the right bank to the left. At some points, the undercut bank reached more than 30 cm deep, and provided protected habitat with the shallow pool beneath it. The small woody debris (SWD) downstream of the logs also creates a shallow pool habitat. The

position of the LWD compared to as-builts of the LWD shows the creek flows pushed the logs downstream.

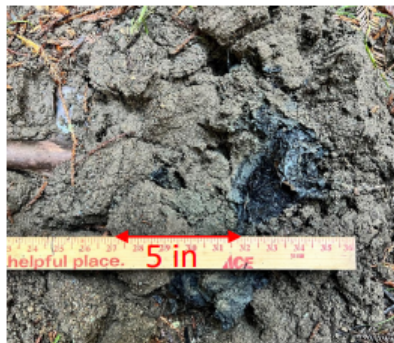
Fig. A1.5: Underlying deposit

NOTES: there is a woody sediment stack in the hydraulic right immediately upstream of the section. Behind the stack is a lens of deposit with a maximum thickness of about 2 ft. The deposit has very fine sediments at the surface $D_{50} < 2$ mm (Figure A1.4). The sediments of the underlying layers (Fig. A1.5) show fine clay particles and decaying woody debris.

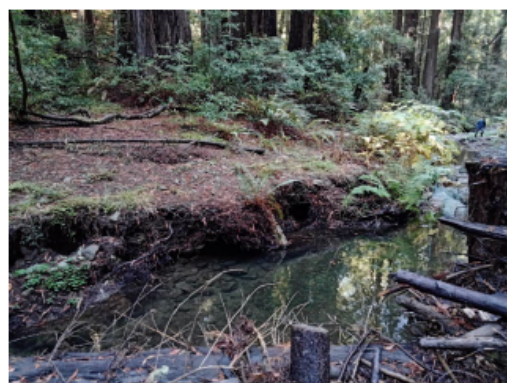
Fig. A4.5: Bank erosion and pool (left side)

NOTES: At the log jam there is the junction of a tributary on the left. Immediately upstream of the log jam, there is a central bar with a lobe of sediment deposits (Fig A4.3). Of the three logs arranged in 2019, the middle one is missing. The logs are blocked by poles and retain branches. On the left downstream of the log there is bank erosion and a deep pool (Fig A4.4 and Fig. A4.5). Downstream there is a grade control structure at the end of which there is a large pool about 1.4 ft deep.

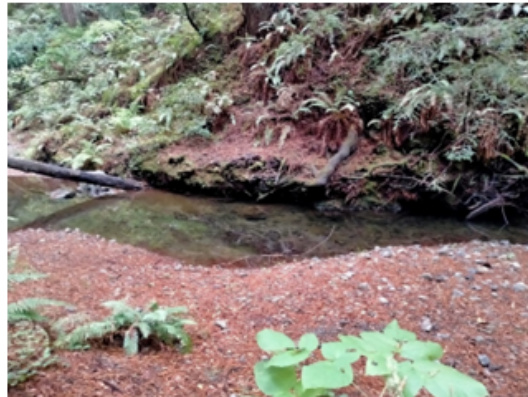
Fig. A11.4: Pool and undercut bank (view toward the right bank)

NOTES: Logs have been moved and oriented in the direction of the flow. Some logs are missing. A pool has formed at the log jam and another further downstream. The right bank is undercut for a long stretch.

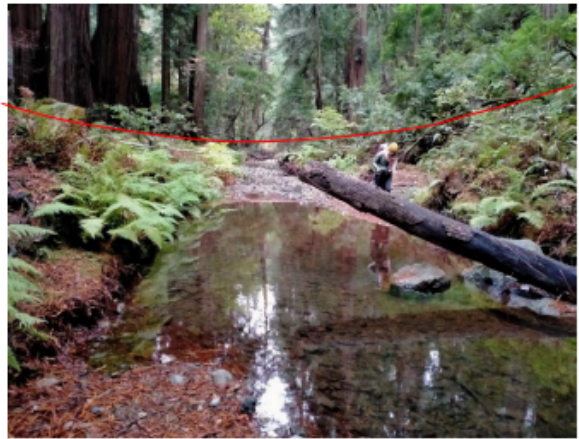
Fig. A12.4: View downstream, post-project

NOTES: There appear to be no significant changes from 2019, other than placement of large woody debris.

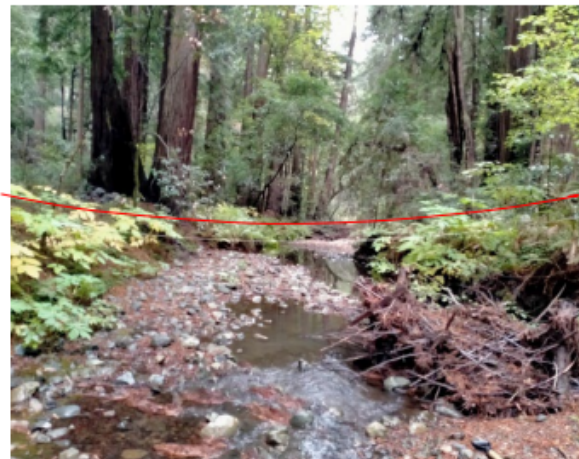
Fig. A13.4: View downstream, post-project

NOTES: The banks have not changed from 2019. The riverbed has slightly lowered (about 0.5 ft). Erosion is more pronounced in the center and on the right side. The right bank is undercut.

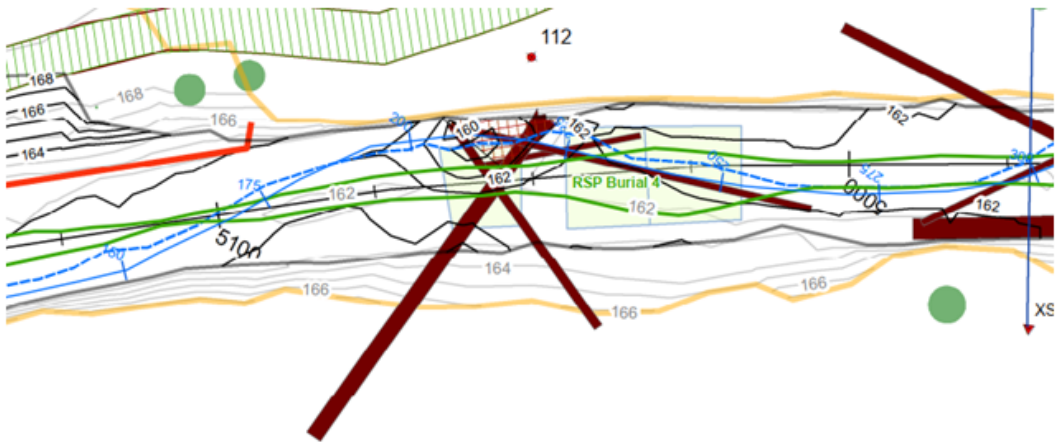
NOTES: Logs have been removed, only one log is left sitting on the toe of the bank. A sediment deposit filled the hole that in 2019 was under the logs

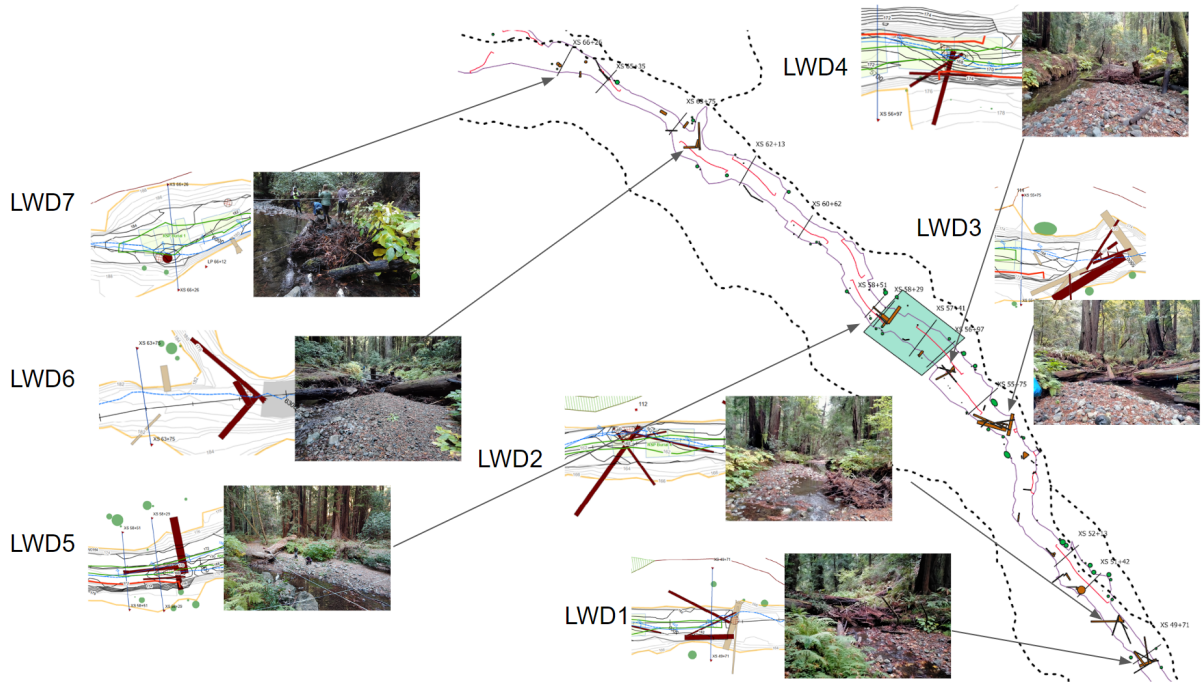
Figure A19. Large Woody Debris Placements

The surveys performed in October and November 2022 found that nearly all existing LWD structures have pools in close proximity that form suitable habitat for the target species (Figure A19). Generally the pools are below the logs if they span the entire channel, or downstream of one end of the log for those not crossing the entire channel. Pools formed below logs (e.g. LWD6 and LWD1) have the advantage of being covered and thus can be particularly useful as refuge habitat. Several logs placed as LWD installed in 2019 which were not pinned in place at the time have been relocated by the peak flow that occurred in 2021. Of the seven LWD structures analyzed, two were secured in place by vertical pin logs, and they remained in place albeit losing a few pieces (LWD6 in Figure A21 and LWD7 in Figure A20). In contrast, two unpinned LWD structures lost several pieces that drifted slightly downstream (LWD5 in Figure A22 and LWD4 in Figure A23). In one case a particularly long log got stuck against a bank

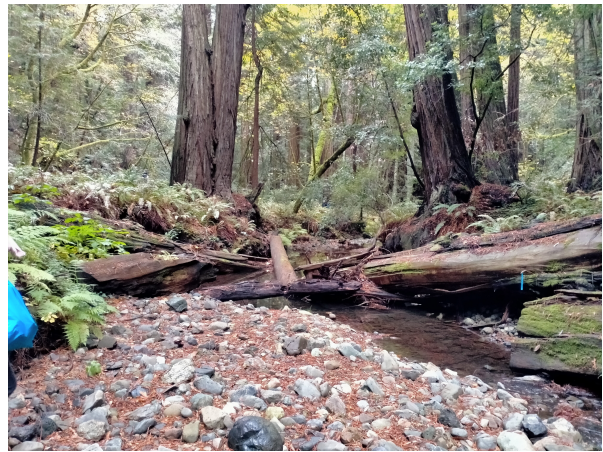
Figure A24. LWD3 as-built (NHE 2019) vs 2022 photo

(LWD3 in Figure A24), while another case saw all the logs dragged away (LWD2 in Figure A25). Finally, just upstream of Bridge 3, where a naturally occurring redwood log spans the channel from bank top to bank top but does not touch the channel bed, wood had been added in 2019 to increase the trapping ability of the log structure. In the October 2021 event, this structure (LWD1 in Figure A26) trapped both large and small diameter logs that had been placed upstream, forming a mechanism for bed scour with substantial cover. The last case is probably a natural condition for rivers flowing through redwood forests under undisturbed conditions as observed, for example, in some sections of Redwood National Park. The observed log mobility seems to align with the findings from Gurnell et al. (2002). The displacement of the LWD logs raises the question of the durability of the project. In the case of LWD being completely removed (e.g. LWD2), the pool was filled up and the bed had regained its pre-project shape. In the case of log rearrangement, the pools migrated downstream with the log end points (e.g. LWD5 and LWD4). Therefore, local shifts are not a problem while complete removal may result in reduced effectiveness of the restoration in a particular subreach. However, the mobilized woody debris may improve channel conditions in a new location downstream, thus still meeting the NPS goal of increasing overall channel complexity.
