Parallel passageways: An assessment of salmon migration in the San Gregorio watershed

**PARALLEL PASSAGEWAYS: AN ASSESSMENT OF SALMON MIGRATION
IN THE SAN GREGORIO WATERSHED
FINAL DRAFT**

Chris Alford

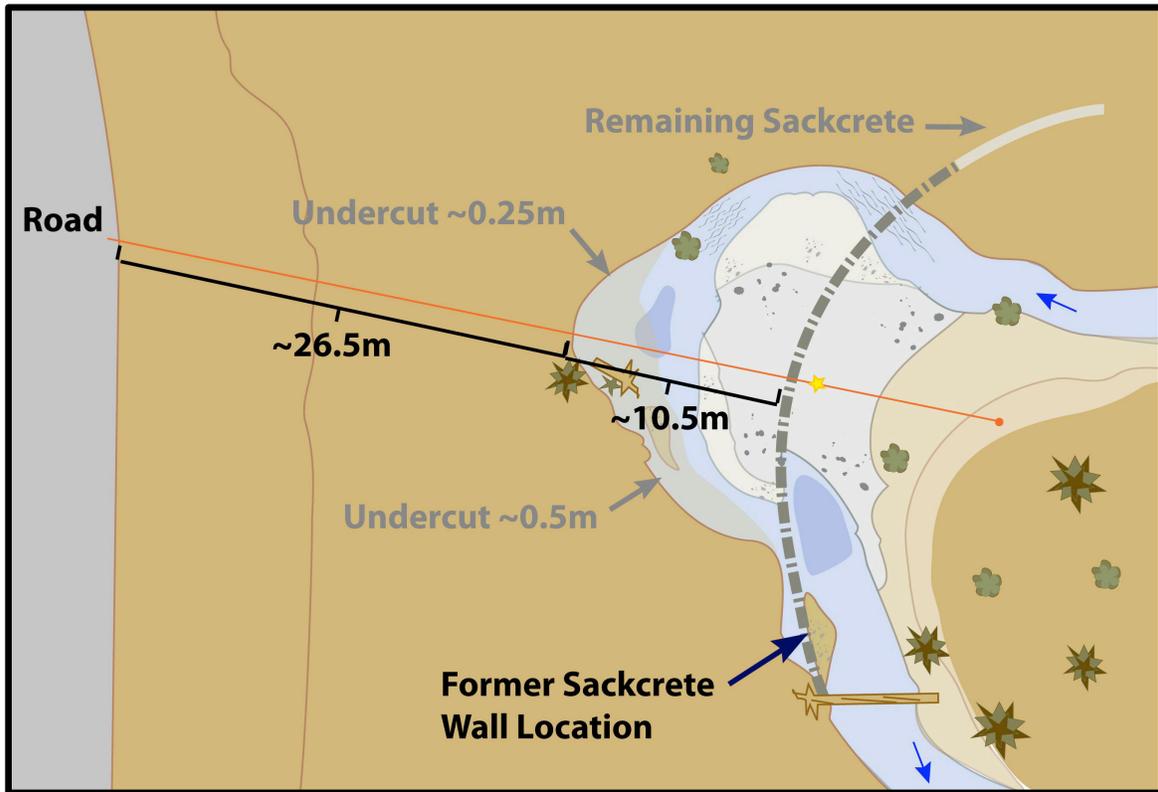
FIGURE 4: Sackcrete Bend current plan view

12. Sackcrete Bend (SM84 9²²) – This bank stabilization project was installed as part of the Highway 84 transportation corridor realignment (Figure 3). At this site the channel bend was moved approximately 40 meters, a sackcrete wall was constructed across approximately 120 meters of the new channel bank, and fill material was used to backfill the site. Approximately 90 meters of the sackcrete wall has completely failed and the channel has since migrated back towards its previous location, transporting most of the original fill material downstream (Figure 4). The channel continues to cut at the base of the channel and the pool below the bend contains a layer of silt deposits. From transects that I surveyed, I calculated that approximately 540 m³ of fill material has been transported downstream from this site since 1954.

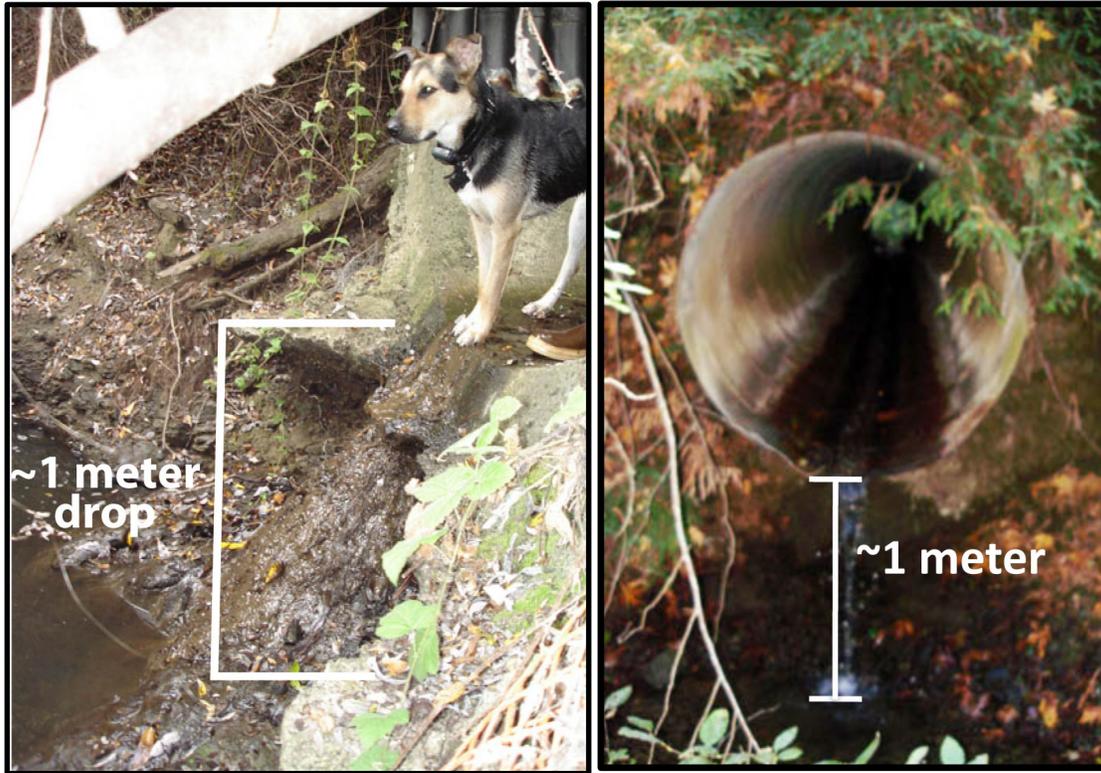
2. Coyote Creek Crossing (SM84 2¹⁰) – There is a 1 meter height difference between the downstream water surface and the culvert outlet, impeding all fish passage during low flows. There is no flow data available or recorded observations of fish in this creek that would indicate whether or not fish passage is possible during winter flows although the upstream channel is gullied and devoid of most vegetation due to grazing activity, making spawning habitat in this creek of poor quality even if it is accessible to fish during high flows.

15. Hanging Tributary Culvert (SM84 9⁷⁸) – This 0.75 meter diameter culvert is the outlet of a small tributary. The outlet is approximately 0.6 meters above the pool that it is draining into and I estimate that the culvert is approximately 25 meters long with a slope between 10-15%. Although this tributary is providing a steady stream of water, it is completely inaccessible to fish due to the height of the culvert opening. Even during higher flows when this outlet may be submerged by the La Honda Creek, its steep slope and long confined profile make passage unlikely for fish at any life stage.

FIGURE 6: Examples of fish passage barriers due to disconnect between culvert outlet and downstream channel (Site 2 and Site 15)

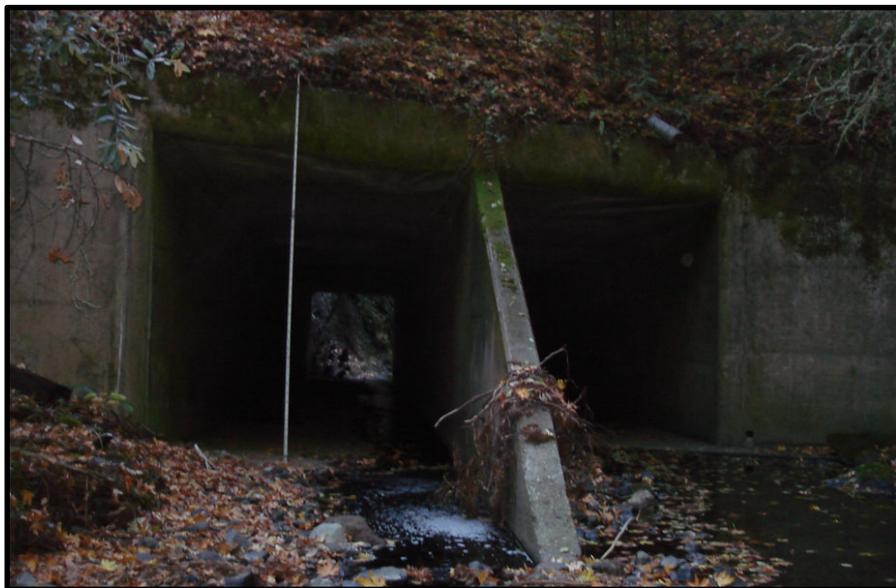
14. La Honda Culvert Crossing (SM84 9⁶⁸) – This road crossing consists of two concrete box culverts that are each approximately 3.5 meters wide, 4 meters tall, and 30 meters long. At the time of the site visit there was a sheet of water approximately 0.04m flowing through the culverts and dropping down approximately 0.25meters into a 0.6 meter deep scour pool at the outlet. This crossing inhibits fish passage during low flows. Even though adult salmon could overcome the obstacle of the elevation change, they would not be able to travel the following 30 meters of culvert.

FIGURE 7: Examples of seasonal fish passage barrier due to insufficient water depth in culvert crossing (Site 14)

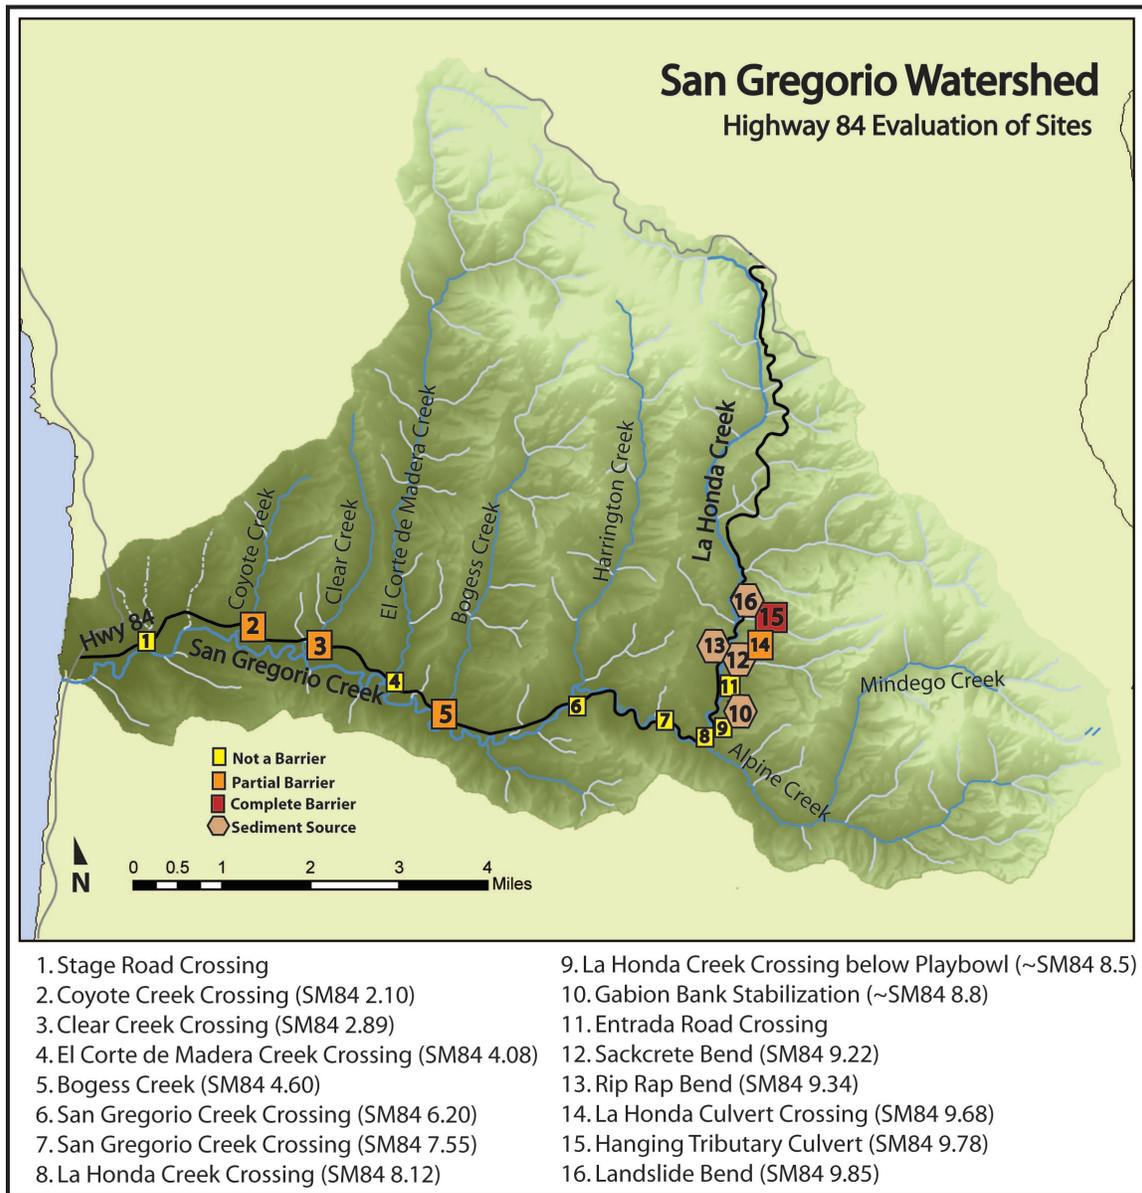
My investigation of the ways in which public infrastructure along the Highway 84 transportation corridor impact fish passage and habitat quality revealed that there are three sites (Site 2, 5, and 14) where Highway 84 bridge crossings impede fish passage during periods of low flow and one site (Site 15) that

completely blocks fish passage (Figure 8). All bank stabilization sites (Sites 10, 12, 13, and 16) and several of the bridge crossing sites (Sites 3, 5, 8, and 9) show evidence of lateral erosion and fine-grained sediment contributions directly to the active creek channel. Bank scour and channel incision is also evident immediately downstream at sites where bank structures encroach in the active channel or otherwise confine flows. Two exceptions to this are the La Honda Creek Site below Playbowl (Site 9) and the Sackcrete Bend Site (Site 12) which both have exposed bedrock that acts as a grade control.

FIGURE 8: Fish passage and sediment source evaluation site assessment results
