Post Project Analysis of a Restored Reach of Redwood Creek

LA222 – Hydrology for Planner  
UC Berkeley – Spring 2012

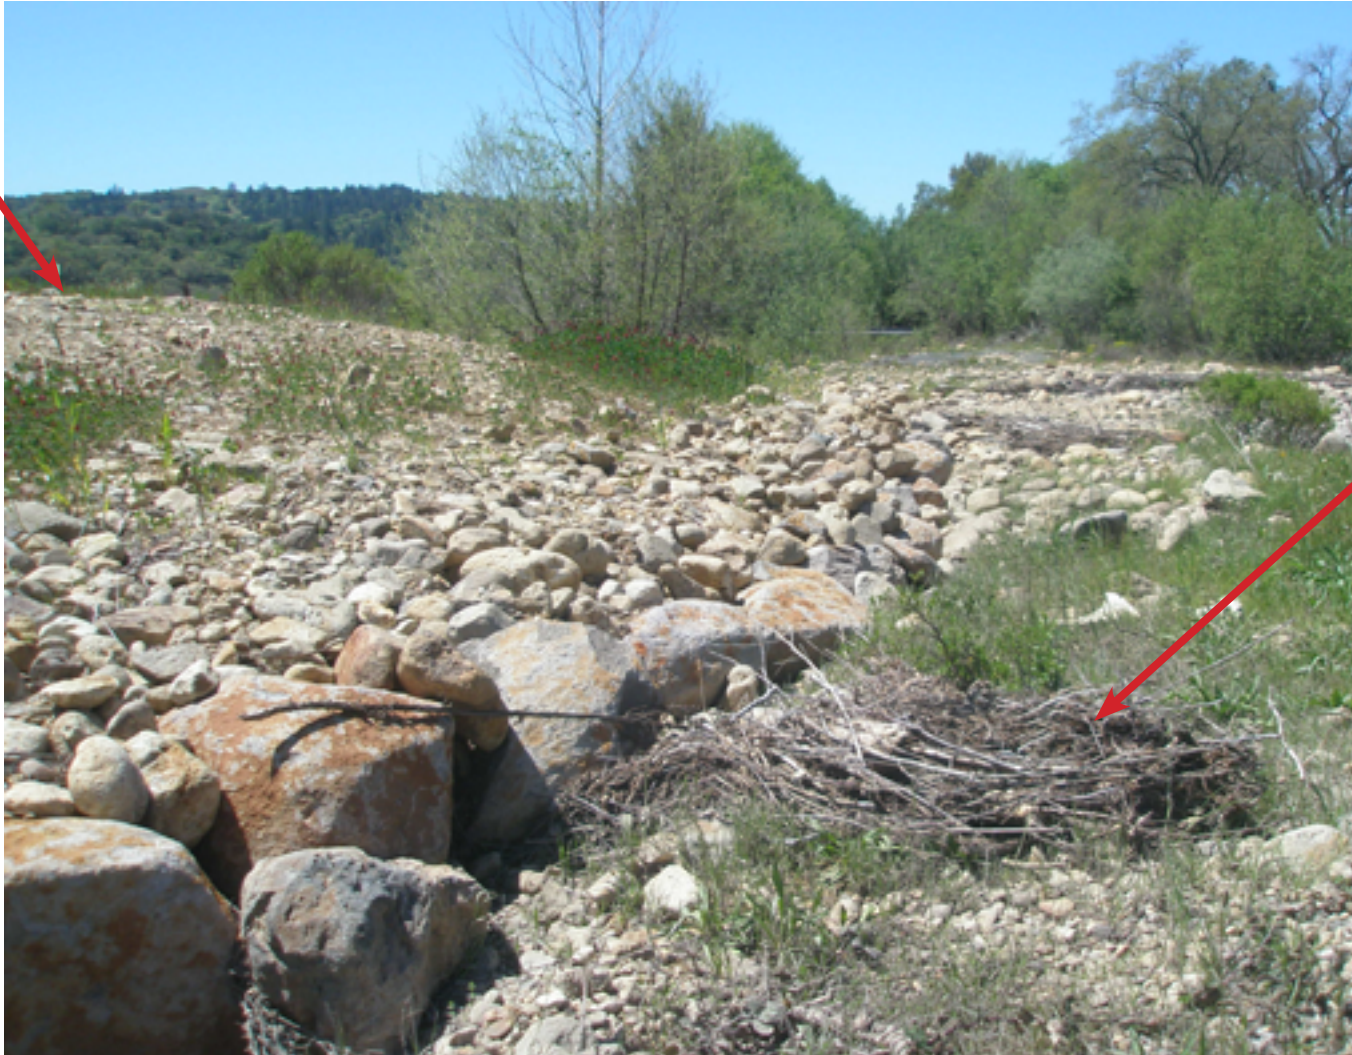
Figure 10. Photo

We observed high water marks from the April 19<sup>th</sup>, 2012 flow, which included debris deposits around mid-bank (figure 10). High water marks and the presence of wetted bed material show that several sub-channels of this braided channel were occupied during the recent rain event and are in the process of drying out. Overbank flow did not occur in this portion of the reach.

High Water  
Marks

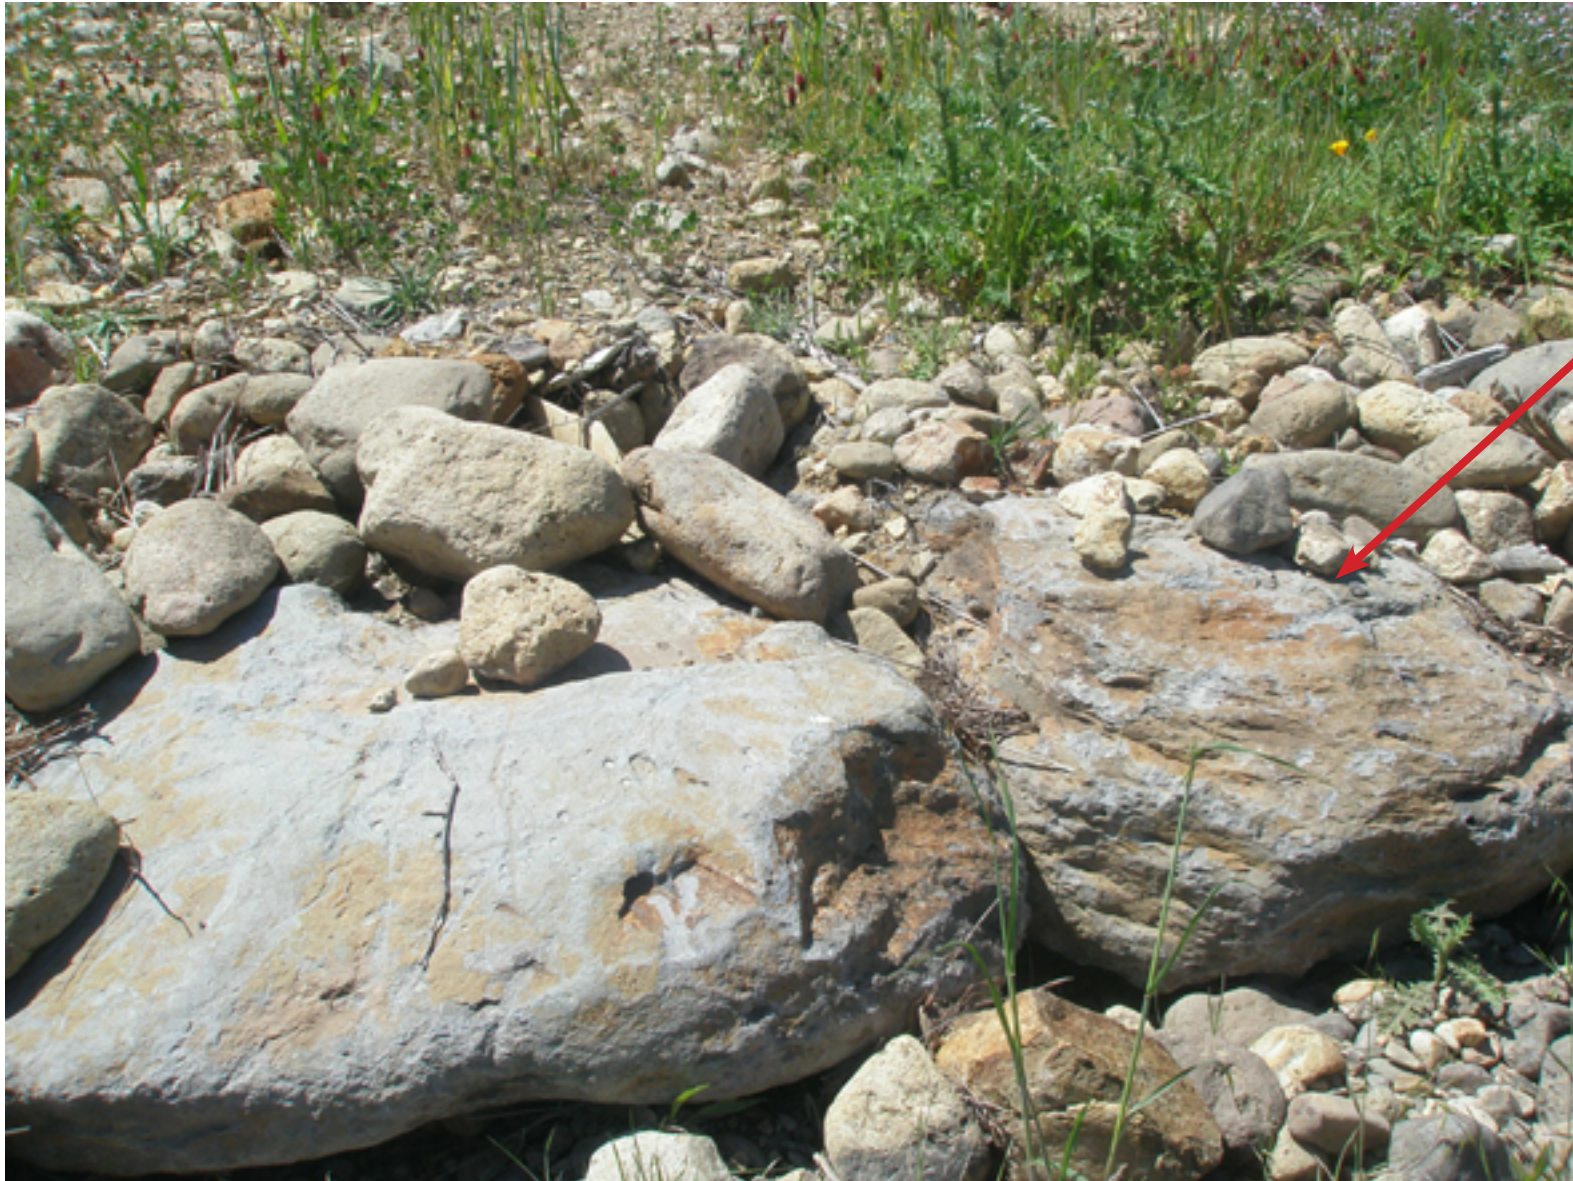
Figure 11. Photo of Rock Groin

Bank  
Protection

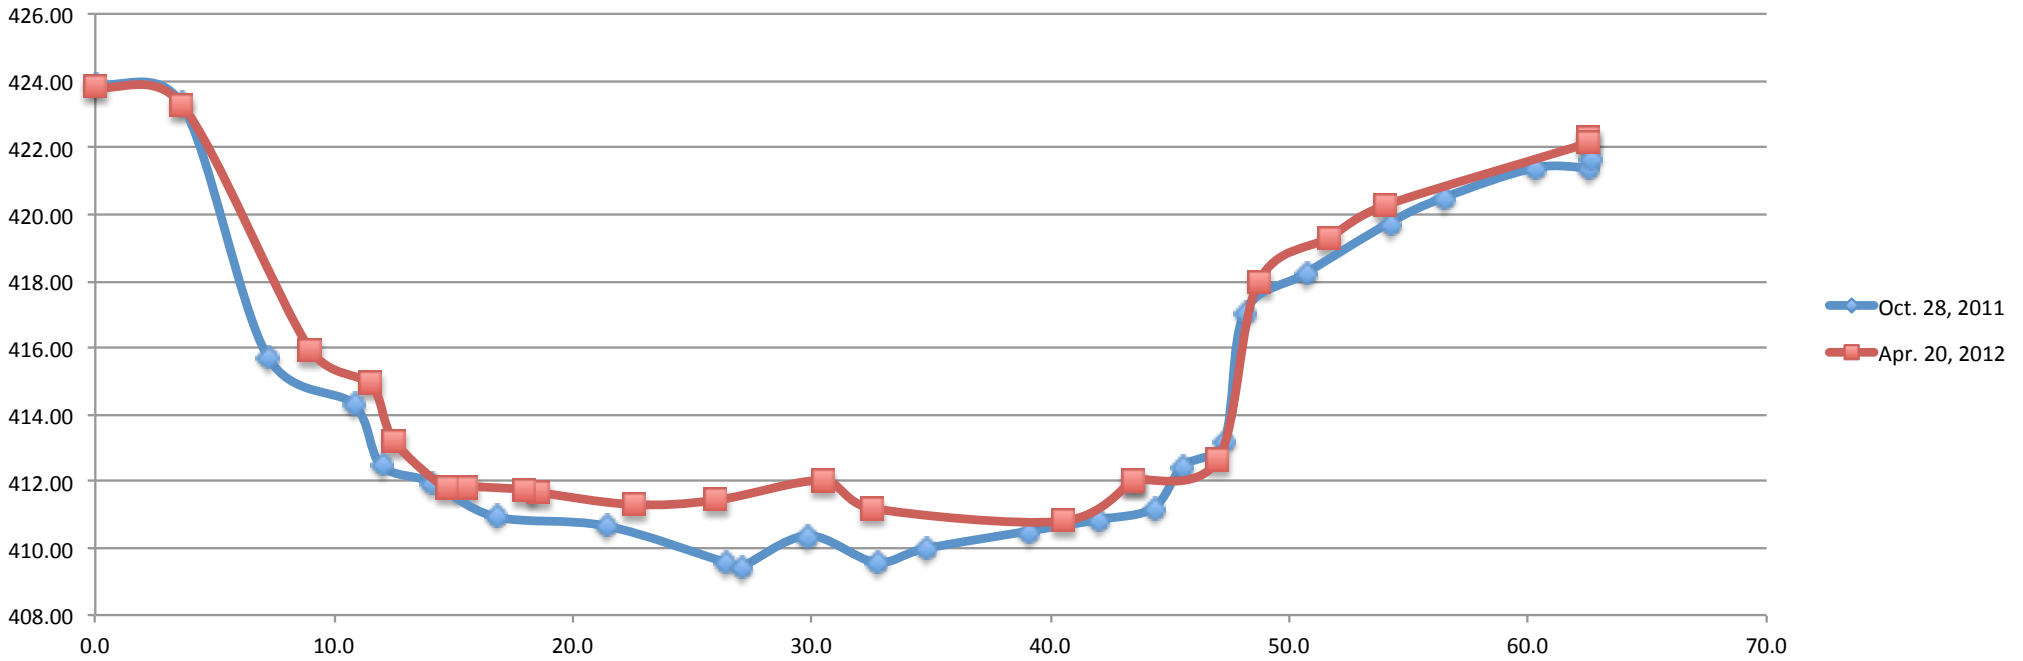
Figure 13. Cross Section Locations

The four cross sections surveyed subsequent to the April 19<sup>th</sup> storm are plotted against the October/November cross-sections. This comparison shows up to 2 ft. of aggradation in cross section one (figure 13). Cross-section three shows less than a ft. of erosion near top of bank, and relatively no changes near bottom of bank (figure 14). Cross section 8 shows up to 2ft of incision to the left sub channel and relatively no changes in the main channel (figure 15). Cross section 10 shows up to 2.5 ft. of aggradation in the gravel bar and relatively no changes to the main channel (figure 16).
