Pedestrian and Bicycle Safety Evaluation in a SMART Corridor

**California PATH Research Report  
UCB-ITS-PRR-2008-25**

Final Report for Task Order 5204

October 2008

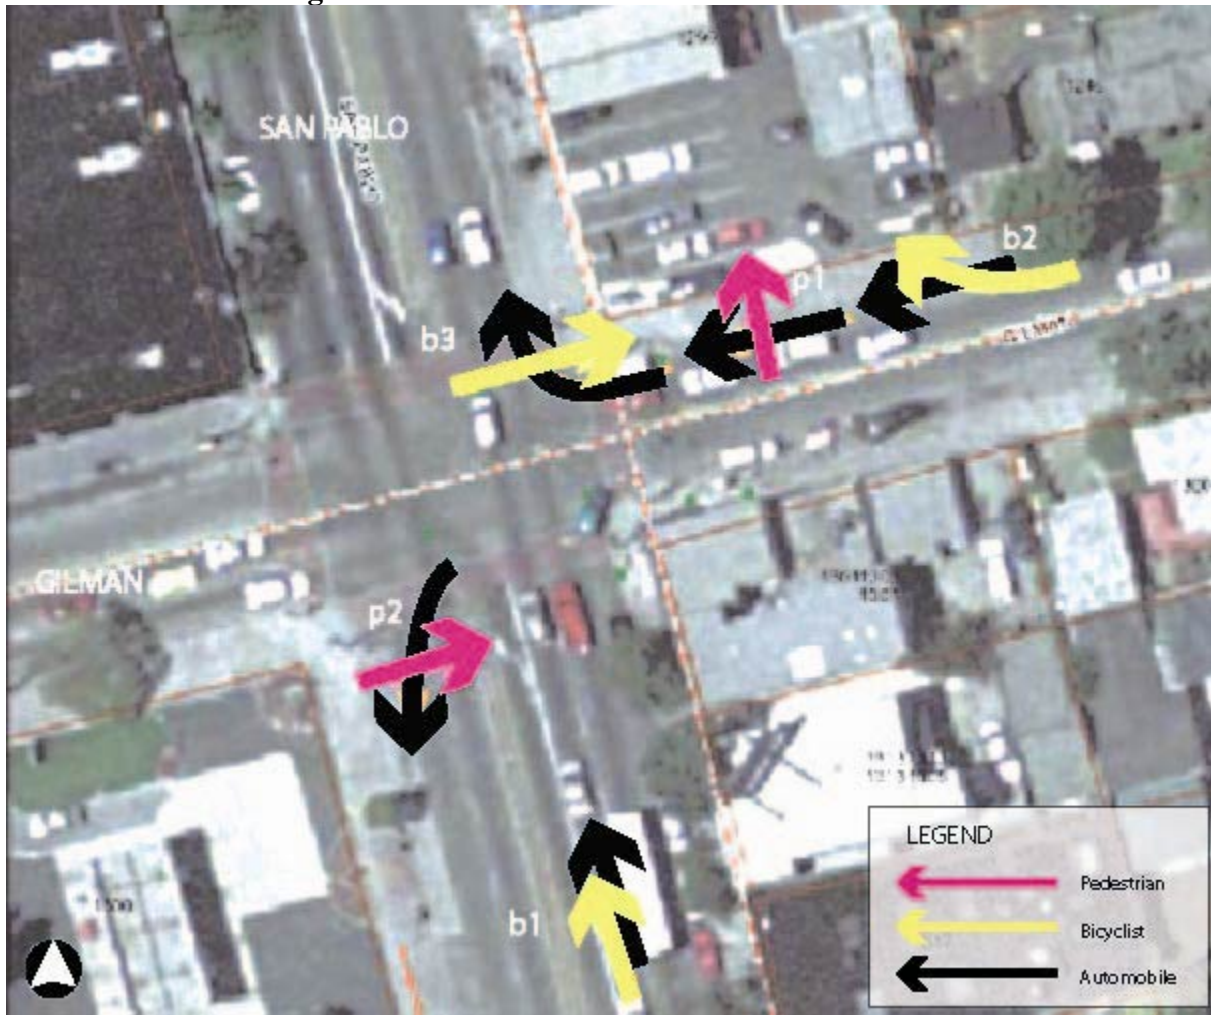
Figure 5.2. San Pablo Avenue and Gilman Street

The intersection is dominated by north-south automobile traffic along San Pablo with a west-to-east squeeze conflict, as a lane drop occurs when Gilman changes from commercial/industrial to residential. A busy shopping center with a regional draw is located to the southwest of the intersection and has entrances on Gilman to the north and San Pablo to the south, which results in traffic backups and conflicts on the sidewalks, driveways, and at a bus stop. A gas station is located on the southwest corner, with entrances and exits located close to the intersection on each side. Gilman also leads to I-80/580 to the west and to and a Target Superstore to the west and north, which draws additional traffic through the intersection. All of this contributes to a very active intersection with vehicles, pedestrians, and bicyclists.

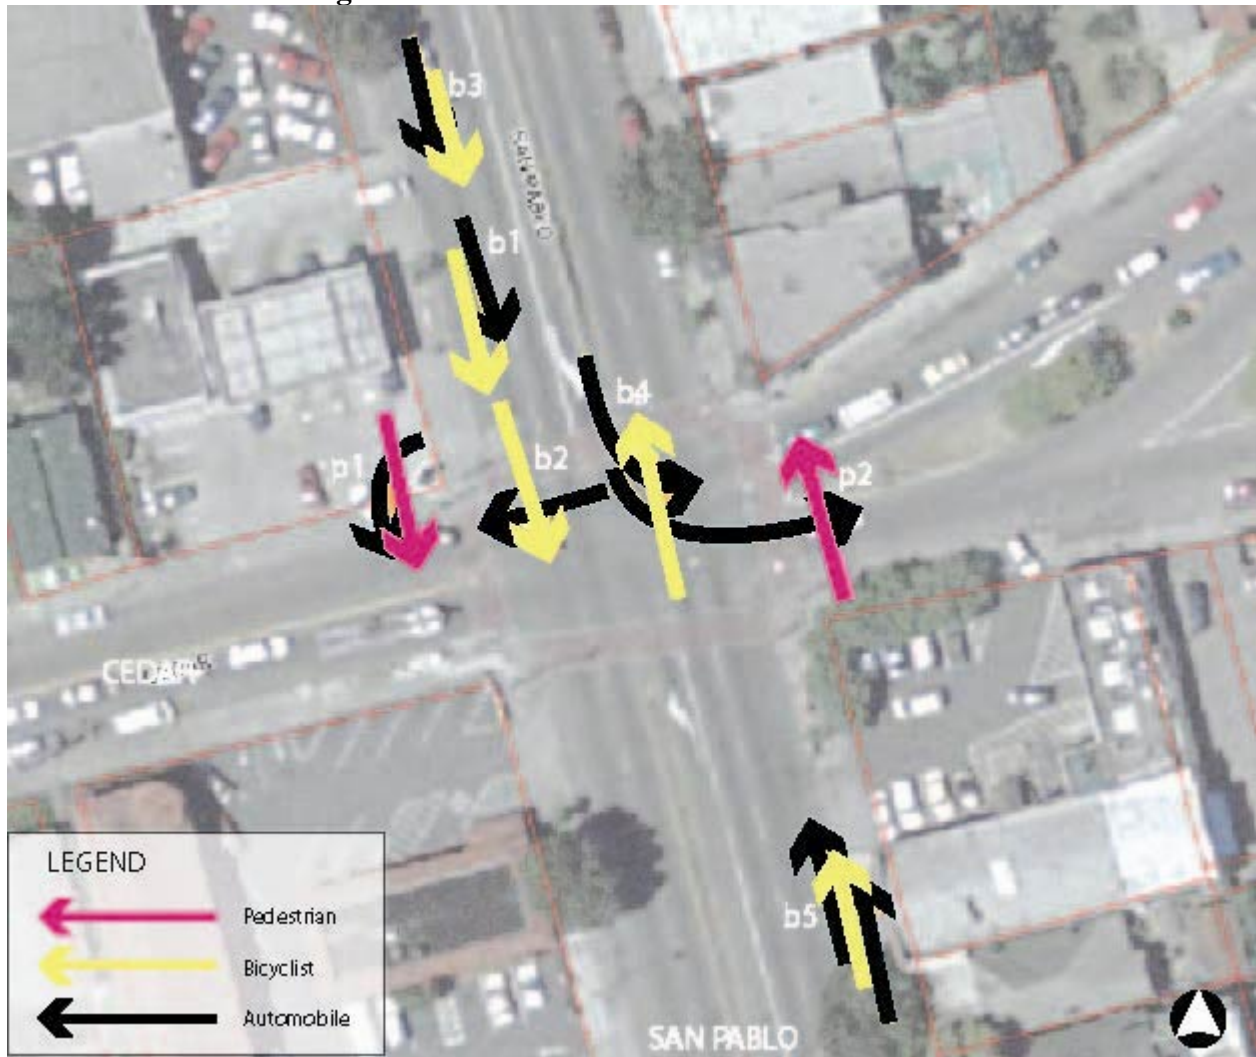
Figure 5.4. San Pablo Avenue and Cedar Street

Collisions between vehicles and five bicyclists, and vehicles and two pedestrians were reported for this intersection between 1998 and 2003. The crash types and previous movements are illustrated in Figure 5.4.

The majority of the crashes appeared to be concentrated in the northwestern quadrant and approach to the intersection. The pedestrian crashes involved a driveway crossing and a left-turning vehicle violation of pedestrian ROW in a crosswalk

The bicyclist crashes involved vehicles entering traffic, bicycles hitting stopped cars, and vehicles cutting-off bicyclists via turning or lane changes.

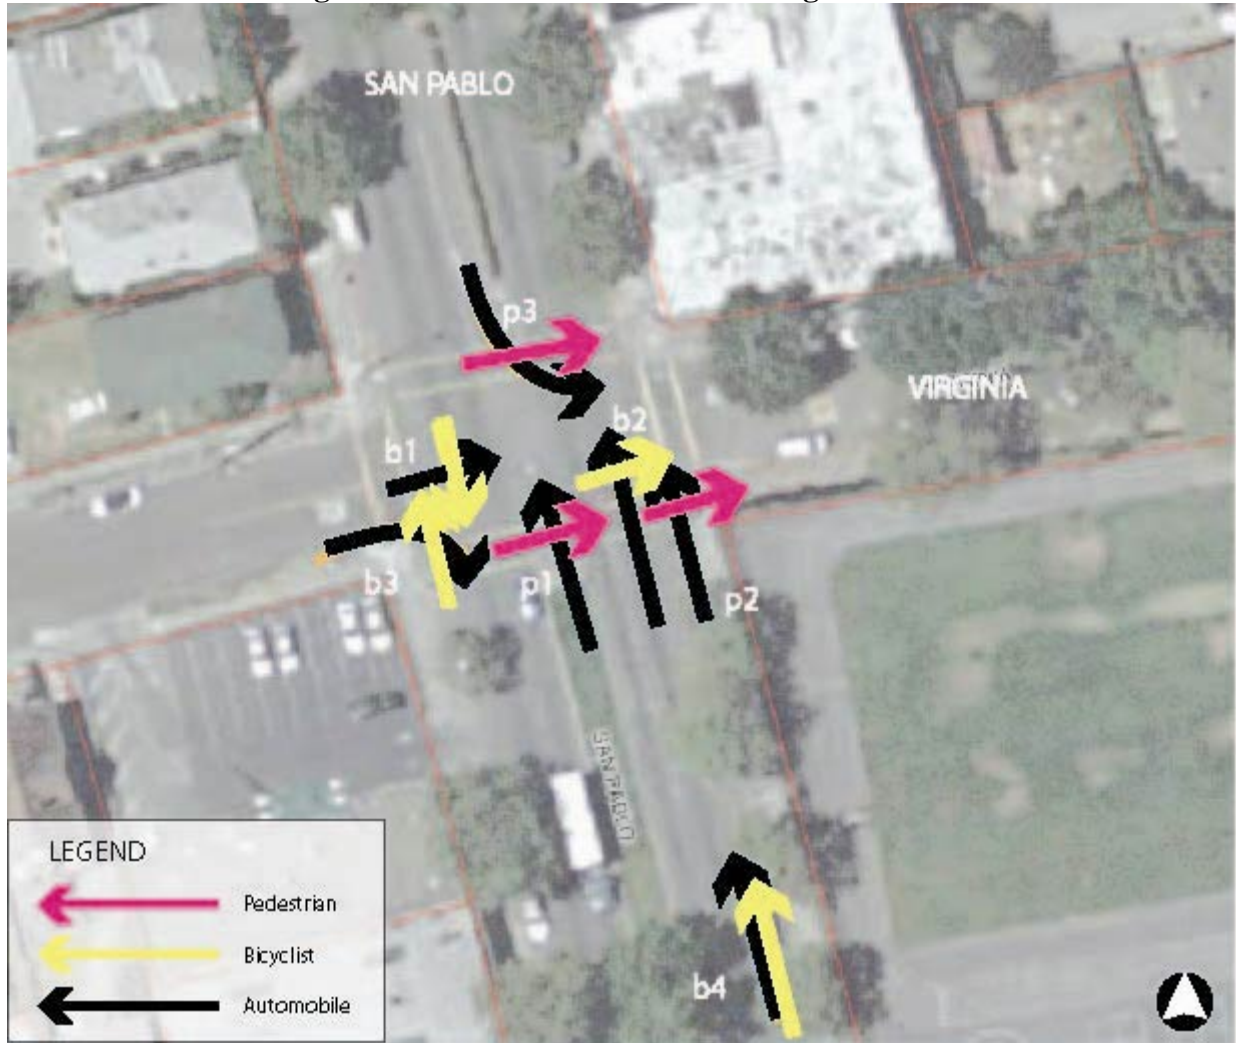
**Figure 5.5. San Pablo Avenue and Virginia Street**

bicycle crashes involved bicyclists in each direction. One bicyclist was moving against traffic, one hit a stopped vehicle, and the others were riding perpendicular to traffic in the intersection. The crash types and previous movements are illustrated in figure 5.5.

This intersection is characterized by intermittent high-speed traffic with no traffic control on San Pablo Avenue and stop-sign control on both Virginia approaches. Additionally, this is a bicycle boulevard<sup>32</sup> crossing with a high level of bicycle traffic.

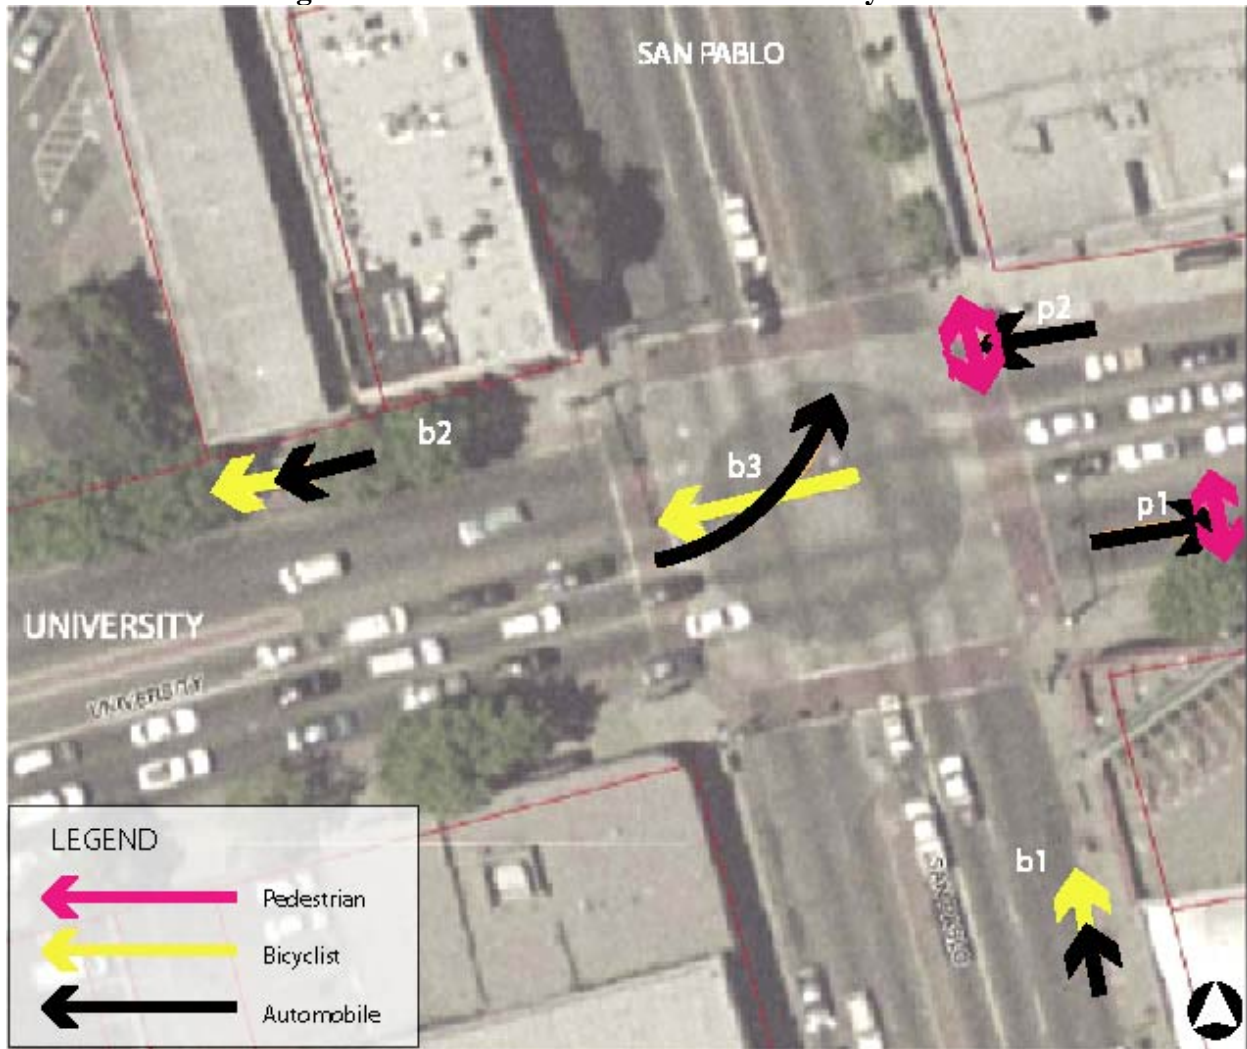
**Figure 5.7. San Pablo Avenue and University Avenue**

Vehicle collisions with four bicyclists and, and vehicle collisions with four pedestrians were reported at this intersection between 1998 and 2003; however, there was no common pattern among the crashes. Two pedestrian crashes were more than 100 feet from the intersection. The crashes involved pedestrian violations such as jaywalking and walking under the influence. The bicycle crashes involved bicyclists hitting stopped vehicles and bicyclists riding against traffic. The crash types and previous movements for these collisions are illustrated in Figure 5.7.

The intersection at San Pablo and University Avenues is at a confluence of two high capacity arterial roadways with bus stops for multiple bus lines located on each corner. The intersection is characterized both by the highest vehicle and pedestrian volumes for all Berkeley intersections studied. Despite low bicyclist volumes, the rate of vehicle collisions with bicycles was high given their relative exposure. One conclusion might be that the bicyclists who use this intersection are most likely there because it is a destination (there are several shops and restaurants at this intersection); otherwise they would use the nearby bicycle route network, which would allow riders to negotiate an easier, less congested route to their destination.

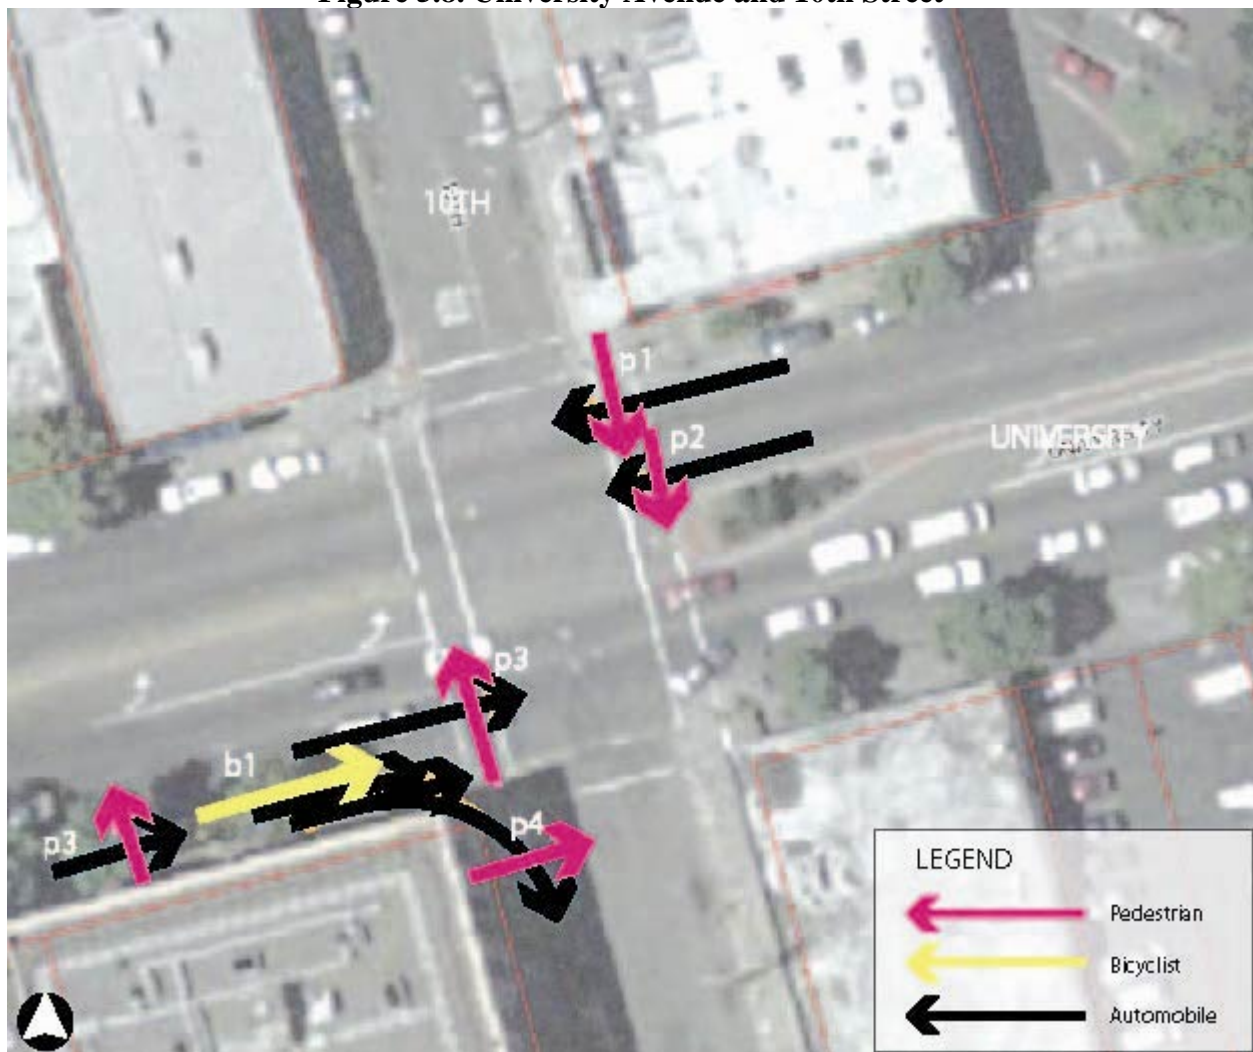
**Figure 5.8. University Avenue and 10th Street**

There were five pedestrian crashes and one bicycle crash reported to SWITRS for this intersection in the past six years. The crash types and previous movements are illustrated in figure 5.8.

The reported collisions between vehicles and pedestrians or bicyclists at the intersection of University Avenue and 10th Street were concentrated on the southwest and northeast corners and approaches to the intersection. Pedestrian crashes occurred in instances of vehicles moving

straight through the intersection, or approaching the intersection, and turning right. In most cases the vehicle violated the pedestrian right-of-way. The single bicycle crash involved straight moving vehicles approaching the intersection.

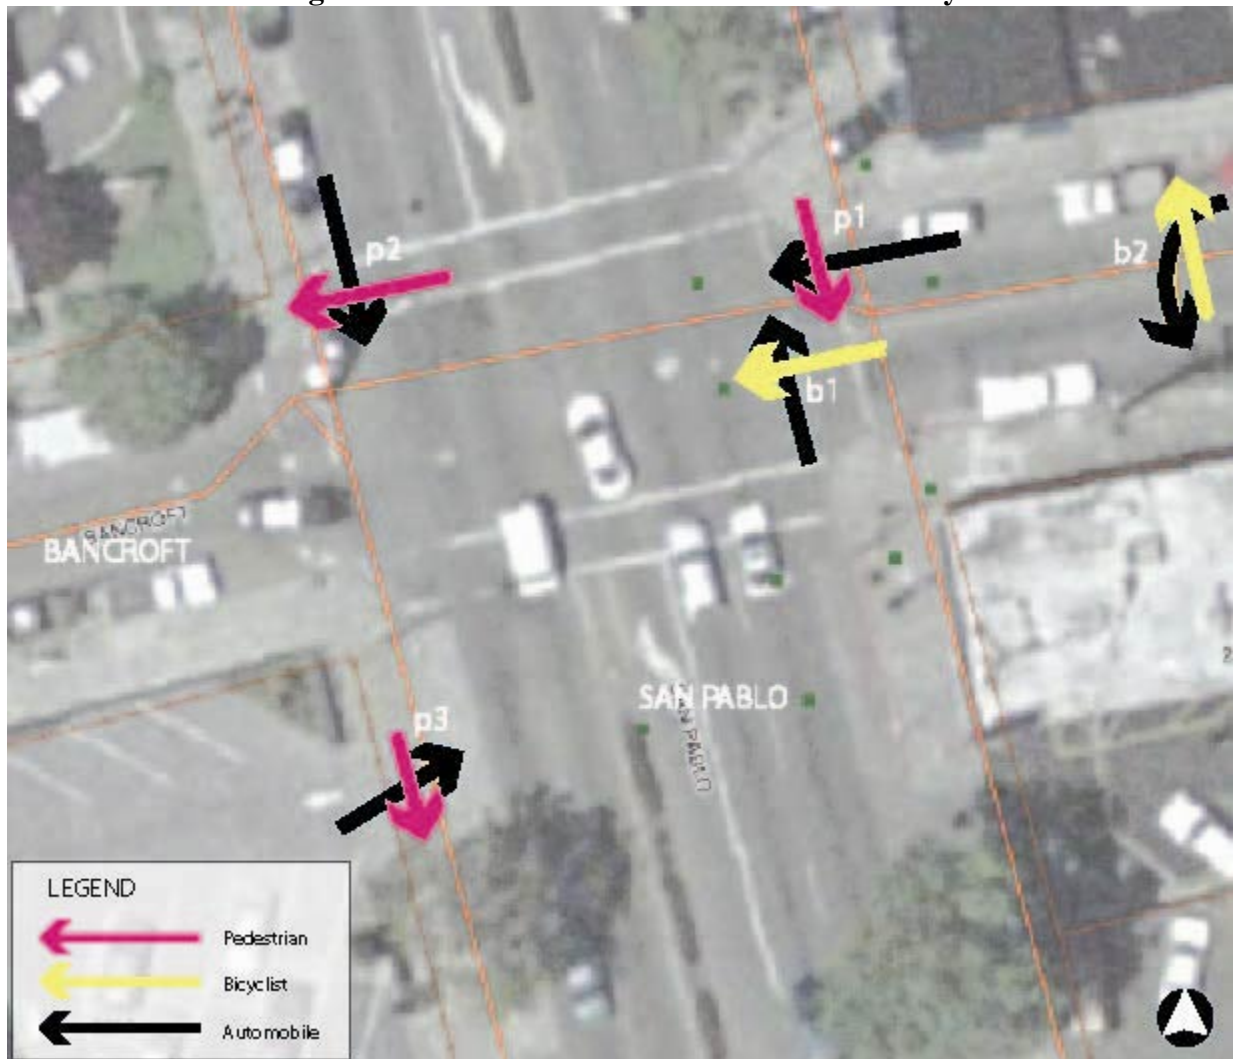
**Figure 5.11. San Pablo Avenue and Bancroft Way**

The intersection at San Pablo and Bancroft is characterized by high vehicle and bicycle traffic and an absence of traffic signals. The crash history has shown a risk for collisions between vehicles making uncontrolled left-turns onto Bancroft and northbound and southbound pedestrians. The infrastructure poses a risk for conflicts between drivers and pedestrians and bicyclists, with several driveways cutting through the sidewalk close to the intersection.

- Speed trailers: discourages speeding, reduces conflict.
- Pedestrian activated flashing beacons: reduces conflict, increases use of crosswalks, however, could reduce pedestrian awareness.
- Upgraded/extended median (pedestrian refuge island): reduce conflict, reduce number of trapped pedestrians, increase number of pedestrians using crosswalk.

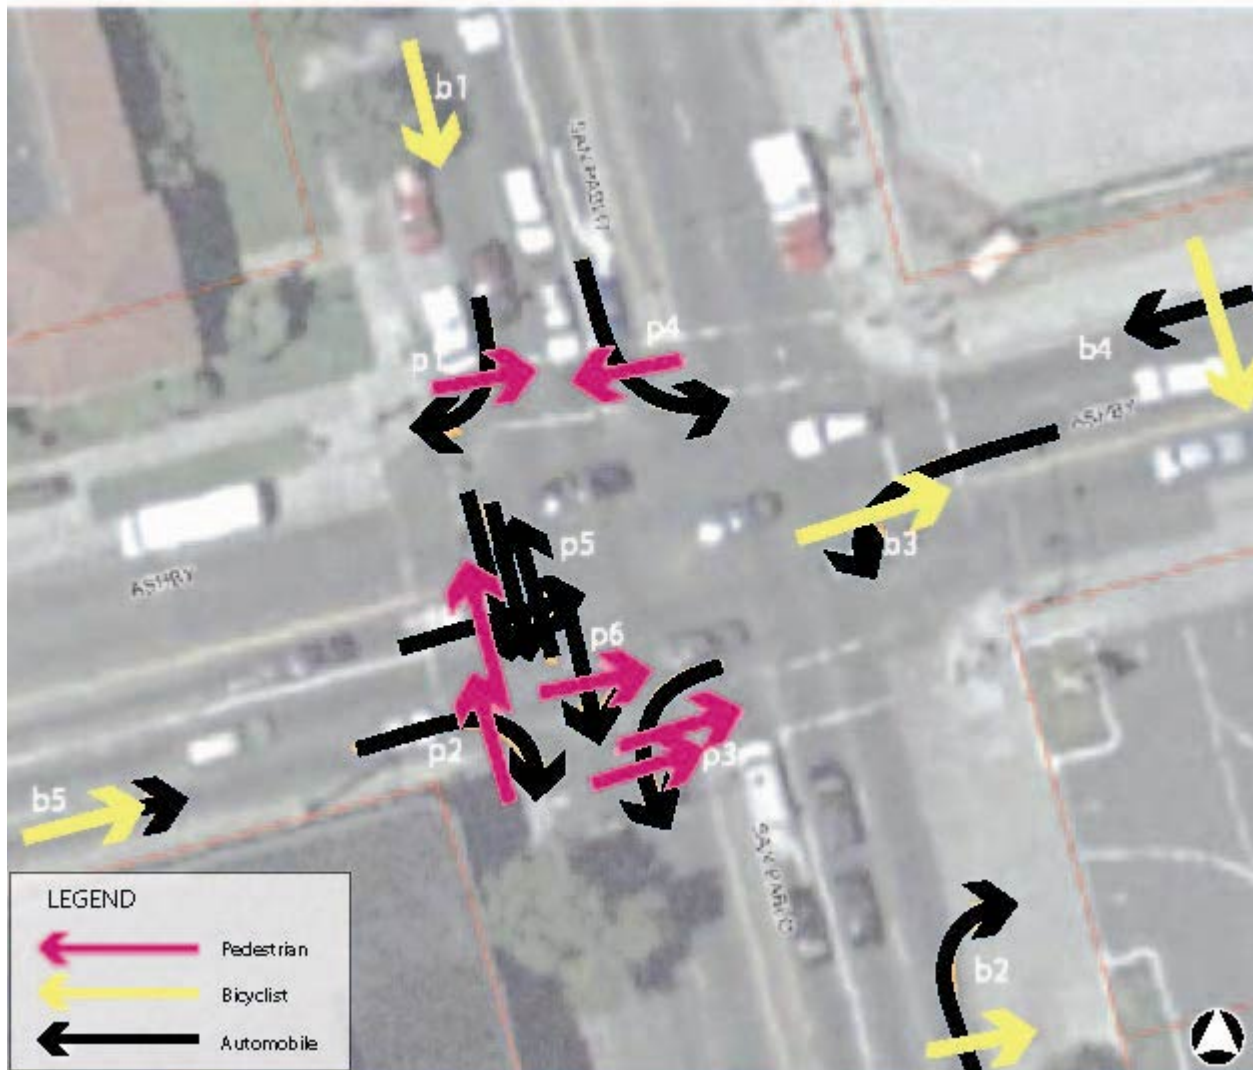
Figure 5.15. San Pablo Avenue and Ashby Avenue

Three of five bicycle crashes occurred outside of the intersection. Two bicyclists were struck while riding on the wrong side of the road against traffic. The bicycle crashes involved right-turning, left-turning, straight-moving and stopped vehicles. Most bicycle crashes involved bicyclist violations. The crash types and previous movements are illustrated in the figure 5.15.

The Ashby intersection was characterized by high speed and high volume vehicle traffic, with 75% of the vehicle flow, 50% of the pedestrians and 200% of the bicycles observed at the intersection of San Pablo and University Avenues. This combination of factors lower volumes of motor vehicles with lower pedestrian volume, generally leads to a higher speed mix due to less congestion. The majority of crashes occurred in the southwest corner of the intersection and typically involved turning vehicles. Similar numbers of pedestrians and bicyclists were involved in collisions with vehicles; however, a significant number of pedestrian crashes involved multiple pedestrians.
