Cyclic Testing of Three Full-Scale Steel Beam-Column Connections

**REPORT NO.
UCB/SEMM-96/01**

**CYCLIC TESTING OF
THREE FULL-SCALE
STEEL BEAM-COLUMN
CONNECTIONS**

Report to ADP/Fluor Daniel

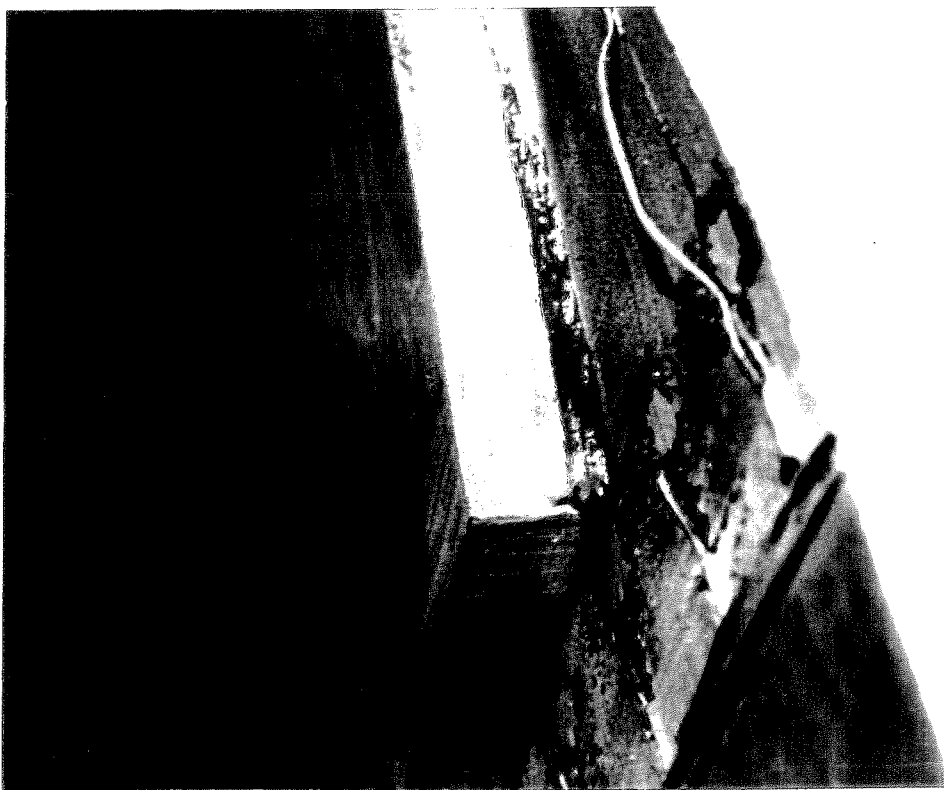
The imposed actuator displacement history is shown in Figure 7. The last cycles were asymmetrical due to some initial offset of the beam end (~ 1.5"). The specimen behaved elastically during the 1" actuator displacement cycles. First yielding was noticed during the first 2" cycle. Some tearing in the corner of bottom cover plate-beam flange weld was noted during the 3" cycles. Small buckling of both beam flanges occurred during 4" cycles. A tear in the corner of the top cover plate-beam flange weld appeared after the first 5" cycle.

FIGURE 27: CRACK IN TOP COVER PLATE-BEAM FLANGE WELD AFTER 5" CYCLES

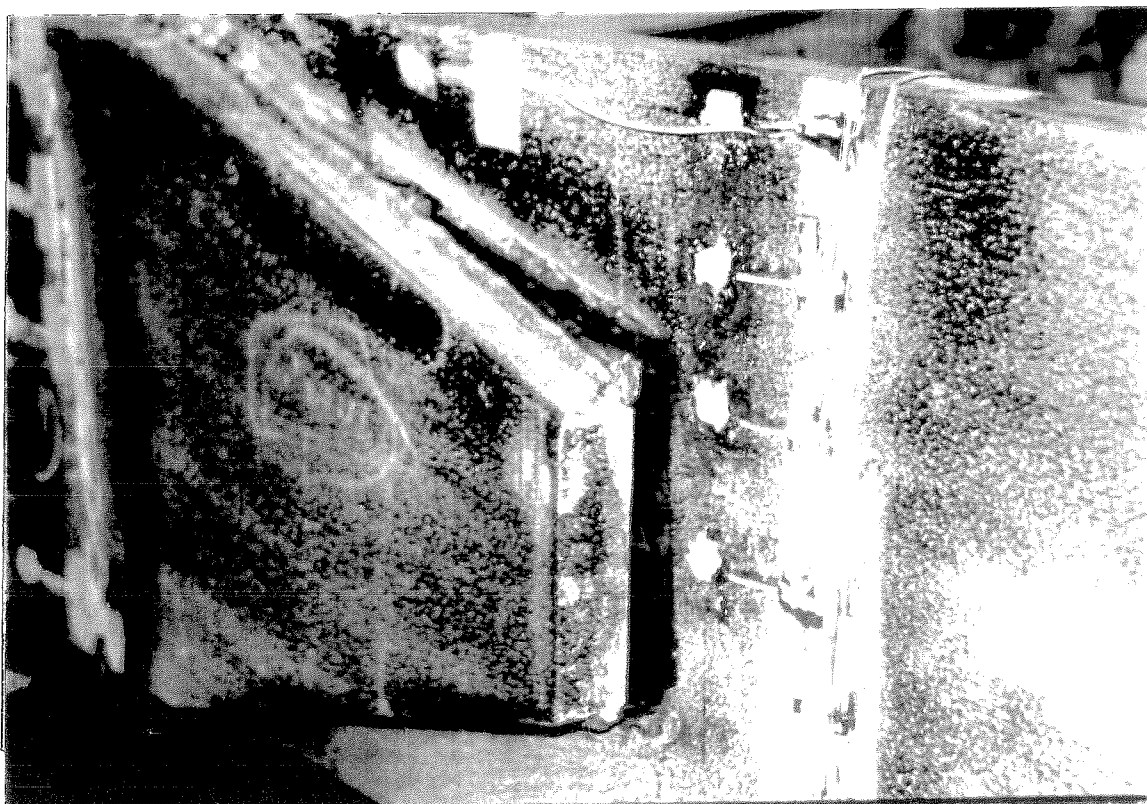
FIGURE 28: CRACK OPENING AFTER 6" CYCLES

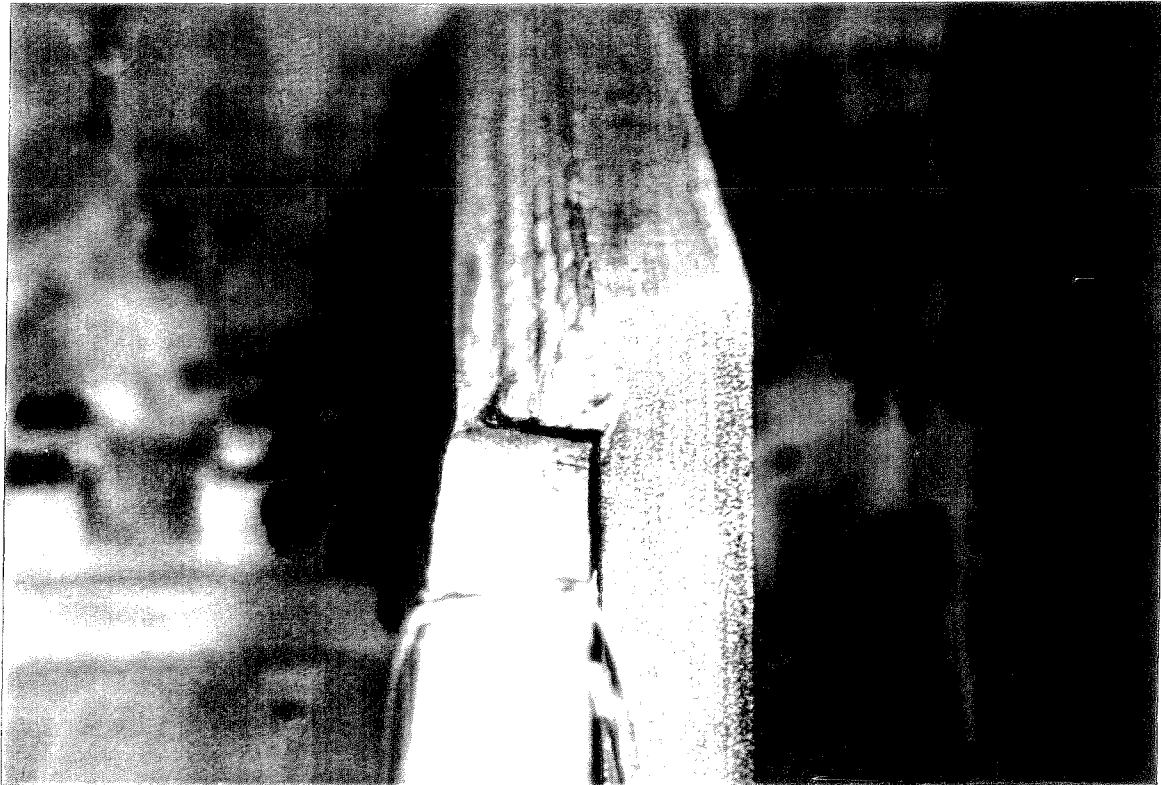
FIGURE 29: BENDING OF BEAM BOTTOM FLANGE (@ 6" DISPLACEMENT)

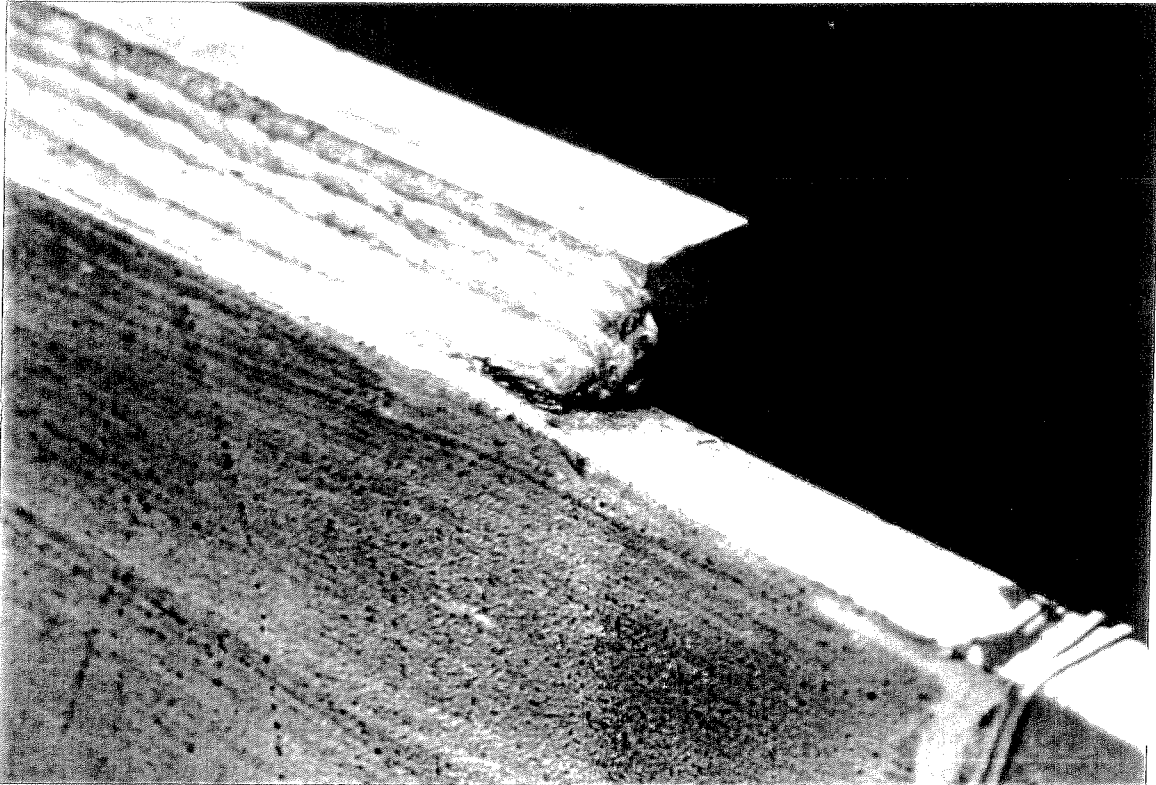
FIGURE 31: TEARING IN TOP COVER PLATE WELD (AFTER 6" CYCLES)

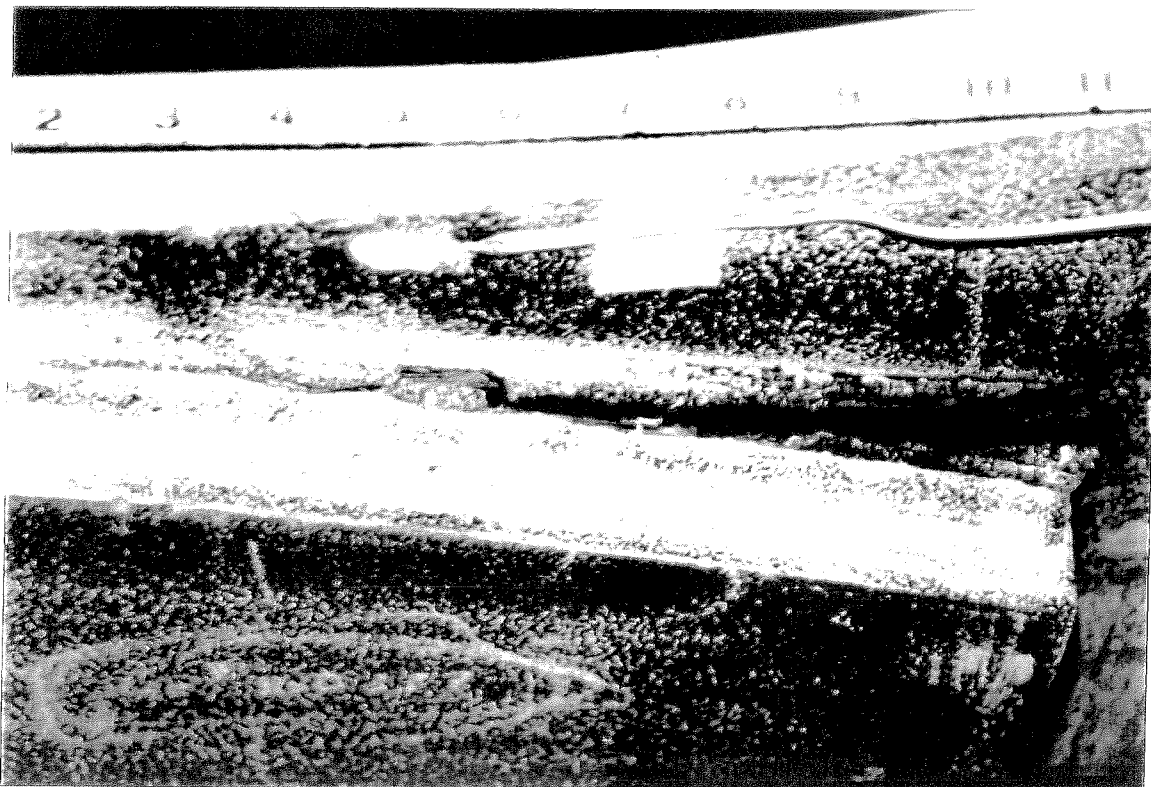
FIGURE 32: TEARING IN TOP COVER PLATE WELD (AFTER 6" CYCLES)

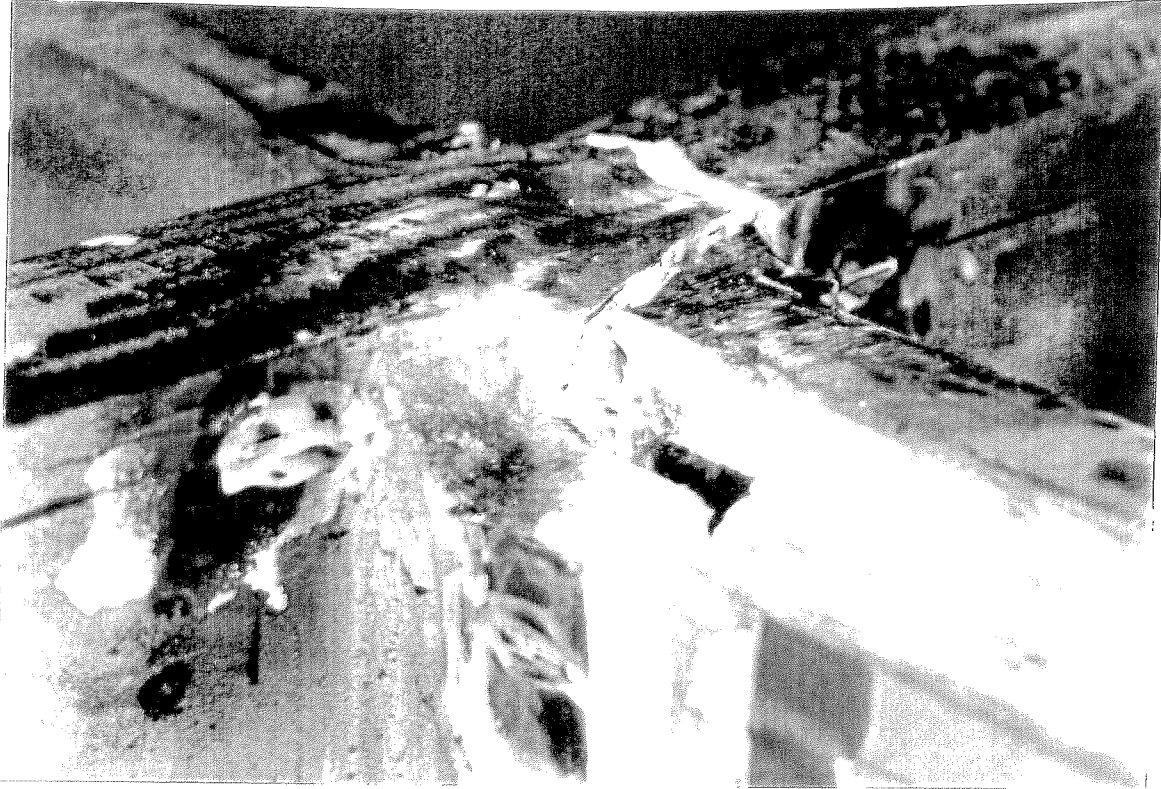
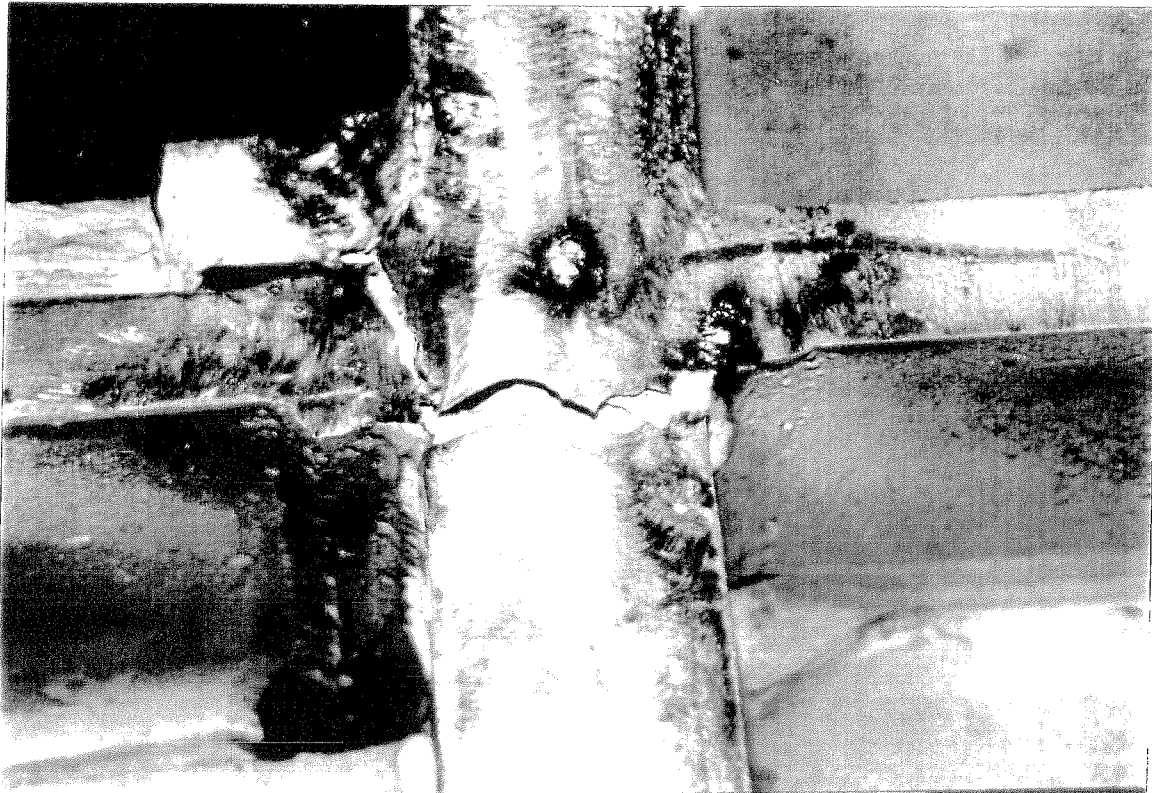
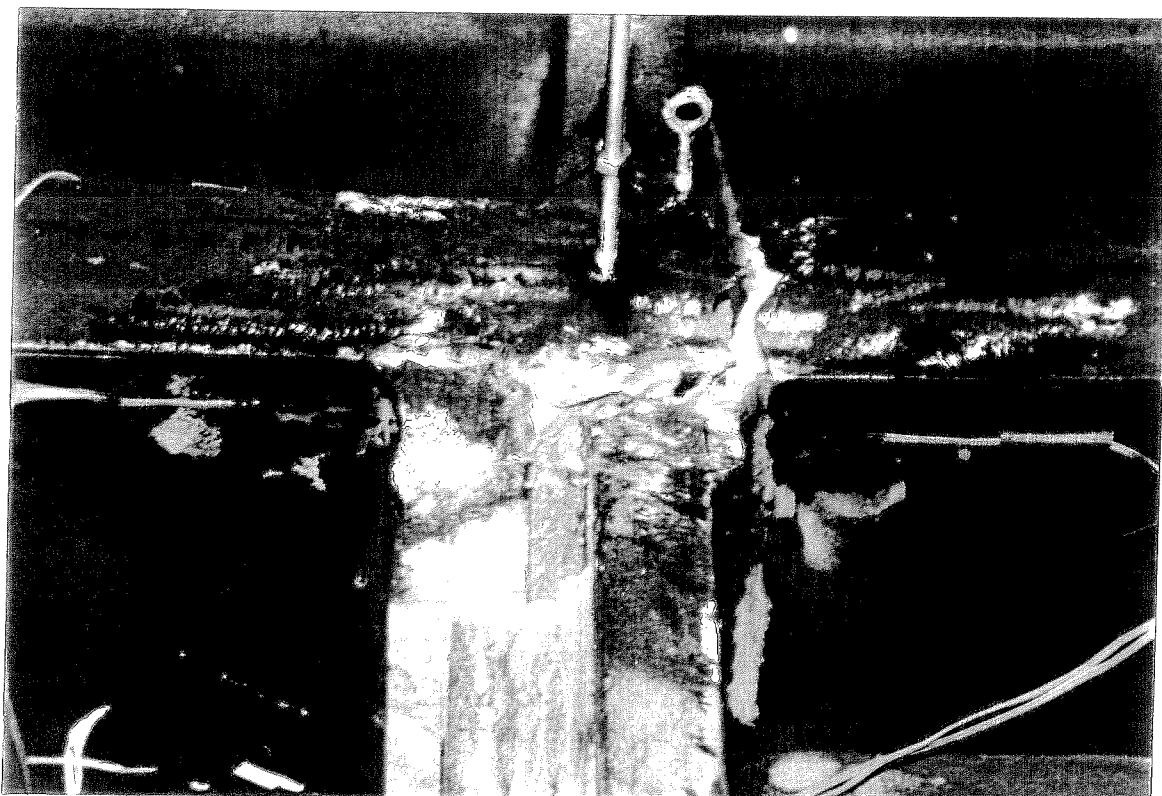
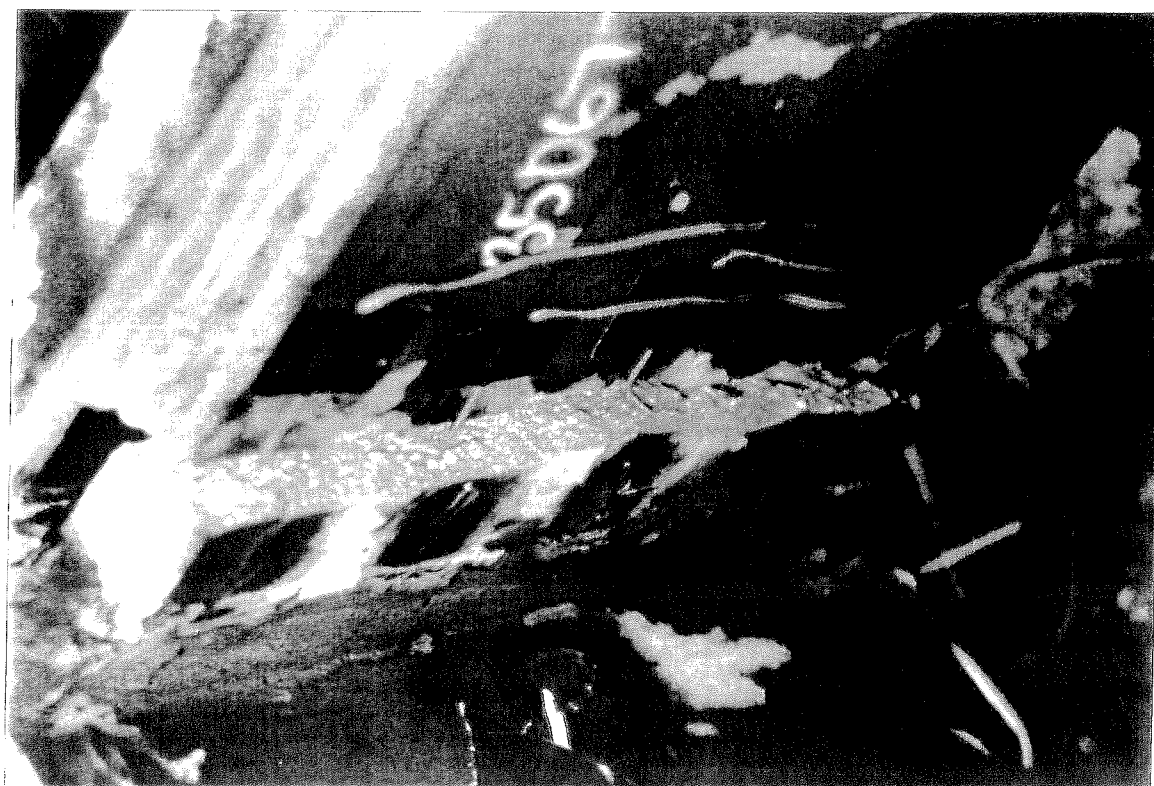
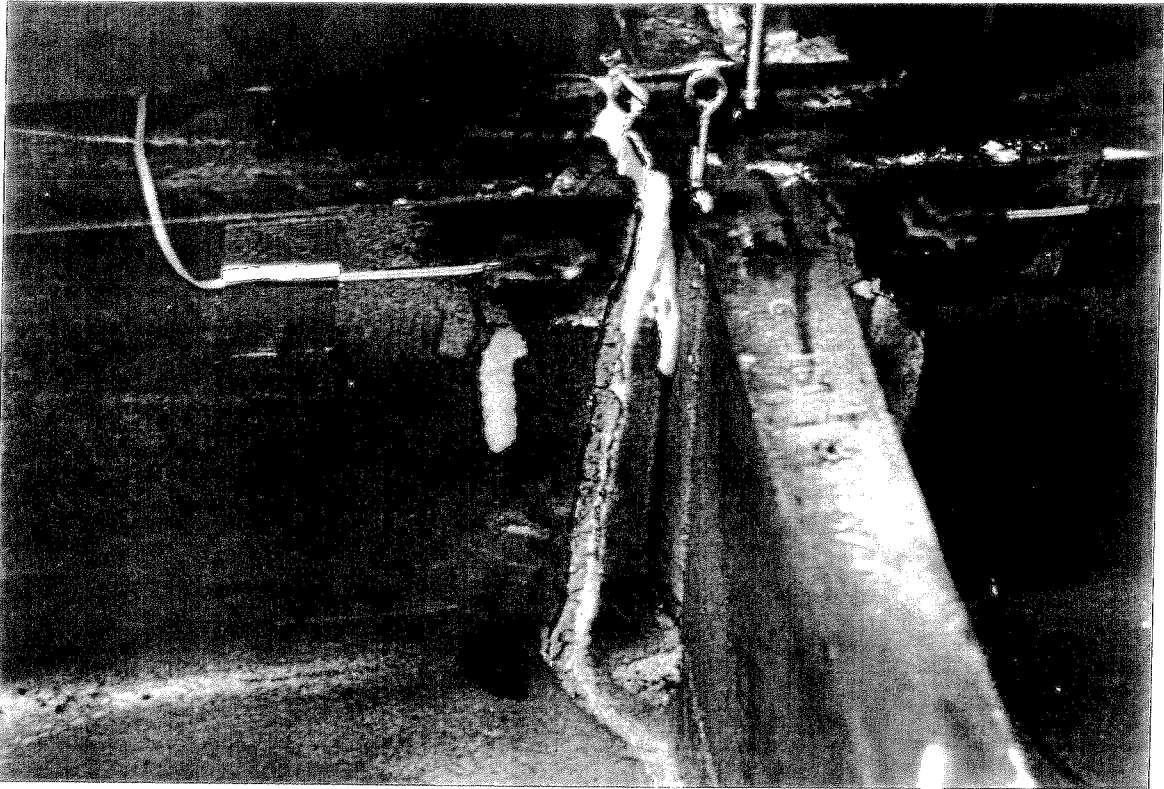
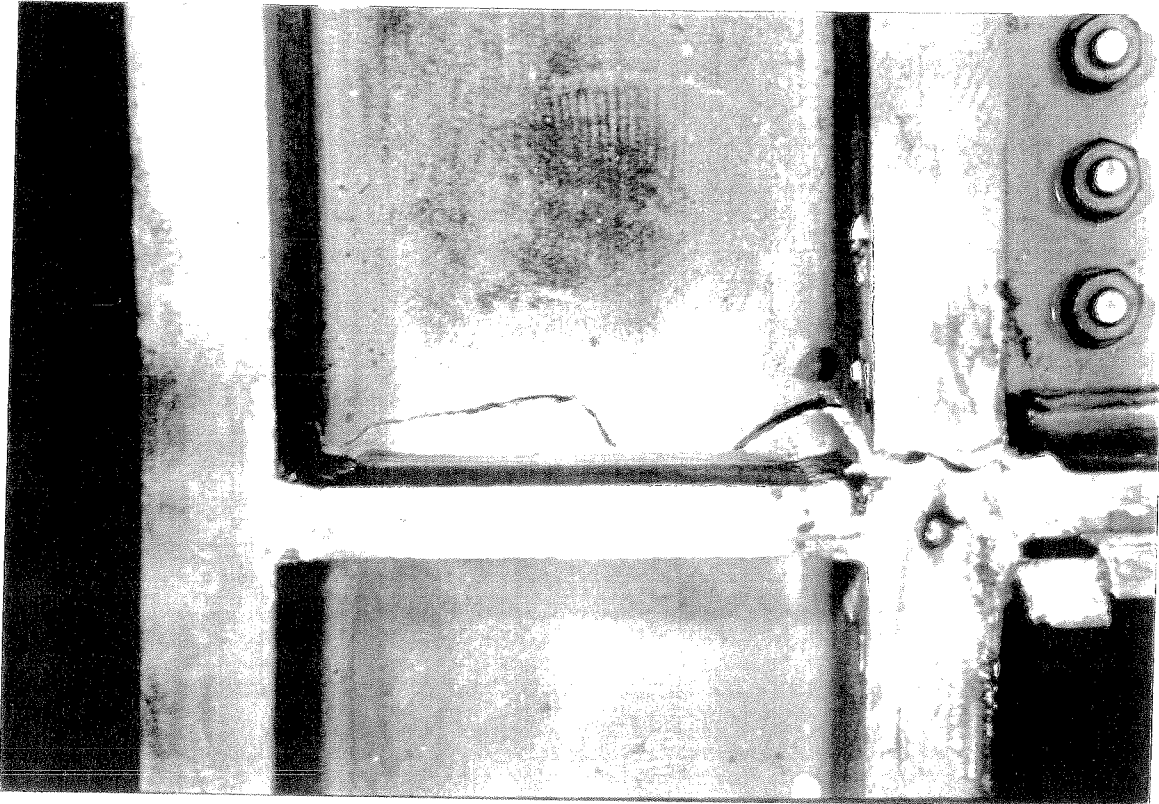
The specimen failed suddenly during the negative excursion of the first 6" cycle. The top cover plate, both column flanges, and the column web were fractured. Photographs in Figures 53 - 58 show fracture of the specimen ADP2.

Inspection of the damaged specimens after the tests seems to indicate that some of the specimens were not fabricated following the welding specifications shown in Figure 1b. This might explain the specimen behavior differences observed during the tests.

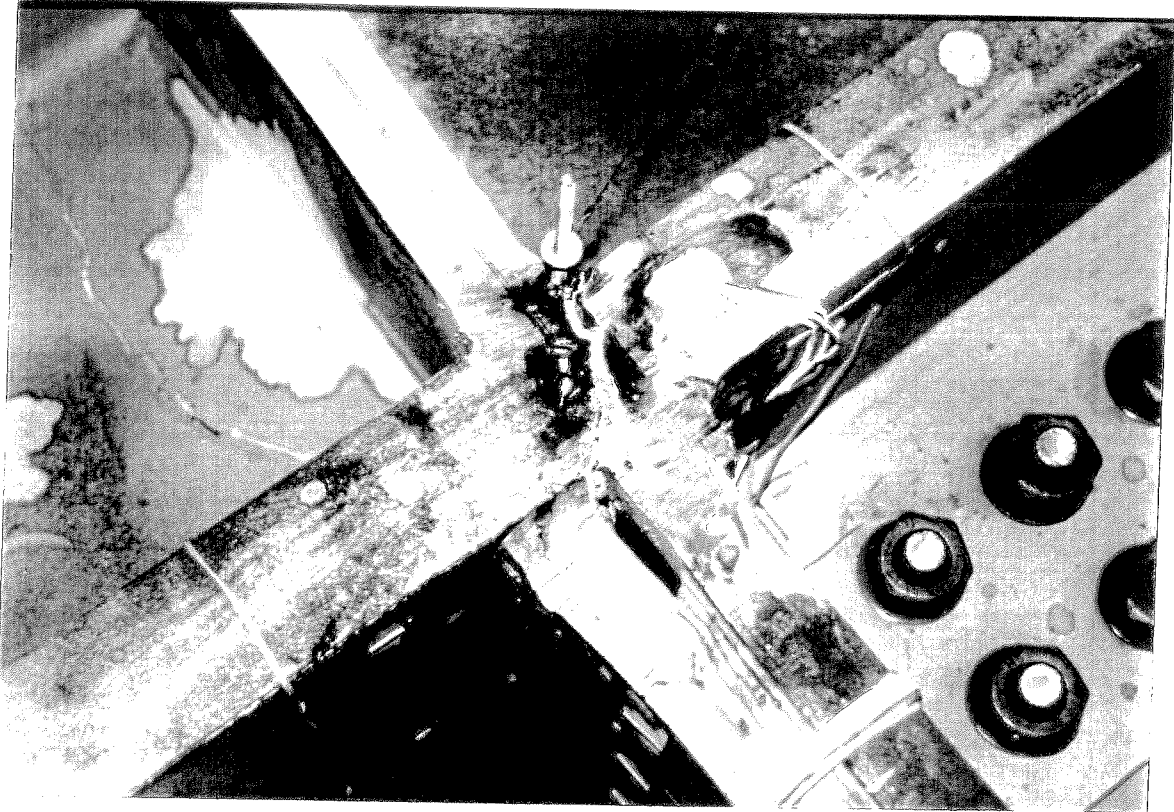
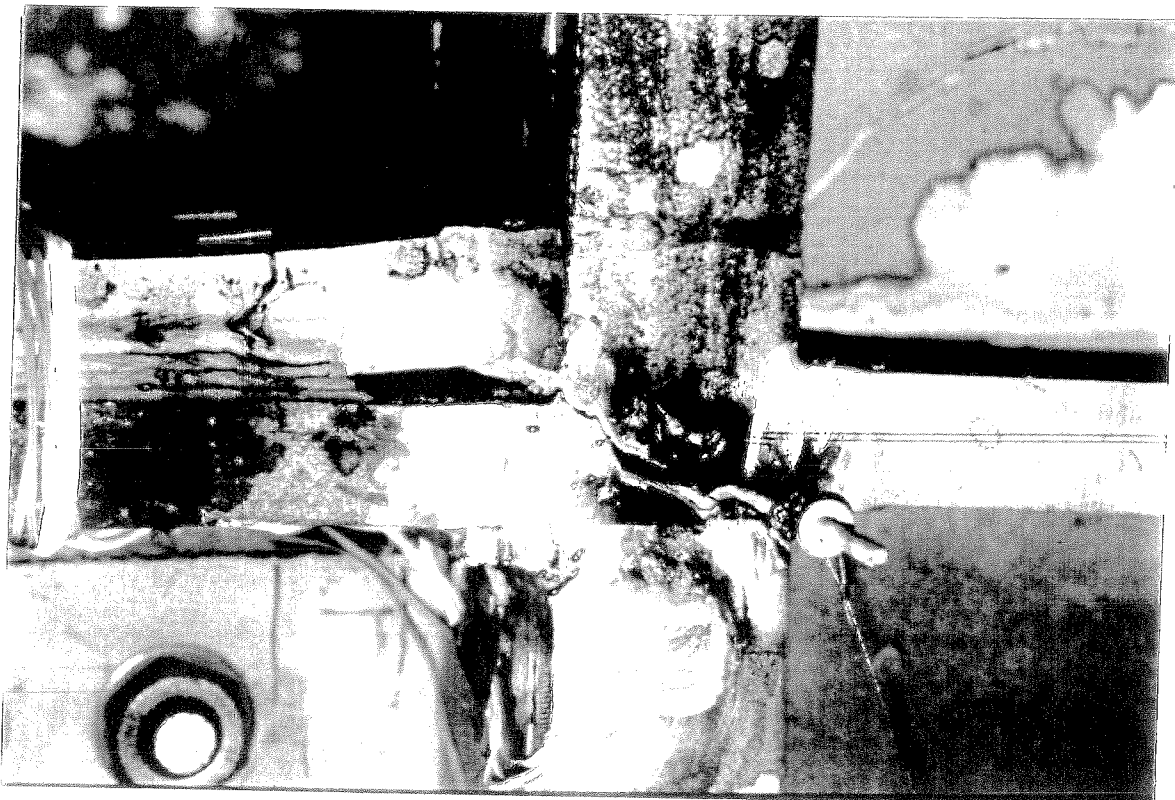
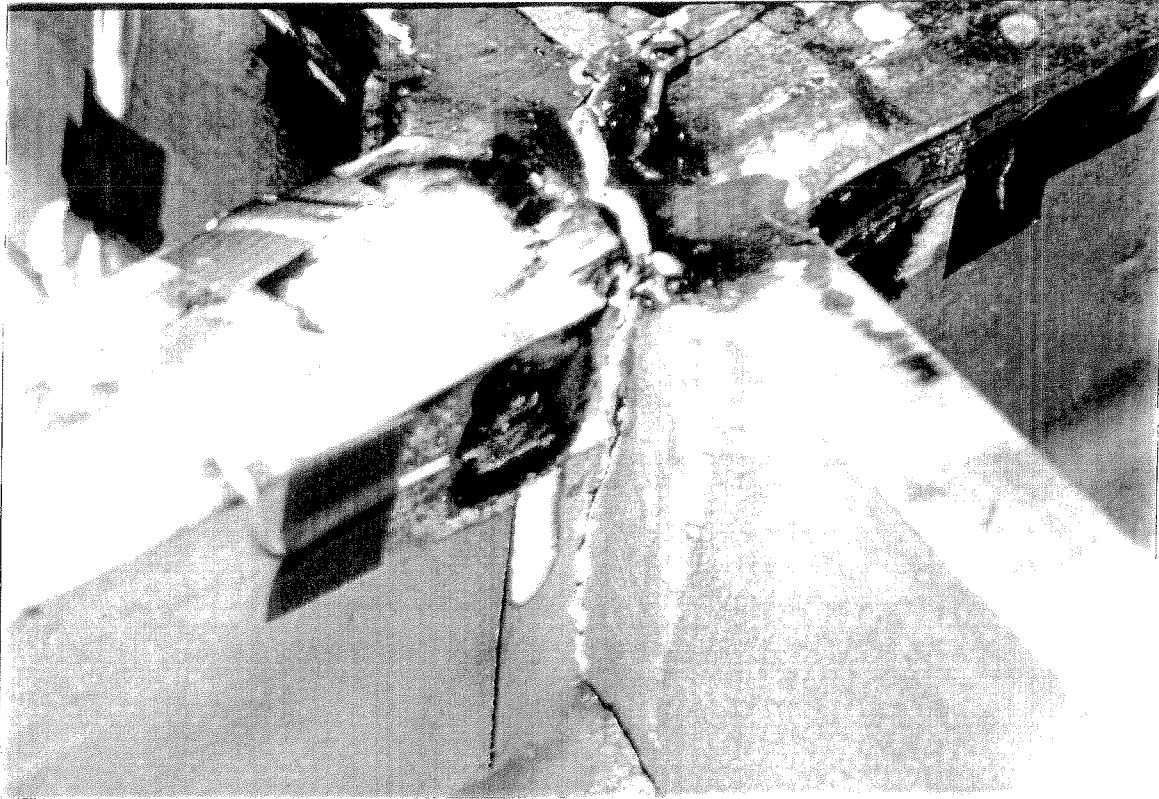
The specimen failed suddenly during the negative excursion of the first 4" cycle. The column flange was fractured completely starting from the junction of top beam flange - cover plate - column flange. Fracture was very similar to that for the specimen 2 but a crack in the column web developed outside the panel zone and the top cover plate was not fractured. Photographs in Figures 79 -82 show fracture of the specimen ADP3.

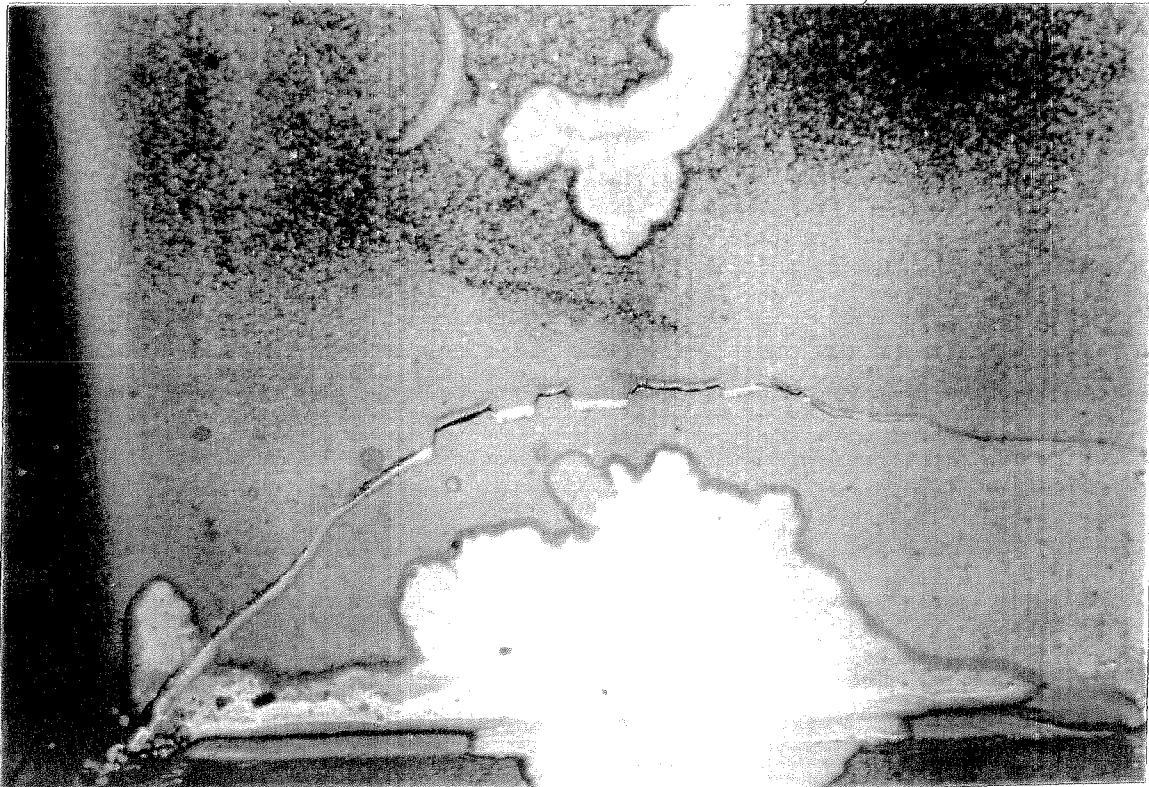
FIGURE 82: PHOTOGRAPH SHOWING FRACTURE OF SPECIMEN ADP3
(COLUMN WEB OUTSIDE PANEL ZONE)
