Post-Project Assessment of Step-Pool and Channel Morphology at Wildcat Creek, Tilden Golf Course

Post-Project Assessment of Step-Pool and Channel Morphology at Wildcat Creek, Tilden Golf Course (Final Draft)

Ashley Cao, Vermouth Li, Carina Swann

LA227 Restoration of Rivers and Streams

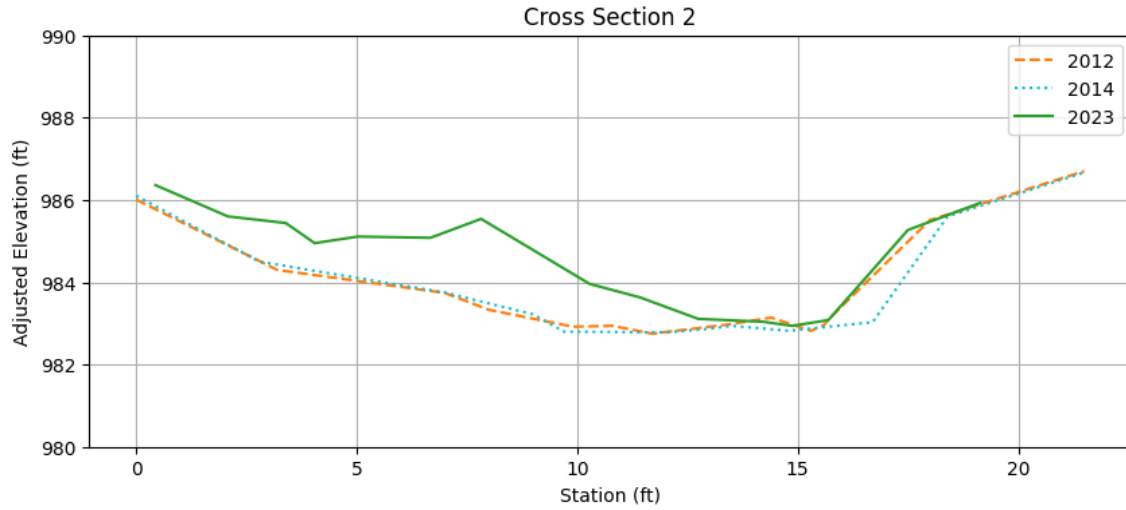
The overlaid cross section profiles of the Restoration Reach are depicted in **Figure 5**. While the left bank aligns remarkably well with the 2012 and 2014 cross sections, we found that the right side of the channel has aggraded. At Station 7.82, the point along the cross section of maximum aggradation, the bank has aggraded 2.17 ft. At the right bank where we found the 2012 stake, the bank aggraded 0.54 ft.

Figure 5: Overlaid 2023 and historical cross sections of Cross Section 2 in the Restoration Reach on Wildcat Creek in Berkeley, CA.

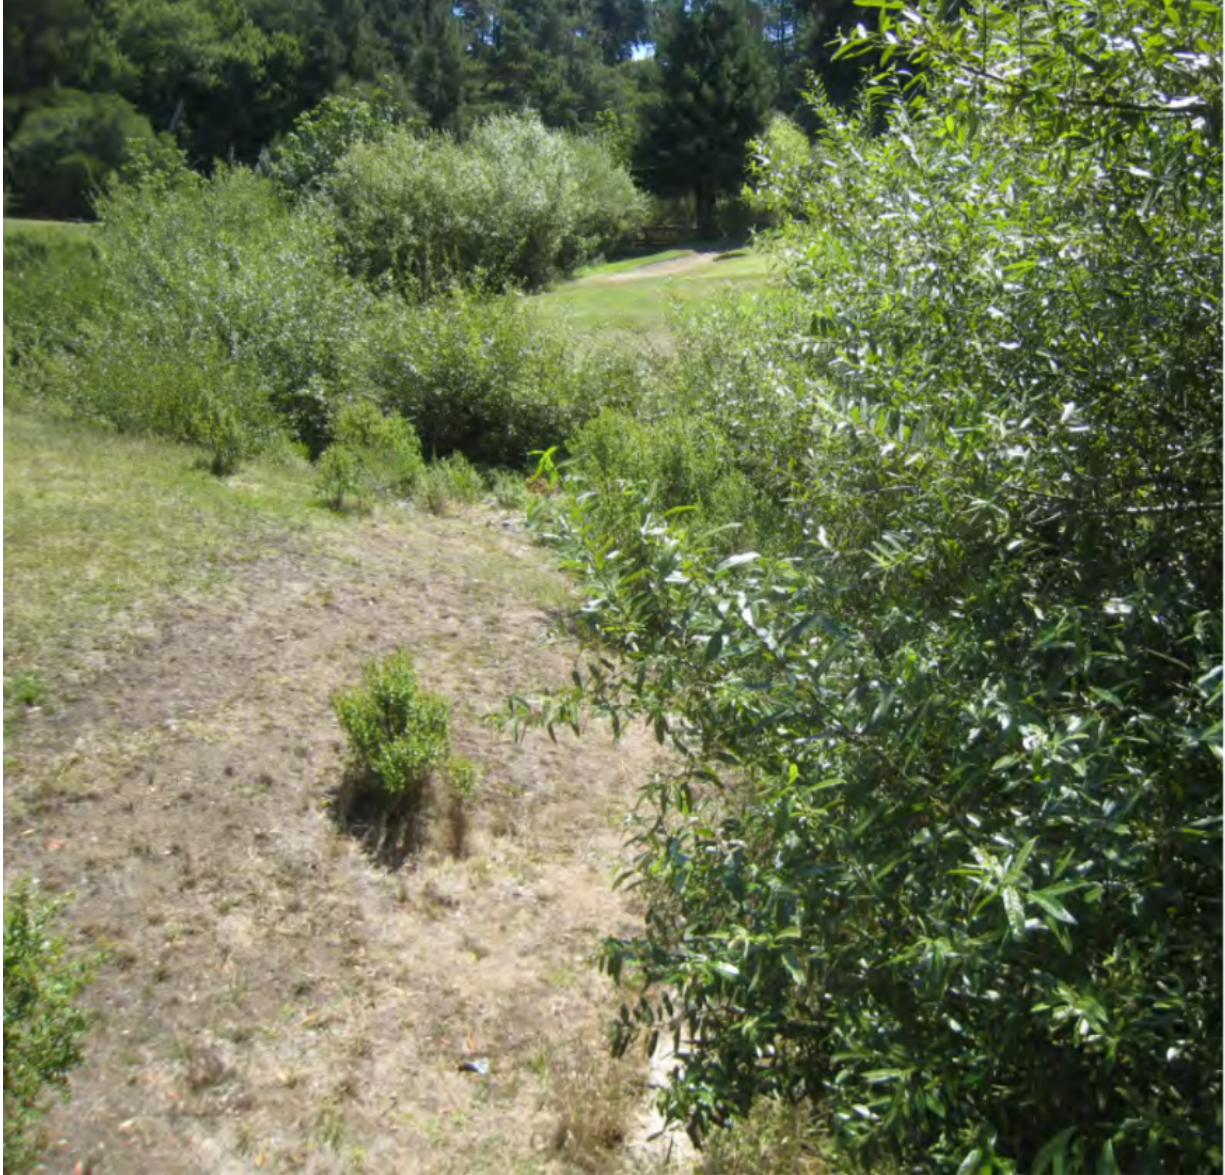
cross-section profile is not always clear in these photos (**Figures 6b & 6c**). The stake that we found from 2012 is located deep underneath thick vegetation of a large willow tree, as shown in **Figure 7**. This is likely why the stake hadn't been found in previous years. Considering the prolific annual growth of willows and that it is highly unlikely that the 2012 and 2014 channel cross sections were taken inside of a willow thicket, we speculate that the large willow tree in the middle of the cross section must have established itself post-2014. We noted that the willow's roots were mostly situated on the right bank where the surface is locally elevated relative to the creek bed. The presence of this willow and its dense root system likely allowed for channel aggradation, as the roots trap sediment and these sediments build over time.

Figure 6b: Photo Point 2, taken in 2014 showing rapid willow growth in just two years post-construction. Originally presented in RDG's 2022 Monitoring Report. Restoration Reach of Wildcat Creek in Berkeley, CA.

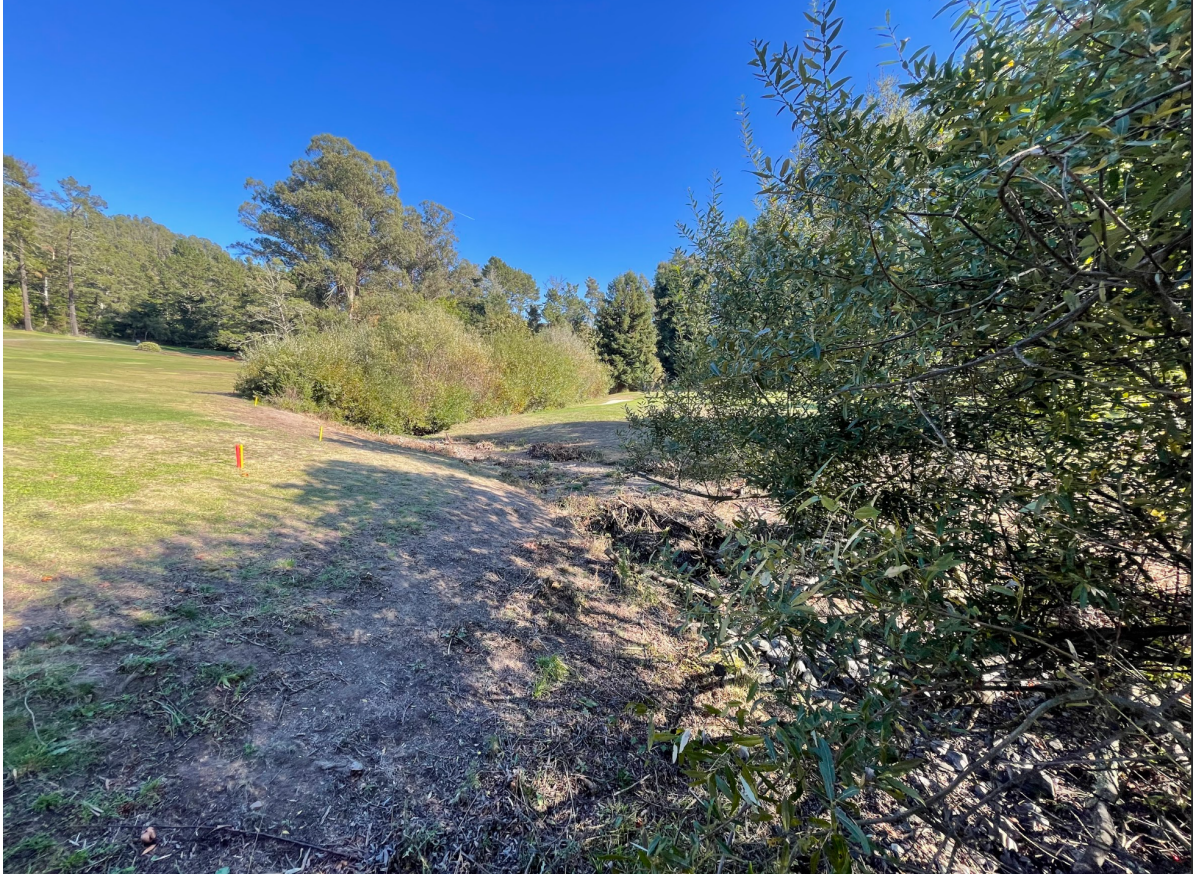
Figure 6c: Photo Point 2, taken in 2023 showing barren area and crop of willow further upstream. Restoration Reach of Wildcat Creek in Berkeley, CA.

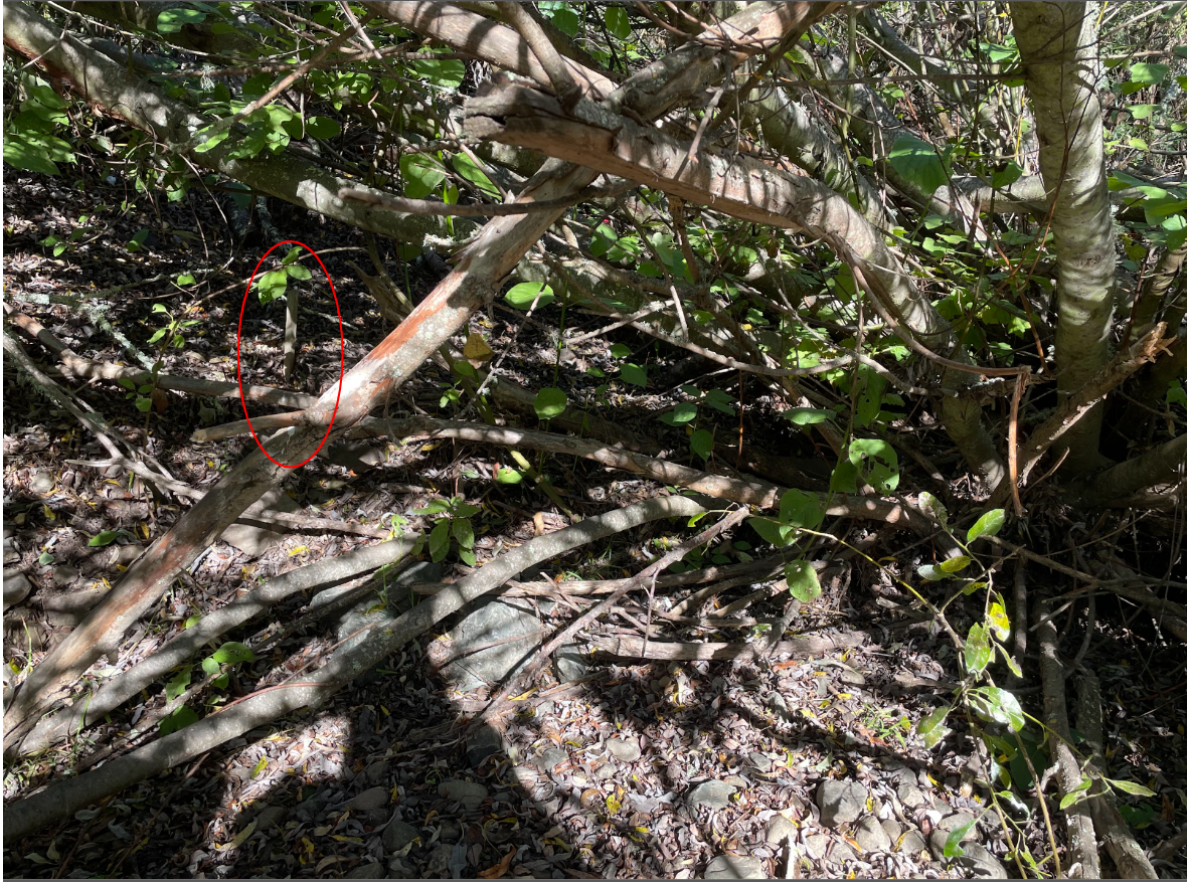
Figure 7: Stake found on the right bank of Cross Section 2 in Restoration Reach at Wildcat Creek in Berkeley, CA.

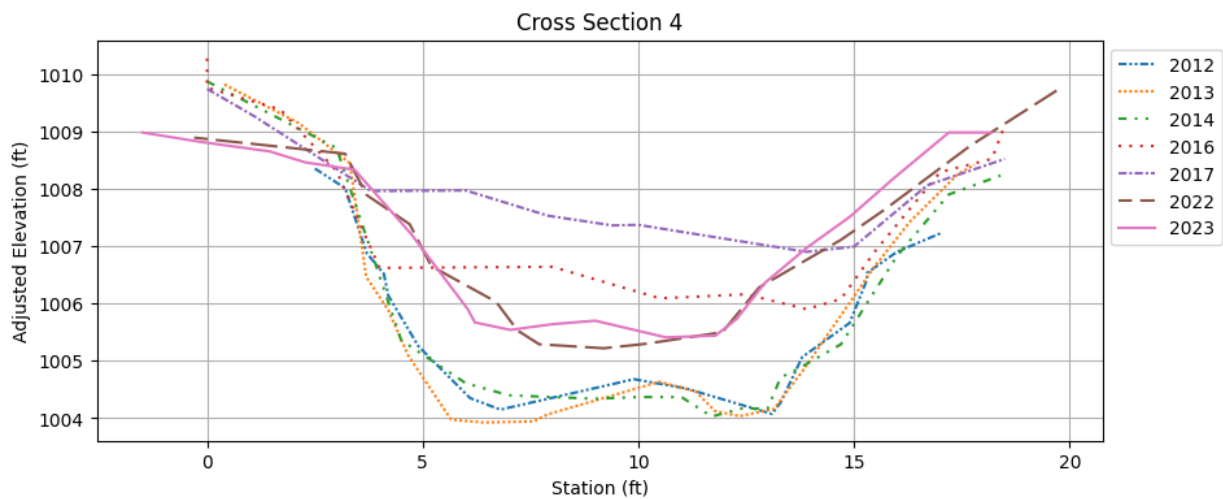
Figure 8 shows the cross-sectional profile of the Experimental Reach for seven years from 2012 to 2023. From 2012 to 2014, the channel morphology remained relatively stable. Between 2014 to 2016, the bed aggraded nearly 3 ft, followed by more than 1 ft of further aggradation from 2016 to 2017. However, between 2017 and 2022, the channel stopped aggrading and instead began to downcut, resulting in a 2 ft lowering compared to 2017. Our 2023 cross section indicates no significant aggradation or incision compared to the 2022 cross section.

We noted in the field that the right bank seemed to be eroding, easily crumbling as we climbed in and out of the channel. Some of this erosion on the right bank is visible by comparing the cross section in 2022 to that in 2023. We did not note, however, any signs of erosion on the Restoration Reach.

Figure 8: Overlaid 2023 and historical cross sections of Cross Section 4 in Experimental Reach on Wildcat Creek in Berkeley, CA.

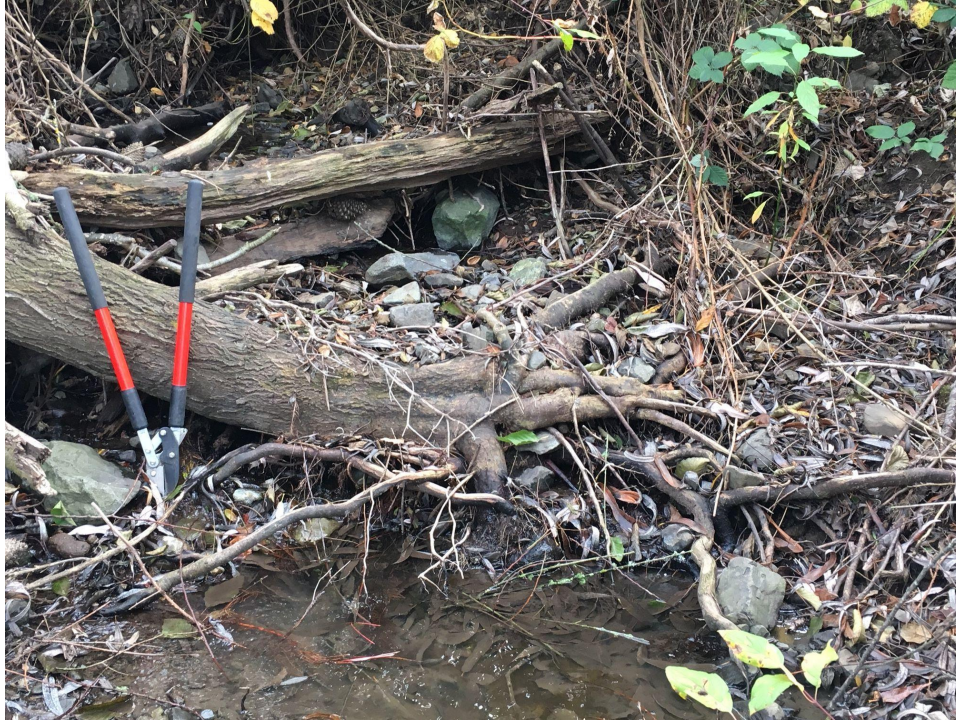
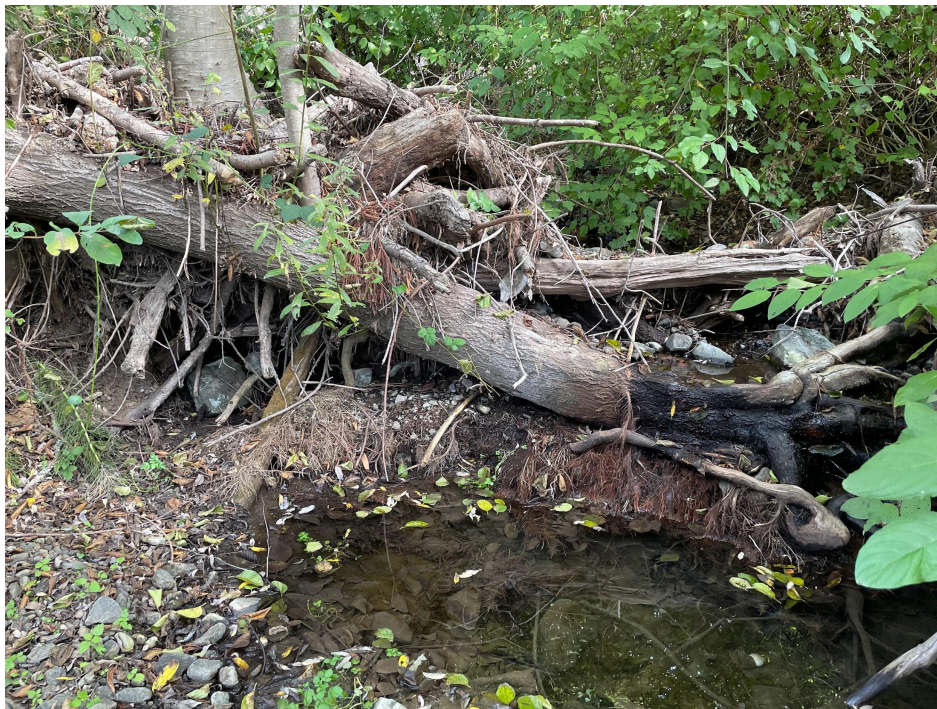
In the winter of 2015-2016, a log jam formed just downstream of the Experimental Reach (**Figure 9 & 9b**), causing 4 ft of aggradation in the upstream Experimental Reach cross section. Despite this disturbance, the 2022 and 2023 cross sections are remarkably similar and in fact echo the original as-built channel form in 2012, suggesting that perhaps the channel may have reached an equilibrium in channel morphology similar to the pre-log jam conditions. Additionally, the log jam may have begun to break down since 2017, allowing increased flows and more incision in the channel bed.

Figure 9a: Photograph of log jam, taken December 2017 by Roger Leventhal and provided in correspondence by Dr. Anne Chin. Experimental Reach of Wildcat Creek in Berkeley, CA.

Figure 9b: Photograph of log jam taken in 2023 Experimental Reach of Wildcat Creek in Berkeley, CA.

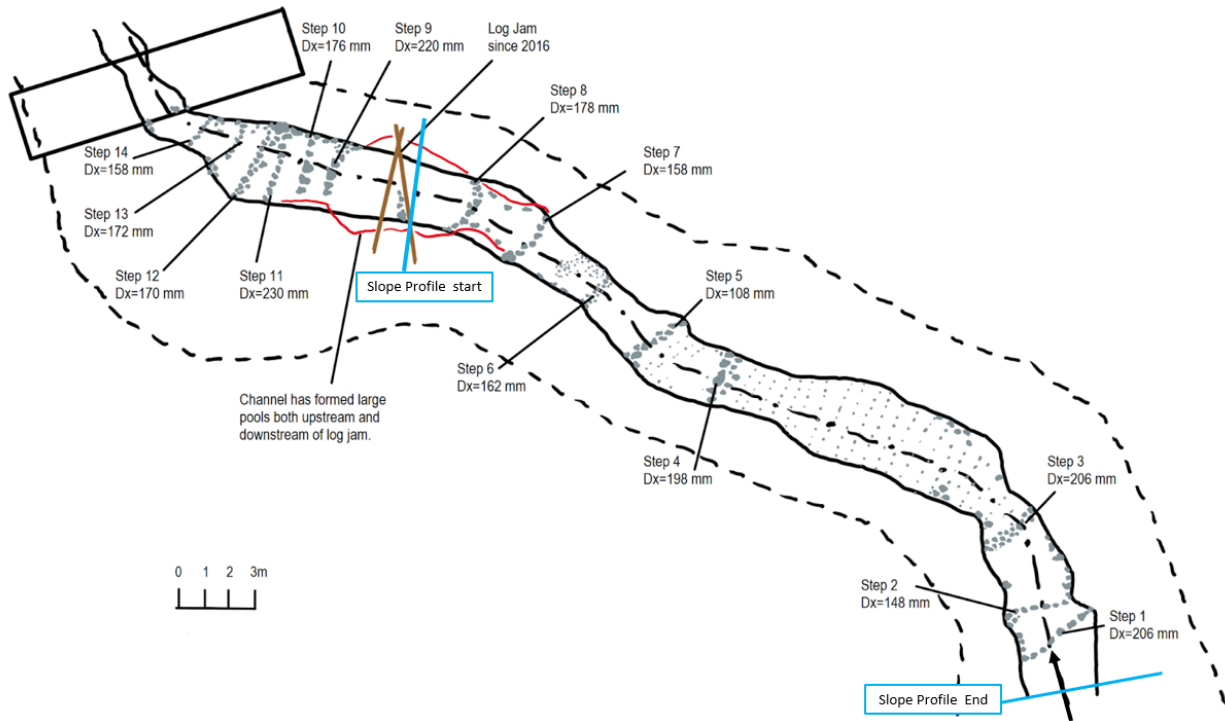
along the Experimental Reach, as we see in the increase in number of step-pools (**Figure 13**). We performed our survey in November, before any significant rains, with no water flow at some spots, and lower creek levels than during Chin's springtime monitoring. This may have led to errors or inconsistencies in our identification of steps.

Upstream of the log jam in the Experimental Reach, the slope decreased from an average of approximately 6.0% in Chin's study from 2012-2015 to 4.2% in our study (**Table 3 & Figure 14**). This slope decrease appears to be due to aggradation from the 2016 log jam, which would reduce transport capacity of the creek and allow finer sediment to deposit (RGD, 2022). Our hypothesis is also corroborated by RGD's Monitoring Report, which noted a reduction in larger sediment in 2022 as compared to previous years due to log jam-induced gravel deposition (RGD, 2022). The change in slope would have little impact on the movement of large rocks out of the reach during high flows, they could substantially impact low flows in their ability to move fine sediment, resulting in increased fine sediment deposition. This log jam has also seemingly altered the channel shape just upstream and downstream the log jam as shown in red in **Figure 13**.

Figure 13: Plan view of step-pool morphology and five-largest rock average at each step in 2023 in the Experimental Reach on Wildcat Creek, Berkeley, CA.

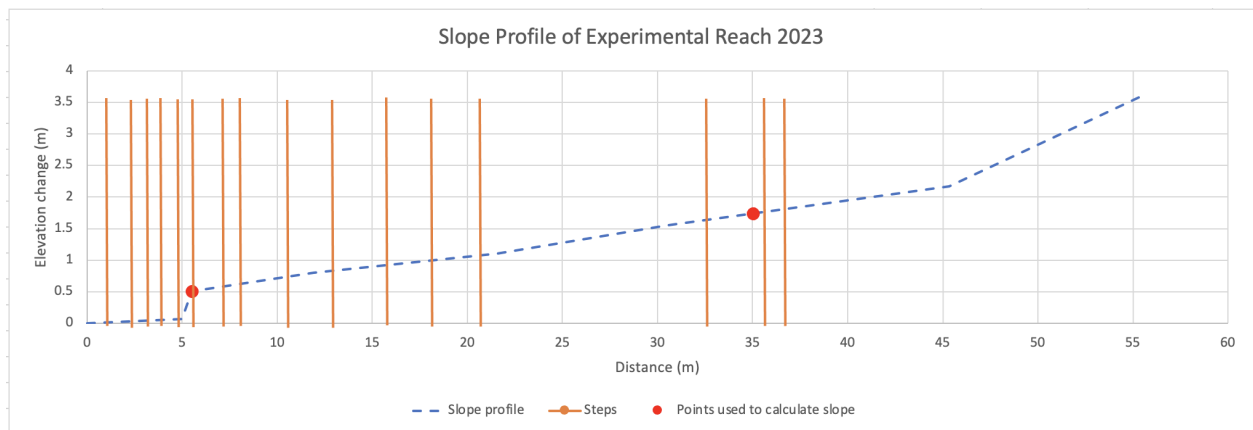
Figure 14: Average slope longitudinal profile and step-pool locations in the Experimental Reach on Wildcat Creek in Berkeley, CA. The red dots indicate the locations used to calculate slope behind the log jam.

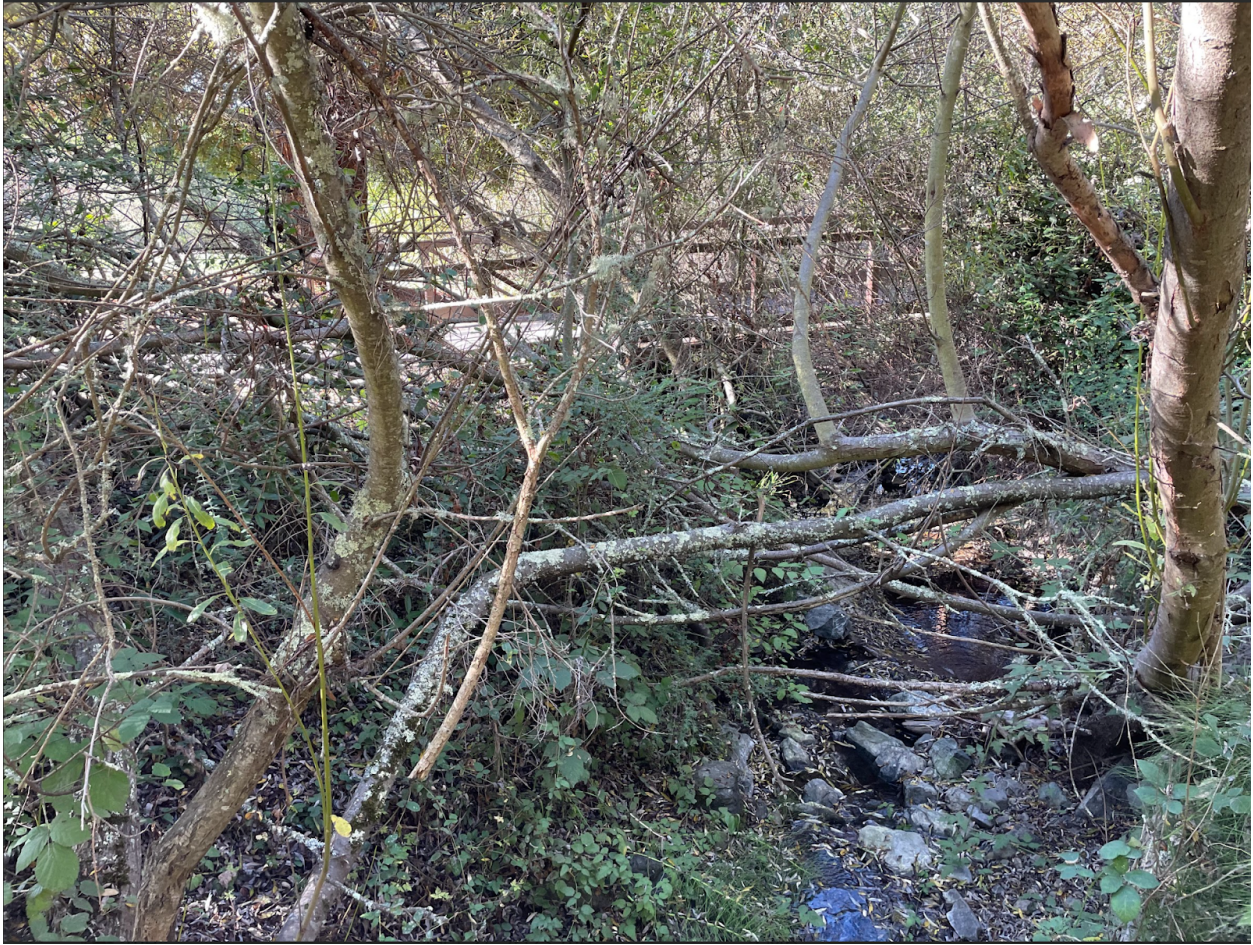
At Photo Point 5, which looks downstream from Middle Hole 11 Bridge at Lower Hole 11 Bridge, there are slight changes to specific rocks within the step-pools pictured in the photo point from 2022 to 2023. However, there remains a notable self-organization of rocks within the channel bed (**Figure 15 & 15b**). Additionally, at Photo Point 6, which looks upstream from Middle Hole 11 Bridge, shows a tree growing horizontally across the middle of the channel bed during the 2012 construction (**Figure 16**). This is likely the tree which fell and created a log jam in 2016, as it disappeared in subsequent photo points post-2016 and in its place is the log jam (**Figure 16b**). Each year's photos since then have shown bed aggradation upstream of the log jam and a resultant large pool forming downstream (**Figure 16c**). Photo Point 7, looking upstream from Upper Hole 11, shows that during the 2012 construction, the rocks were organized in very neat clasts creating steps and pools (**Figure 17a**). This distinct arrangement remained fairly visible in 2017 (**Figure 17b**), but in 2023, more medium-sized rocks appeared within the pools, creating a less clear distinction between step and pool than in the 2012 construction (**Figure 17c**). Apart from aforementioned photo points, most others, including ours and previously documented ones, are not very useful for comparing changes in the channel bed, as they were either taken at different perspectives than previous years or the landscape features of interest are obscured by vegetation.

Figure 15b: Experimental Reach on Wildcat Creek, Berkeley, CA. Photo Point 5, taken in 2023. There are some changes in how the rocks are organized in the channel bed between 2022 and 2023.

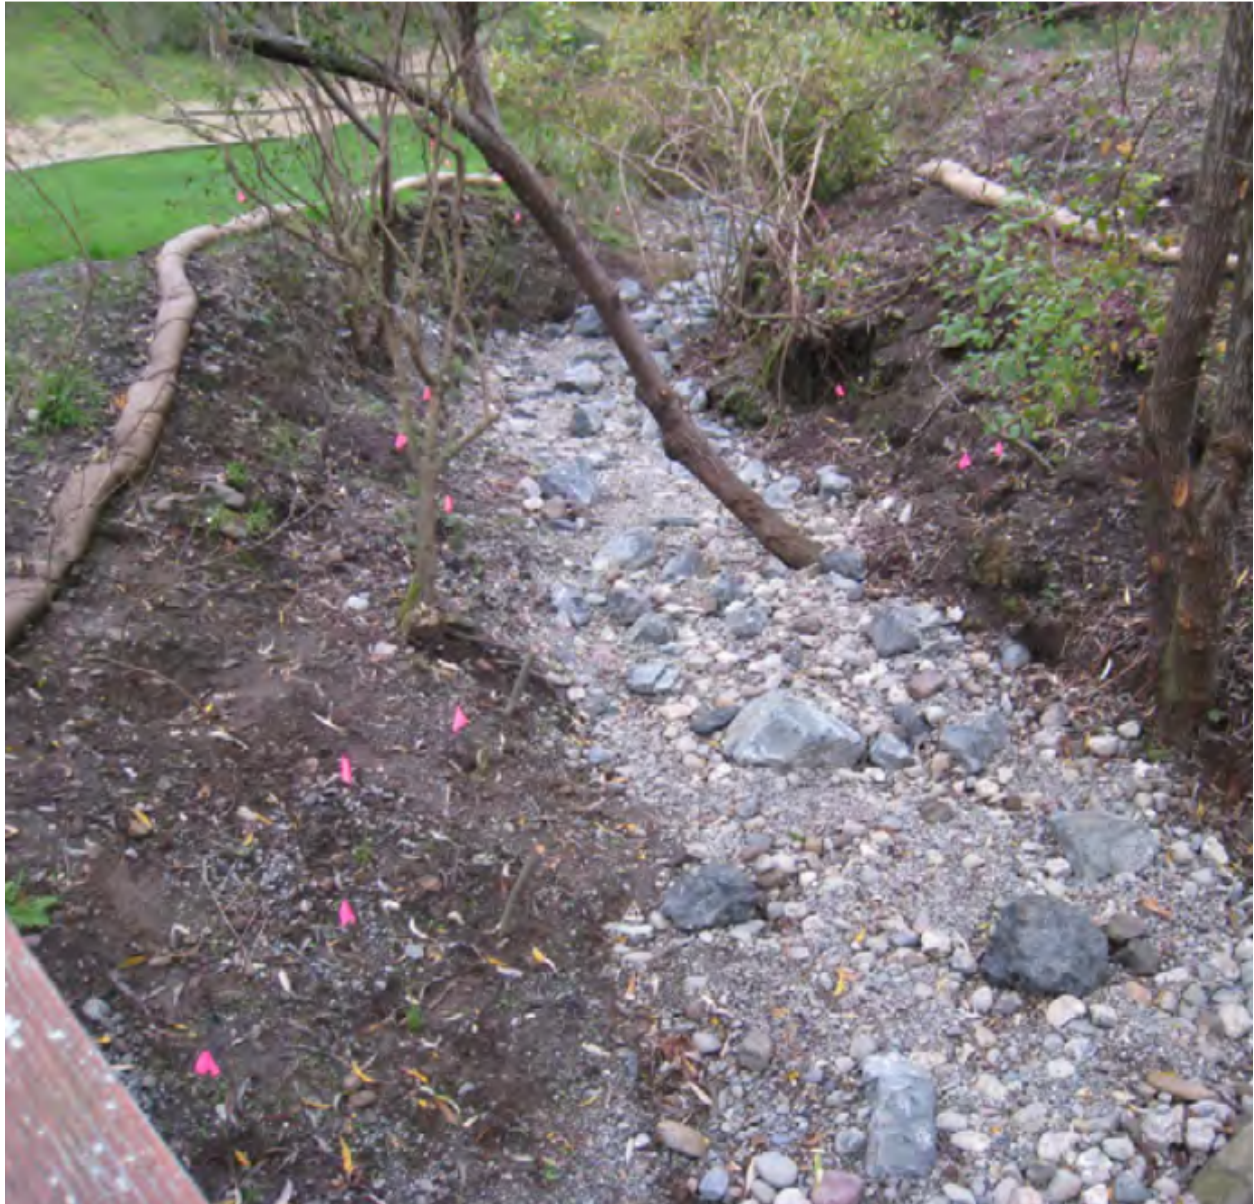
Figure 16a: *Experimental Reach on Wildcat Creek, Berkeley, CA. Photo Point 6, taken post-construction in 2012. The willow growing in the bed is likely the willow which fell and caused the log jam in 2016. Originally presented in RDG's 2022 Monitoring Report.*

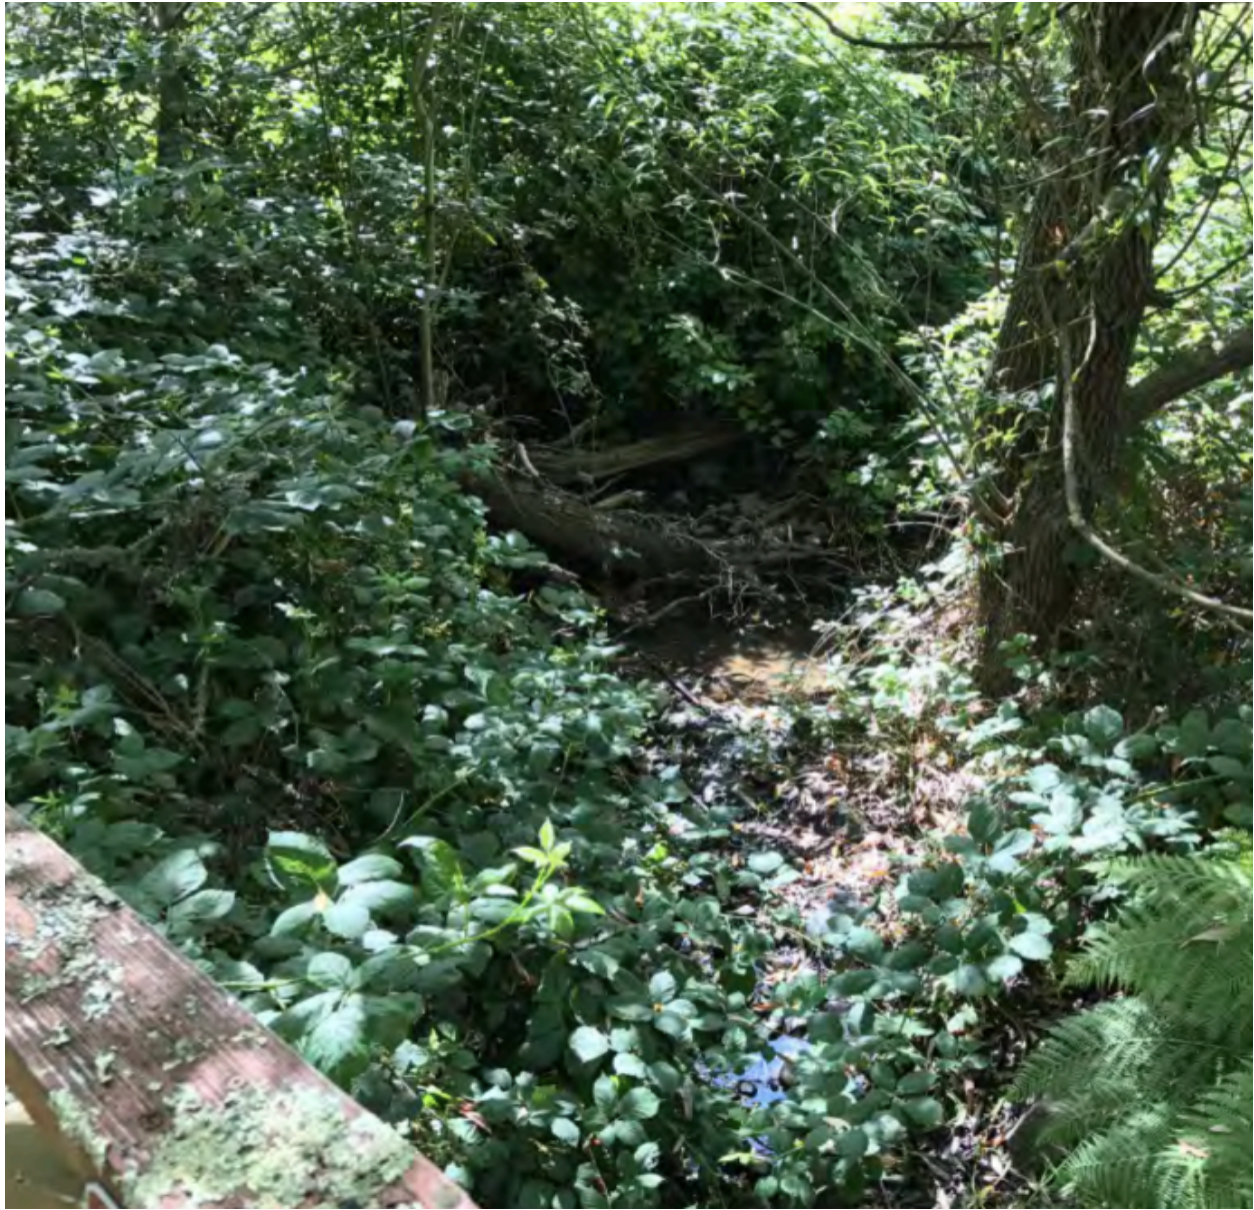
Figure 16b: *Experimental Reach on Wildcat Creek, Berkeley, CA Photo Point 6, taken in 2017 . The willow pictured in Figure 16a has fallen and created a log jam. Originally presented in RDG's 2022 Monitoring Report*

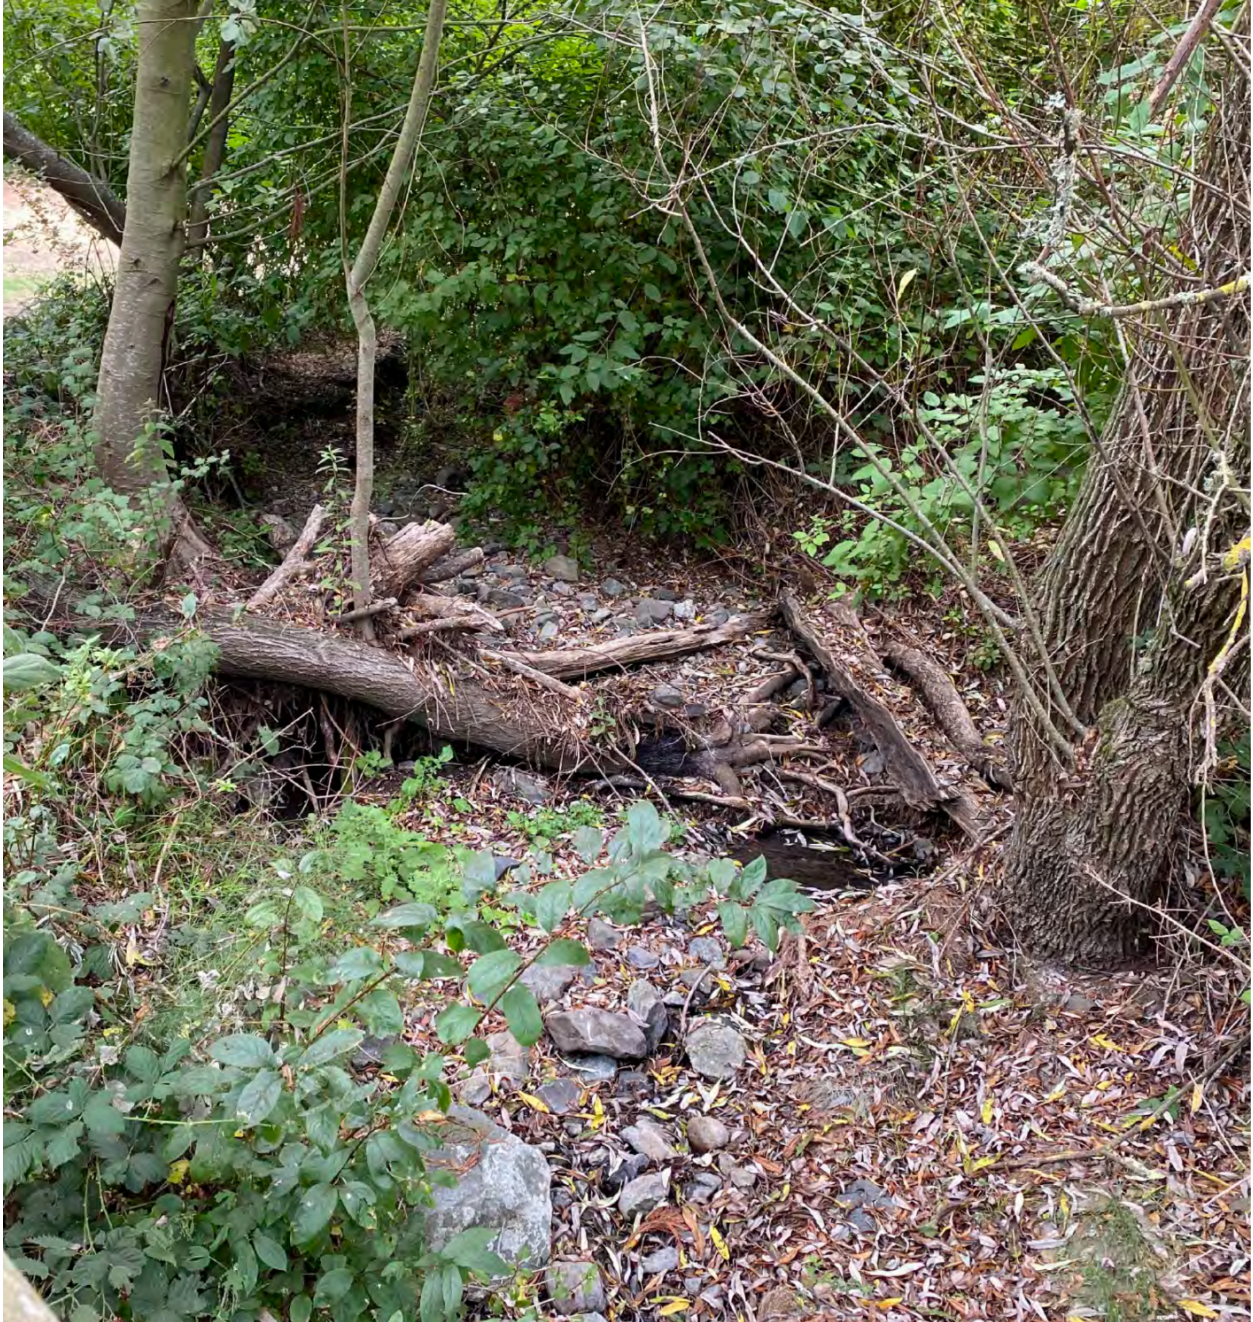
Figure 16c: *Experimental Reach on Wildcat Creek, Berkeley, CA Photo Point 6, taken in 2022. The fallen willow is shown as well as a deep pool which has formed immediately downstream of the log jam. Originally presented in RDG's 2022 Monitoring Report.*

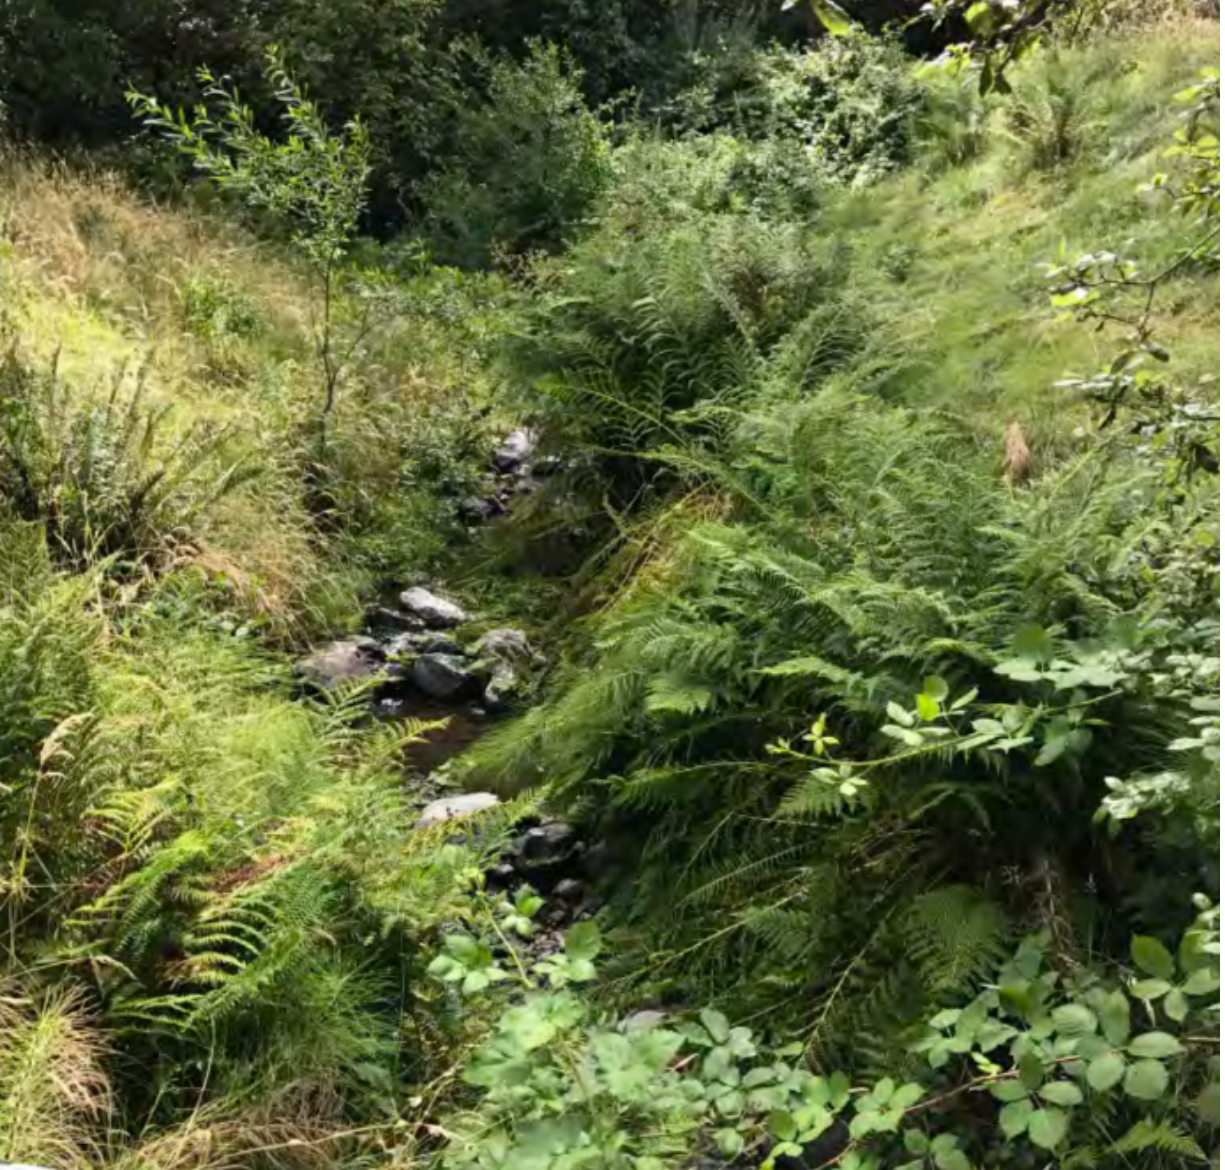
Figure 17b: *Experimental Reach on Wildcat Creek, Berkeley, CA. Photo Point 7, taken in 2017. The structure of steps and pools is still very much clear and present here.*

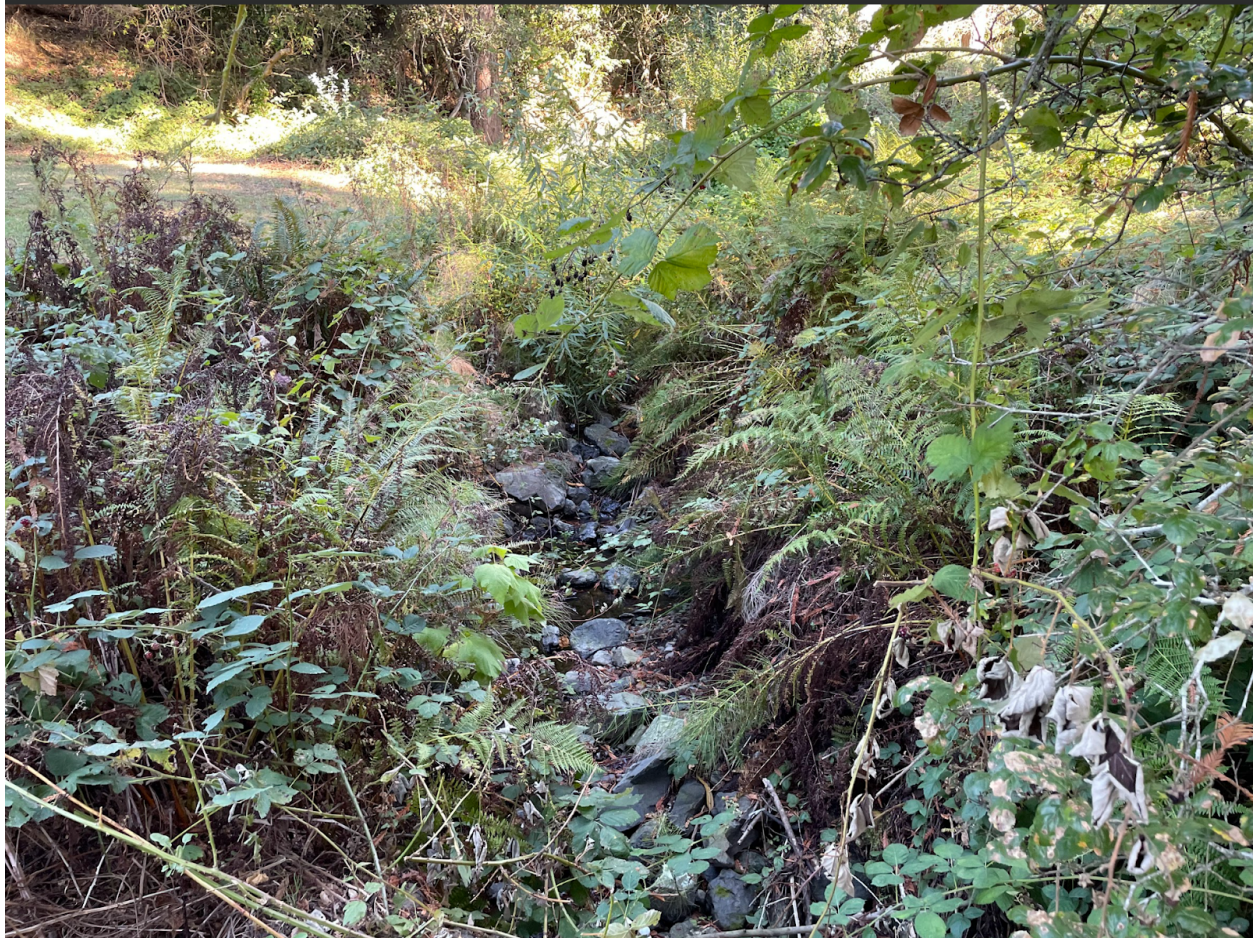
Figure 17c: Experimental Reach on Wildcat Creek, Berkeley, CA. Photo Point 7, taken in 2023. More medium-sized rocks are present, making the clear distinction between steps and pools less visible here.
