The implementation of the Lower Silver Creek watershed project

# The Implementation of the Lower Silver Creek Watershed Project

**Christina Keenan and Mariah McPherson**

**November 12, 2003**

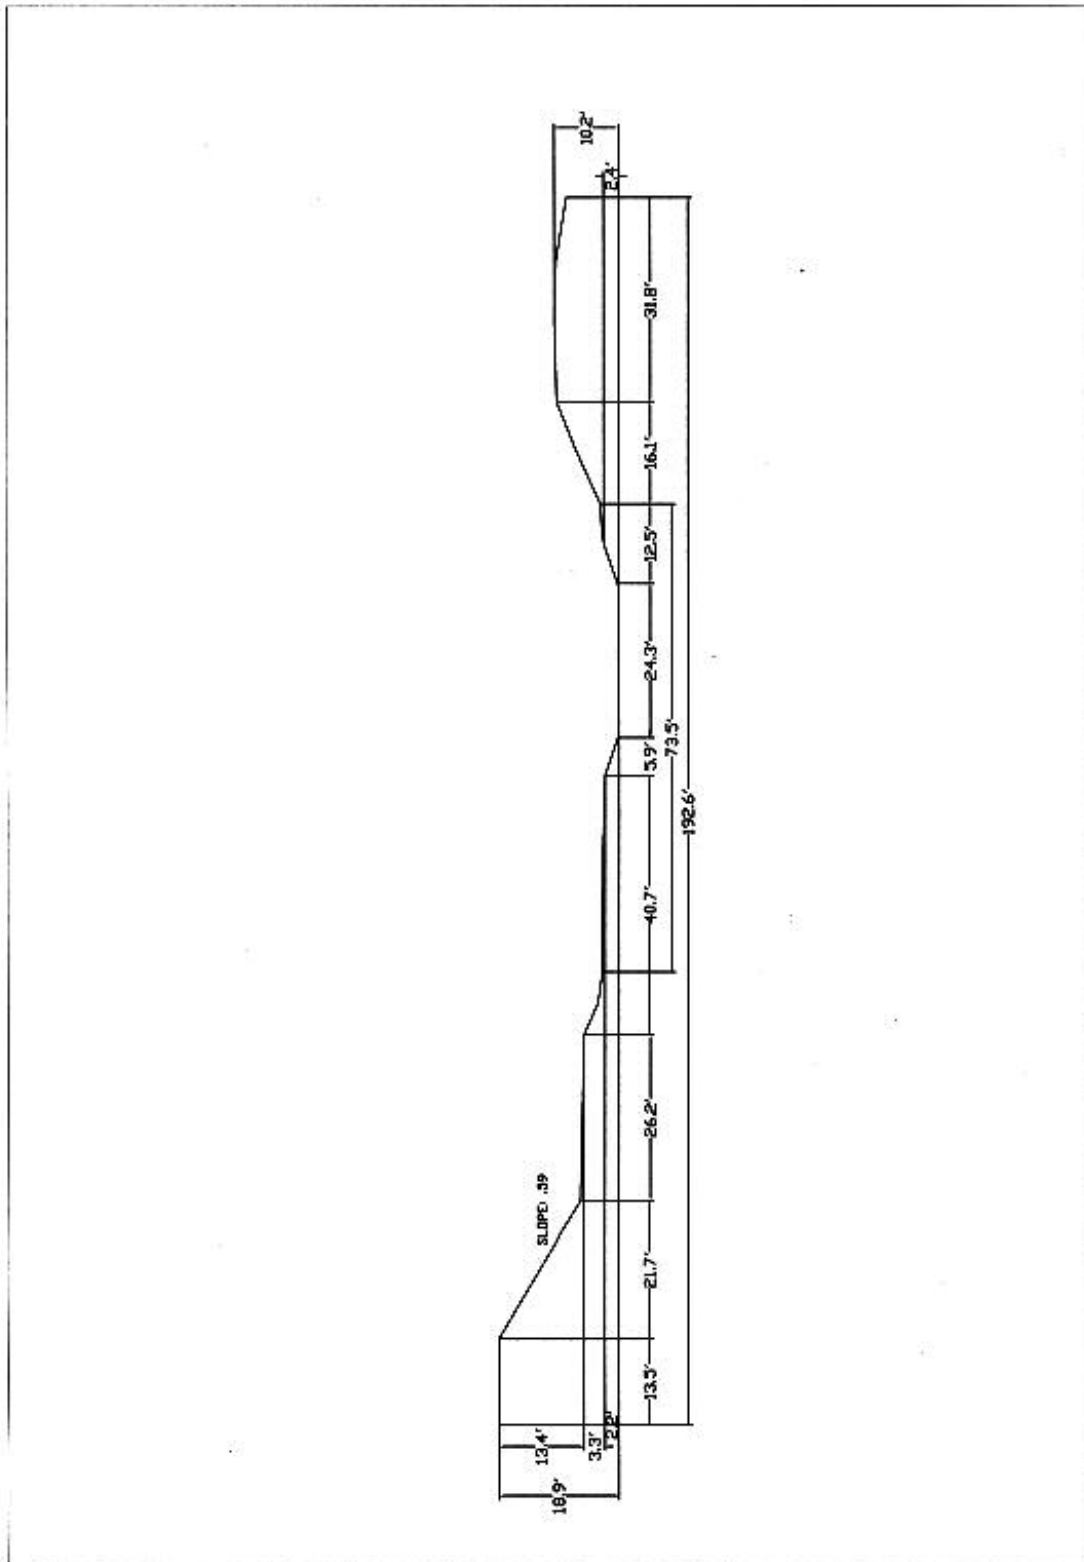
Figure 6: Cross Section One

The depth from the bottom of the channel to the top of the bank was designed to be approximately 18 feet. This dimension was consistent with actual measurements with the exception of the south bank of cross section one, which was only 10.2 feet high. This deviation should not affect the channel's ability to carry flood water due to its proximity to the confluence with Coyote Creek. During a large flood, Coyote Creek will inundate the area near the south bank of cross section one regardless of the height of the bank.

One major discrepancy between the designs and the surveyed cross sections was the width of the low-flow channel. The 1998 plans specified a low-flow channel that was 6 feet in width that would be held in place with willow fascines and a tri-lock block

maintenance road. However, the actual width was approximately 24 feet in cross section one and 19.5 feet in cross section two. Alterations were made to the design drawings in 2001 and the low-flow channel was widened to carry channel-forming flows. The width of this sediment transport channel, unspecified in the 2001 Alteration Plans, is maintained by buried rock walls. A meandering low-flow channel with riffles and pools is expected to form 'freely' after a one- or two-year flood event and establishment of vegetation. The plan anticipates the formation of wetlands in the sediment channel, outside of the low-flow channel. This coupled with the riparian vegetation will decrease the velocity of water (M. Tompkins, University of California, personal communication, 2003).

We recommend that a monitoring plan be continued for reach 1a of Lower Silver Creek. Monitoring could include resurveying cross sections one and two using the established

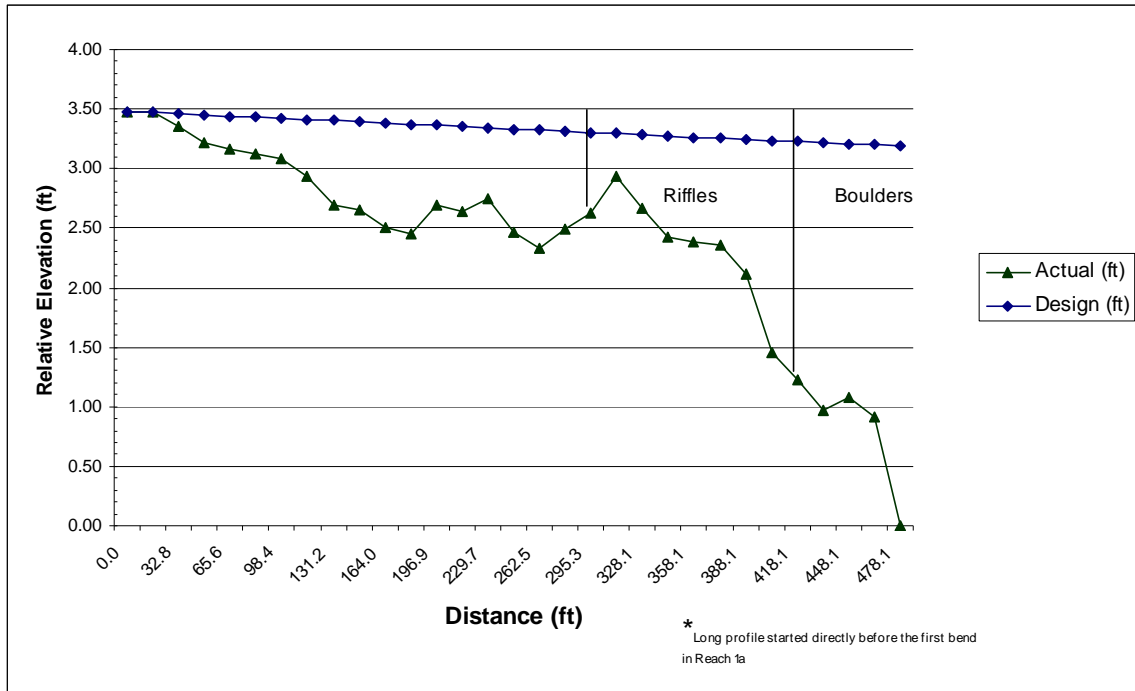
Figure 8: Longitudinal profile

The second difference between the designs and the survey measurements was the slope of the low-flow channel. We used the 500-foot longitudinal profile for the straight section of reach 1a (Figure 8) to determine the channel slope. The design slope was 0.0006 and the actual slope was 0.0055 to 0.0073, an order of magnitude steeper. The longitudinal profile shows a fairly constant slope until a sharp drop-off at the last measured data point. Small pools, corresponding to the last point, had formed behind the rocks at the confluence with Coyote Creek and may have exaggerated the slope at the end of the stream. The 0.0055 value is the slope of the profile calculated without including the last point. Possible explanations for the discrepancy between the design and actual slopes include poor design, local scouring at the confluence of Coyote Creek, and surveying error. The slope may decrease over time due to sediment deposition at the confluence of Coyote Creek and formation of the meandering low-flow channel within the sediment transport channel.

The combination of a higher channel bed slope and a lower roughness has multiple negative implications for this project. The maximum channel capacity, velocity, and shear stress will be significantly higher than planned, resulting in increased sediment transport and the mobilization of larger sediments. This erosion will lead to bank destabilization and could potentially wash out portions of the project. An example of erosion can be seen in photographs 58 through 61, which show the results of a burst one-inch irrigation pipe on an un-vegetated bank in reach 1a. Additional examples of erosion can be seen in photographs taken by M. Tompkins on November 9, 2003 during a rain event and by C. Keenan on November 16, 2003 after several small storms. The elevated flow during these rain events exposed the buried rock walls and caused a new channel to form around the rocks near the confluence of Coyote Creek (Photographs 63-71). It is evident from these photographs that erosion will be extensive if there is a large rain event before vegetation is planted or before vegetation is established.
