Concrete Overlay on Asphalt Pilot Project at Woodland SR 113: Construction

**REPORT DATE OF PUBLICATION: July 2021**  
**Research Report: UCPRC-RR-2020-01**

Partnered Pavement Research Center (PPRC) Project Number 3.39 (DRISI Task 3201):  
Implementation and Field Performance Evaluation of Concrete Overlay on Asphalt

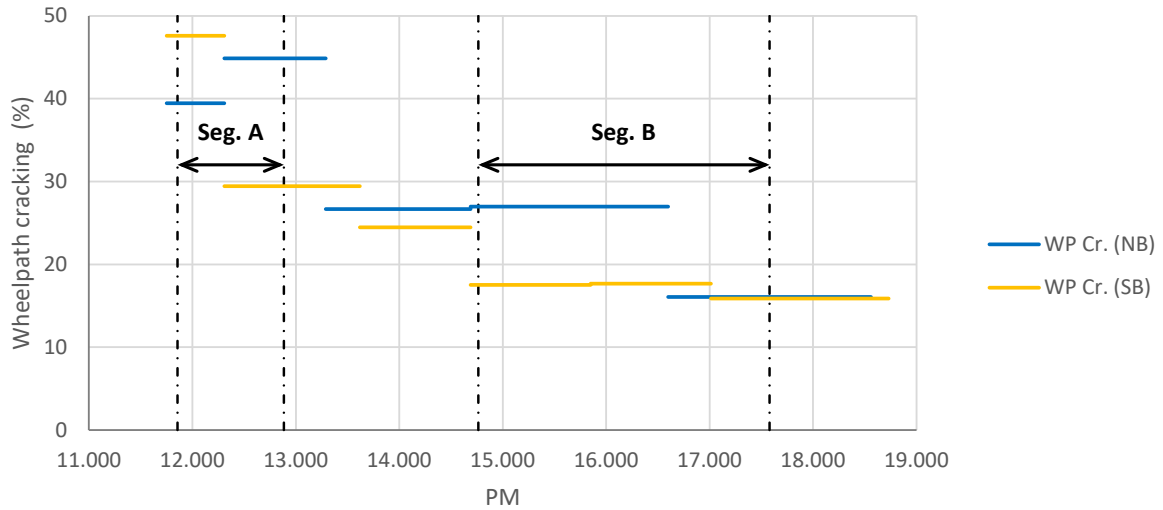
Before construction, the condition of the existing asphalt pavement at the project site was relatively poor, mainly due to the presence of alligator cracking in the wheelpaths (Figure 2.2). Cracking was more severe in Segment A than in Segment B, probably due to the greater number of trucks and their heavier weights. Rutting was relatively low, varying from 0.1 to 0.2 in. (Figure 2.3). The data used to generate Figure 2.2 and Figure 2.3 come from the Caltrans Automated Pavement Condition Survey. The evaluation of the existing asphalt pavement's condition included coring and falling weight deflectometer (FWD) testing, as explained below.

Figure 2.2: Condition of the existing asphalt pavement: cracking.

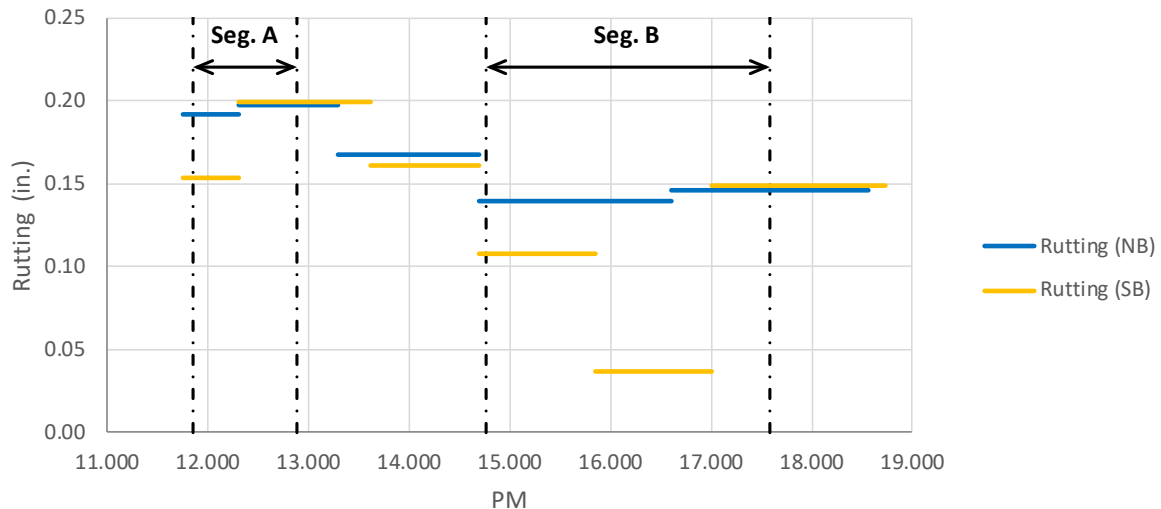
Figure 2.3: Condition of the existing asphalt pavement: rutting.

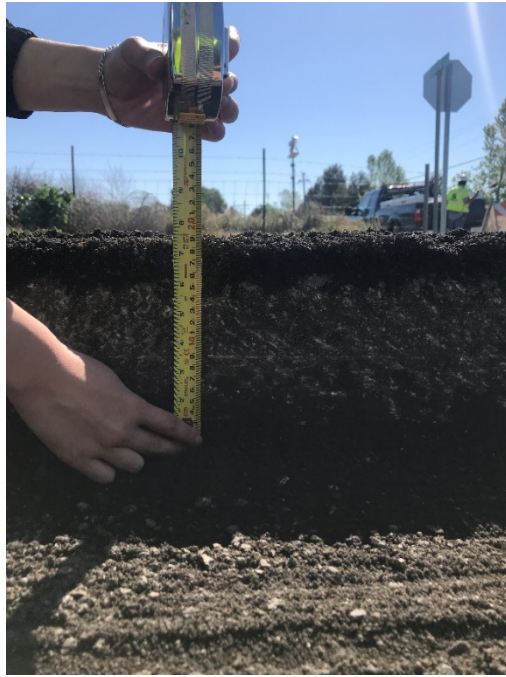
**Figure 4.2: Milled asphalt thickness deeper than the 6 in. target value.**

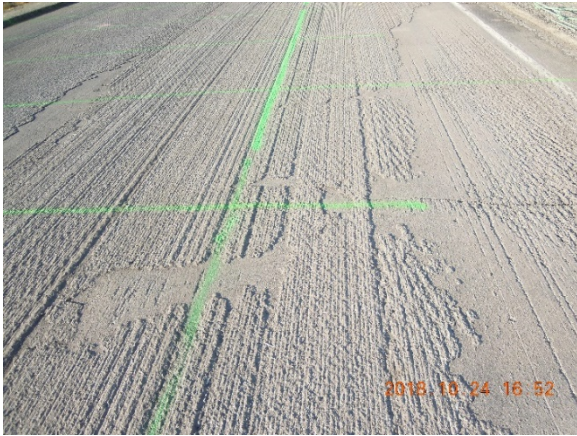
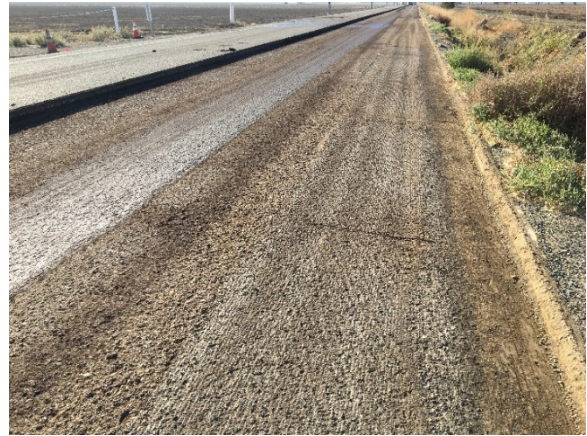
Overall, the milling operation revealed an asphalt base in poor condition. Cracking and areas of delamination were present all over the project (examples in Figure 4.3). Further, in many locations the milling operation either left an insufficient asphalt base or entirely removed the asphalt base at the shoulder edge of the roadway, as shown in the photographs in Figure 4.4. As can be seen in those photographs, the width of the available milled asphalt base was too narrow to provide a continuous support under the COA slabs, which would leave the shoulder edge of the exterior slabs resting on the aggregate subbase instead of the milled asphalt base. This structural condition may eventually cause longitudinal cracking of the concrete overlay. At some locations, the shoulder edge of the milled roadway was paved with asphalt to provide a uniform support for the COA slabs (Figure 4.5).

Segment B: Asphalt cracking and areas with delamination

**Figure 4.3: Appearance of the asphalt surface after milling.**

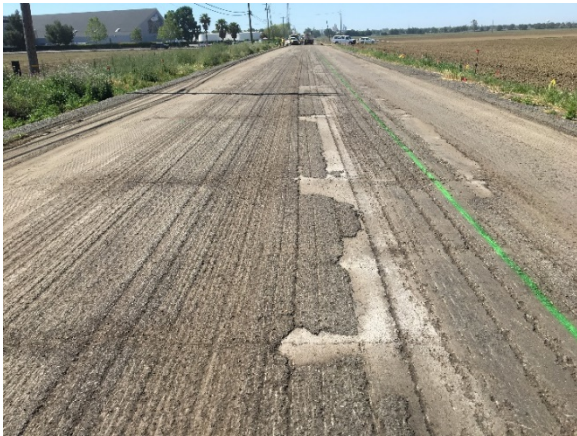
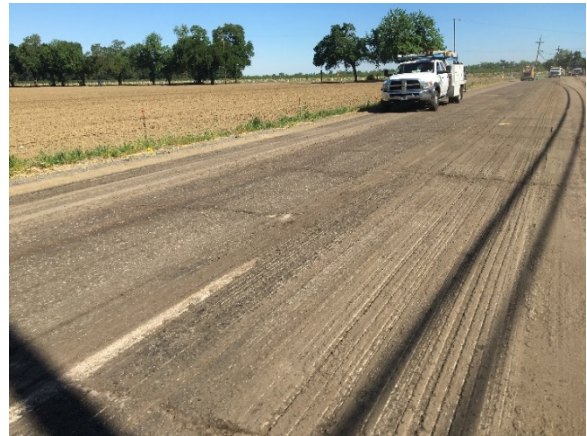
Segment A: Asphalt cracking and areas with delamination

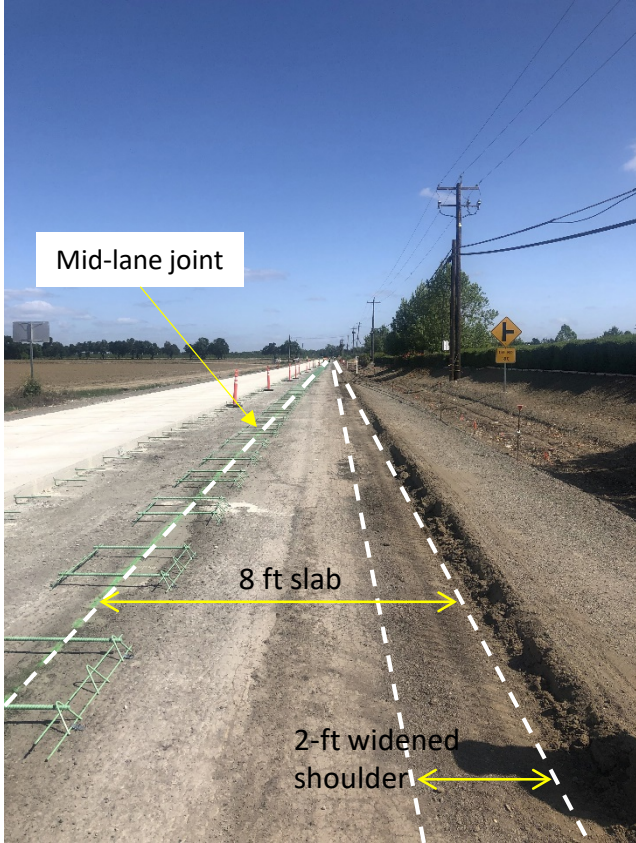
Example on Segment A

**Figure 4.4: Insufficient or and missing asphalt base.**

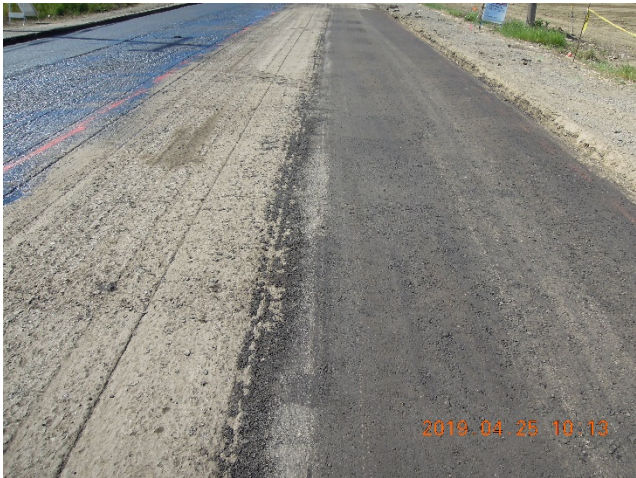
See asphalt patch on the right side of the picture

**Figure 4.5: Asphalt patching on areas with insufficient or missing asphalt base.**

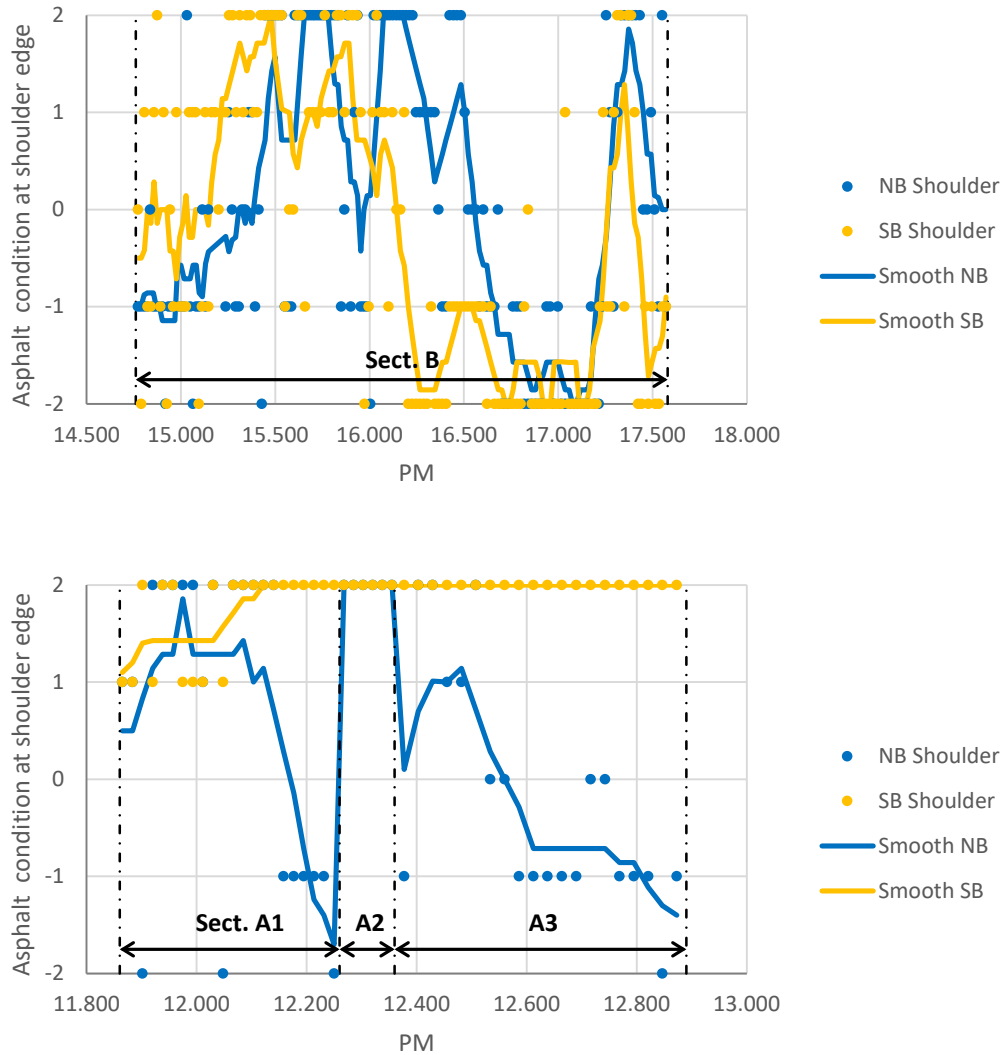
The data in Figure 4.7 indicate that the lack of asphalt base at the shoulder edge of the roadway occurs all over the project, with the exception of Segment A in the southbound direction. In Segment B, the asphalt base condition at the shoulder was especially poor. This segment's condition was attributed to (1) its original asphalt thickness only being 9 to 11 in., (2) the milling depth exceeding the 6 in. target value by 1 to 2 in., and (3) the thicker asphalt in the wheelpaths and at the center of the road than at the shoulder. As milling progressed on the overall project, the cross-slope produced by the operation occasionally exceeded the existing slope, resulting in greater milling depth at the shoulder than at the center of the roadway. This seemed to have occurred on southbound Segment B, between PM 16.000 and PM 17.580.

**Figure 4.7: Asphalt condition at the shoulder edge of the COA slabs.**

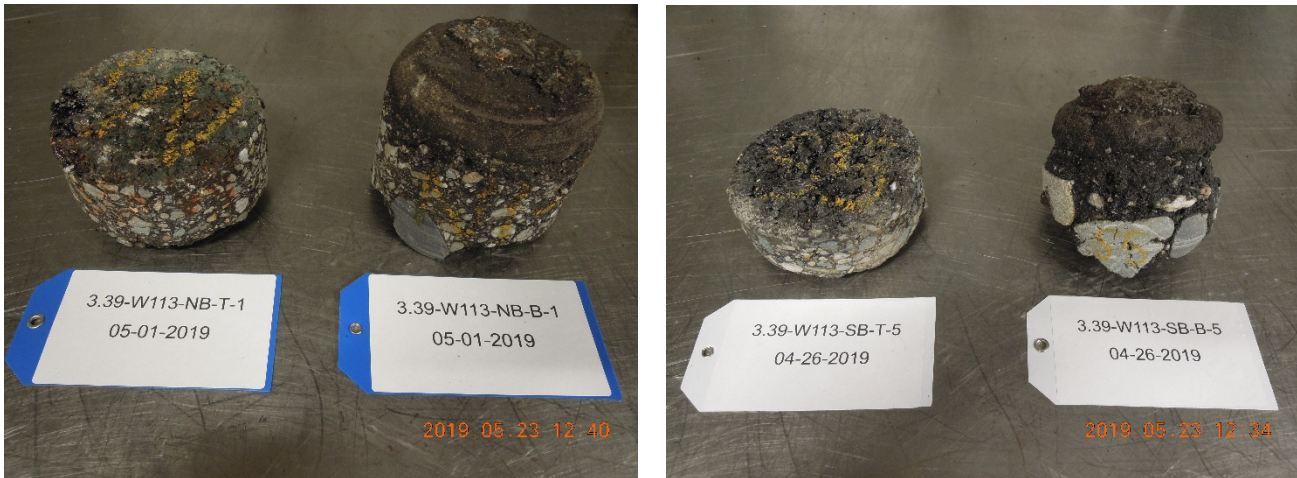
It should be noted that all the cores extracted from the newly placed RHMA-G showed debonding between the asphalt lifts. The total thickness was extracted in two pieces: (1) the top piece, which was 2.5 in. thick on average, included the newly placed RHMA-G plus bonded old HMA and (2) the bottom piece, which was 2.3 in. thick on average, included the debonded part of the old HMA (see examples in Figure 4.10).

Note: The top pieces of the cores (on the left in each picture) included the newly placed RHMA-G plus the bonded old HMA; the bottom pieces included the debonded part of the old HMA.

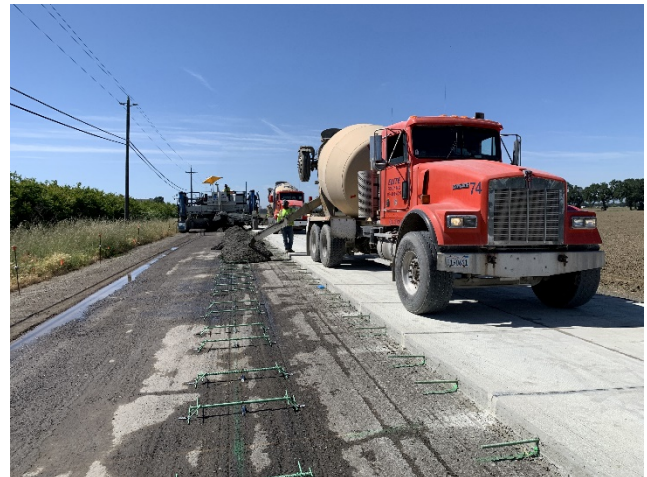
Before placement of the concrete overlay, the asphalt surface was wet conditioned by a truck that sprayed water on it. Overall, the asphalt surface was adequately wet conditioned; it was wet but free of standing water, approximating a saturated surface-dry condition (Figure 4.15, left). At some spots, however, the asphalt surface dried before the concrete was placed (Figure 4.15, right) and it would have been beneficial to have sprayed these spots with water manually. At other locations, the irregularity of the milled asphalt surface caused water ponds to form at the shoulder edge of the roadway (Figure 4.15, right). This standing water may have had a negative effect on the concrete poured at these locations.

Asphalt surface is not adequately wet conditioned: some dry areas; standing water at the shoulder

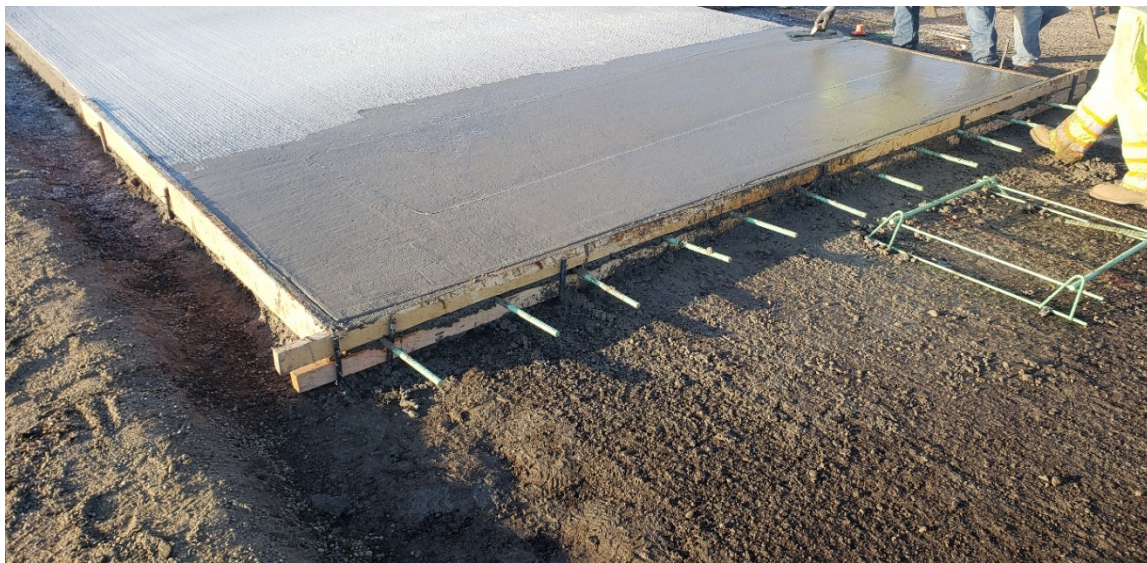
Some of the transverse construction joints (beginning/end on paving shifts) were built incorrectly. Specifically, at the first construction joint (Section B, northbound direction, between paving Shifts 1 and 2), tie bars rather than dowels had been installed (Figure 4.24). After learning of the issue, the resident engineer instructed the contractor to use dowels at the transverse construction joints. Even though this was done, in some cases lubricant was applied either poorly or not at all. As a result, some of these joints may have locked.

**Figure 4.24: Installation of tie bars instead of dowels at a transverse joint (end of paving Shift 1).**
