Pedestrian and Bicycle Safety Evaluation for the City of Emeryville at Four Intersections

Powell and Frontage, Powell and Route I-80, Powell and Christie, and Christie and Shellmound

August 2005

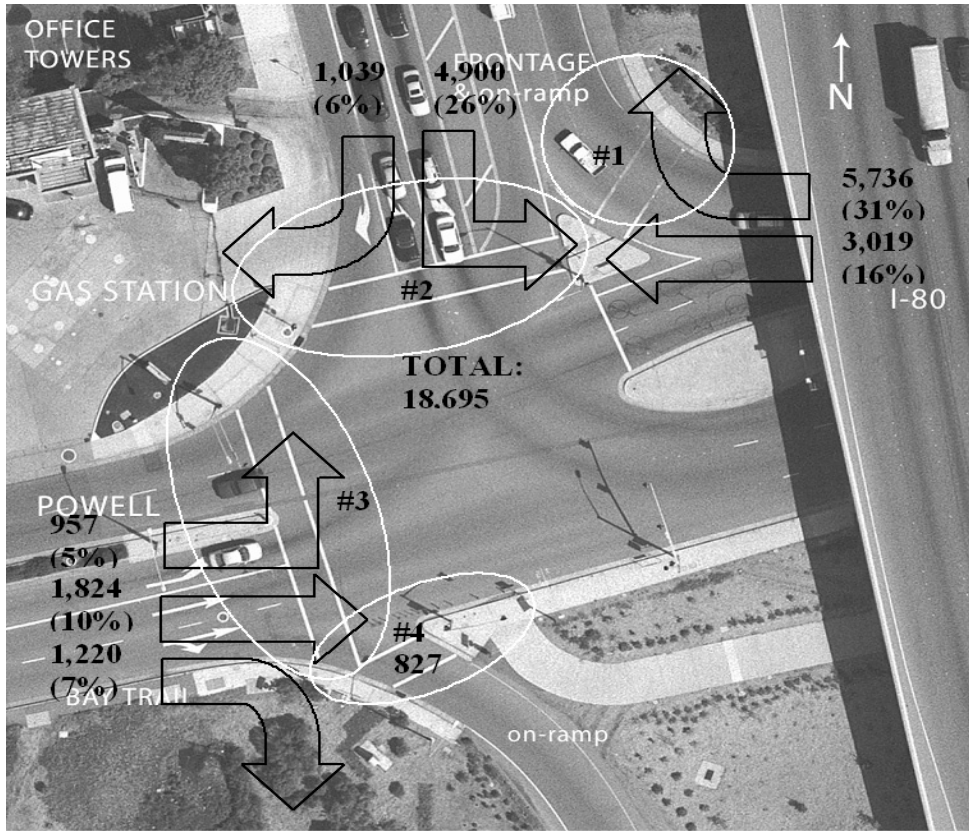
Figure 5: Aerial Photo of Powell and Frontage

The major issue at this intersection is violation of pedestrian right of way by right-turning vehicles that accelerate when approaching (#4) or entering (#1) freeway on-ramps. The vast majority (82%) of encroachment on pedestrian right of way occurred with right-turning vehicles. Visibility is a problem both for pedestrians and drivers. Drivers often are not looking for pedestrians when making these turns, and pedestrians have a difficult time seeing vehicles approaching from behind them (e.g., crossing west on #1 and crossing east on #4).

Pedestrian compliance with crossing signals is also an issue. Fully half of the observed pedestrians finished crossing with a “solid red hand” signal, the highest percentage of the four intersections. In part, this is because 36% of pedestrians began crossing either on the “flashing red hand” or the “Solid red hand” signals. Also, the long crossings (#2 and #3) are difficult to complete in time, and the lack of safe refuges increases pedestrian exposure to risk. The existing signal timing is inadequate, particularly at Crossing #3.

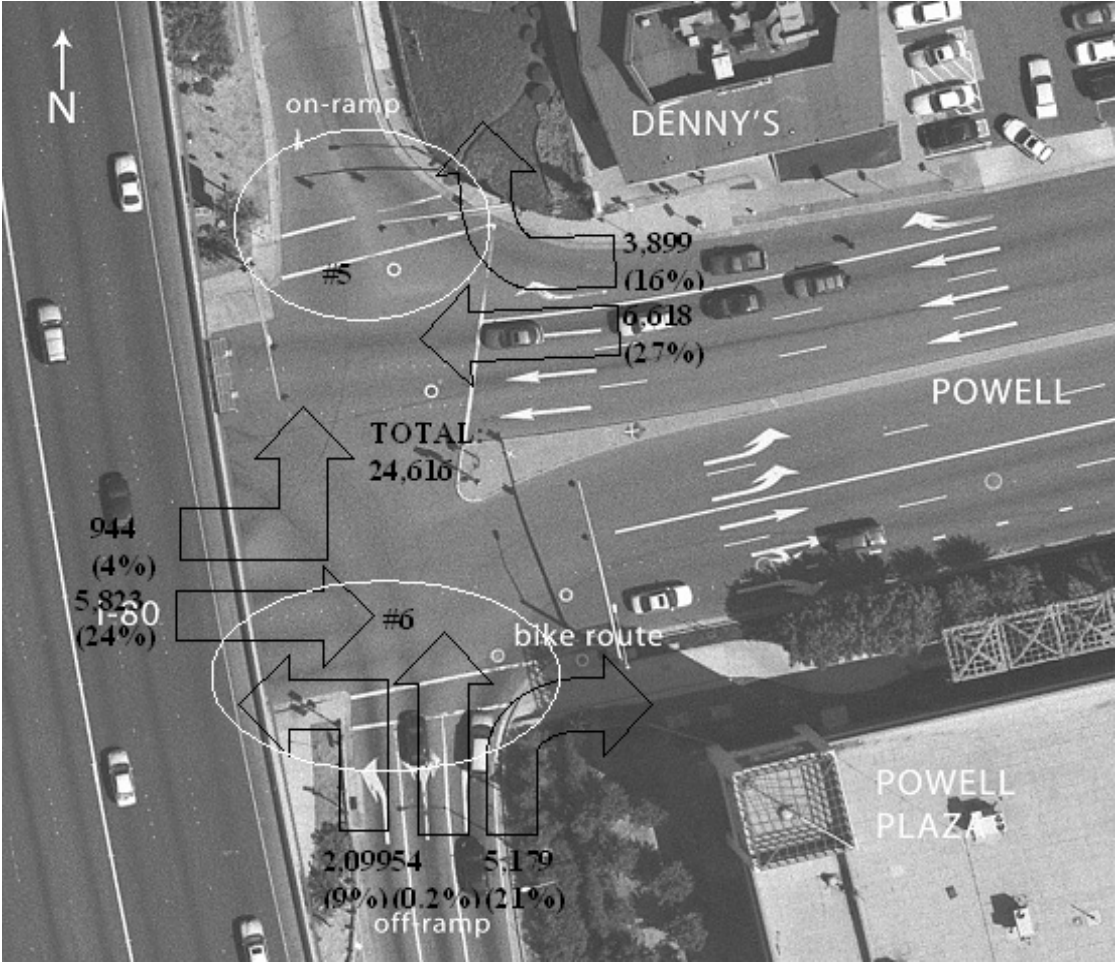
Figure 6: Aerial photo of Powell and I-80 on-ramps

During periods of high congestion, many drivers use this intersection to bypass traffic on I-80. This is facilitated by the “through” option in the center lane from the off-ramp which allows vehicles to simply exit, cross through the intersection, and then re-enter the freeway. The vehicle data provided by the City indicates a low number of northbound through vehicles (54) during the two observation periods combined. However, during periods of heavy freeway congestion, many vehicles per cycle using this intersection to bypass the freeway were observed.

Compared to the other intersections, pedestrians at Powell and I-80 were more likely to change stride to avoid a vehicle. The intersection also had the second highest number of vehicle violations of pedestrian right of way. All encroaching vehicles were turning right.

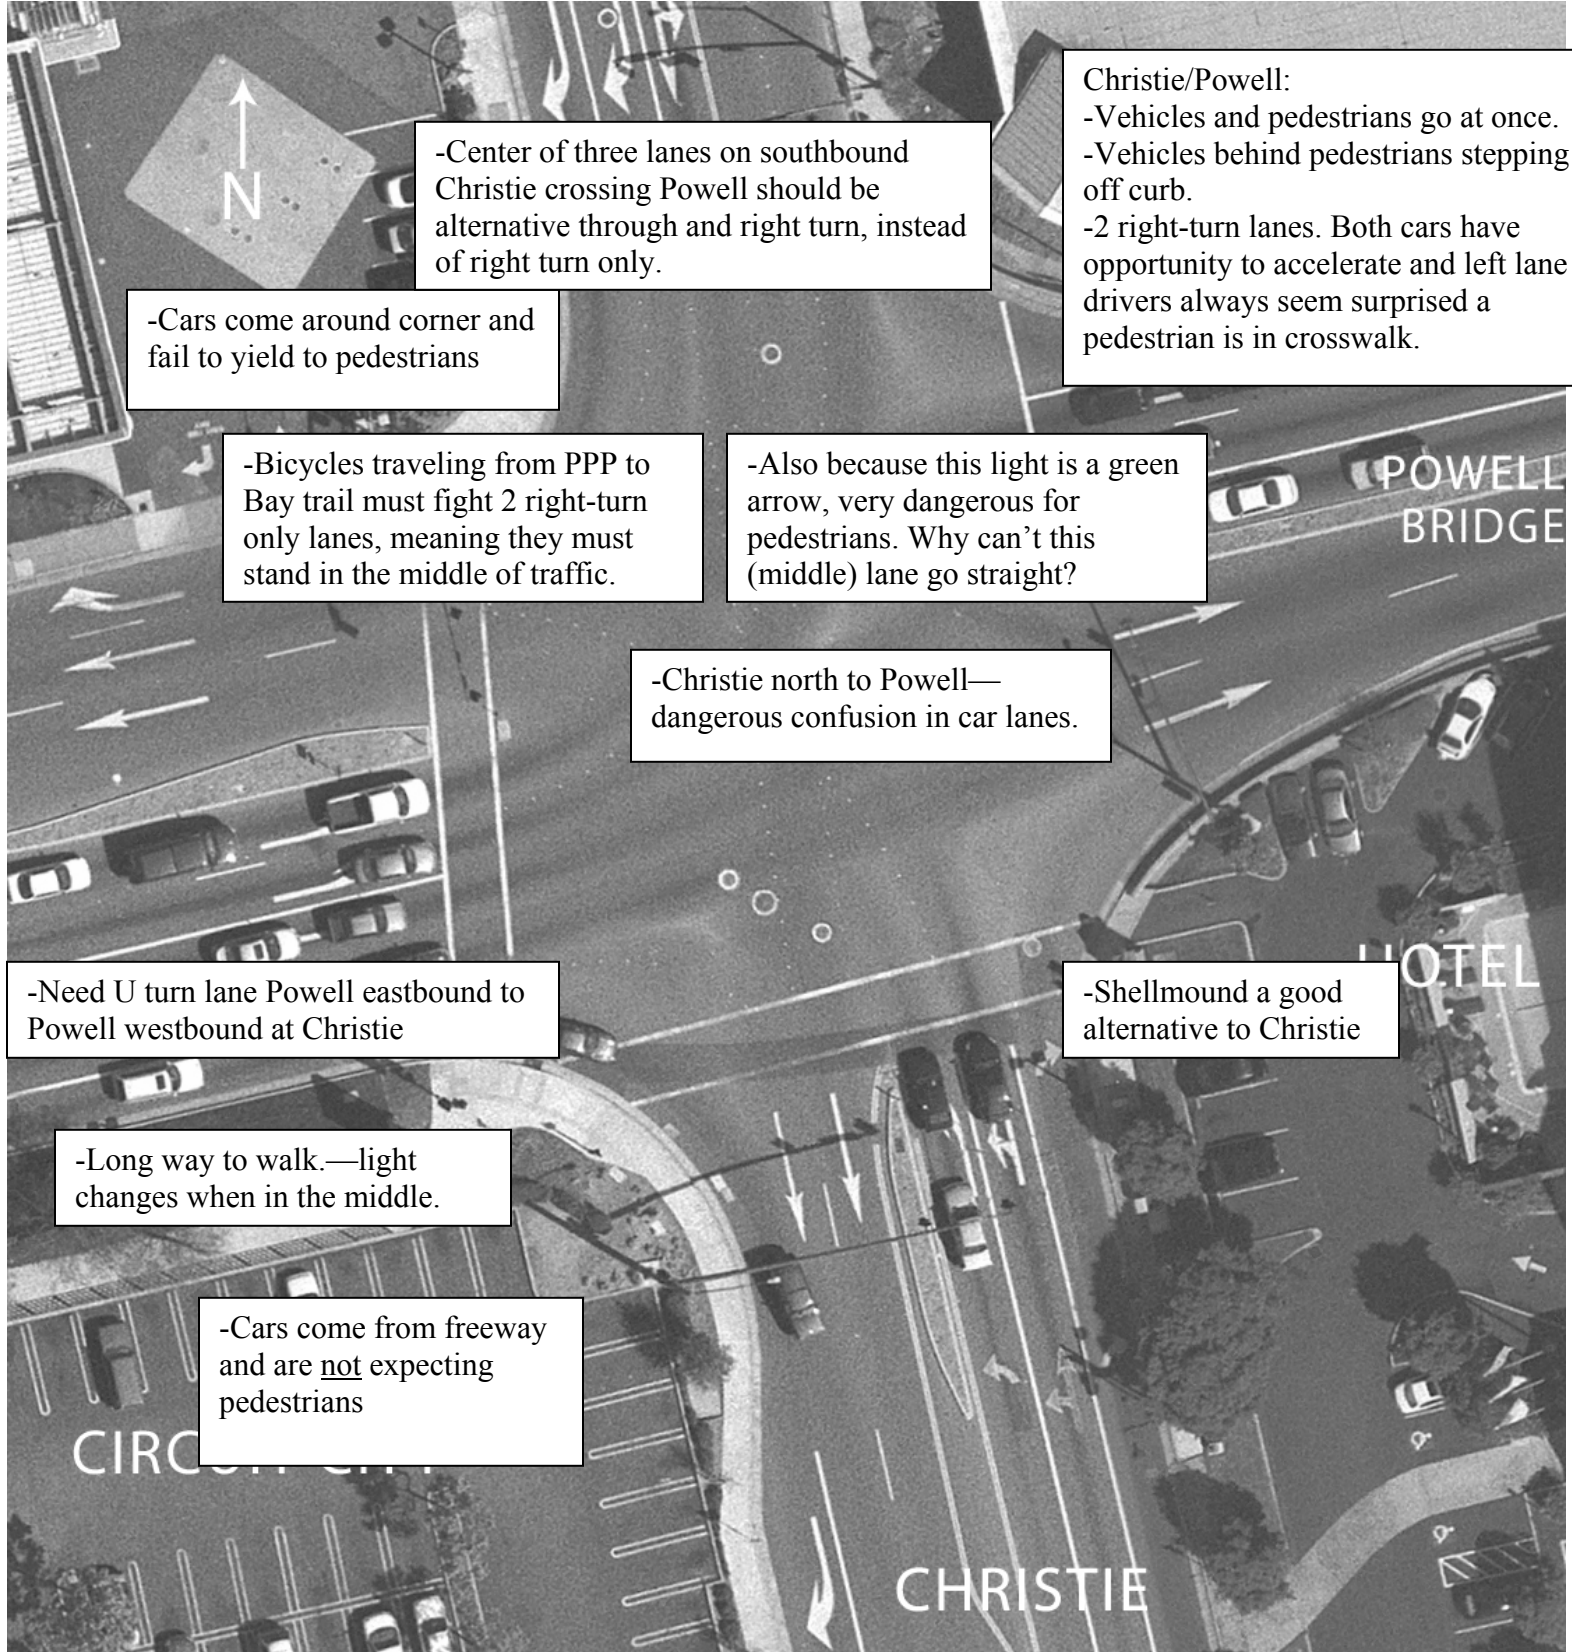
Powell and Christie

Christie/Powell:
-Vehicles and pedestrians go at once.
-Vehicles behind pedestrians stepping off curb.
-2 right-turn lanes. Both cars have opportunity to accelerate and left lane drivers always seem surprised a pedestrian is in crosswalk.

-Center of three lanes on southbound Christie crossing Powell should be alternative through and right turn, instead of right turn only.
