Landslides caused by the Mw7.8 Kaikōura earthquake and the immediate response

Bulletin of the New Zealand Society for Earthquake Engineering, 50(2)

LANDSLIDES CAUSED BY THE MW7.8 KAIKŌURA EARTHQUAKE AND THE IMMEDIATE RESPONSE

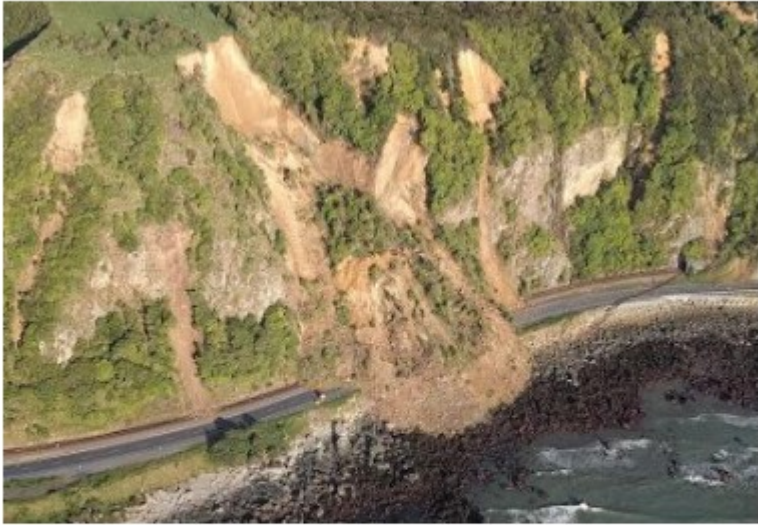
Figure 2: Landslide blocking the railway line and State Highway 1 north of Kaikōura. The landslide has broken the railway line and dragged the tracks across the road on the right hand side of the photo. The coastal uplift at this site is also visible in the exposed shoreline covered with sub-tidal seaweed. (Photo: S. Dellow 14/11/2016).

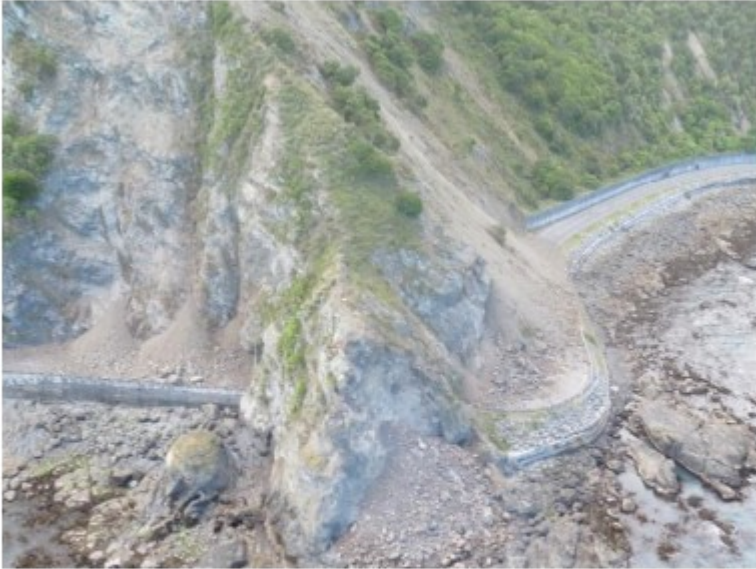
Figure 3: Landslides on either side of the Paratatahi Tunnels, State Highway 1, south of Kaikōura. The railway line at this location is enclosed in a rock shelter, and so was not directly affected. (Photo: S. Cox, 20/11/2016).

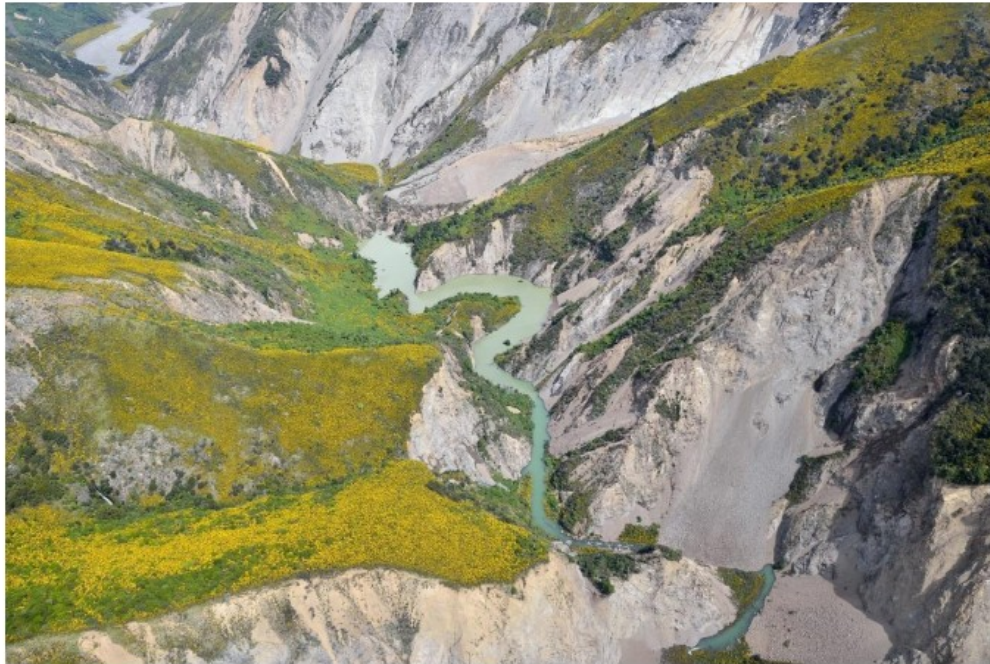
Figure 4: Landslide dams in the upper reaches of the Conway River in the Seaward Kaikōura Ranges. Two landslide dams are visible in the photo with water still impounding behind both. The source material for the landslides is Torlesse Greywacke which typically forms disrupted rock slides because of the closely jointed and fractured nature of the source rock mass. The resulting debris can be described as an angular gravel and is highly permeable. As a result, none of the large greywacke derived landslides overtopped under non-flood conditions, but developed flows through the permeable material forming the dam. (Photo: D. Townsend, 16/11/2016).

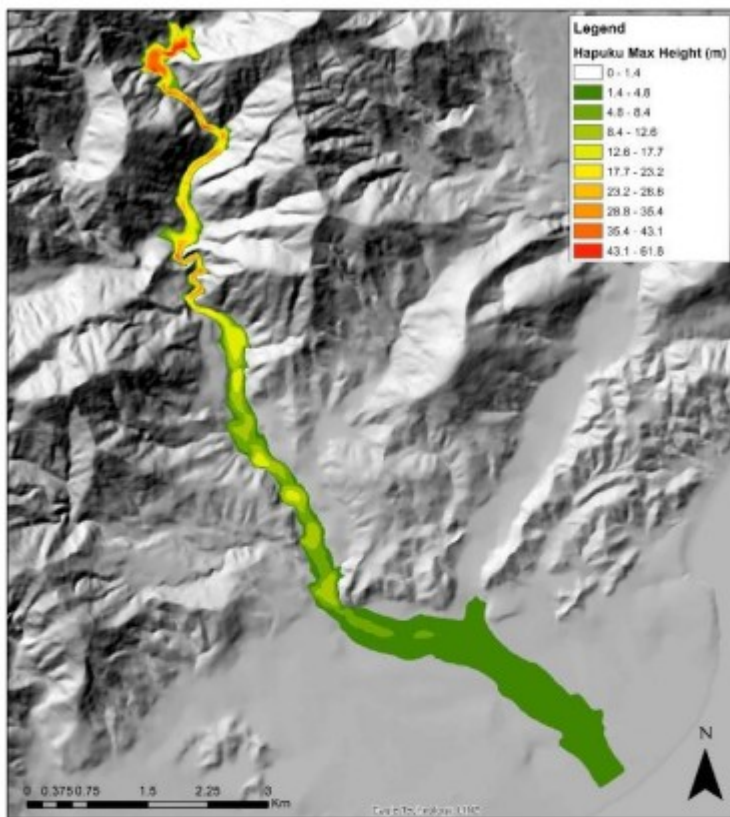
Figure 5: RAMMS modelling of the flow heights from rapid failure of the Hapuku landslide dam. Model parameters include a dam height of 80 m, dam width of 230 m; total volume of flow of $3 \times 10^6 \text{ m}^3$; and a maximum discharge of $13,000 \text{ m}^3/\text{s}$. Even with good data a range of scenarios is possible. This model run depicted the maximum credible flow height from rapid dam failure.

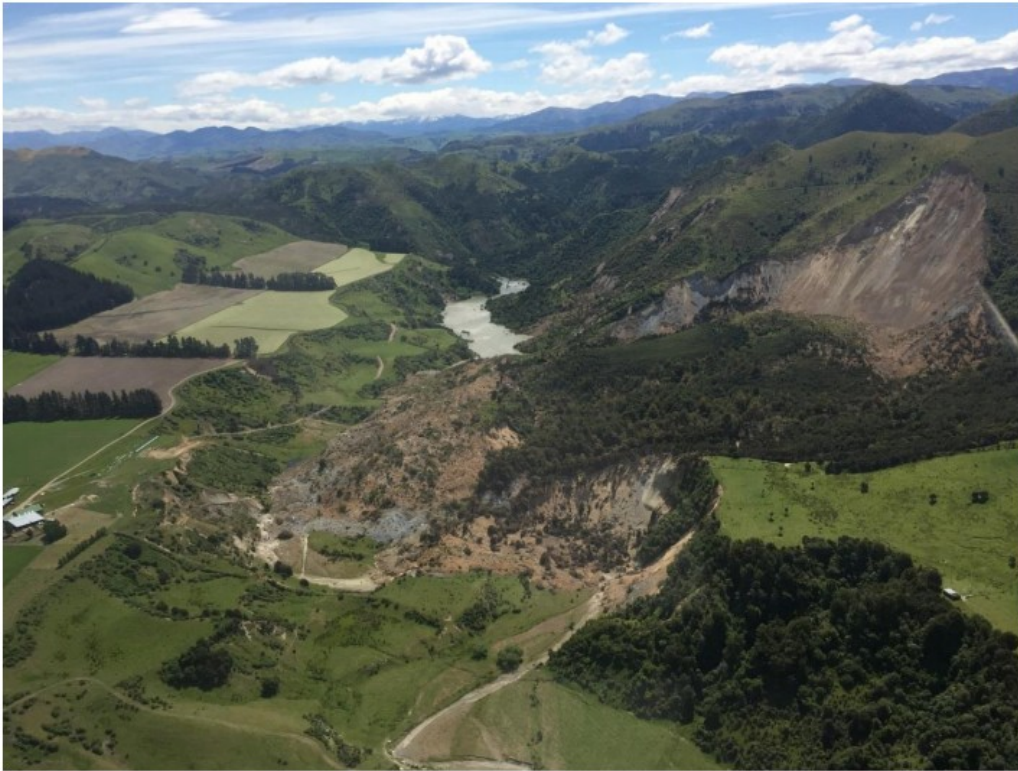
Figure 6: Landslide dam on the Leader River shortly after the earthquake. The landslide is a slump/block slide in a siltstone unit and is characteristic of the large landslides in weak Neogene rocks. The landslide dam overtopped and partially breached on the 13-14 February 2017 (Environment Canterbury).

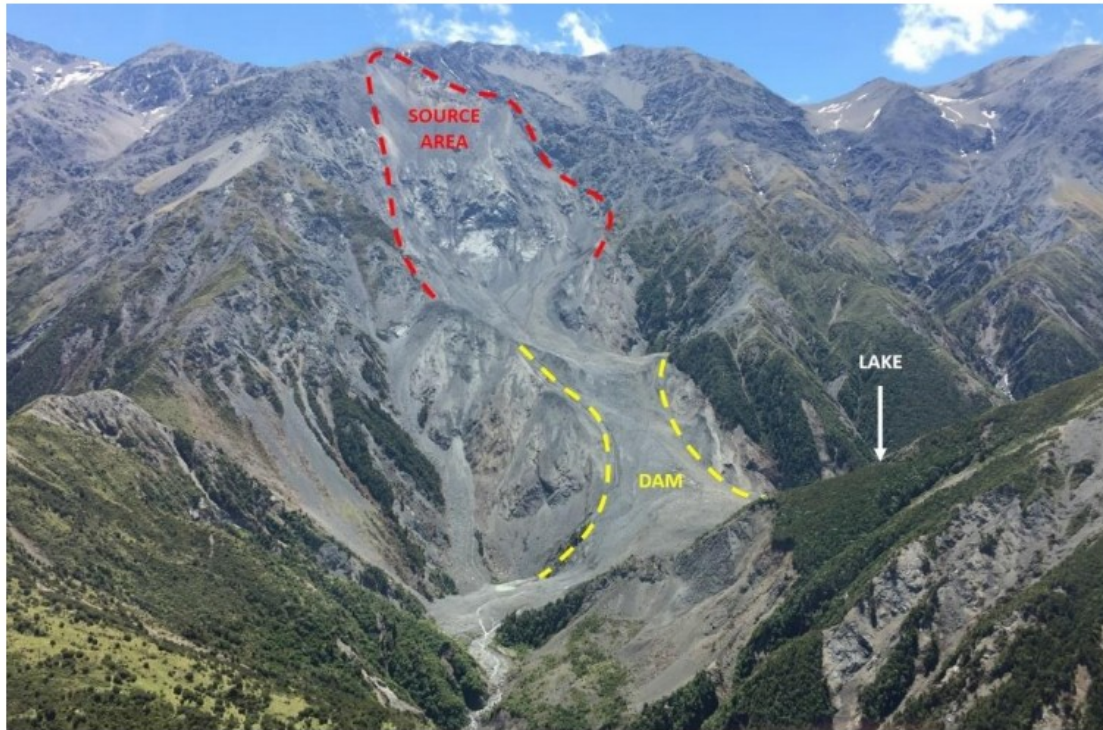
In one case, the largest landslide dam in the upper reaches of the Hapuku River (Figure 7), the terrestrial laser scanning process has been repeated three times. This showed that the landslide dam itself was slowly deforming (lowering at the crest by a nearly one metre over a period of nearly four months and bulging at the toe, again by a nearly one metre).

Figure 7: Hapuku River Landslide dam showing source area, landslide dam and valley downstream of dam. The landslide is a rock avalanche with a horizontal distance between top of the source area and the toe of the debris of 2.7 km. The volume of material in the landslide dam is estimated at $12 (\pm 2) \times 10^6 \text{ m}^3$. This is an example of a greywacke dam with internal flows readily apparent as seepage discharges near the toe of the dam on the downstream face.

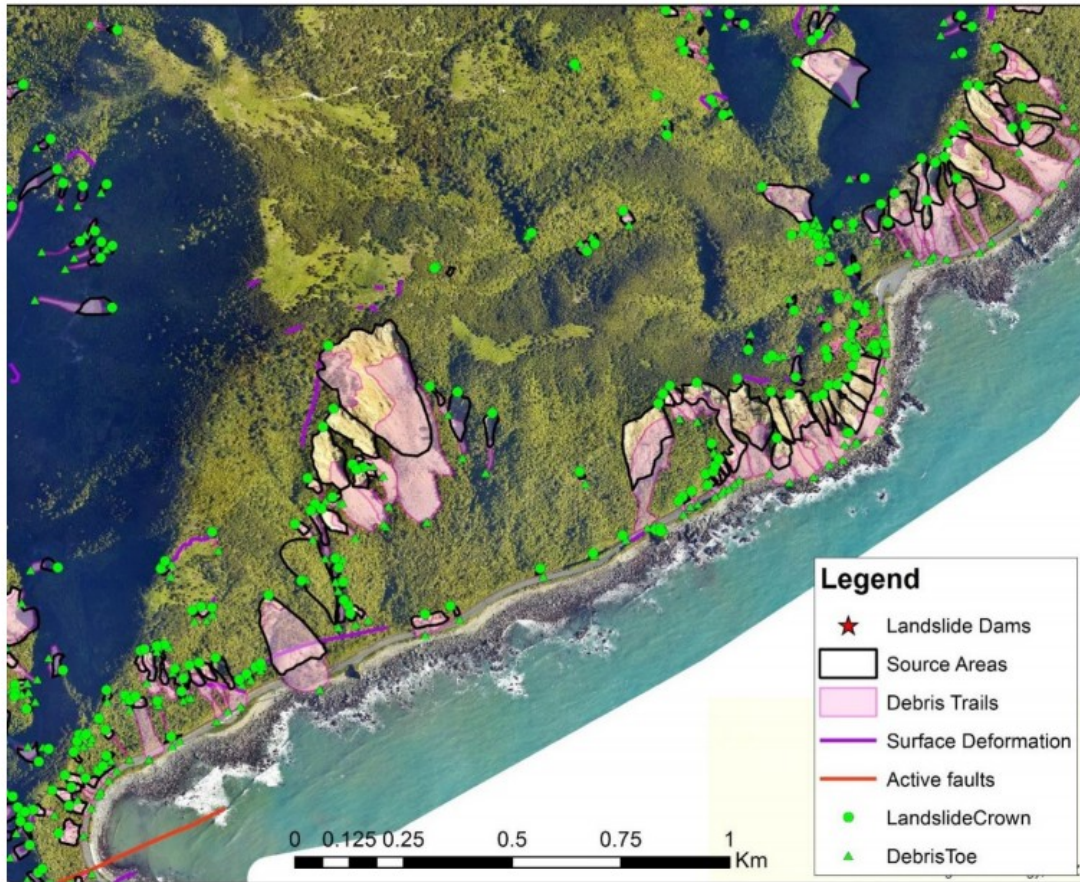
Figure 8: An example of landslide inventory mapping on the coast north of Kaikōura. The large landslides in the centre left of the photo did not reach the foot of the slope and the debris is a hazard that could remobilize in an aftershock or rainstorm and will present an ongoing risk to road and rail users if mitigation measures are not determined and implemented.
