Post Project Appraisal of Cerrito Creek at El Cerrito Plaza

FINAL DRAFT

Sarah Berndt and Fran Smith
Graduate Students, Civil and Environmental Engineering
University of California, Berkeley

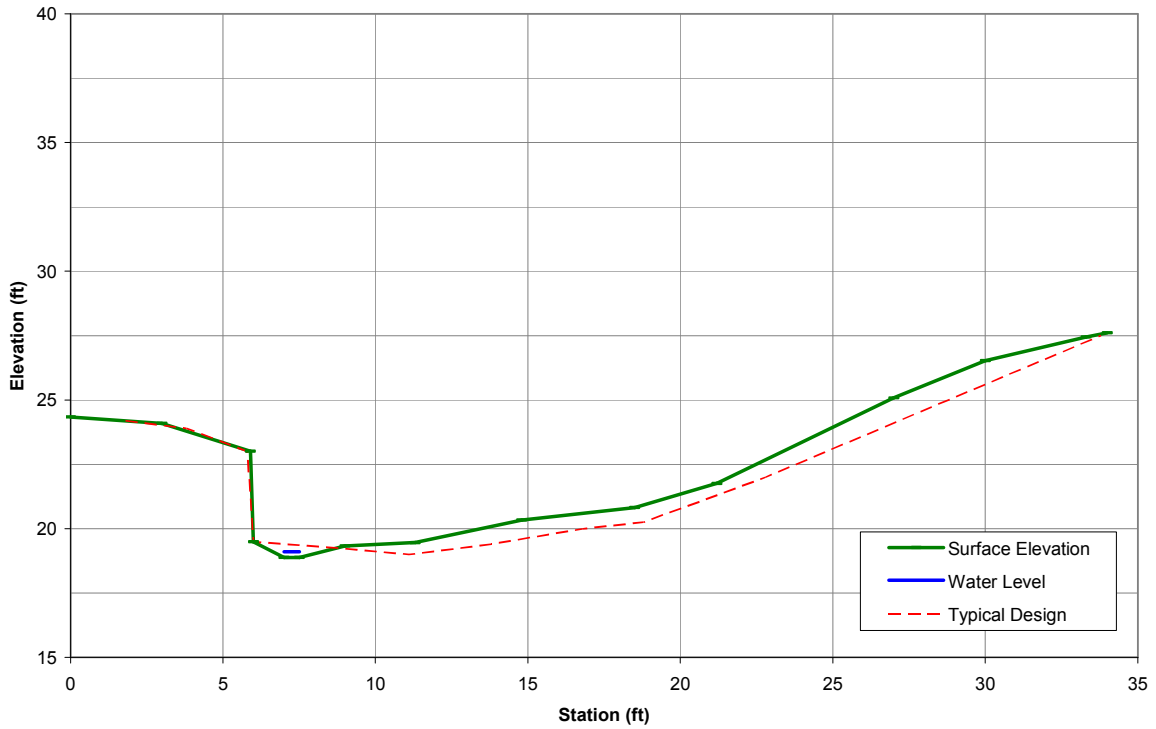
Since we were able to compare cross-section A directly with the design drawings, we noticed some major differences. The stream has shifted completely over to the left bank with a slight scouring of the retaining wall such that the bottom of the wall is exposed. The stream shift is shown in Figure 2. The current stream bed is only two feet in width compared to the 10 foot design channel. There has been deposition on the right (north) side creating one of the only gravel bars within the channel. Overall the slope on the right side appears to be unchanged. During our field investigation we observed a large Redwood tree on the right bank between the edge of the bank and the pedestrian path. The leaf and stick debris from this and other surrounding Redwoods is forming a thick layer of ground cover which is inhibiting any other plants from growing in this section. We matched the cross sections using the bottom of the retaining wall; doing so suggests that the debris on the north bank may be as high as six inches.

Figure 2: Cross Section A, STA 0+25 upstream from Kains Avenue culvert

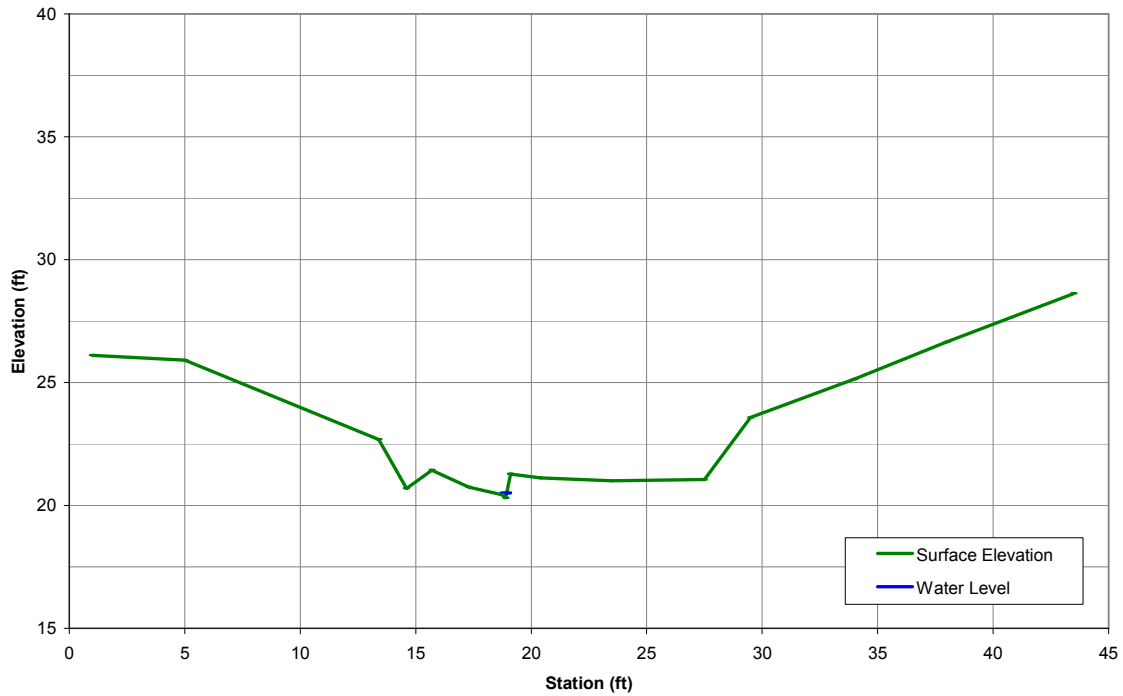
Cross-section B (Figure 3) is taken across a fully-functional rock weir. Because there is low flow in the channel, the water is routed through a small crevasse in the rock weir. At the time of the survey there is no overflow. The channel at this point is slightly wider than the ten

foot channel however the design shape is still present. We were unable to match this cross section because none of the design cross sections are taken at a rock weir.

Figure 3: Cross Section B, STA 1+10 upstream from Kains Avenue culvert

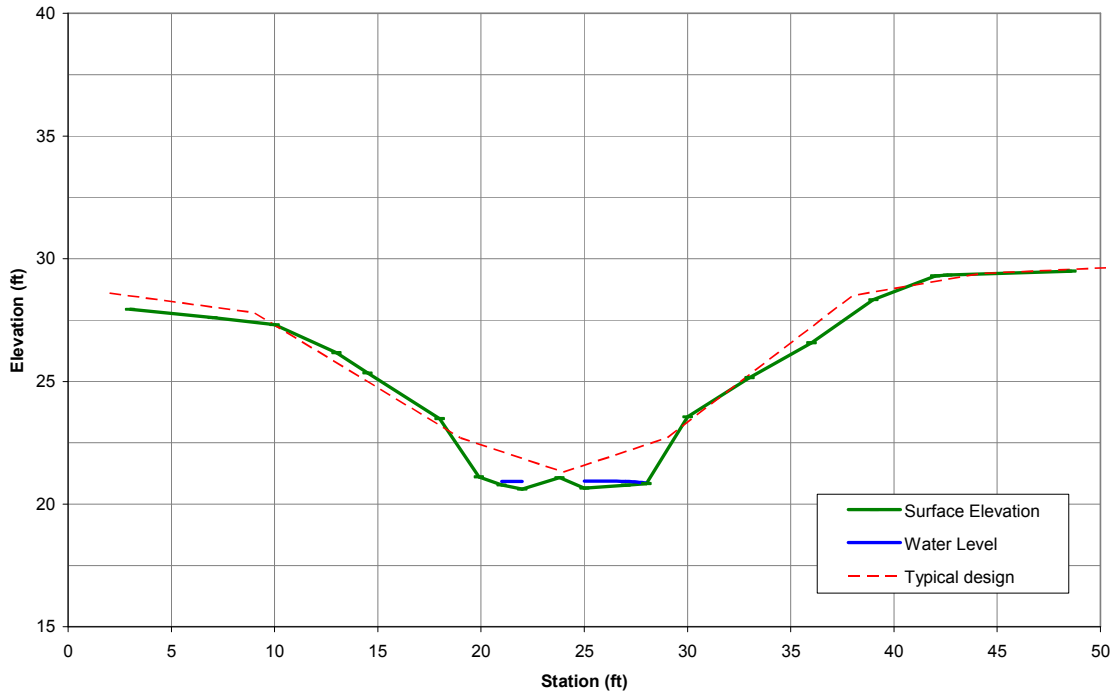
Cross Section C, at the failed rock weir, shows some interesting changes. We used a cross-section taken at 2+15 to examine slope changes. Looking at Cross Section C (Figure 4), we see the upper slopes have remained relatively unchanged however it is evident that there was significant scour of the stream bed. This suggests that the rock weir was in fact blown out during highflow, including those rocks that were initially embedded.

Figure 4: Cross Section C, STA 2+00 upstream from Kains Avenue culvert

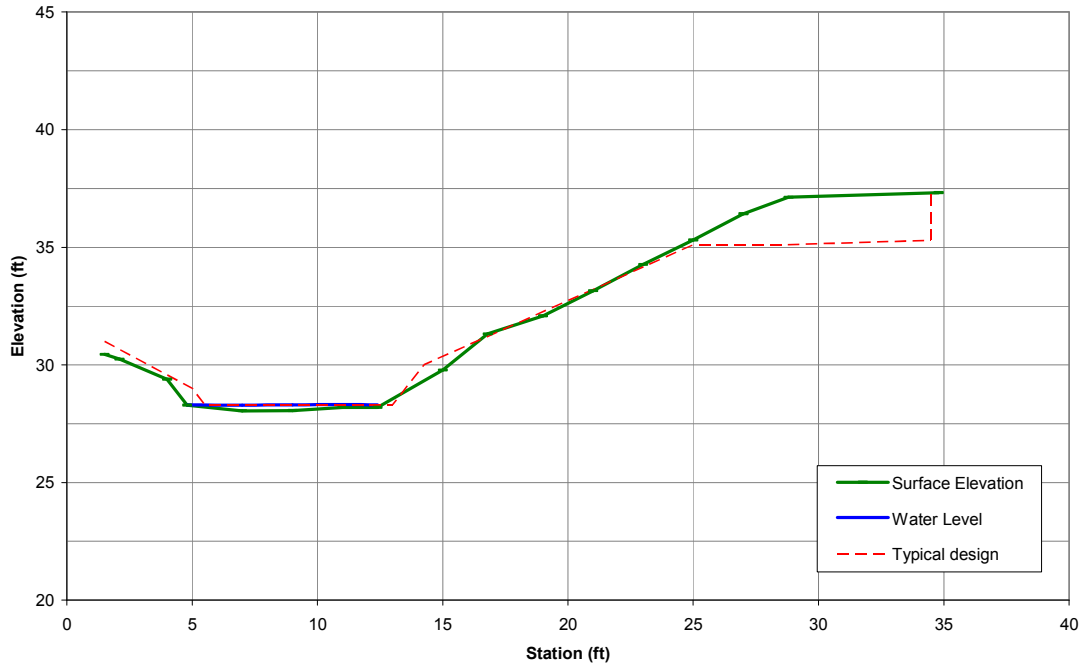
Cross Section D was also compared to a typical cross section in this reach. Again, we would like to emphasize that this typical cross section, identified at “typical design” in Figure 5, does not represent the as-built and is merely being used to identify changes in slope. The current slope looks almost identical to the design. Again, the rock toe is dictating the channel shape and direction of flow. The current channel is slightly wider than the ten foot design channel.

Figure 5: Cross Section D, STA 6+20 upstream from Kains Avenue Culvert

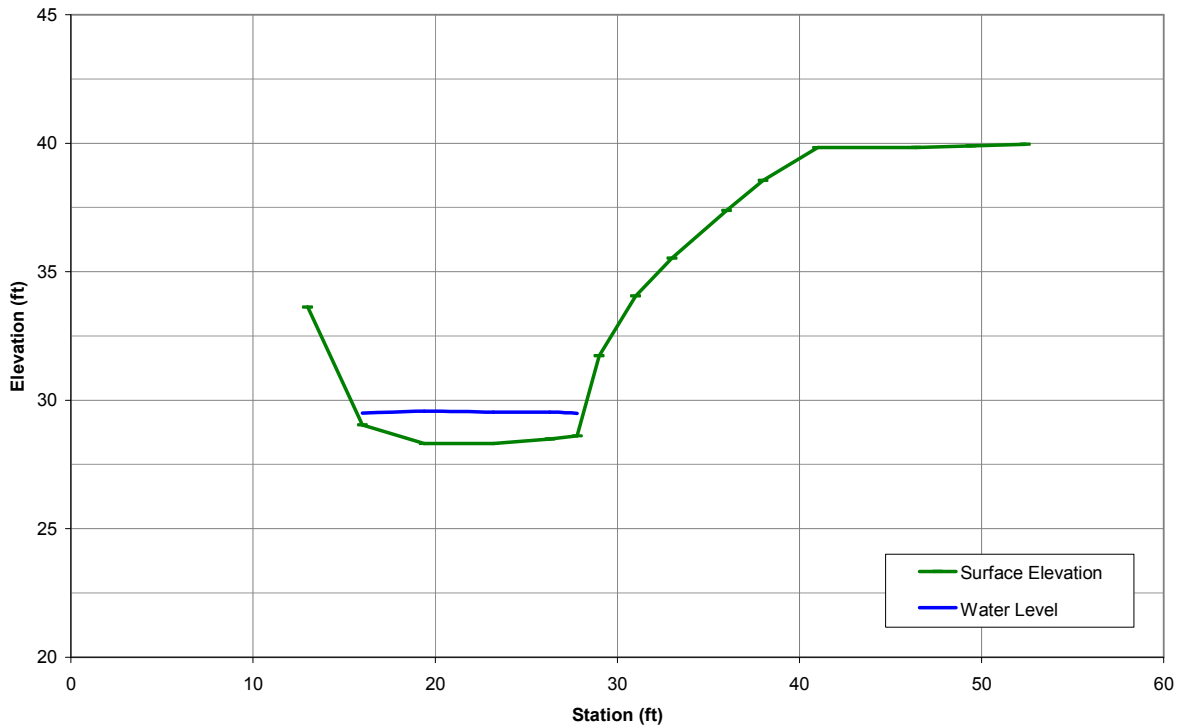
Lastly, Cross Section E (Figure 6) is taken the furthest upstream, only 4 ft from the culvert outflow. This is the deepest pool of the reach and seems to be growing in depth. The design cross section end at STA 6+50 with a bottom channel elevation of 30.2 feet. Our cross section taken at STA 6+90 shows a bottom channel elevation of 28.3 feet. Because this location is upstream of the design, we would assume that the channel bed would be at a higher elevation. However, at the site, the source culvert is approximately 1.5 feet above the water surface. During high flows, the water will shoot out of this culvert at very high velocities which can create significant scour of the bed. There is little to no sediment in the upper reach. The bed is covered with mud and the mud bars on either side are now overgrown with watercress. The sediment size and channel depth are consistent with high scouring flows in this reach.

Figure 6: Cross Section E, STA 6+90 upstream from Kains Avenue culvert

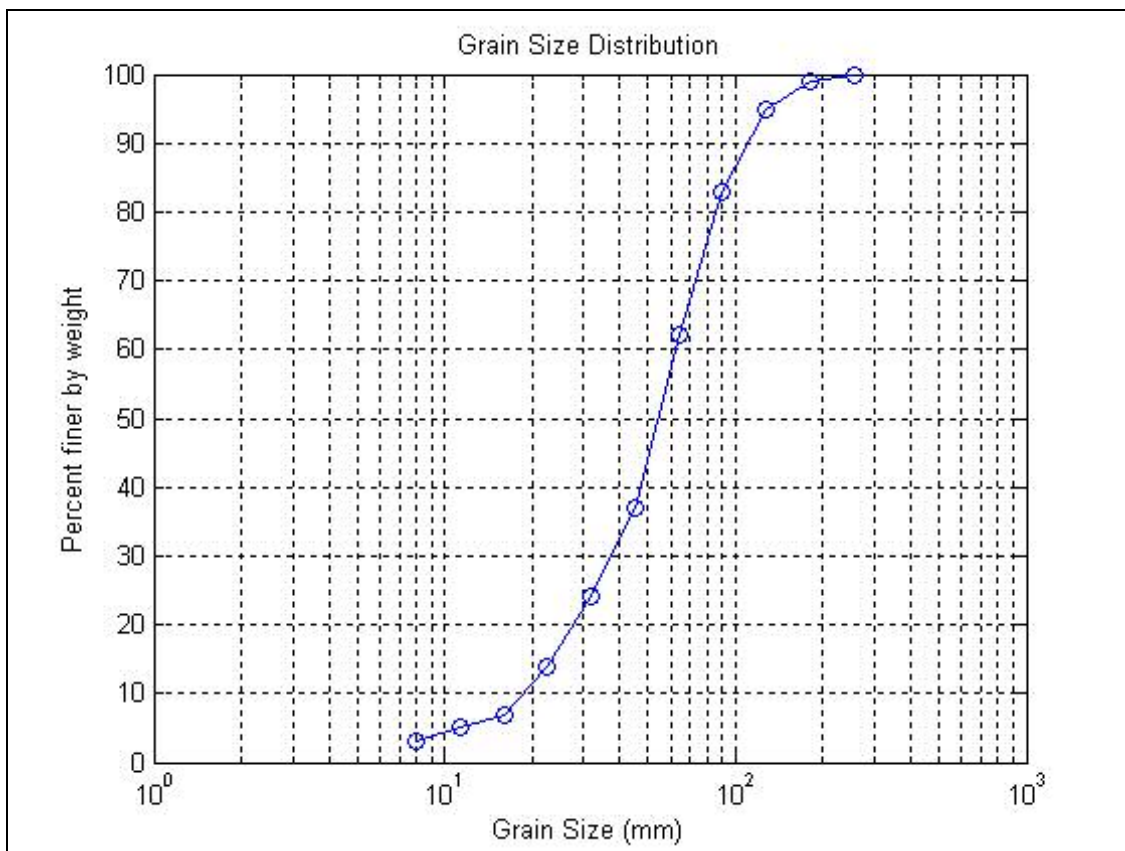
We observed very little fine sediment along the entire project and very few gravel bars. The downstream reach has a uniform sediment size in both the bed and the two gravel bars; the upstream reach is covered in mud. Given that the upstream portion of the creek comes from an underground culvert that is linked further upstream to a rectangular concrete channel, there is not a large upstream sediment supply. Additional flows will come from the parking lot runoff and surrounding residential areas. Our pebble count indicated a median grain size of 55mm (Figure 7, Table 6), with most particles in the “coarse gravel” category, typical of the entire project reach. The pebble count data is shown in Appendix C.

Figure 7: Grain Size Distribution Chart (Sieve Analysis)
