Tidal channel and marshplain development : Cooley Landing salt pond restoration

Tidal Channel and Marshplain Development

Cooley Landing Salt Pond Restoration

December 8, 2003

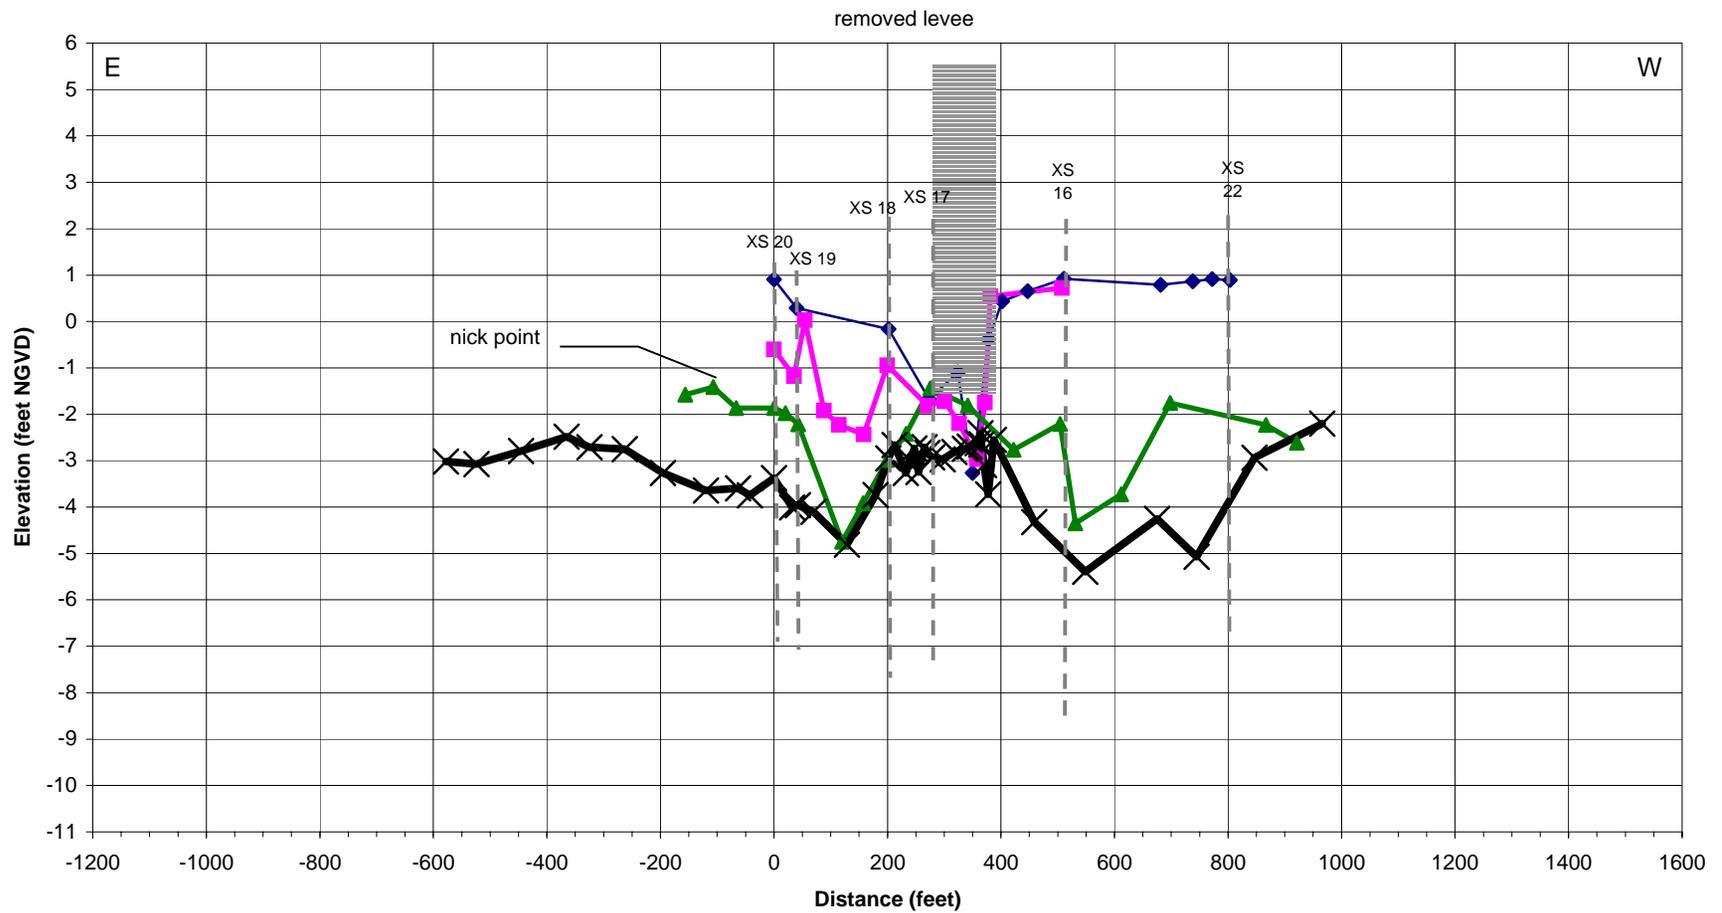
figure 6

The north and south breach longitudinal thalweg profiles (Figures 6 and 7) and the three breach channel cross-sections located bay-ward of the outboard marsh (Figures 8, 9, 10)

show rapid erosion of the outboard mudflat channels. Since September 2001, the thalwegs of both breach mudflat channels have down-cut by an average of 1.5 ft. Farther out towards the Bay, the thalwegs of both mudflat channels slope upwards to a maximum thalweg elevation of -2.5 ft NGVD or 6.8 ft below MHHW. The expected long-term equilibrium depths for the north and south breach channels (7.7 and 8.1 ft respectively, Table 1) are approximately 1 ft below the current maximum thalweg elevation. The mudflat channels have also widened substantially compared to the breach channels upstream.

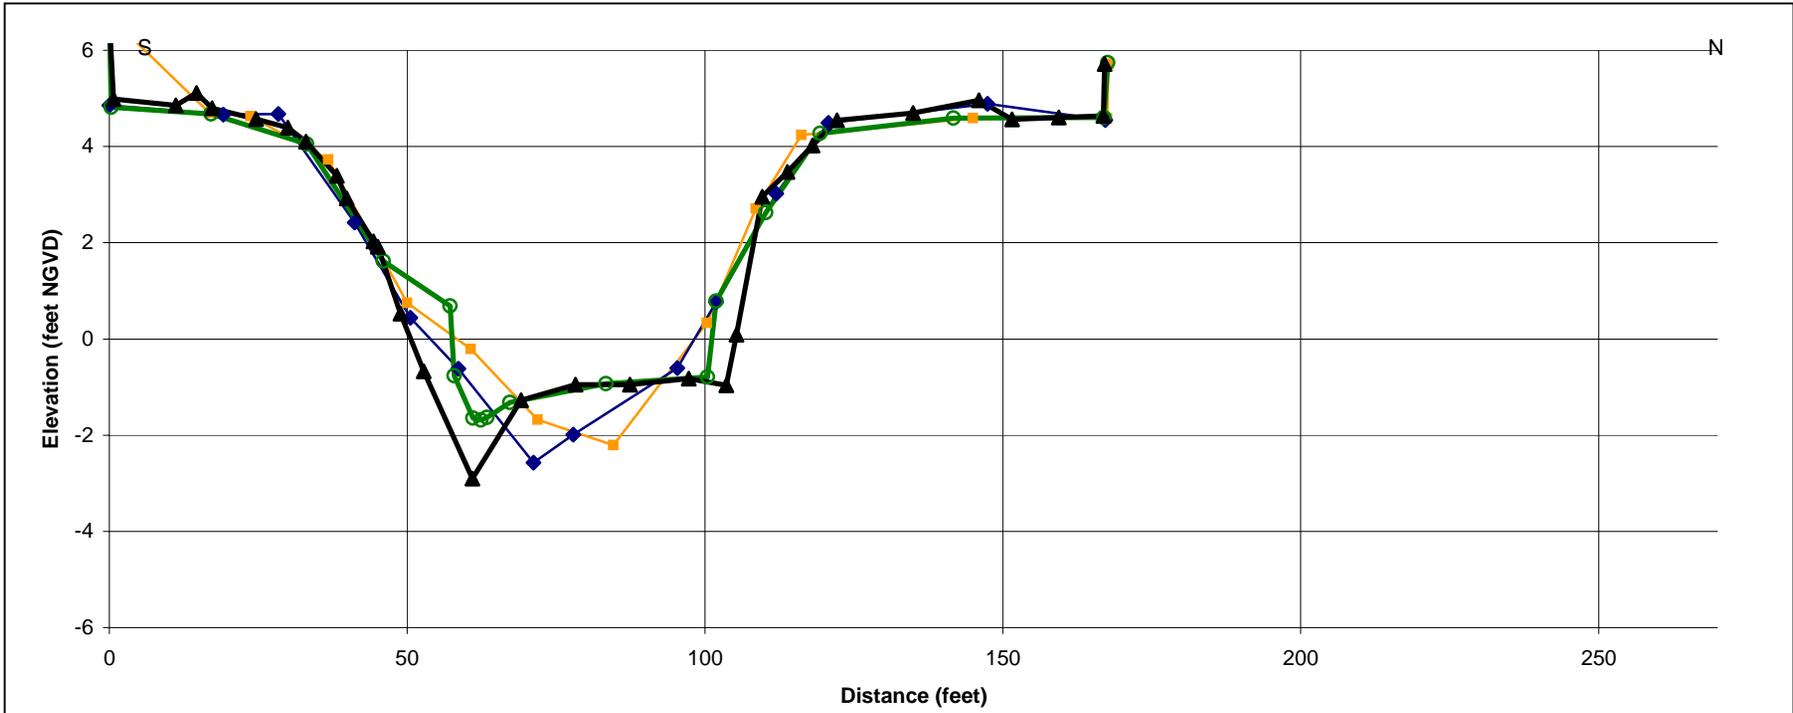
figure 11

The cross-sections for the Cooley Landing breach cross-sections in the outboard marsh and at the former levee are plotted in Figures 11-14. In the outboard marsh, the cross-sectional area of the north breach channel has increased since September 2001. The channel thalweg depth and top width have not changed significantly. The channel through the north levee breach has down-cut by 1.3 ft at the thalweg and has widened through bank erosion since September 2001. If the current rate of channel erosion by down cutting persists, the channels will reach expected long-term depths within two years. The shell bed shown in the photographs in Figure 15 may slow the scour of the bottom of the north breach channel. The current cross-sectional areas and widths are larger than the predicted equilibrium dimensions and do not cause tidal muting within the site (PWA et al 2002).

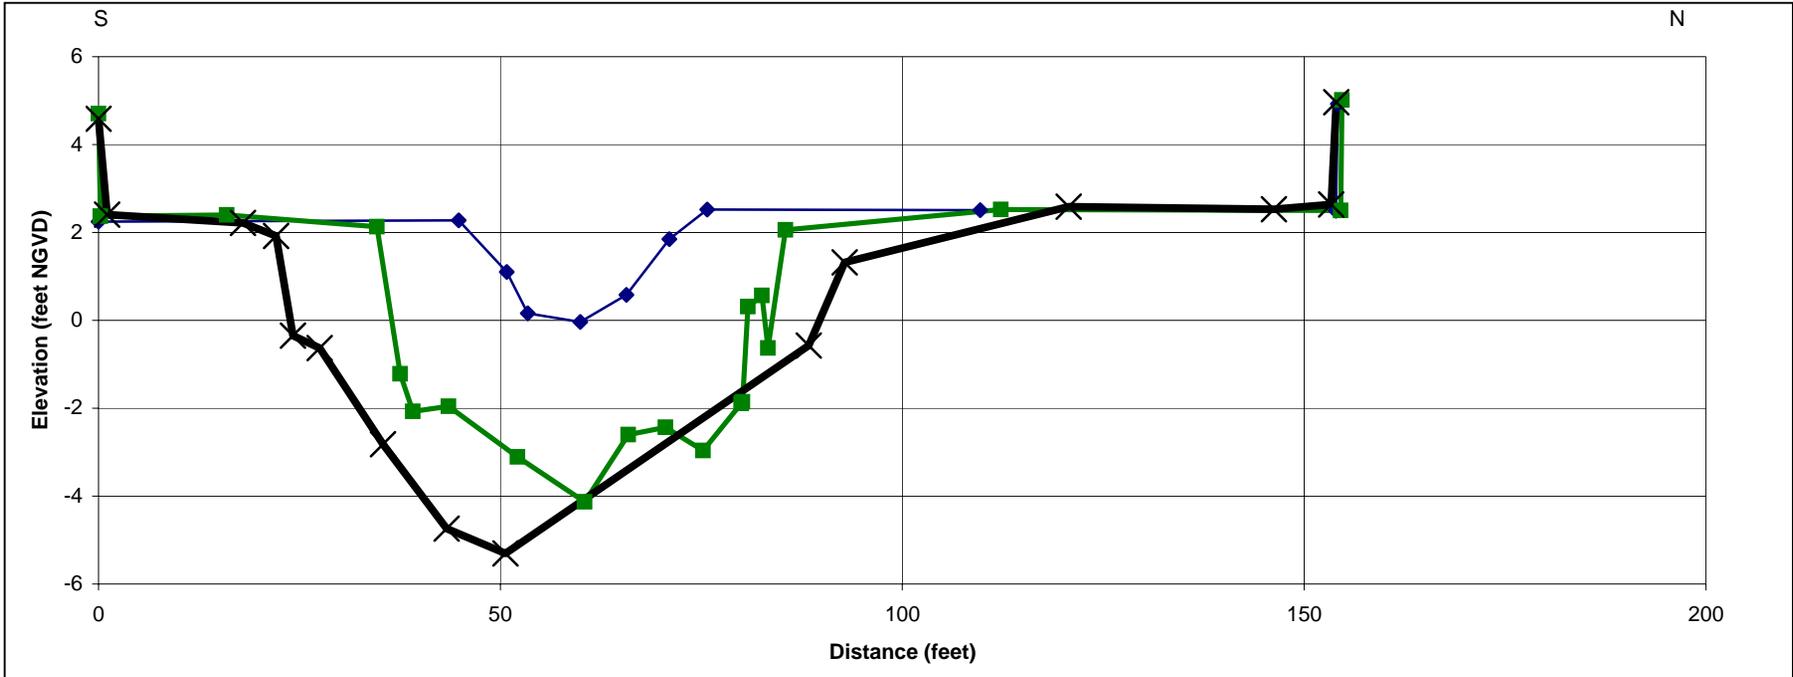
figure 14

The south breach channel has widened and down-cut by more than a foot in the outboard marsh (Figure 14). The amount of channel erosion in the outboard mudflat has been

greater than channel erosion at the levee. A large hole has scoured to a maximum depth of 14.6 ft below MHHW (elevation -10.3 ft NGVD) in the south breach channel between the training berms. The aerial photograph shows the formation of mudflat channels that drain around the ends of the training berms. This suggests that the scour hole has formed as the mudflat areas on either side of the training berms drain around the ends of the berms. Due to channel scour caused by the large tidal prism draining through the south breach (see discussion of tidal drainage below), the current dimensions of the south breach channel are larger than the predicted long-term dimensions (Table 1). The force of this drainage would have certainly scoured the borrow ditch along the former levee in the absence of the training berms. A small channel has formed parallel to the north side of north training berm that connects to a short portion of the borrow ditch (Figure 16), however this small channel may not persist as the marshplain accumulates sediment and vegetation establishes.

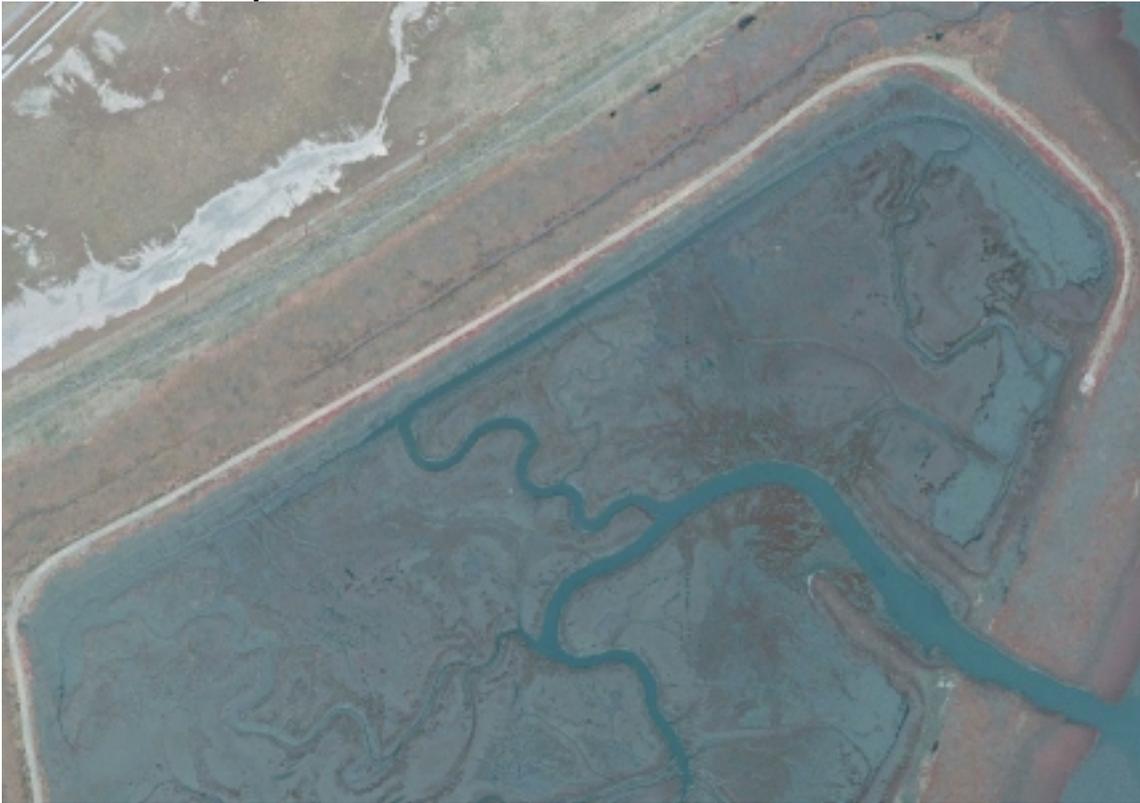
a) Northeast site boundary.

The formation of a long linear channel in the borrow ditch parallel to the northeast site boundary is evident in the aerial photograph, shown in detail in Figure 16. The Cooley Landing restoration design did not include a borrow ditch block for this borrow ditch. The northeast site boundary truncates two large slough channels and therefore there are no low order historic channels in this part of the site that can be re-occupied. A short portion of a small channel has also occupied a segment of the borrow ditch north of the north breach, however this channel is relatively minor. The density of borrow ditch channels at Cooley Landing is significantly less than at four older marsh restoration sites (Table 2).

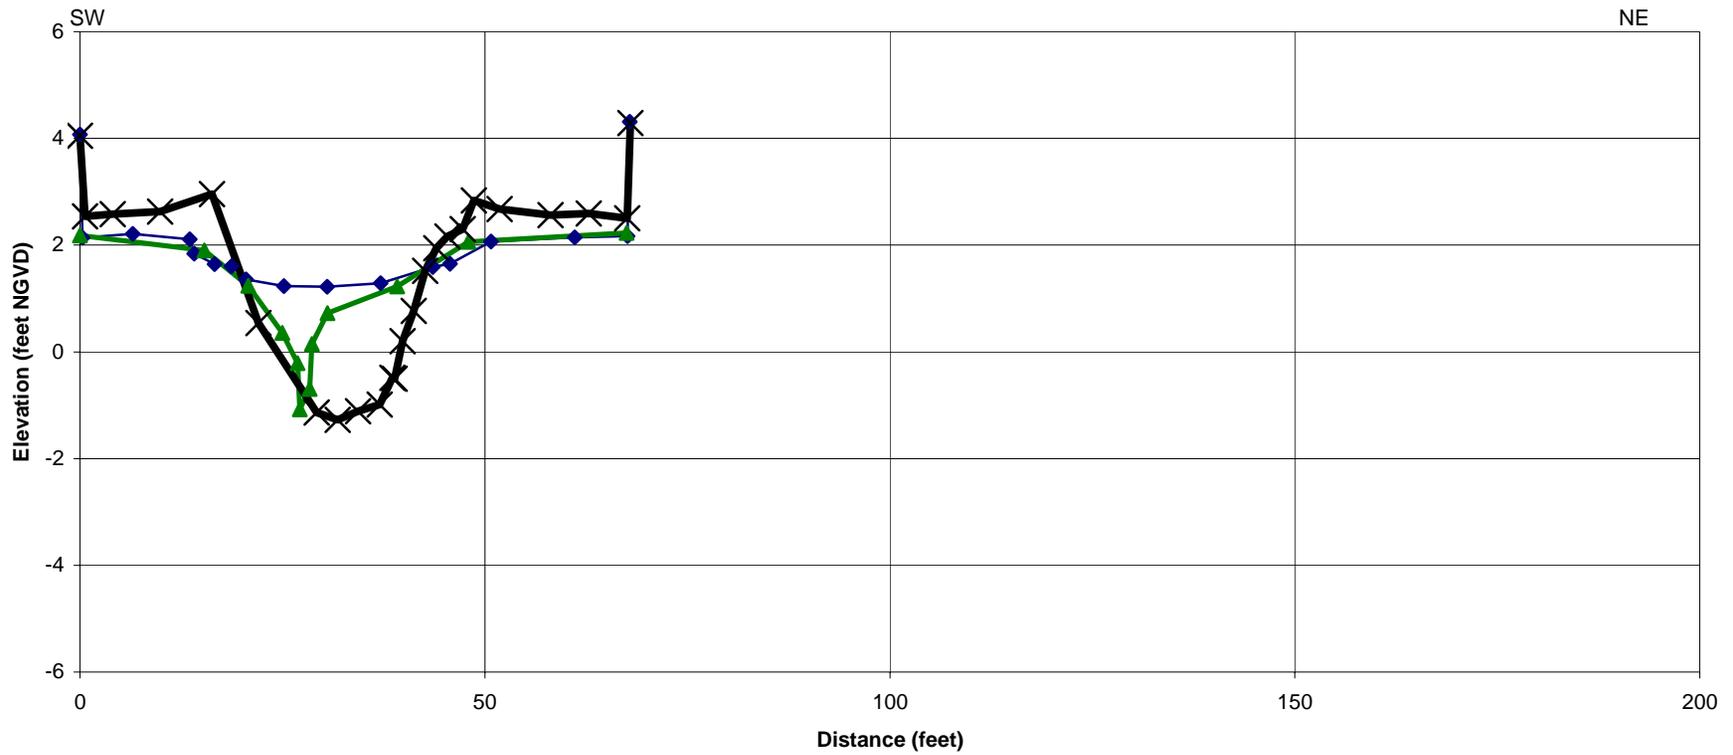
figure 17
Cooley Landing
Channel Cross Section 3

Cross-sections of lower order channels upstream of the south breach (Figure 17 to 20) show the re-occupation of these historic channels through scour. The marshplain transect along the PG&E boardwalk also shows the formation of several smaller channels (first and second order) across the site. PWA identified a channel nick-point that scoured the pre-breach grade of the historic channel bottom up to 800 ft upstream of the south breach by September 2001. Since then, the main branch of the historic channel has scoured beyond XS 6 (Figure 20), which is 2,500 ft upstream of the breach. At the back of the site near the boardwalk (Figure 21), this channel has filled with sediment, however the photo-documentation shows that other mudflat channels have formed in the location of historic channels in this part of the site (Figure 22).

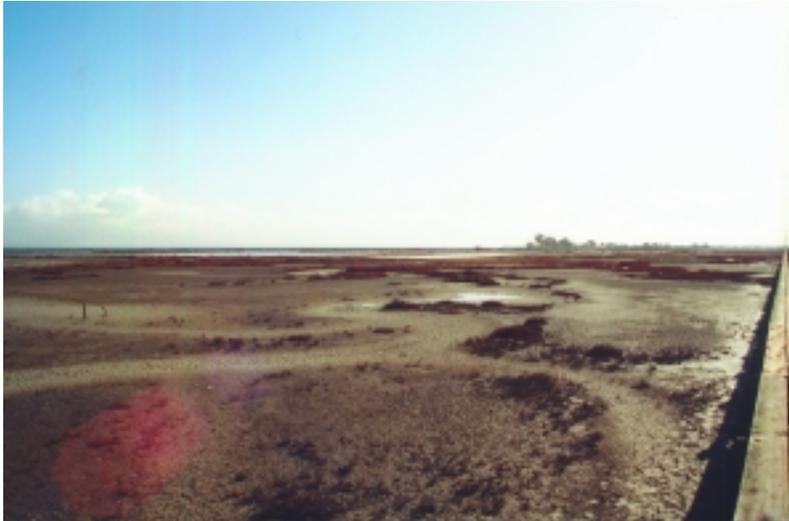
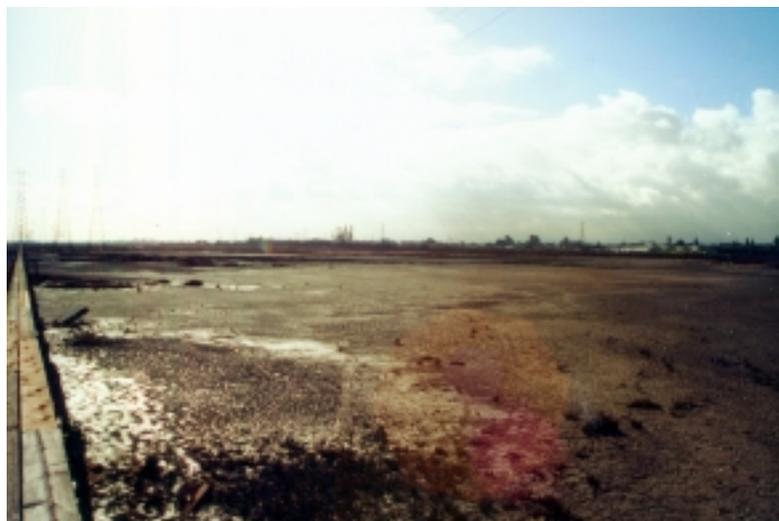
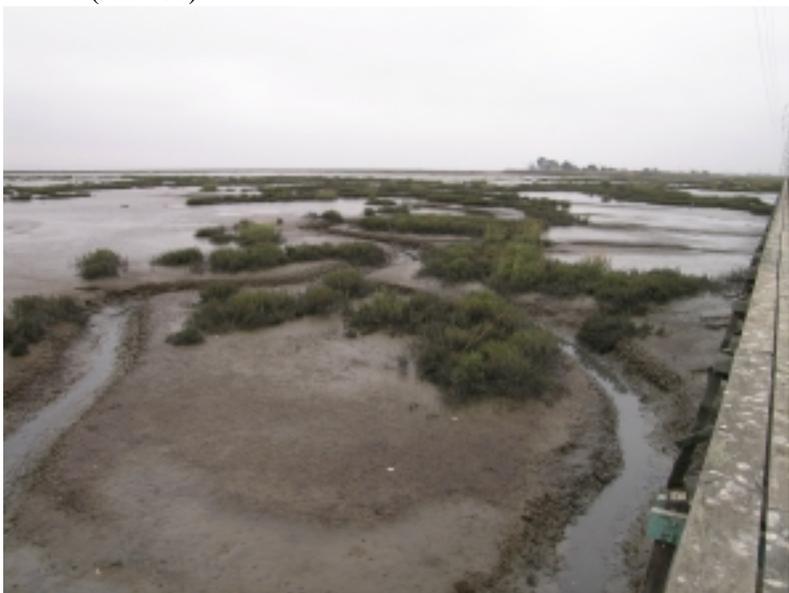
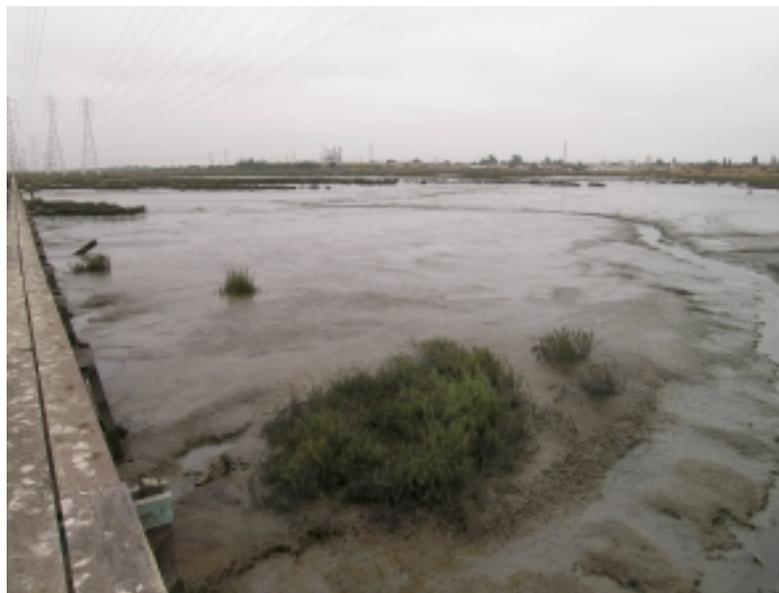
Figure 22. North-west end of boardwalk, looking south-east. Pre-Breach (12/12/00)

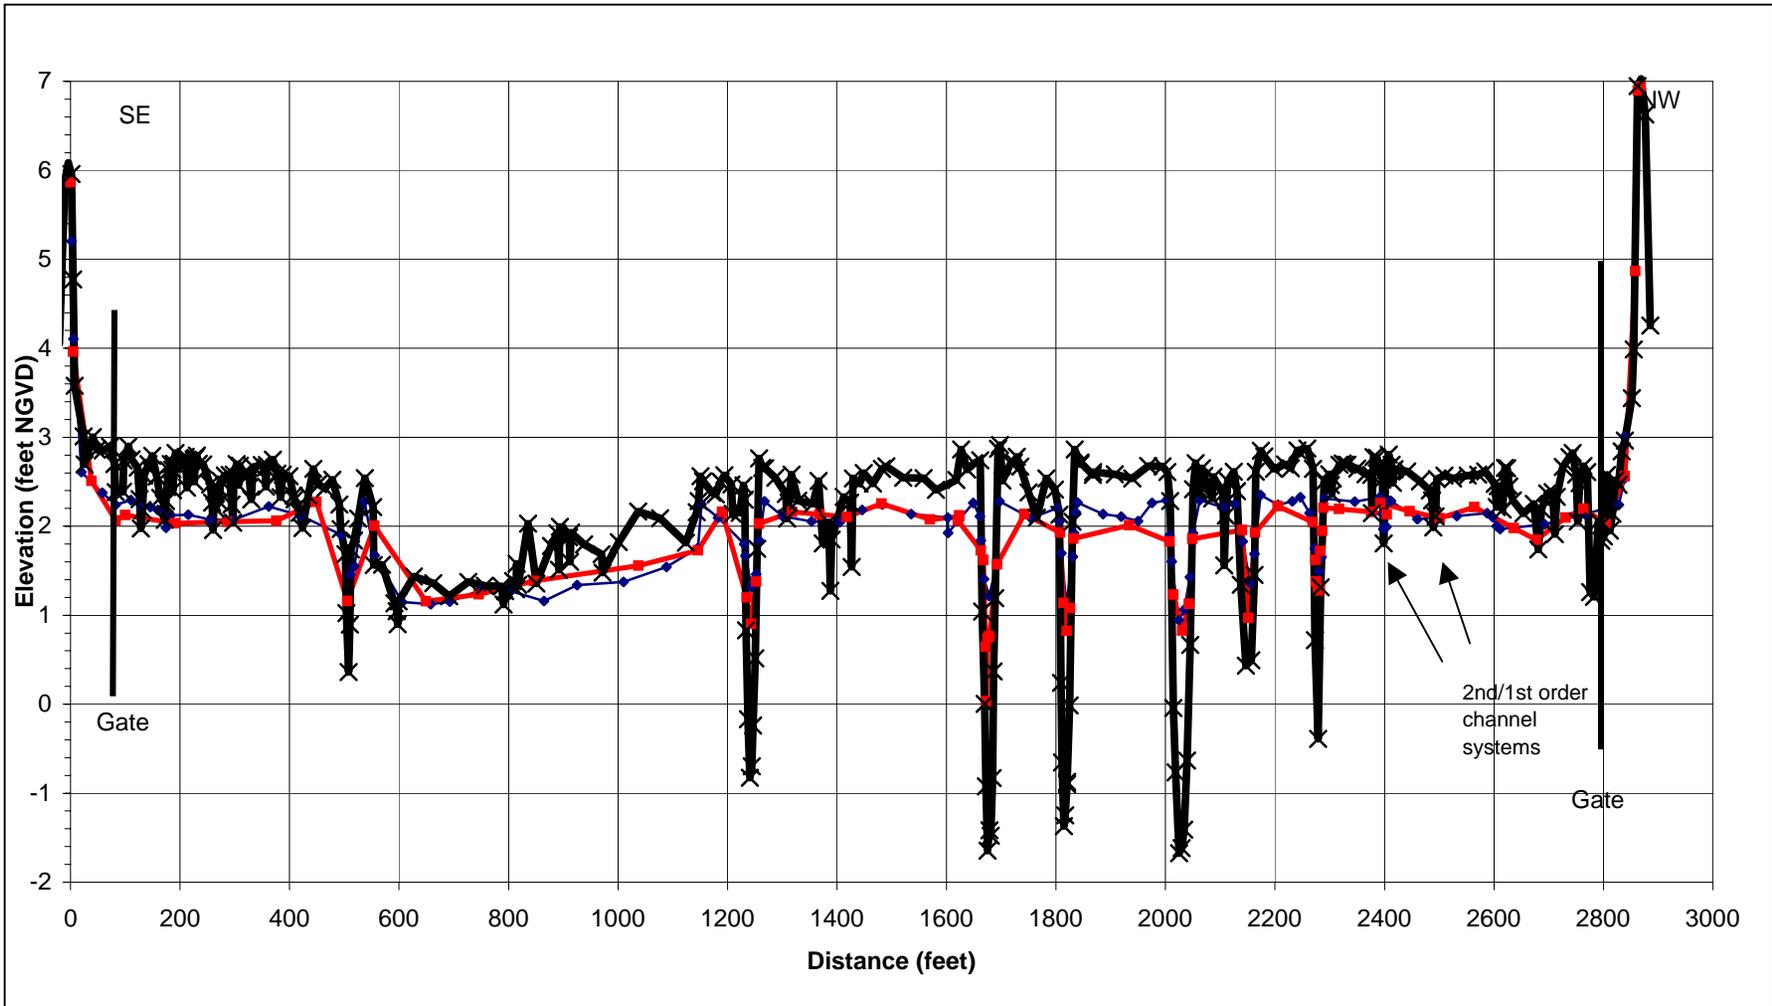
figure 23

The marshplain transect along the boardwalk (Figure 23) shows that the marshplain is aggrading across the site, except for a low mudflat area drained by the culvert in the southern portion of the site. The marshplain has aggraded by as much as 0.6 to 0.8 ft to an elevation of 2.6 ft NGVD (2.2 ft above MTL) along the northern half of the boardwalk

transect. Along the southern boundary of the site, it has aggrades up to an elevation of 2.8 ft NGVD (2.4 ft above MTL). Low marsh vegetation species (i.e. cordgrass) establish on mudflats starting at elevations of 1 ft above MTL (1.4 ft NGVD for Cooley Landing). Most of the marshplain is above the minimum elevation for vegetation colonization. The color infrared aerial photograph (Figure 5) shows many individual colonies and larger patches of vegetation that are concentrated on the channel banks have established. Photo-documentation shows that the vegetation is pickleweed. Figures 24 and 25 shows the extensive pickleweed coverage that has colonized the outboard levee and channel training berms.

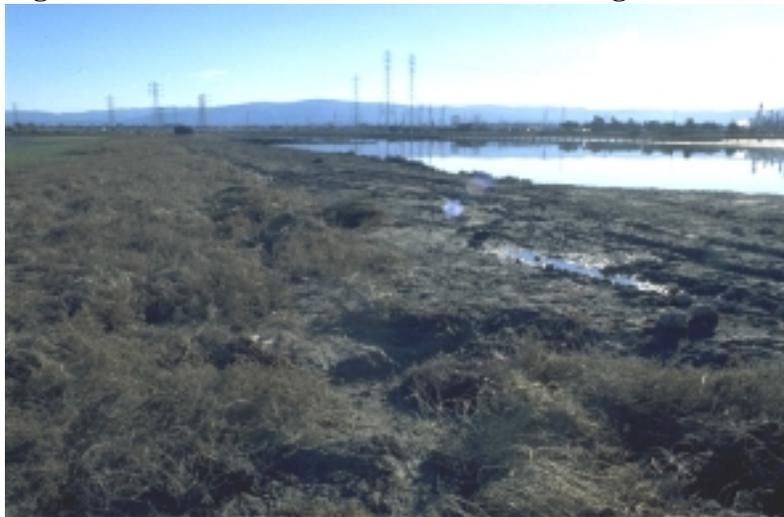
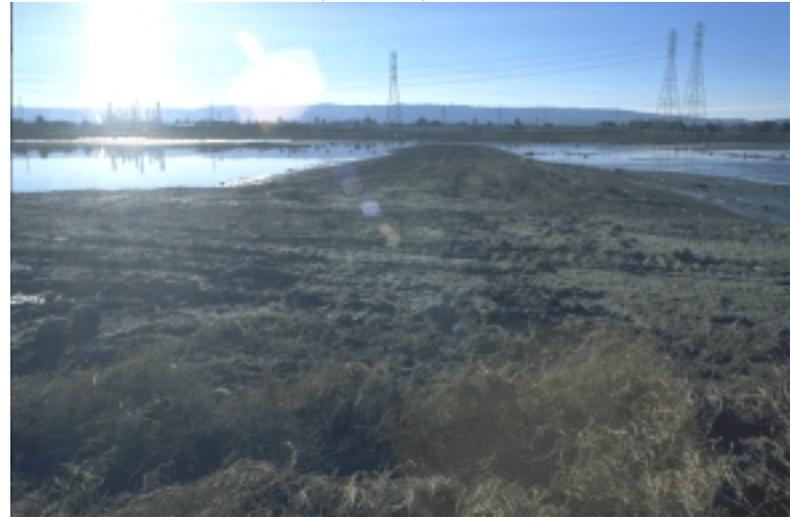
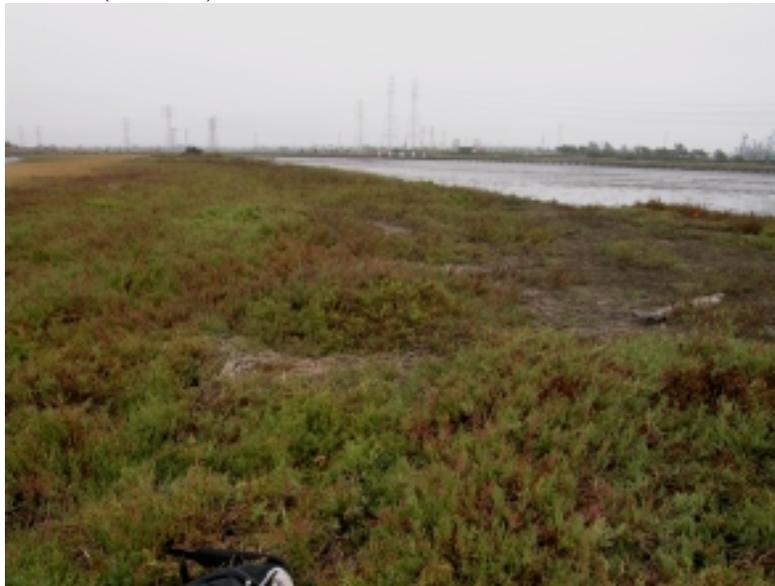
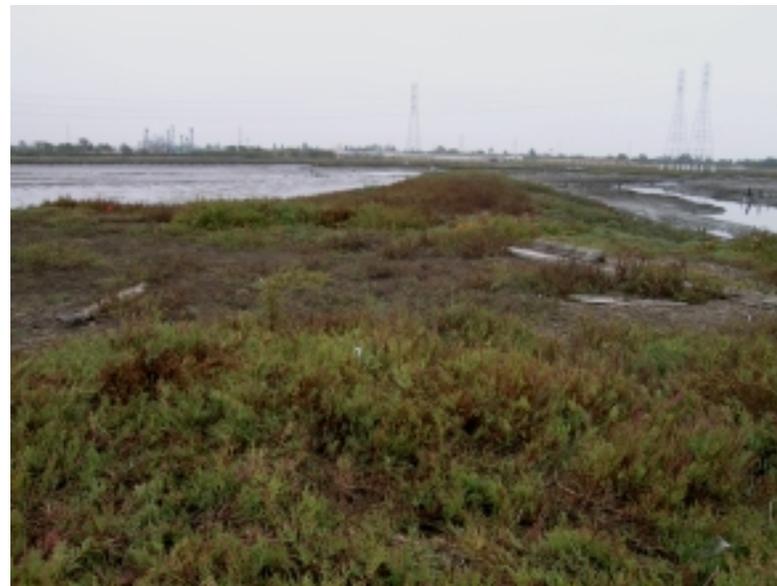
Figure 24. Outboard levee and south training berm of south breach. Post-breach (1/17/01)

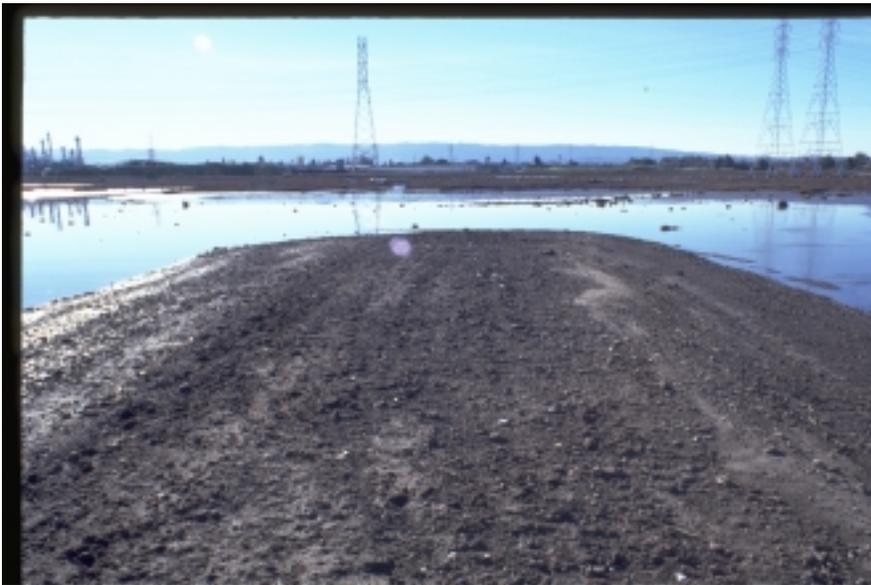
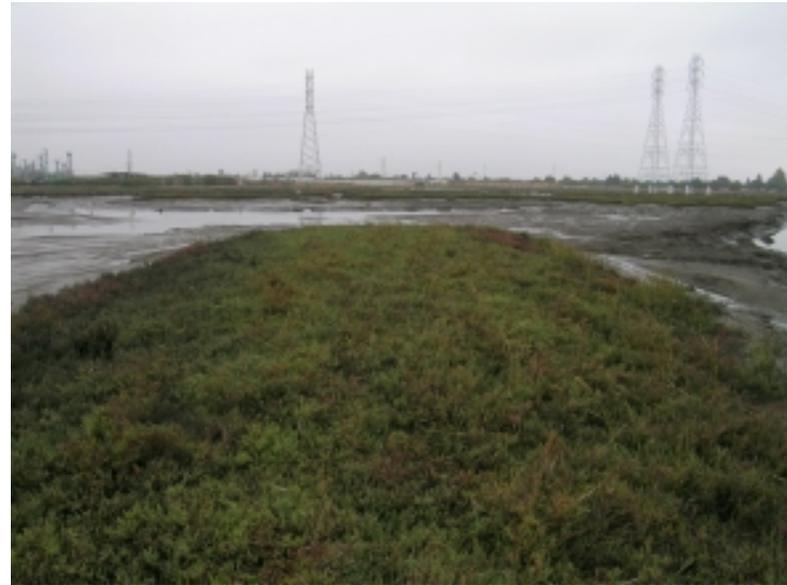
Figure 25. Tip of south channel training berm of south breach looking west.

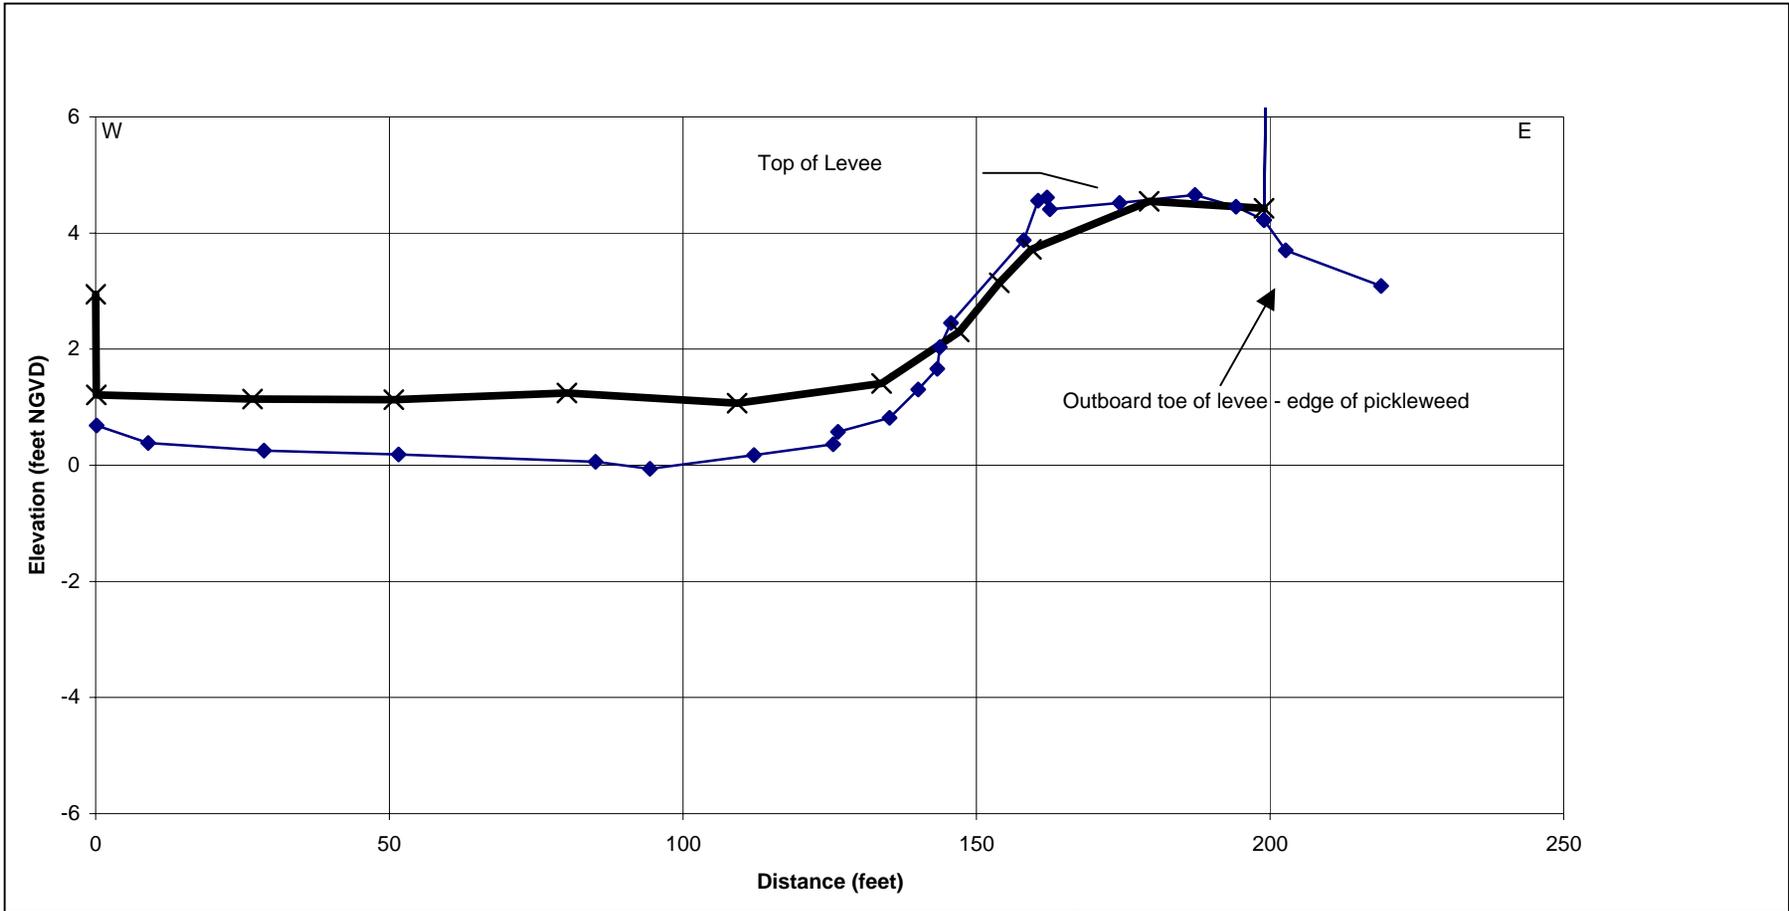
figure 26

The borrow ditches have filled in with an average of 1 ft of sediment (Figures 26 to 28). The borrow ditch at the northern part of the site (Figure 28) has experienced the most sedimentation (1.5 ft) and is 1 ft below the adjacent marshplain. The elevations of the borrow ditches range from 1.2 to 1.5 ft NGVD, which are close to the minimum elevation for vegetation establishment. The borrow ditches have not vegetated probably due to the fact that the colonization elevation for pickleweed, which is the dominant species at the site, is above the minimum elevation for vegetation establishment (PWA, unpublished data).

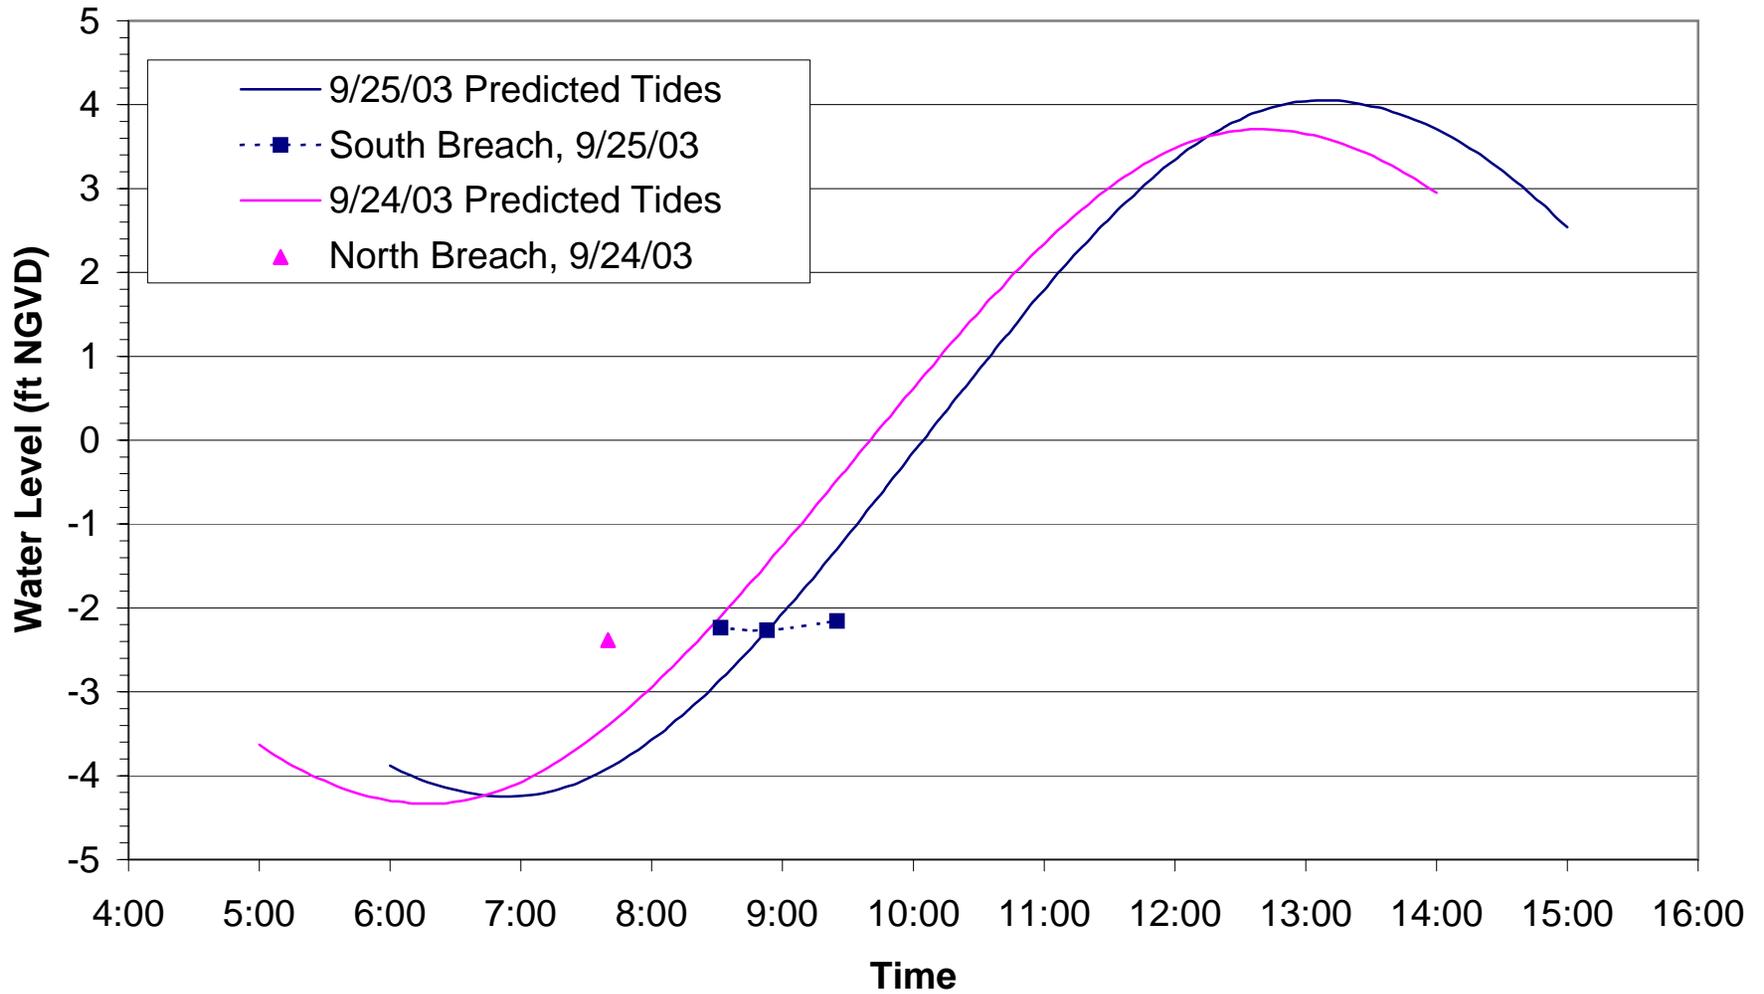
Figure 29 shows the water surface elevations surveyed in the north and south breach channels plotted with the predicted tide levels in the Bay. The low water survey elevations are -2.2 ft NGVD for the north breach and -2.3 ft NGVD for the south breach. The surveyed water surface elevations are more than a foot lower than the minimum

water level determined for the south breach in September 2001 (-1 ft NGVD, PWA et al 2002).

The current minimum surveyed water surface elevations are slightly above the maximum mudflat channel thalweg depths (-2.5 ft NGVD). This suggests that the elevation of the mudflat channel thalweg controls low tide drainage. Currently, the majority of the site is drained at low tide and certain portions of the deeper channels remain subtidal. The formation of mudflat channel that cut around the south training berm of the south breach suggest that the limited rate of drainage through the culvert to the south of the south breach forces water from this area to drain to the south breach along a path where there is not a historic channel. However, the culvert does not limit site drainage as the area is adequately drained by the south breach.

Figure 29. Surveyed water surface elevations and predicted tide levels.
