Finding a Foothold on an Uncertain Bank: An Assessment of Cerrito Creek into the Blake Garden

Nery Barrera Lopez, Moyan Chen, Timothy Cole, Tanner Howe, and Sara Mahmoud

LA 227 Restoration of Rivers and Streams  
University of California, Berkeley  
December 16th, 2019

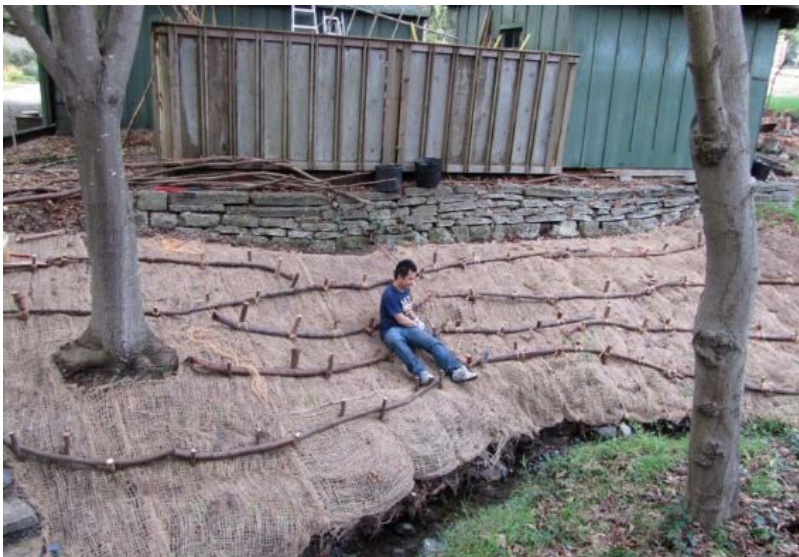
In 2009-2012, the period of multiple studies by the UC Berkeley LA 227 Restoration of Rivers and Streams class, the garden staff were undertaking a few restoration activities. Mostly this has consisted of removing the invasive species Algerian ivy and thornless elm-leaved blackberry. This seemingly never ending task continues today. The banks on either side of a bridge that leads to the main office were landscaped with geo-textile netting and planted with native and riparian plants (Figure 3).

Figure 3. A student stakes down a geotextile fabric on the northern bank of the upper reach of Cerrito Creek within Blake Garden. Upper reach of Cerrito Creek Phase 1 restoration, February 2012 (Blake Garden).

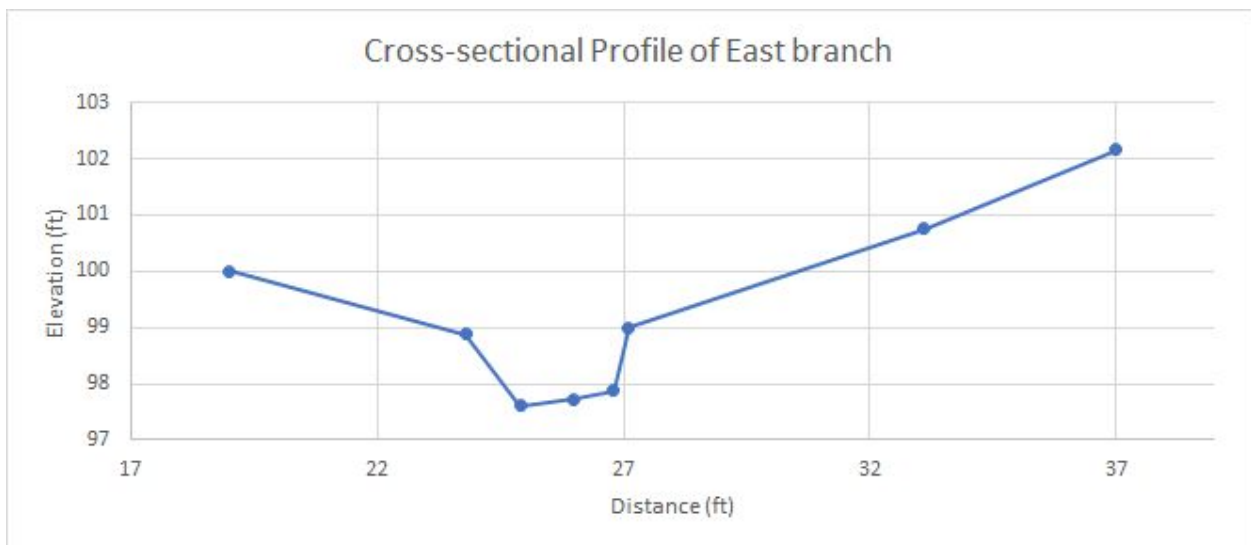
The cross-sectional profiles allowed us to see that both branches possess a wide channel. However, we could determine that vertical incision is occurring in the east branch of the upper reach, which, we have observed over the past year to carry less water (Figure 9). This might be an indication of regressive erosion in the east branch. In contrast, the bottom of the north branch has a wider bottom (Figure 10). This part of the channel was widened and its banks were reinforced with concrete (Sasaki et

Figure 9. Cross sectional profile of the east branch of the upper reach.

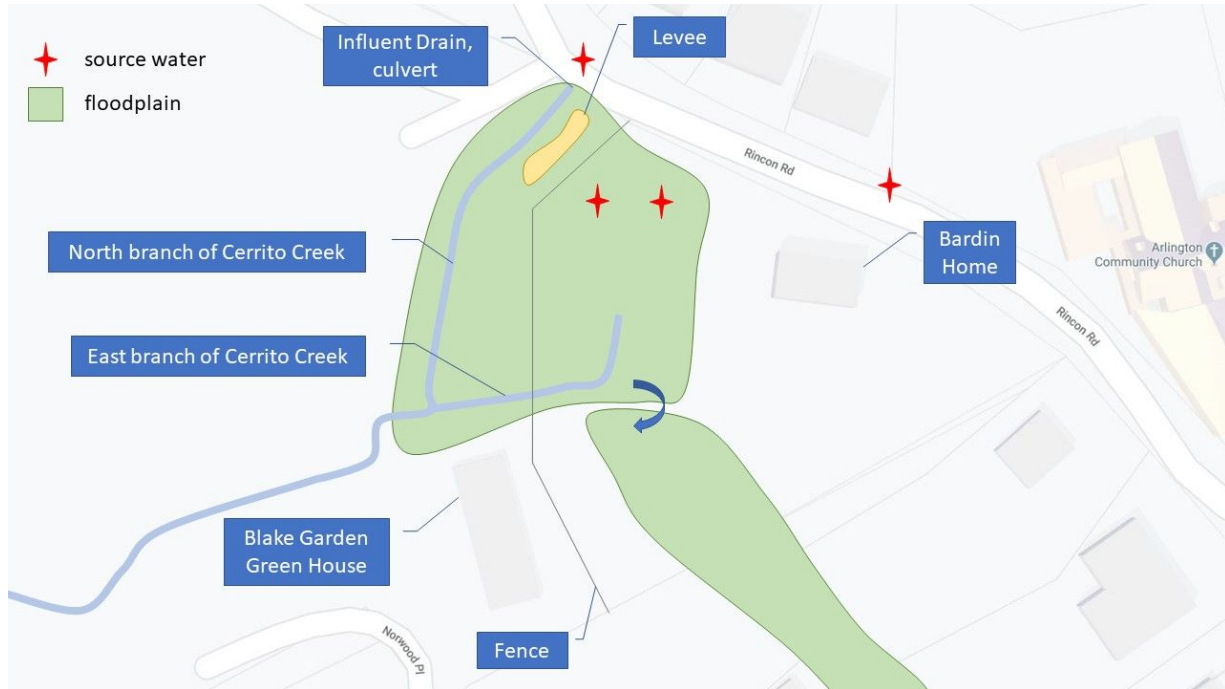
In analyzing the floodplain it is important to note that there is a rudimentary levee to the east of the influent line at the north of the property. (Figure 15) It was constructed by Blake Garden staff at an unrecorded time (likely part of the late 1960's bank stabilization measures). This levee was probably constructed to prevent the north branch of the upper reach of Cerrito Creek within Blake Garden from migrating into the Bardin property. As a result of the levee construction nearly all flows from the junction boxes on Rincon Rd. run through the main creek channel. Exceptions to this have been observed, such as

when the channel is overgrown with blackberry, the resulting impedance has caused flows to breach the levee. Also, in heavy rain events, a stream can be observed overflowing the ditch across Rincon Rd. and flowing into the Bardin property before the Blake Garden junction box.

Figure 15. Extent of floodplain influenced by the upper reach of Cerrito Creek within Blake Garden.

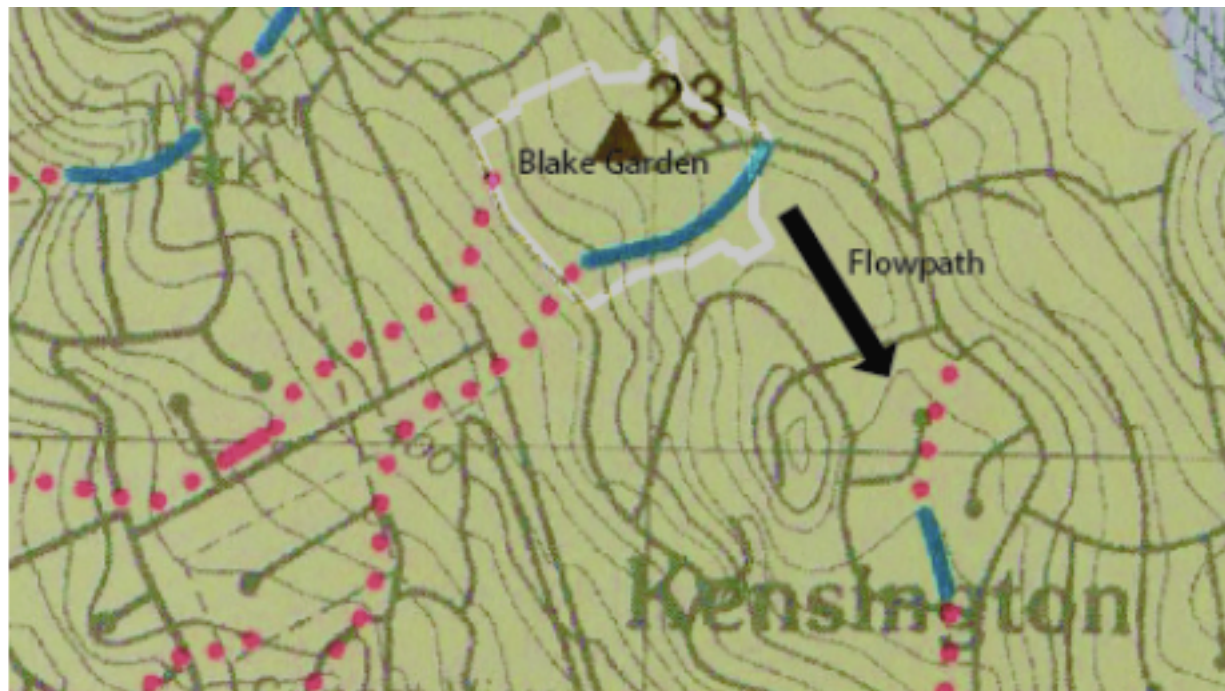
As we further examined the topographic map, we observed the possibility of a connection between the two branches of Cerrito Creek (Figure 16). The extent of the floodplain and topography suggest at least a historical or possible (under certain conditions) connection between the two branches. Upon observation of the land between the two branches, we discovered riparian vegetation and standing water suggesting there is a belt of continuous moisture through the region and possibly flow in the subsurface. We expect that with high enough flows surface water would flow over the divide between the two branches of Cerrito Creek, feeding both branches as depicted in the topographic map detail (Figure 16).

Figure 16. Potential flowpath between floodplain and lower branch of Cerrito Creek.
