Post-project appraisal of year one Re-vegetation performance at the Nathanson Creek Restoration Project, Sonoma County, CA

2010-12-14

Alanna Blough

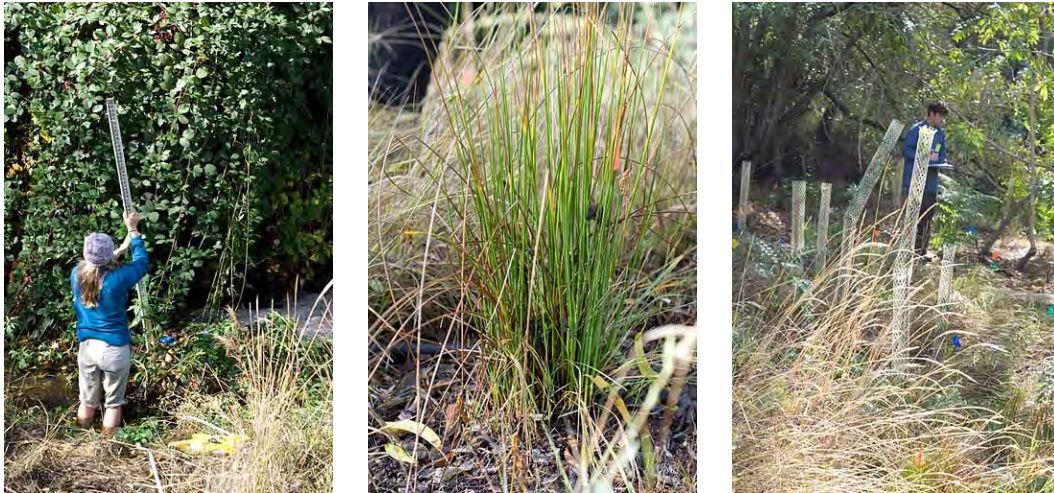
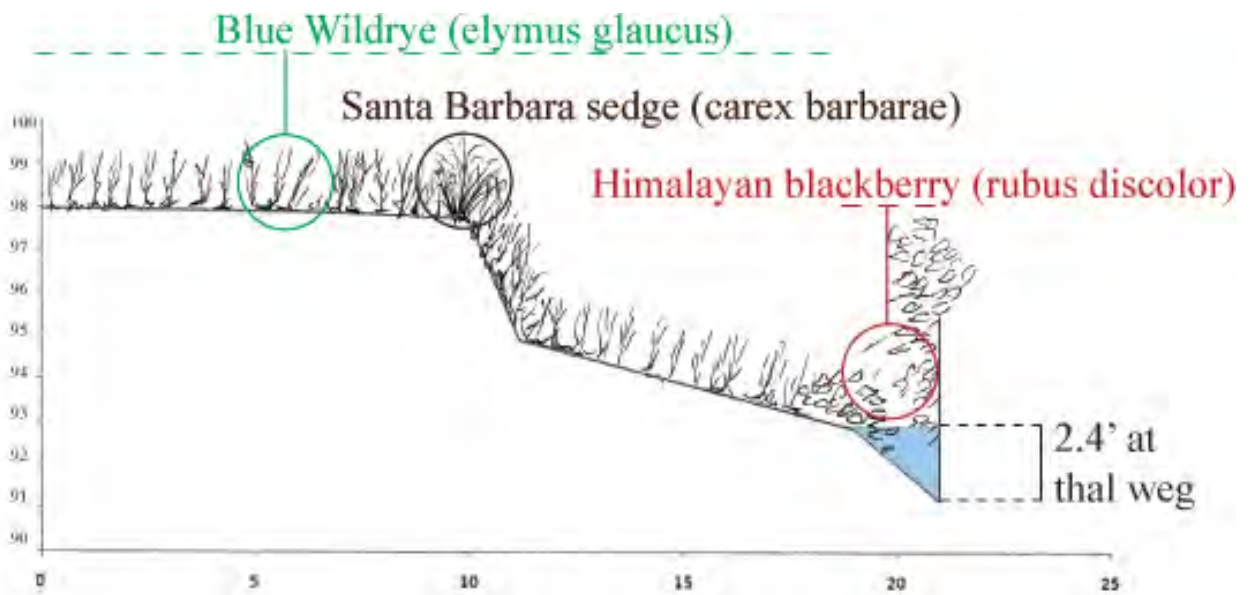
Transect 1:

From left to right: Himalayan blackberry growing over the bank stabilizing wall, a healthy Santa Barbara sedge at Transect 1, and the general condition of the grasses around Transect 1 (a protective screen over some of the plantings)

The Northernmost transect is thirty feet south of East Macarthur road bridge. A rock wall stabilizes the right bank and Himalayan blackberry bushes spill over the top of the wall

providing partial cover over the primary area of flow. Higher flow on the right side has continued to erode the streambed next to the rock wall so that the thalweg (2.4' deep) is immediately adjacent to the wall, with deposition building up on the left bank. The upper left bank is eroding and the root systems are exposed where the land drops off. On the higher and flatter ground on the left-bank there is evidence of re-vegetation, but the plants are still small and don't appear to impact the channel morphology. Blue Wildrye has sprung up on its own and dominates the landscape around the transect.

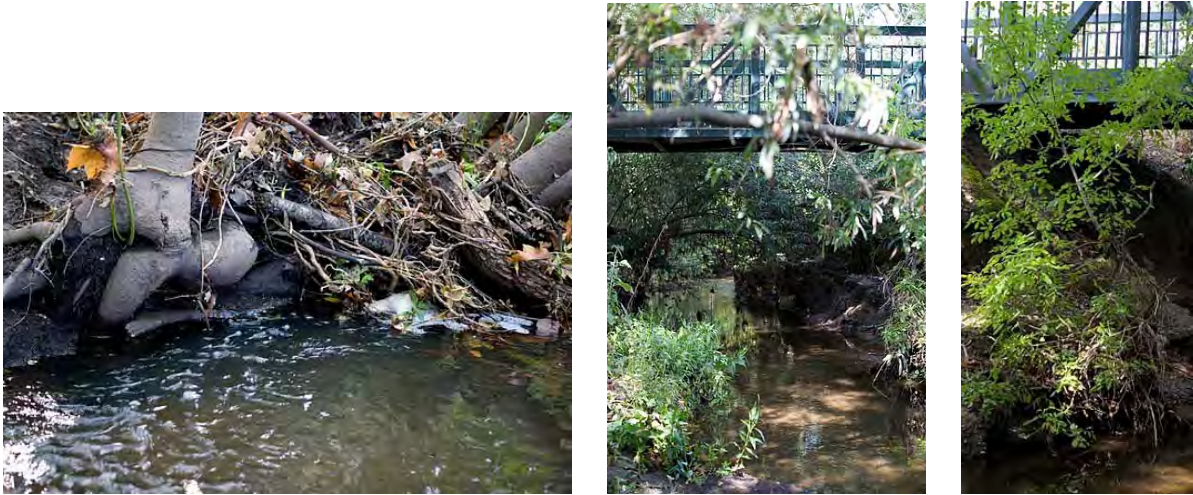
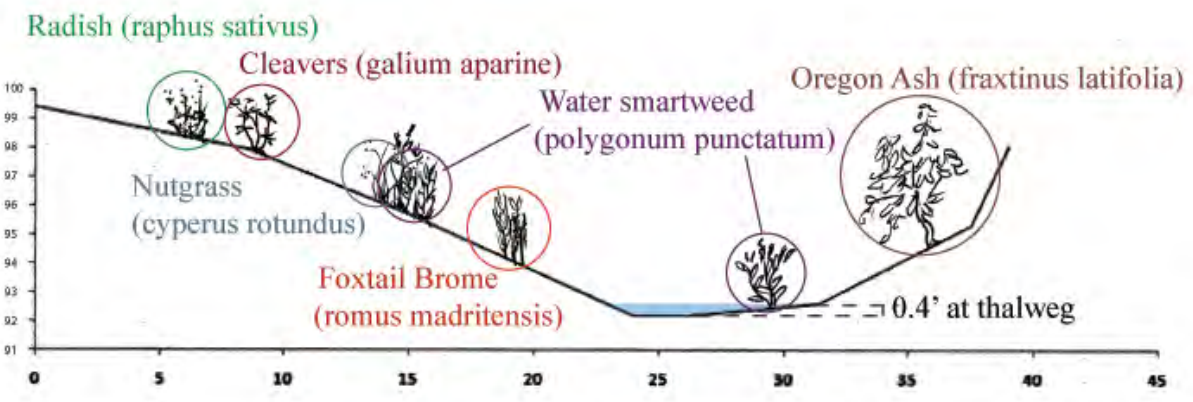
Transect 2:

Left to right: Next to Transect 2 the bank had eroded out from underneath this tree, one of several footbridges passes over the stream just North of Transect 2 (looking upstream), the Oregon Ash tree at Transect 2 at the water's edge

The next transect was also just downstream of a bridge crossing (a footbridge in this case). The bank here was much more stable with little evidence of stream-flow erosion or deposition. The depth of the water at the thalweg was 0.4 feet. Invasive species are not visibly apparent. The flow was slower than at Transect 1 with some ripples along the large aggregate in the bed.

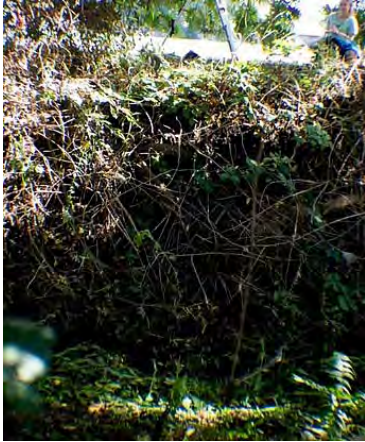
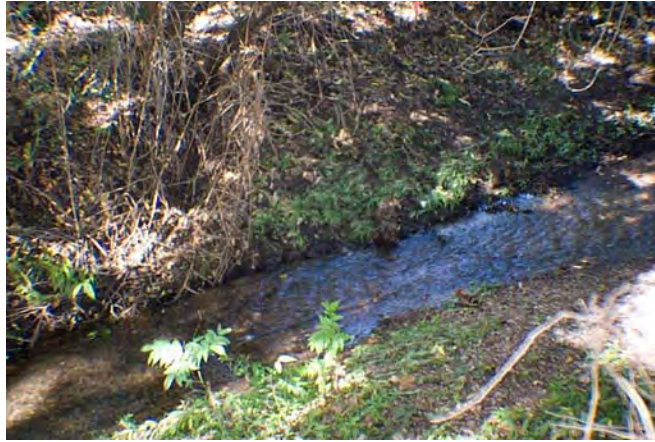
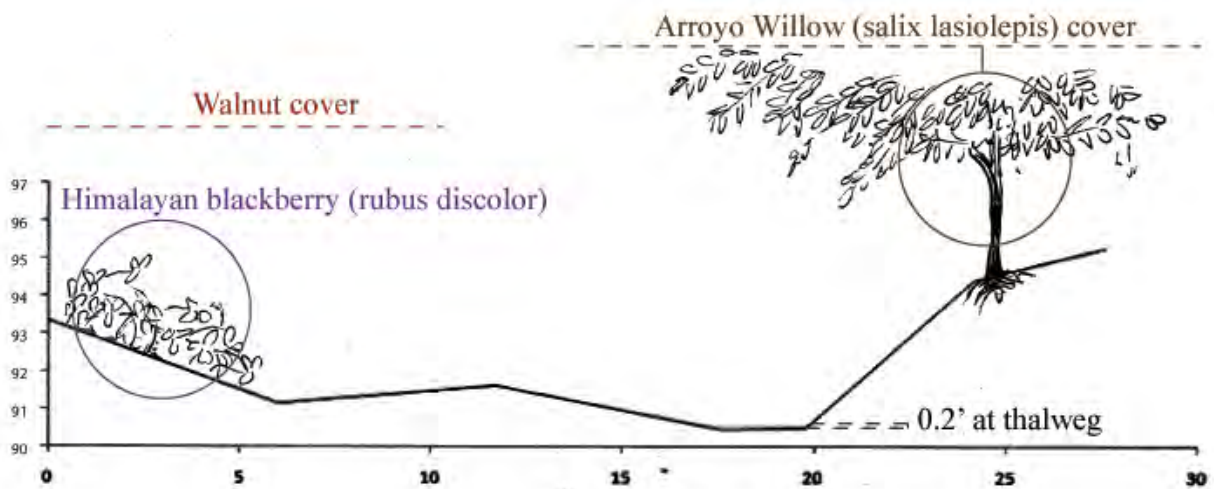
Transect 3:

Left: H. blackberry on the left bank with erosion occurring underneath; Right: thin stream width (stream flow to left)

The left bank at this transect was visibly eroded. To the left of the main channel was another channel for overflows with a loose sediment sand-bar formation in-between. The right bank was also actively eroding. On both banks, the root systems were exposed. Although the banks upstream and downstream of this section were re-vegetated, this particular stretch did not have any recent plantings. The depth of the channel at the thalweg was 1.85 feet and the flow was relatively slower than at transect 1 and 2.

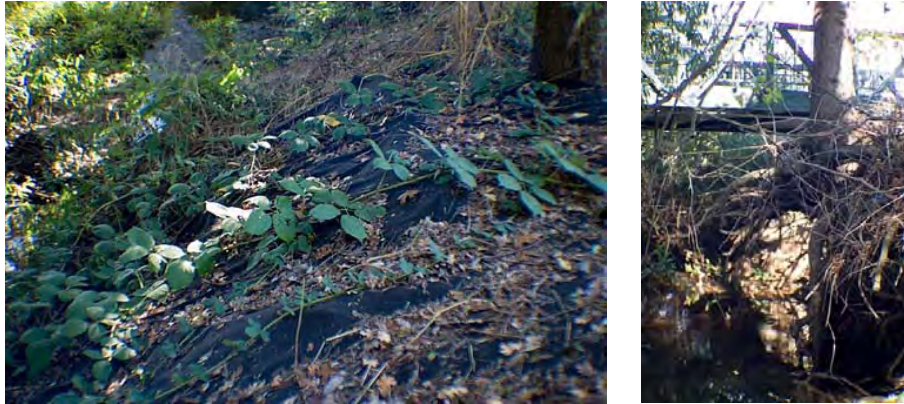
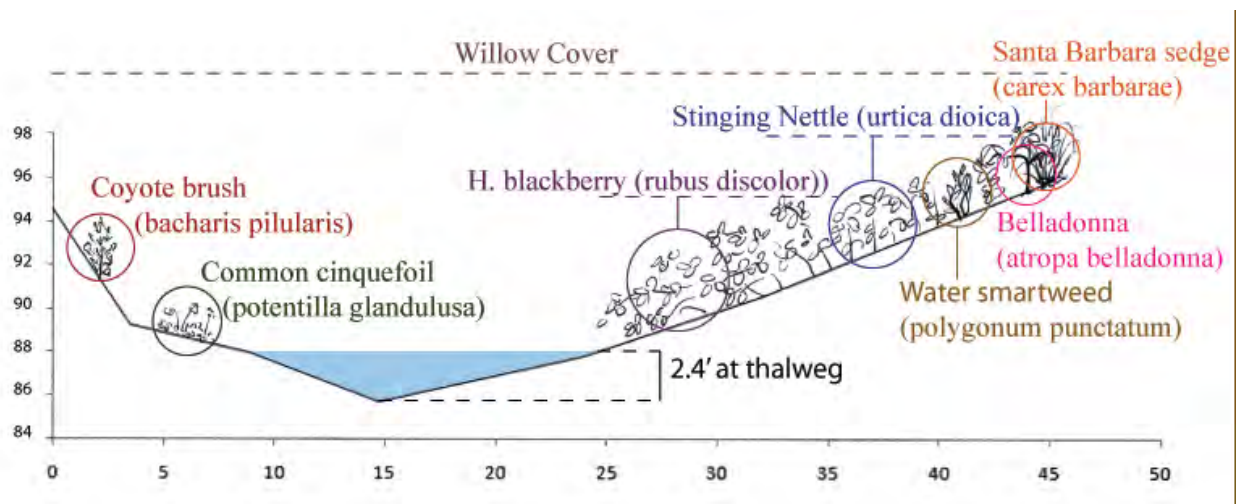
Transect 4:

Left: H. blackberry growing up and over the eradication tarps; Right: root systems stick out of the eroded left bank

This transect ran through one of the larger pools along the creek. Both sides had been planted. H. blackberry bushes overwhelmed the right bank, reaching out over the pool. Stinging nettle was also prevalent on the right bank and grew up and around the plantings. The left bank had some larger aggregate and both banks were actively eroding despite the plantings. A few large trees provide almost complete cover and their root systems dominate the lower left bank and part of the pool floor. Flow is hardly noticeable. The depth at the thalweg was 2.4 feet.

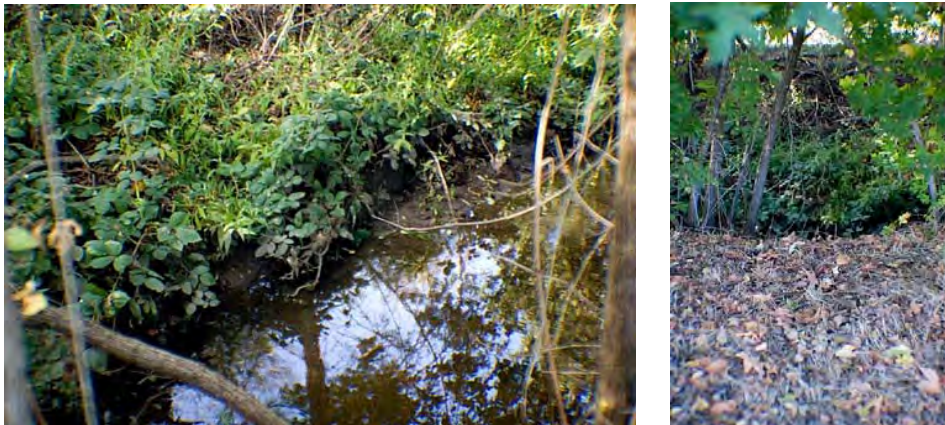
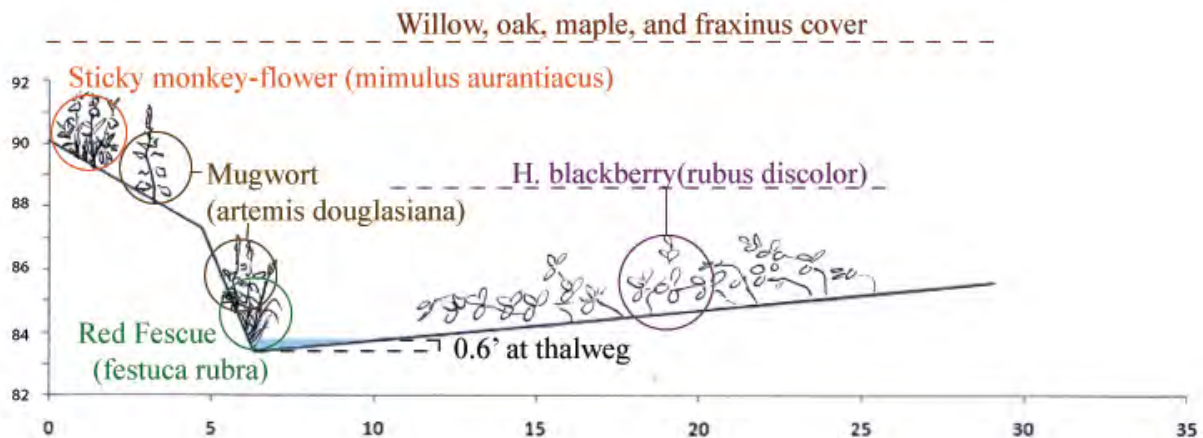
Transect 5:

Left: right bank is covered in blackberry and the flow is very slow; Right: looking across to the right bank from the top of the left bank—the ground cover changes from leaf litter and small grasses on the planted side (left/foreground) to the full cover of H. blackberry on the unplanted side

The left bank has been planted but the plantings seem to do little to alter the course of erosion. On the left bank trees (of a range of maturity) hold onto the eroding bank with their roots. Some blackberry bushes remain. The right bank showed some evidence of erosion and was dominated by the spontaneous growth of understory native species, some debris from trees, and Himalayan blackberry. Large trees grew on the upper right bank. The depth at the thalweg was 0.55 feet.

The banks of the creek show significant erosion and are even undercut in places. We suggest that major channel geometry enhancement and bank and bed stabilization be included in future restoration efforts if for flood control and habitat restoration. The plan to install pathways and viewing platforms should be postponed until proper channel reformation has been completed to avoid deconstruction.

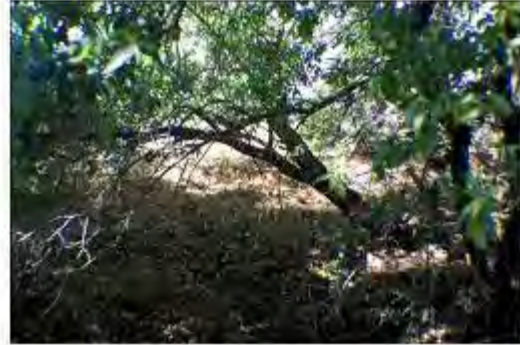
transect 3 bank erosion  
and overgrown veg

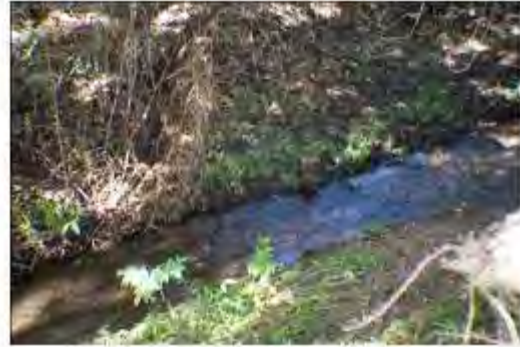
transect 3 right bank veg  
condition no new plantings done

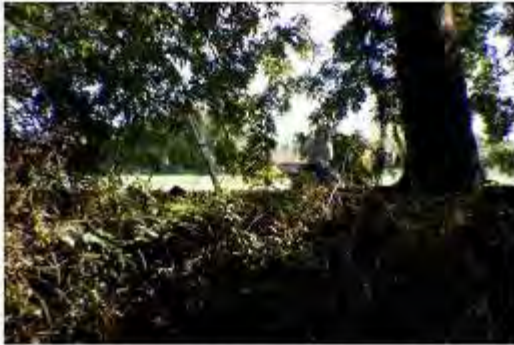
transect 3 stream width very thin lots of sediment

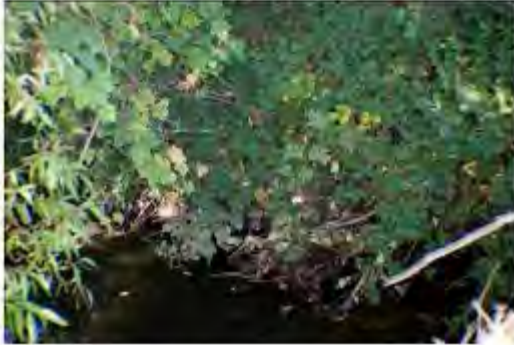
transect 4 backberry bush right bank overgrown over channel

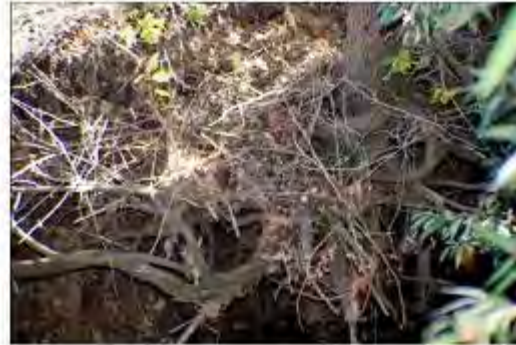
Transect 4 close up left bank root erosion

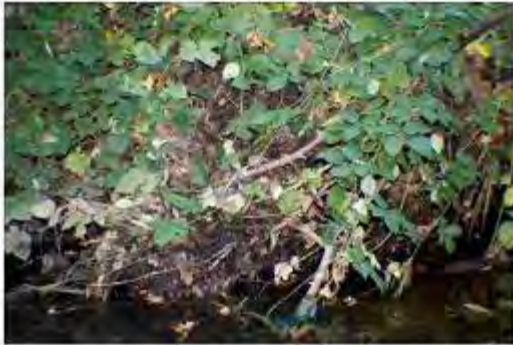
transect 4 right bank blackberry and trash in channel

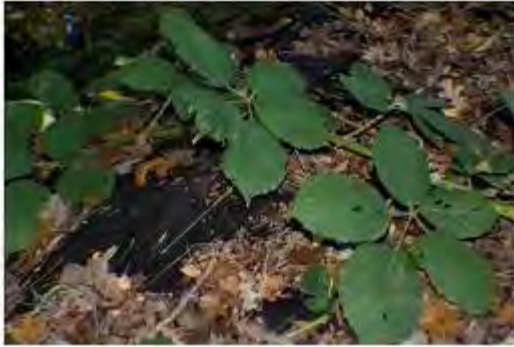
Transect 4 veg overgrowing tarps close-up

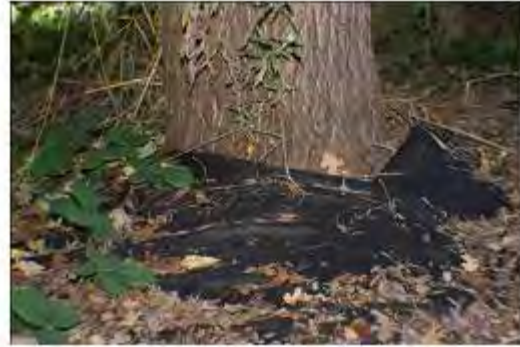
Transect 4 veg overgrowing tarps right bank location of tarp around tree

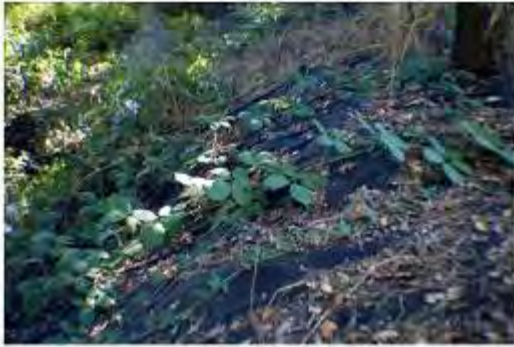
Transect 4 veg overgrowing tarps
