Liquefaction and Related Ground Failure from July 2019 Ridgecrest Earthquake Sequence

Bulletin of the Seismological Society of America, 110(4)

# Liquefaction and Related Ground Failure from July 2019

## Ridgecrest Earthquake Sequence

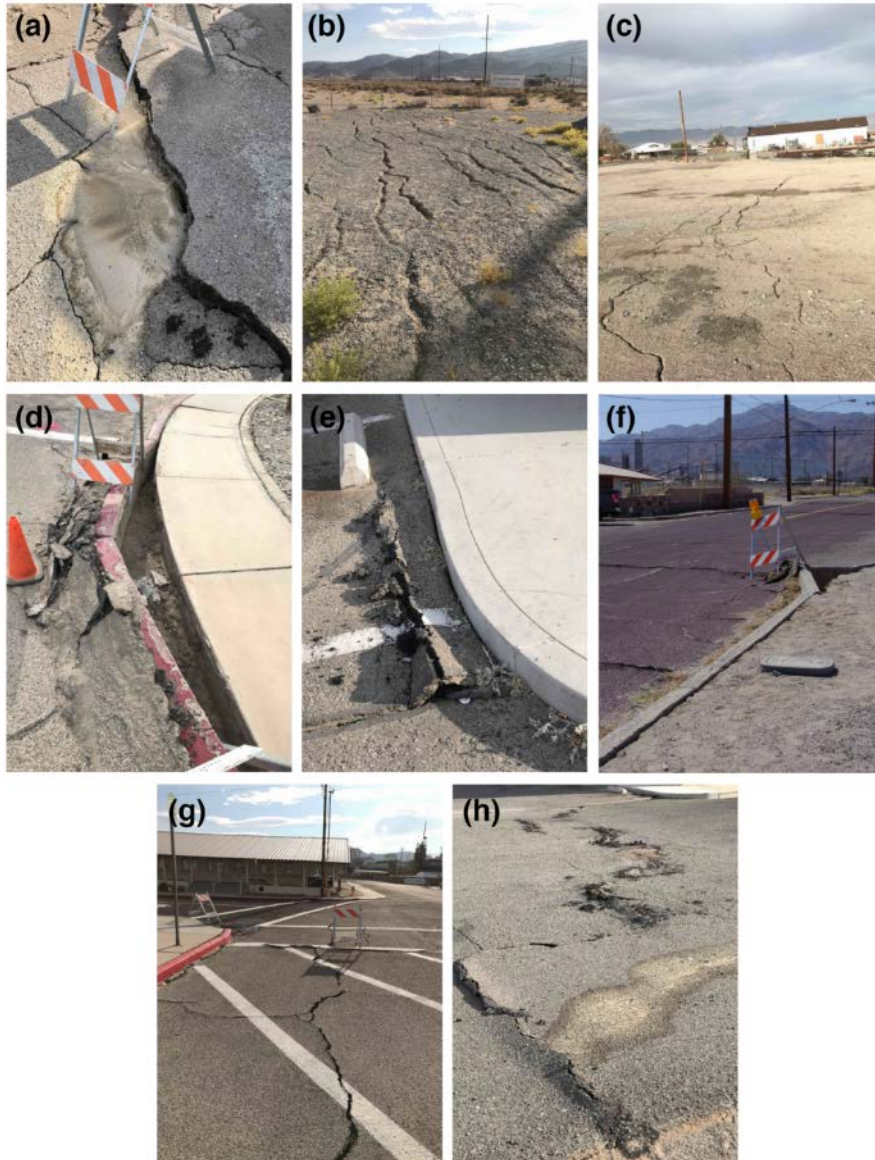
367 Ground cracks caused by extensional strain due to lateral spreading were apparent near  
368 the sand boils, and throughout the investigated region (Figure 6: b, c, g). The orientation  
369 of the extensional cracks was variable. Many cracks trended toward the northeast,  
370 parallel to the lake perimeter, but other cracks were at different angles. We interpret this  
371 to indicate that the lateral spreading was predominantly toward the lakebed, but lateral  
372 movement occurred in other directions as well, possibly due to the influence of structures  
373 on ground displacements, or due to ground oscillation (Figure 6g). In addition to the  
374 extensional ground cracks, compressional features were also observed in various regions

375 (Figure 6: d, e, f, h), as evidenced by buckled concrete curbs, and regions where the  
376 asphalt pavement cracked and rode up over adjacent pavement.

389 As shown in Figure 5, transect TT2 was oriented in a nearly north-to-south direction,  
390 starting near the northwest limit of the ground failure region and ending at the Family  
391 Dollar parking lot. Transect TT2 is approximately 122 m long with elevations (from Google  
392 Earth Pro) that range from 503 - 500 m MSL (north to south-southeast), indicating an  
393 average gradient of approximately 2.3%. As shown in Figure 7, the sum of the ground  
394 crack widths measured along TT2 is 71 cm. Example images of ground cracks along  
395 Transect TT2 are shown in Figure 6c.

396 Transect TT3 was initiated at the intersection of Magnolia Avenue and Argus Avenue and  
397 continued southeast, ending at the intersection of Argus Avenue and Trona Road.  
398 Transect TT3 is approximately 53 m long and the elevation difference (from Google Earth  
399 Pro) is estimated as 2 m, indicating an average ground surface slope along the transect  
400 of approximately 4%. The sum of the ground crack widths measured along TT3 is 45 cm.  
401 Example images of ground cracks along Transect TT3 are shown in Figure 6f.

897  
 898 **Figure 6.** Ground failure from liquefaction in Trona. (a) Sand boil along a pavement crack  
 899 created from lateral spreading (35.757483°, -117.37806°). (b, c) Extensional cracks  
 900 caused by lateral spreading (35.757325°, -117.377705°; 35.75966°, -117.375892°). (d, f)  
 901 Damaged asphalt from buckled curb edge (35.75936°, -117.37676°; 35.762387°, -  
 902 117.372586°). (e, h) Compressional features from lateral spreading (35.75897°, -  
 903 117.37561°; 35.75909°, -117.37552°). (g) compressional and adjacent extensional

904 features/cracks caused by lateral spreading and ground oscillation (35.75986°, -  
905 117.37651°).

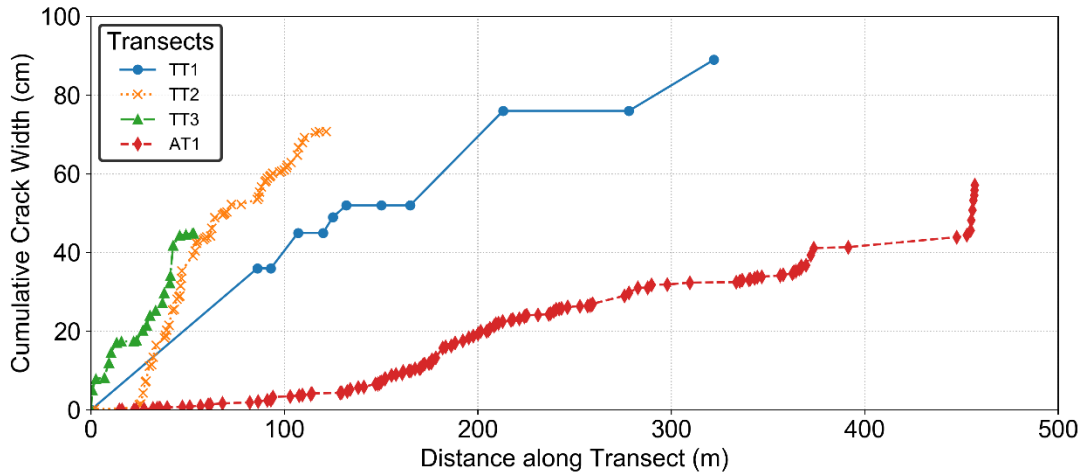
377 Field mapping to record locations of cracks and approximate crack widths were performed  
378 along three transects in Trona (shown in Figure 5). Transect TT1 was initiated at Mountain  
379 View Street and continued east to Jones Street, ultimately ending near the northeast  
380 corner of the Family Dollar store. Transect TT1 is approximately 325 m long with  
381 elevations (from Google Earth Pro, see Data and Resources section) that range from 506  
382 - 501 m MSL (west to east), indicating an average ground surface slope along the transect  
383 of approximately 1.6%. Figure 7 shows cumulative crack width versus distance along the  
384 transect. The sum of the ground crack widths measured along TT1 is 89 cm. Example  
385 images of ground cracks along Transect TT1 are shown in Figure 6h. We acknowledge  
386 that the sum of crack widths along a transect, as shown in Figure 7, may underestimate

402 The tension cracks in Trona that are documented in the transects occurred within a region  
403 that had been subject to pre-earthquake ground deformations. This was evident from  
404 patched cracks in pavement, some of which re-opened during ground shaking. To the  
405 extent possible, the field teams sought to document “fresh” cracks that they believed  
406 opened during the earthquake, and only those features are included in the transects  
407 reported in Figure 7.

419 in Figure 7. An example of lateral displacement cracking observed along Transect AT1 is  
420 shown in Figure S19. The sum of ground crack widths measured across the 457 m-long  
421 transect was approximately 57 cm.

907 **Figure 7.** Cumulative crack width along transects in Trona and Argus. Transection  
908 locations are shown in Figures 4 and 7.

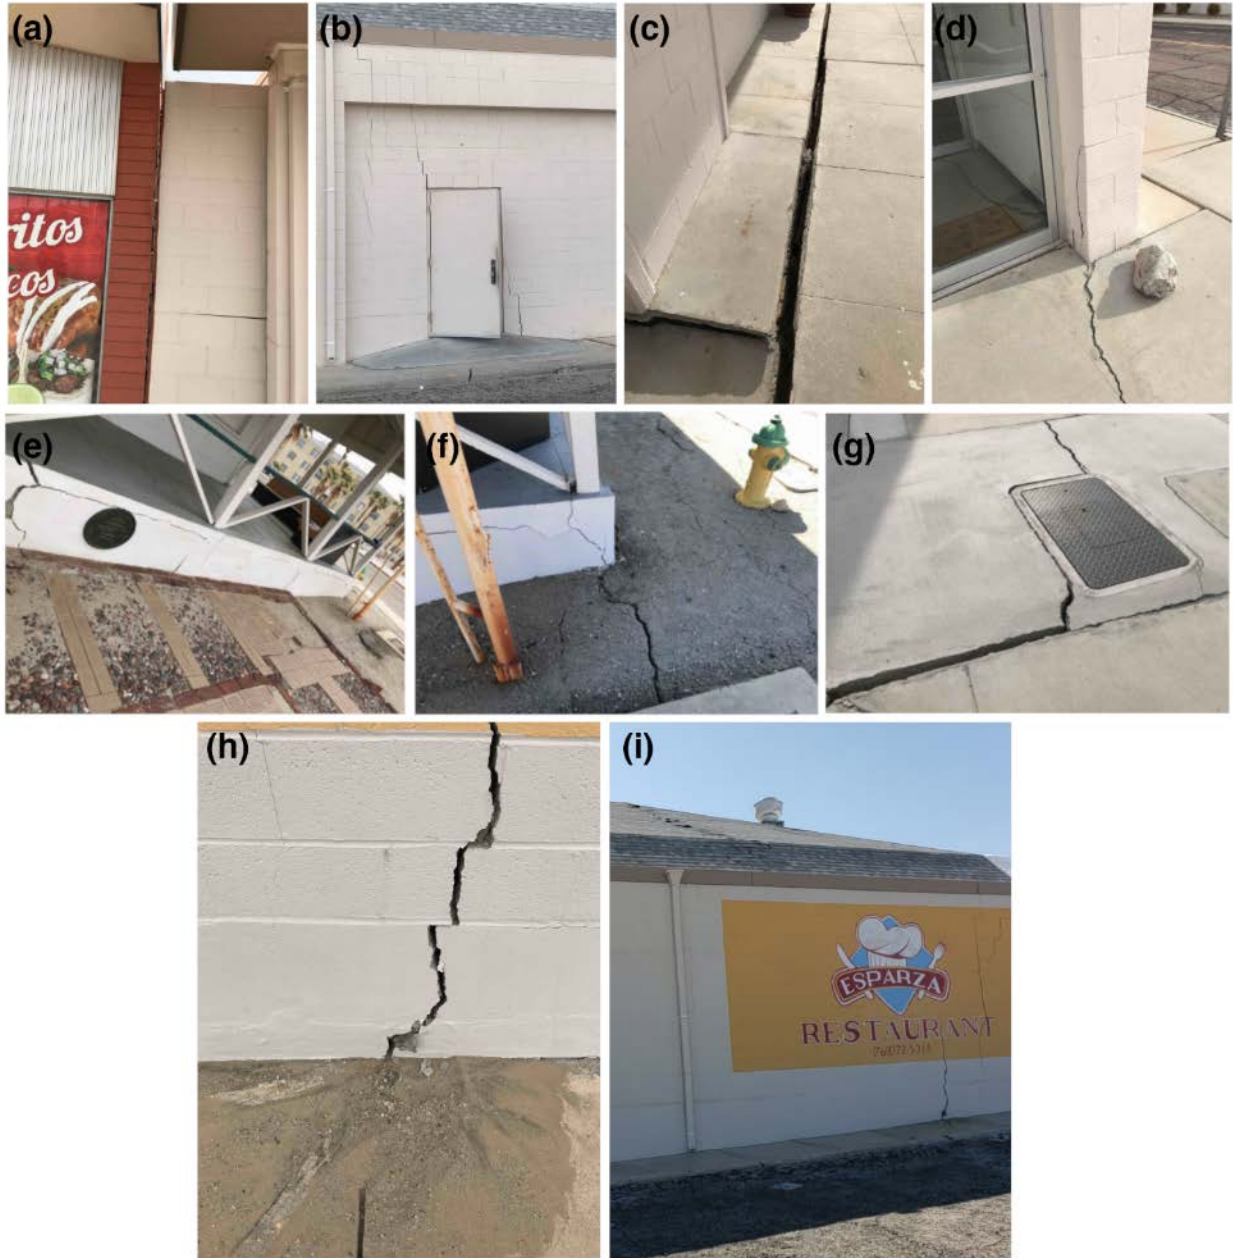
438 Structures in the Towns of Trona and Argus appear to have been affected by liquefaction-  
439 induced ground failure/movement, primarily from lateral spreading. Figure 9 shows  
440 examples of buildings that experienced damage in Trona, some of which may have been

441 liquefaction-related. Figure 9a shows a 2.5 cm-wide crack in the wall connecting the  
442 Esparza Restaurant and the adjacent building that occurred as a result of lateral  
443 spreading in combination with ground shaking. Figure 9b shows wall cracks on the  
444 eastern side of the Esparza Restaurant that has misaligned the door frame and caused  
445 the door to remain ajar. Figure 9c and 9d show significant displacement and cracking of  
446 a sidewalk due to lateral spreading (there is a 0.5 L plastic bottle within the crack in Figure  
447 9c). Figure 9e and 9f show structural damage in the form of large cracks in the floor slab  
448 of a museum due to lateral spreading, while Figure 9d shows a compressional crack in a  
449 sidewalk, along with damage to the adjacent building column. Figure 9h shows the  
450 Esparza Restaurant, which experienced wall cracks from lateral spreading in the **M6.4**

451 event that were widened in the **M7.1** event, which the GEER team photographed after  
452 each event. It is possible that some of the observed cracks pre-dated the earthquake  
453 sequence and were subsequently widened by the earthquake. The crack shown in Figure  
454 9h on the eastern wall of the Esparza Restaurant building continued up to the roof, and  
455 the roof diaphragm was pulled apart, as shown in Figure 9i. Apparent effects of  
456 liquefaction on structures also occurred in Argus where structures that were heavily  
457 damaged were located on or near the alluvial fan, which exhibited evidence of lateral  
458 spreading in the form of tension cracks. Structural damage took the form of chimney  
459 separations from buildings, masonry cracks from extensional movements, toppled walls,  
460 and punch-through in retention walls (Stewart et al. 2019).

914 **Figure 9.** Ground failure effects on buildings in Trona. (a) Crack at screen wall between  
 915 two buildings (35.75979°, -117.376315°). (b, h, i) Wall cracks at the eastern side of the  
 916 Esparza restaurant with associated sand ejecta and roof damage (35.75957°, -  
 917 117.37611°). (c, g) Sidewalk pavement crack and offset likely from lateral spreading and

918 ground oscillation (35.75982°, -117.37637°; 35.75980°, -117.37606°). (e, f) Cracks in floor  
 919 slab from lateral spreading and ground oscillation (35.759802°, -117.376808°).

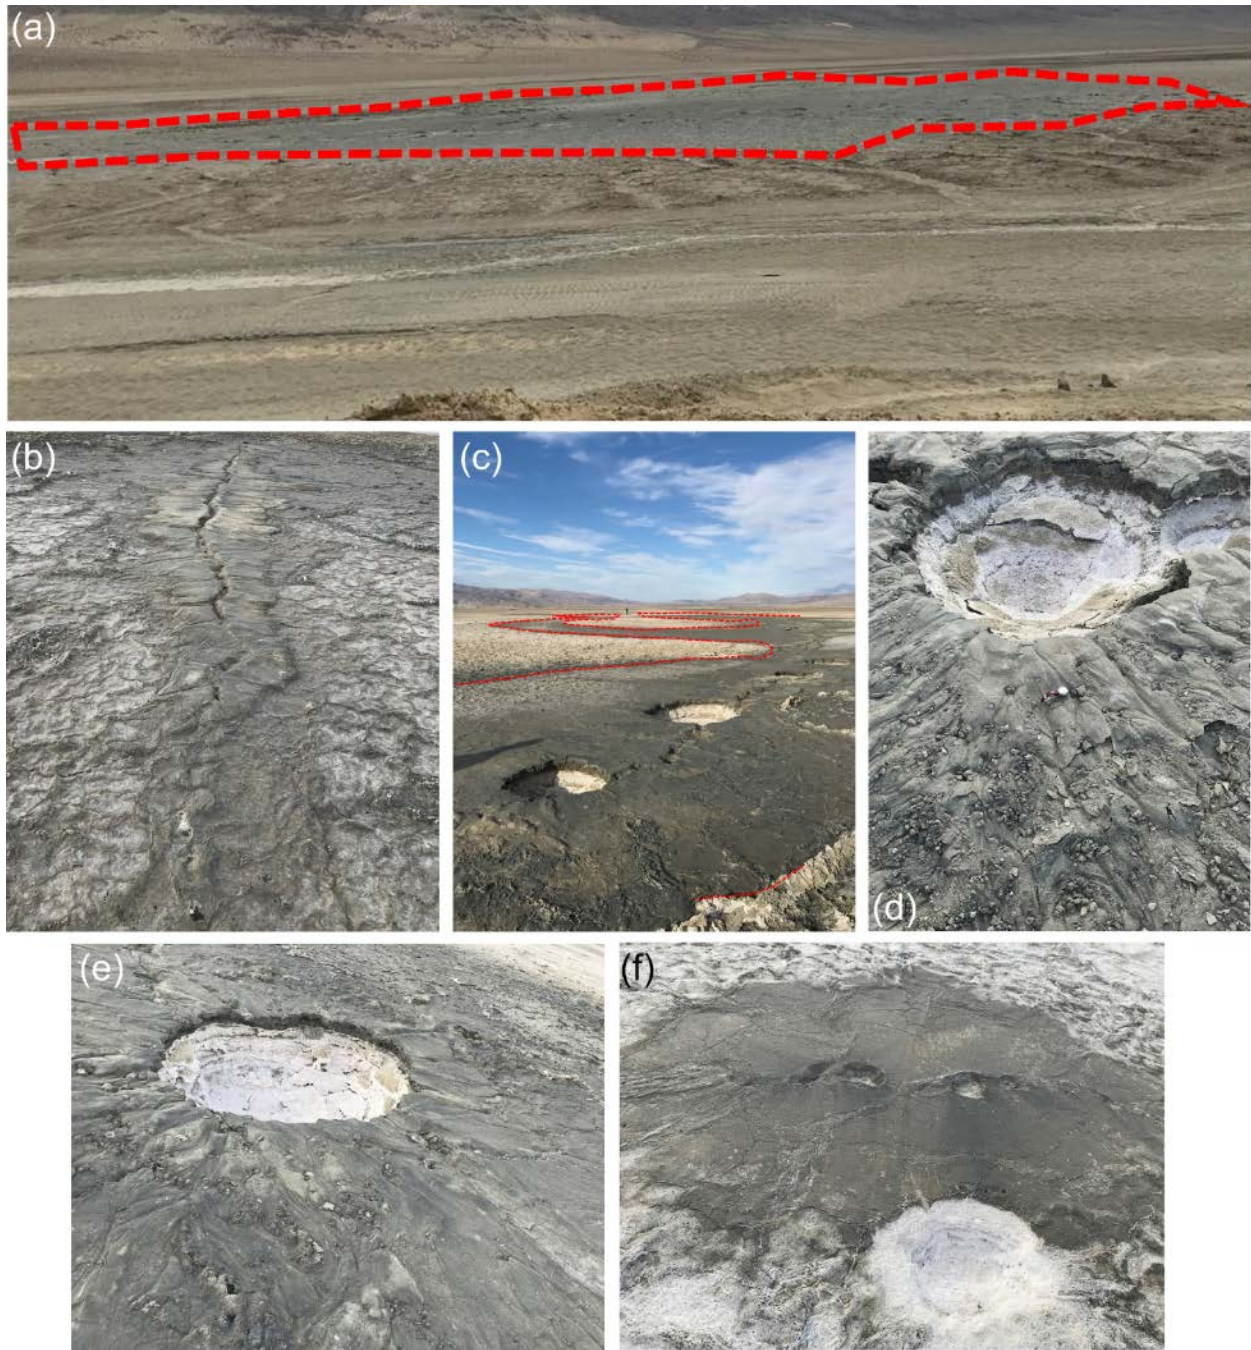
500 Figure 10 shows the track log from the reconnaissance and locations of geotagged  
501 photos. Figure 10 also provides an overview of the reconnaissance findings. Figure 12a  
502 shows a photo of the central zone of the eastern edge of the lake (Zone 1 in Figure 10).  
503 This photo was taken from the road located southwest of the linear damage zone

504 highlighted by the DPM. It shows a relatively narrow (about 110 m wide) zone covered by  
505 greyish ejecta with different coloration than surrounding material. This zone is potentially  
506 useful to study liquefaction susceptibility as it is a clear example of variable liquefaction  
507 performance over a short length scale. At this location the probability of liquefaction  
508 predicted by the USGS liquefaction hazard map is ~4%.

509 Massive liquefaction was observed near the southwest edge of the lake (labelled Zone 2  
510 in Figure 10). Thousands of sand boils (Figure 12c), ground fissures and cracks (Figure  
511 12d), and abundant sand, gravel (Figure 12d,e), and brine-evaporite ejecta (Figure 12f)  
512 were observed along the relatively narrow NW-SE line depicted on the DPM. We use the  
513 term brine-evaporite to indicate that after the brine fluid was ejected onto the surface,  
514 evaporites precipitated out of the solution as it evaporated. Figure 12f shows a sand boil  
515 entirely covered by a thin brine-evaporite layer. This sand boil covers an area containing  
516 sand from two smaller (and older) boils. Two hypotheses can be formulated to explain  
517 this phenomenon: (1) both manifestations occurred during the same event - the smaller  
518 sand boils were caused by liquefaction occurring in a more surficial layer, while the brine

519 boil occurred in a deeper layer, or (2) the two liquefaction manifestations were triggered  
520 by separate events. The correct hypothesis cannot be identified from the available data,  
521 because reconnaissance was performed following the major events in the earthquake  
522 sequence. Within Zone 2, the USGS liquefaction hazard map predicts a probability of  
523 liquefaction ranging between 5-8%.

929 **Figure 12.** (a) Narrow liquefaction ejecta zone located in the central portion of the  
 930 northeast edge of Searles Lake (35.72701°, -117.27801°), (b-f) fissures, sand boils with  
 931 sand, gravel, and brine-evaporite ejecta observed towards the southwestern edge of the  
 932 lake (35.694858°, -117.339622°; 35.6955°, -117.34235°; 35.695913°, -117.34113°;  
 933 35.695208°, -117.340462°; 35.695217°, -117.341072°).
