The removal of Saeltzer Dam on Clear Creek : an update

## **The Removal of Saeltzer Dam on Clear Creek: An Update**

Mike Ferry and Peter Miller  
June 2, 2003

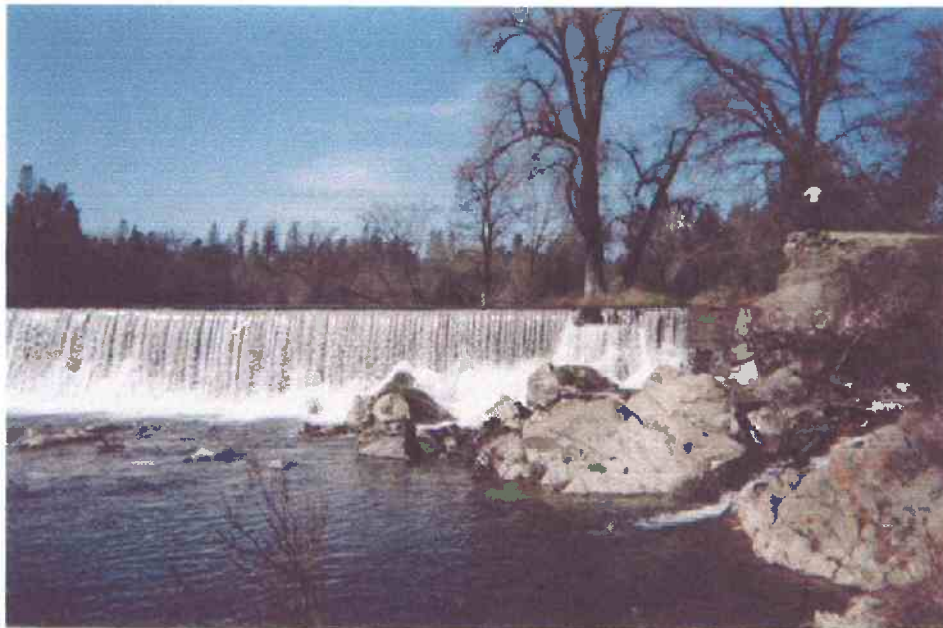
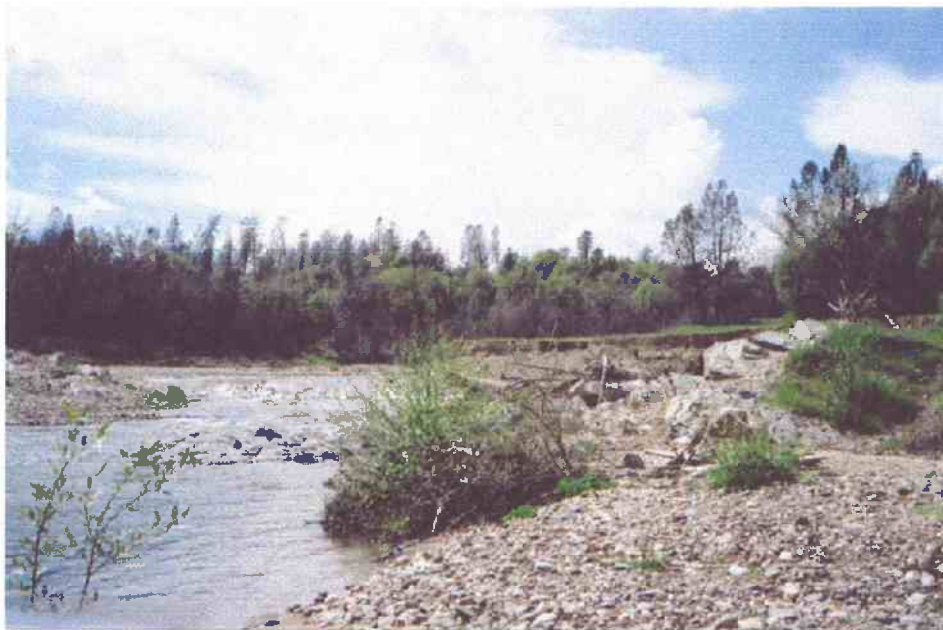
Figure 4: Saeltzer Dam, Before and After Removal, View Upstream

Three pairs of pre- and post-dam removal photographs are presented in Figures 4, 5, and 6. The “pre” photographs were collected as part of the environmental assessment of dam removal and were given to us by Mike Urkov of CH2M Hill (see Table 1). The post-dam photographs were taken by us on April 4, 2003. In each case we attempted to duplicate pre-existing photographs of Saeltzer Dam.

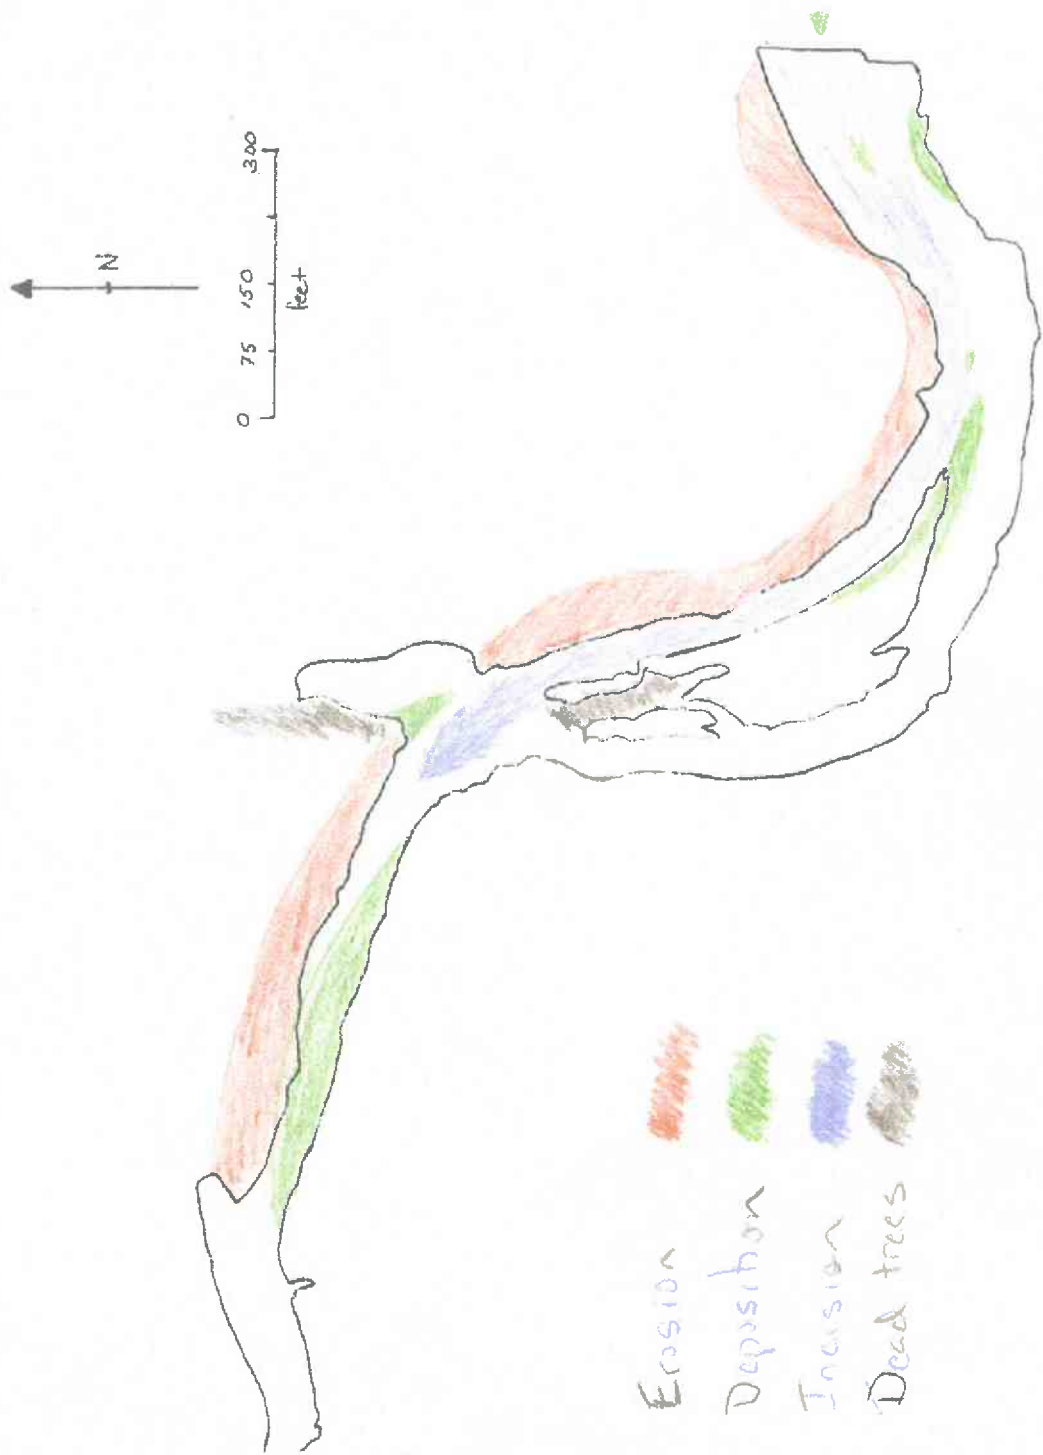
Figure 8: Changes to Study Site Since Removal of Saeltzer Dam

Figure 8 provides a schematic map indicating the principal geomorphic and riparian impacts from the removal of Saeltzer Dam that we were able to identify. The four types of impacts we identified are erosion, deposition, incision, and riparian mortality.

Finally, we were able to identify a number of locations with a total of approximately 50 - 100 dead or dying riparian trees (see Figure 8). These trees are located on the former waterline of the impoundment area, but are now 10 to 30 feet above the current water surface.

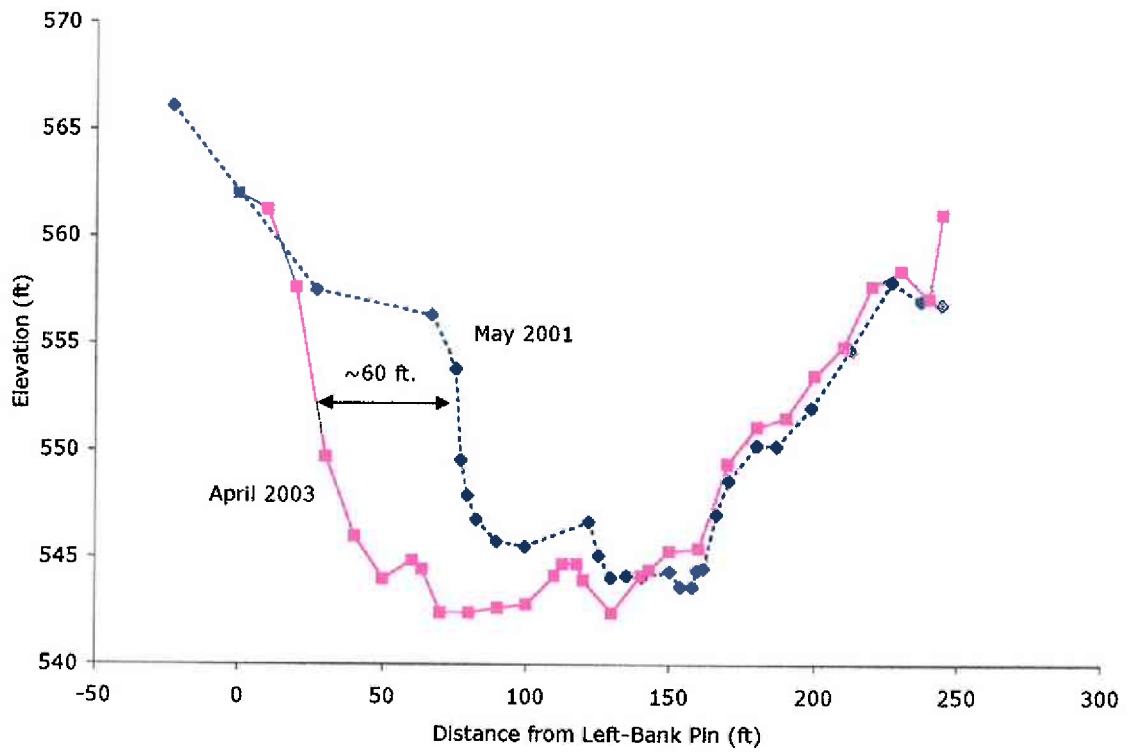
Figure 10: Cross Section #1

We were able to identify erosion of 50 feet or more in the unconsolidated banks along the left (i.e. north) bank of the creek. The erosion was concentrated at two locations: 1.) at the outside of the river bend in the upper half of the former reservoir, and 2.) just above the former dam site, where we believe an erosive eddy caused by bedrock controls on the opposite bank has cut as much as 60 feet into the steep unconsolidated bank.

Evidence for this finding comes, in part, from a comparison of a cross section we surveyed (XS#1) with a cross section surveyed in May 2001(XS#0) by Stillwater Sciences, six months after the dam was removed. The locations of these two cross sections are indicated on Figure 9. As can be seen, XS#1 and XS#0 are slightly offset.<sup>2</sup> However, we believe that the two cross sections are close enough to provide a clear indication of the extent of the changes that have occurred. The two cross sections are plotted in Figure 10. This figure shows erosion of the left bank of approximately 60 feet but with little change in the right bank topography.

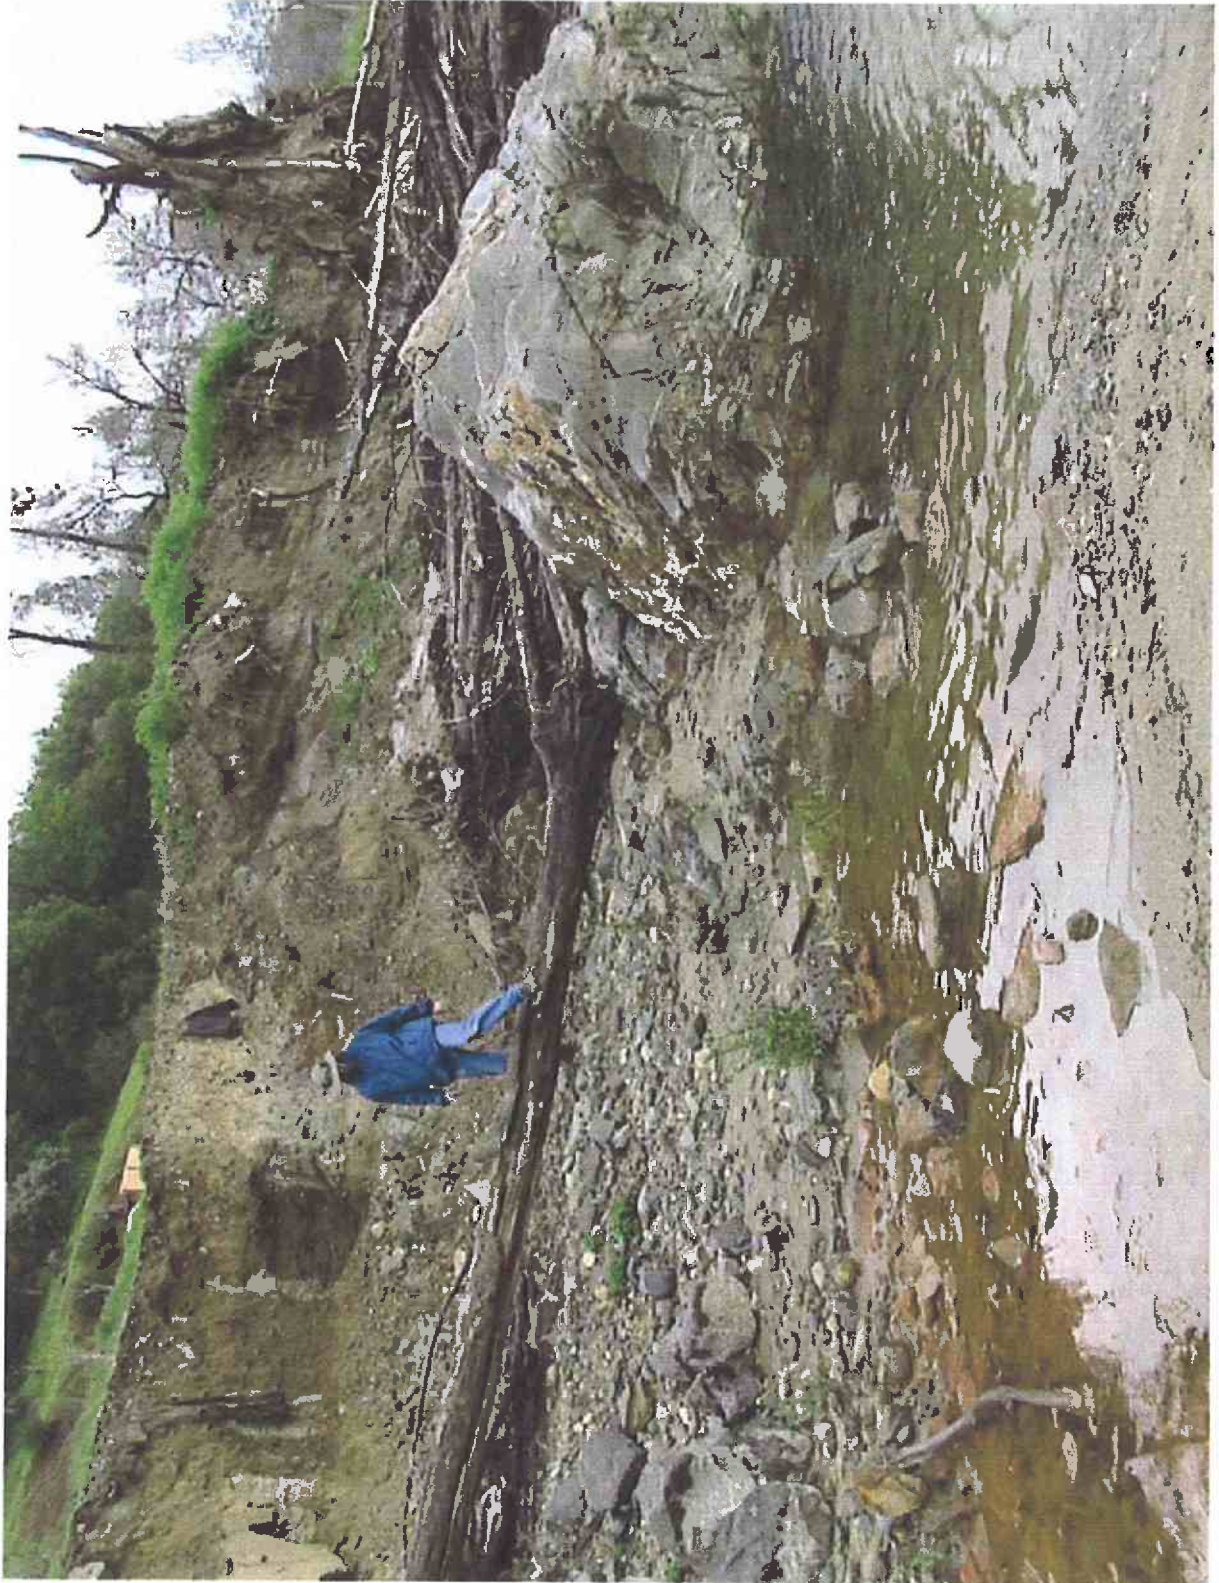
Figure 11: Photograph of Eroded Bank at Cross Section #1

This conclusion was corroborated by visual inspection of the bank. (Figure 11) The bank at this point is composed of mixed unconsolidated sediments, with large cobbles in a matrix of sand. The top layer of the bank appears to be a layer of mixed sand, gravel and rip rap approximately two feet thick on top of landscaping fabric. Lengths of the landscaping fabric now emerge from the bank and a number of rip rap rocks line the side of the creek. A large tree (50+ feet tall) which can be identified from

site photos that was at least twenty feet from the reservoir edge was completely undercut by the erosion and is now lying partially submerged in the creek.

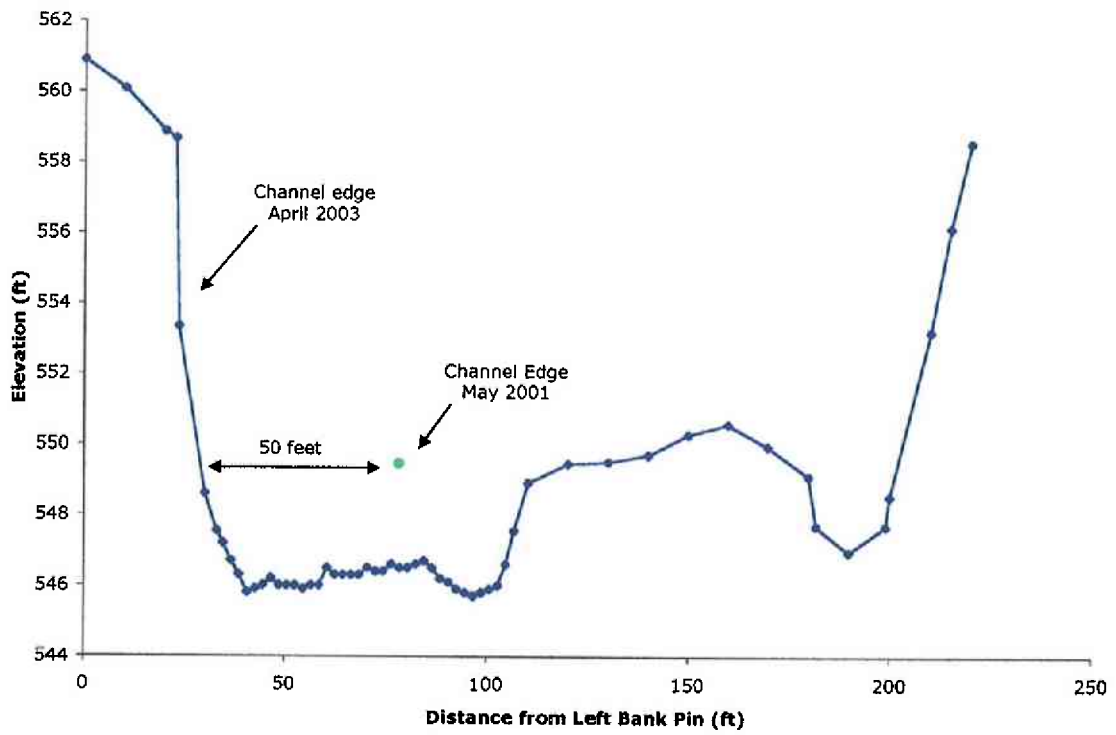
Figure 12: Cross Section #2

There also appears to have been substantial erosion at the site of our second cross section (Figure 12). While we do not have cross sectional data from 2001 at this location that we can use to evaluate changes in bed profile, the limited survey data from 2001 for this location suggests that there has been lateral erosion of approximately 50 feet into the left bank. In addition, a line of riparian trees lining this bank can be clearly identified in the aerial photograph taken prior to removal of the dam. These trees are now completely absent, presumably due to erosion of the portion of the bank on which they were located. The bank at this location is likewise composed of unconsolidated fine sediments mixed with cobbles, and it is not difficult to imagine that substantial erosion would occur at high flows.<sup>3</sup>

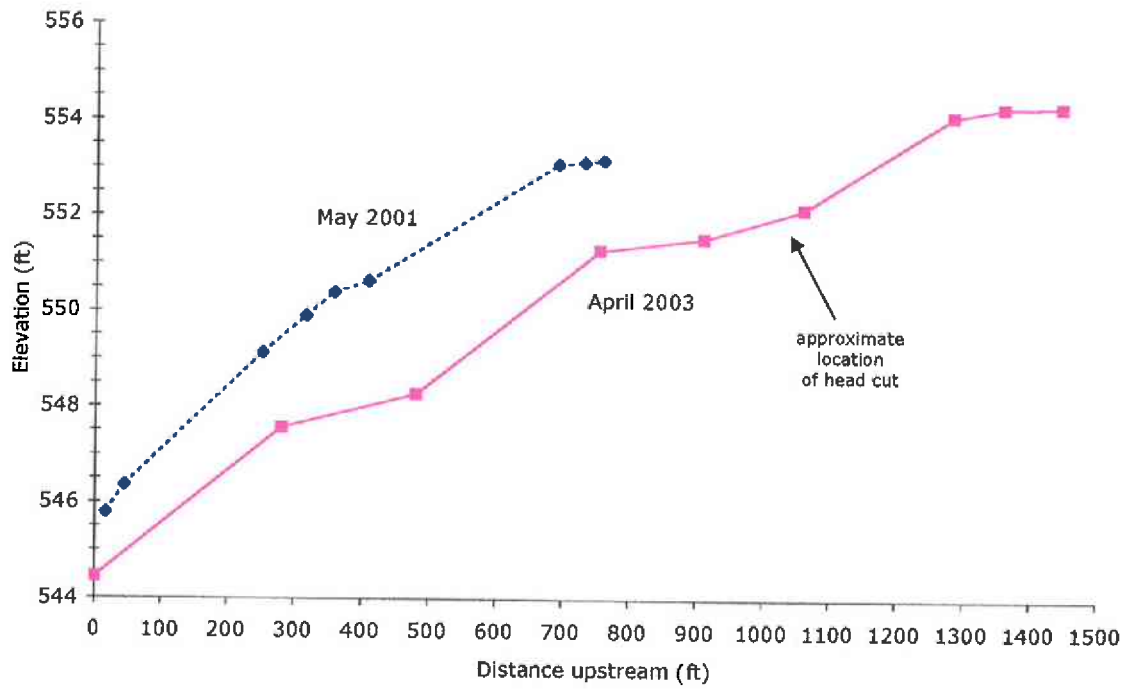
Figure 13: Water Surface Profile

Figure 13 provides the results of our survey of water surface elevation along with water surface data from the May 2001 survey. It is important to note that the water surface profiles for our survey and the May 2001 survey vary both due to the difference in flow levels and because of changes in bed topography.<sup>5</sup> Specifically, flow levels in May 2001 were roughly half the 300 cfs measured during our visit, so the differences in water surface profile represent a minimum estimate of the amount of incision.

In general, there has been continued incision of the bed, with greater incision farther upstream (2 to 3 feet) than near the dam site (1 to 1.5 feet). This incision has reduced the average slope of the 750-foot reach immediately upstream of the dam site by 10% (from 1% in 2001, to 0.9% in 2003).

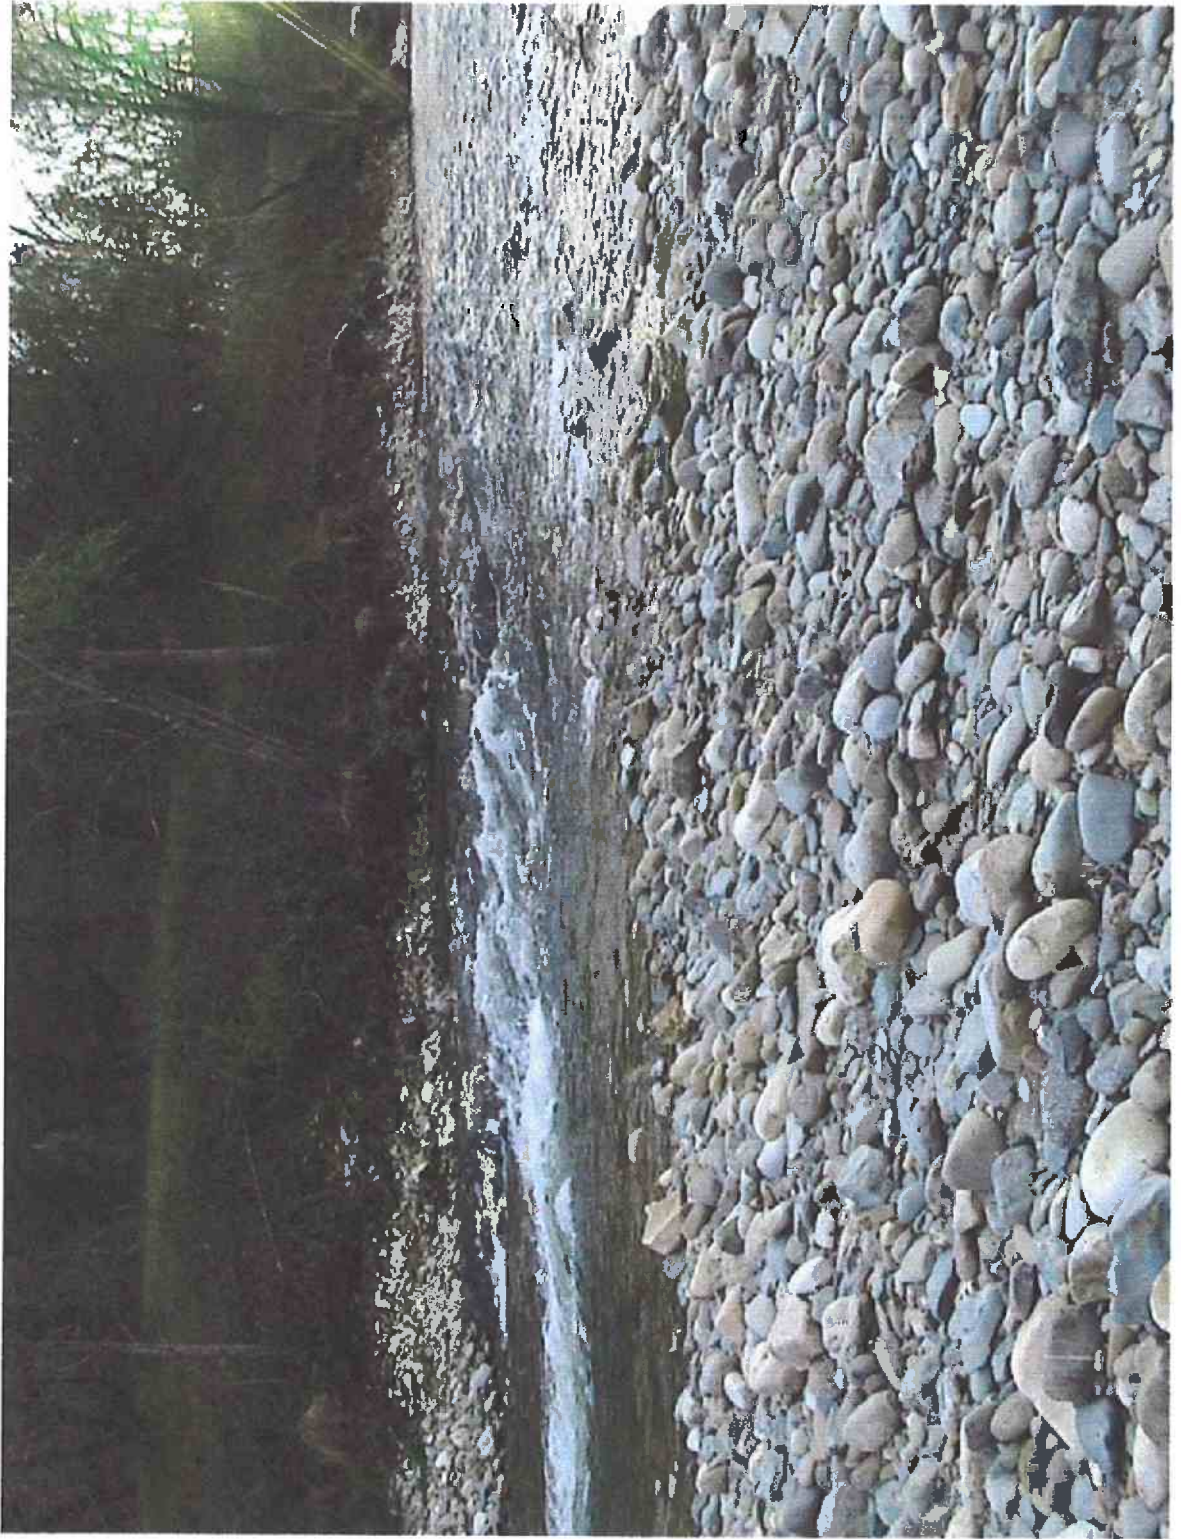
Figure 14: Photograph of Head Cut

We also identified what appeared to be a head cut approximately 1,050 feet upstream of the Dam site (Figure 14). This head cut appeared to create a vertical drop of about 18 inches over a distance of 10 to 20 feet.
