Using neutrons to fight forest fires

USING NEUTRONS TO FIGHT FOREST FIRES

Hal Egbert, Ronald Walker, R. Flocchini

THE UNIVERSITY OF CALIFORNIA, DAVIS- MCCLELLAN NUCLEAR RADIATION CENTER
MCCLELLAN, CALIFORNIA, USA

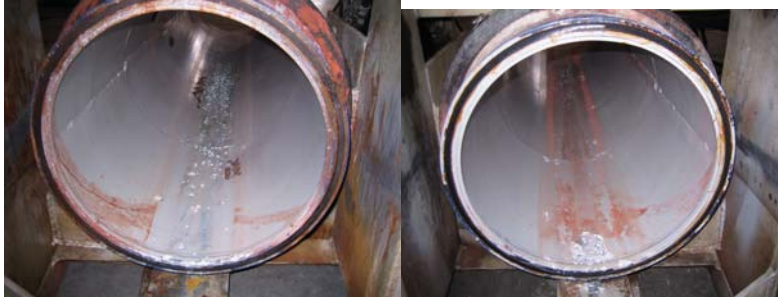
We completed the certification of the first four units. First we looked at two of the delivery tubes. Dyncorp's first approach was media blasting of the interior surfaces of the tubes, followed by visual inspection of the cleaned surfaces.

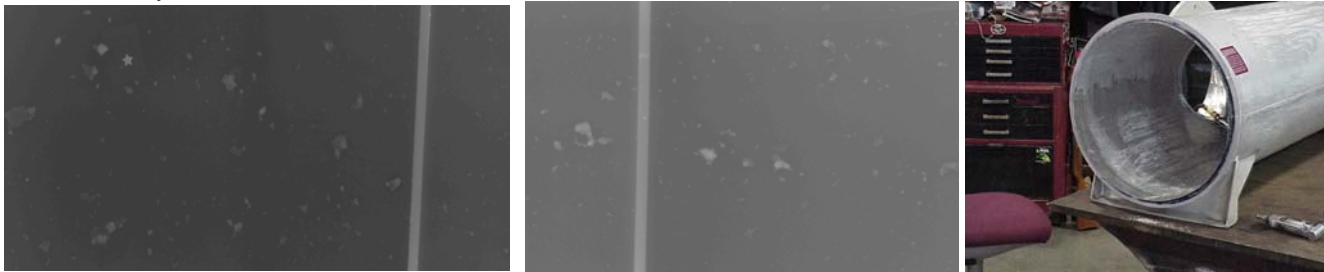
We then performed neutron computed radiography of the delivery tubes. The radiographs showed all the pitting they've seen when they media blasted the tubes.

After the visual and radiography of two of the tubes, Dyncorp blasted and cleaned all of the ten tubes. They manufactured and welded liners into the bottom half of each of the ten tubes.

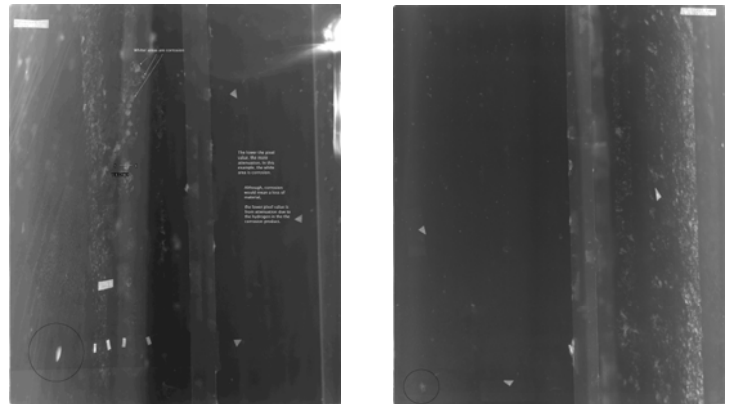
The MAFFS tanks have no openings big enough to allow a person entry inside to perform a visual inspection. A digital camera was inserted into an opening in the bottom of the tank. The photographs showed irregularities on the inner surface of the end bell of the tanks. Because of the uncertainty of what was seen in the photographs, Dyncorp asked us to see what could be learned through neutron radiography.

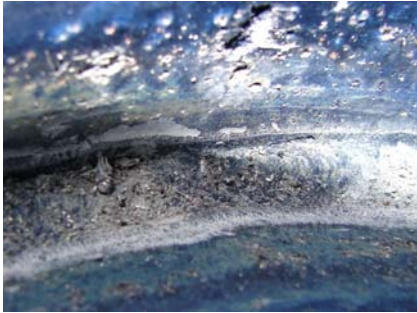
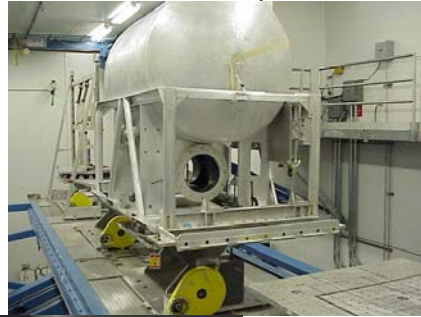
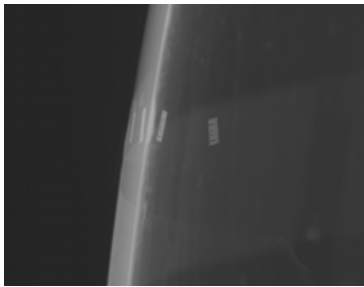
Initial radiographs revealed the same thing seen in the photographs only, from the outside of the tank looking in. Evaluation of the corrosion penetration into the inner surface of the tank wall could not be easily made.

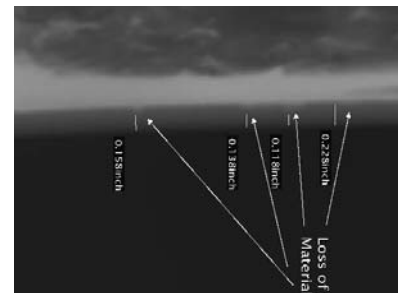
We started shooting profiles of the tank wall to see if metal loss had occurred. Rotating slightly with each exposure, we could evaluate if an indication was evasion into the wall or buildup on the inside of the tank wall. However, because of the size of the tanks and the number of radiographs that may be required with these profiles, the decision was made to limit the inspection to only the bottom of the tank since that's where the retardant and water would lay. Any resulting corrosion and evasion of the wall thickness should be in the bottom of the tank. Wall thickness evasion was easily identified and measured. The end bell was cut off the tank with the most significant amount of evasion. Pitting sites were identified by an overlay of the original radiograph. Depth micrometer readings agreed with radiograph depth measurements with in 0.005". Our process was validated.

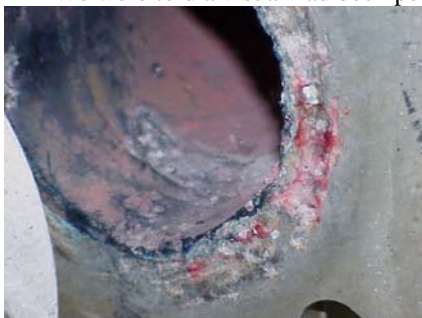
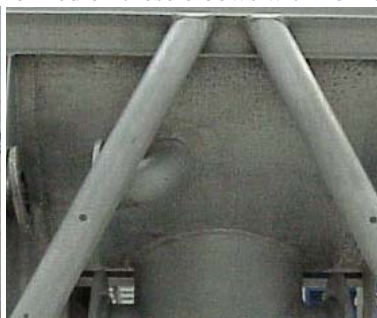
We were told a visual had been performed on these elbows with no major concerns?

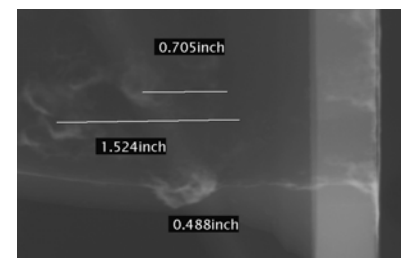
The radiographer suspected a problem when he looked inside this elbow? We decided to radiograph these concerns. Engineering determined the elbows were of a different grade aluminum than the tanks. The elbows on all twenty tanks were replaced with new elbows on the same grade aluminum as the tanks.
