Report of Field Site Visit District 3, Sacramento Interstate 5, PM 17.2-17.9 RAC-O Overlay

**Report of Field Site Visit  
District 3, Sacramento  
Interstate 5, PM 17.2-17.9  
RAC-O Overlay**

**Technical Memorandum TM-UCB-PRC-2005-7**

June 2005

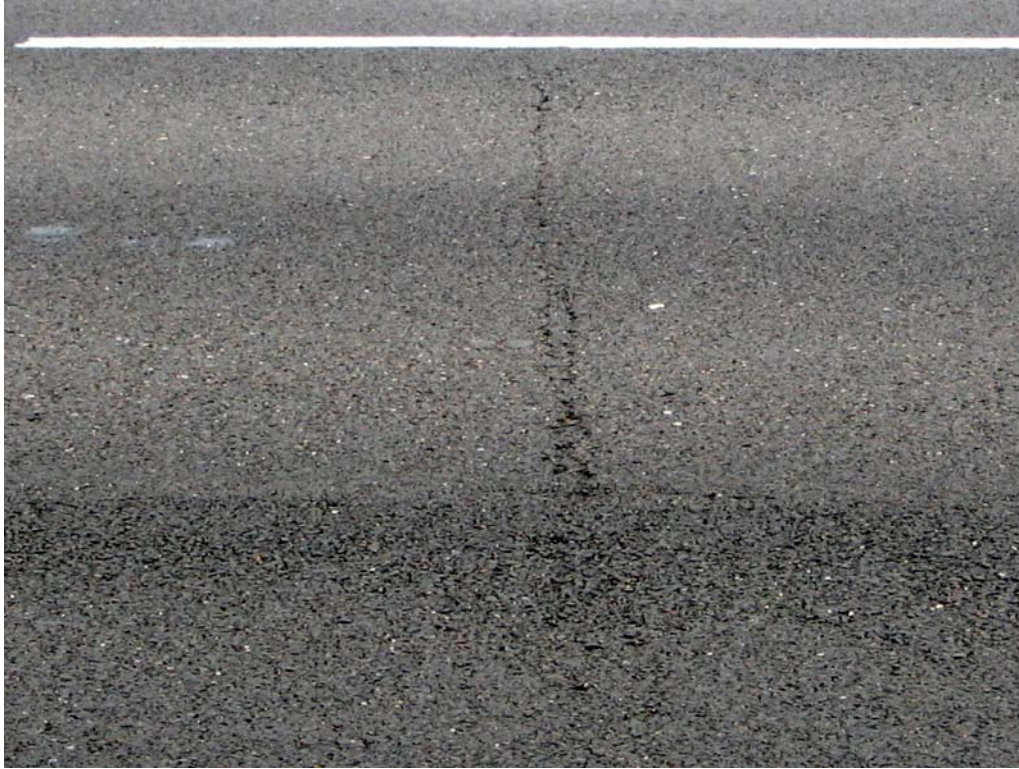
Reflection cracking was evident in the outside lanes on the south end of the southbound direction. The cracking was less frequent in the northern portion. Figures 5 and 6 show examples of the reflection cracking between Station 51+00 and Station 52+00.

**Figure 5. Reflection cracking between Station 51+00 and Station 52+00(southbound lanes).**

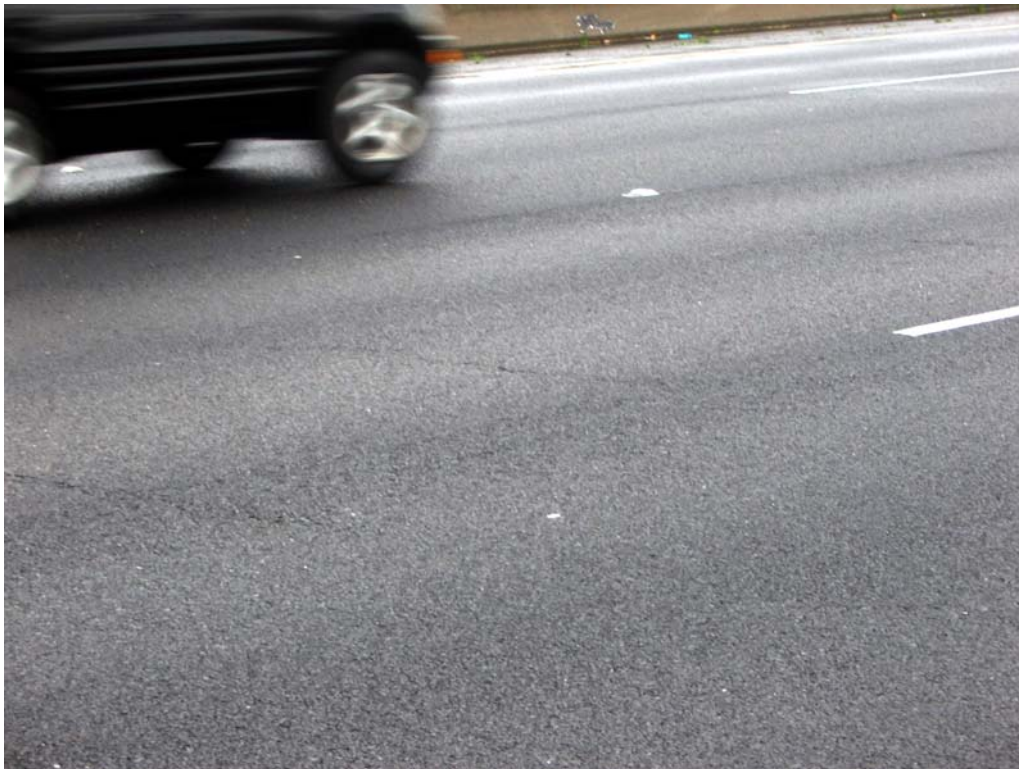
**Figure 6. Reflection cracking between Station 51+00 and Station 52+00 (southbound lanes).**

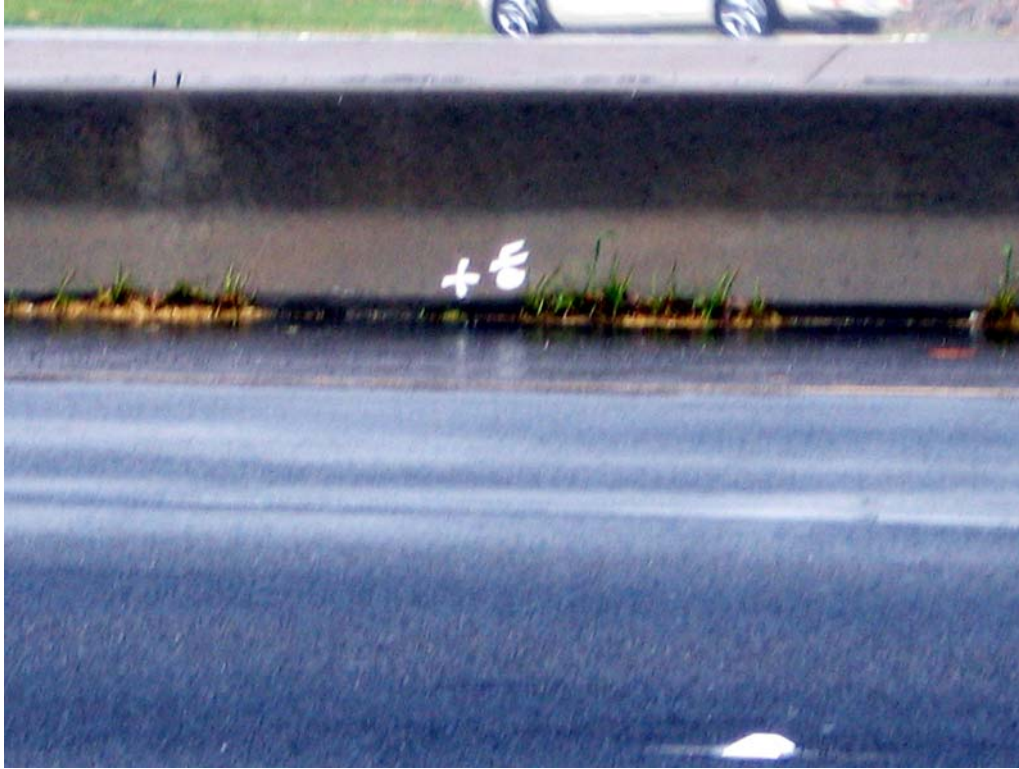
Ponding was present in the same locations as the reflection cracking. Water flowed easterly (from outside to inside lanes) on the southern portion of the project as shown in Figure 2. Moving northward against traffic in the southbound lane, the section climbs a mild hill, and then descends and the super-elevation reverses in the middle of the section, with water in the northern part of the southbound direction flowing westerly (from inside to outside lanes). Figures 7 through 12 show the pavement and ponding on the southbound direction of the site as the viewer progresses against traffic.

**Figure 7 . Ponding at Station 50+40 (inside lanes, southbound).**

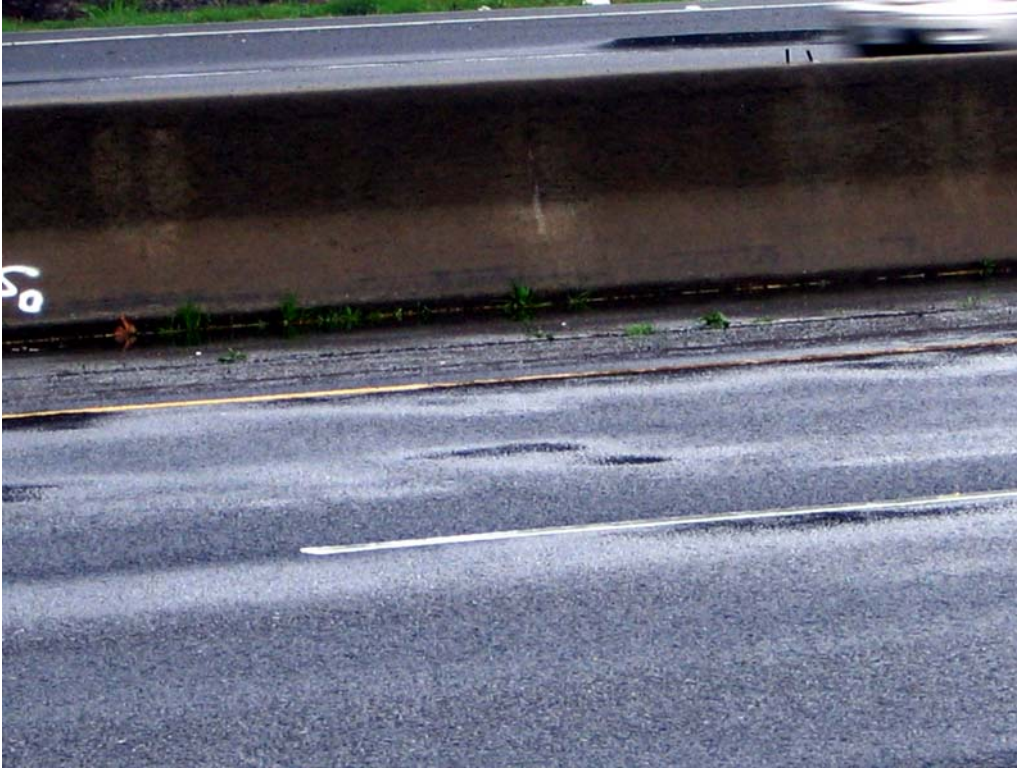
**Figure 11. Ponding at Station 51+60 (inside lanes, southbound).**

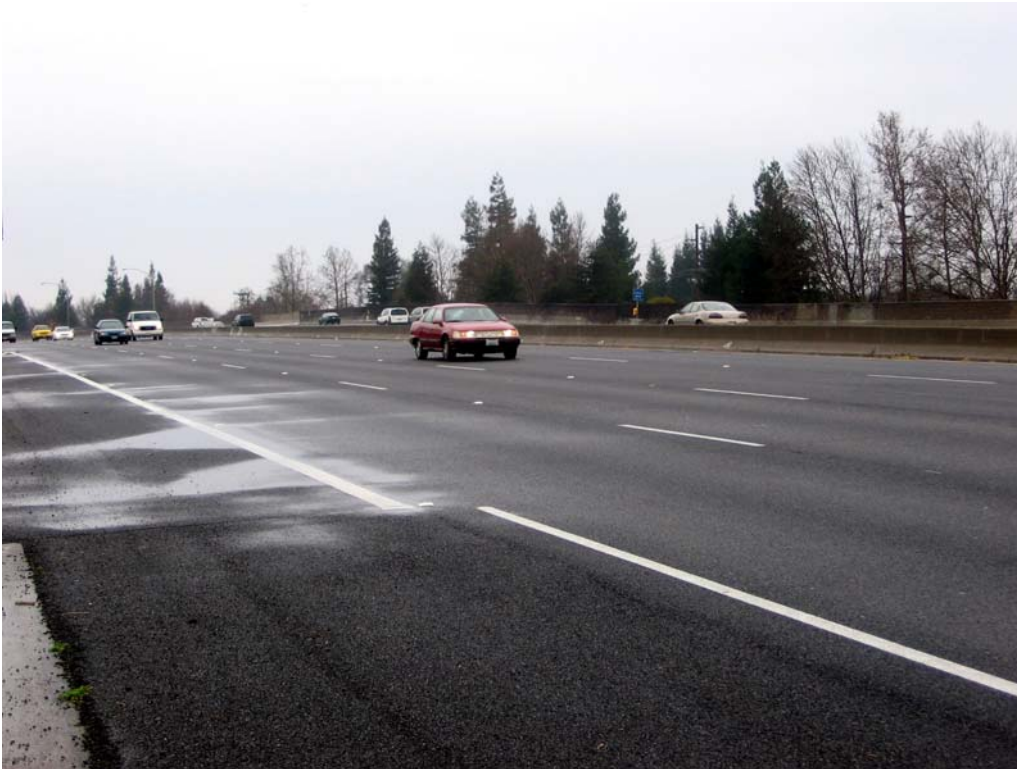
**Figure 12. Ponding looking north from Station 55+00 (outside lanes, southbound).**

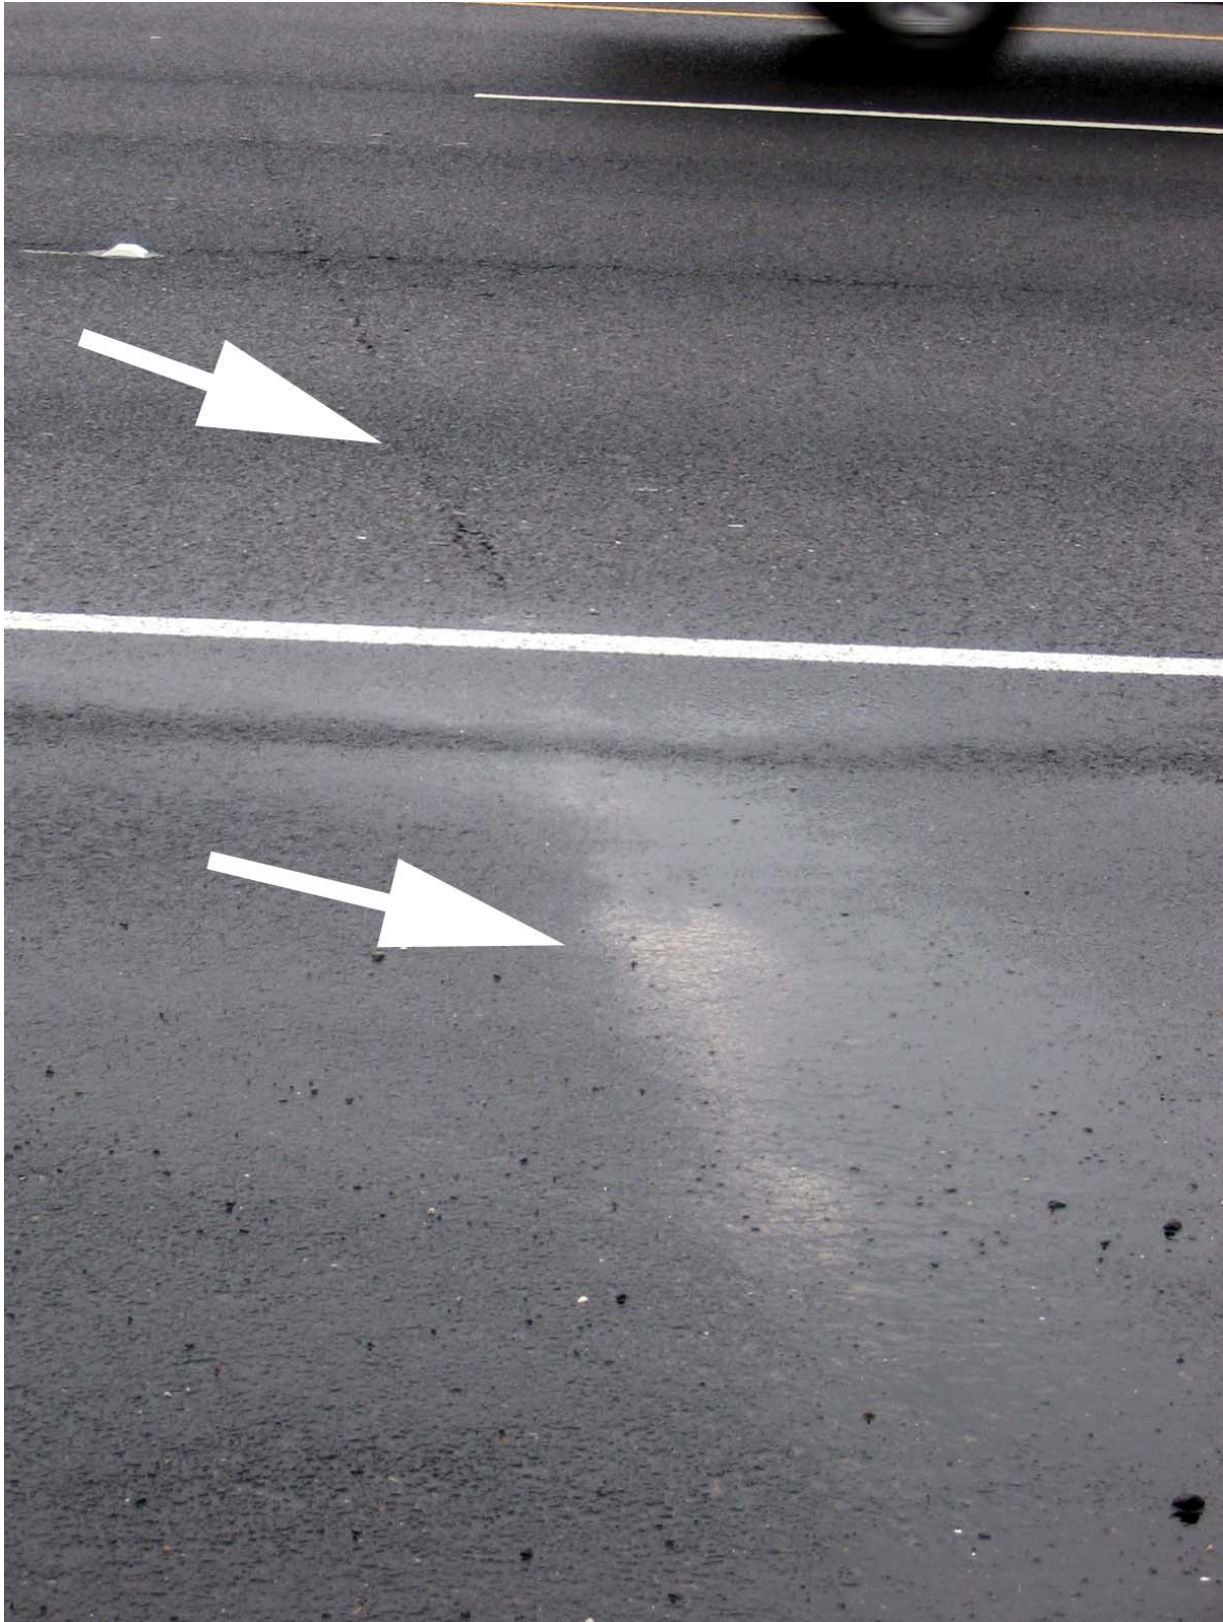
As in the southbound direction, reflection cracking was evident in the outside lanes on the south end of the northbound direction and were less frequent in the northern portion. Also, pumping of fines was evident at some transverse joints in the south end of the northbound direction. Figure 14 shows the reflection cracking while Figures 15 and 16 show reflection cracking and pumping of fines.

**Figure 15. Reflection cracking and pumping of fines between Station 52+00 and 53+00 (northbound lanes).**

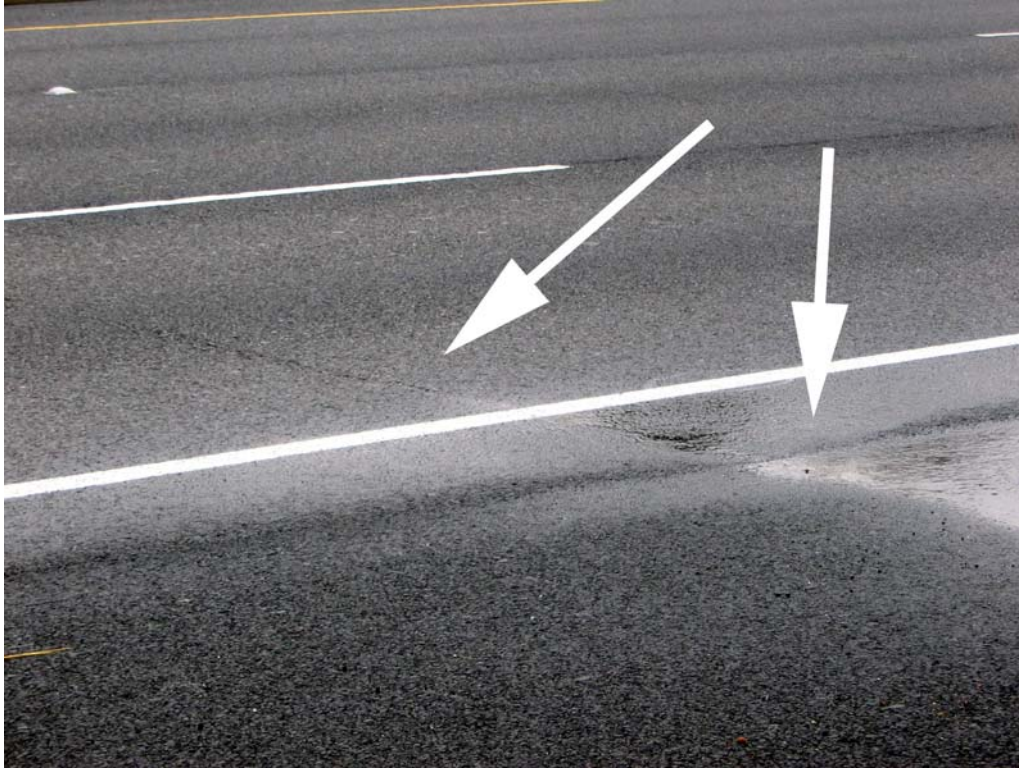
**Figure 16. Reflection cracking and pumping of fines between Station 52+00 and 53+00 (northbound lanes).**

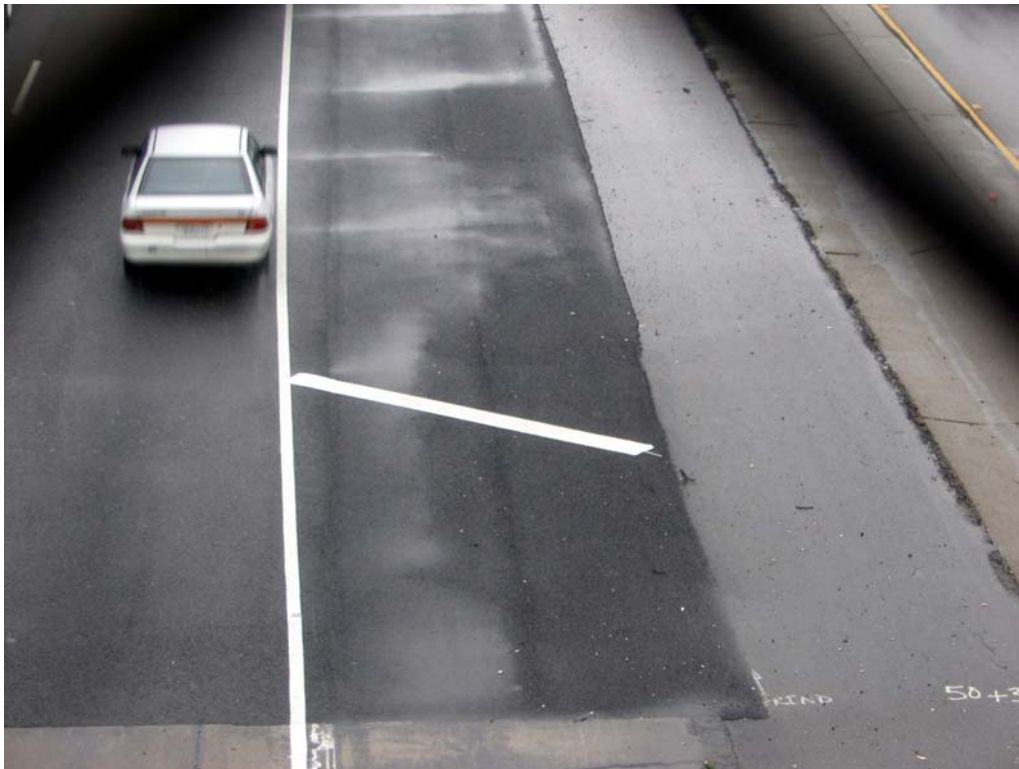
As in the southbound direction, water flow was easterly on the southern portion of the project and westerly on the northern portion of the project. Therefore, in the northbound direction, ponding occurred on the outside lanes at the southern portion and inside lanes in the northern portion. Figures 17 through 21 show the ponds on the northbound direction.

**Figure 17. Ponding at Station 50+00 (outside lanes, northbound).**

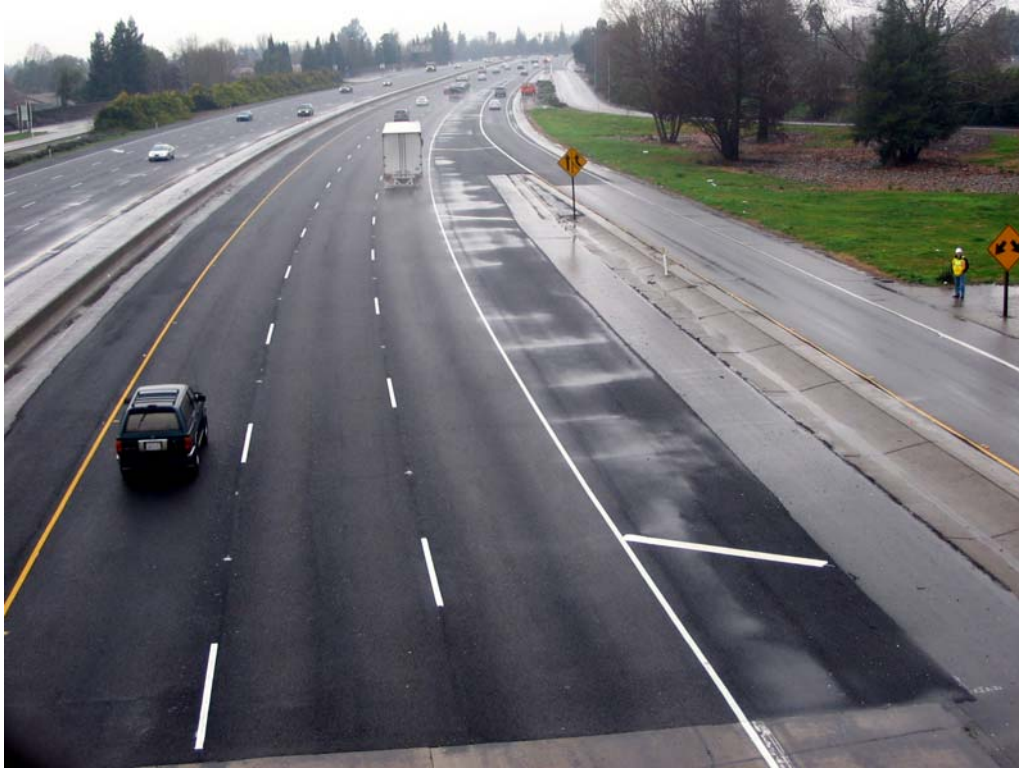
**Figure 18. Ponding starting at Station 50+00 (outside lanes, northbound).**

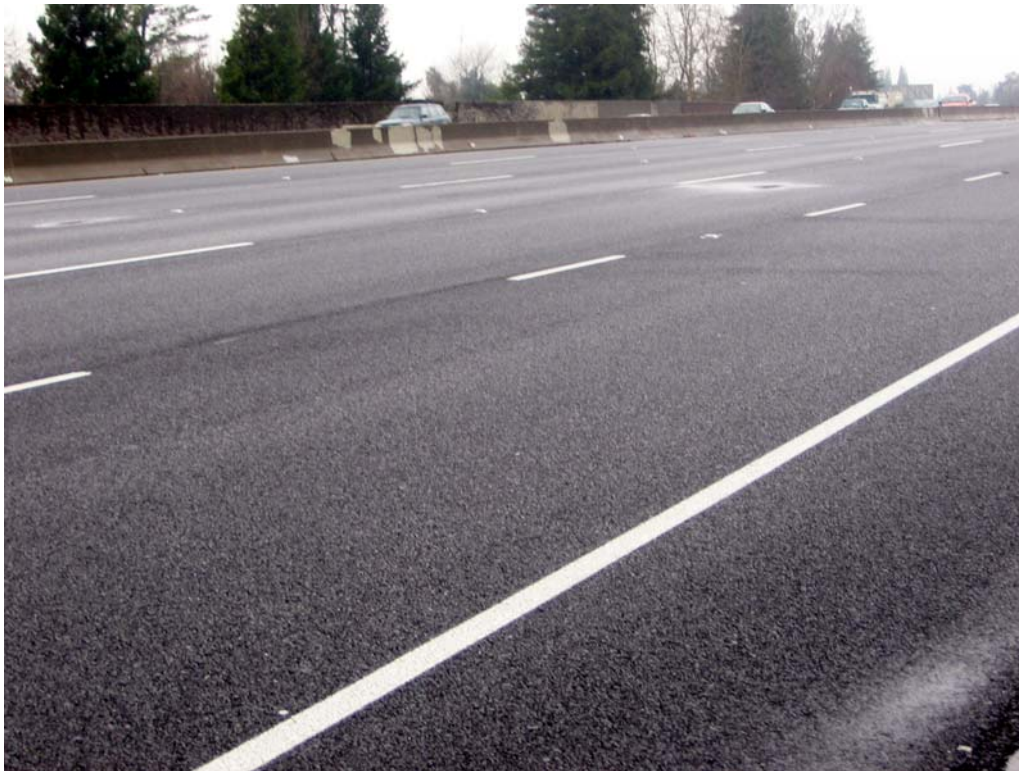
**Figure 21. Ponding between between Station 54+00 and 56+00 (inside lanes, northbound).**

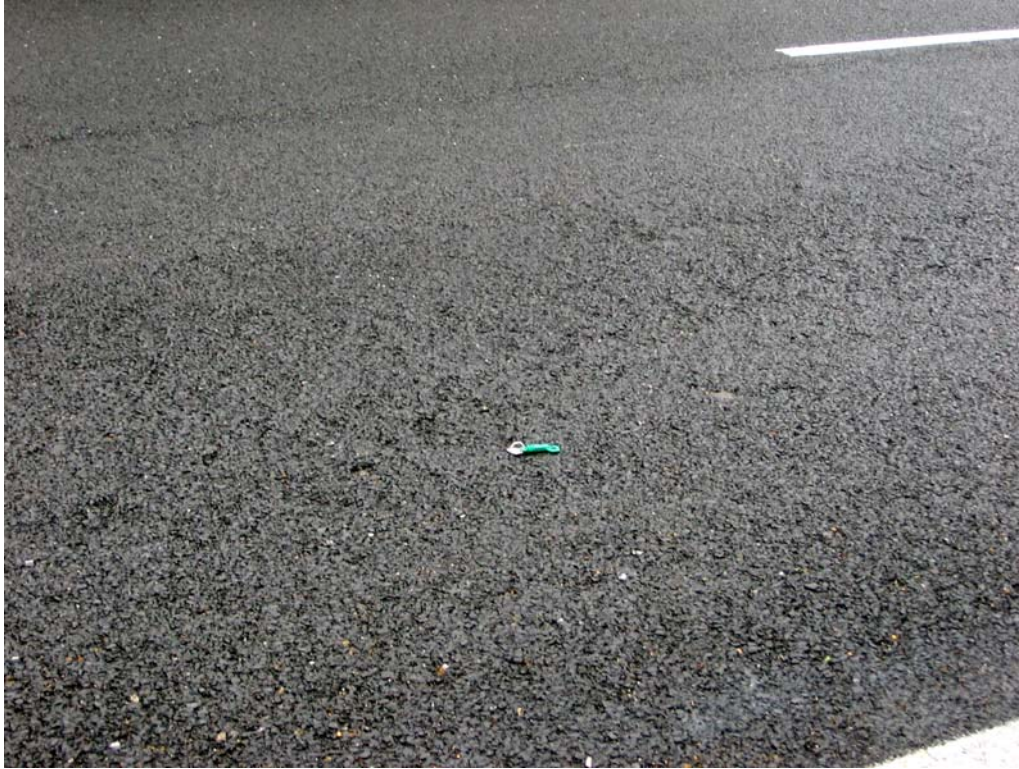
Raveling and a 1-2 inch diameter hole were observed at Station 56+80 on the northbound direction (Figures 22–24).

**Figure 22. Raveling at Station 56+80 (northbound direction).**

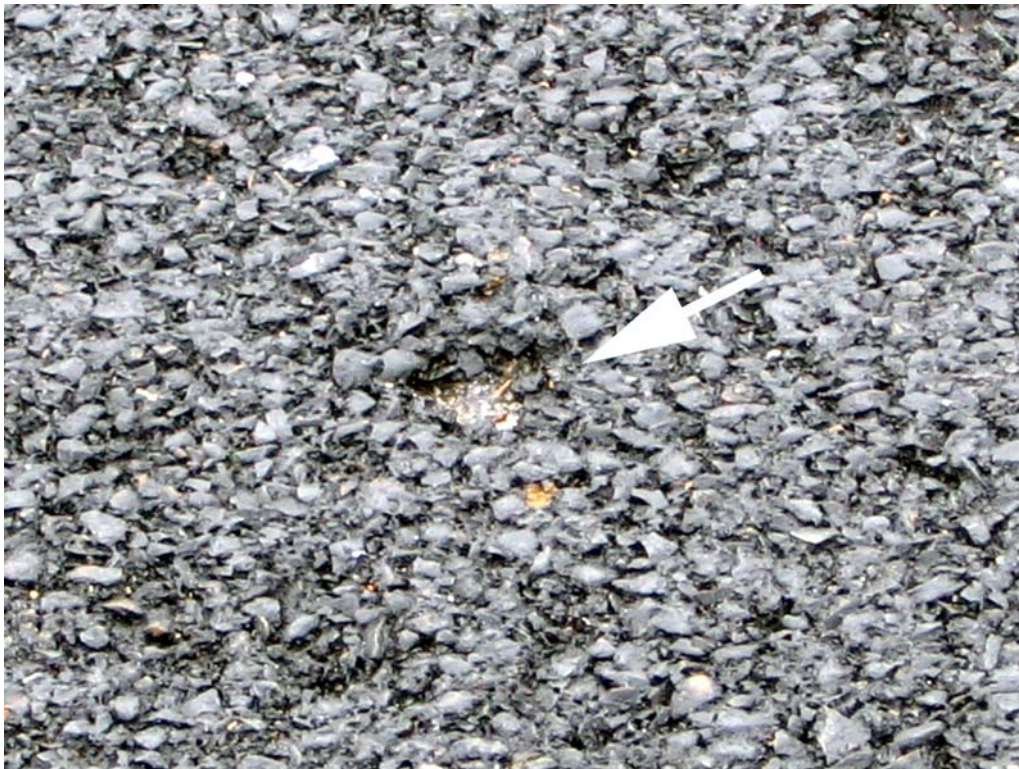
**Figure 23. Hole at Station 56+80 (northbound direction).**

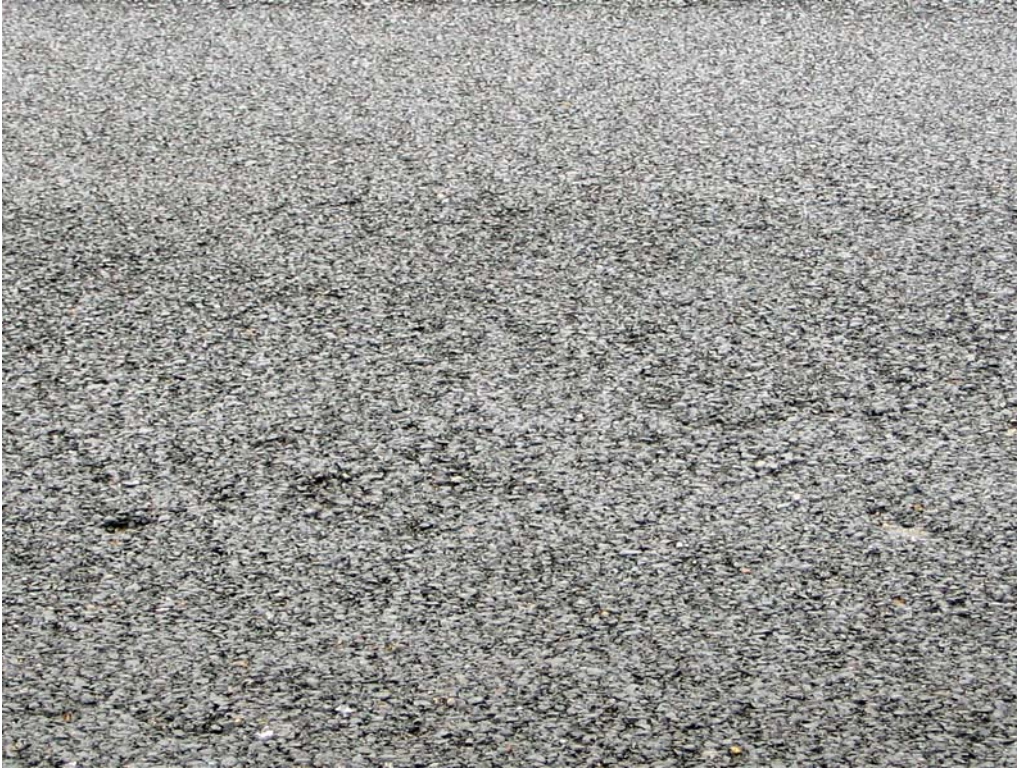
**Figure 24. Raveling at Station 56+80 (northbound direction).**
