EXTENDED FLATTOP OPERATION OF EEVATRON RESULTS FROM STUDIES OF GENERATOR DOVETAIL FAILURE

UCRL-18779

W. W. Salsig and H. W. Vogel

February 20, 1969

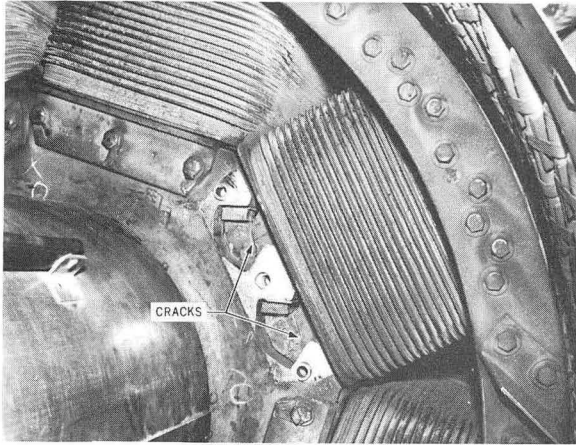
The initial dovetail neck fractures were discovered at a regular weekly maintenance inspection. The air gap over a particular pole was much reduced. Closer inspection disclosed the parted dovetails. However, the extent of the fracture was not fully appreciated until the pole was removed (see Figs. 1 and 2). A second pole had approximately 1/3 this degree of fracturing, and the outer faces of two other dovetails were cracked entirely across.

Fractures had started at the top of the pole-retaining key, which was also the tangent point (stress concentration point) of a dovetail radius. The top of the key was sharp and appeared to have generated a detectable notch in the dovetail laminations. This would appear to be sufficient cause for the observed damage. However, as more poles were removed and examination became more comprehen-

sive, this theory had to be relegated to that of a contributing factor, not the fundamental cause, because many dovetails had cracks on the face opposite the key and no crack on the key side. Of 64 possible locations for fracture initiation, 40 had cracks. Five end laminations were fractured entirely across, 16 cracks had started on the key side, and 14 had started on the face opposite the key.

Fig. 1 Cracks on Dovetails

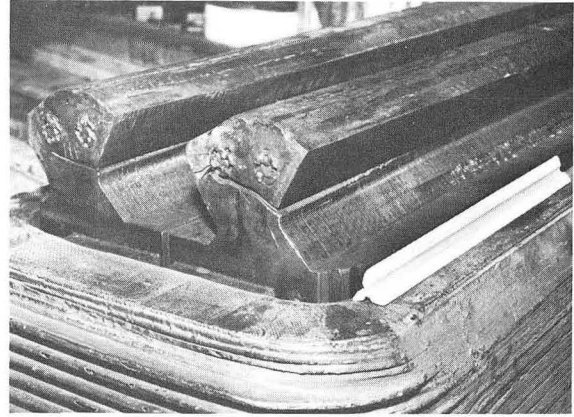
Fig. 2 Extent of Dovetail Cracks

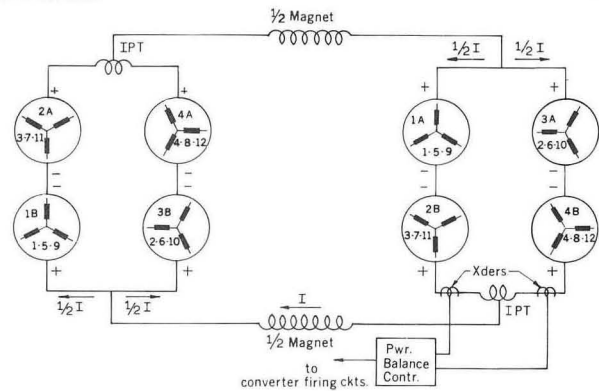
Fig. 5 Preferred Flattop Reconnection

The fourth reconnection was a reorganization of the converter units with each parallel branch containing one unit of each generator (see Fig. 5). This again required synchronizing the generators, but now each branch was sequentially symmetrical. This sequential phase order of the converter units permitted the postcasting of the torsional oscillations. The converters were controlled to force the net voltage and current excitation to the stator of each generator to be identical at all times. To maintain continuous speed regulation, the power was balanced by controlling the current through the parallel branches. A current error was obtained from transducers and was used to differentially control the firing angles of the inverting converter units only during the flat-top period of the pulse; the currents were sufficiently balanced during the rise and fall time of the magnet current. With the power balanced, synchronization was accomplished by sensing the difference in electrical phase of the generators and differentially adjusting the power flow of the drive motors of each M.G. set. Power balance must be better than 0.5% to stay within the control range of the motor. A 6° phase error in synchronization produced high voltage across the interphase transformer abnormally stressing the winding insulation. Larger phase errors produced severe unbalancing of the currents in the parallel branches during the converter switching periods, thereby forcing the generators out of synchronism or "relaying" the generators. The optimum phase displacement is 0° between corresponding phases of two generators. For a given pulse loading on the M.G. set the average speed can be adjusted, thereby changing the speed profile. If the speed reference is set too low a noticeable 300-Hz noise is emitted from the generator. Previous vibration analysis of the rotor confirms resonances at this frequency, therefore operation is maintained above this speed.

This reconnection was acceptable, and was selected for extended operational evaluation.

The preferred reconnection of the power supply was installed on a temporary basis for testing and evaluation on June 24, 1968. The 6000-A flat-top period has been extended from the original limit of 800-ms to 2.25-s with a maximum speed range of only 70 rpm; an even longer flat-top period is permissible. There has been no detectable growth in the dovetail fractures, no new damage to amortisseur bars, and the cracking of field pole connections has been arrested. Magnet control signals derived from the synchronized generators have provided more reliable operation; pulse-to-pulse repeatability of the magnet current is better. Synchronizing the generators requires approximately 2-min after they are excited and loaded. Preparations are being made to finalize the designs and to install the connection permanently.
