Early Shear Failure of a 3-Peg Modified Dome Patellar Implant.

## Case Report

## Early Shear Failure of a 3-Peg Modified Dome Patellar Implant

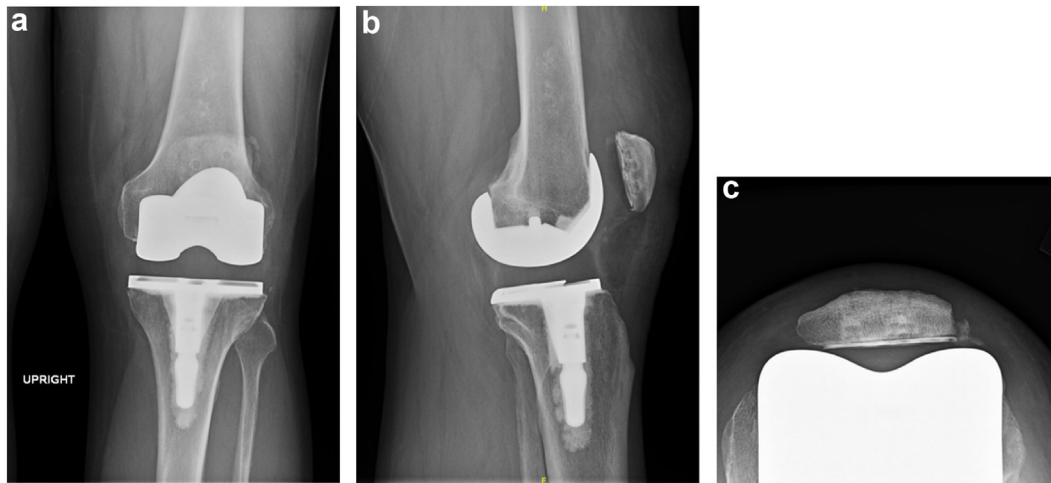
radiographs at 4 months postoperatively of primary TKA are shown in Figure 1a-c. His medical history was relevant for osteoarthritis and a body mass index of 37 kg/m<sup>2</sup>. He enjoyed light recreational activities on a weekly basis.

**Figure 1.** (a-c) Prefailure radiographs at 4 months postoperatively of primary TKA showing anteroposterior, lateral, and sunrise views. Note the radiolucency between the cement and the patellar bone, best observed on the sunrise view. In hindsight, this may have been an early indication of failure at the cement-bone interface.

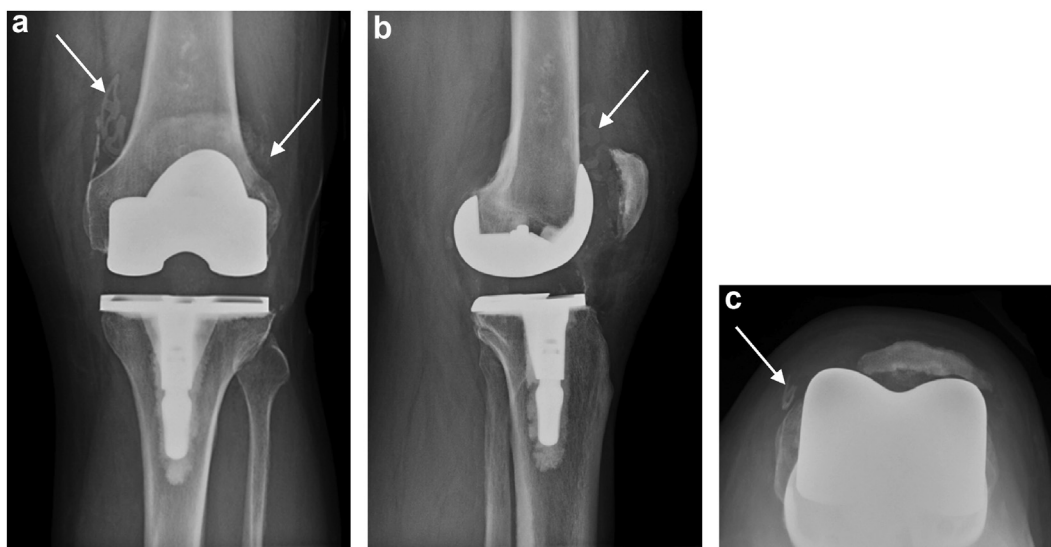
**Figure 2.** (a-c) Postfailure radiographs at 16 months postoperatively of primary TKA with failed patella implant. Anteroposterior radiograph (a) shows well-fixed implants, soft-tissue swelling, and a knee effusion. Arrows point to displaced polyethylene patella fragments. In lateral view (b), the patellar implant shadow is seen within the supra-patellar pouch (arrow). (c) shows sunrise view with absent polyethylene implant shadow. Note peg cement shadows that suggest the polyethylene pegs are still within the cement. Arrow points to a patella fragment.

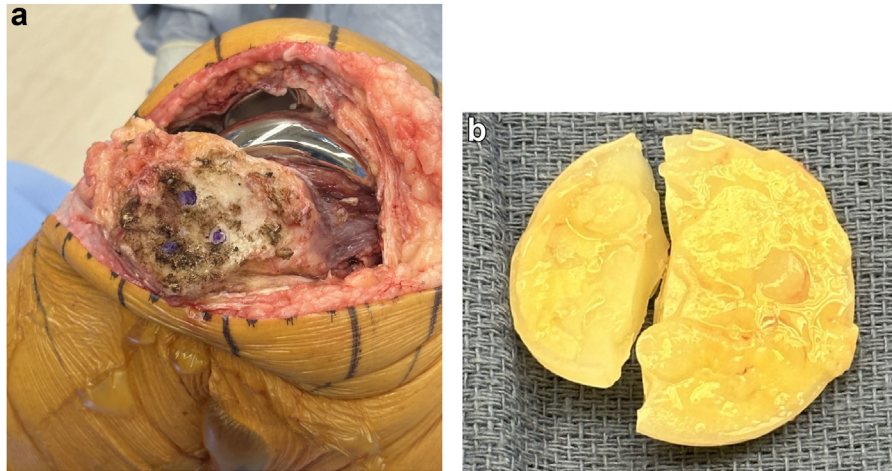
**Figure 3.** (a and b) Intraoperative findings of failed patella implant. (a) shows the debrided patella with the 3 polyethylene pegs well-fixed within the patella (marked with violet pen). (b) shows the fractured polyethylene button, which was located in the medial gutter.

In May 2023, a revision procedure was performed consisting of an extended arthrotomy, synovectomy, modular tibial bearing exchange, and revision of the patellar implant. [Figure 3a](#) shows the intraoperative findings of the patellar implant's shearing from its 3 pegs, which were still well fixed within bone. In addition, the patellar implant had broken into 2 pieces ([Fig. 3b](#)). The patellar pegs were removed with the Ultra-Drive (Zimmer-Biomet), an ultrasonic cement removal device, and the patellar bone deficiencies were

Our explanation for the early failure is mechanical shear. Intraoperative inspection showed all 3 pegs solidly fixed with cement in the patellar bone, which required removal with ultrasonic tools. All pegs failed at the level of the prosthetic-bone interface, similar to the failures reported by Stulberg and by Huang [4,10]. We believe multiple causative factors were involved in this case, resulting in a “perfect storm” creating shear forces great enough to cause early failure. In Table 1, we summarize factors that may contribute to increased patellar shear.

augmented with 6 2.0-m patellar rebar screws placed vertically [7]. Another patellar implant of the same design and size was cemented into the patella using 3 new peg holes drilled adjacent to the prior holes. After performing a lateral retinacular release, the revised patella showed central patellar tracking testing with a "no thumbs" technique. Radiographs of the reconstructed patella are shown in [Figure 4a-c](#). He underwent an uneventful recovery and, at 12 months postoperatively, reports returning to all customary activities with good pain relief.

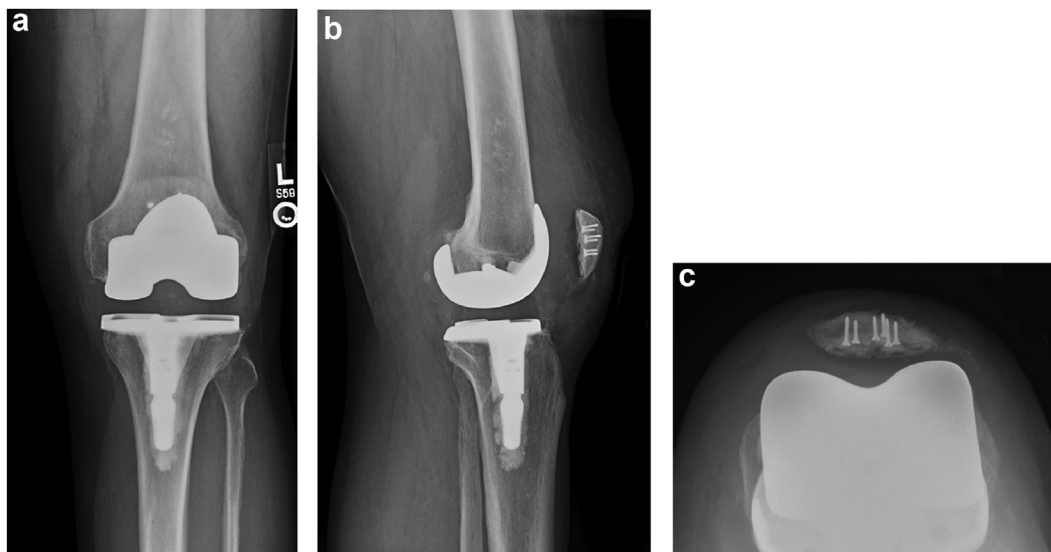
**Figure 4.** (a-c) Radiographs of revised patella 12 months postoperative. Anteroposterior radiograph (a) shows patella centrally overlying the trochlea. Lateral view (b) of patella demonstrates the cement-bone interface augmented with patellar rebar screws placed into the dorsal cortex. The sunrise view (c) suggests subtle residual lateral patellar tilt.

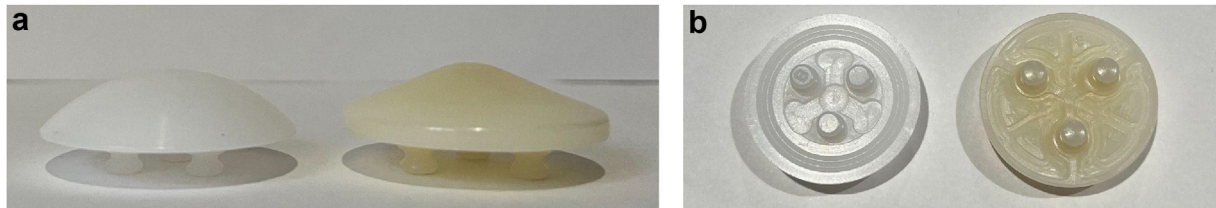
One factor we believe pertinent is the trochlear/patellar implant shape. The Persona Modified Dome patella closely resembles a cone design (Fig. 5a) [11], as opposed to the more common standard dome design. This cone design confers more constraint, as during flexion, the patella enters into the cone shaped metallic trochlear groove and congruently mates with the trochlea. If, however, the extensor mechanism is misaligned with the trochlea, the prosthetic trochlea groove will force the patella into the central channel. Consequently, a mechanical shear force is created, as seen in this

case. We theorize that there was an extensor mating mismatch significant enough to cyclically fatigue the polyethylene pegs. To our knowledge, this is the first reported peg failure of a patella with a cone-like design.

**Figure 5.** (a and b) Images comparing Vanguard dome patella (left) to Persona cone patella (right) with implants of similar size. (a) shows the side view and (b) shows the backside view. A comparison of features is listed in Table 2.
