SMALL RADIUS COARSE FIELD CAGE

**ENGINEERING NOTE**

PEP-4

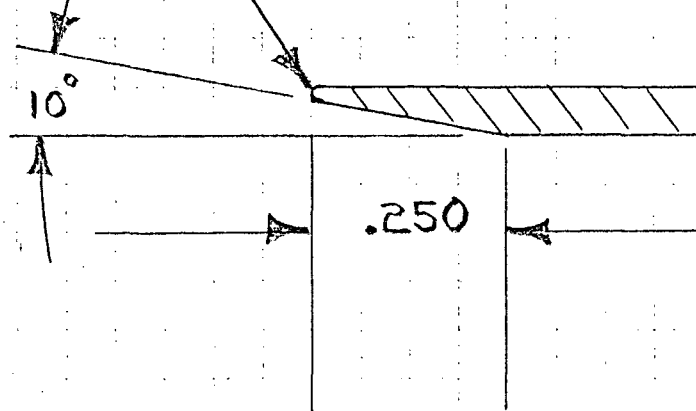
LEAVE APPROX .015 FLAT  
THEN RADIUS SHARP CORNER  
& BLEND IN (SAND)

MACHINING DETAIL FOR  
CUTTING ANGLE ON INNER  
CYLINDER SHOULD BE INCLUDED  
IN 20C0316 MACHINING DETAIL

I.D. OF NEMA G10 INNER CYLINDER  
15.750

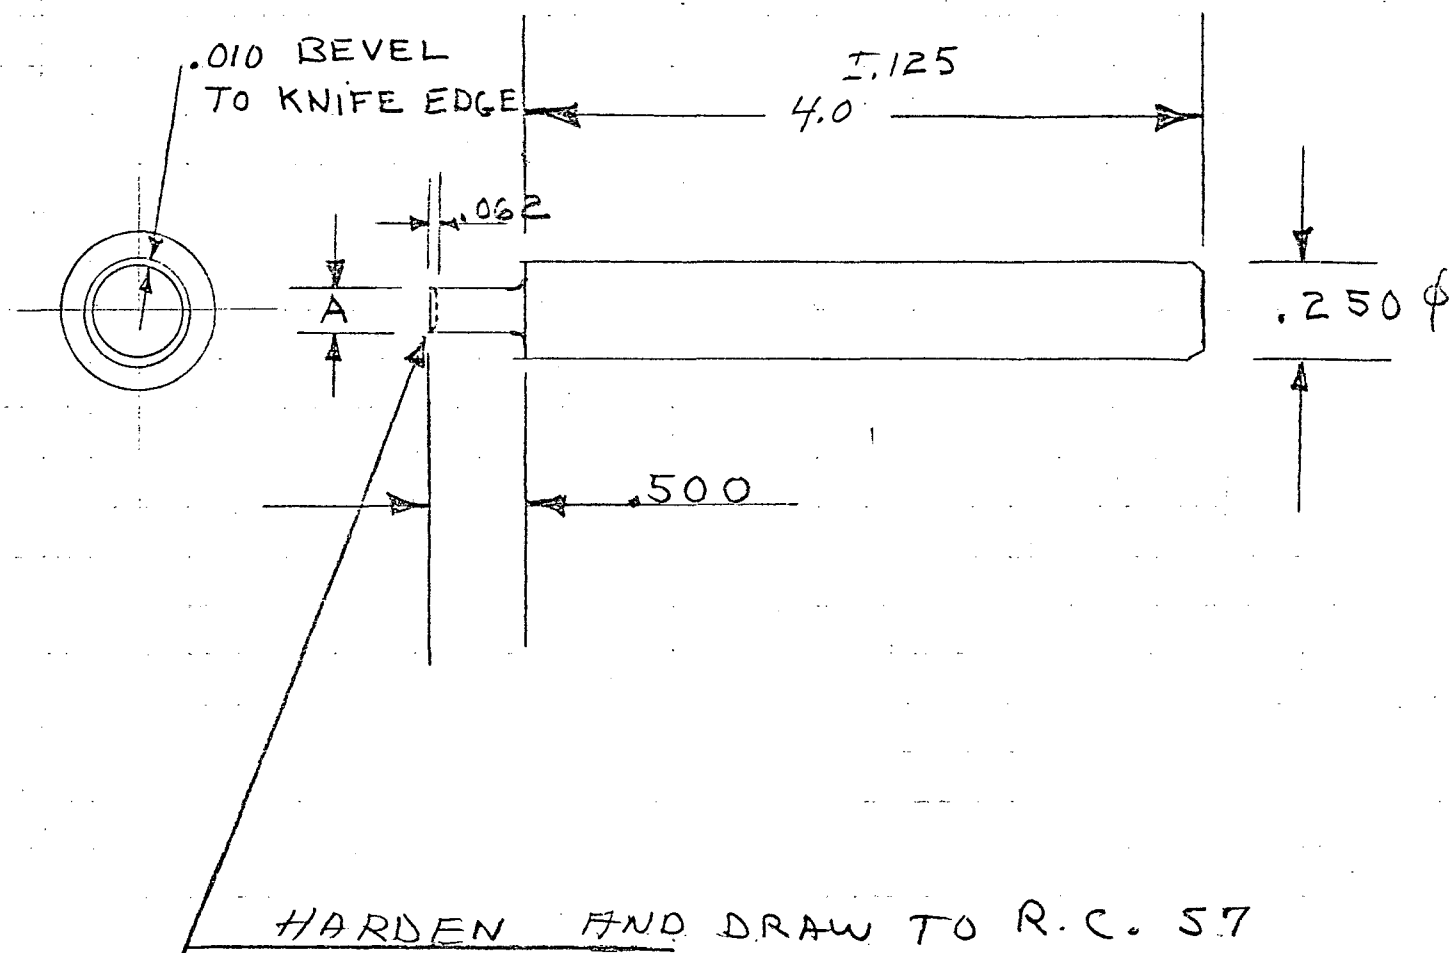
COOKY PUNCH

USED WITH KAPTON PUNCHING  
TEMPLATES 20C1676C & 20C2456C
