Blackberry Creek Daylighting Project, Berkeley : Ten-Year Post-Project Appraisal

Blackberry Creek Daylighting Project, Berkeley: Ten-Year Post-Project Appraisal

By Stephanie Gerson, Jane Wardani, and Shiva Niazi

Landscape Architecture 227, Fall 2005, Professor Matt Kondolf

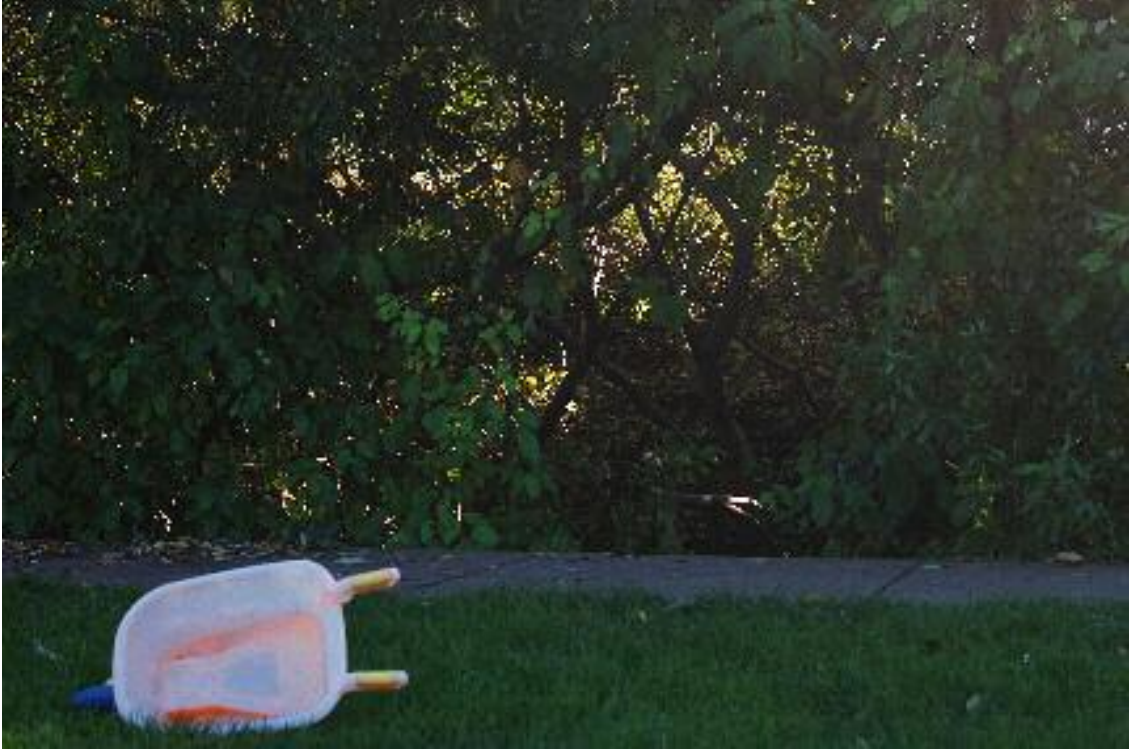
Within the immediate future, light maintenance of the site could alleviate dissatisfaction with vegetation bushiness. Pruning the willows would make the site more visually accessible and attractive. Ultimately, the creek is located in an urban park and neighbors expect a “tame” (rather than wild) place, safe for their children to play (Riley, 1998). Erosion could also pose a problem in the future. We recommend monitoring of bank stability (only as related to flood capacity) by a city technician to prevent flooding issues. We understand that our conversations were informal and sample size was not adequate to represent the Thousand Oaks community, giving us only a general pulse of how the community perceives and engages with the creek. They did reveal potential for further investigation into the project’s social dimension, and we recommend that formal interviews be undertaken in future Blackberry Creek PPAs.

Figure 5: Dense vegetation blocking view of creek from park; Dec 2005

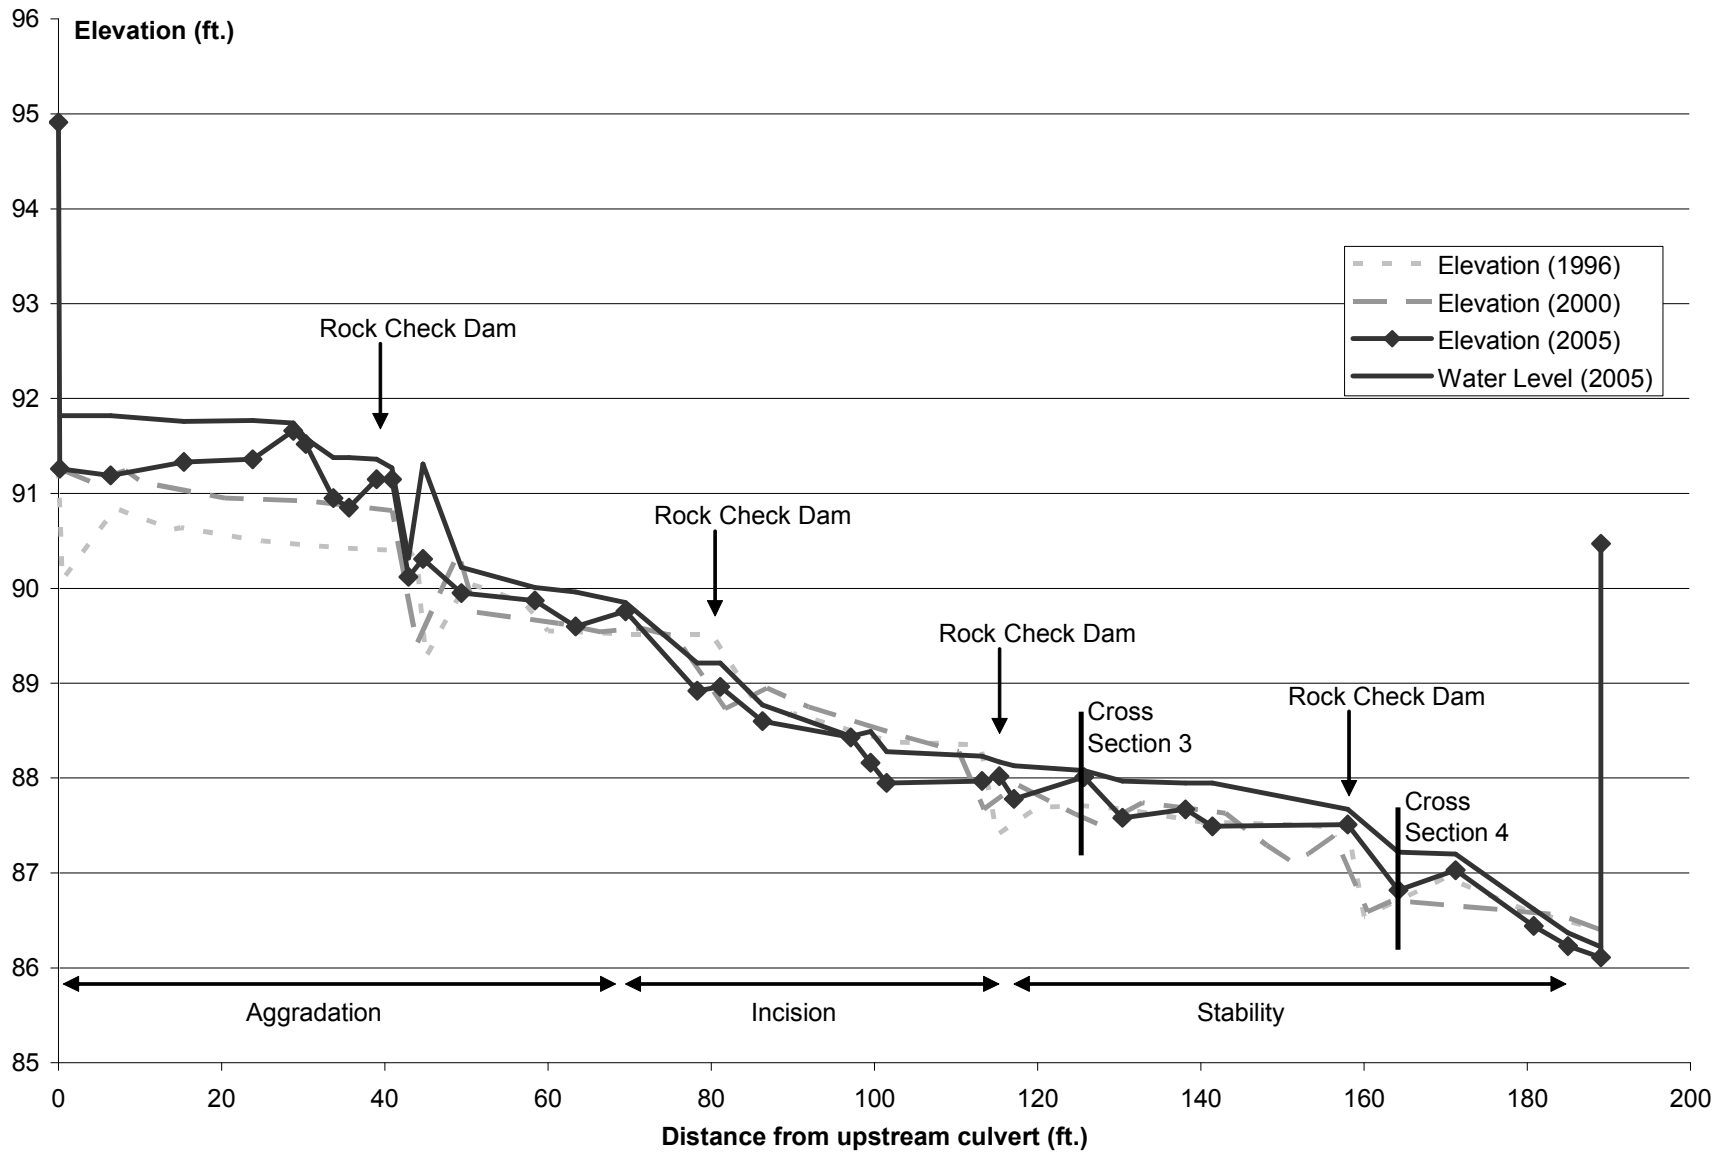
We compared the 2005 profile to those from 1996 and 2000 and found that grade control measures constructed during the project have been successful. All four rock check dams are still present at Stations 0+40, 0+80, 1+13, and 1+58. Channel gradient seems stable with minor accretion and downcutting (see Figure 6).

Sediment deposition just upstream of the dam 38 feet from the upstream culvert resulted in sediment accretion of 0.7 feet from 2000 figures and of 1.2 feet from 1996 figures. Elevation then remains stable for about 25 feet downstream before downcutting begins at about 65 feet from the upstream culvert. We observed downcutting of up to 0.5 feet (from 1996 and 2000 figures) in the next 45 feet of channel. We found the channel bed stable and slightly aggrading below the third rock check dam at 113 feet from the upstream culvert. The channel bed takes a small dip of about 0.3 feet before entering the downstream culvert.

The channel also displayed more pools and riffles than observed in past PPAs. The 1996 PPA documented two riffles and four pools (Askew, 1996), the 2000 PPA found seven riffles and six pools (Imanishi, 2000), while our long profile shows at least nine riffles and seven pools. This increase in pools and riffles is evidence that the channel gradient is stabilizing and the grade control structures are therefore performing well.

Figure 6: Longitudinal profile of Blackberry Creek; 1996, 2000, and 2005

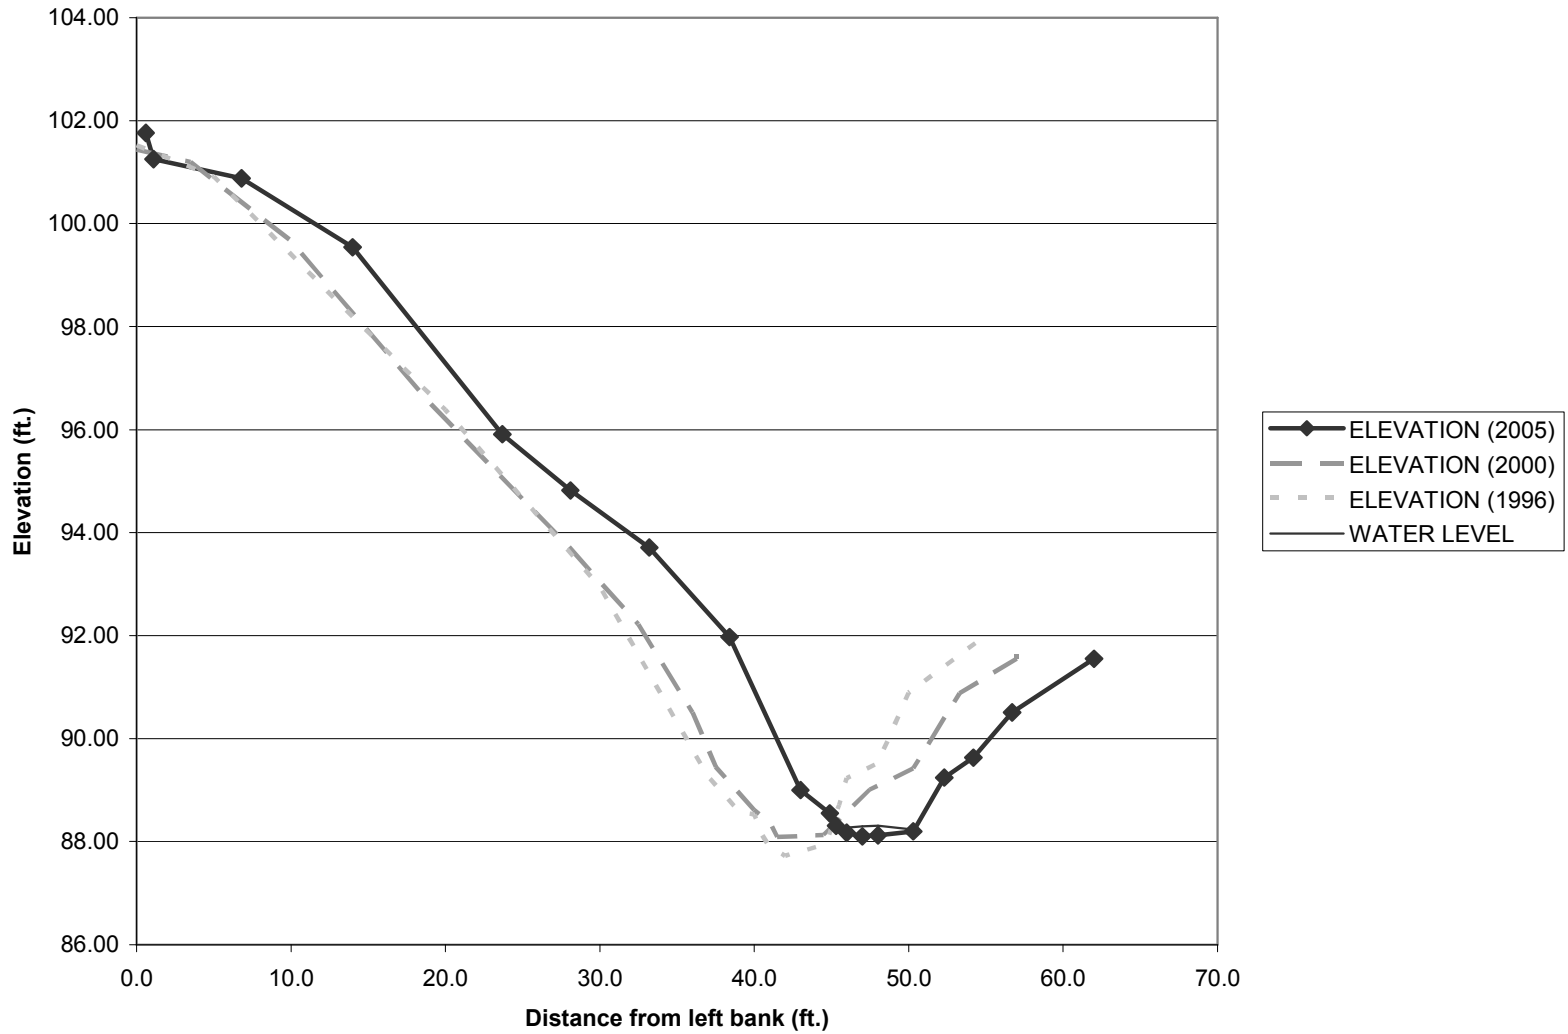
From the two cross sections we surveyed, the channel appears to have migrated towards the right bank over the decade. At Cross Section 3, the channel's thalweg appears to have moved by about 5 feet towards the right bank, and at cross Section 4 (Station 1+65) by 3.1 feet towards the right bank (see Figures 7a and 8). Such migration

is unlikely considering the stream size and rainfall data, and we deem it an artifact of inconsistent surveying. We made a second attempt to survey these cross sections, but without certainty as to cross section locations, were unable to produce meaningful results (see Methods section above). Since the channel shape appears to have remained relatively constant, we conclude that the channel geometry has not changed significantly (Figure 7b and 8). However, rainfall data below may shed light on the amount of rain the site experienced between the 2000 and current surveys.

Figure 7a: Profile of Cross Section 3 (Station 1+25), facing downstream; 1996, 2000, and 2005. Note possible survey error.

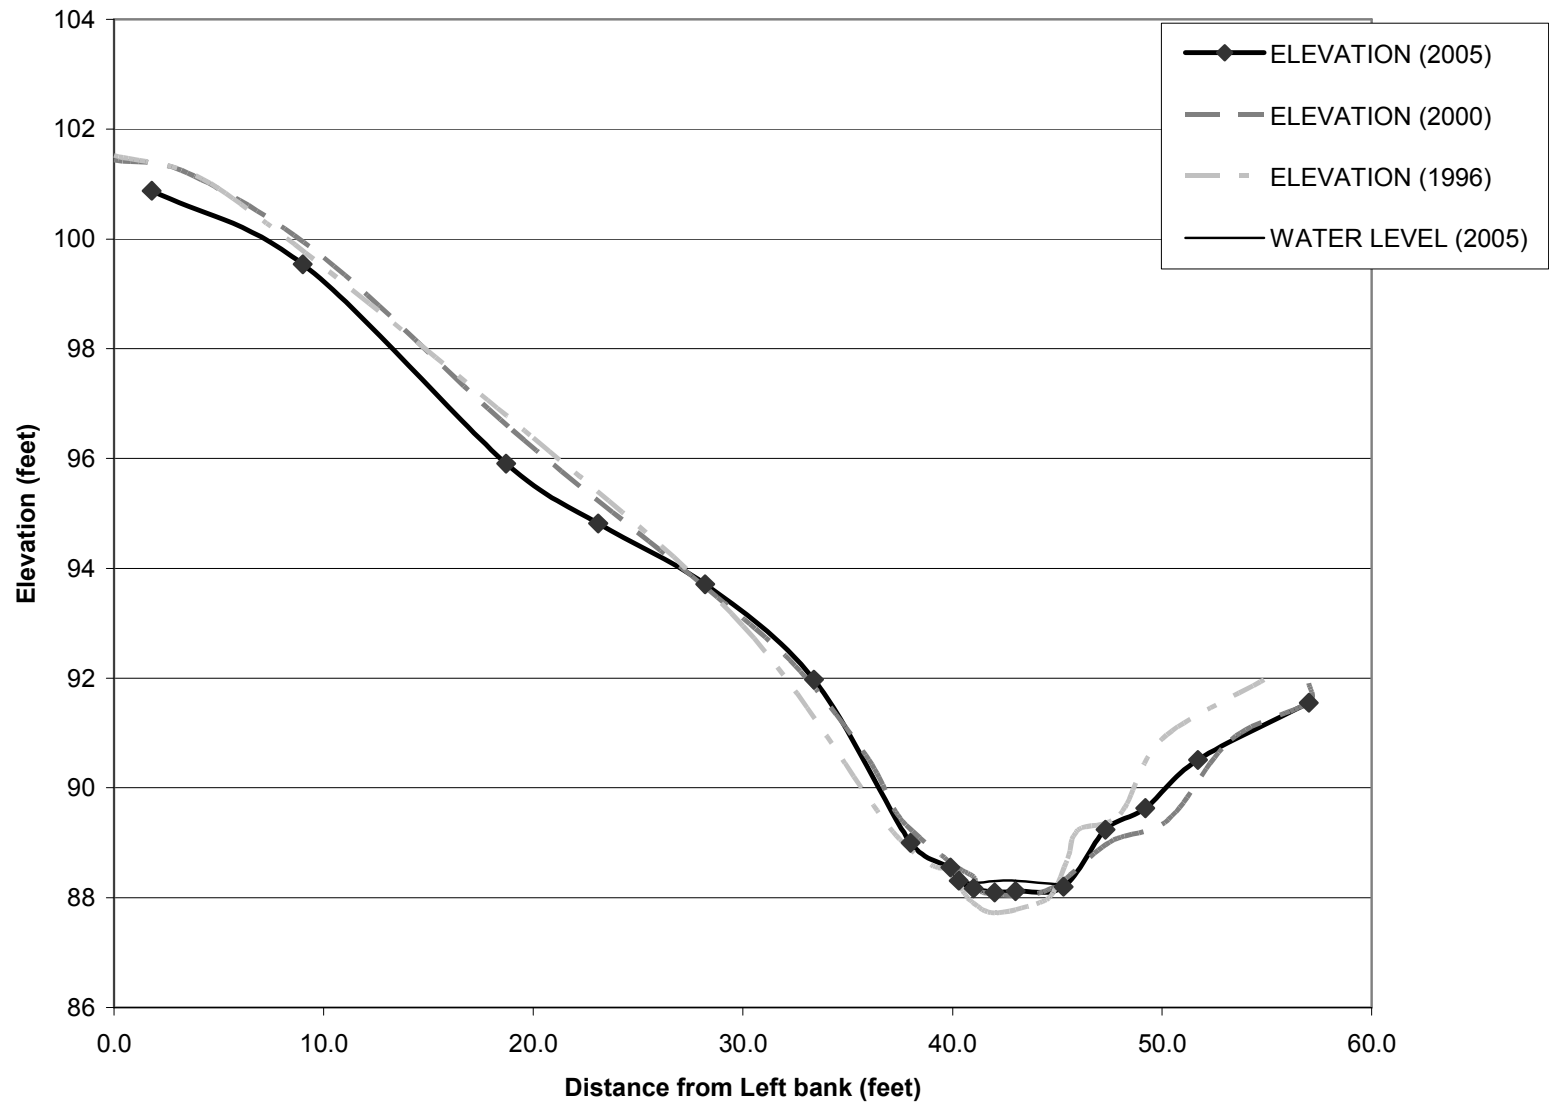
Figure 7b: Profile of Cross Section 3 (modified for possible survey error)

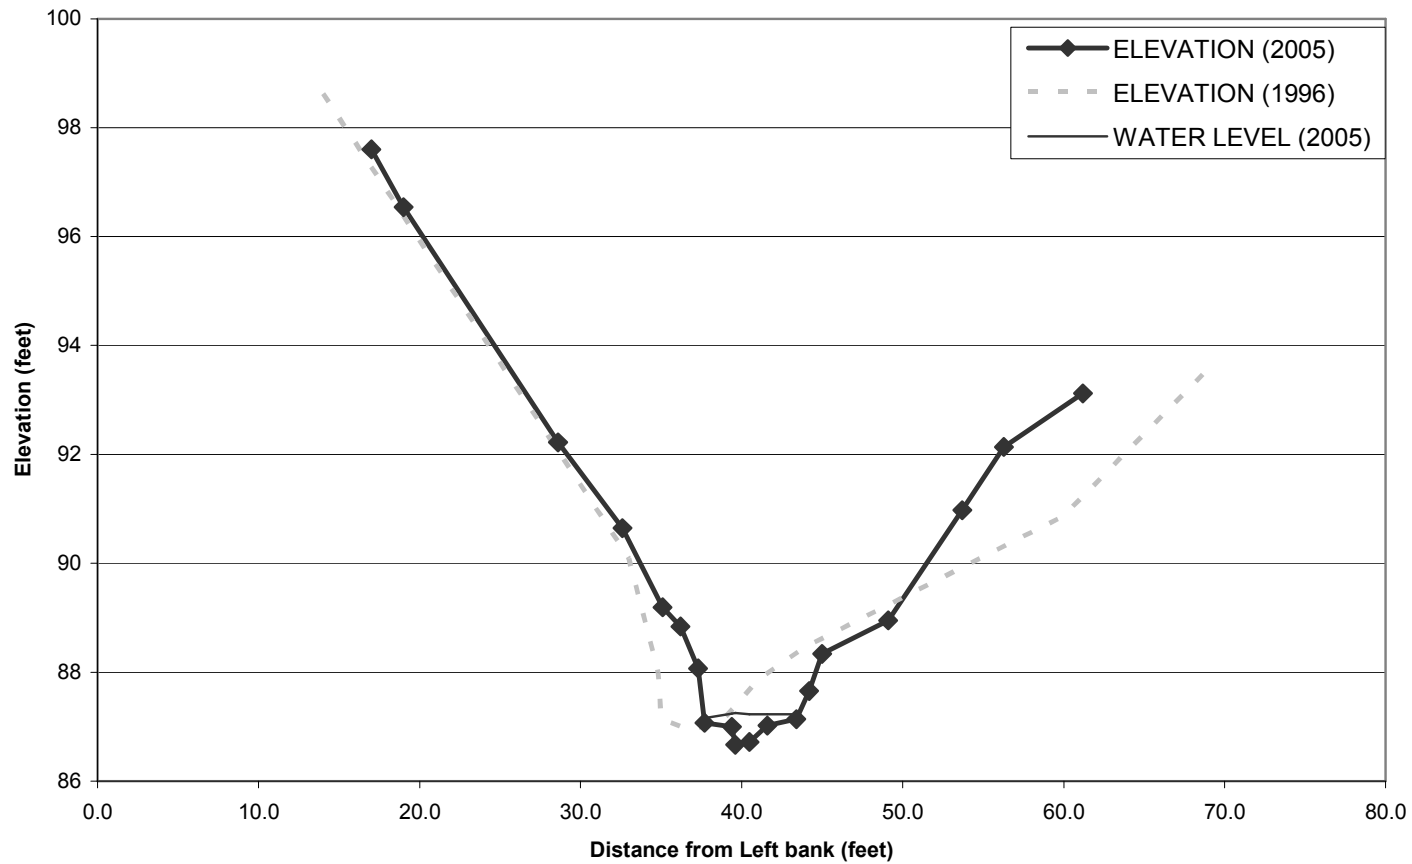
Figure 8: Profile of Cross Section 4 (Station 1+65), facing downstream: 1996 and 2005

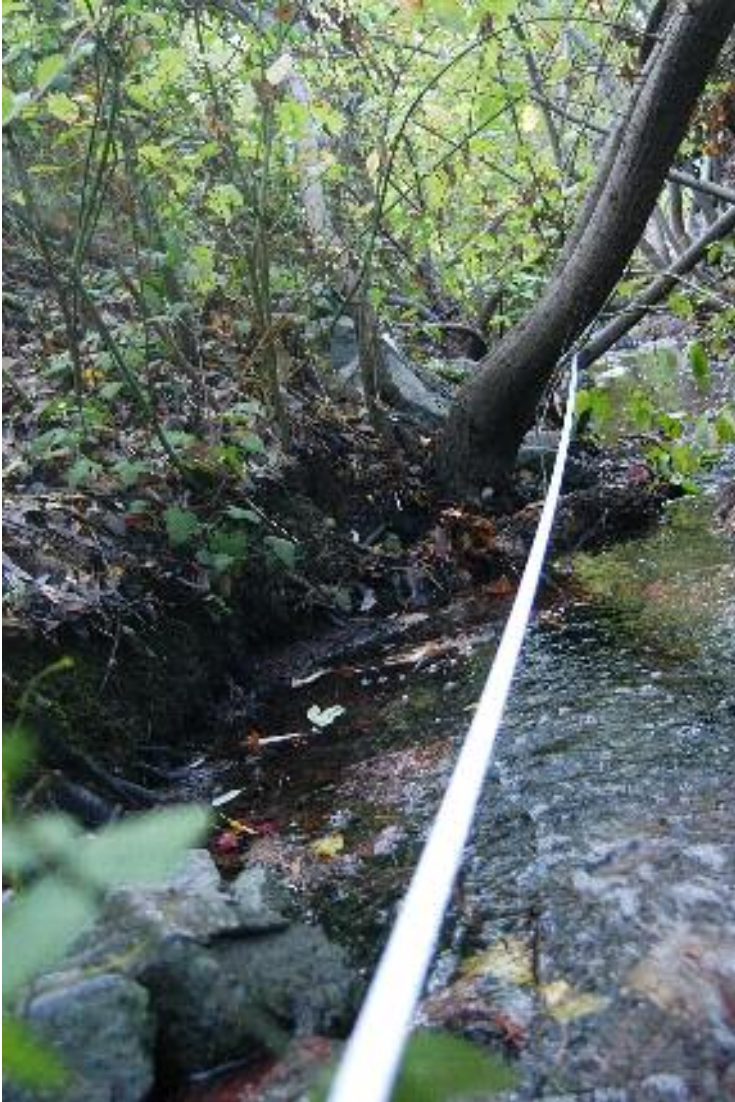
Visually, we observed more pronounced bank erosion in the middle reach where the channel is more accessible by people than in the lower reach where there is less direct access. The right bank also suffered more erosion, perhaps because stairs leading down from the park's footpath in turn allowed for easier access.

Figure 9: Erosion of Left bank (Station 1+03 facing downstream); Dec 2005

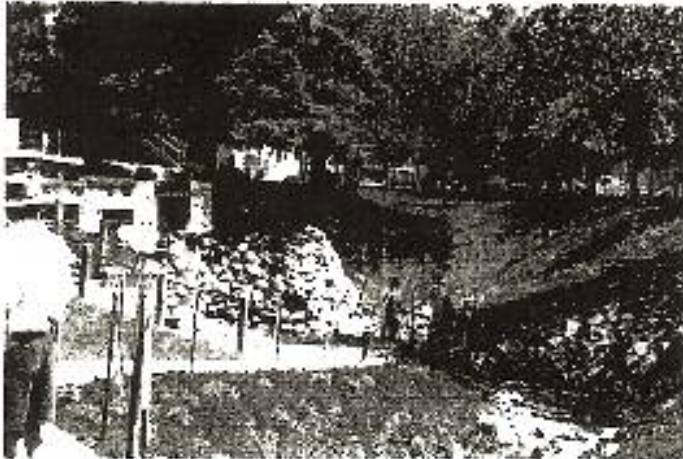
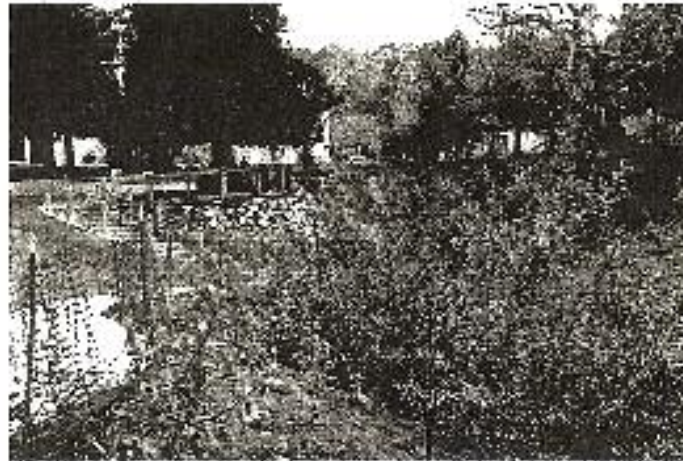
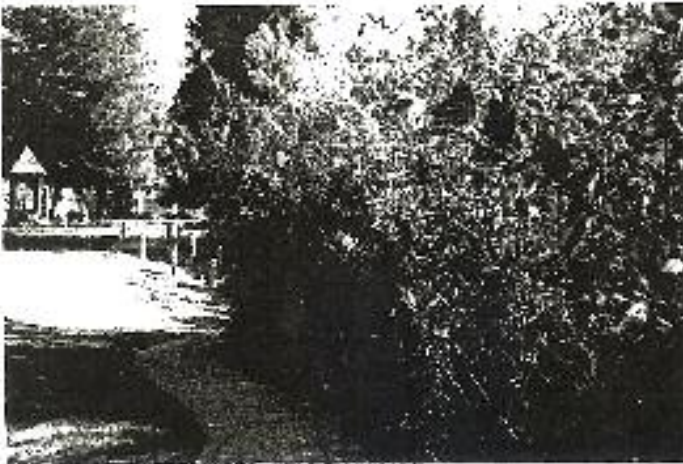
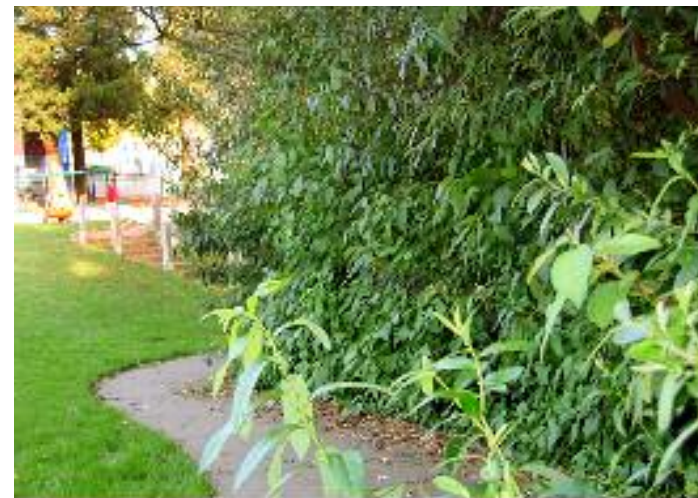
From the photos taken in 1995, 1996, and 2000 at photo points 1 and 2 (see Appendix A for location of photo points), we noticed that the vegetative canopy has increased in height and density (see Figures 10 and 11). Our densiometer survey results are found in Table 4. We calculated canopy cover to be between 81 - 100%, a high value indicating little sunlight penetration (Figure 12). Because of this, ground cover was sparse (see Figure 13). Forest floor species that had sustained or increased in abundance from the 1996 to the 2000 PPA (e.g. Douglas' iris and Buttonbush) were not found in November of 2005. Looking at the vegetation present, we noted differences

Figure 10: Photo Point 1; 1995 (As-Built), 1996, 2000, and 2005. Reference feature: sidewalk.

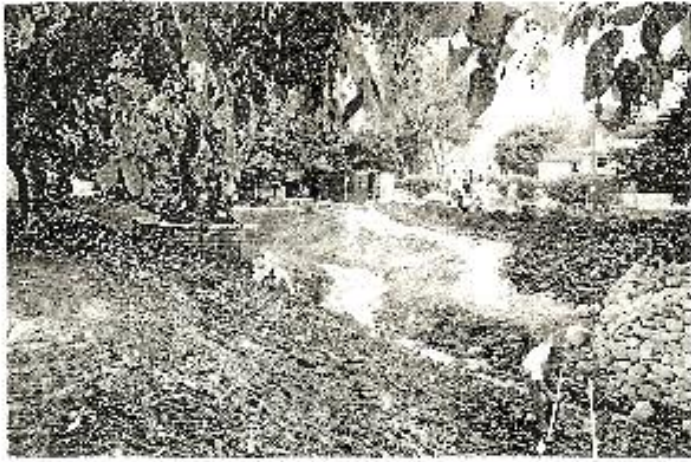
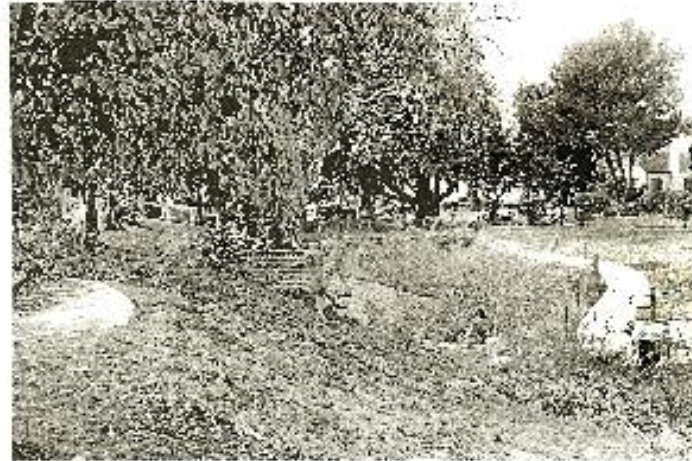
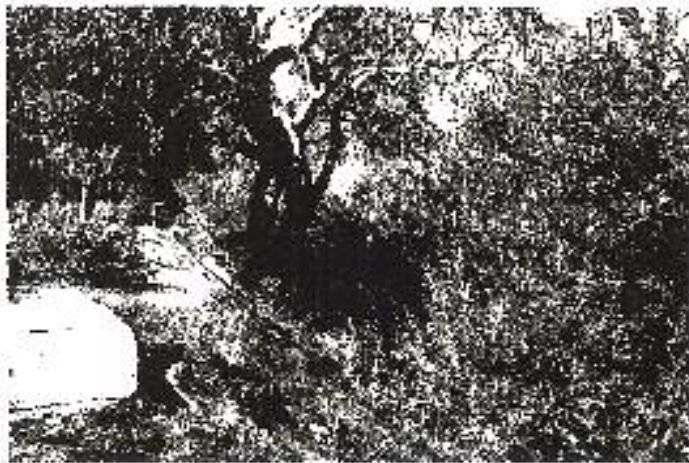
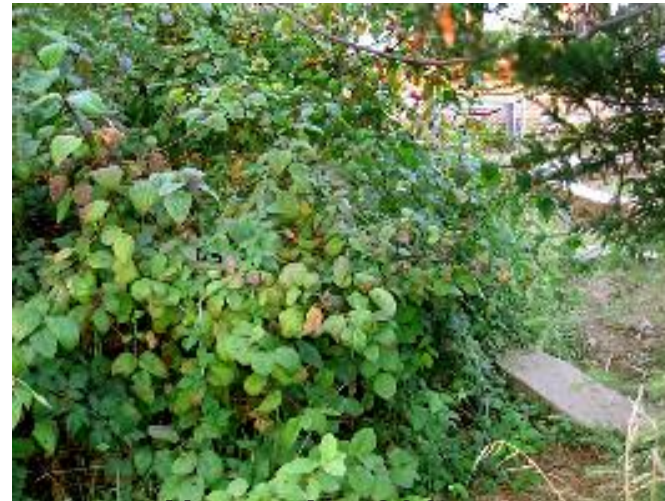
Figure 11: Photo Point 2; 1995 (As-Built), 1996, 2000, and 2005. Reference feature: Stairs at right of 1996 and 2005 photos

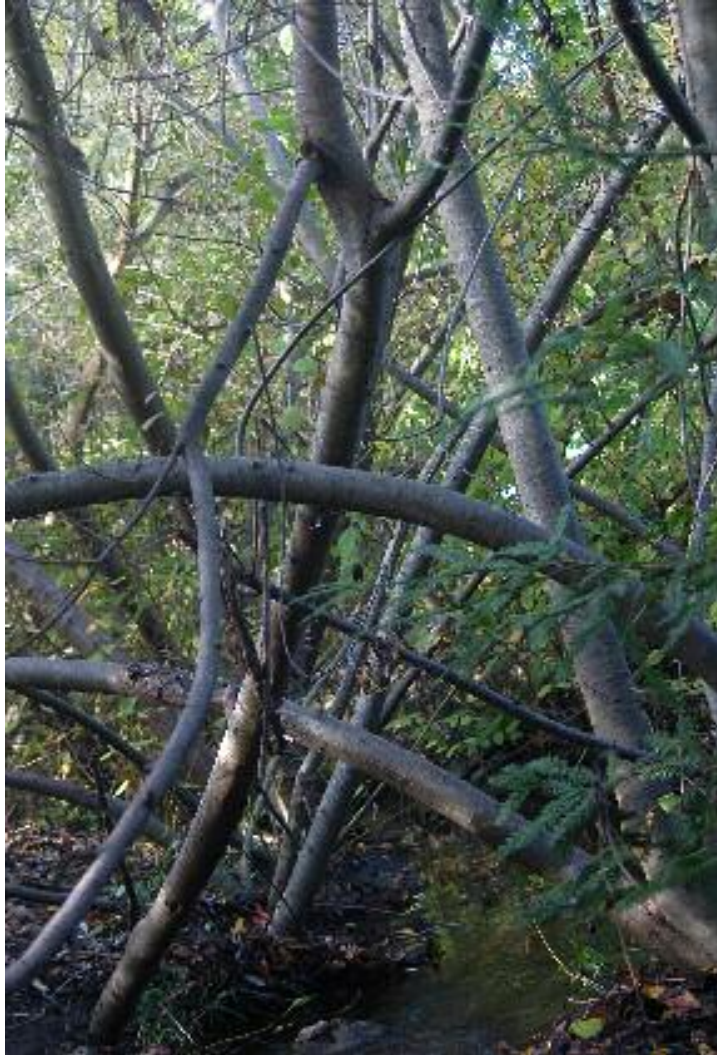
Figure 12: Full canopy cover at Station 0+43, facing upstream; Dec 2005
