Blackberry Creek Daylighting Project, Berkeley: Ten-Year Post-Project Appraisal

By Stephanie Gerson, Jane Wardani, and Shiva Niazi

Landscape Architecture 227, Fall 2005, Professor Matt Kondolf

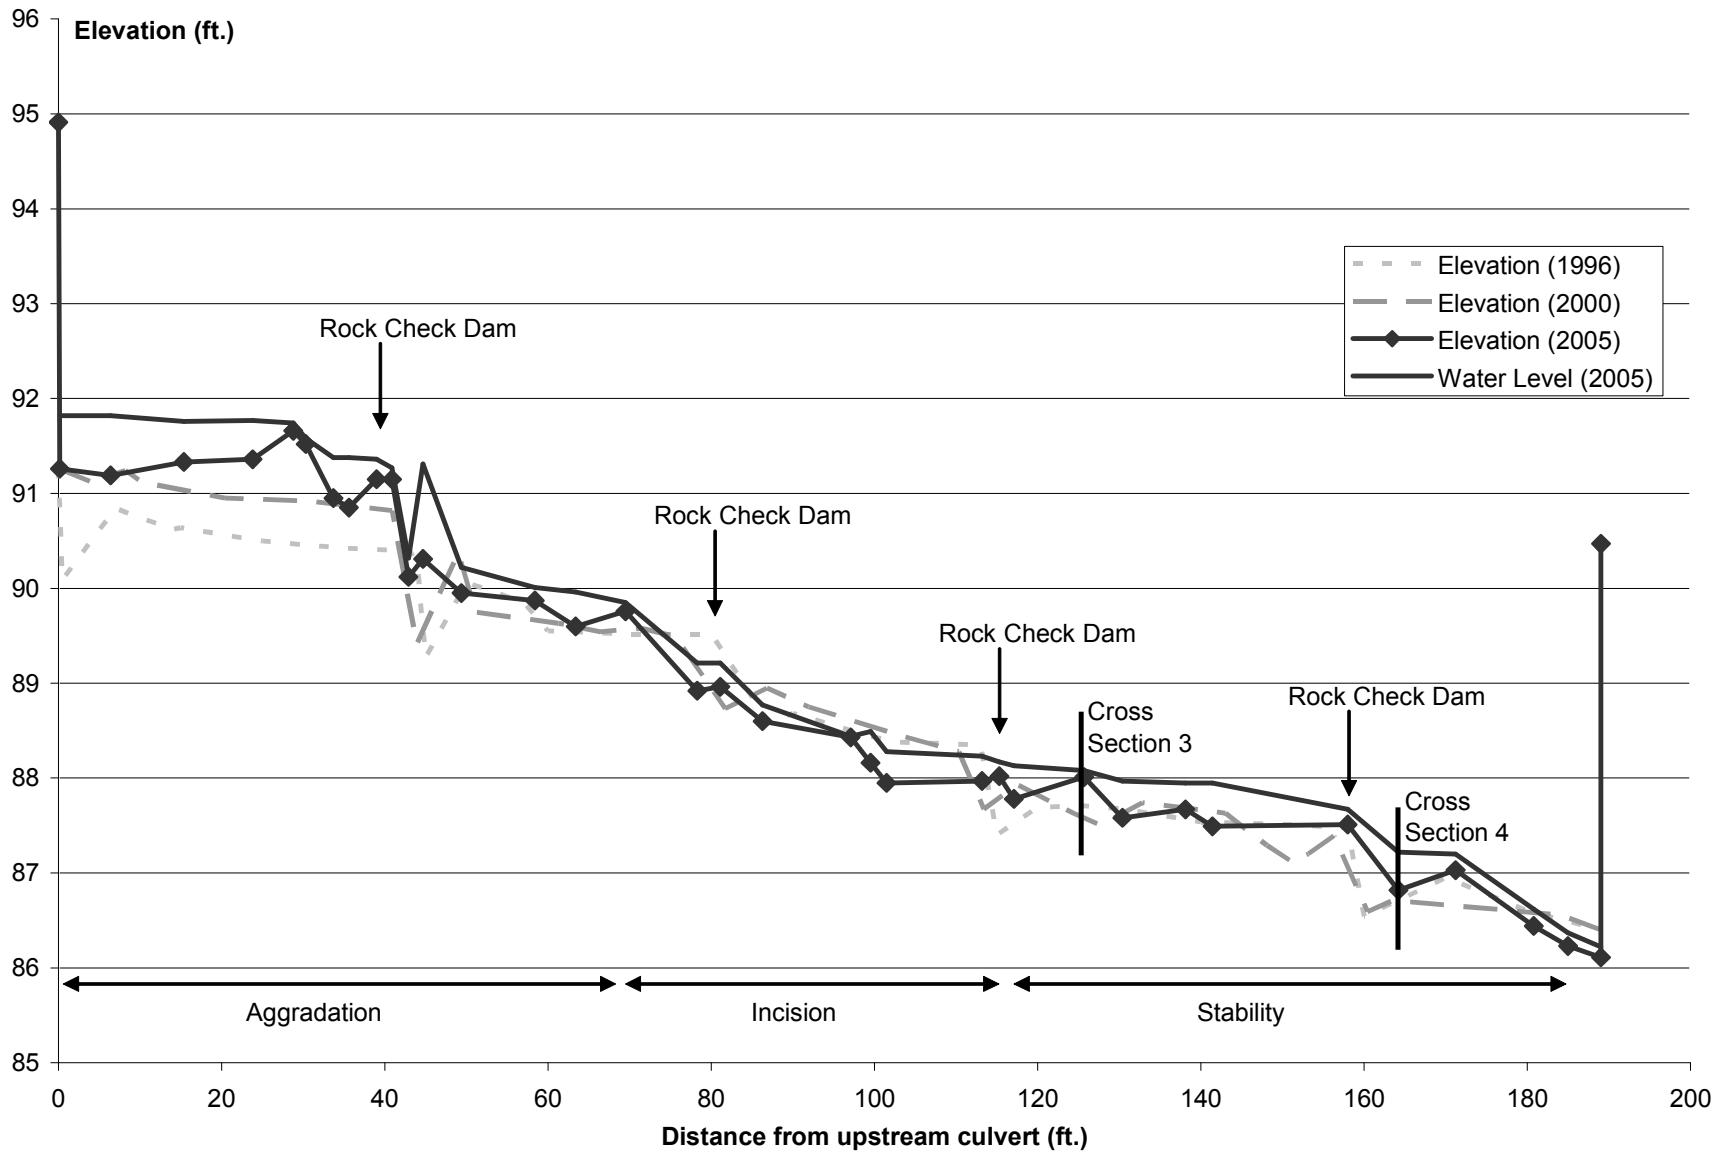
We compared the 2005 profile to those from 1996 and 2000 and found that grade control measures constructed during the project have been successful. All four rock check dams are still present at Stations 0+40, 0+80, 1+13, and 1+58. Channel gradient seems stable with minor accretion and downcutting (see Figure 6).

Sediment deposition just upstream of the dam 38 feet from the upstream culvert resulted in sediment accretion of 0.7 feet from 2000 figures and of 1.2 feet from 1996 figures. Elevation then remains stable for about 25 feet downstream before downcutting begins at about 65 feet from the upstream culvert. We observed downcutting of up to 0.5 feet (from 1996 and 2000 figures) in the next 45 feet of channel. We found the channel bed stable and slightly aggrading below the third rock check dam at 113 feet from the upstream culvert. The channel bed takes a small dip of about 0.3 feet before entering the downstream culvert.

The channel also displayed more pools and riffles than observed in past PPAs. The 1996 PPA documented two riffles and four pools (Askew, 1996), the 2000 PPA found seven riffles and six pools (Imanishi, 2000), while our long profile shows at least nine riffles and seven pools. This increase in pools and riffles is evidence that the channel gradient is stabilizing and the grade control structures are therefore performing well.

Figure 6: Longitudinal profile of Blackberry Creek; 1996, 2000, and 2005

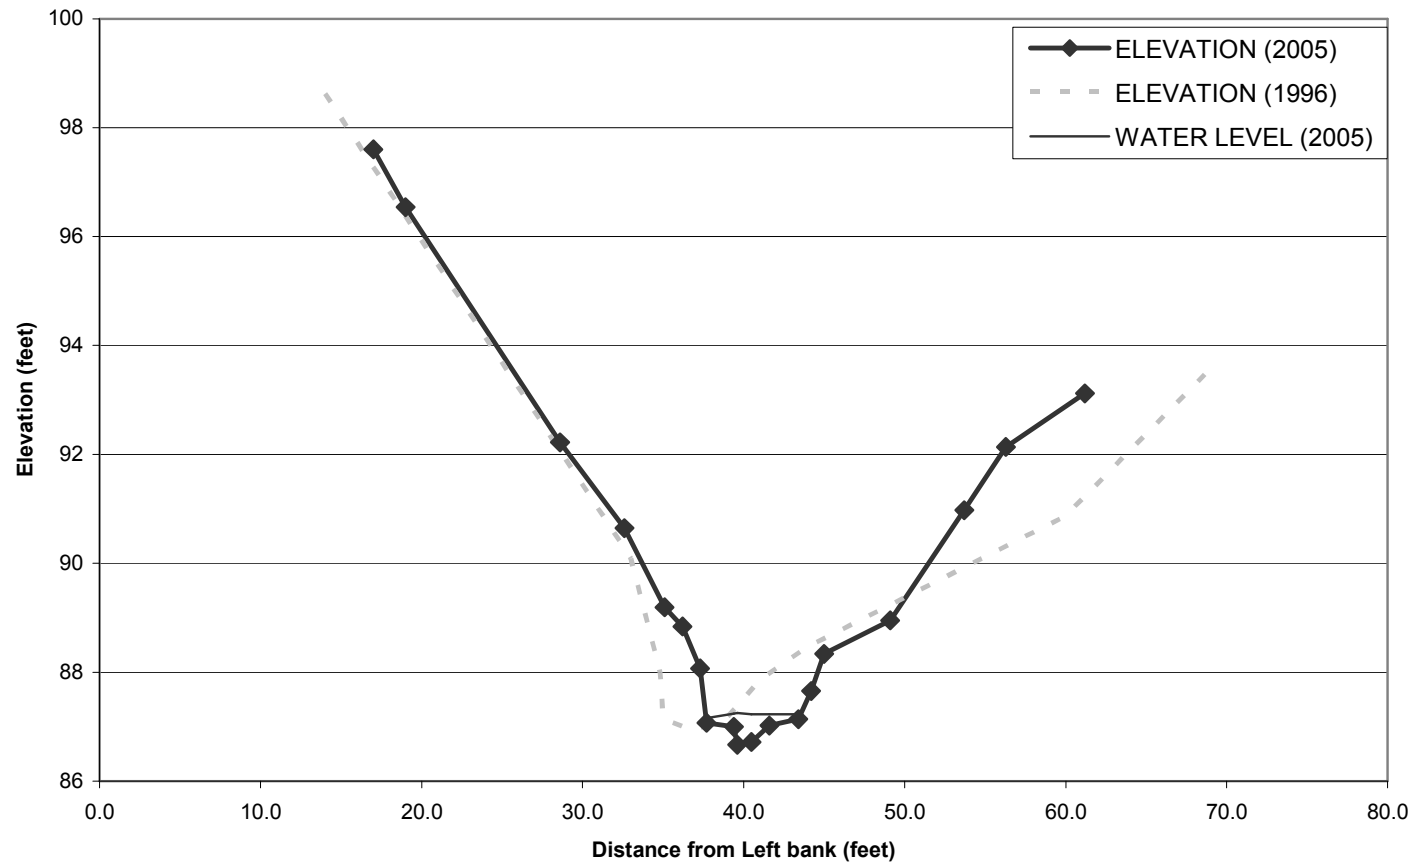
From the two cross sections we surveyed, the channel appears to have migrated towards the right bank over the decade. At Cross Section 3, the channel's thalweg appears to have moved by about 5 feet towards the right bank, and at cross Section 4 (Station 1+65) by 3.1 feet towards the right bank (see Figures 7a and 8). Such migration

Figure 8: Profile of Cross Section 4 (Station 1+65), facing downstream: 1996 and 2005

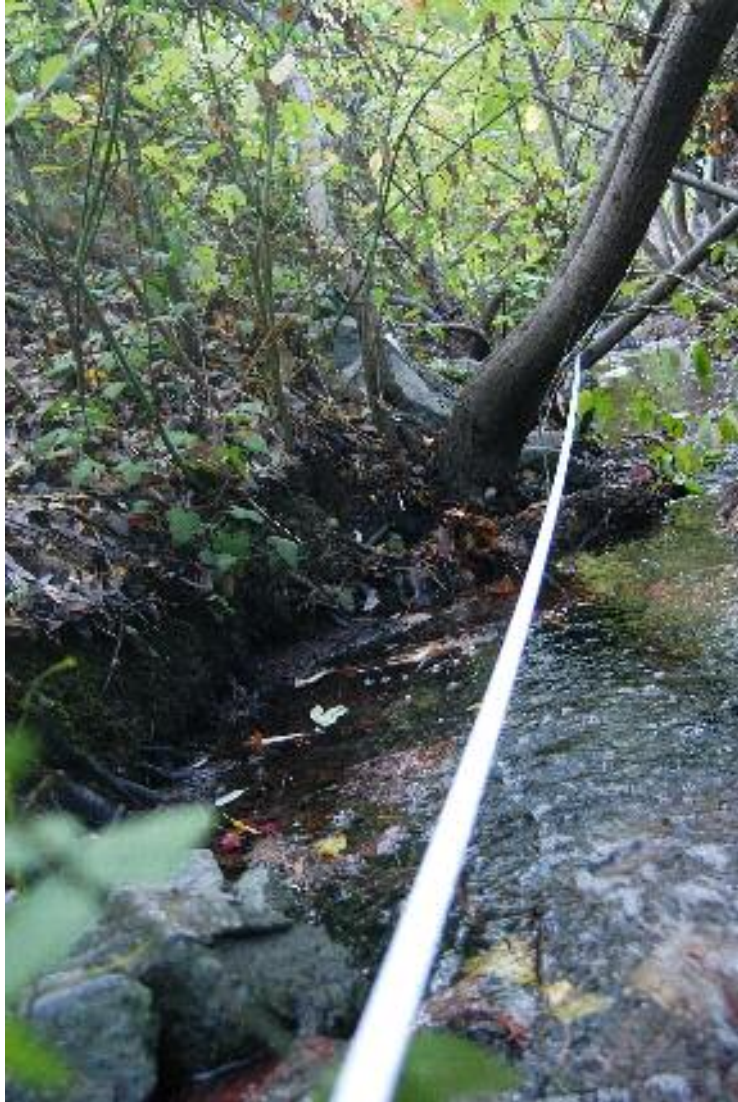
Visually, we observed more pronounced bank erosion in the middle reach where the channel is more accessible by people than in the lower reach where there is less direct access. The right bank also suffered more erosion, perhaps because stairs leading down from the park's footpath in turn allowed for easier access.

Figure 9: Erosion of Left bank (Station 1+03 facing downstream); Dec 2005

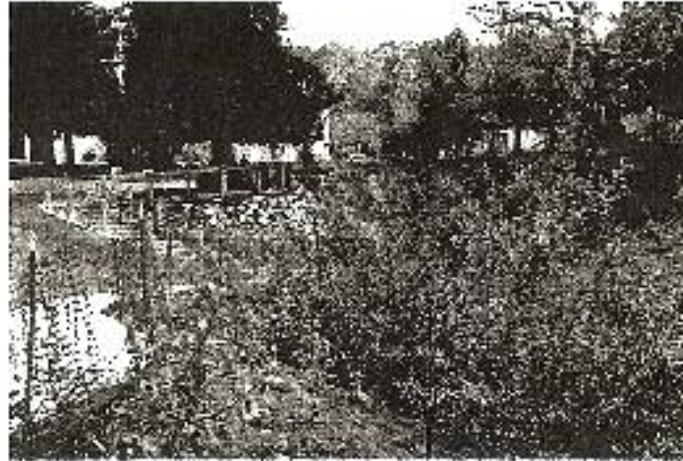
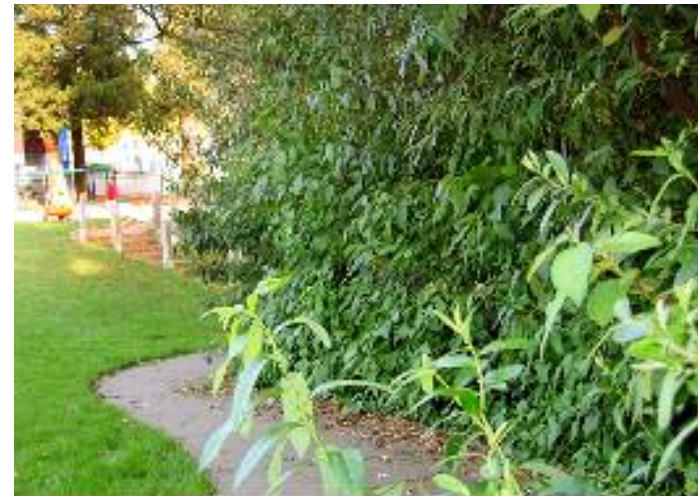
From the photos taken in 1995, 1996, and 2000 at photo points 1 and 2 (see Appendix A for location of photo points), we noticed that the vegetative canopy has increased in height and density (see Figures 10 and 11). Our densiometer survey results are found in Table 4. We calculated canopy cover to be between 81 - 100%, a high value indicating little sunlight penetration (Figure 12). Because of this, ground cover was sparse (see Figure 13). Forest floor species that had sustained or increased in abundance from the 1996 to the 2000 PPA (e.g. Douglas' iris and Buttonbush) were not found in November of 2005. Looking at the vegetation present, we noted differences

Figure 10: Photo Point 1; 1995 (As-Built), 1996, 2000, and 2005. Reference feature: sidewalk.

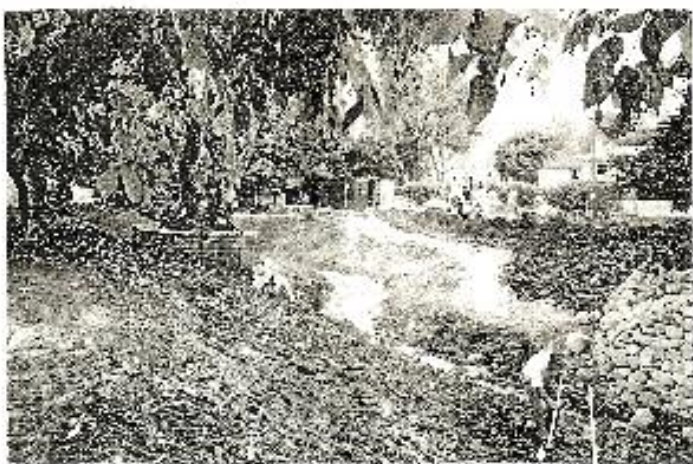
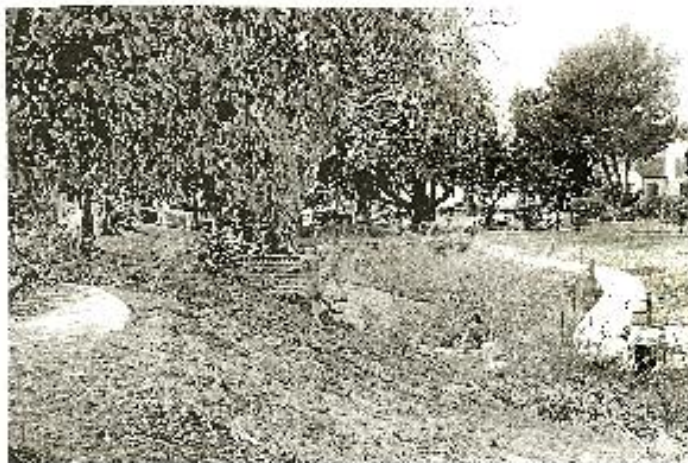
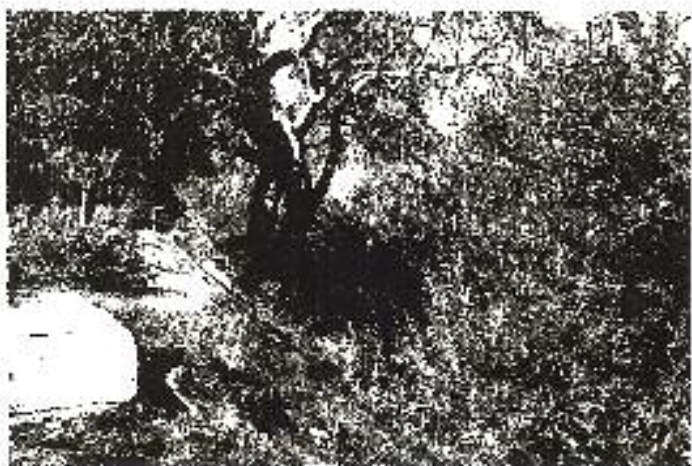
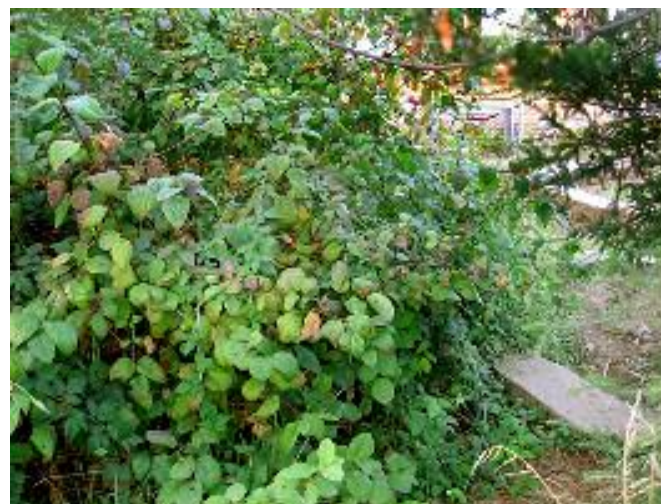
Figure 11: Photo Point 2; 1995 (As-Built), 1996, 2000, and 2005. Reference feature: Stairs at right of 1996 and 2005 photos

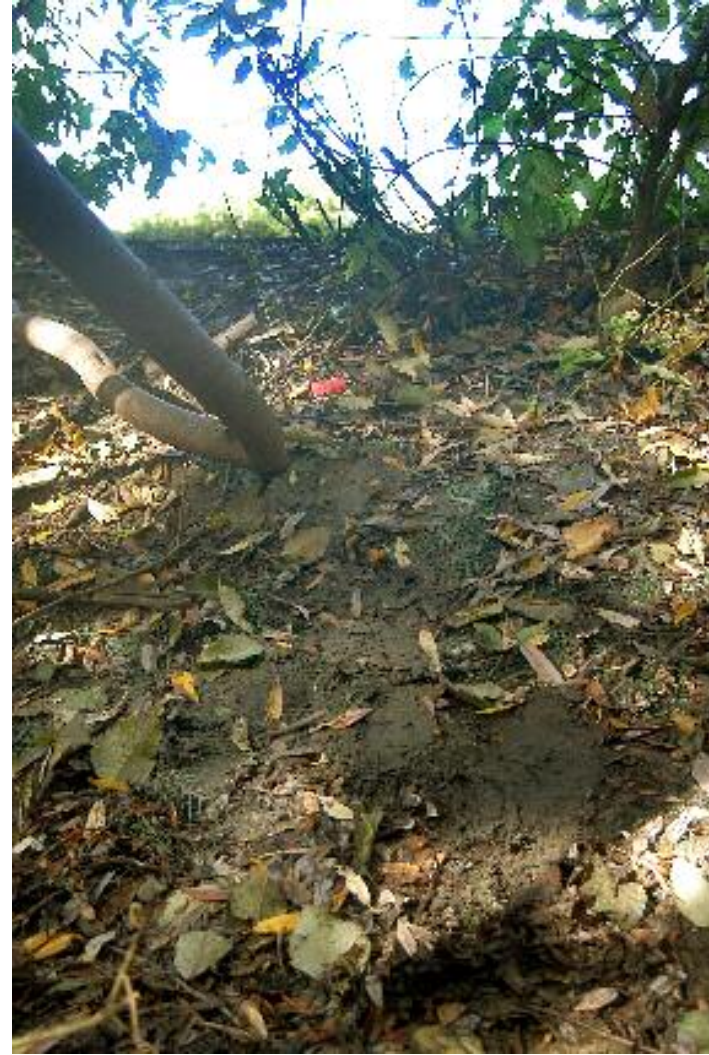
Figure 13: Sparse ground cover at Station 1+65, facing Right bank, Dec 2005
