Post-project appraisal of a channel reconstruction on Cuneo Creek, California

AREN HANSEN

Department of Civil and Environmental Engineering
University of California, Berkeley
Berkeley, California 94720
Term Project for LA 227: River Restoration
Presented to Professor G. Mathias Kondolf
Submitted December 8, 2003

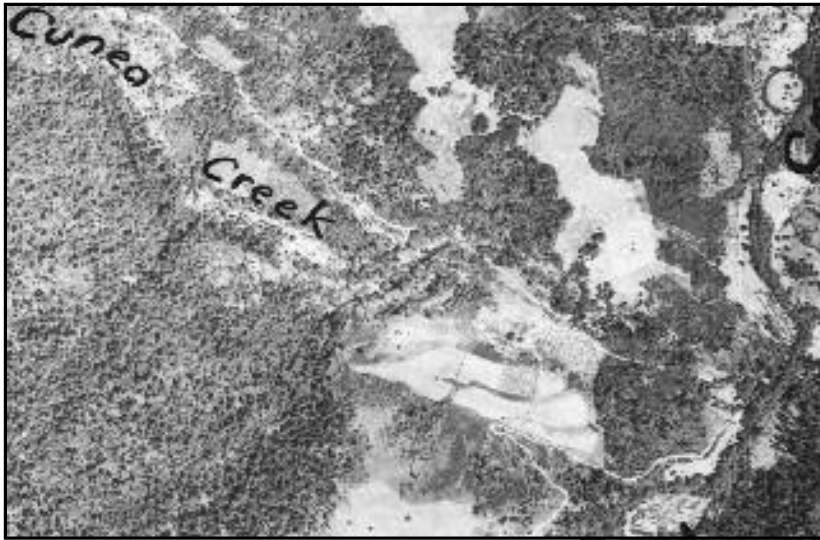
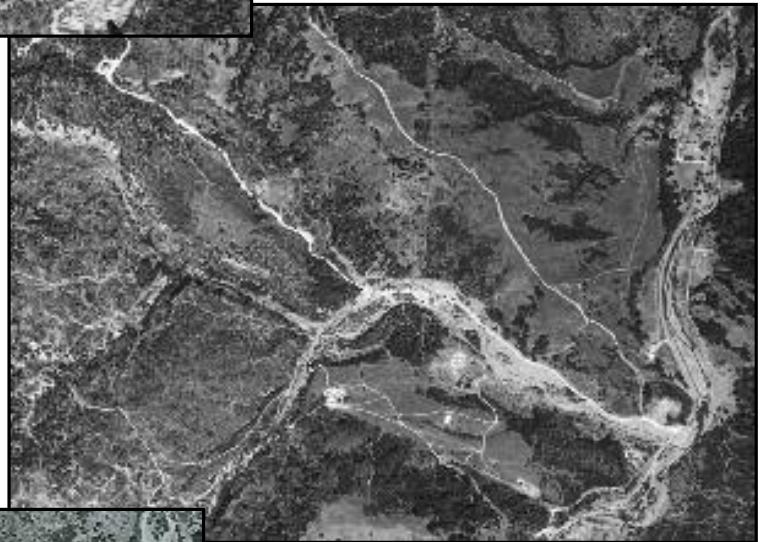
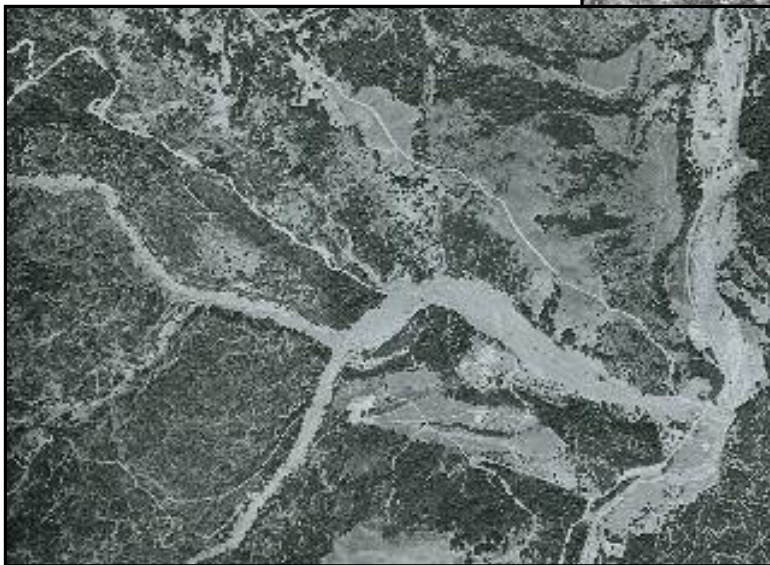
The basin's climate and geology, combined with the effects of logging in the 1950's and '60's, created a high susceptibility to erosion. High-intensity storms hit the region in 1955 and 1964 and caused extensive erosion in the headwaters of Cuneo Creek and equally impressive channel widening and aggradation in lower Cuneo Creek as a result of the sediment deposition. Aerial photographs clearly illustrate the change in channel morphology during this period (Figure 3). Since 1955 the Cuneo Creek basin has been contributing large amounts of sediment to Bull Creek, which has led to destruction rare old-growth redwood groves through channel aggradation in the Bull Creek flats. Approximately 5 meters of sediment was deposited on top of the floodplain of lower Cuneo Creek in 1955 and another 5 meters was deposited in 1964,

Figure 2: Changes in Cuneo Creek Channel Configuration (1942-1965). Upper photograph is from 1941 prior to extensive logging. Middle photograph is from 1964, after extensive logging and channel aggradation due to 1955 flood. Lower photograph is from 1965 after further logging and shows extreme channel aggradation due to 1964 flood.

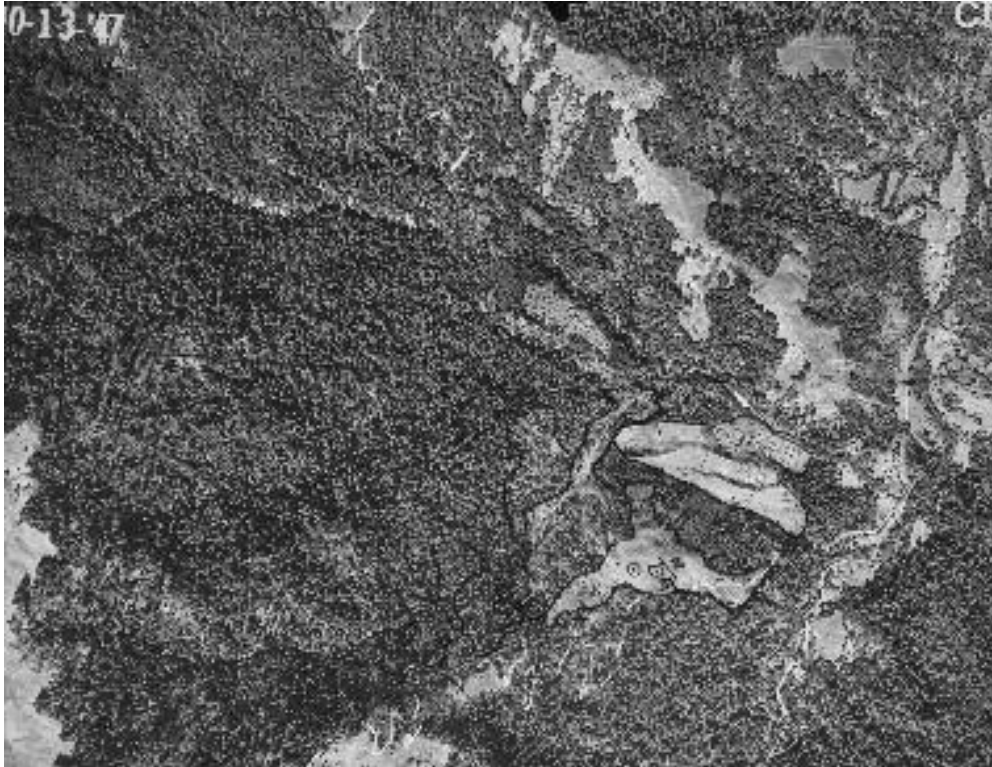
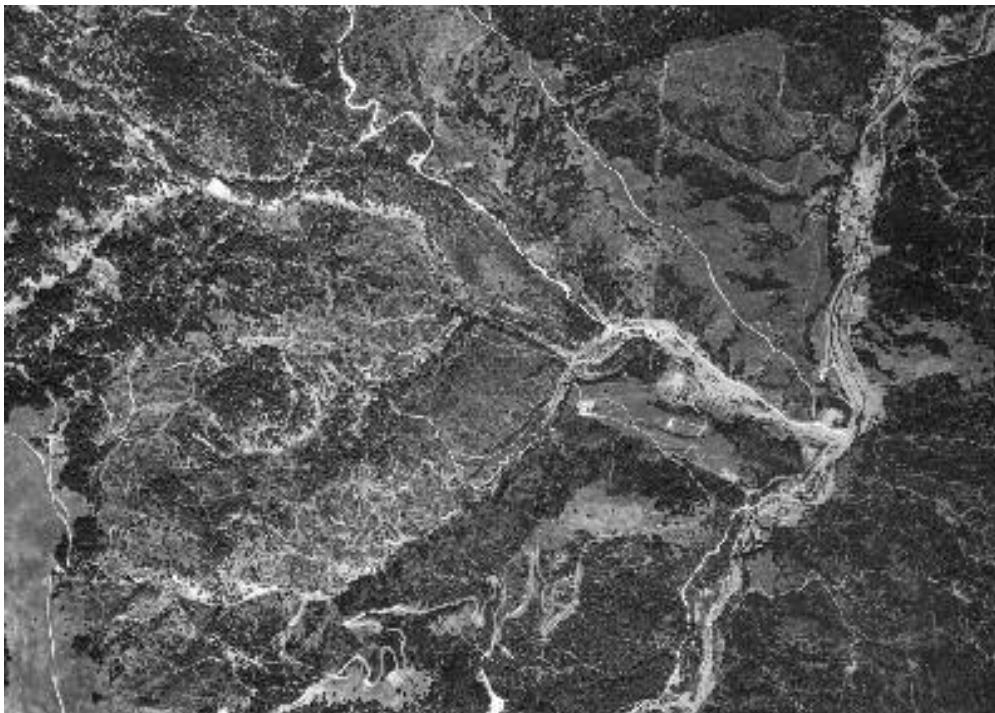
a) 1947: Cuneo Creek watershed prior to extensive logging.

b) 1964: Cuneo Creek watershed after extensive logging.

Figure 3: Logging Impacts. a) The aerial photograph from 1947 shows pre-logging state of the watershed with a large amount of Douglas fir covering hillslopes. b) The aerial photograph from 1964 shows significant decrease in vegetative cover on the hillslopes due to logging. Also notice the maze of skid trails.

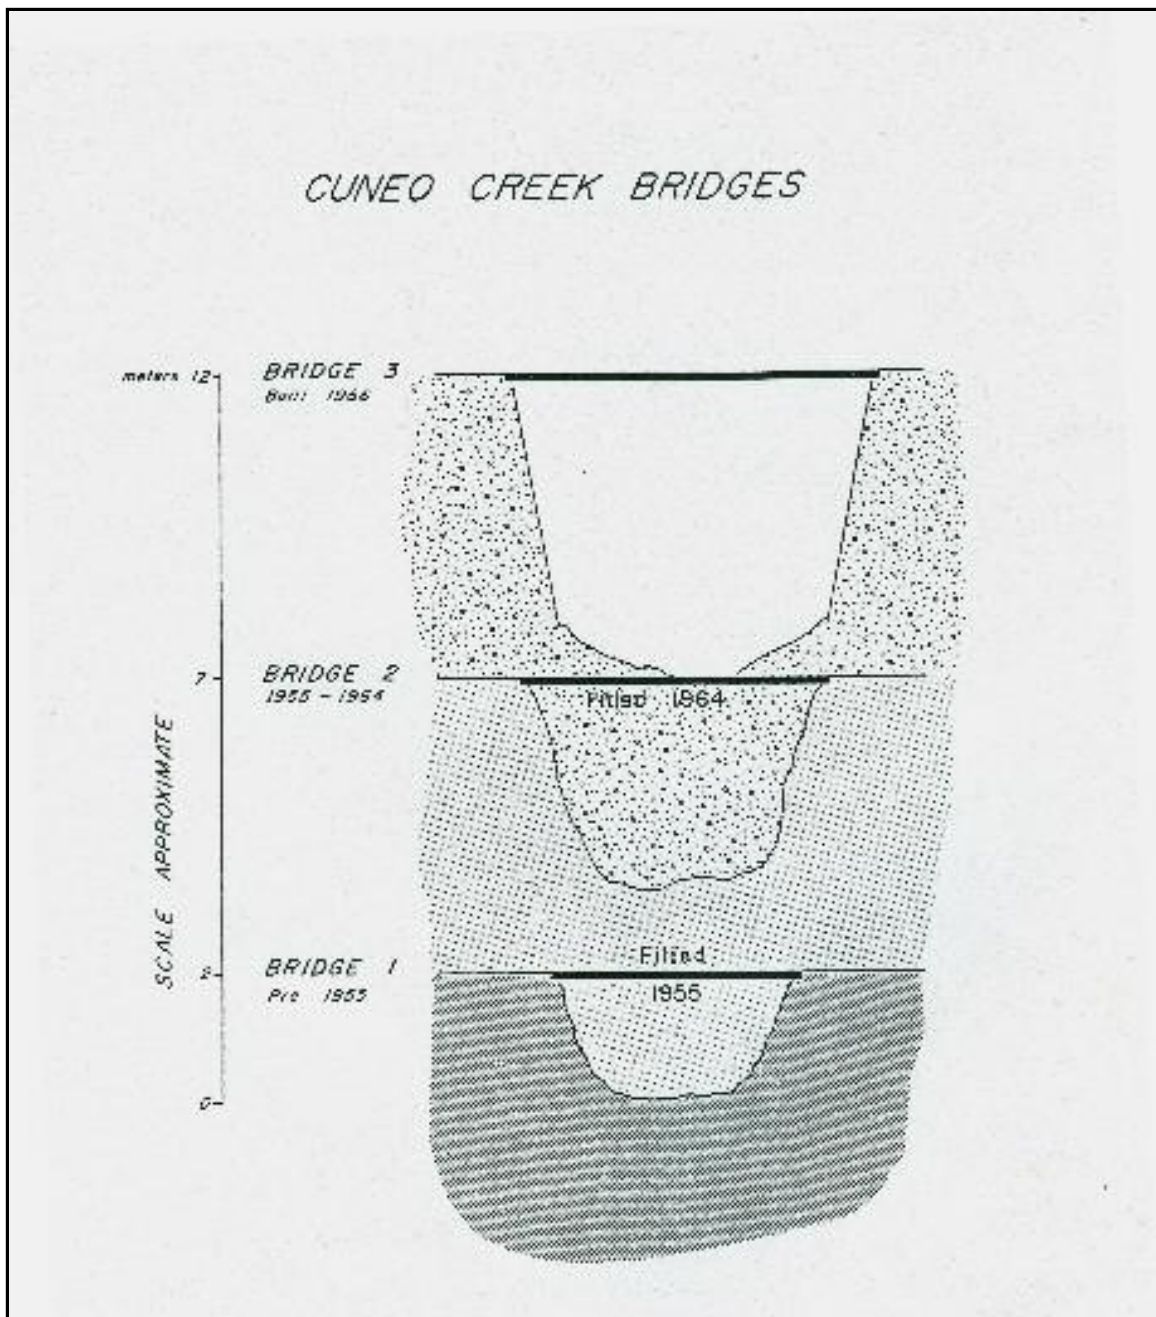
each time burying the bridge spanning Cuneo Creek (Figure 4). In the late 1960's, the Humboldt Redwoods State Park (Park) purchased all of the land encompassing the Bull Creek watershed and began restoration efforts to protect the large redwood trees growing in lower Bull Creek. The South Fork of Cuneo Creek is currently still plagued with active landslides, such as the Devil's Elbow landslide, which contribute large amounts of sediment to the basin during significant rain events (Short 1993). The objective of the channel reconstruction project in 1991 was to reduce sediment transport to Bull Creek flats in an effort to protect the old growth redwood groves (US ACE Permit).

Figure 4: Cuneo Creek Bridges. Shows succession of three bridges over Cuneo Creek and approximate sediment deposited (Short 1993).

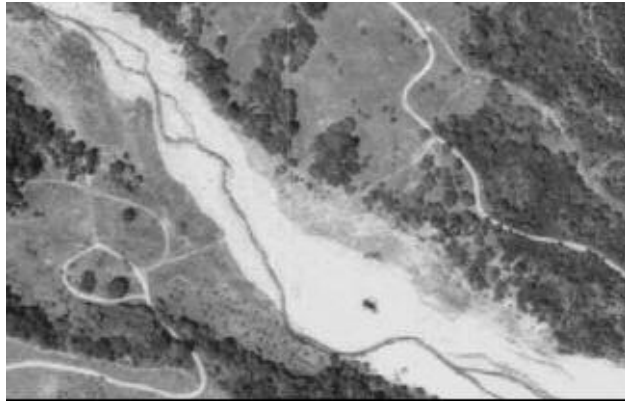
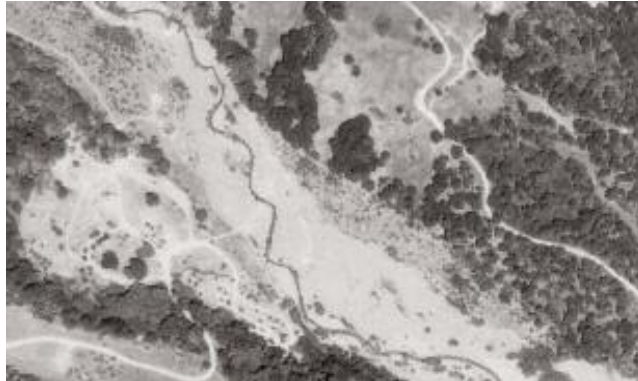
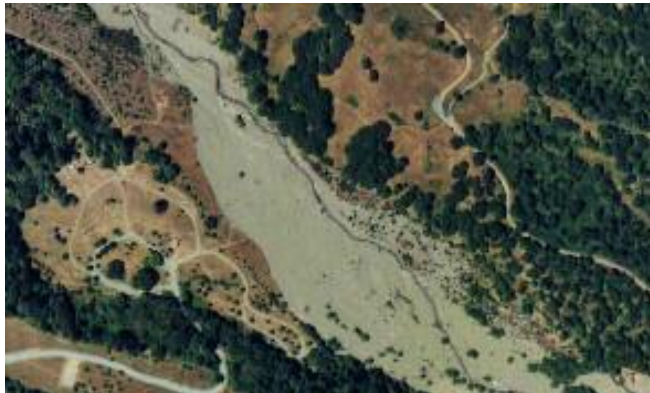
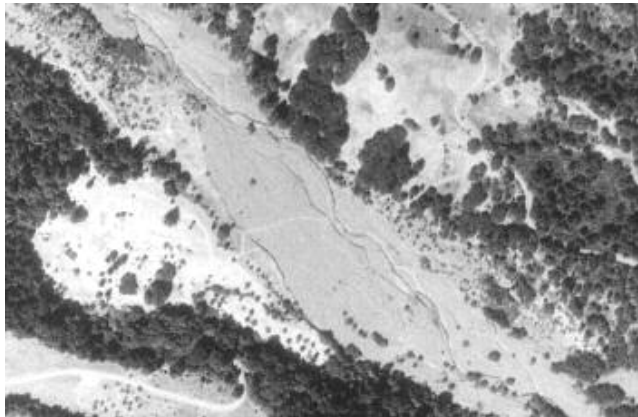
Figure 5: Changes in Active Channel Configuration.

A review of historical aerial photographs dated between 1942 and 1998 show that the lower reach of Cuneo Creek has consistently favored a slightly meandering and occasionally braided channel since severe channel aggradation occurred in 1955 and 1964. It is also evident

from the photographs that the channel configuration and position have been consistently changing over the years (Figure 5).

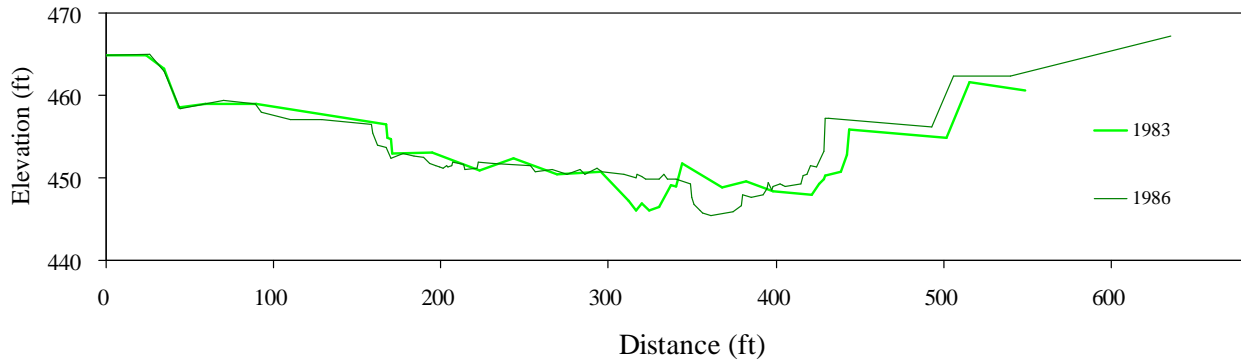
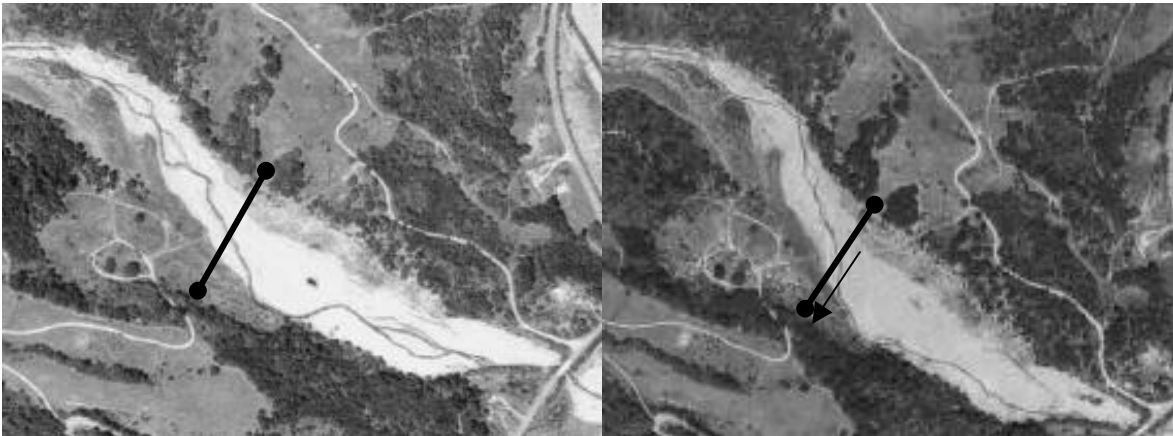
Mainstem Cuneo Creek
xs 25+46

Using cross sectional data and aerial photographs from previous years, I calculated the approximate flood frequency that caused a channel migration observed in the mid-1980's. Cross-sections along transect xs25+46, surveyed by Darci Short in 1983 and 1986 show a thalweg migration of approximately 40 feet to the right looking downstream (Figure 6). Assuming this migration resulted from the high flow observed in February of 1986, the channel-forming flood that caused the migration was estimated to have a recurrence interval of about 6 years. Based on a combination of the photographic evidence, cross-sectional surveys and streamflow data, it is evident that channel form in Cuneo Creek is influenced by floods with frequencies greater than the common 'bankfull' approximation of 1.5 years. Unfortunately, consistent cross-sectional survey data were not available to conduct a similar analysis within the lifetime of the reconstructed channel (1991-1996).

Figure 6: Channel Migration in 1986. a) The cross-sectional survey shows a channel migration of approximately 40 feet towards the right bank between 1983 and 1986. (Survey conducted by Darci Short). b) Aerial photographs taken in 1984 and 1988 show a similar migration. Black line indicates location of cross section xs25+46, arrow in second photograph indicates direction of channel migration.

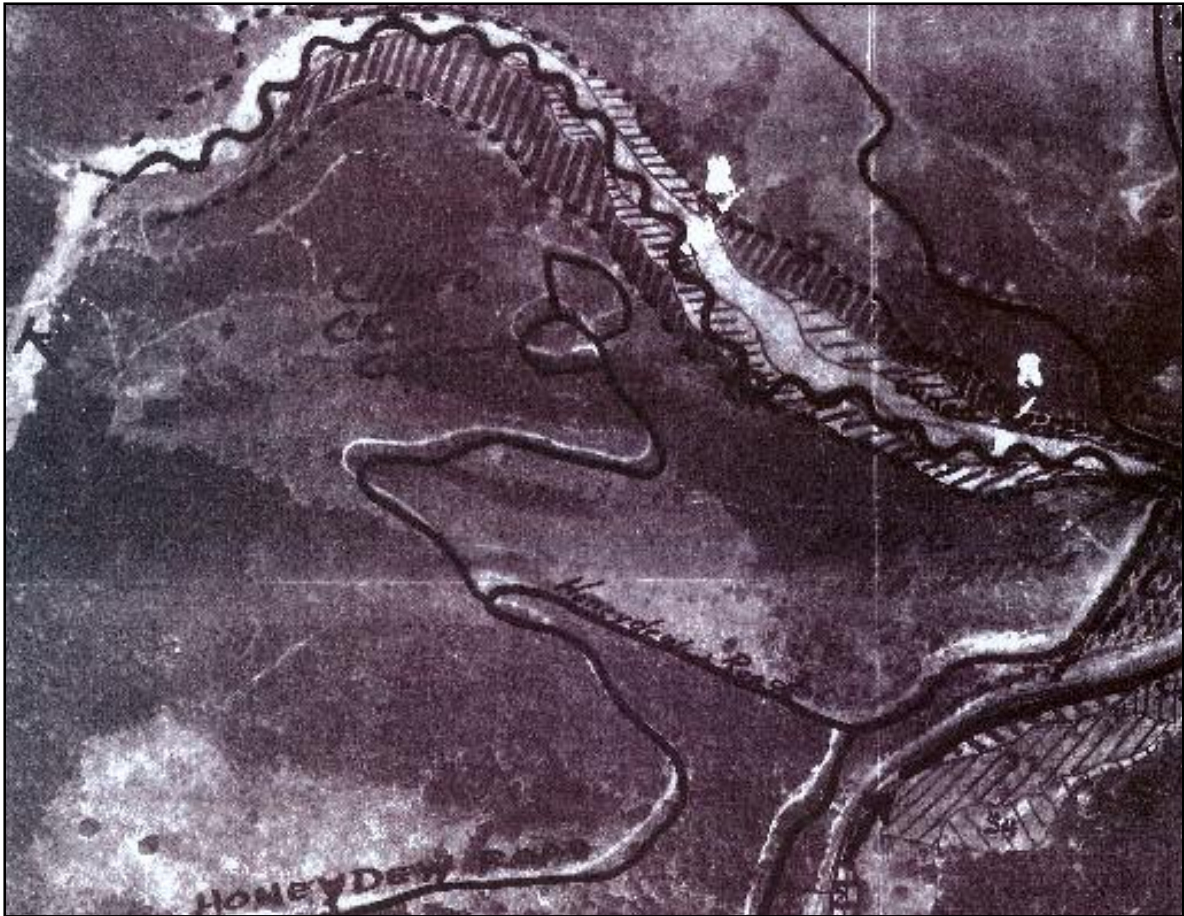
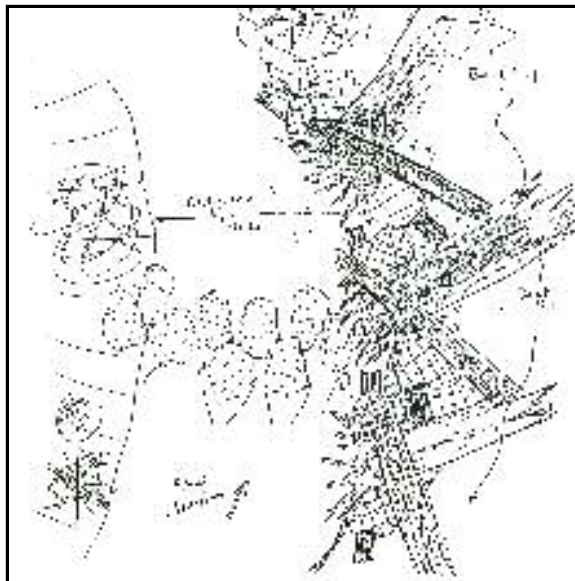
The original design for the channel reconstruction involved a reach of 5,200 feet and was to construct a total of 43 sinuous meander bends (Figure 7). Revetments composed of logs, root boles, and rock were proposed to stabilize the outside of each meander bend and the cross-over reaches were to be stabilized using a series of two “vortex rock weirs” (grade control structures) upstream and two downstream of each bend (Rosgen 1992, also in Figure 7). Detailed documentation discussing the geomorphic basis for the channel design was not available, but the project appeared to be a straightforward application of the Rosgen classification scheme (C3-type channel) based on an estimate of the bankfull discharge (usually $Q_{1.5}$). These projects typically involve two steps: (1) Determining the ‘proper’ stream type using data collected on site and expectations of transitions from one type to another; and, (2) Using heavy equipment to construct ‘proper’ channel configuration with the expectation that it will be inherently stable (Kondolf et. al 2003).

In comparison with historical channel configurations, as seen in aerial photographs, the proposed sinuous channel is drastically inconsistent with the form that has been preferred by

the creek for the past 40 years. No evidence was presented supporting that such a channel would naturally occur in the watershed, had historically occurred, or that such a channel could be expected to be stable in such a dynamic environment. Additionally, the channel was designed using the bankfull concept, which may not be appropriate for stream channels that tend to be dominated by more infrequent floods and periodic disturbance, as is common in a Mediterranean climate (Kondolf et. al 2003).

Figure 7: Sketch of Proposed Channel Design. The top sketch shows the proposed sinuous meandering channel along a reach of approximately 5200 feet with 43 bends. The bottom sketch illustrates the proposed bank revetment structure and grade control structures.

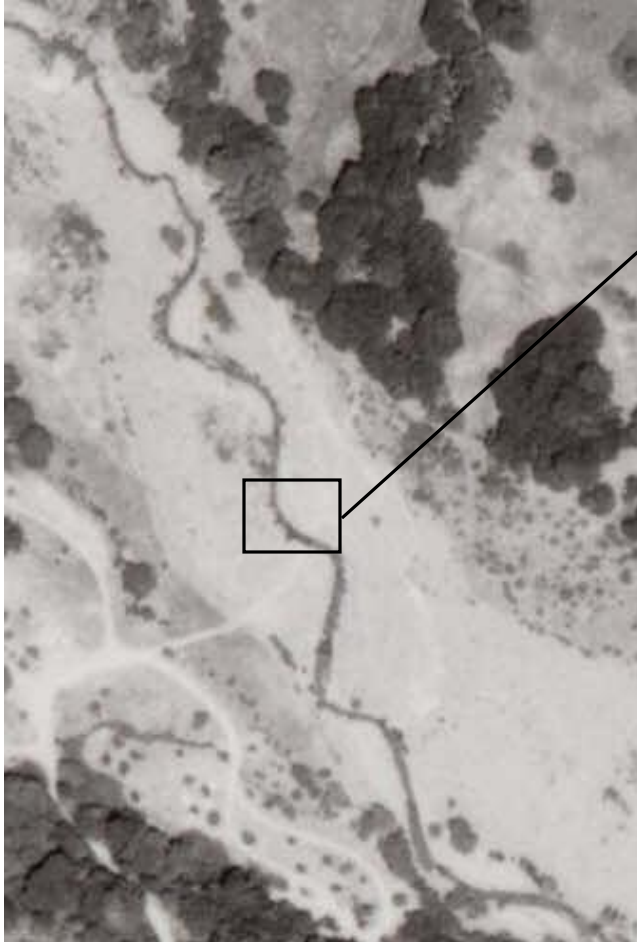
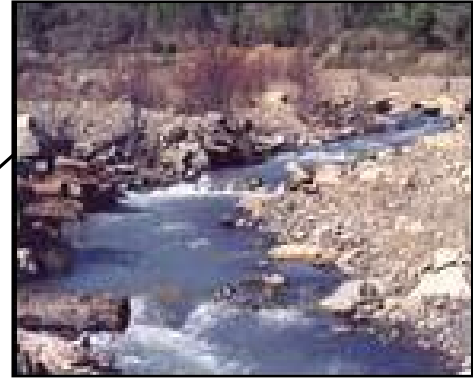
The channel actually constructed involved a reach of only 1,700 feet and included only 8 meander bends (Figure 8). David Burnson modified the proposed design specifications after field observations indicated that significant recovery had occurred in the upper portion of project reach (Burnson 1992). Modifications of the proposed C3-type channel design led to construction of a channel that was slightly less sinuous and meandering and more closely resembled a B-3 configuration (Conversation with David Burnson 2003). The outside of the meander bends were stabilized with rock and log revetments as designed, but only one vortex rock weir was built along the cross-over reaches upstream and downstream of each bend. Surveys were conducted along certain transects after project completion and indicated that the channel was built within the tolerance limits of the design specifications (Burnson 1992). In addition to the channel reconstruction, low profile groins constructed of half-buried upright logs were constructed along the valley floor to buffer future debris flows.

In correspondence after construction of the channel, the design consultant raised concerns that the project would not be stable due to the as-built channel cross-over reaches having only one vortex rock weir, instead of two as designed (Rosgen 1992). However, since the flood of 1996 was the highest on record and active landslides were still occurring within the upper Cuneo Creek basin, it is plausible that the revetments and grade control structures were not eroded, but instead were buried in sediment brought down from active landslides. Additionally, the creek may have abandoned the channel as it cut through the largely unvegetated floodplain, which likely had a low frictional resistance and high overbank flow velocities leading to chute erosion across meander bends. This tendency has been observed in similar classification-based channel reconstruction projects such as the Deep Run project evaluated by Smith (1997), and was presumed to be the cause for failure of a project on Uvas Creek (Kondolf 2001). In combination, these studies are beginning to raise important questions regarding the use of the Rosgen classification system in the design of river and creek restoration projects.

Figure 8: Constructed Channel. a) Aerial photograph from 1996 showing constructed channel configuration. Flow is from upper left to lower right b) Photograph of a constructed bend. Notice rock and log revetments on left of photo. Obtained from <http://www.terrawavesystems.com>

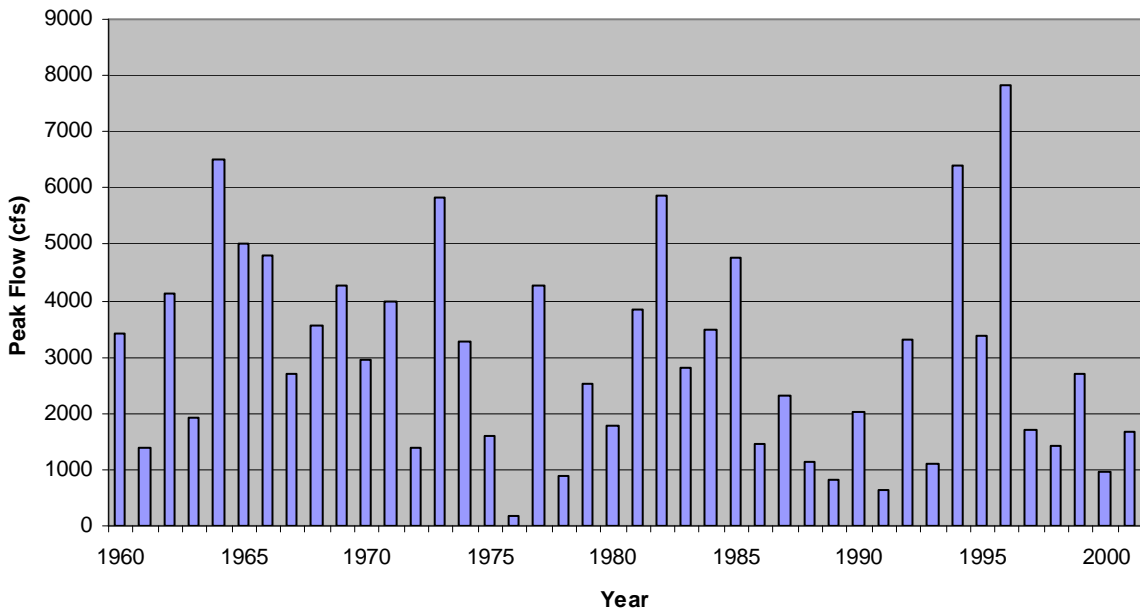
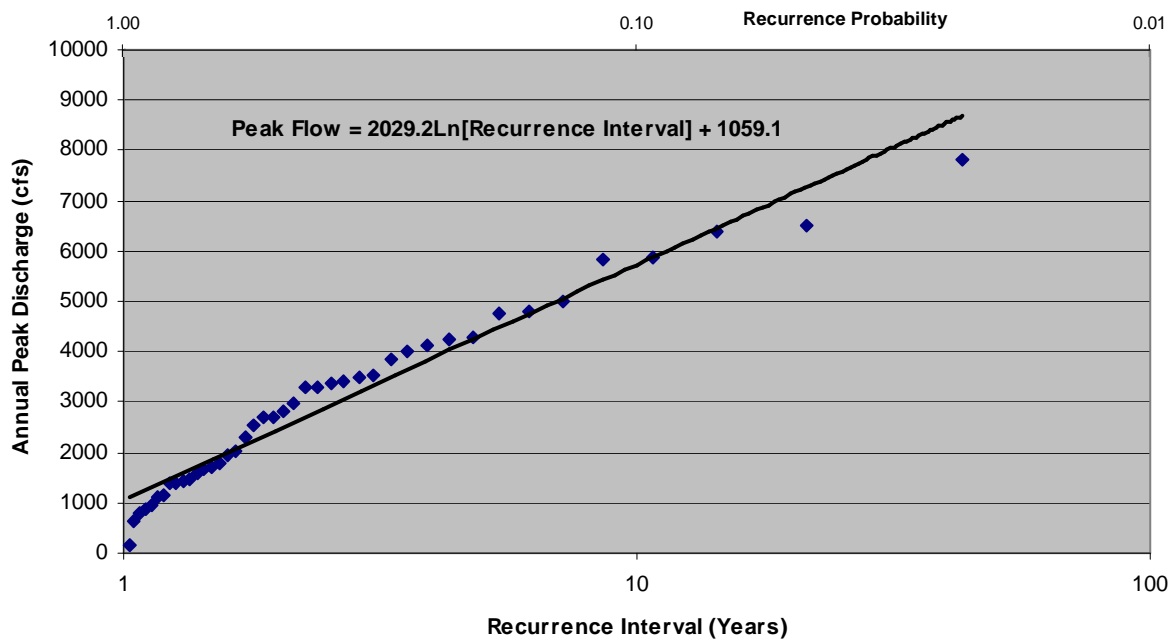
Annual peak flows (measured as momentary discharge) at the Bull Creek stream gauge from 1960-2002 varied between 173 cubic feet per second (cfs) to 7,830 cfs (Figure 9a). The 1996 flood that washed out the constructed channel was the highest momentary peak flow on record (7,830 cfs), even greater than the historic 1964 flood (6,520 cfs). By constructing a flood frequency plot (Figure 9b) a linear flood frequency curve was developed with the following equation:

where Q_T is equal to the peak flow measured in cfs and T is recurrence interval measured in years (Dunne and Leopold 1978). Using this equation, I calculated the recurrence interval of the flood observed in 1996 flood to be approximately 30 years.

Figure 9: Flood Frequency. a) Plot of annual peak flow data for USGS stream gauge number 11476600 on Bull Creek about 4 km downstream of confluence of Cuneo Creek with Bull Creek. b) Flood frequency plot showing linearized flood frequency equation and annual recurrence probability.

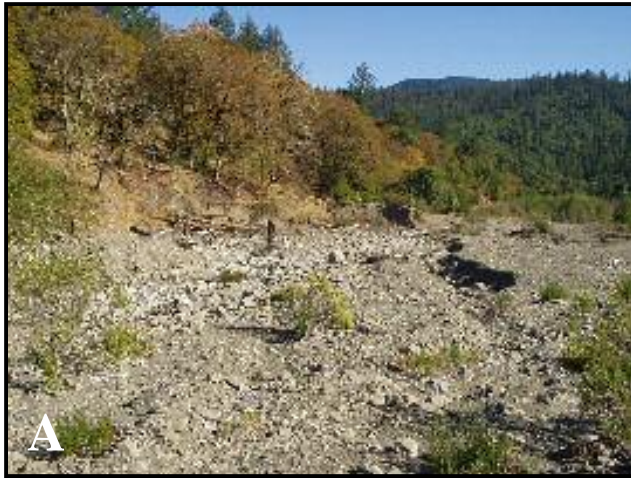
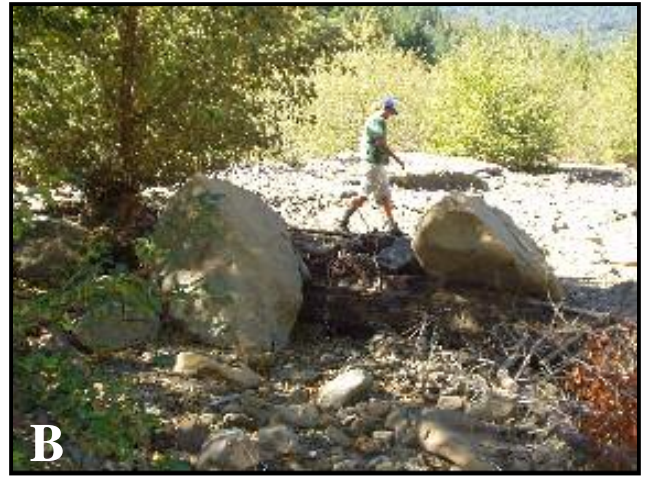
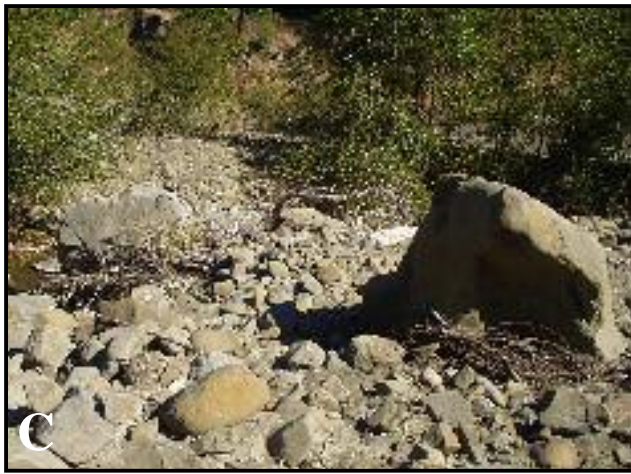
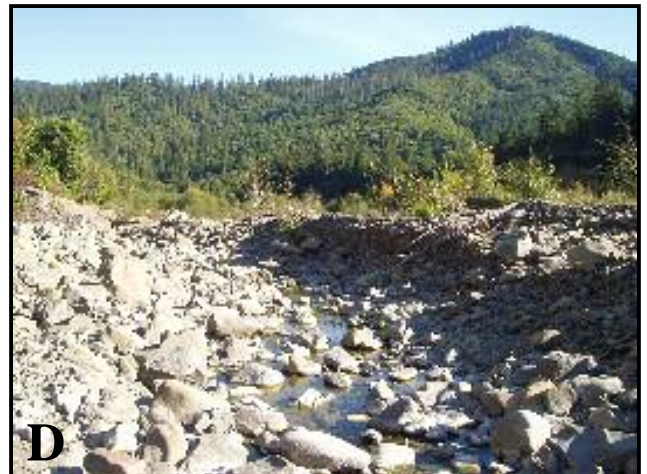
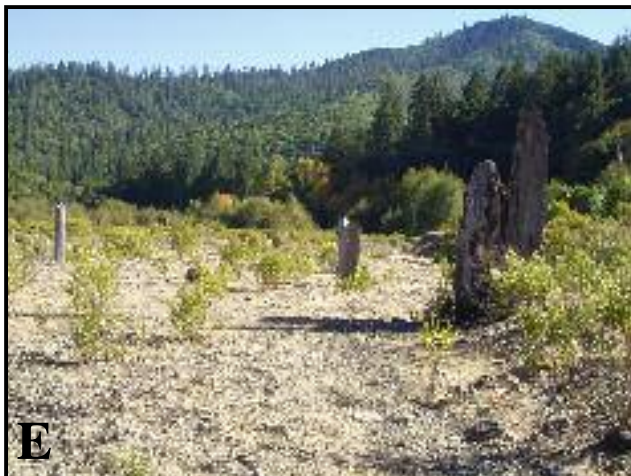
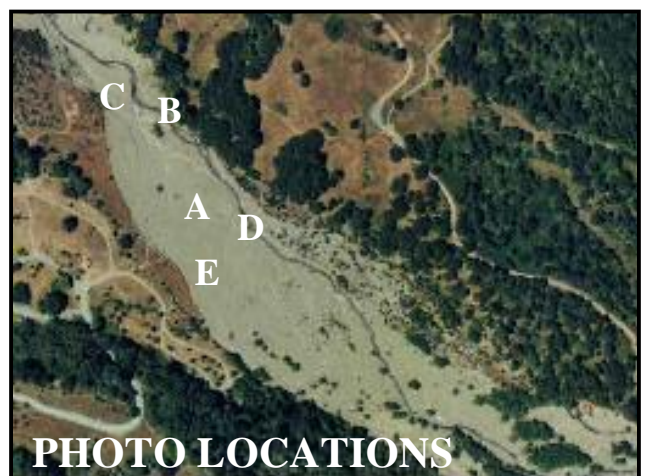
During the field visit in October 2003, a colleague and I utilized aerial photographs to determine the approximate locations the meander bends that were constructed in 1991 and had washed out by 1996. We explored these areas for any structural evidence of the project and found only a few large boulders at two upstream locations that were potentially remnants from the bank revetments or vortex rock weirs (Figure 10). The majority of remnants that were observable were the debris flow structures that were constructed on the valley floor outside of the active channel (Figure 10E). During the field visit, we also inspected the Devil's Elbow landslide, the largest landslide in the basin that actively contributes large amounts of sediment during heavy rains to the South Fork of Cuneo Creek (Figure 11).

Figure 10: Remnants of Channel Reconstruction Project. A) Abandoned channel B) Suspected remnants of rock and log revetment; C) Suspected remnants of vortex rock weir; D) Active channel looking downstream; E) Vertically placed logs in floodplain that are remnants of debris flow regulation structures.

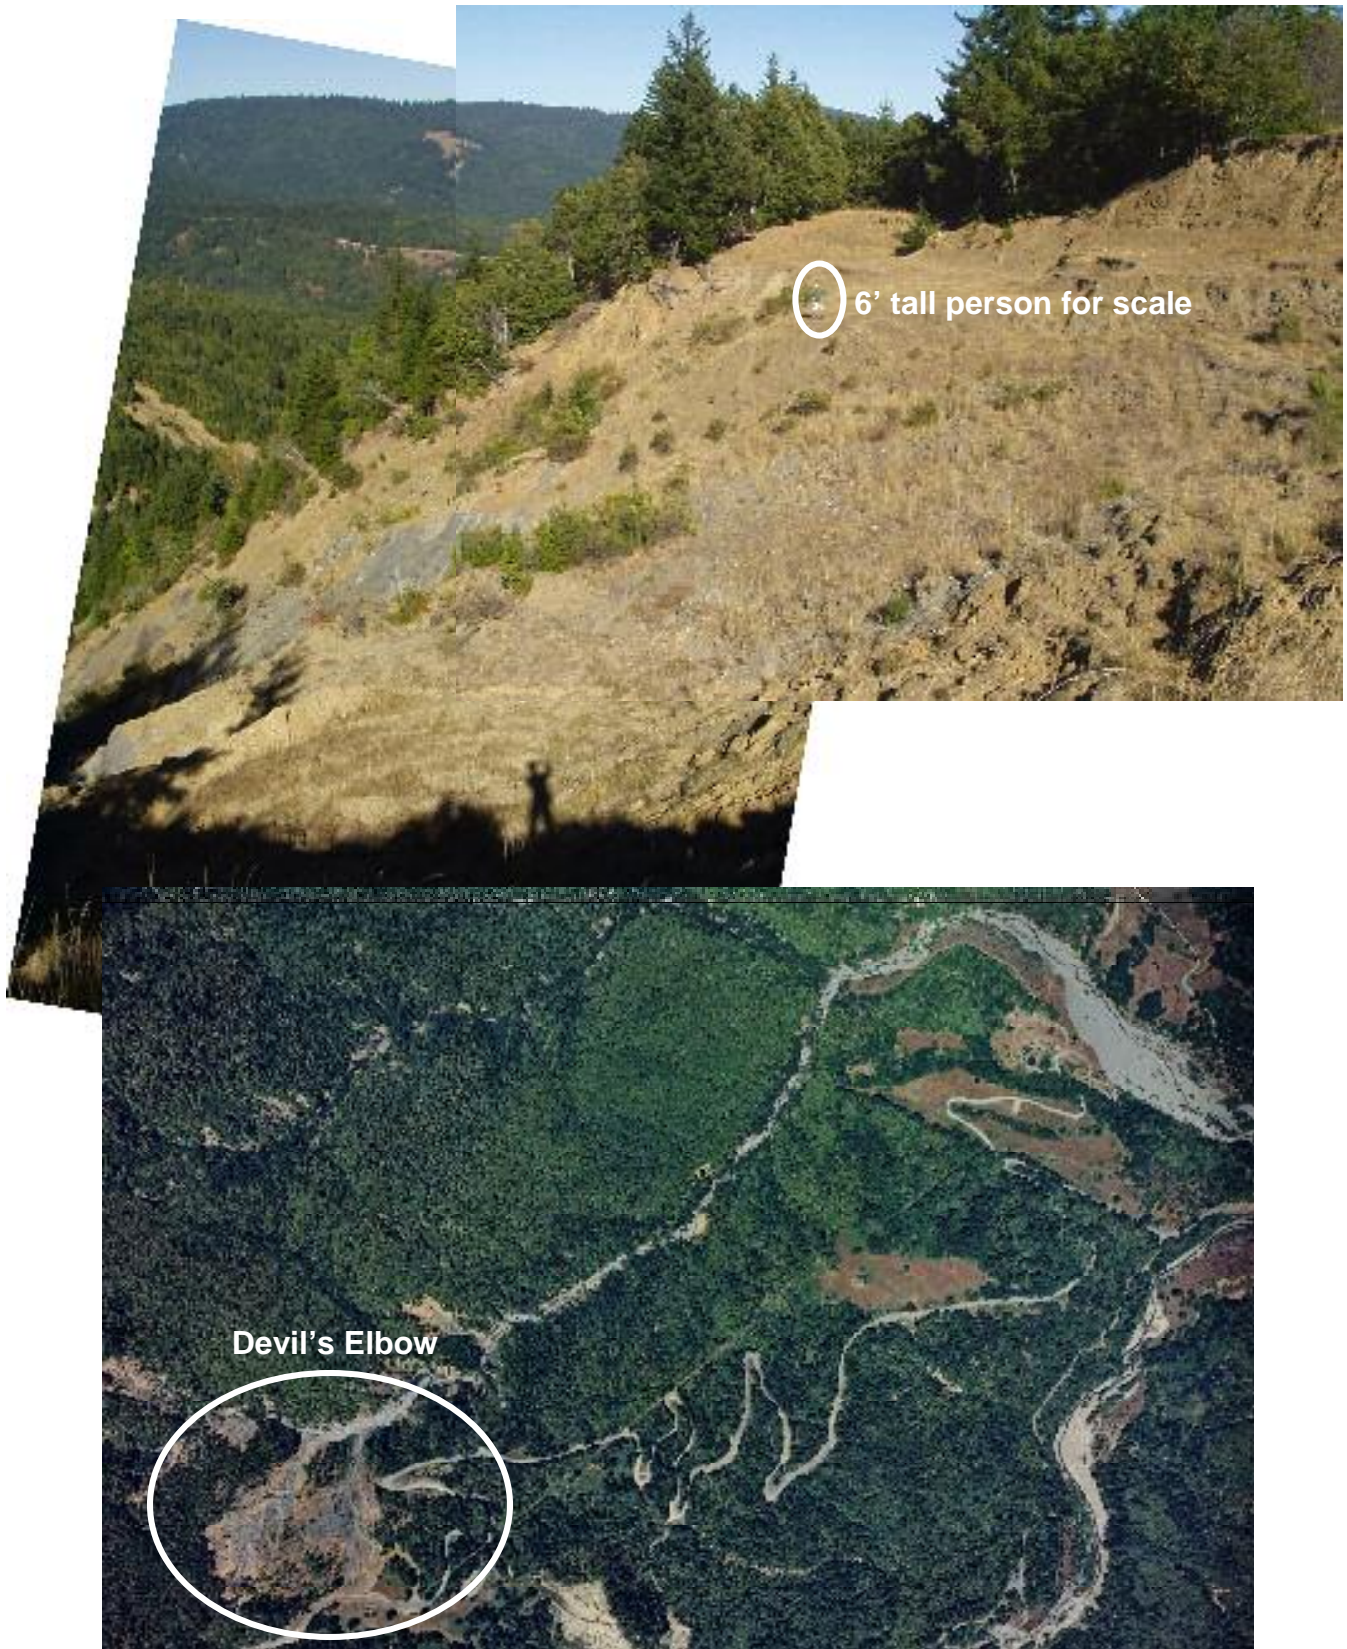
Figure 11: Devil's Elbow Landslide. Devil's Elbow landslide is located in the upper reach of the South Fork of Cuneo Creek and contributes large amounts of sediment to the lower Cuneo Creek. Top photographic overlay shows landslide in October 2003. Bottom aerial photograph is from 1997 showing landslide location with respect to lower Cuneo Creek.

questionable merit. The channel reconstruction appeared to focus on fixing the symptom of a watershed problem (accelerated sediment transport), but did not address the overlying problem itself. A more holistic approach to restoration, acknowledging the geomorphic processes of the basin, likely would have focused more on decommissioning unused roads or stabilizing landslides before in-stream channel reconstruction was attempted.
