Case study field evaluation of a systems approach to retrofitting a residential HVAC system

# Case Study Field Evaluation of a Systems Approach to Retrofitting a Residential HVAC System

Iain Walker, Jennifer McWilliams and Steven Konopacki  
Energy Performance of Buildings Group  
Lawrence Berkeley National Laboratory  
Berkeley, California 94720

September 2003

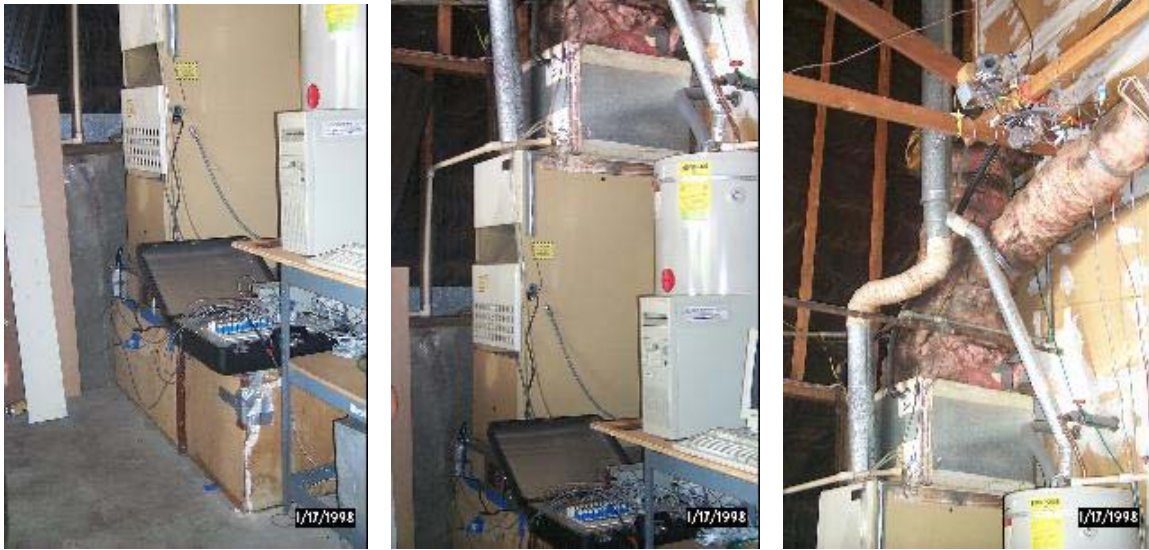
The house had the following combination of problems: low-efficiency heating and cooling equipment (**Figures 3** and **4**), leaky and poorly insulated ducts (**Figure 5**), and a leaky exterior envelope (also in **Figure 5**). In addition, the air handler, furnace, cooling coils and most of the duct system were located outside the conditioned space in the garage and attic. A few major components of the shell leakage were easily identified in this house: several large mechanical chases that were open to the attic, as well as a building cavity return that was open to the garage and the attic. The HVAC system was undercharged and operating at only 2/3 of its rated capacity. We suspected that the refrigerant line had a leak due to the low charge in the system. Also, the homeowner reported problems in cooling the upstairs of the house.

**Figure 3. Existing HVAC equipment in garage [left to right: return plenum, air handler, furnace, cooling coil and supply ducts].**

4. The existing gas furnace and air-handler were removed from the garage and replaced with a downsized high-efficiency unit in the attic to allow for the use of an economizer. An Amana Air Command 95IIQ GUYA horizontal flow variable speed two-stage gas furnace (GUYA070BX40) with a ¾ hp blower motor was selected with the following specifications: 66,900 Btu/h (20 kW) high-fire rate output, 46,400 (13.5 kW) Btu/h low-fire rate output and 95.5 AFUE at standard conditions. In direct vent mode, this furnace

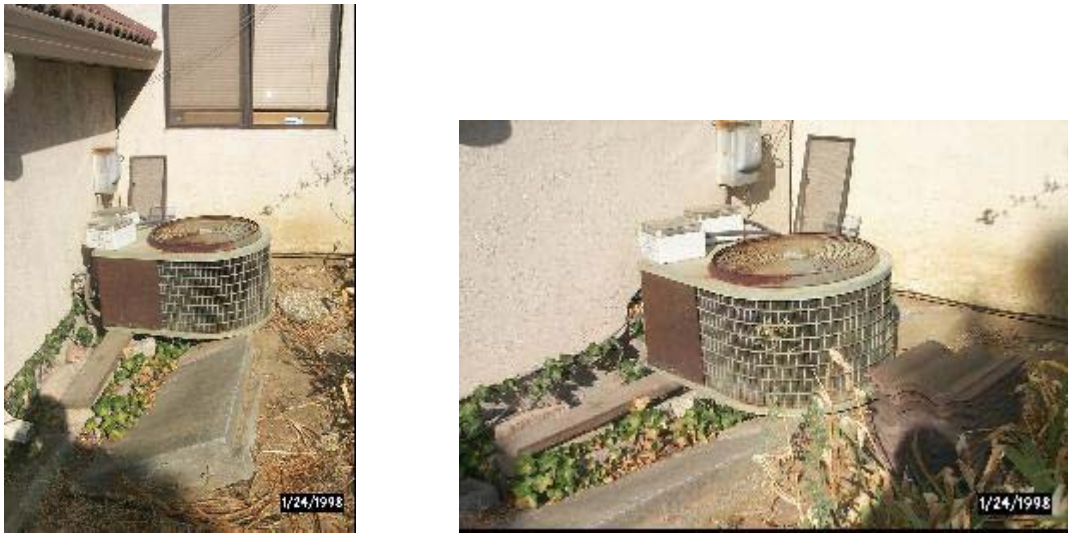
**Figure 4. Existing AC condensing unit outside near rear of garage showing poor condition of unit [heavily corroded sheet metal fasteners and significant dirt/dust accumulation blocking flow into coil] and subsided slab [stressed refrigerant tubing and subsequent leakage of refrigerant].**

3. A downsized *Amana Prestige Ultra* RCE high efficiency split system air-conditioning package consisting of a remote condensing unit (RCE36A2D) and an over-sized cooling coil (Aspen BBL48+X2: 48 kBtu/h (14 kW)) was selected with the following specifications: 36,000 Btu/h (10.5 kW) nominal capacity, 0.73 SHR and 14 EER at standard conditions and 1200 cfm. A Seasonal Energy Efficiency Ratio (SEER) of 12 or greater is the standard for an Energy Star® qualifying central air conditioner. The cooling coil was relocated from the garage to the attic. The condensing unit was relocated from a sun-exposed area behind the garage with unstable soil to a shaded area on the opposite end (north) of the house with a new slab on stable soil as shown in **Figure 8**. The old unit was placed on a very poor slab that has tilted considerably.

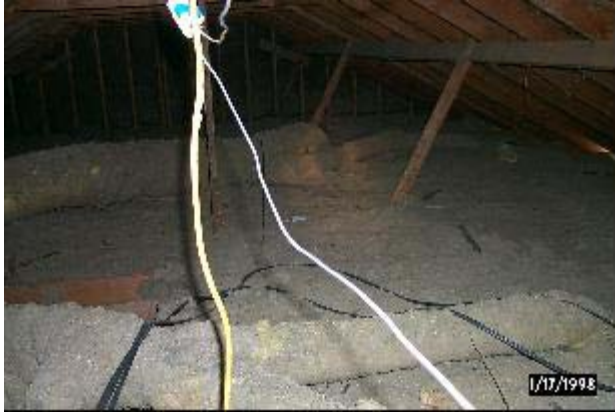
**Figure 5(a).** Existing attic floor showing insulated metal ducts and insulation coverage.

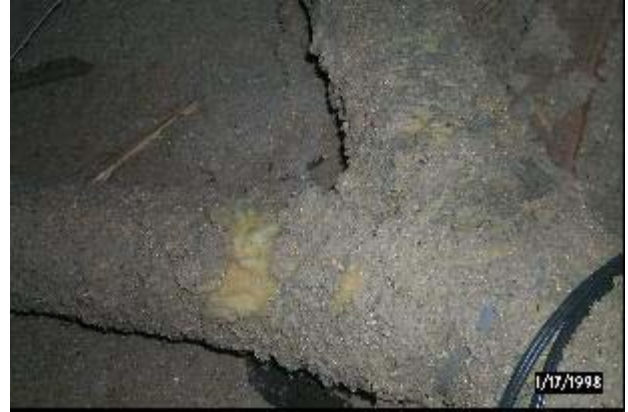
**Figure 5(b).** Existing insulated metal duct splitter and insulation coverage.

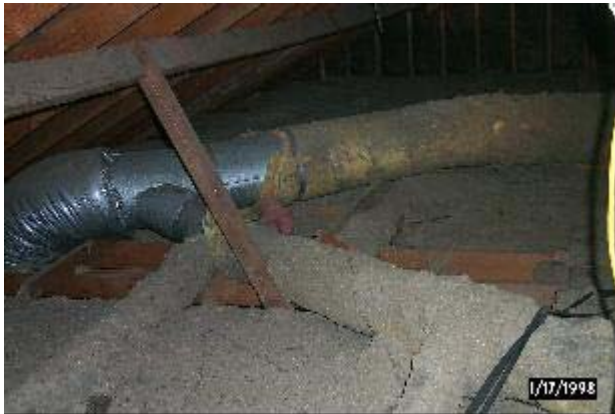
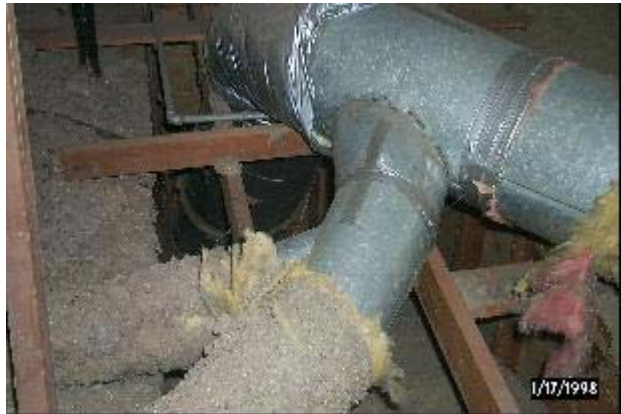
**Figure 5(c).** Existing supply duct run from garage to attic showing large openings in attic floor plane [above stairway dropped ceiling].

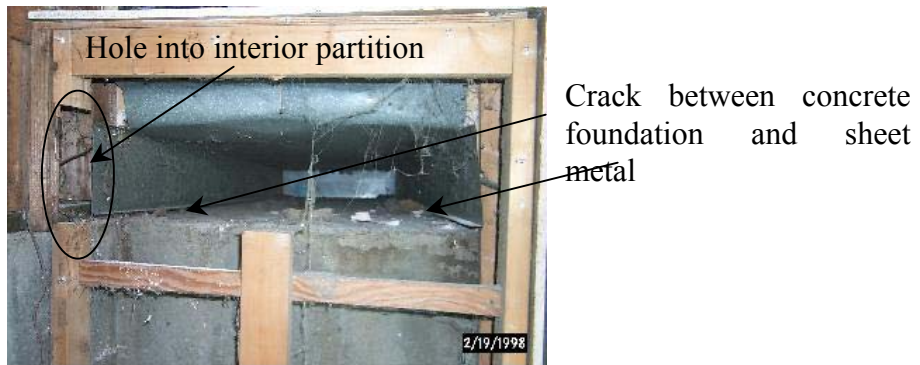
**Figure 5(d).** Existing return cavity between foundation and lower level floor.

2. Unused cavity returns were sealed (after HVAC installation).

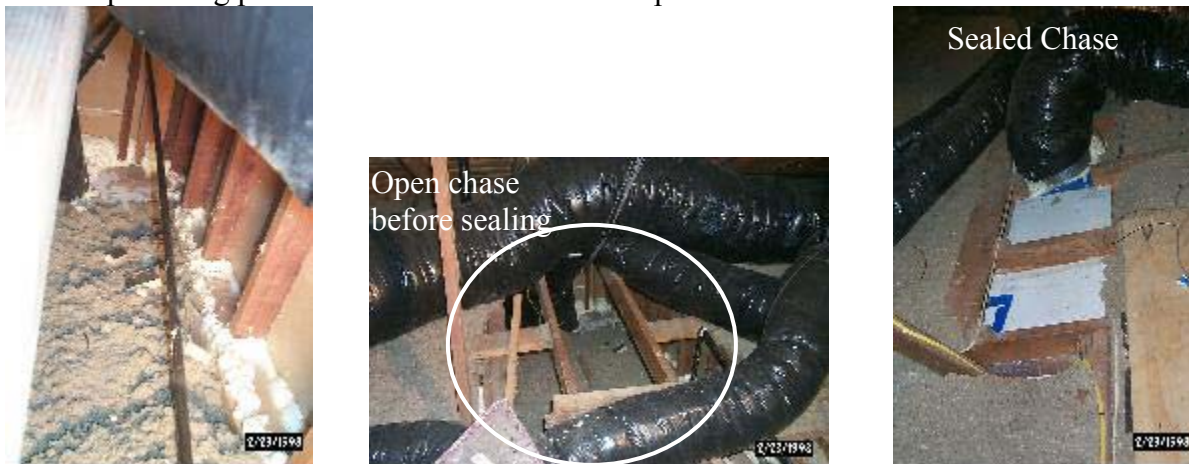
**Figure 6. Sealing cavities connecting the house to the attic. Foam is a useful sealing tool for small holes and cracks at building component intersections (left). Duct board insulation can be used to block off large open areas (center and right)**

1. The sealing of the envelope was very successful – mostly because this particular house had significant large leaks that we were able to access. We sealed over 1200 cfm of leakage at 50 Pa (about one-quarter of the total leakage). The sealing included: air-sealing of the attic floor plane (2 large chases) as shown in **Figure 6**, the installed Therma-Dome (attic pull-down staircover), leaks between the old return (which communicated with the garage) and the conditioned space, and plumbing penetrations in the conditioned space.

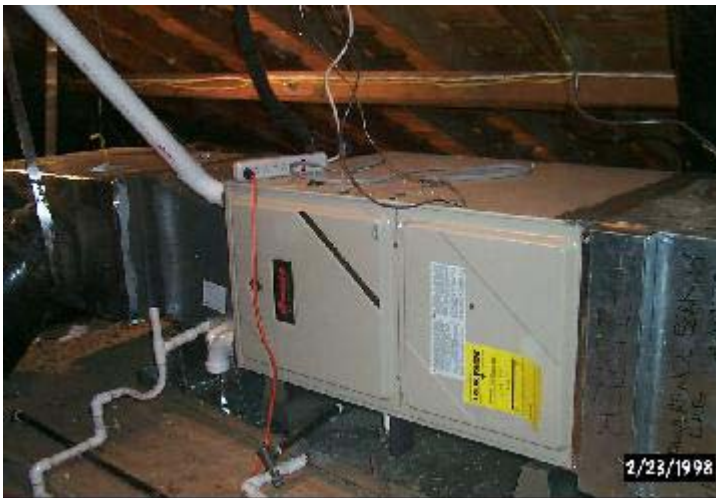
**Figure 7(a). New cooling and heating equipment on attic floor [right to left: return plenum, air filter, air handler, furnace, cooling coil and supply plenum].**

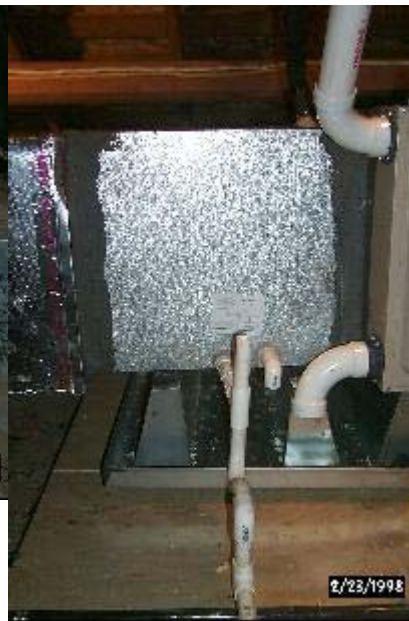
**Figure 7(b). New cooling coil with condensate drains and top of furnace with combustion air intake and exhaust.**

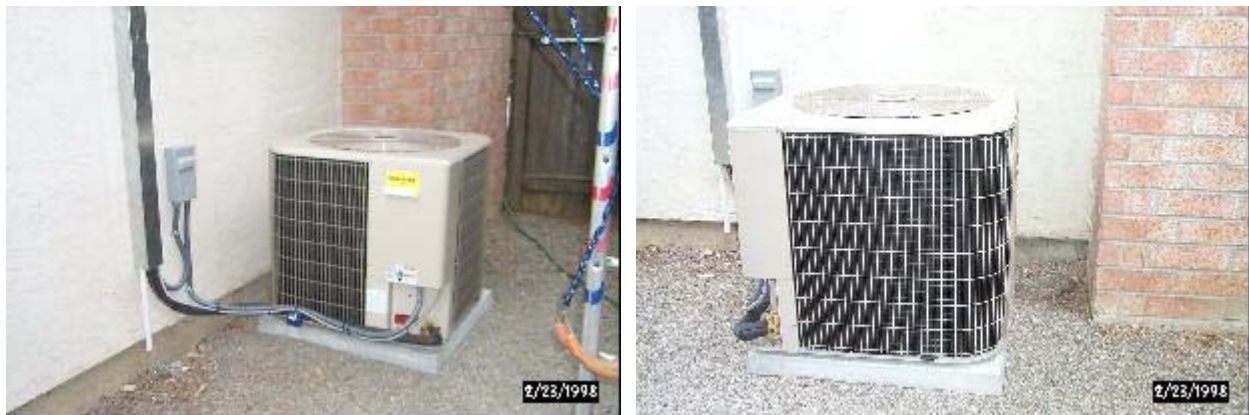
**Figure 8. New AC condensing unit on shaded side of house.**

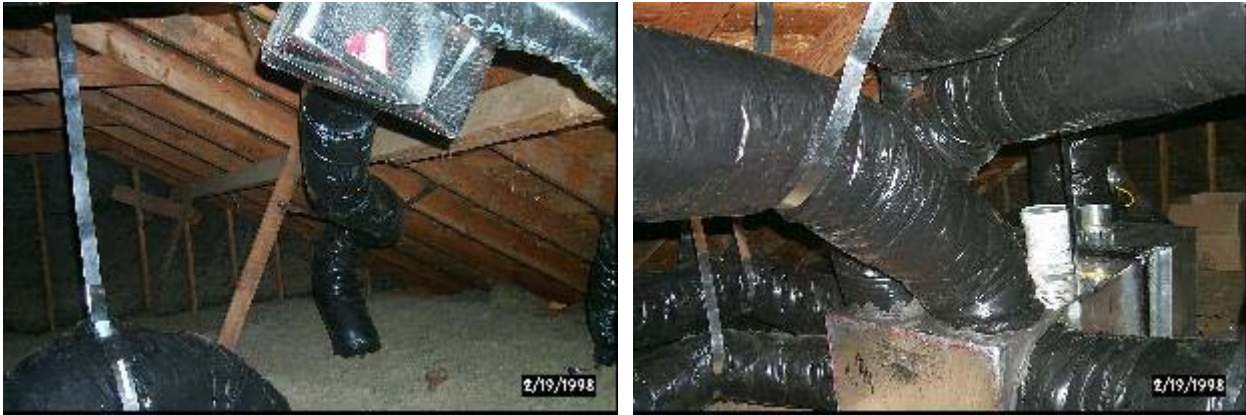
**Figure 12. Initial installation of ductwork hanging from ceiling of attic [right shows smooth bend out of plenum].**

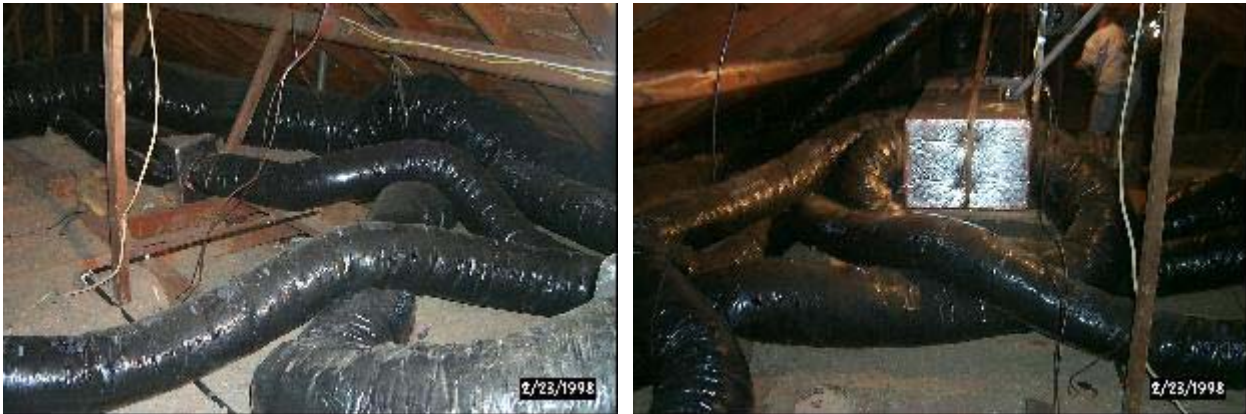
**Figure 13. Second and final installed retrofit of ductwork after being moved to attic floor and before adding insulation.**

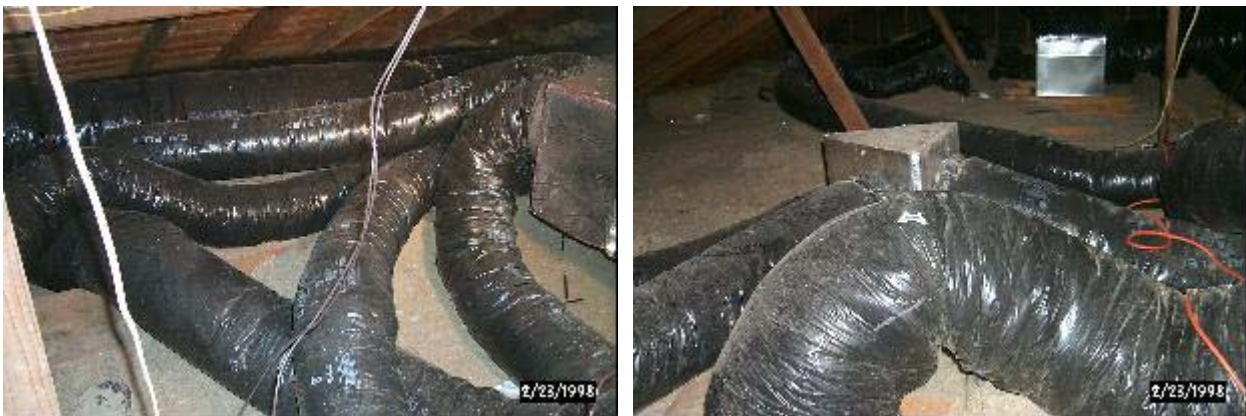
**Figure 14. Second and final installed retrofit of ductwork after being moved to attic floor and before adding insulation showing tight bends.**

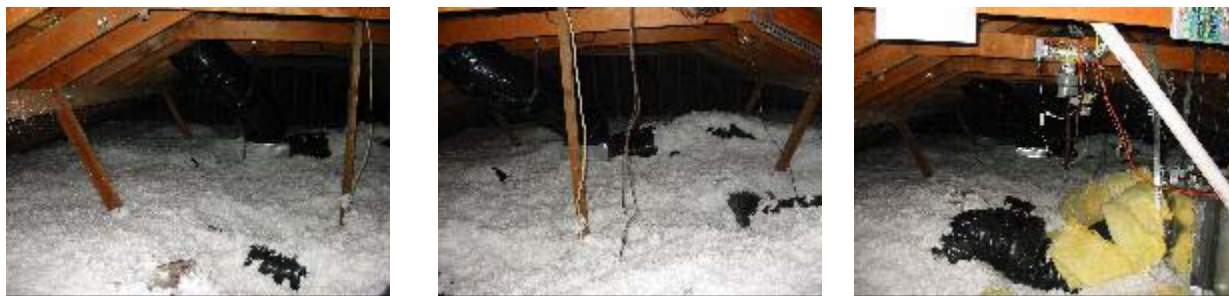
**Figure 15. Attic floor with flexible ducts and additional blown-in insulation over ducts. The yellow material is fiberglass wrap insulation.**

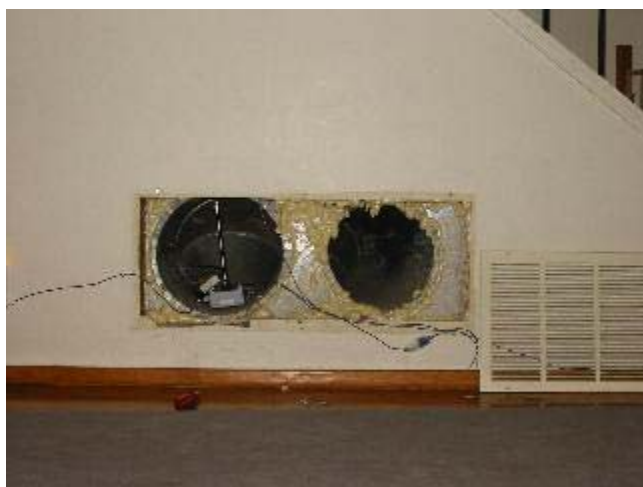
**Figure 16. Duct sealing of downstairs return using foam. [the sensor that is visible is a relative humidity sensor, there is also a temperature sensor in the duct].**

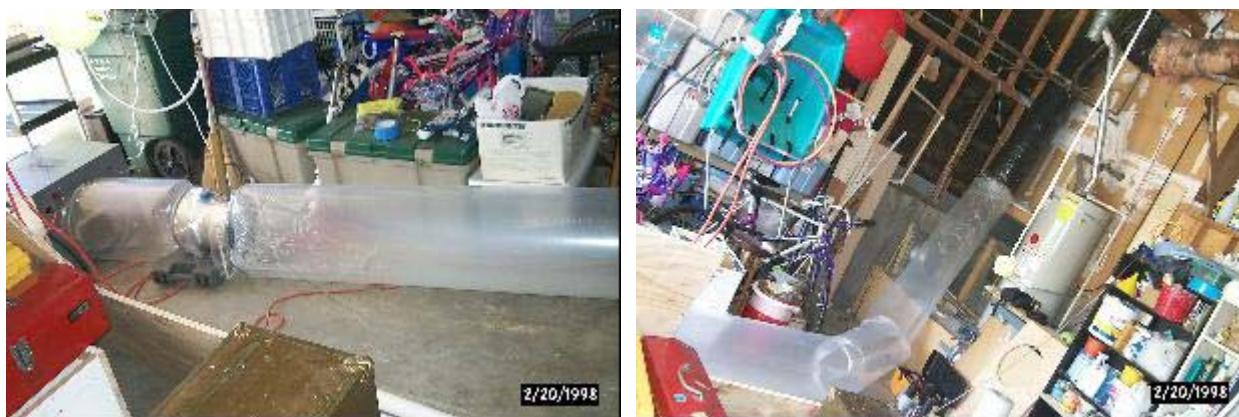
**Figure 17. Aerosol apparatus for duct sealing in garage.**

14. Our goal was to seal supply and return ducts to less than 10% of air handler flow, which is the standard for best practices (e.g. Energy Star Ducts). The ducts were sealed using manual methods and with the aerosol method developed by LBNL. But we did not meet this specification (14% return leakage, 9% supply leakage) due to excessive leakage at the economizer outdoor air damper. **Figure 16** shows the duct sealing using foam of the downstairs return. The aerosol method internally seals leaky ducts by injecting an aerosol sealant into the duct system as shown in **Figure 17**.
